# ANNUAL NSW SPEED CAMERA PERFORMANCE REVIEW

NSW Centre for Road Safety

JULY 2012

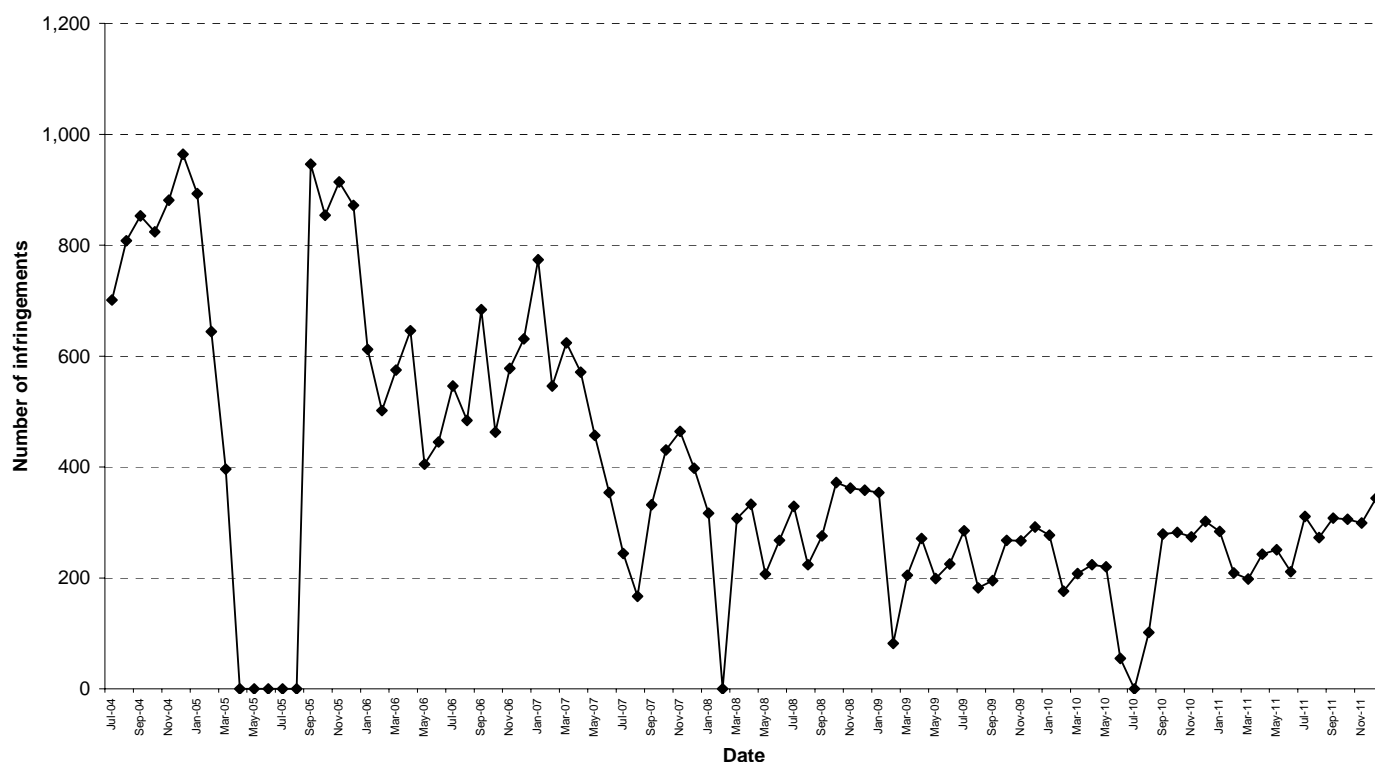
CASTLE HILL ROAD WEST PENNANT HILLS

## Infringements at fixed speed camera location

The fixed speed camera on Castle Hill Road, West Pennant Hills was installed in July 2002. There is one camera installed at this location.

The infringement graph details the trend in infringements at this location since July 2004. Infringement data before this date are not available. While speeding has reduced at this location, there are still around 200-300 speeding infringements recorded per month. Based on the reduction in crashes and casualty crashes, and the consistent level of speeding recorded at this location it is recommended that this camera is retained.

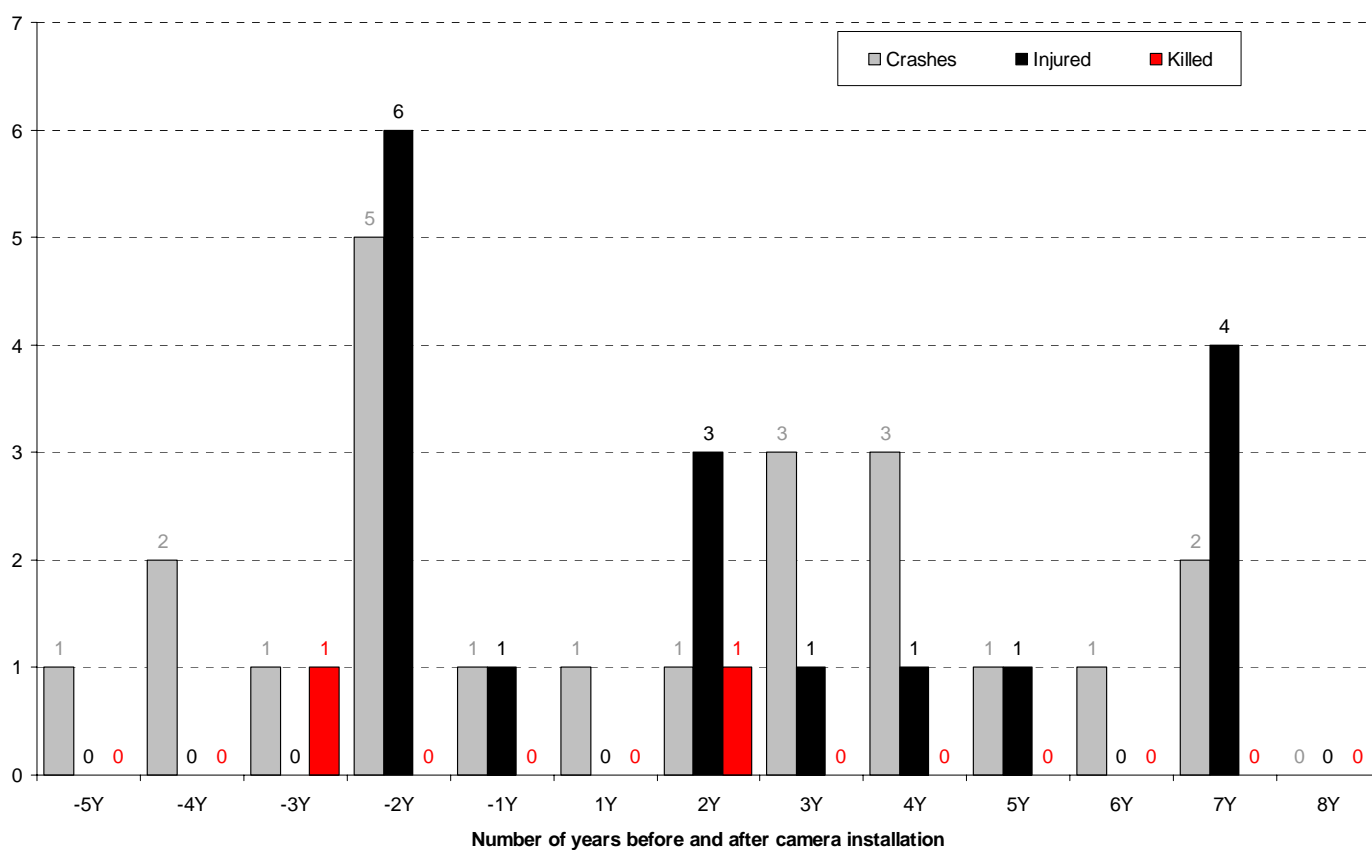
### Crashes at fixed speed camera location

Five years before – November 1997 – November 2002 - Totals				
Fatality Persons	Injury Persons	Casualty Persons	Crashes	Casualty Cost (\$M)
1	7	8	10	6.632
After (most recent five year period) – 2006 to 2011 - Totals				
Fatality Persons	Injury Persons	Casualty Persons	Crashes	Casualty Cost (\$M)
0	6	6	7	0.684

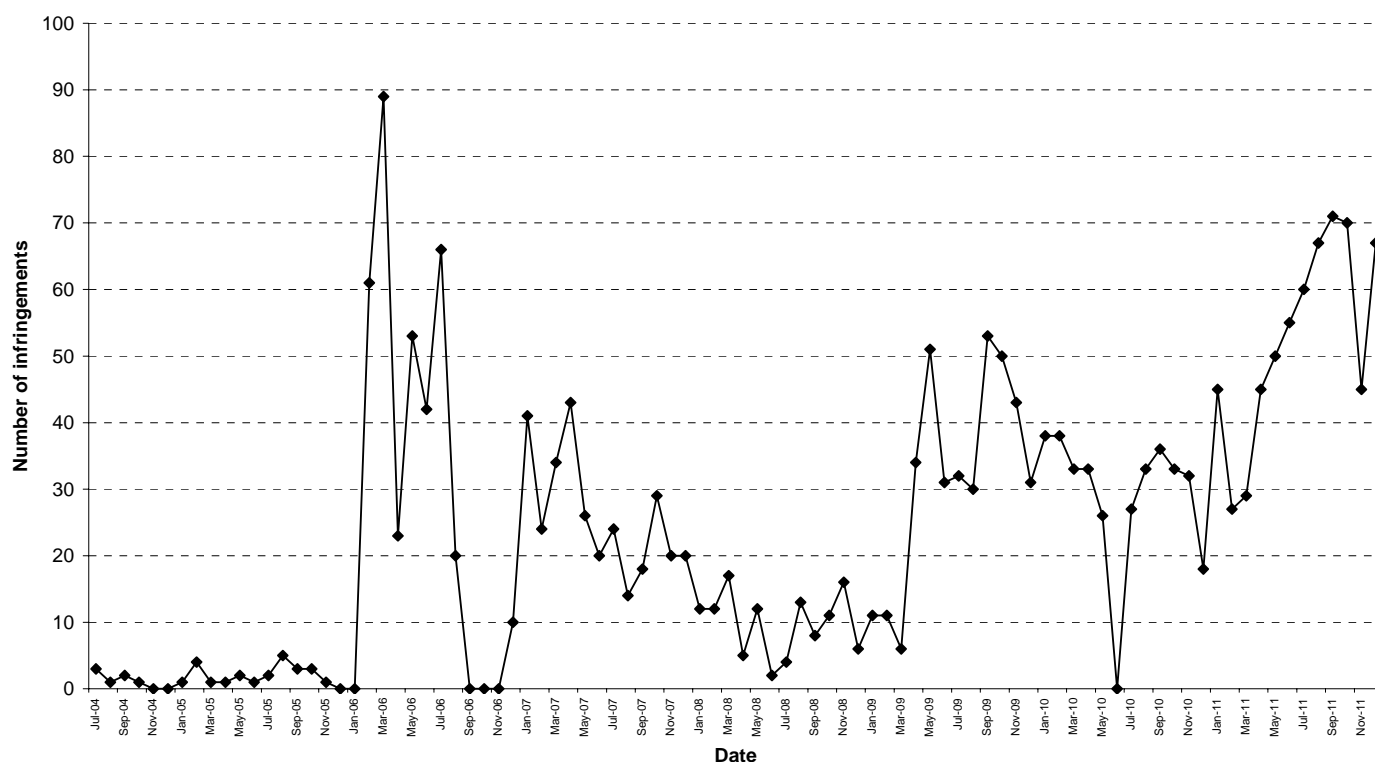
BRUXNER HWY WOLLONGBAR

## Infringements at fixed speed camera location

The fixed speed camera on the Bruxner Highway, Wollongbar was installed in February 2006. There is one camera installed at this location.

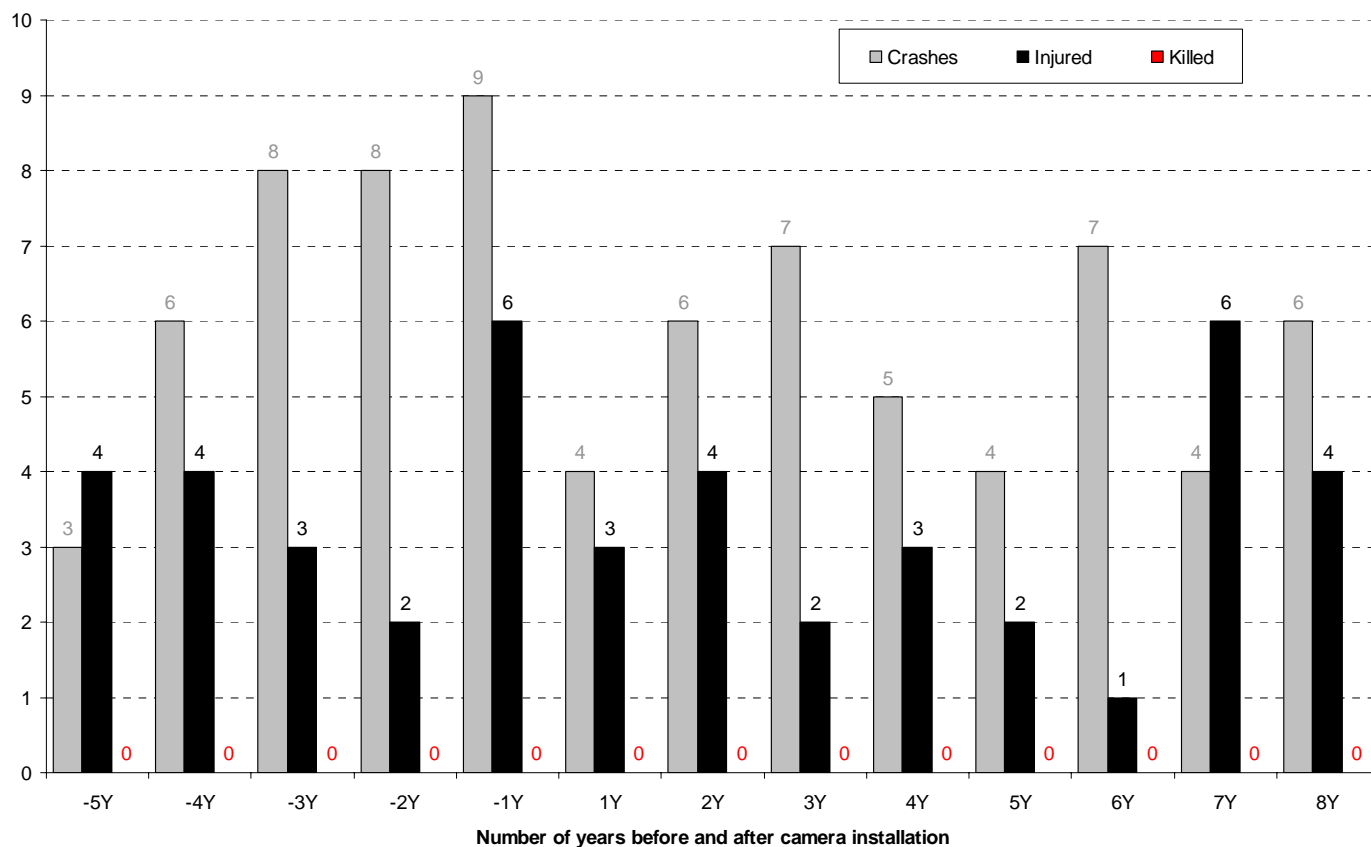
### Crashes at fixed speed camera location

Five years before – April 1998 – April 2003 - Totals				
Fatality Persons	Injury Persons	Casualty Persons	Crashes	Casualty Cost (\$M)
0	19	19	34	2.166
After (most recent five year period) – 2006 to 2011 - Totals				
Fatality Persons	Injury Persons	Casualty Persons	Crashes	Casualty Cost (\$M)
0	16	16	26	1.824

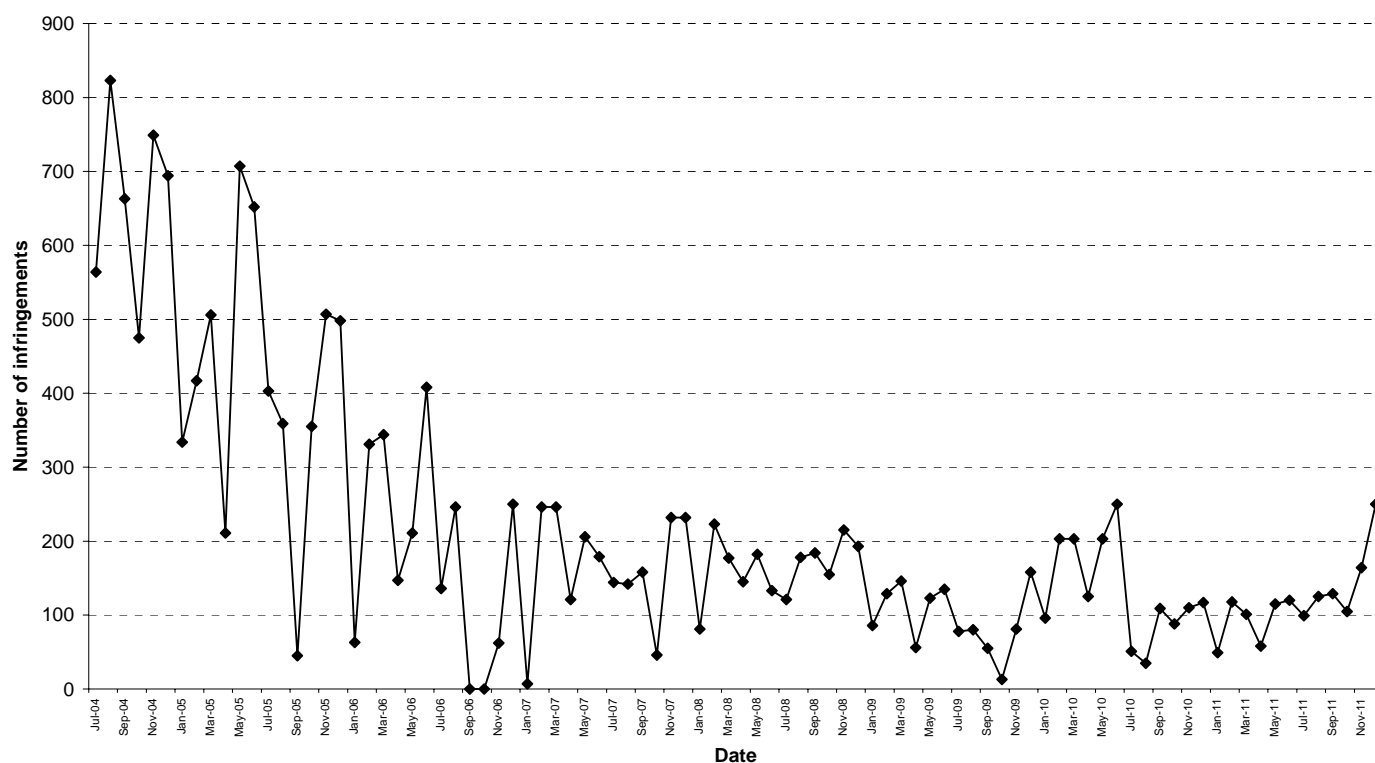
PRINCES HIGHWAY WOLLONGONG

## Infringements at fixed speed camera location

The fixed speed camera on the Princes Highway, Wollongong was installed in July 2003. There is one camera installed at this location.

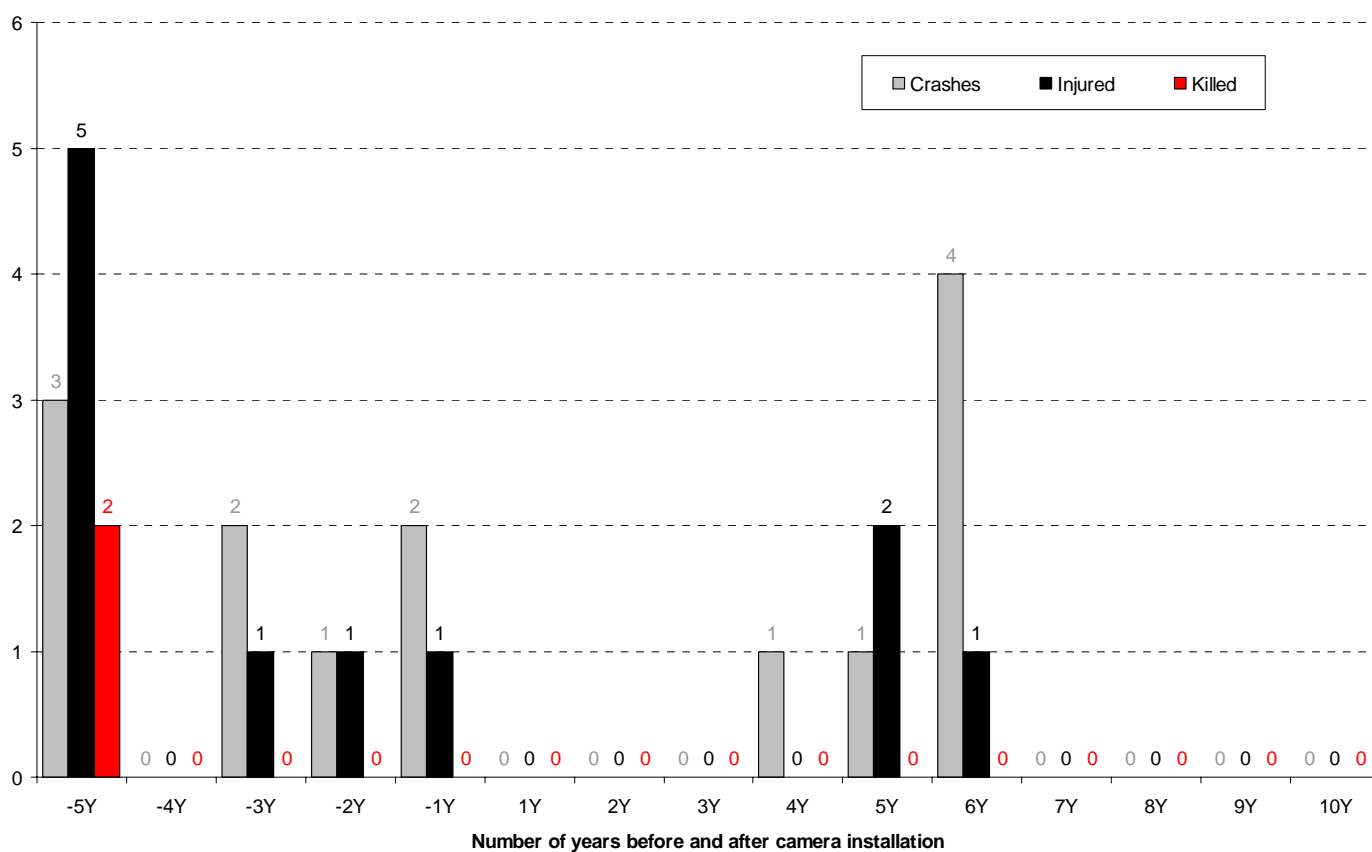
### Crashes at fixed speed camera location

Five years before – December 1995 to December 2000 - Totals				
Fatality Persons	Injury Persons	Casualty Persons	Crashes	Casualty Cost (\$M)
2	8	10	8	12.58
After (most recent five year period) – 2006 to 2011 - Totals				
Fatality Persons	Injury Persons	Casualty Persons	Crashes	Casualty Cost (\$M)
0	1	1	4	0.114

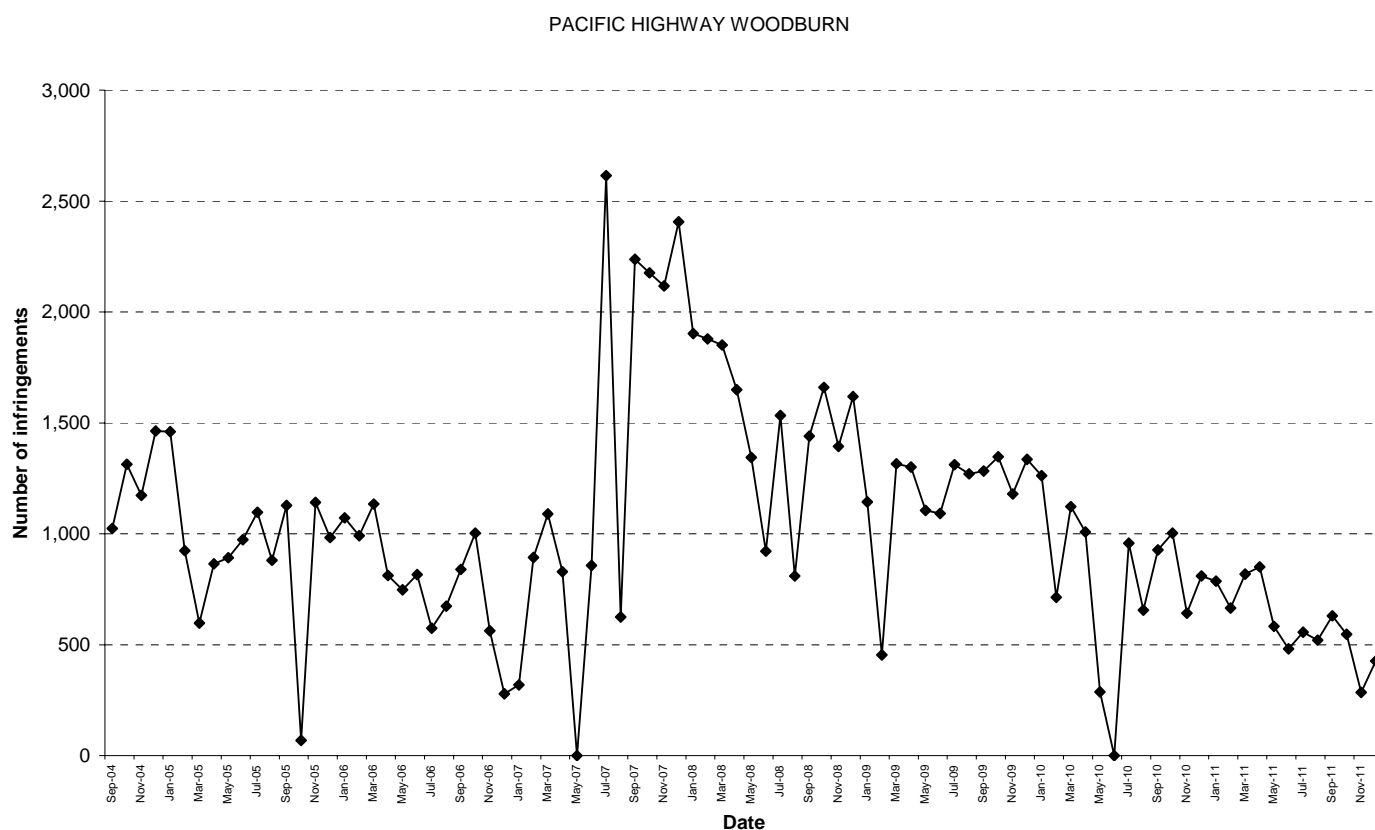
## Infringements at fixed speed camera location

The fixed speed camera on the Pacific Highway, Woodburn was installed in March 2001. There is one camera installed at this location.

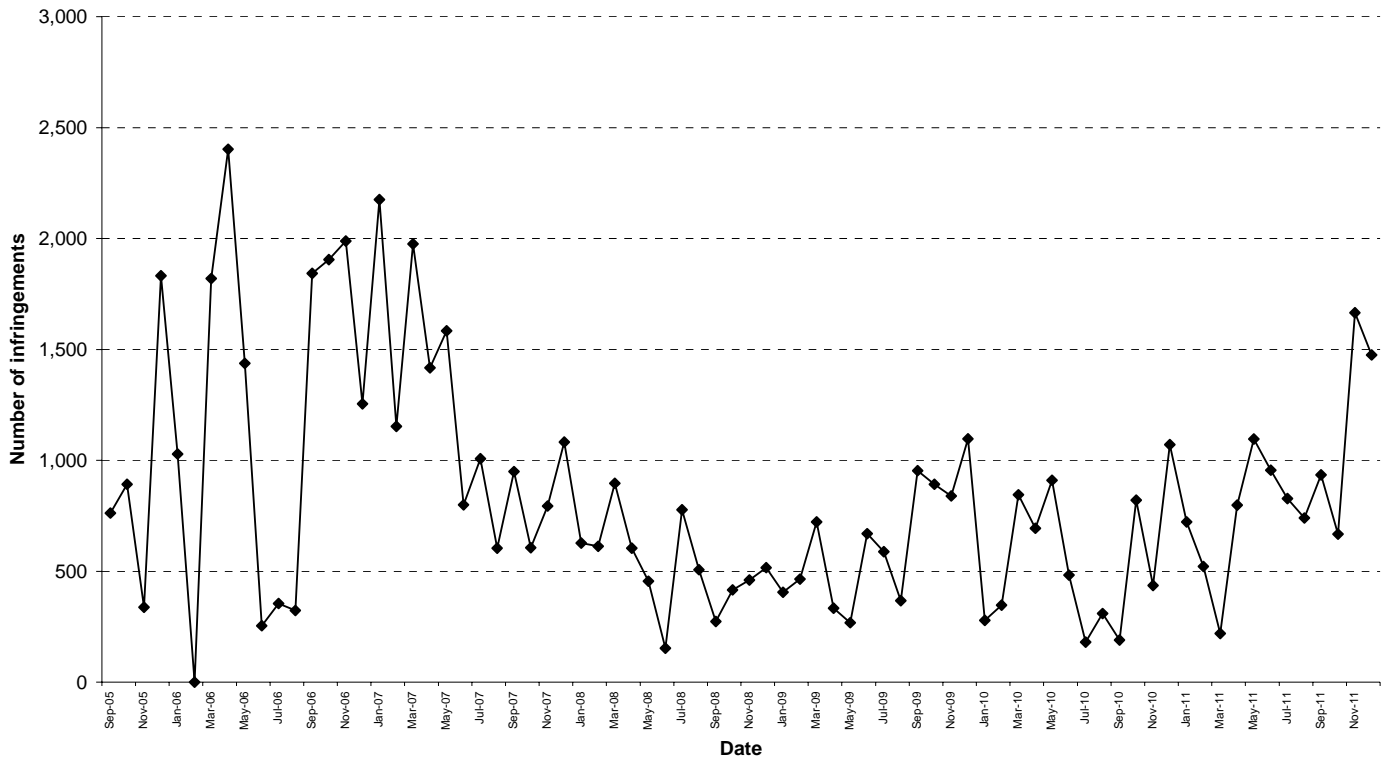
CROSS CITY TUNNEL WOOLLOOMOOLOO EAST SYDNEY

## Infringements at fixed speed camera location

The fixed speed cameras in the Cross City Tunnel, Woolloomooloo/ East Sydney were installed in September 2005. There are two speed cameras installed at this location.

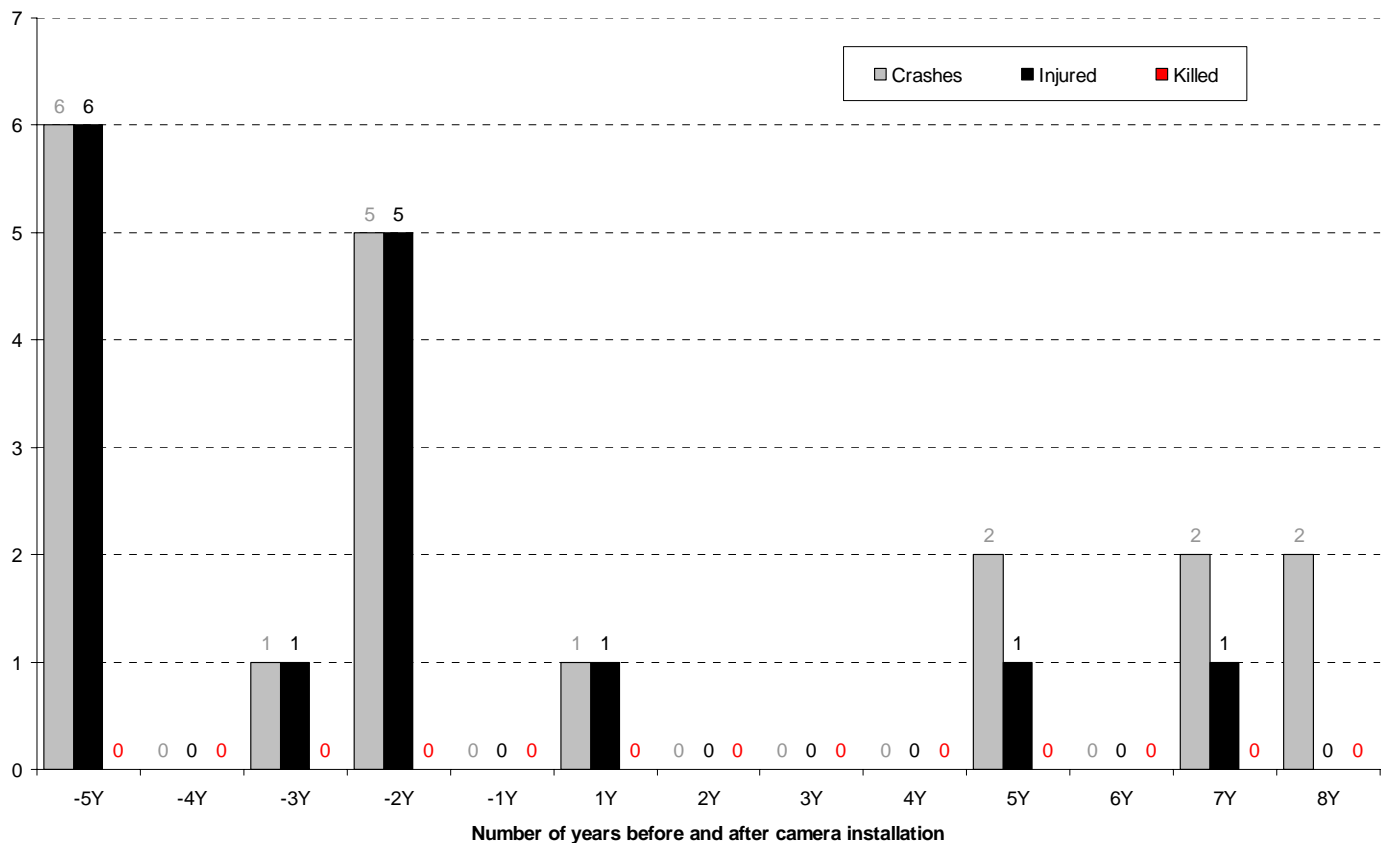
### Crashes at fixed speed camera location

Five years before – April 1998 to April 2003 - Totals				
Fatality Persons	Injury Persons	Casualty Persons	Crashes	Casualty Cost (\$M)
0	12	12	12	1.368
After (most recent five year period) – 2006 to 2011 - Totals				
Fatality Persons	Injury Persons	Casualty Persons	Crashes	Casualty Cost (\$M)
0	2	2	6	0.228

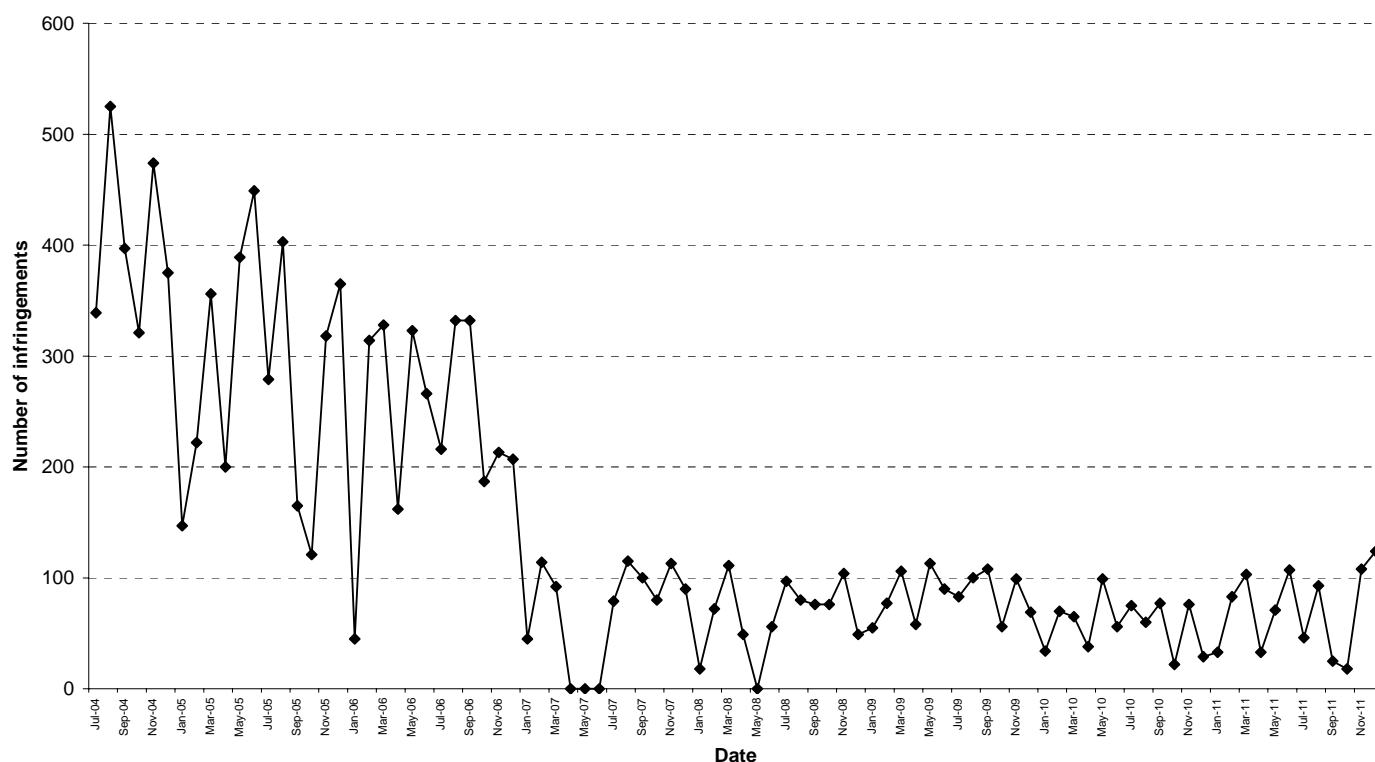
HENRY PARRY DRIVE WYOMING

## Infringements at fixed speed camera location

The fixed speed camera on Henry Parry Drive, Wyoming was installed in July 2003. There is one camera installed at this location.

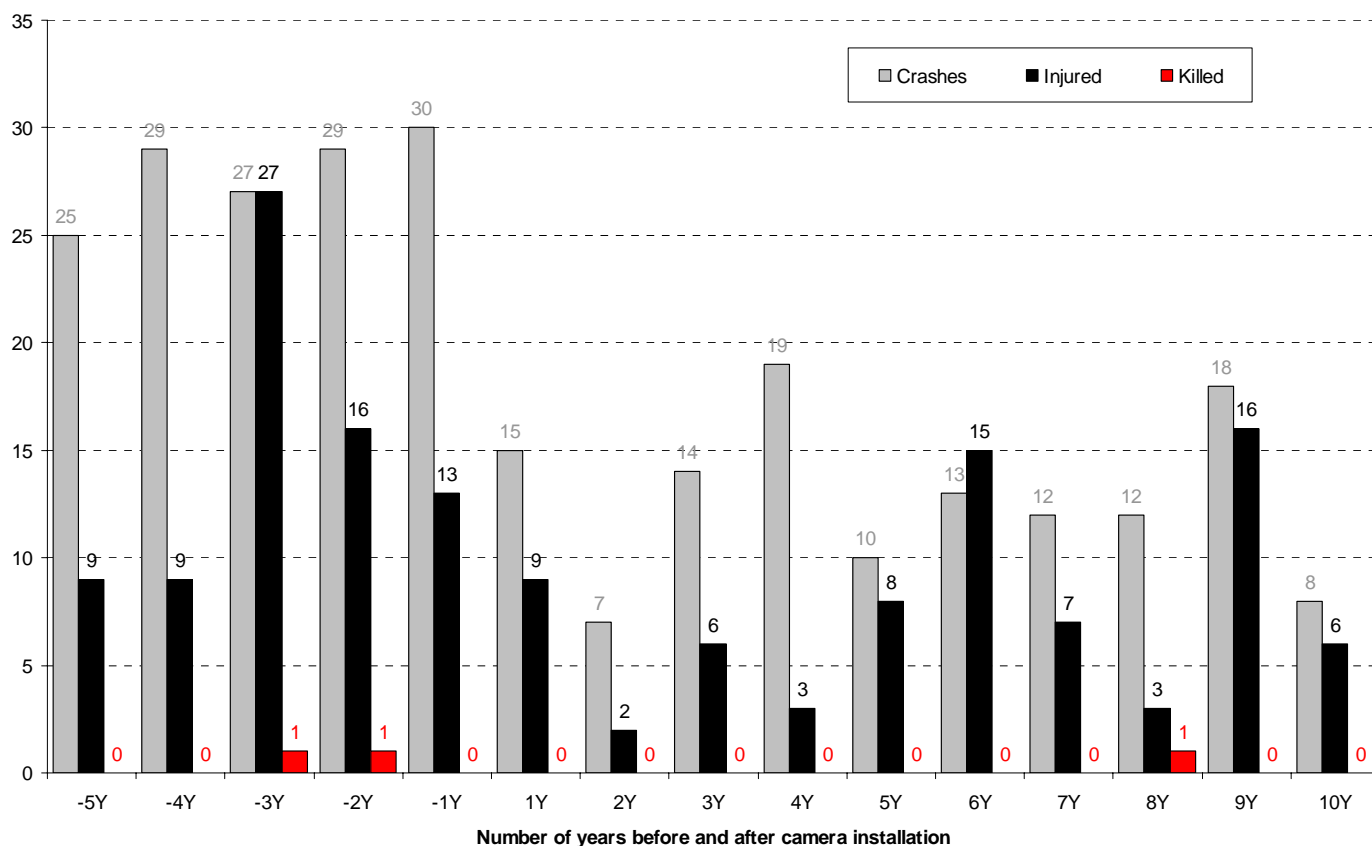
### Crashes at fixed speed camera location

Five years before – September 1996 to September 2001 - Totals				
Fatality Persons	Injury Persons	Casualty Persons	Crashes	Casualty Cost (\$M)
2	74	76	140	20.104
After (most recent five year period) – 2006 to 2011 - Totals				
Fatality Persons	Injury Persons	Casualty Persons	Crashes	Casualty Cost (\$M)
1	47	48	63	11.192

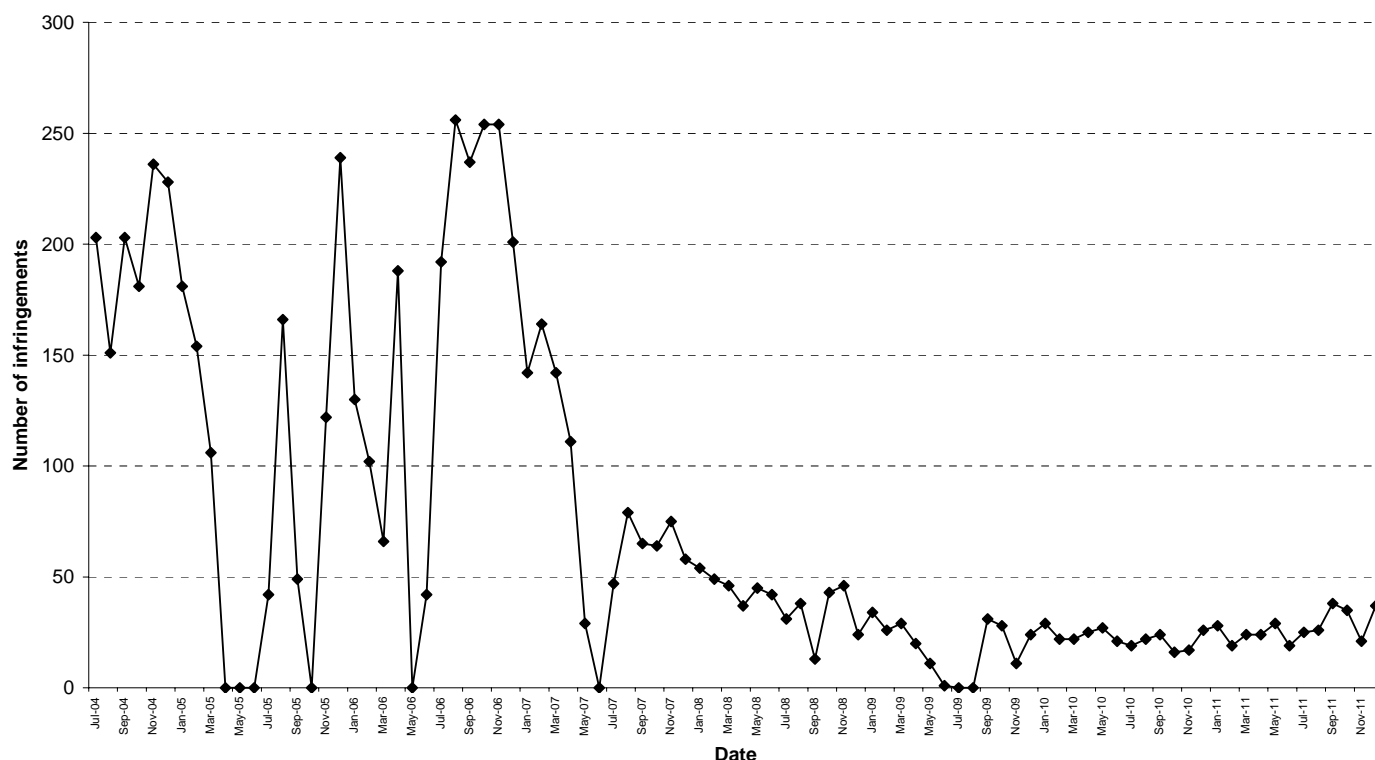
HUME HIGHWAY YAGOONA

## Infringements at fixed speed camera location

The fixed speed camera on the Hume Highway, Yagoona was installed in December 2001. There is one camera installed at this location.

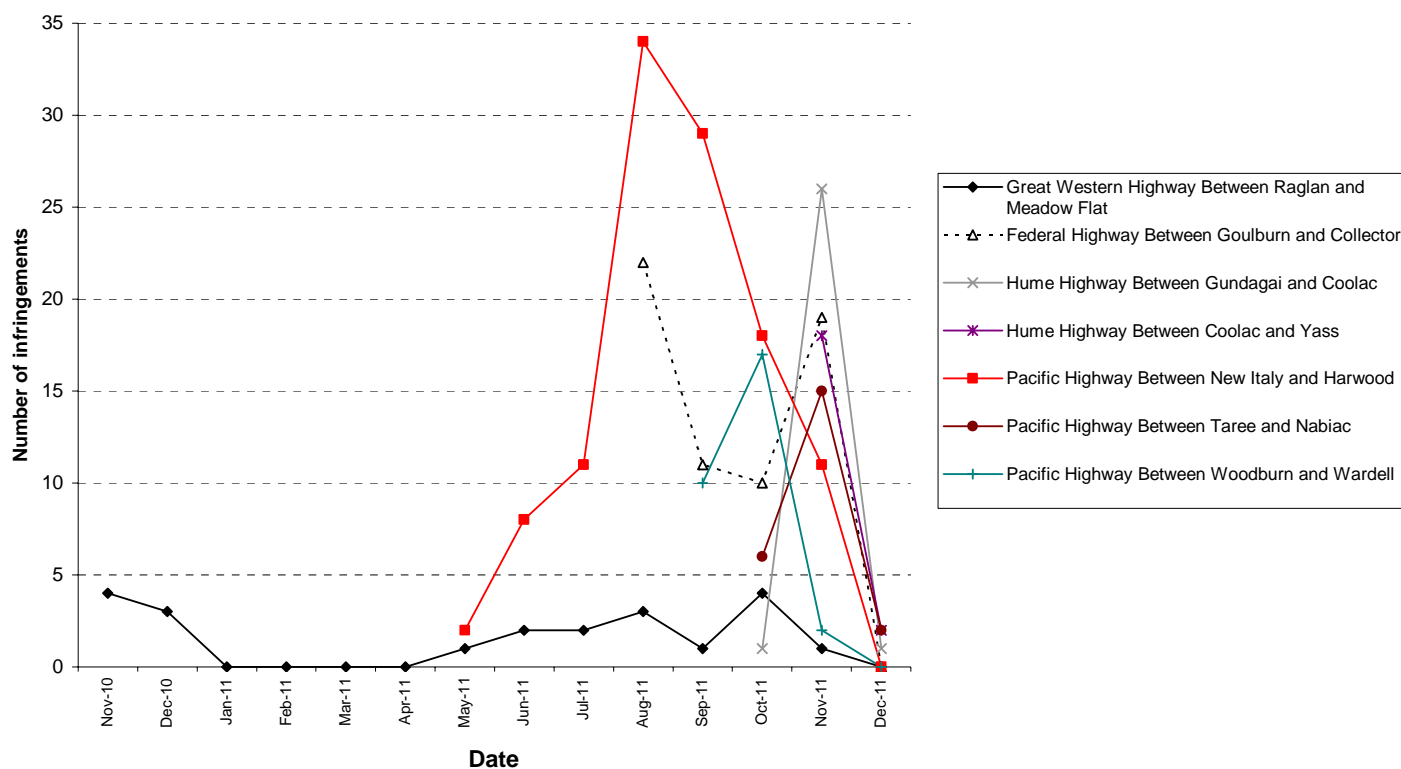
Point-to-point speed infringements to December 2011

## Infringements at point-to-point enforcement locations

A large proportion of the point-to-point enforcement program was rolled out during 2011. Of the 24 lengths that are part of the program, two point-to-point lengths (Great Western Highway, Meadow Flat to Raglan; Pacific Highway, Harwood to New Italy) were installed in 2010, 13 lengths were installed during 2011 and the remaining nine are being rolled out in 2012 and 2013. Of these lengths only Great Western Highway between Meadow Flat and Raglan enforced for the entire 2011 review period.
