Transport  
for NSW

# ANNUAL NSW SPEED CAMERA PERFORMANCE REVIEW

NSW Centre for Road Safety

AUGUST 2013

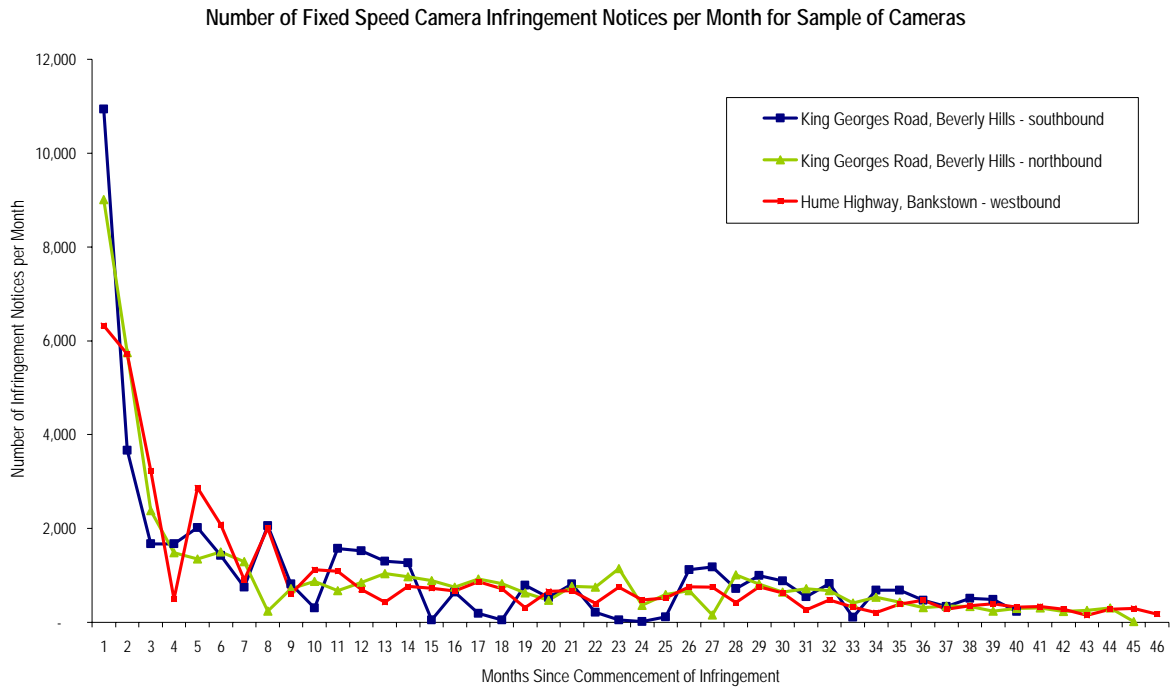
Figure 1: Example of trend in speed camera infringements over time.

Speed cameras are used to change driver behaviour, which can be measured by changes in infringements over time. An example of this trend is illustrated in Figure 1 which depicts the number of infringements per month since the commencement of enforcement at three high profile fixed speed camera locations. This pattern shows an initial high number of infringements followed by a rapid and sustained decrease in infringements as drivers modify their behaviour which is reflected in a reduction in crashes over time. Appendix C contains this type of infringement graph for every fixed speed camera location.

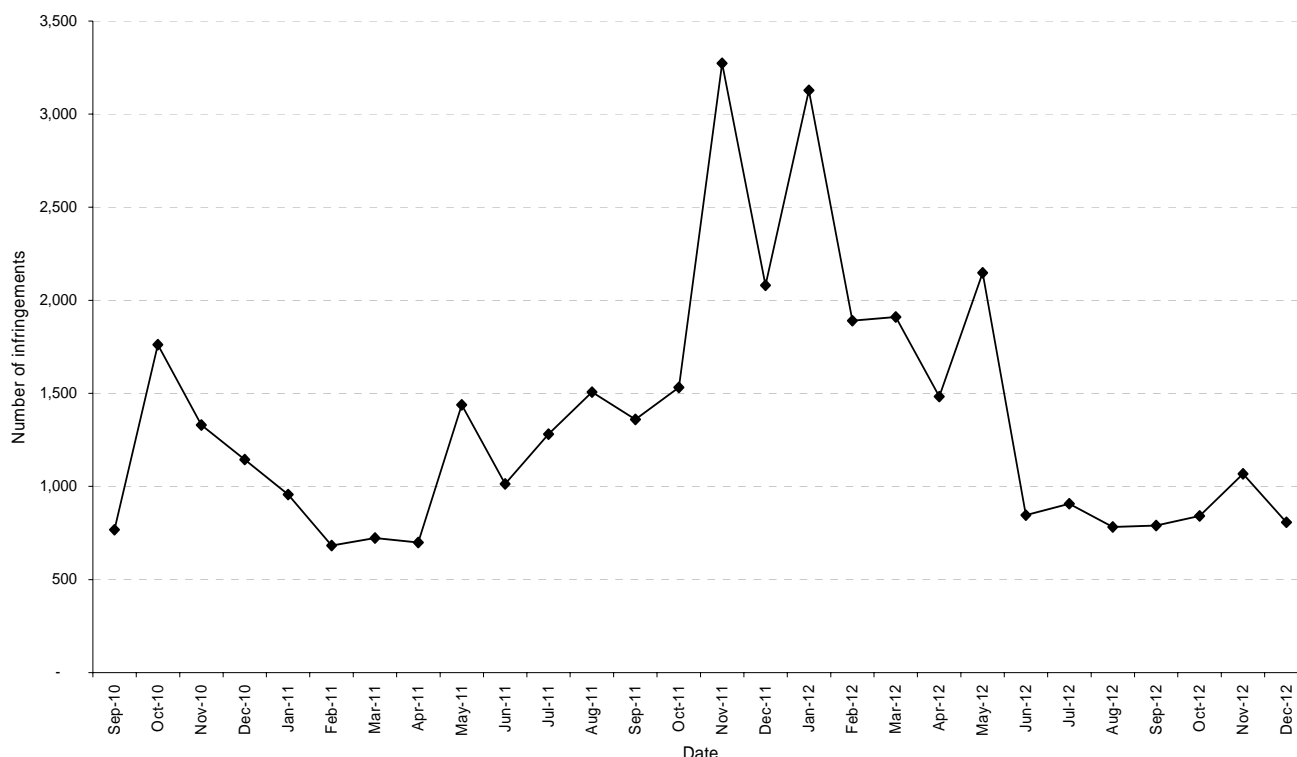
Mobile speed camera program infringement data

In 2012 there were a total of 17,371 infringements resulting in total fine revenue of \$2.87 million from mobile speed camera enforcement. The infringement data for mobile speed cameras show a downward trend in the number of infringements issued during 2012.

Since the program commenced, the number of sites available for use and the number of sites used each month has increased over time as ongoing assessments to identify suitable enforcement sites are completed. However, all selected sites are published on the Centre for Road Safety website. In 2011, there are two months where there are peaks in infringement volumes. An increase in infringements usually comes when mobile speed cameras are enforcing in less frequently used locations or locations that have not been used before. In both May 2011 and November 2011 there were increases in the number of sites used for enforcement in those months. In the months following the use of new sites, the number of infringements decreased or stabilised. This trend is to be anticipated; for example fixed speed enforcement follows the same type of pattern, with the difference being that fixed speed cameras are in the same place 24/7 meaning that reductions in infringements are more consistent.

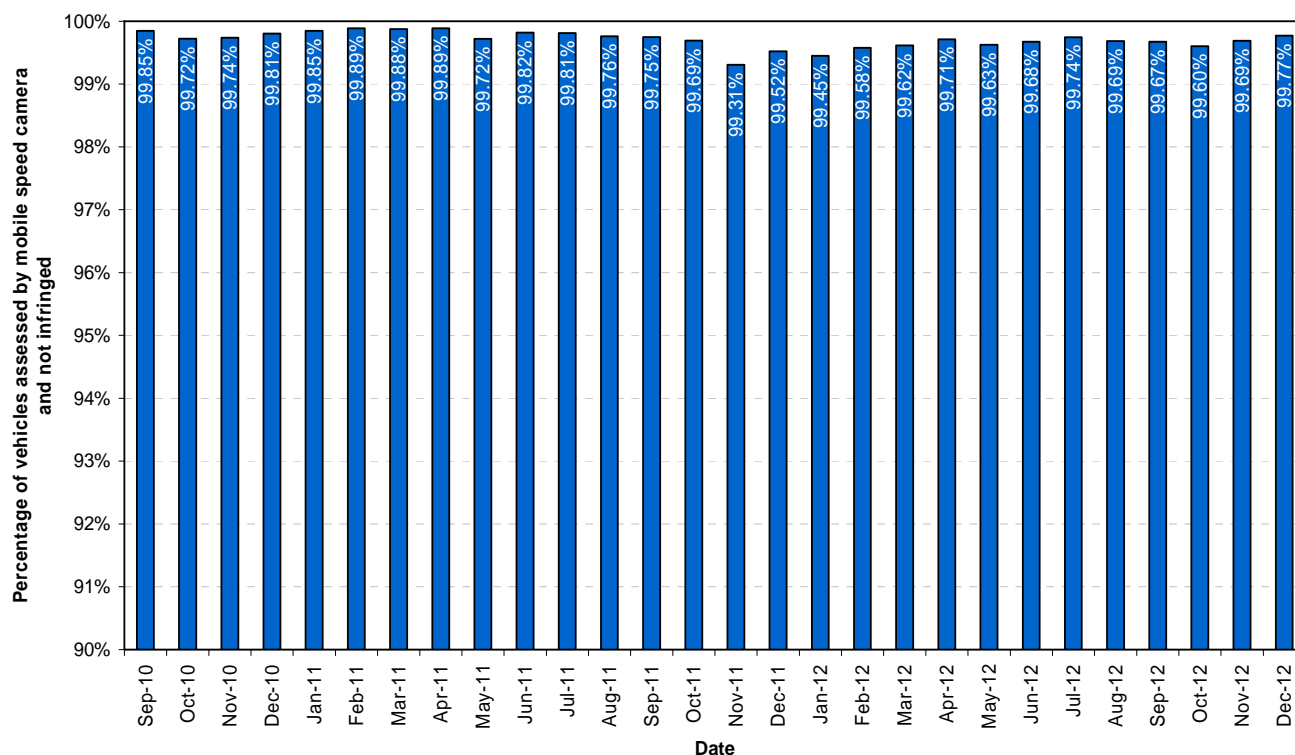
### Compliance rate of vehicles at mobile speed camera locations

The figure below shows the compliance rate of vehicles at mobile speed camera locations. Compliance data compares the number of vehicles that pass a camera with the number of fines detected by the camera. As can be seen below, over 99 per cent of vehicles passing mobile cameras are not infringed for speeding.

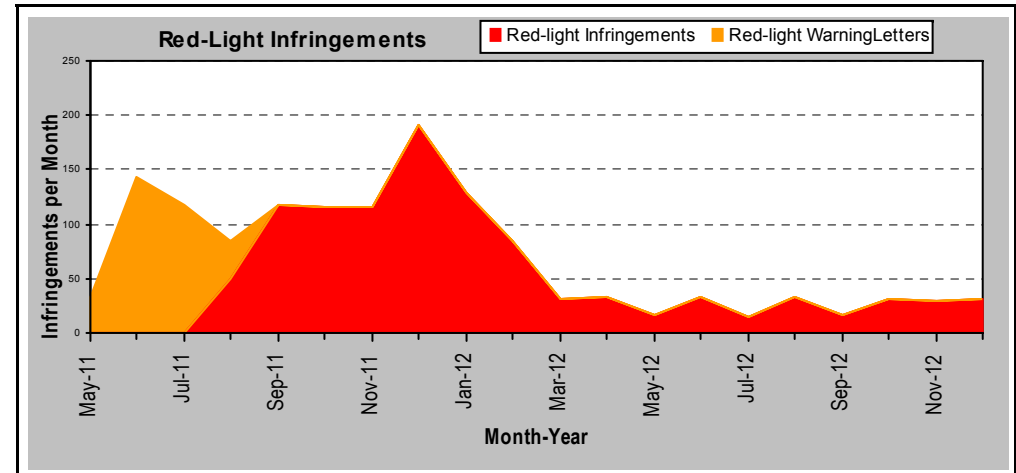
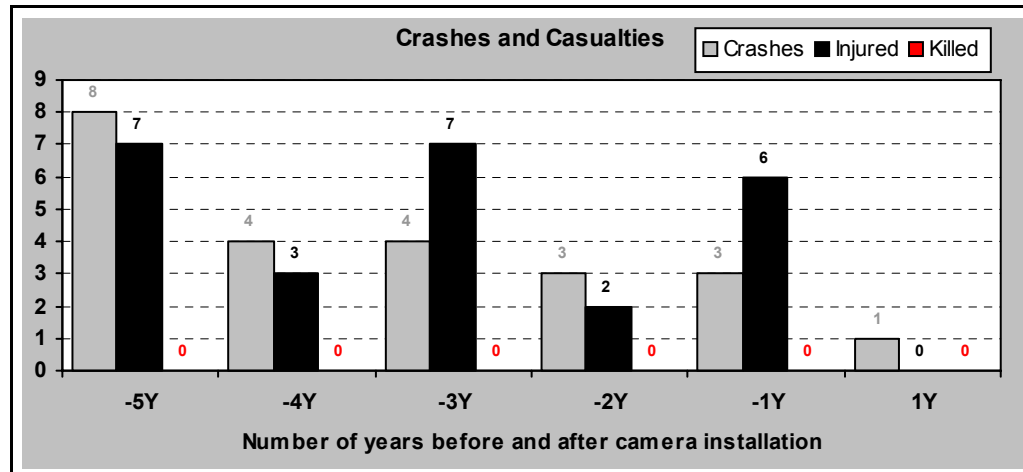
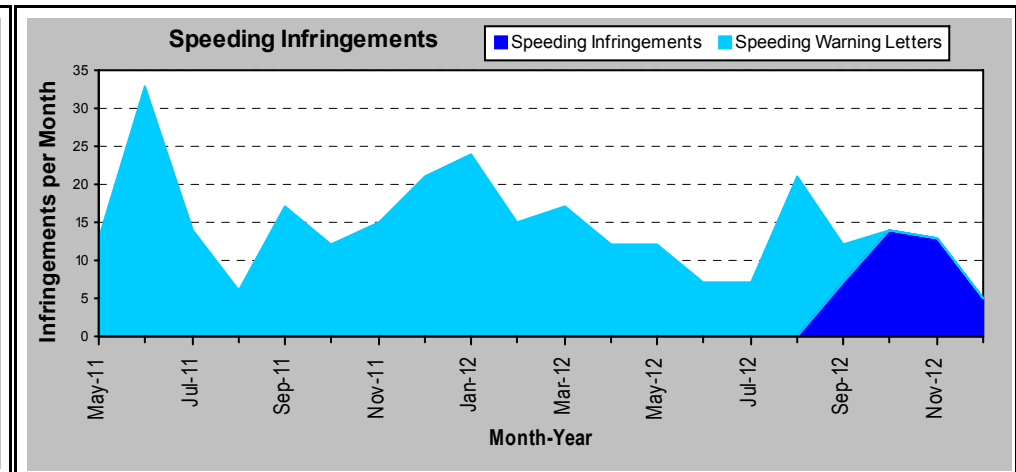
### Infringements at safety camera location

- There are two cameras at this intersection. This was previously a wet-film red-light camera location.
- Both cameras at the intersection of McEvoy St and Botany Rd commenced issuing warning letters in June 2010.
- While early results indicate a slight increase in crashes, a more comprehensive analysis over a longer time period is required before making any conclusions about the effectiveness of the cameras.
- The infringement graphs show the number of warning letters and infringements issued at this intersection as well as the trend in infringements since the camera began operation. Roadworks and camera maintenance may influence the number of infringements issued.

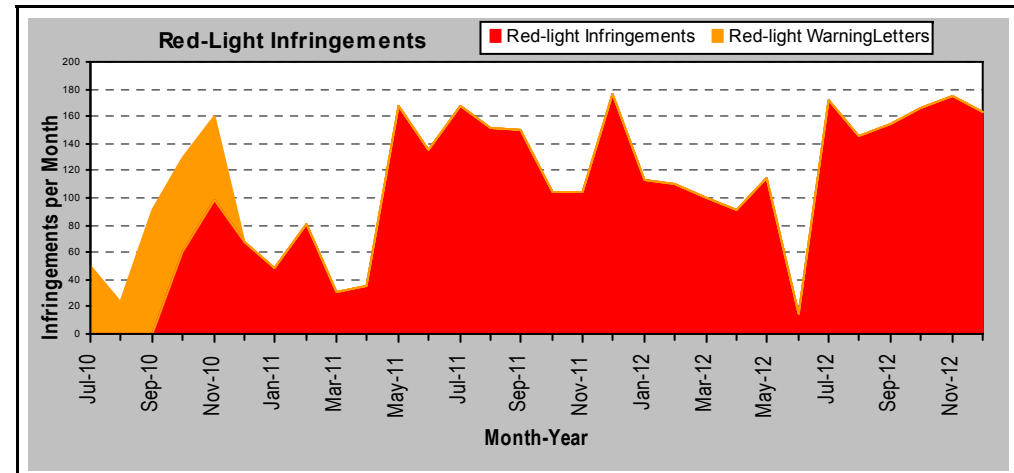
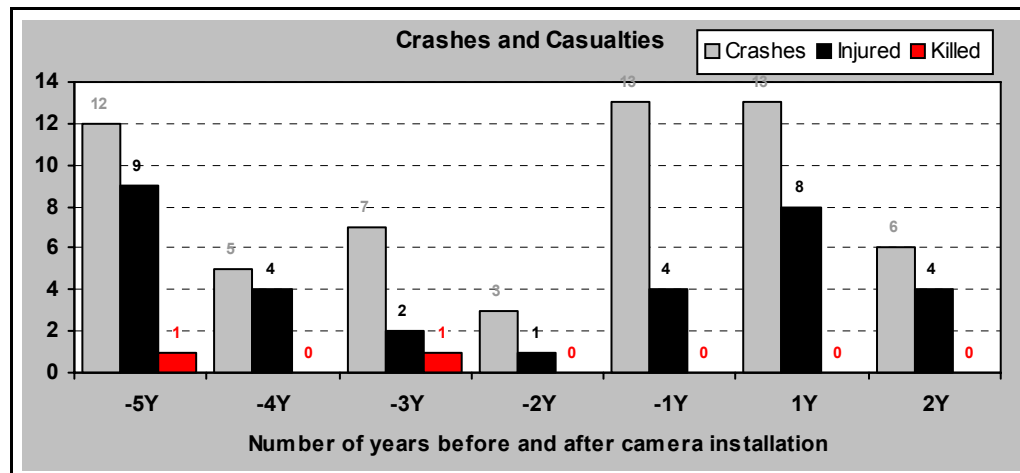
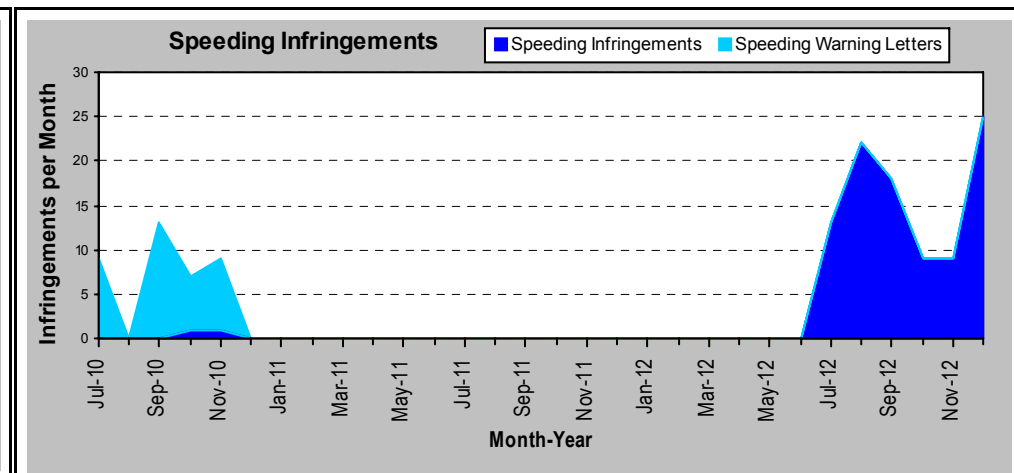
### Infringements at safety camera location

- There is one camera at this intersection. This was previously a wet-film red-light camera location.
- The camera at the intersection of Frederick Street and Hume Highway commenced issuing warning letters in March 2011.
- While early results indicate a slight increase in crashes, a more comprehensive analysis over a longer time period is required before making any conclusions about the effectiveness of the camera.
- The infringement graphs show the number of warning letters and infringements issued at this intersection as well as the trend in infringements since the camera began operation. Roadworks and camera maintenance may influence the number of infringements issued.

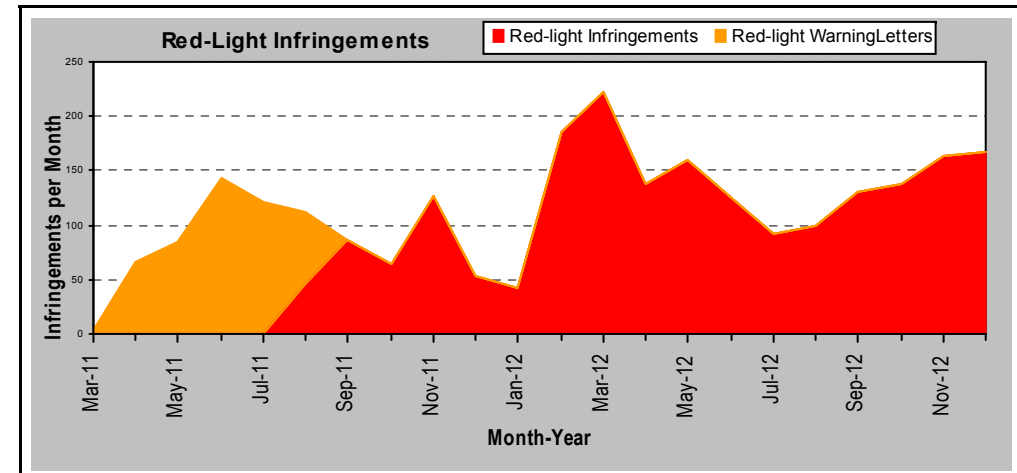
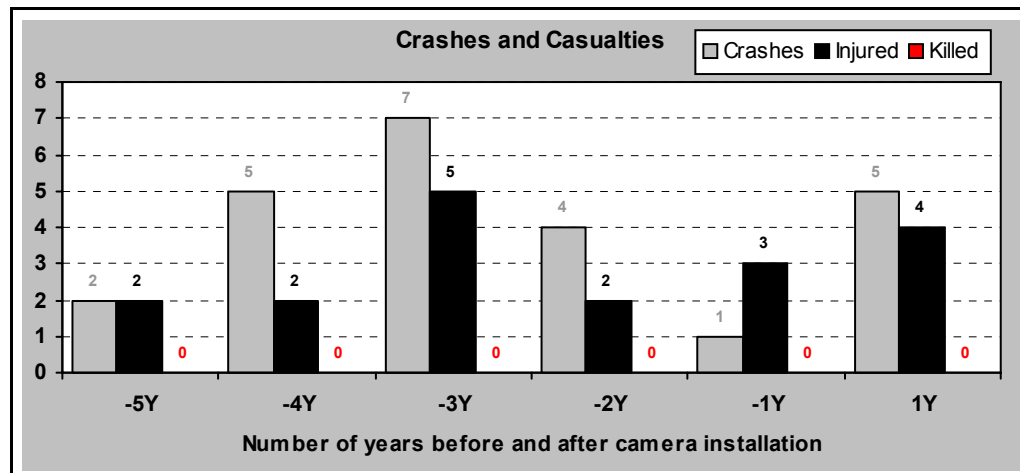
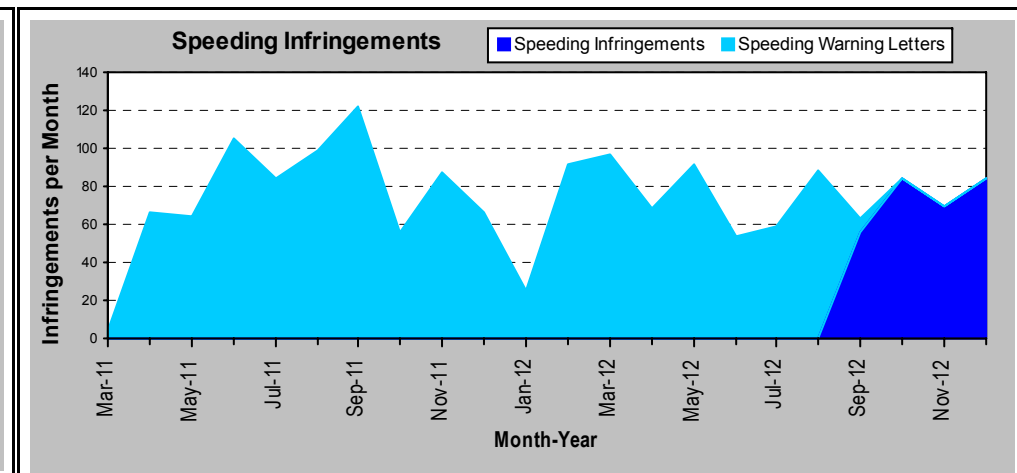
### Infringements at safety camera location

- There are two cameras at this intersection.
- The camera at the intersection of M4 West bound off ramp and Silverwater Rd commenced issuing warning letters in June 2011.
- The camera at the intersection of Silverwater Rd and M4 West bound on ramp commenced issuing warning letters in July 2010.
- While the results available show a decrease in crashes, a more comprehensive analysis over a longer time period is required before making any conclusions about the effectiveness of the cameras.
- The infringement graphs show the number of warning letters and infringements issued at this intersection as well as the trend in infringements since the camera began operation. Roadworks and camera maintenance may influence the number of infringements issued.

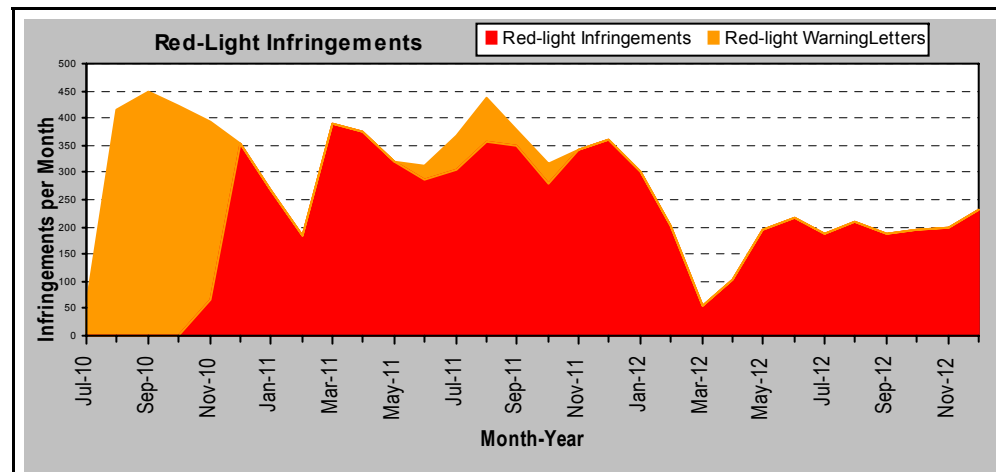
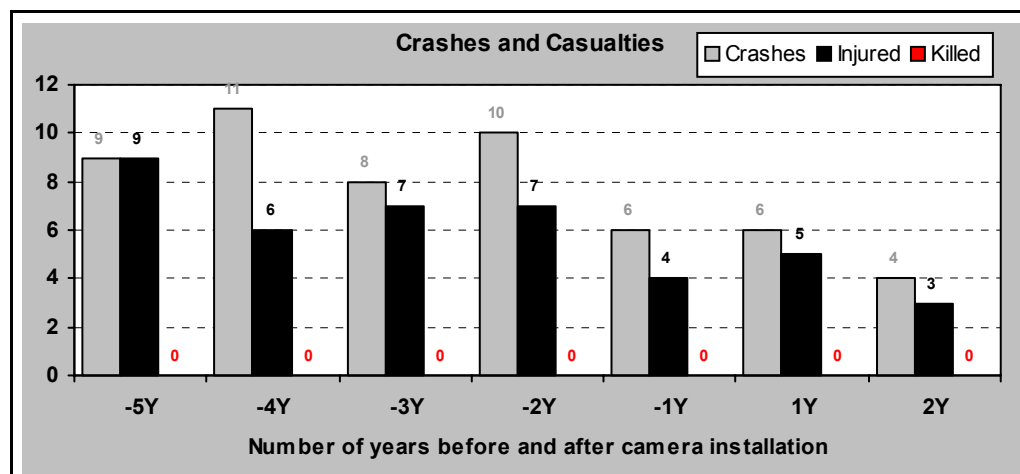
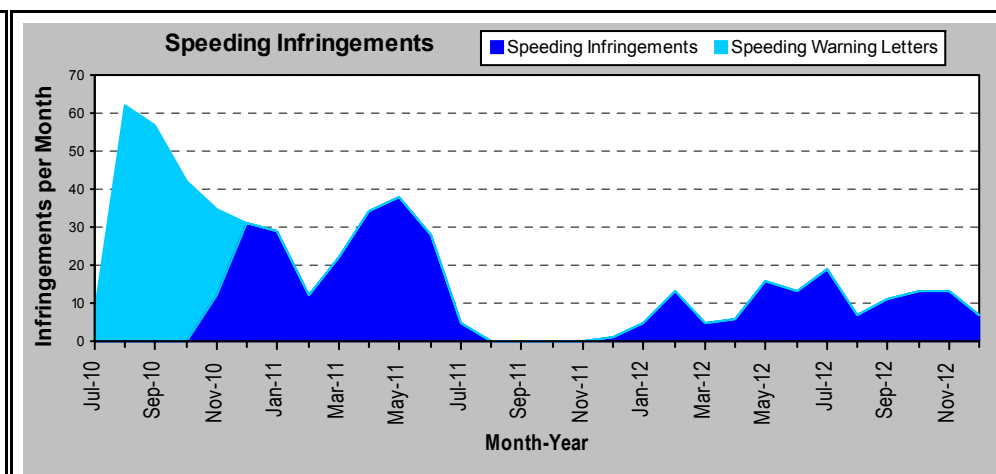
### Infringements at safety camera location

- There is one camera at this intersection. This was previously a wet-film red-light camera location.
- The camera at the intersection of Meredith St and Hume Hwy commenced issuing warning letters in December 2010.
- While early results indicate a slight increase in crashes, a more comprehensive analysis over a longer time period is required before making any conclusions about the effectiveness of the camera.
- The infringement graphs show the number of warning letters and infringements issued at this intersection as well as the trend in infringements since the camera began operation. Roadworks and camera maintenance may influence the number of infringements issued. There were no speeding infringements at this intersection up to the end of 2012.

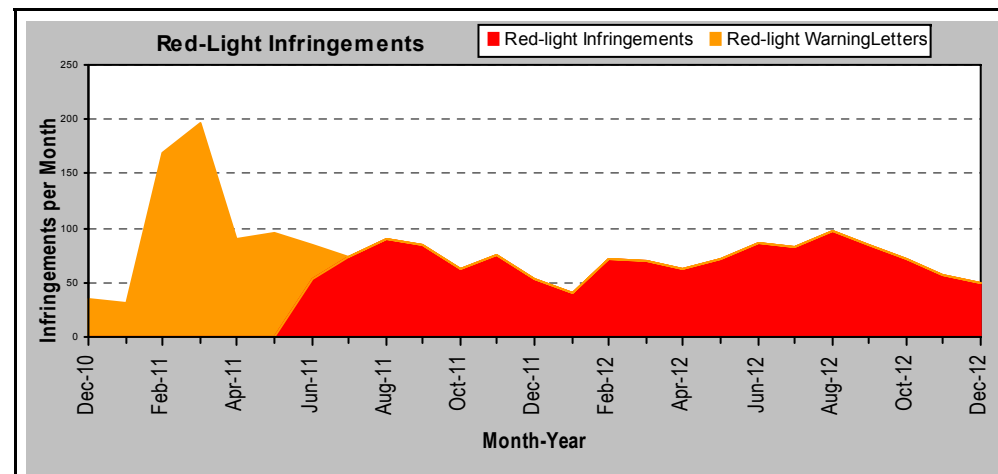
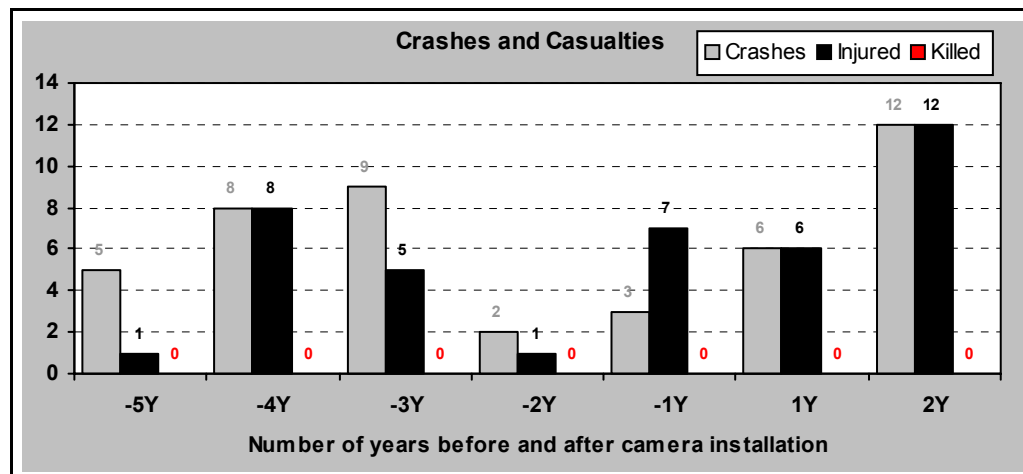
### Infringements at safety camera location

- There are two cameras at this intersection. This was previously a wet-film red-light camera location.
- The camera at the intersection of Windsor Rd and Old Northern Rd commenced issuing warning letters in September 2010.
- The camera at the intersection of Windsor Rd and Seven Hills Rd commenced issuing warning letters in September 2010.
- While the results available show a decrease in casualty crashes, a more comprehensive analysis over a longer time period is required before making any conclusions about the effectiveness of the cameras.
- The infringement graphs show the number of warning letters and infringements issued at this intersection as well as the trend in infringements since the camera began operation. Roadworks and camera maintenance may influence the number of infringements issued.

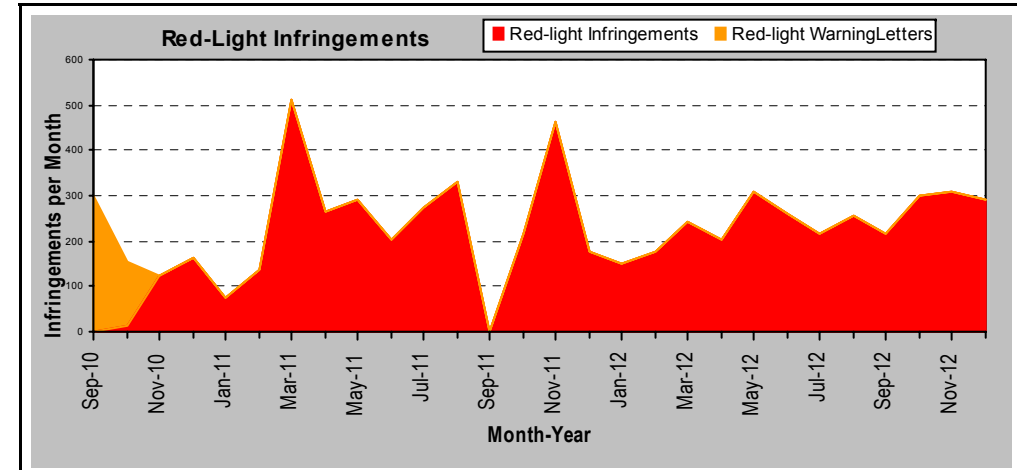
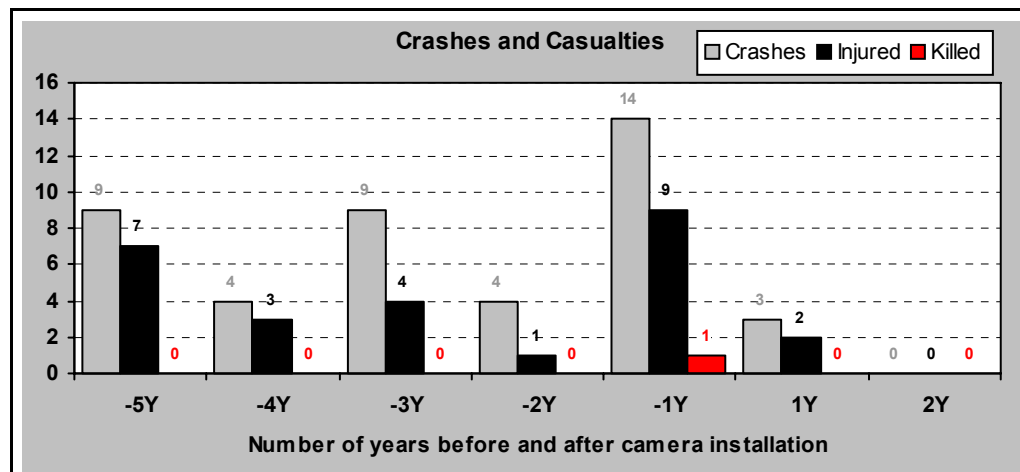
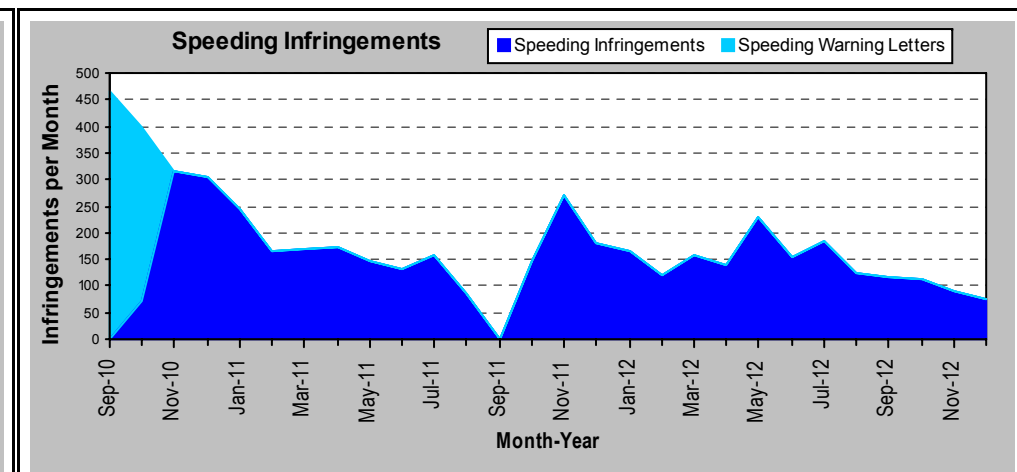
### Infringements at safety camera location

- There is one camera at this intersection. This was previously a wet-film red-light camera location.
- The camera at the intersection of Forest Road and Harrow Road commenced issuing warning letters in June 2011.
- While the results available so far are encouraging, a more comprehensive analysis over a longer time period is required before making any conclusions about the effectiveness of the camera.
- The infringement graphs show the number of warning letters and infringements issued at this intersection as well as the trend in infringements since the camera began operation. Roadworks and camera maintenance may influence the number of infringements issued.

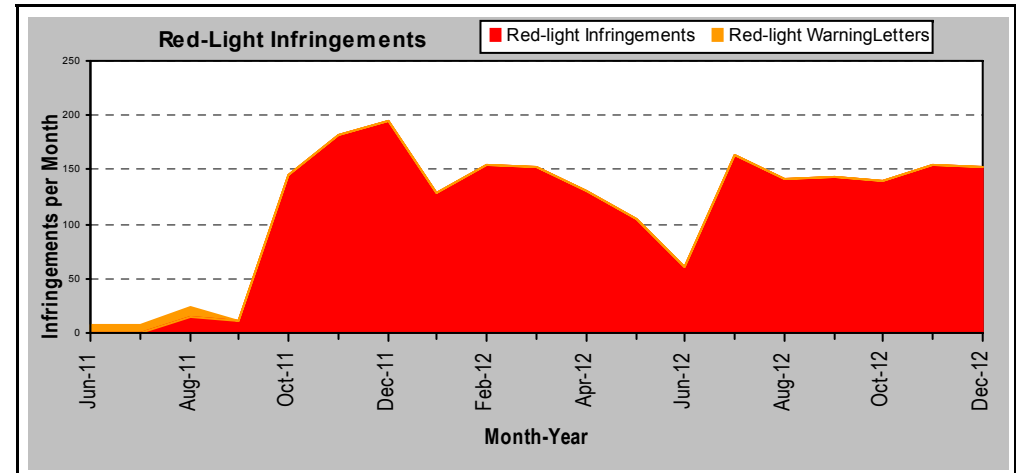
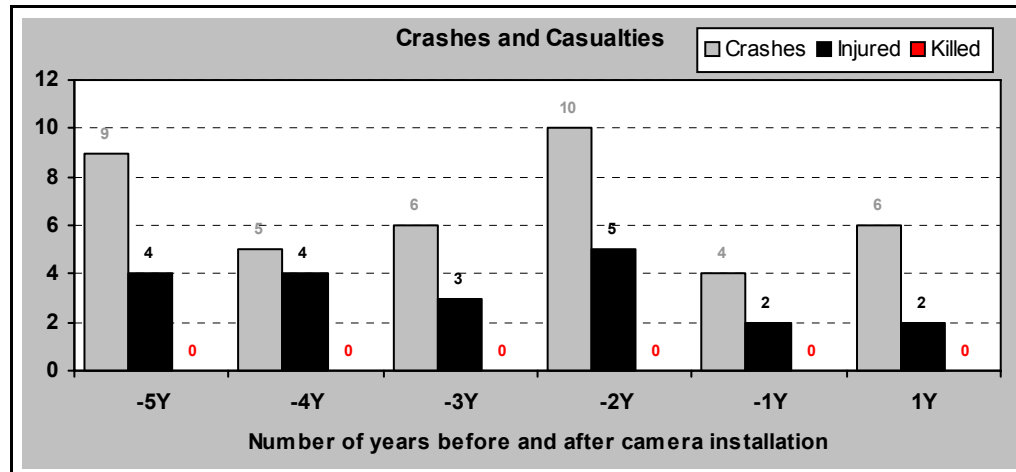
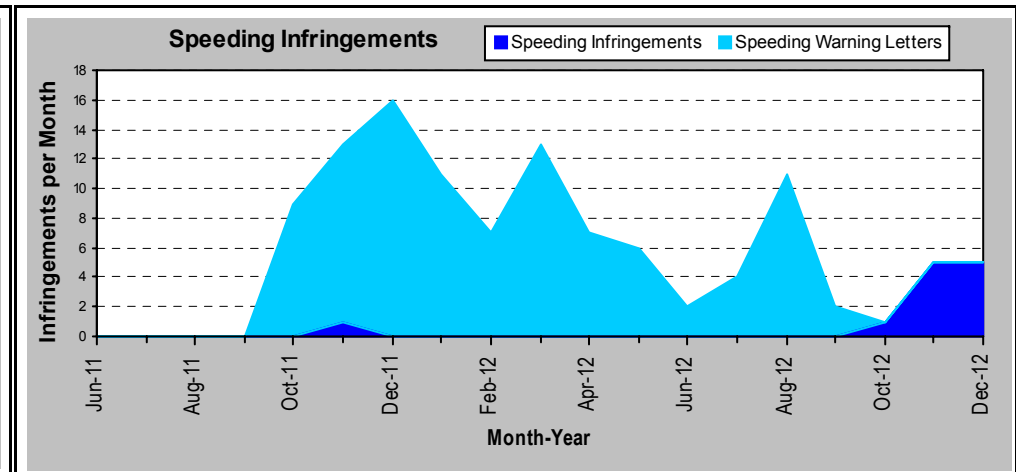
### Infringements at safety camera location

- There is one camera at this intersection. This was previously a wet-film red-light camera location.
- The camera at the intersection of Bungarribee Rd and Reservoir Rd commenced issuing warning letters in September 2010.
- While early results indicate a slight increase in crashes, a more comprehensive analysis over a longer time period is required before making any conclusions about the effectiveness of the camera.
- The infringement graphs show the number of warning letters and infringements issued at this intersection as well as the trend in infringements since the camera began operation. Roadworks and camera maintenance may influence the number of infringements issued.

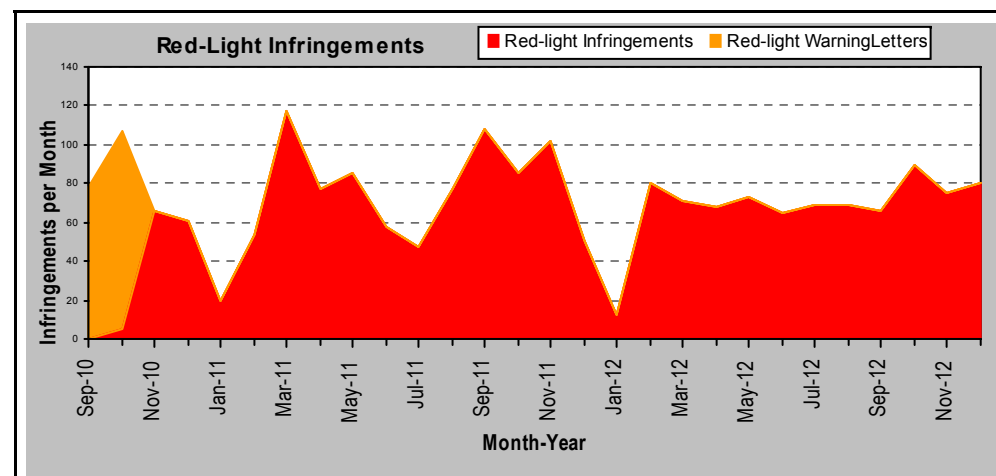
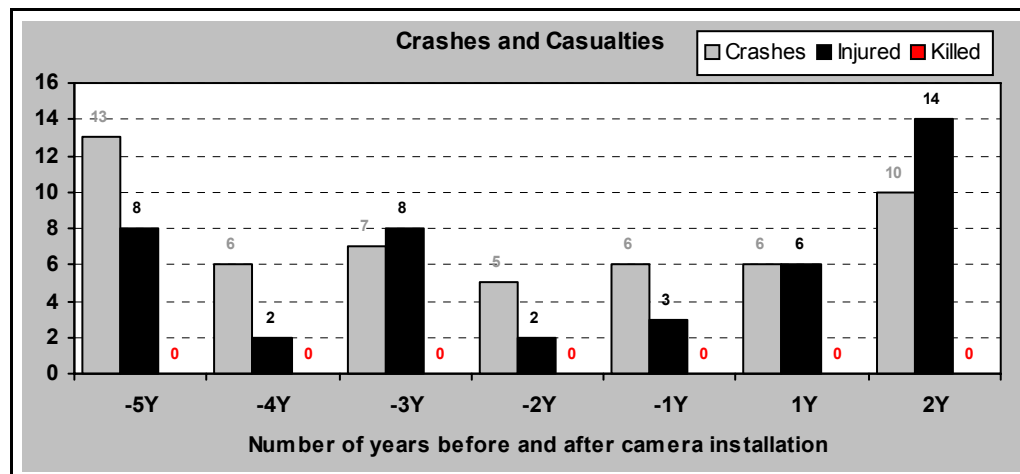
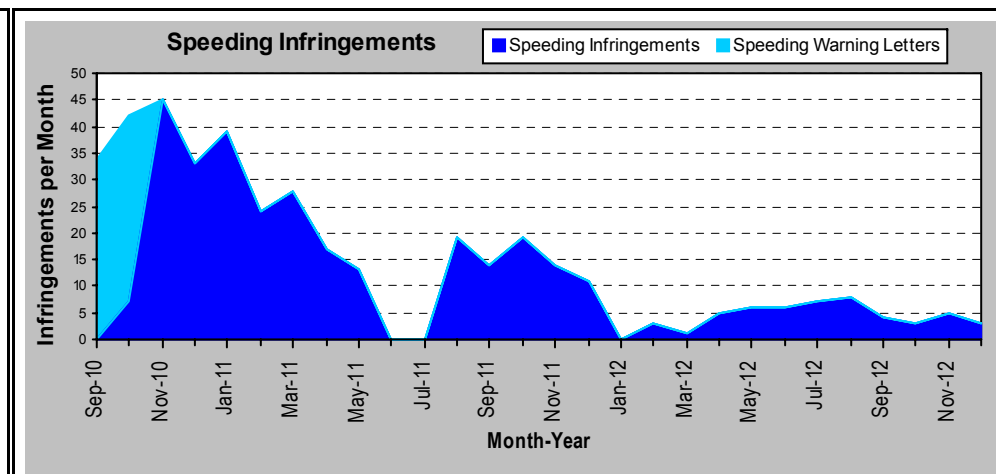
### Infringements at safety camera location

- There is one camera at this intersection. This was previously a wet-film red-light camera location.
- The camera at the intersection of Great Western Hwy and Reservoir Rd commenced issuing warning letters in December 2010.
- While the results available show a decrease in casualty crashes, a more comprehensive analysis over a longer time period is required before making any conclusions about the effectiveness of the camera.
- The infringement graphs show the number of warning letters and infringements issued at this intersection as well as the trend in infringements since the camera began operation. Roadworks and camera maintenance may influence the number of infringements issued.

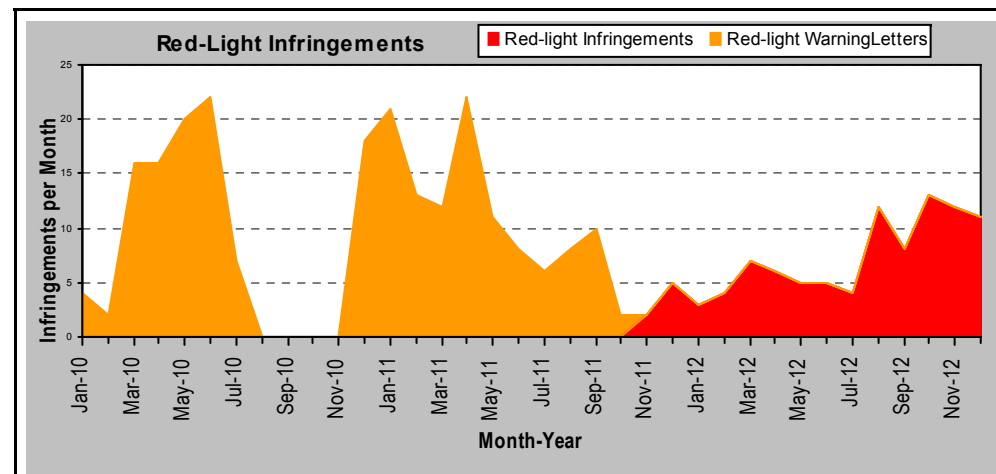
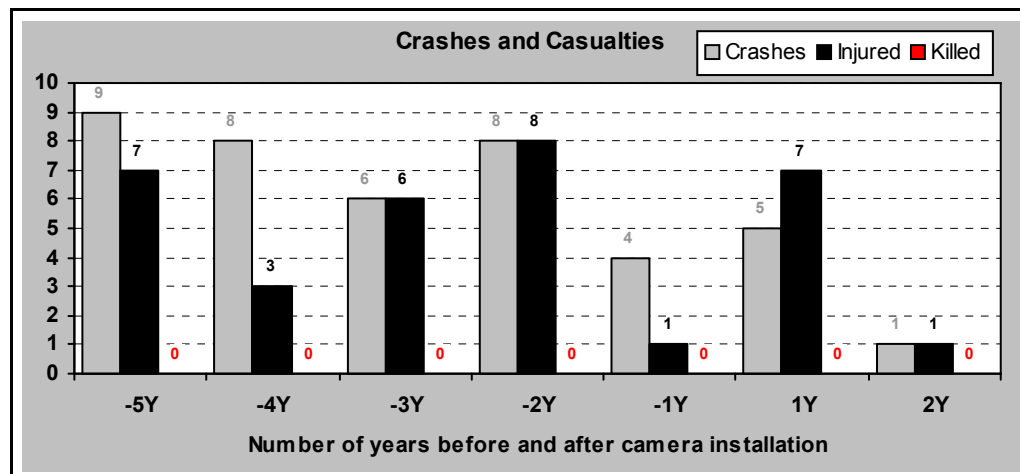
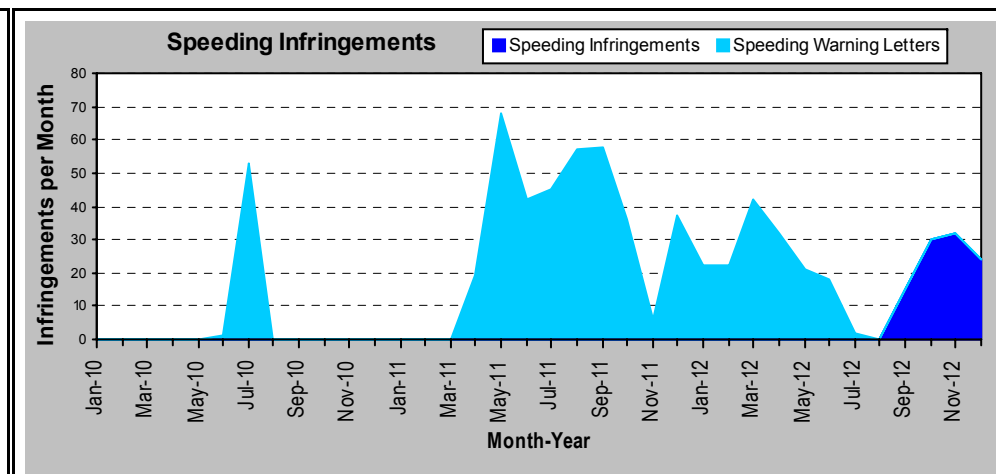
### Infringements at safety camera location

- There is one camera at this intersection. This was previously a wet-film red-light camera location.
- The camera at the intersection of Lancaster St and Kildare Rd commenced issuing warning letters in November 2010.
- While the results available so far are encouraging, a more comprehensive analysis over a longer time period is required before making any conclusions about the effectiveness of the camera.
- The infringement graphs show the number of warning letters and infringements issued at this intersection as well as the trend in infringements since the camera began operation. Roadworks and camera maintenance may influence the number of infringements issued.

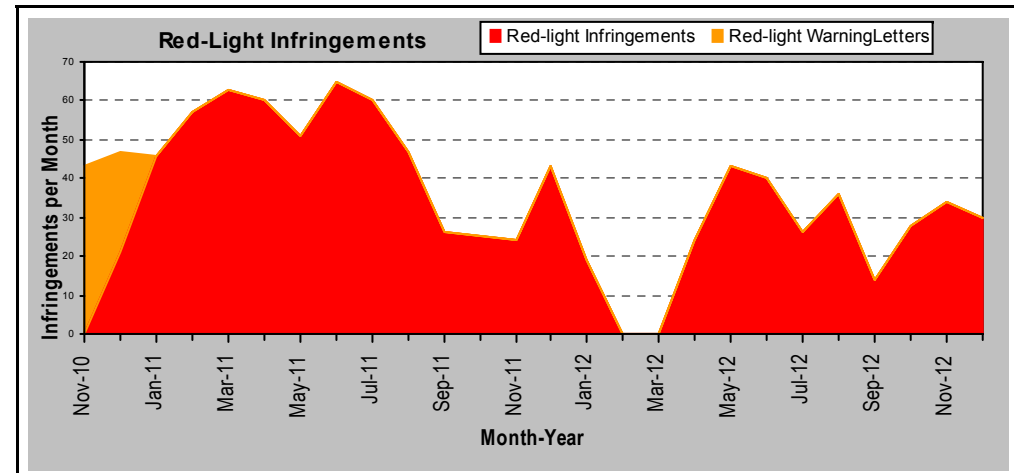
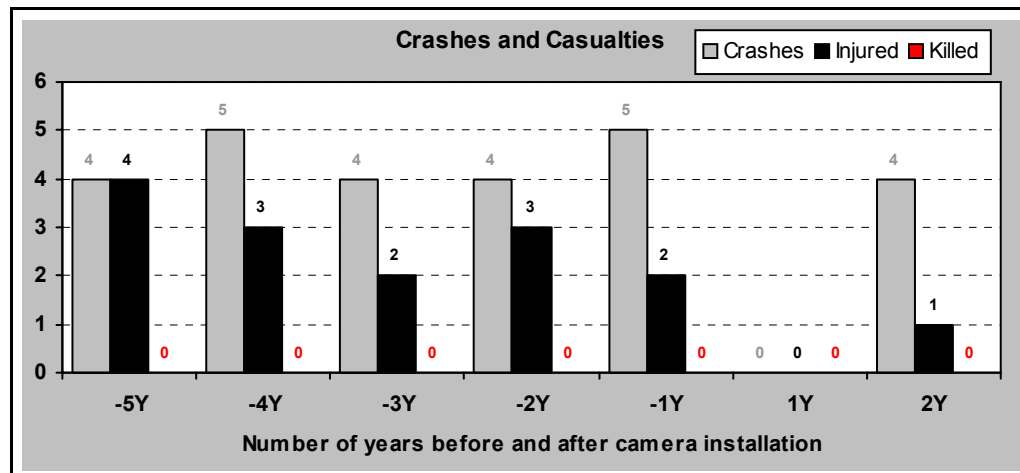
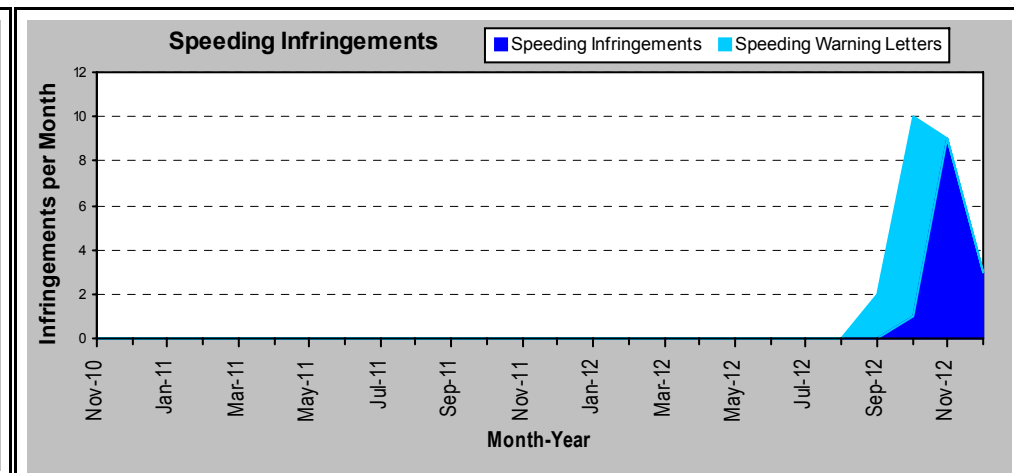
## Infringements at safety camera location

- There is one camera at this intersection. This was previously a wet-film red-light camera location.
- The camera at the intersection of Newton Rd and Flushcombe Rd commenced issuing warning letters in October 2010.
- While the results available show a decrease in casualty crashes, a more comprehensive analysis over a longer time period is required before making any conclusions about the effectiveness of the camera.
- The infringement graphs show the number of warning letters and infringements issued at this intersection as well as the trend in infringements since the camera began operation. Roadworks and camera maintenance may influence the number of infringements issued.

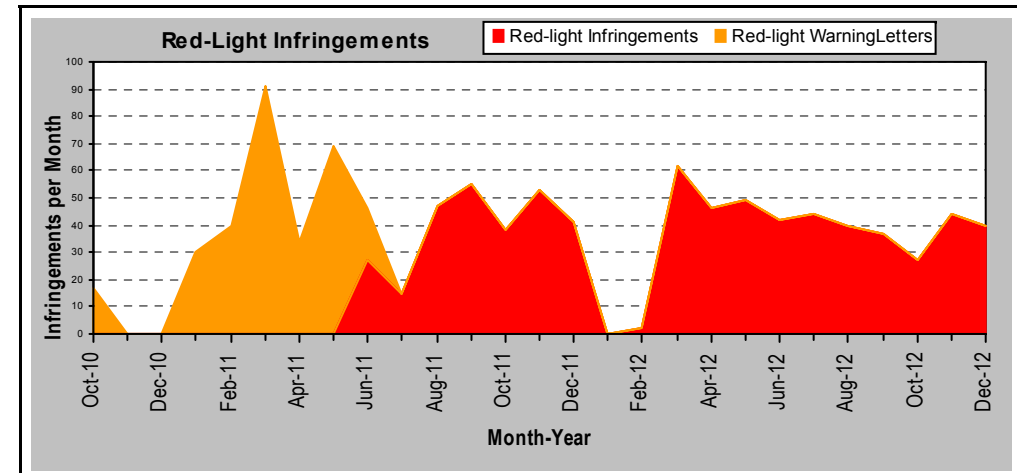
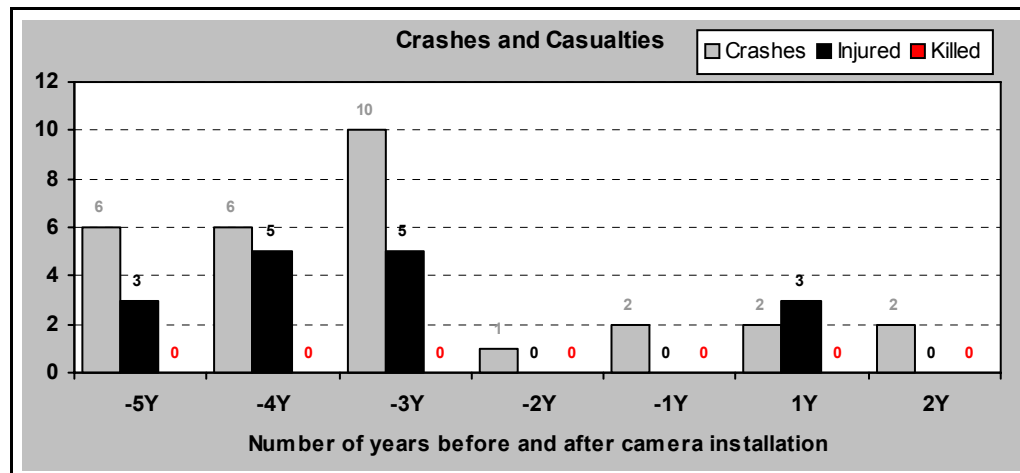
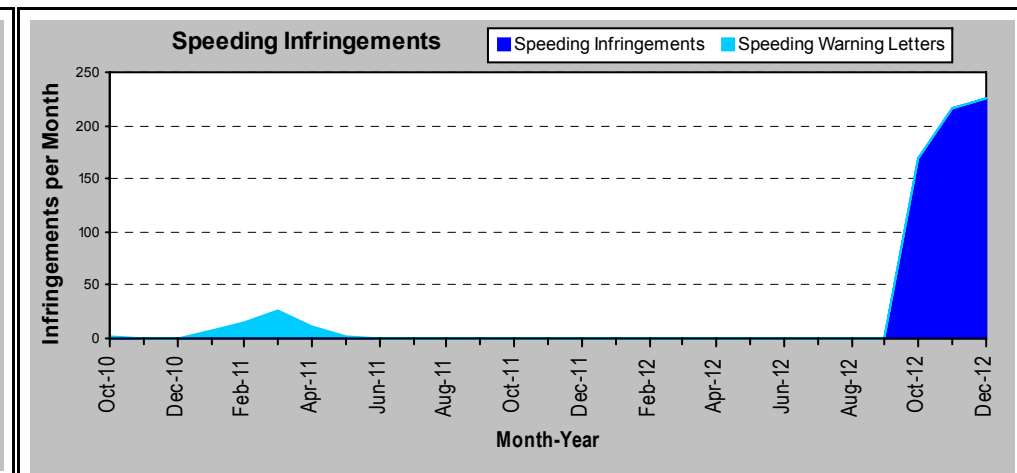
### Infringements at safety camera location

- There is one camera at this intersection. This was previously a wet-film red-light camera location.
- The camera at the intersection of Sunnyholt Rd and Main St commenced issuing warning letters in November 2010.
- While the results available so far are encouraging, a more comprehensive analysis over a longer time period is required before making any conclusions about the effectiveness of the camera.
- The infringement graphs show the number of warning letters and infringements issued at this intersection as well as the trend in infringements since the camera began operation. Roadworks and camera maintenance may influence the number of infringements issued.

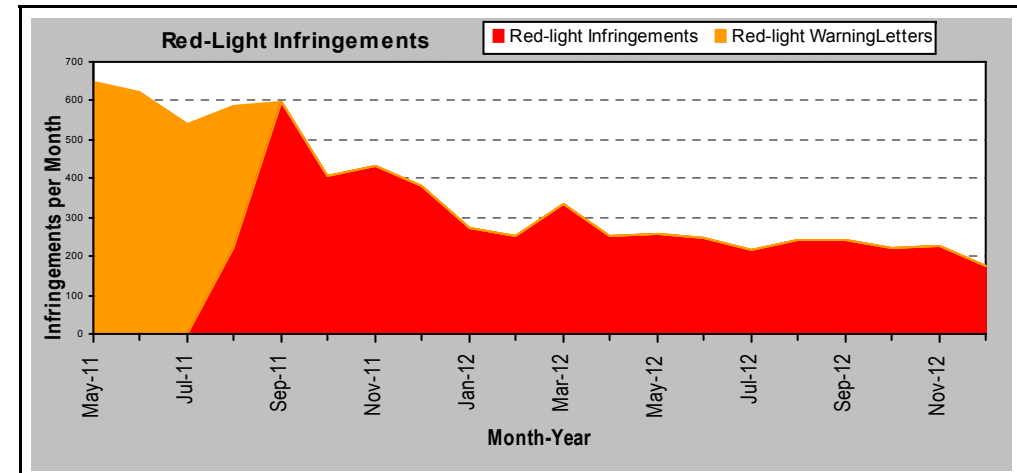
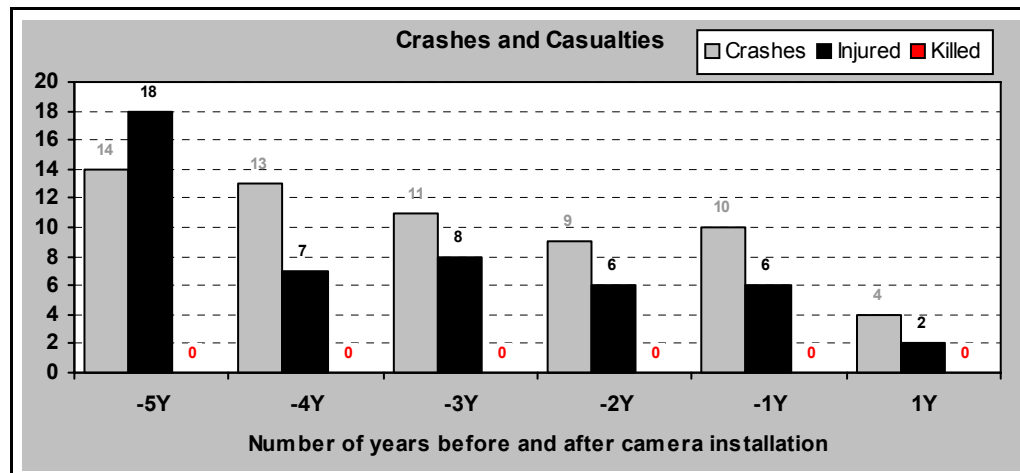
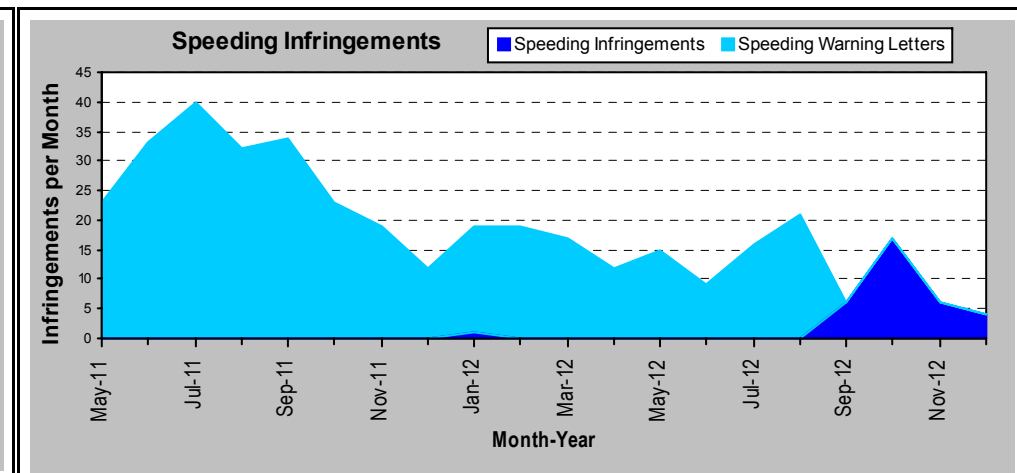
### Infringements at safety camera location

- There are two cameras at this intersection. This was previously a wet-film red-light camera location.
- Both cameras at the intersection of Moore-Oxley Bypass and Broughton St commenced issuing warning letters in June 2010.
- While the results available show a decrease in casualty crashes, a more comprehensive analysis over a longer time period is required before making any conclusions about the effectiveness of the cameras.
- The infringement graphs show the number of warning letters and infringements issued at this intersection as well as the trend in infringements since the camera began operation. Roadworks and camera maintenance may influence the number of infringements issued.
