Transport  
for NSW

# ANNUAL NSW SPEED CAMERA PERFORMANCE REVIEW

NSW Centre for Road Safety

AUGUST 2013

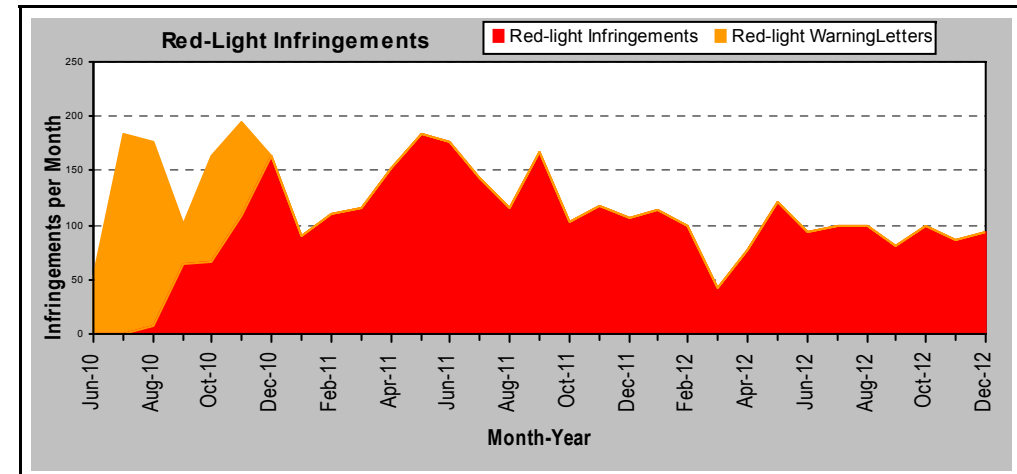
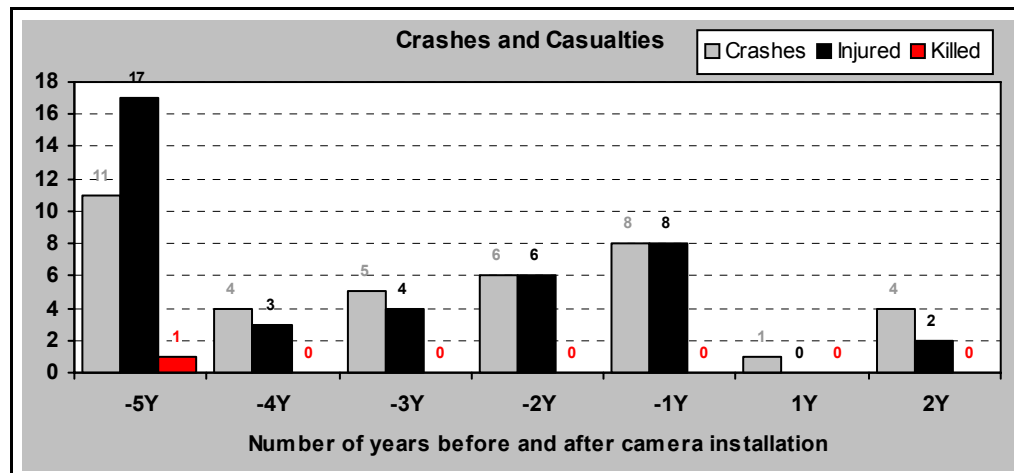
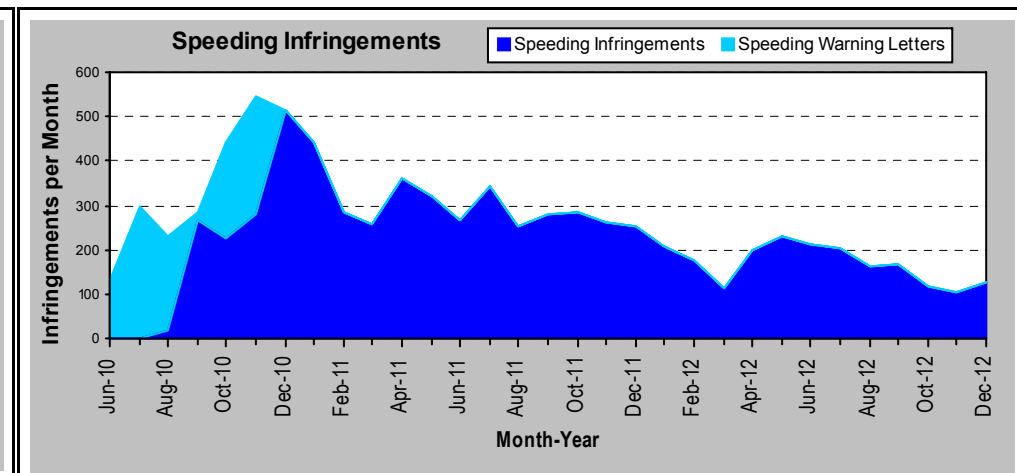
### Infringements at safety camera location

- There is one camera at this intersection. This was previously a wet-film red-light camera location.
- The camera at the intersection of Canterbury Rd and Bexley Rd commenced issuing warning letters in October 2010.
- While the results available so far are encouraging, a more comprehensive analysis over a longer time period is required before making any conclusions about the effectiveness of the camera.
- The infringement graphs show the number of warning letters and infringements issued at this intersection as well as the trend in infringements since the camera began operation. Roadworks and camera maintenance may influence the number of infringements issued.

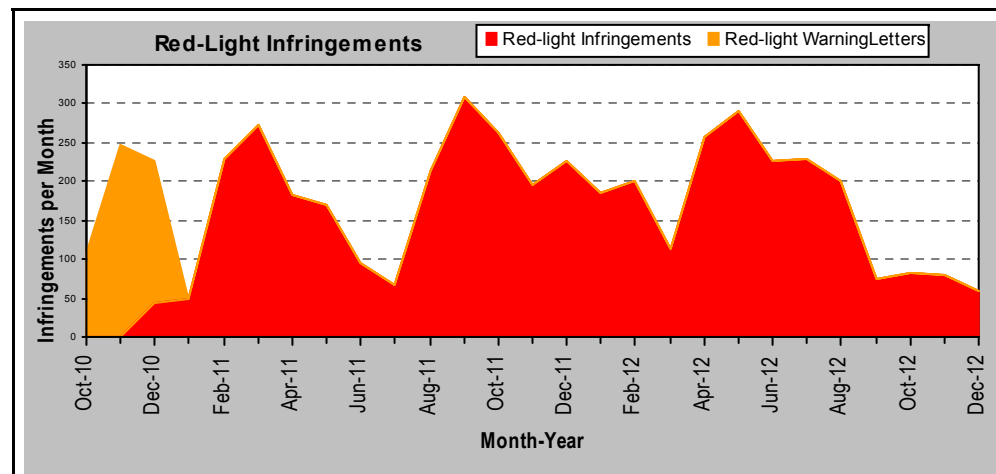
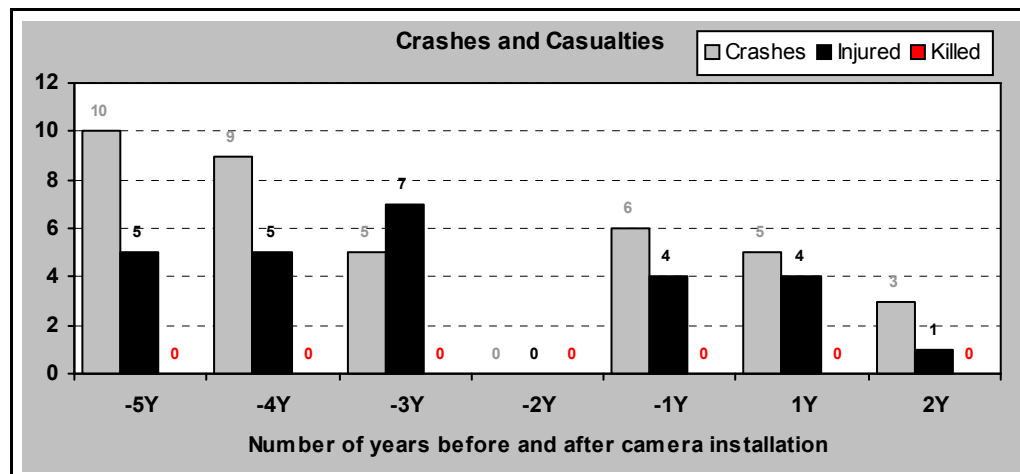
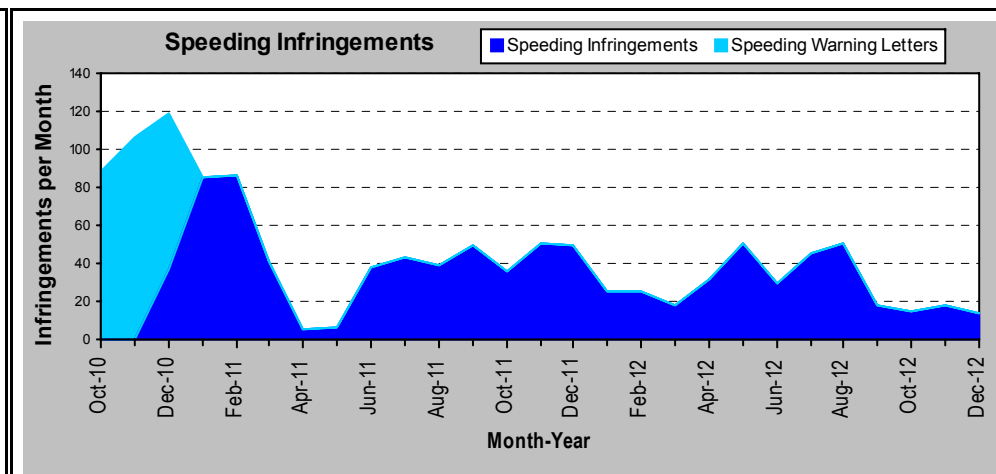
### Infringements at safety camera location

- There is one camera at this intersection. This was previously a wet-film red-light camera location.
- The camera at the intersection of Cumberland Hwy and St Johns Rd commenced issuing warning letters in December 2009.
- While the results available so far are encouraging, a more comprehensive analysis over a longer time period is required before making any conclusions about the effectiveness of the camera.
- The infringement graphs show the number of warning letters and infringements issued at this intersection as well as the trend in infringements since the camera began operation. Roadworks and camera maintenance may influence the number of infringements issued.

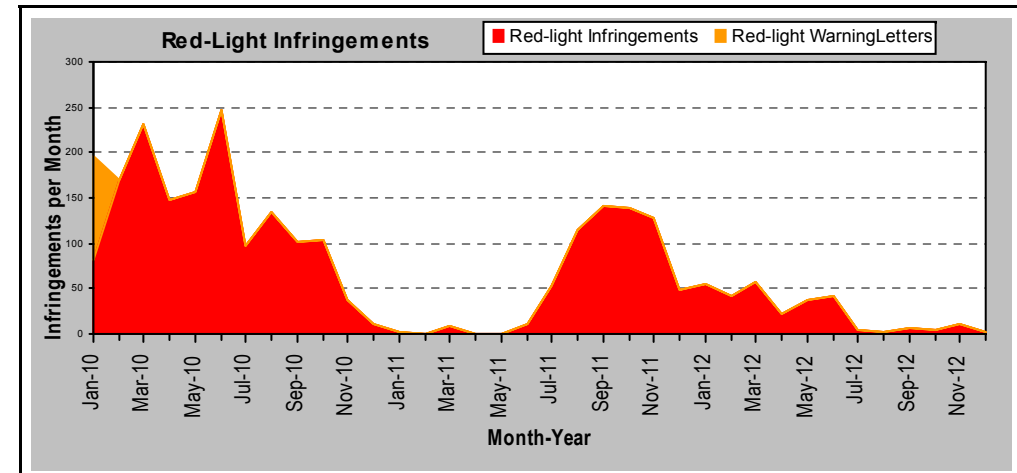
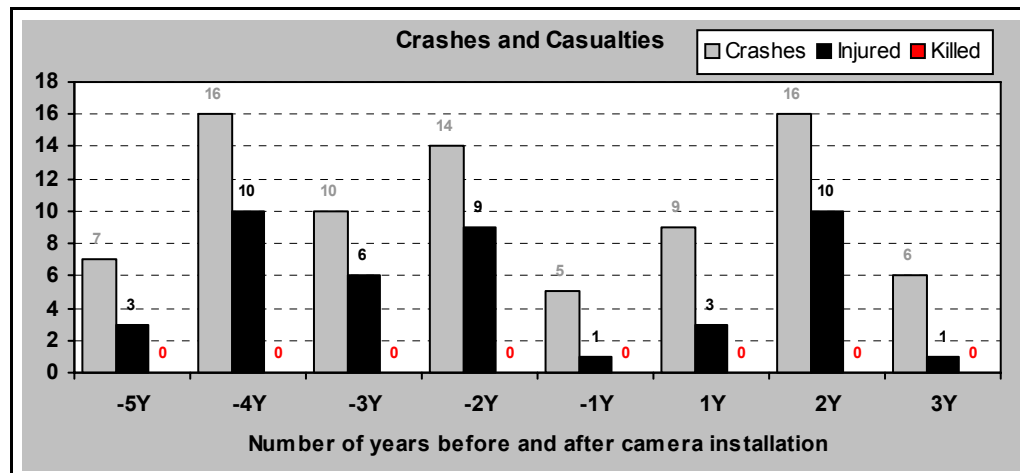
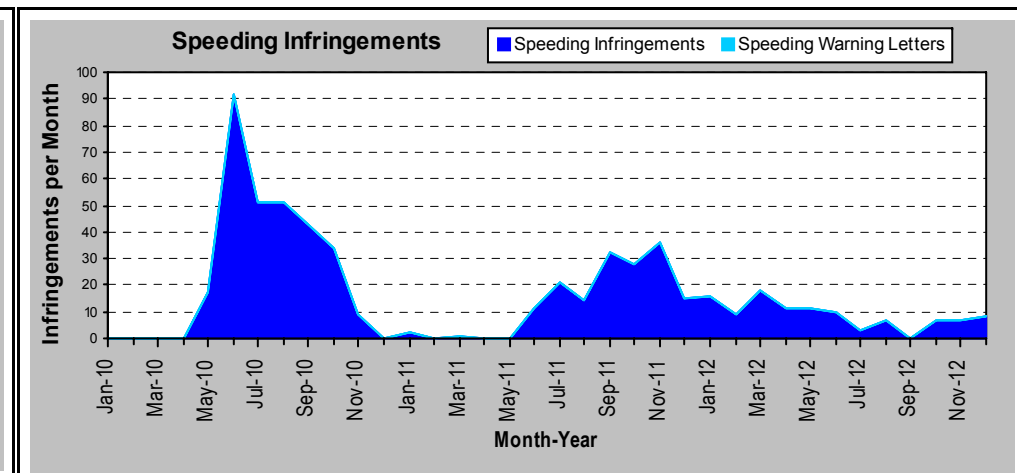
### Infringements at safety camera location

- There is one camera at this intersection. This was previously a wet-film red-light camera location.
- The camera at the intersection of Sackville Street and Canley Vale Road commenced issuing warning letters in April 2011.
- While early results indicate a slight increase in crashes, a more comprehensive analysis over a longer time period is required before making any conclusions about the effectiveness of the camera.
- The infringement graphs show the number of warning letters and infringements issued at this intersection since the camera began operation. Roadworks and camera maintenance may influence the number of infringements issued.

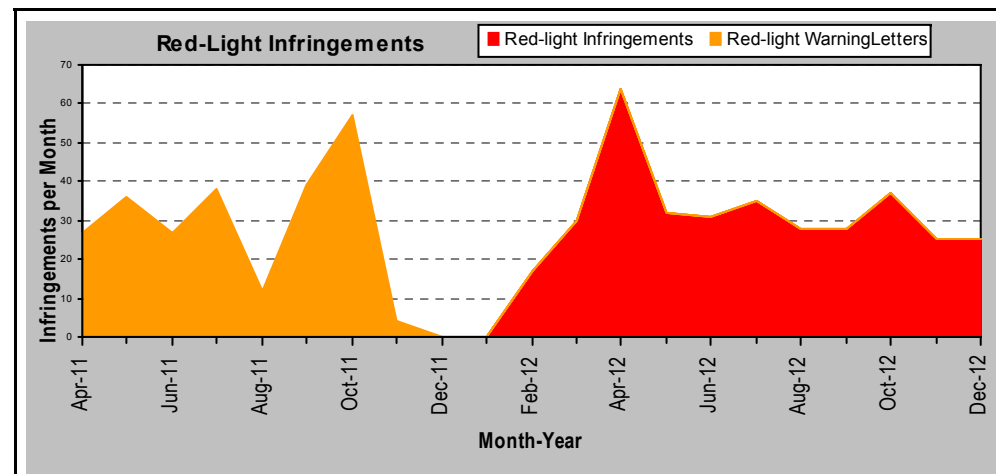
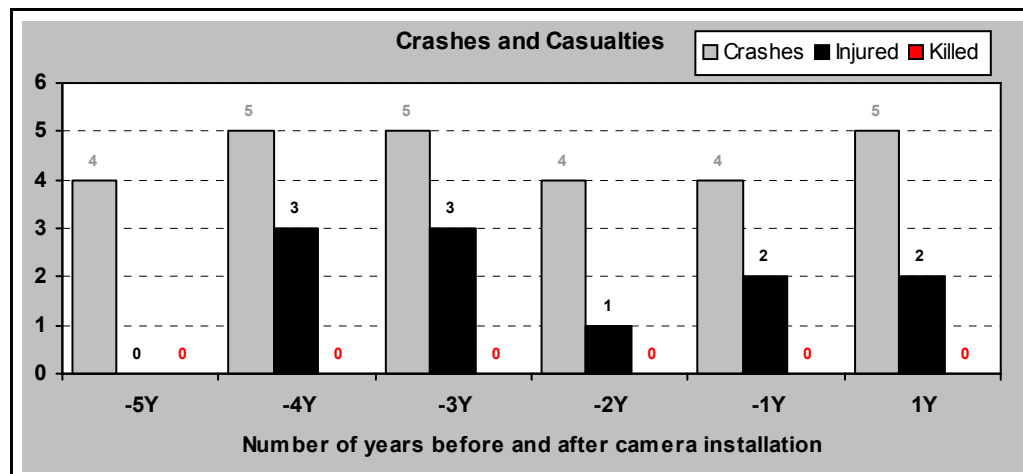
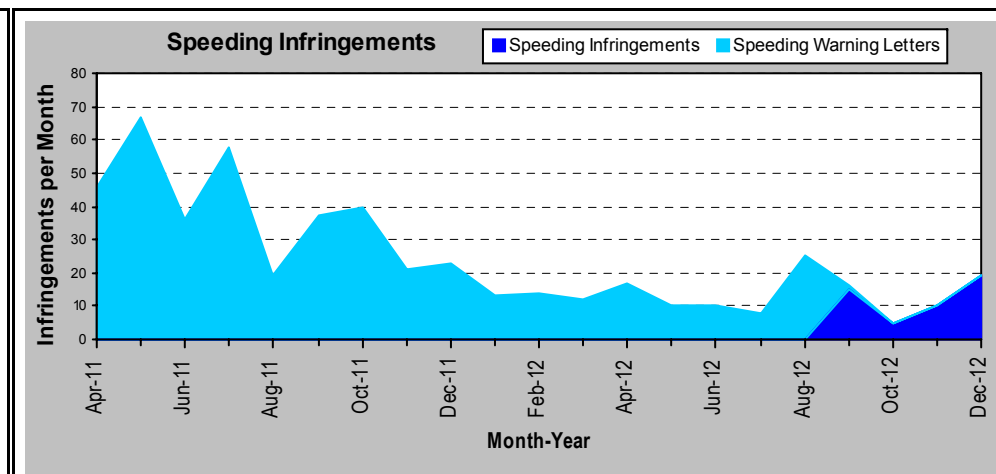
### Infringements at safety camera location

- There is one camera at this intersection. This was previously a wet-film red-light camera location.
- The camera at the intersection of Kingsway and Gannons Rd commenced issuing warning letters in September 2010.
- While the results available show a decrease in crashes, a more comprehensive analysis over a longer time period is required before making any conclusions about the effectiveness of the camera.
- The infringement graphs show the number of warning letters and infringements issued at this intersection as well as the trend in infringements since the camera began operation. Roadworks and camera maintenance may influence the number of infringements issued.

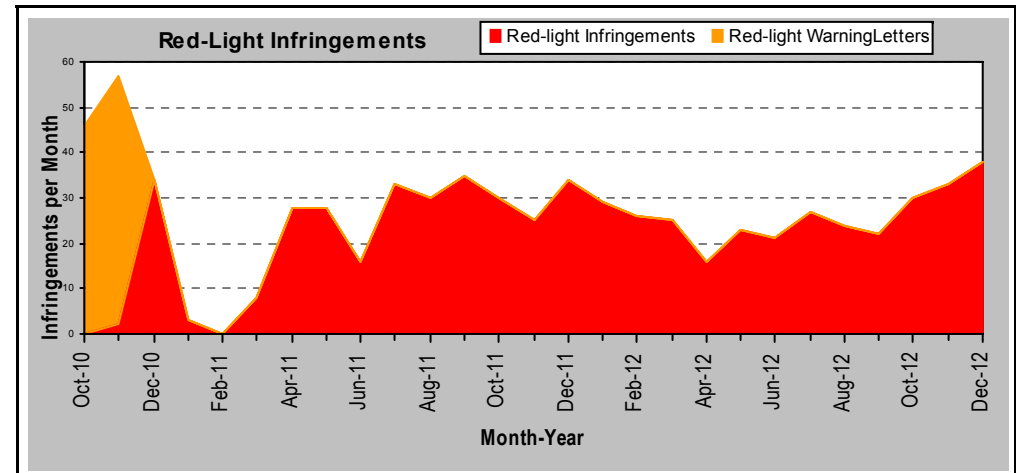
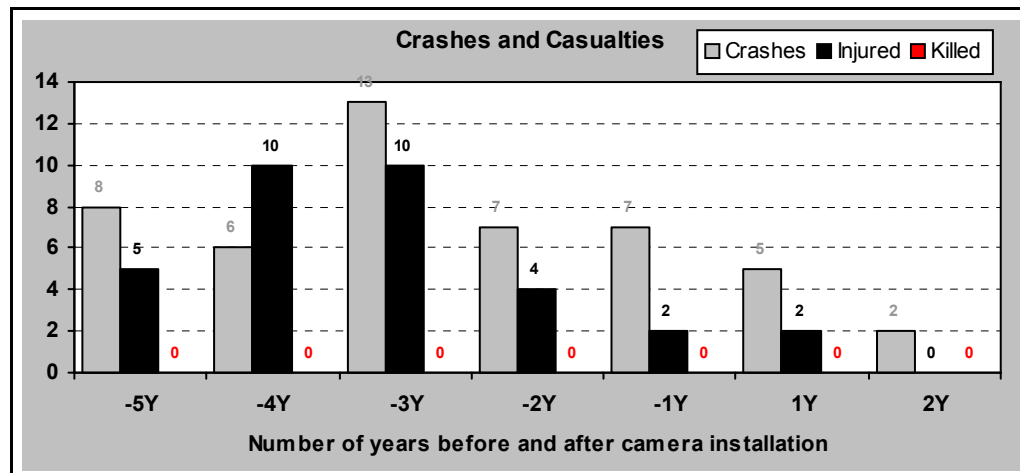
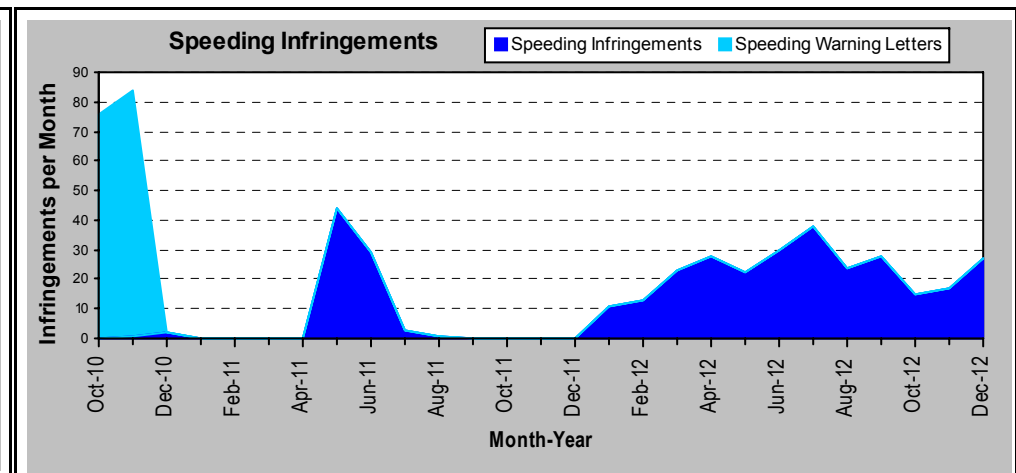
### Infringements at safety camera location

- There is one camera at this intersection. This was previously a wet-film red-light camera location.
- The camera at the intersection of Showground Rd and Victoria Av commenced issuing warning letters in February 2010.
- While the results available show a decrease in casualty crashes, a more comprehensive analysis over a longer time period is required before making any conclusions about the effectiveness of the camera.
- The infringement graphs show the number of warning letters and infringements issued at this intersection as well as the trend in infringements since the camera began operation. Roadworks and camera maintenance may influence the number of infringements issued.

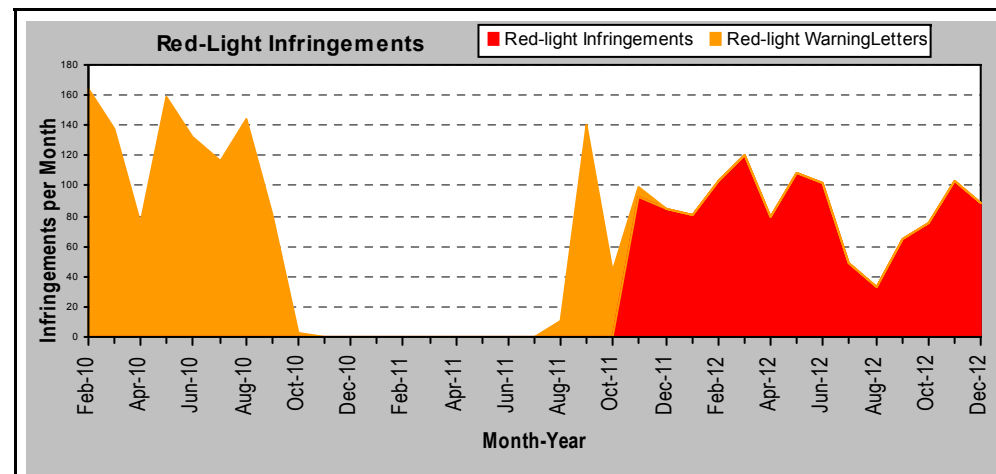
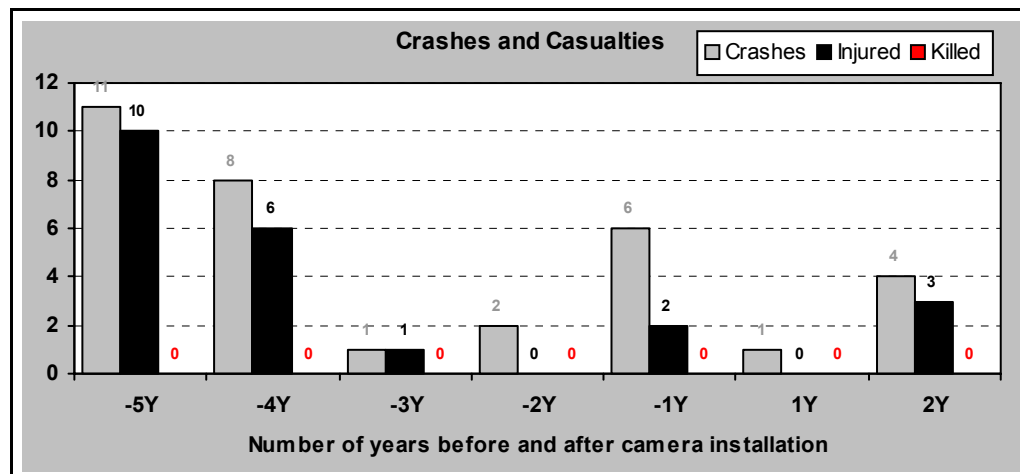
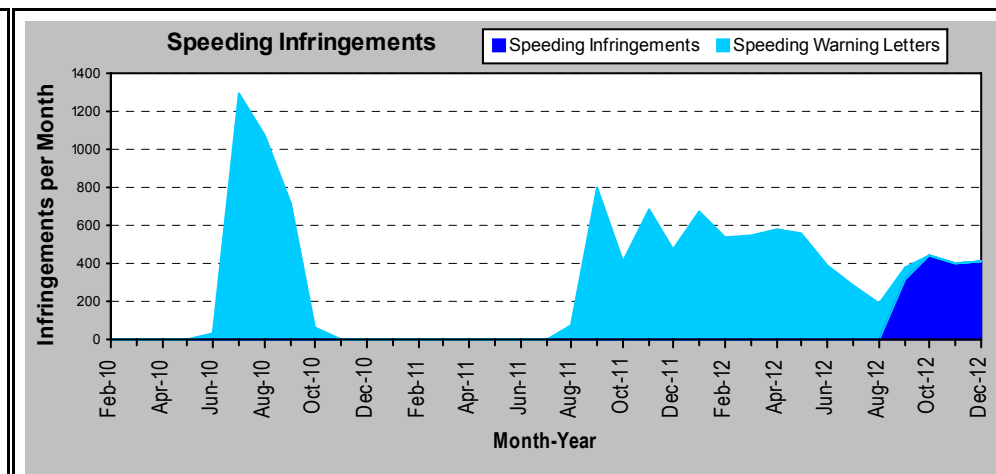
### Infringements at safety camera location

- There are two cameras at this intersection.
- The camera at the intersection of Waldron Rd and Hector St commenced issuing warning letters in July 2010.
- The camera at the intersection of Waldron Rd and Hector St commenced issuing warning letters in August 2010.
- While early results indicate a slight increase in crashes, a more comprehensive analysis over a longer time period is required before making any conclusions about the effectiveness of the cameras.
- The infringement graphs show the number of warning letters and infringements issued at this intersection as well as the trend in infringements since the camera began operation. Roadworks and camera maintenance may influence the number of infringements issued.

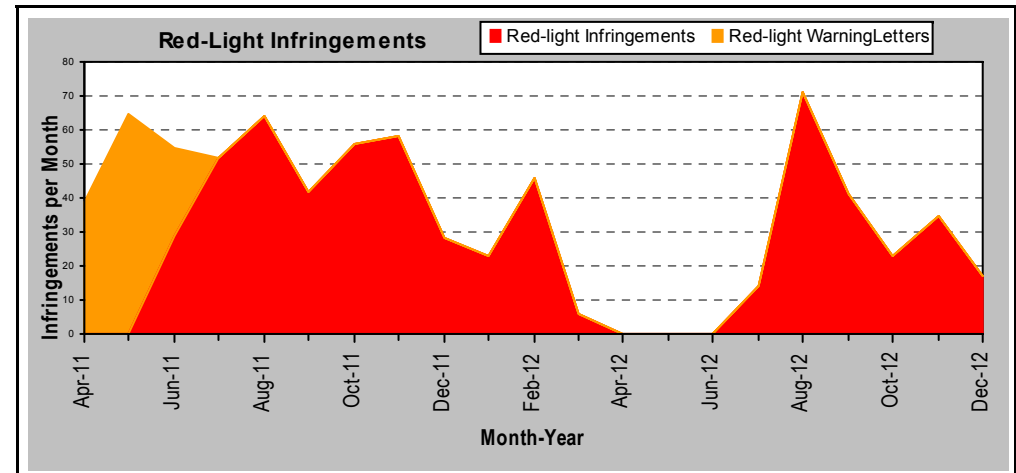
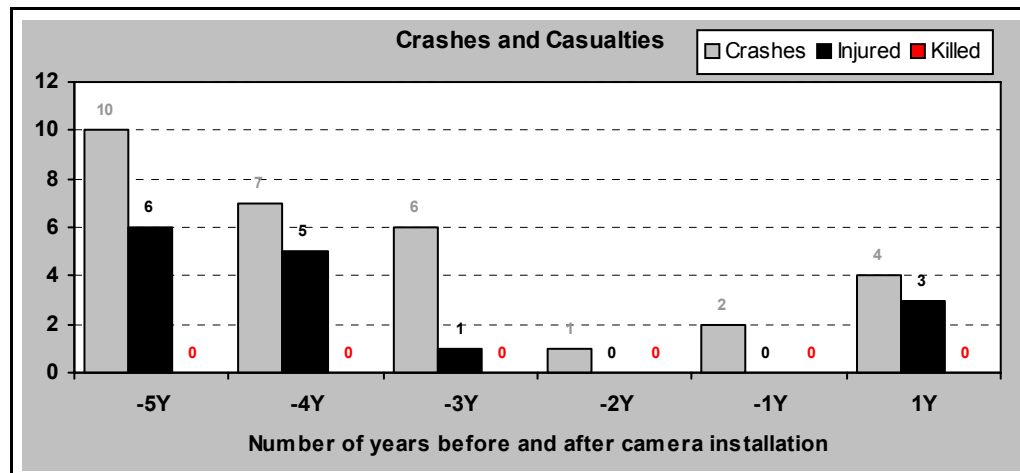
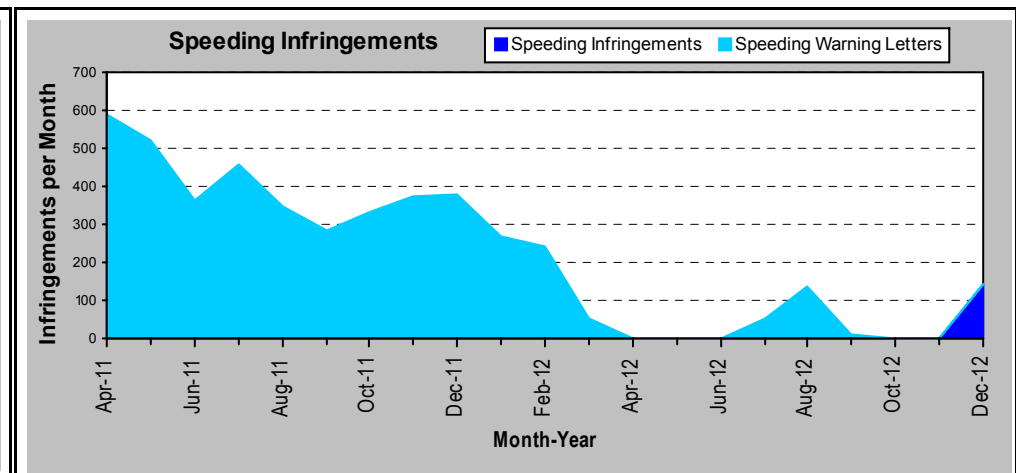
### Infringements at safety camera location

- There is one camera at this intersection. This was previously a wet-film red-light camera location.
- The camera at the intersection of Blaxland Road and May Street commenced issuing warning letters in April 2011.
- While the results available so far are encouraging, a more comprehensive analysis over a longer time period is required before making any conclusions about the effectiveness of the camera.
- The infringement graphs show the number of warning letters and infringements issued at this intersection as well as the trend in infringements since the camera began operation. Roadworks and camera maintenance may influence the number of infringements issued.

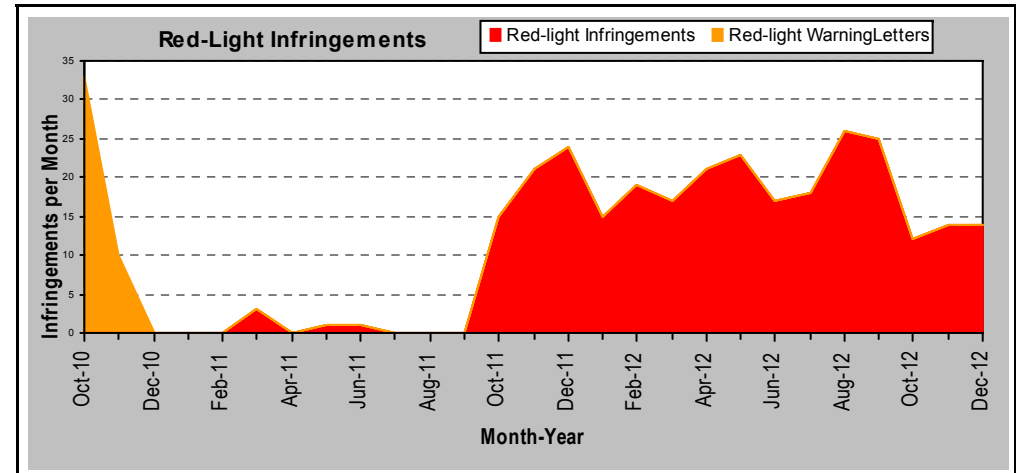
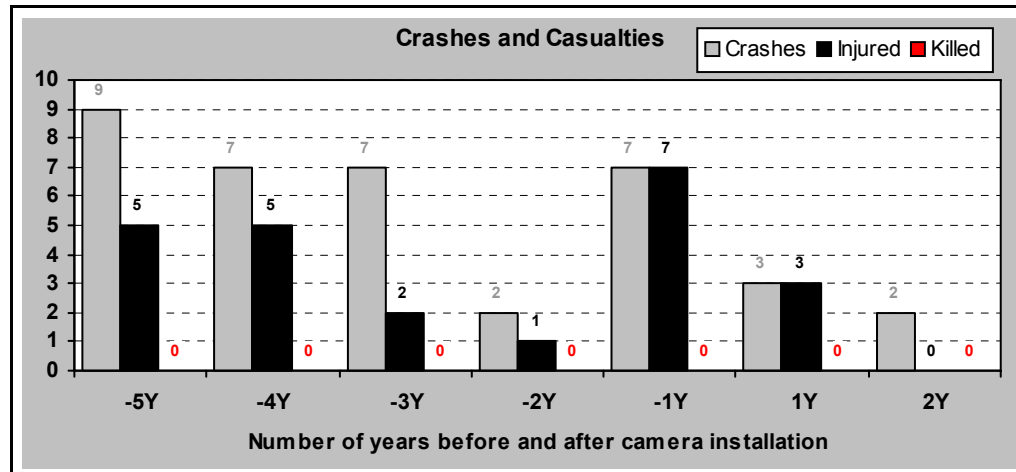
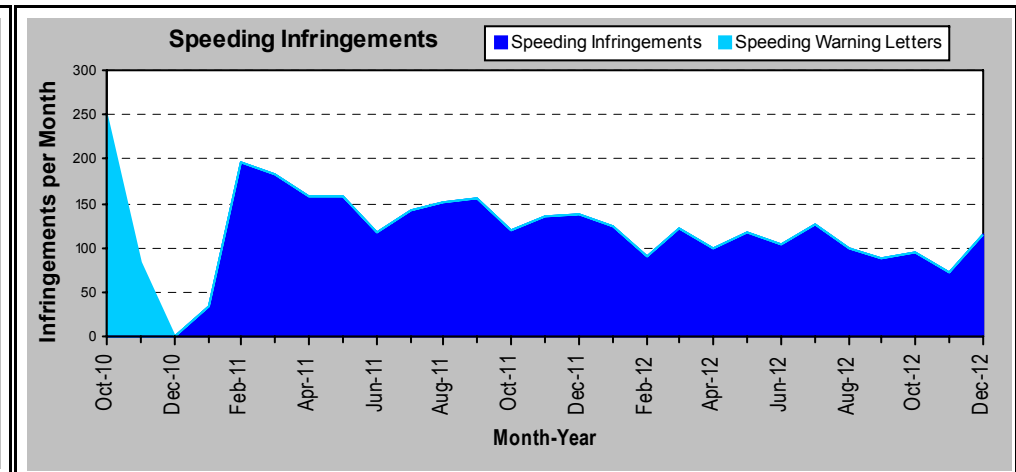
### Infringements at safety camera location

- There is one camera at this intersection. This was previously a wet-film red-light camera location.
- The camera at the intersection of Hamilton Rd and The Boulevarde commenced issuing warning letters in October 2010.
- While the results available show a decrease in casualty crashes, a more comprehensive analysis over a longer time period is required before making any conclusions about the effectiveness of the camera.
- The infringement graphs show the number of warning letters and infringements issued at this intersection as well as the trend in infringements since the camera began operation. Roadworks and camera maintenance may influence the number of infringements issued.

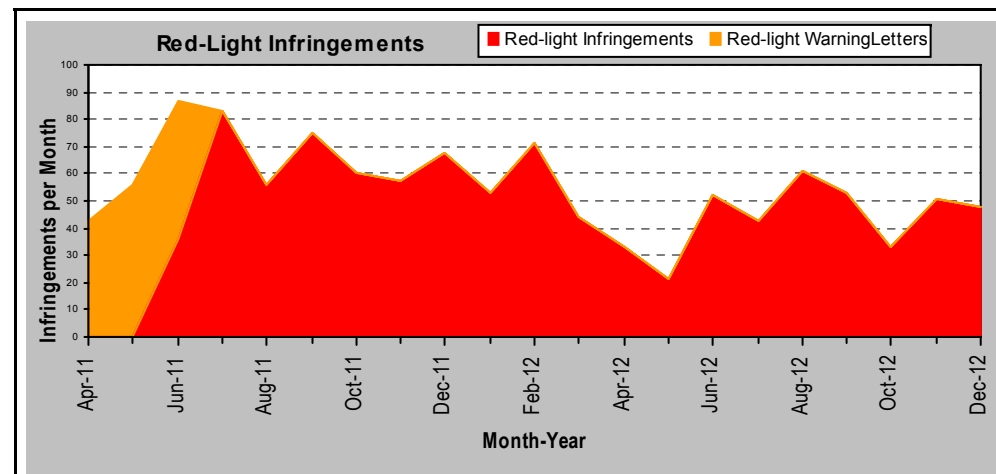
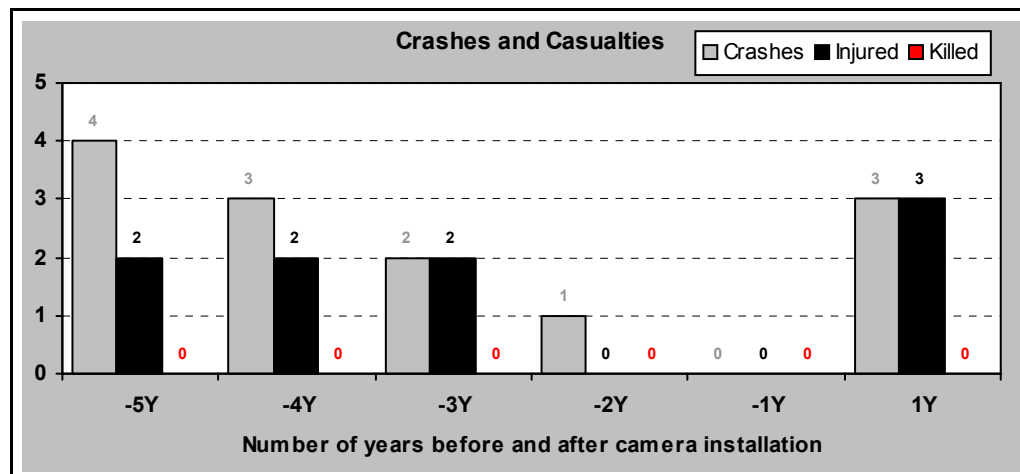
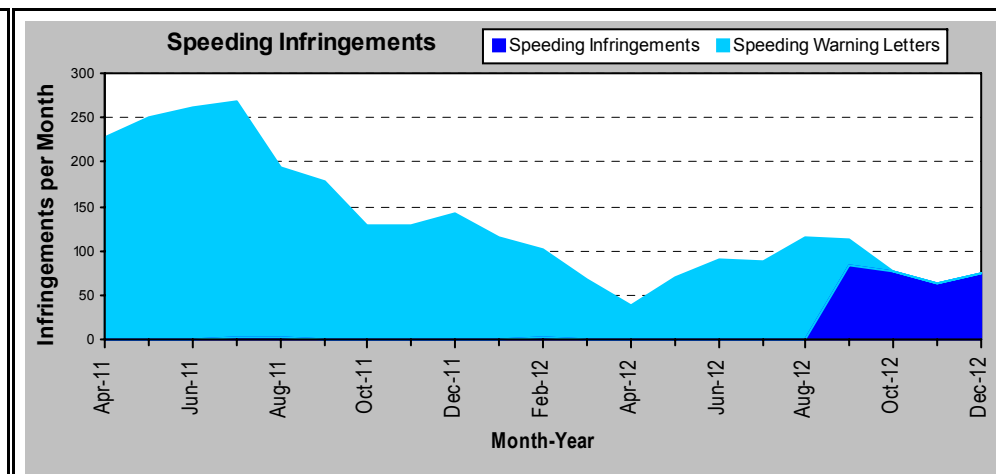
### Infringements at safety camera location

- There is one camera at this intersection. This was previously a wet-film red-light camera location.
- The camera at the intersection of Princes Highway and O'Briens Road commenced issuing warning letters in April 2011.
- While early results indicate a slight increase in crashes, a more comprehensive analysis over a longer time period is required before making any conclusions about the effectiveness of the camera.
- The infringement graphs show the number of warning letters and infringements issued at this intersection as well as the trend in infringements since the camera began operation. Roadworks and camera maintenance may influence the number of infringements issued.

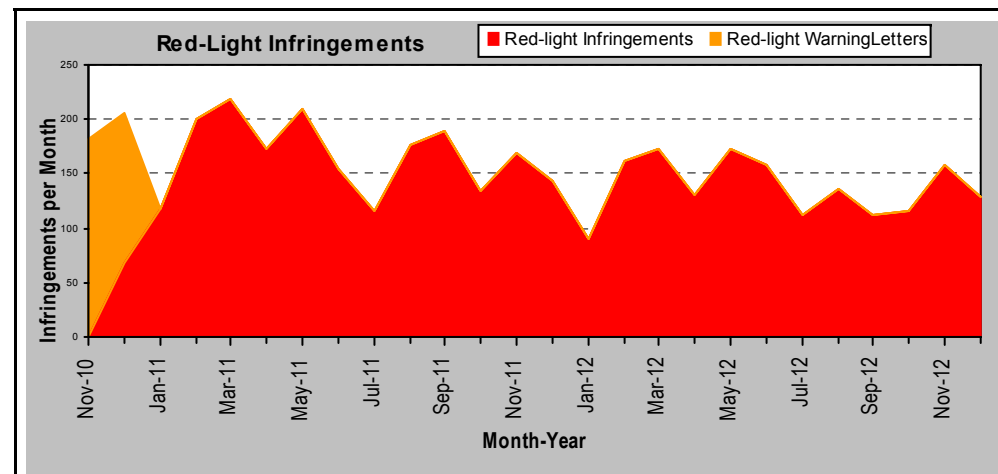
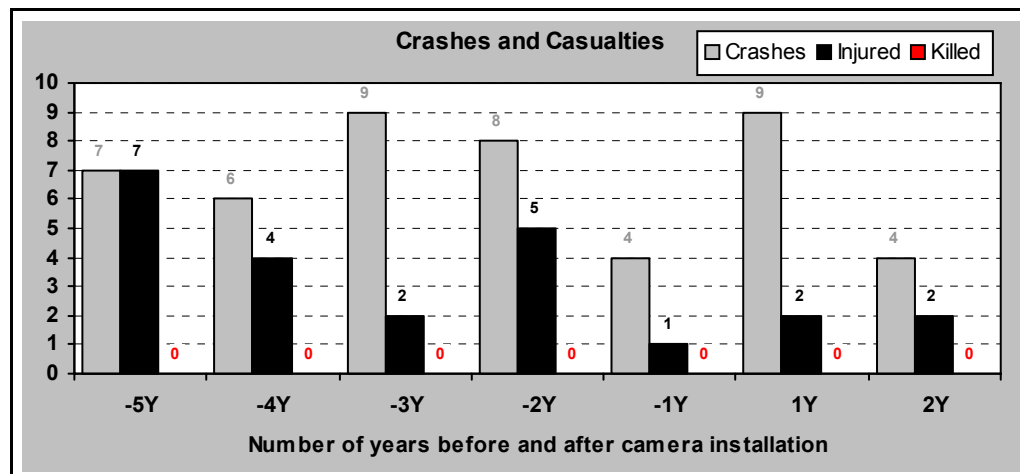
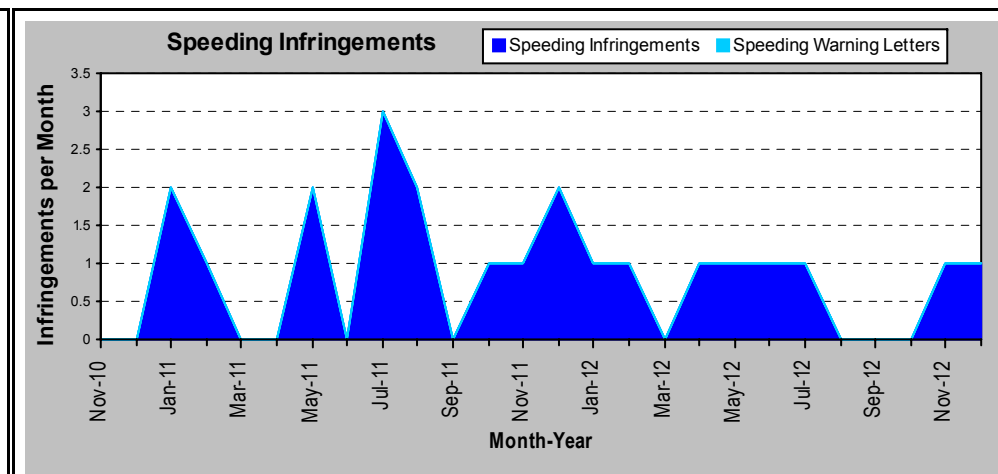
### Infringements at safety camera location

- There is one camera at this intersection. This was previously a wet-film red-light camera location.
- The camera at the intersection of Fairlight St and Ramsay Rd commenced issuing warning letters in November 2010.
- While the results available so far are encouraging, a more comprehensive analysis over a longer time period is required before making any conclusions about the effectiveness of the camera.
- The infringement graphs show the number of warning letters and infringements issued at this intersection as well as the trend in infringements since the camera began operation. Roadworks and camera maintenance may influence the number of infringements issued.

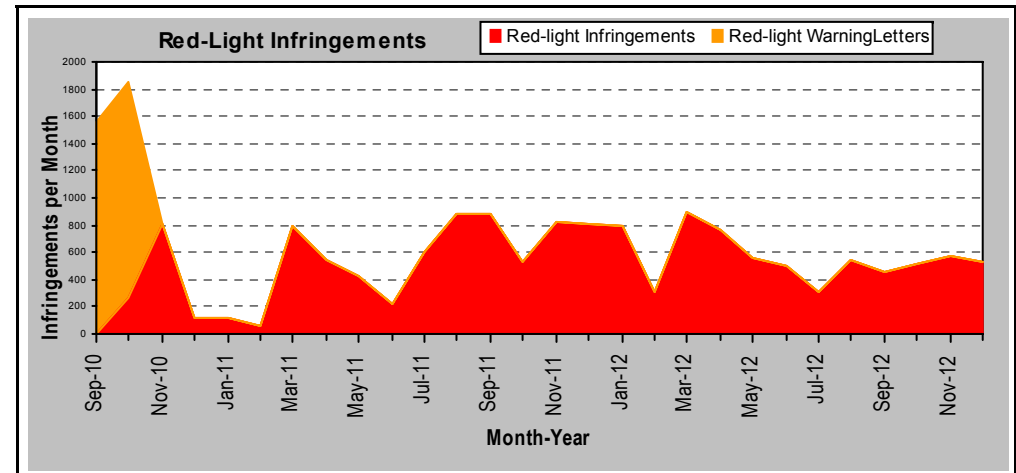
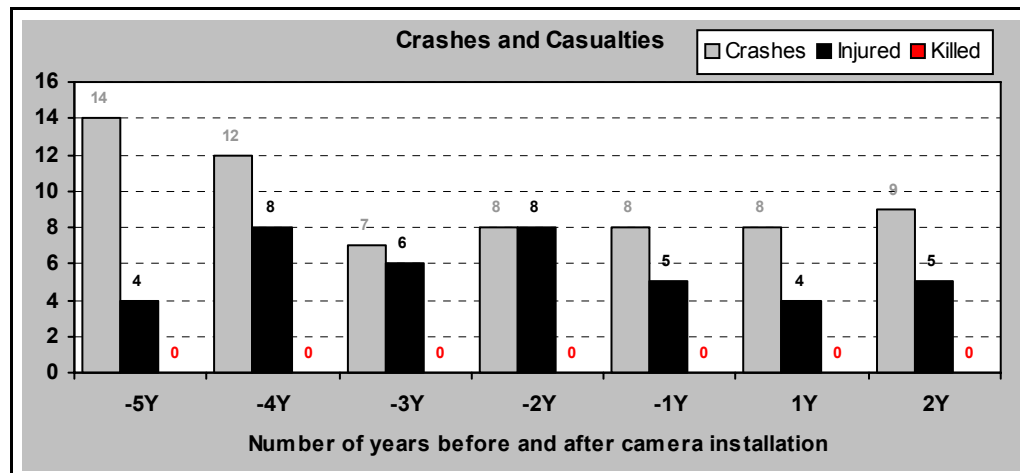
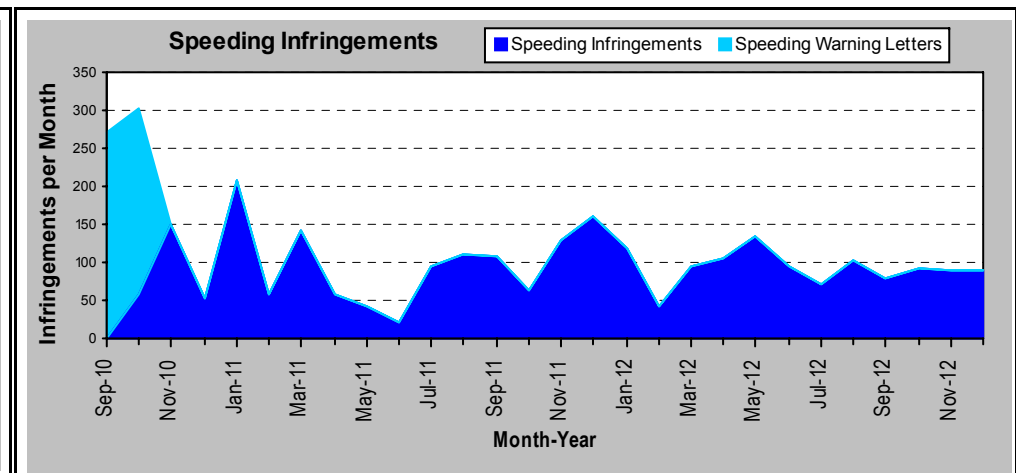
## Infringements at safety camera location

- There is one camera at this intersection.
- The camera at the intersection of Woodville Rd and M4 on ramp commenced issuing warning letters in September 2010.
- While the results available so far are encouraging, a more comprehensive analysis over a longer time period is required before making any conclusions about the effectiveness of the camera.
- The infringement graphs show the number of warning letters and infringements issued at this intersection as well as the trend in infringements since the camera began operation. Roadworks and camera maintenance may influence the number of infringements issued.

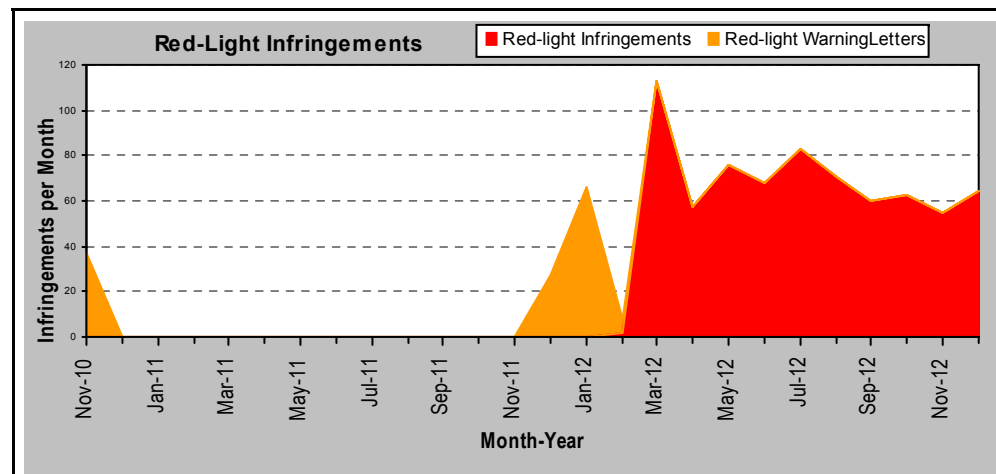
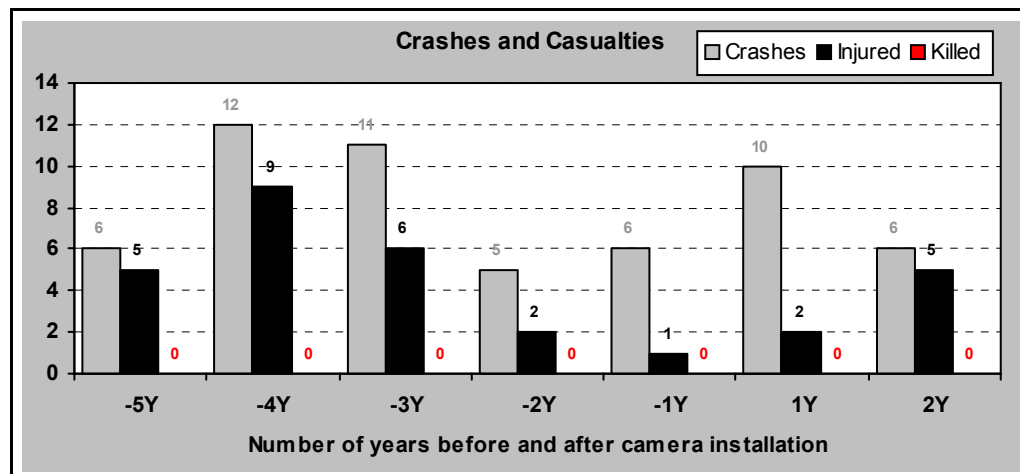
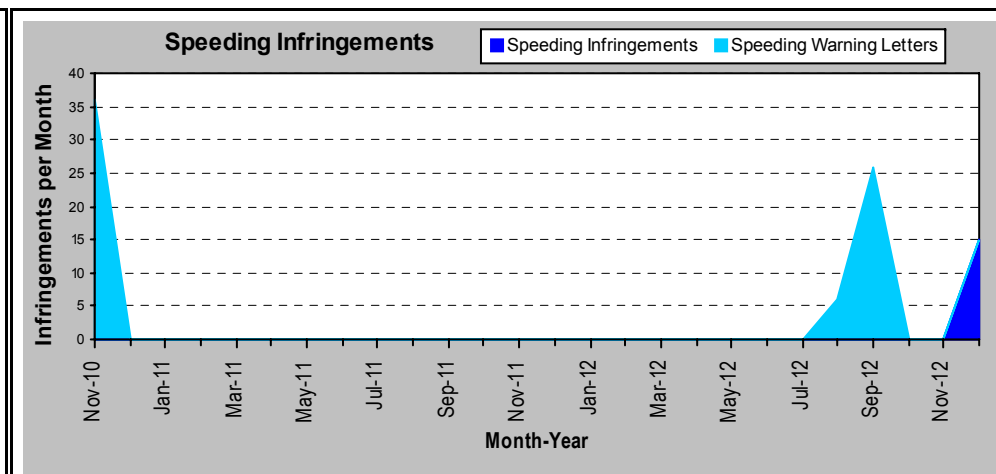
### Infringements at safety camera location

- There is one camera at this intersection. This was previously a wet-film red-light camera location.
- The camera at the intersection of Woodville Rd and Guildford Rd commenced issuing warning letters in November 2010.
- While the results available so far are encouraging, a more comprehensive analysis over a longer time period is required before making any conclusions about the effectiveness of the camera.
- The infringement graphs show the number of warning letters and infringements issued at this intersection since the camera began operation. Roadworks and camera maintenance may influence the number of infringements issued.

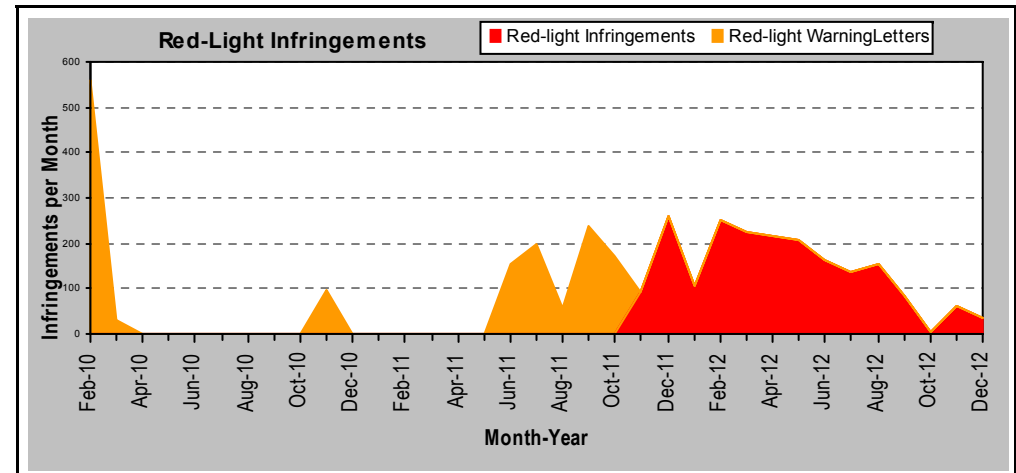
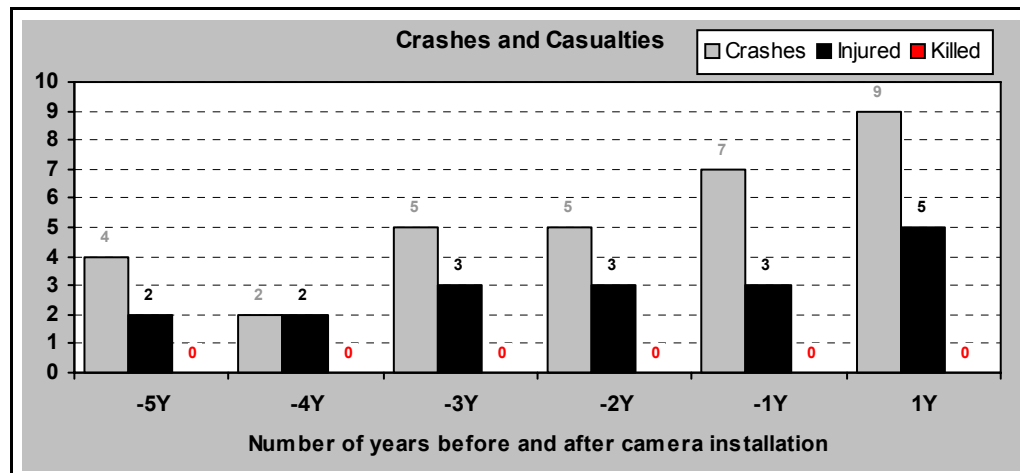
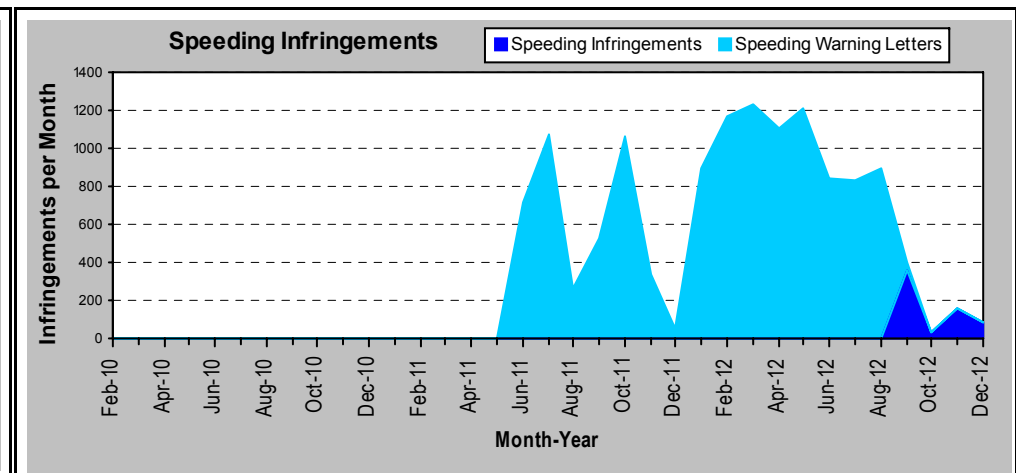
### Infringements at safety camera location

- There is one camera at this intersection. This was previously a wet-film red-light camera location.
- The camera at the intersection of Dobroyd Pde and Mortley Drive commenced issuing warning letters in June 2011.
- While early results indicate a slight increase in crashes, a more comprehensive analysis over a longer time period is required before making any conclusions about the effectiveness of the camera.
- The infringement graphs show the number of warning letters and infringements issued at this intersection as well as the trend in infringements since the camera began operation. Roadworks and camera maintenance may influence the number of infringements issued.

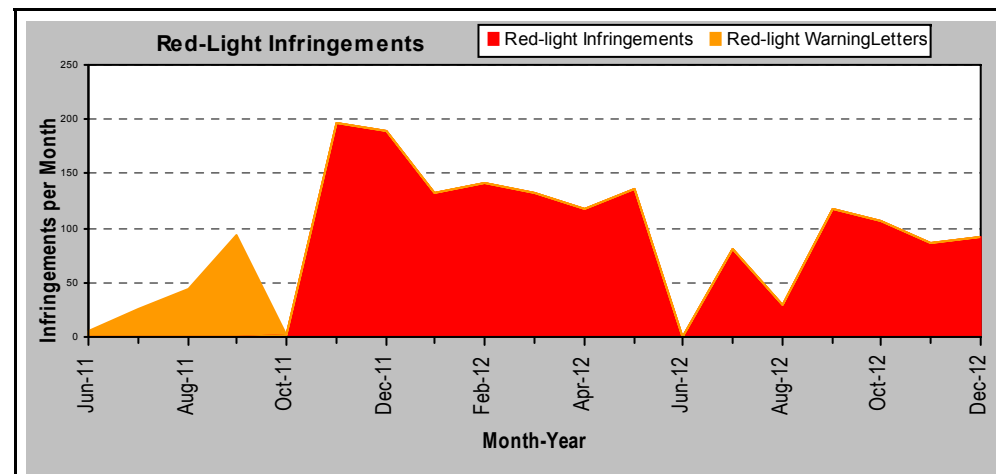
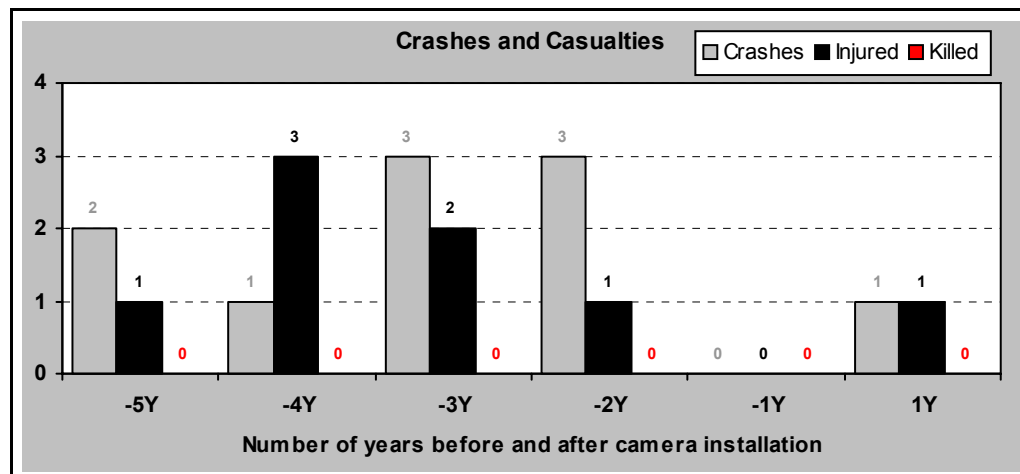
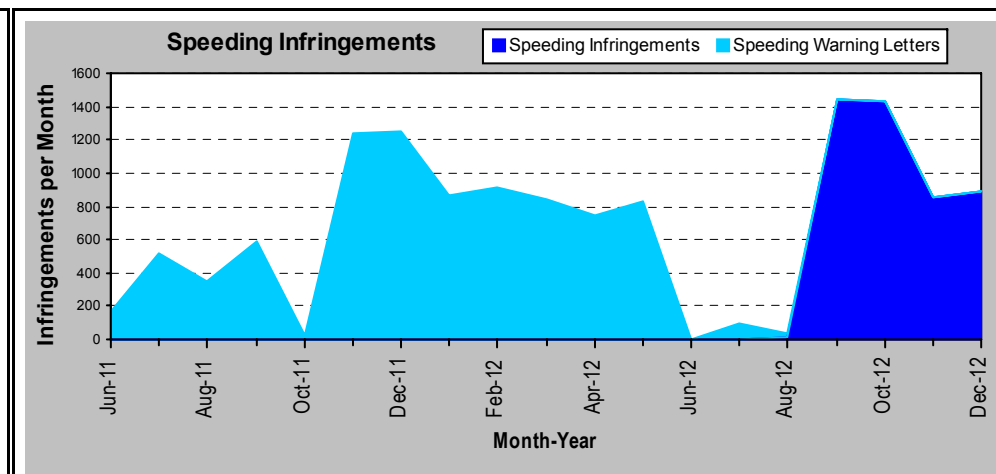
### Infringements at safety camera location

- There is one camera at this intersection. This was previously a wet-film red-light camera location.
- The camera at the intersection of Parramatta Road and Sloane Street commenced issuing warning letters in June 2011.
- While the results available so far are encouraging, a more comprehensive analysis over a longer time period is required before making any conclusions about the effectiveness of the camera.
- The infringement graphs show the number of warning letters and infringements issued at this intersection as well as the trend in infringements since the camera began operation. Roadworks and camera maintenance may influence the number of infringements issued.
