Transport  
for NSW

# ANNUAL NSW SPEED CAMERA PERFORMANCE REVIEW

NSW Centre for Road Safety

AUGUST 2013

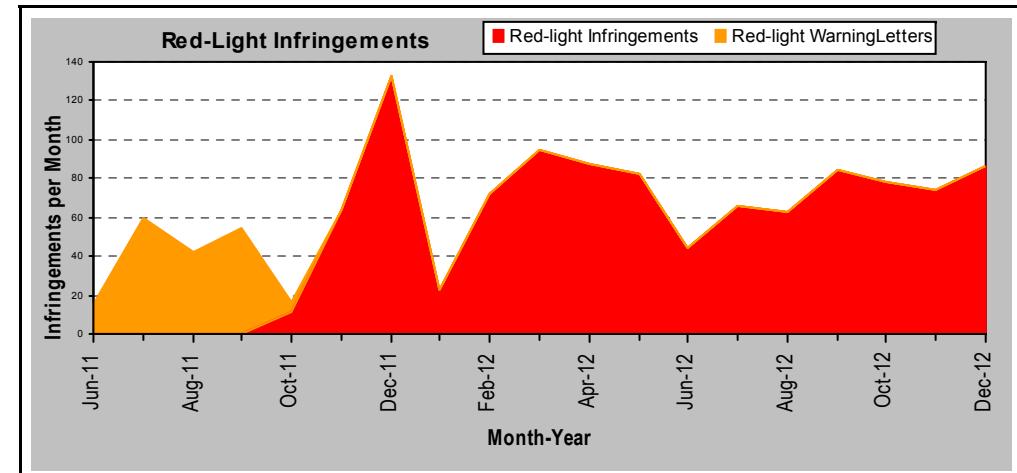
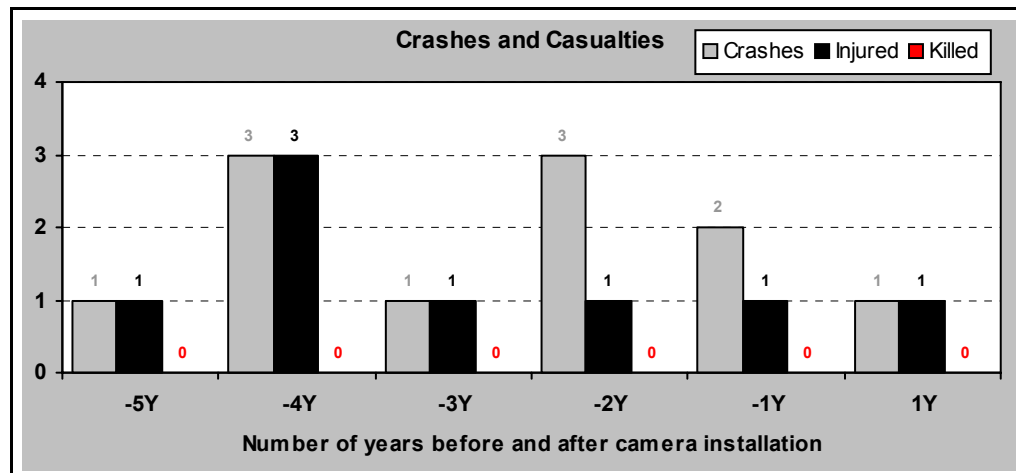
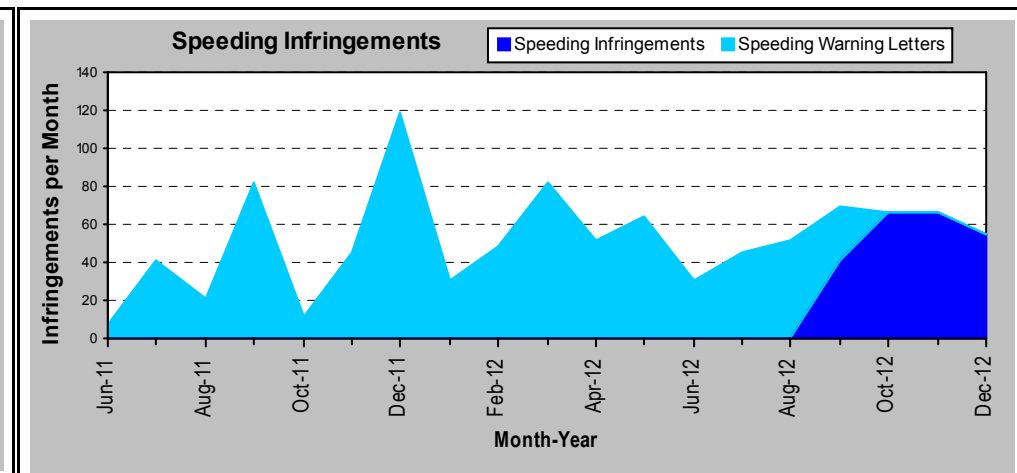
### Infringements at safety camera location

- There is one camera at this intersection. This was previously a wet-film red-light camera location.
- The camera at the intersection of Tudor Street and Beaumont Street commenced issuing warning letters in June 2011.
- While the results available so far are encouraging, a more comprehensive analysis over a longer time period is required before making any conclusions about the effectiveness of the camera.
- The infringement graphs show the number of warning letters and infringements issued at this intersection as well as the trend in infringements since the camera began operation. Roadworks and camera maintenance may influence the number of infringements issued.

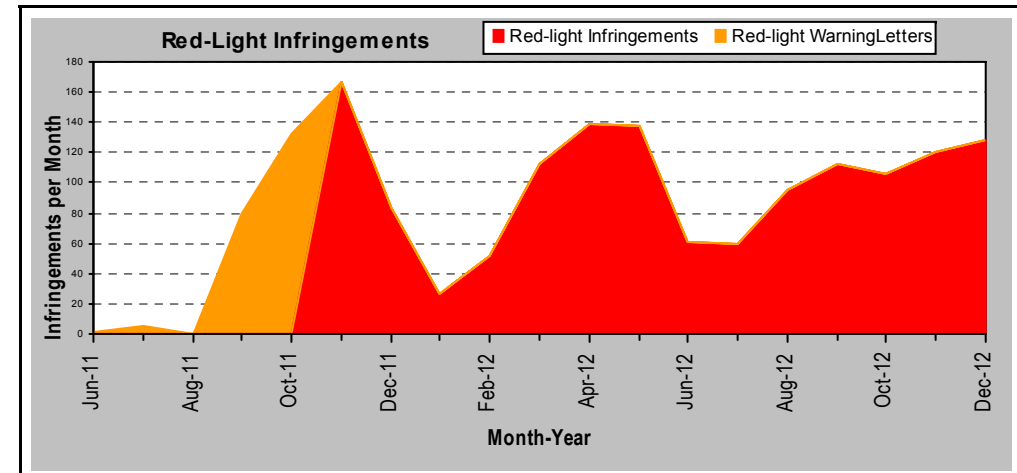
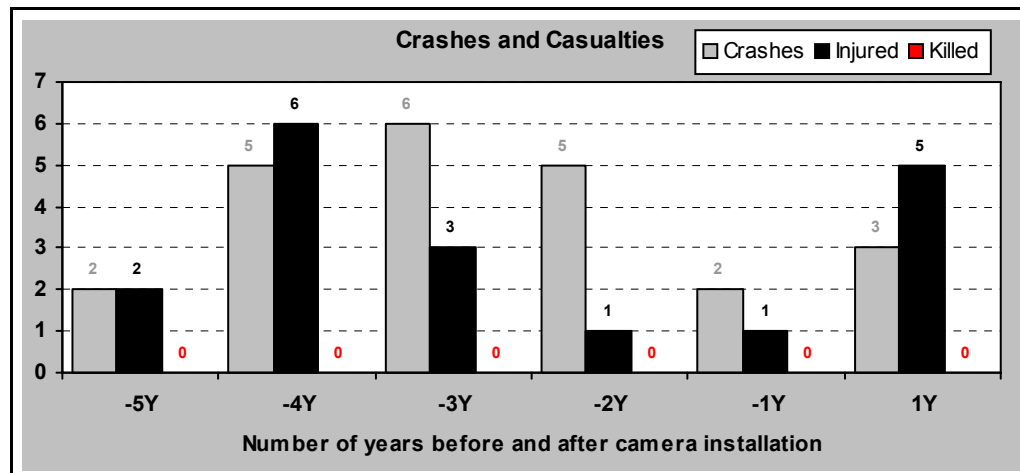
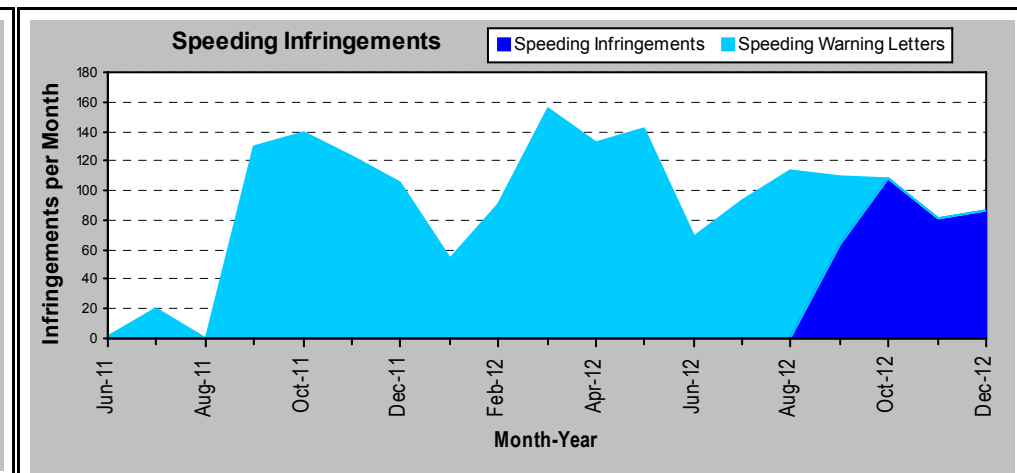
### Infringements at safety camera location

- There is one camera at this intersection.
- The camera at the intersection of Pacific Highway and Parry Street commenced issuing warning letters in June 2011.
- While early results indicate a slight increase in casualties, a more comprehensive analysis over a longer time period is required before making any conclusions about the effectiveness of the camera.
- The infringement graphs show the number of warning letters and infringements issued at this intersection as well as the trend in infringements since the camera began operation. Roadworks and camera maintenance may influence the number of infringements issued.

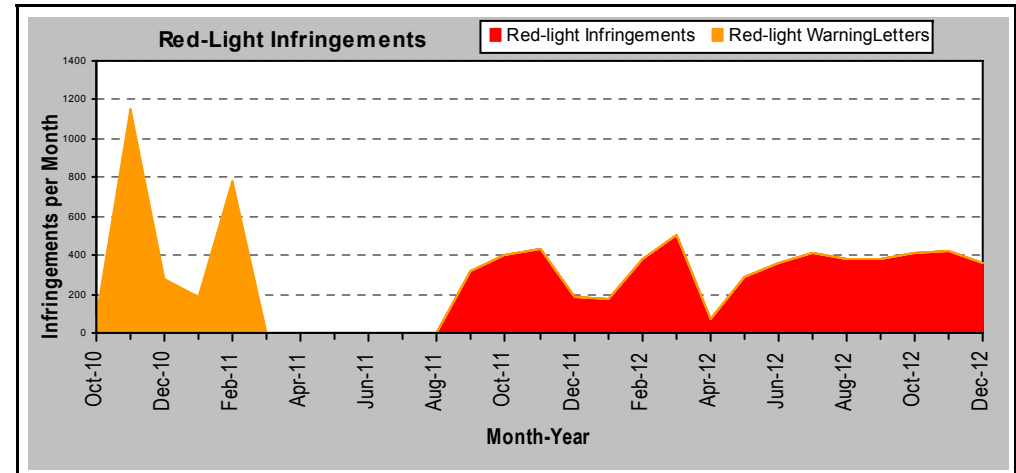
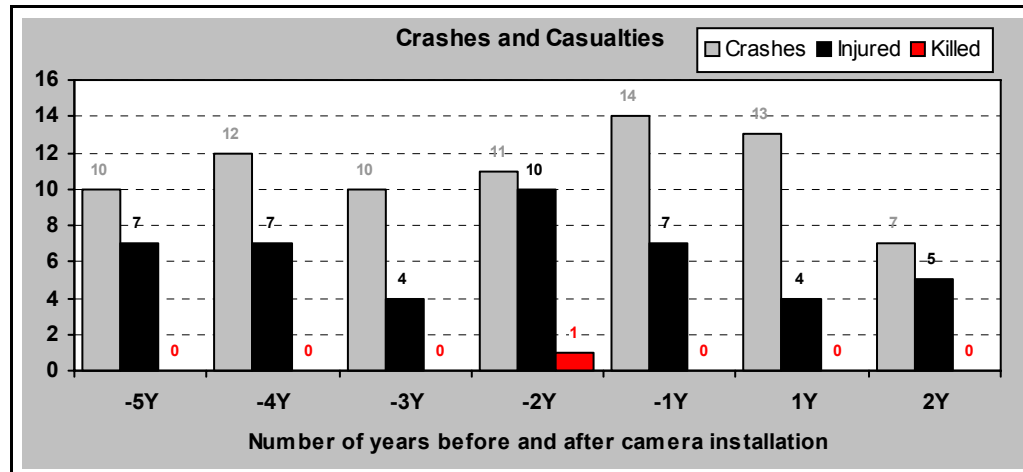
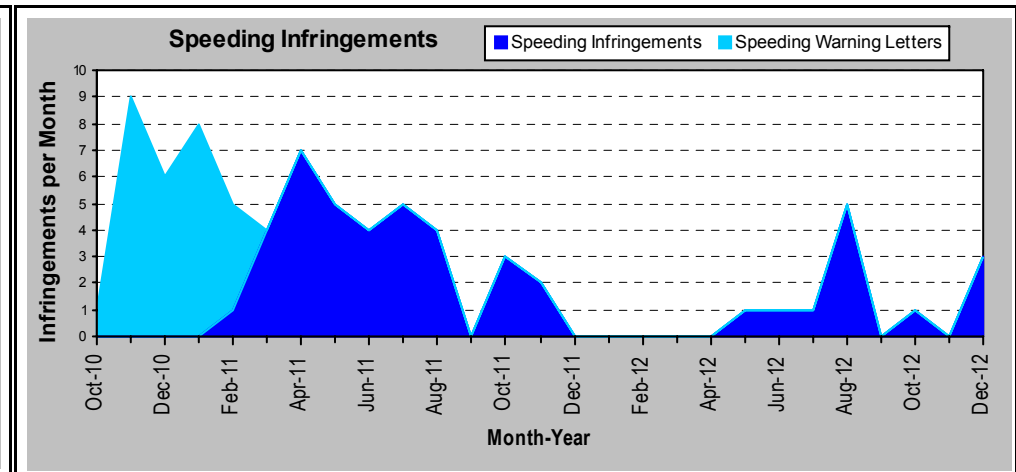
### Infringements at safety camera location

- There is one camera at this intersection. This was previously a wet-film red-light camera location.
- The camera at the intersection of Arthur St and Centenary Dr commenced issuing warning letters in October 2010.
- While the results available so far are encouraging, a more comprehensive analysis over a longer time period is required before making any conclusions about the effectiveness of the camera.
- The infringement graphs show the number of warning letters and infringements issued at this intersection as well as the trend in infringements since the camera began operation. Roadworks and camera maintenance may influence the number of infringements issued.

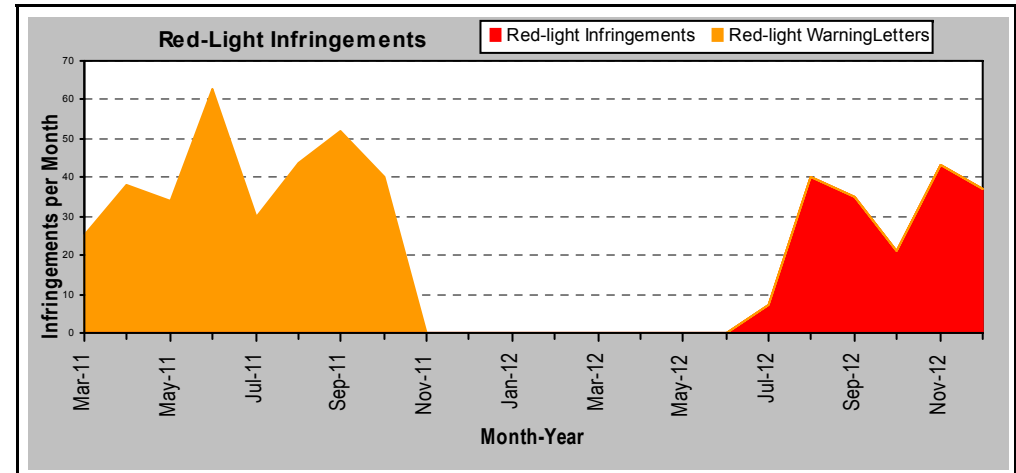
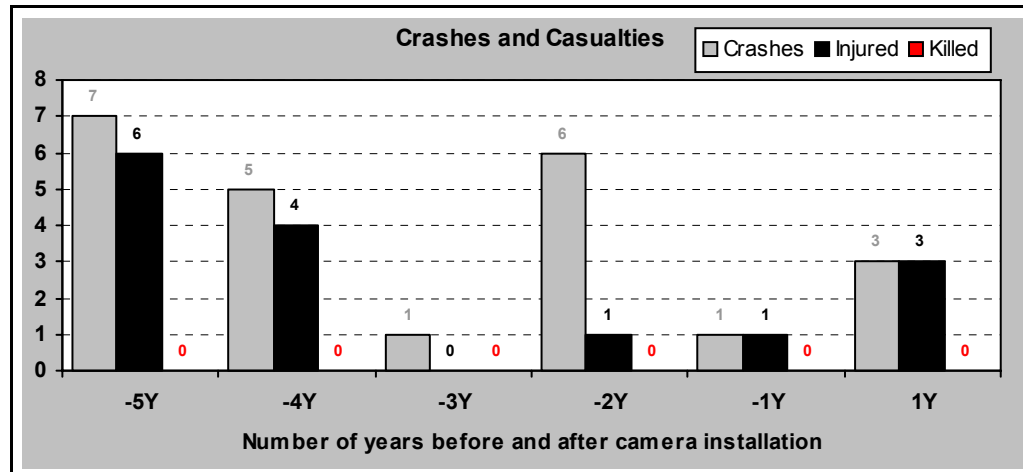
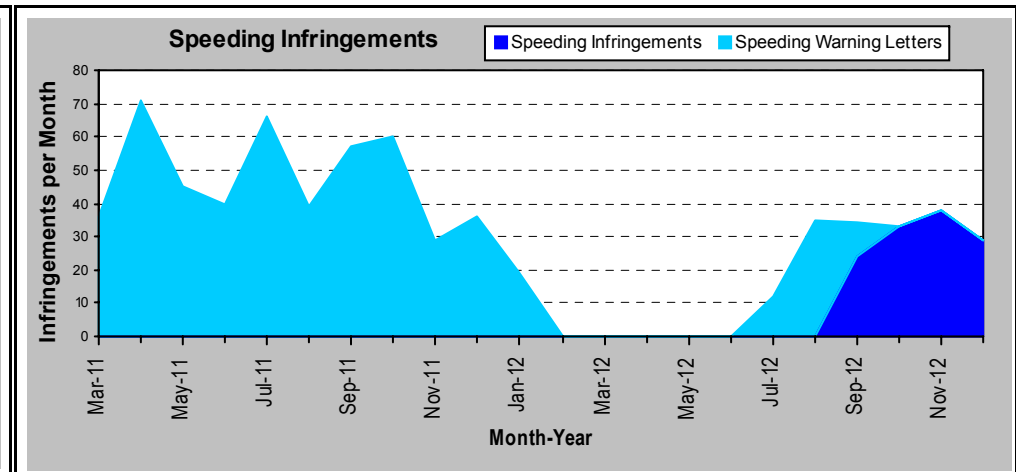
### Infringements at safety camera location

- There is one camera at this intersection. This was previously a wet-film red-light camera location.
- The camera at the intersection of Ryde Road and Pittwater Road commenced issuing warning letters in March 2011.
- While early results indicate a slight increase in casualties, a more comprehensive analysis over a longer time period is required before making any conclusions about the effectiveness of the camera.
- The infringement graphs show the number of warning letters and infringements issued at this intersection since the camera began operation. Roadworks and camera maintenance may influence the number of infringements issued.

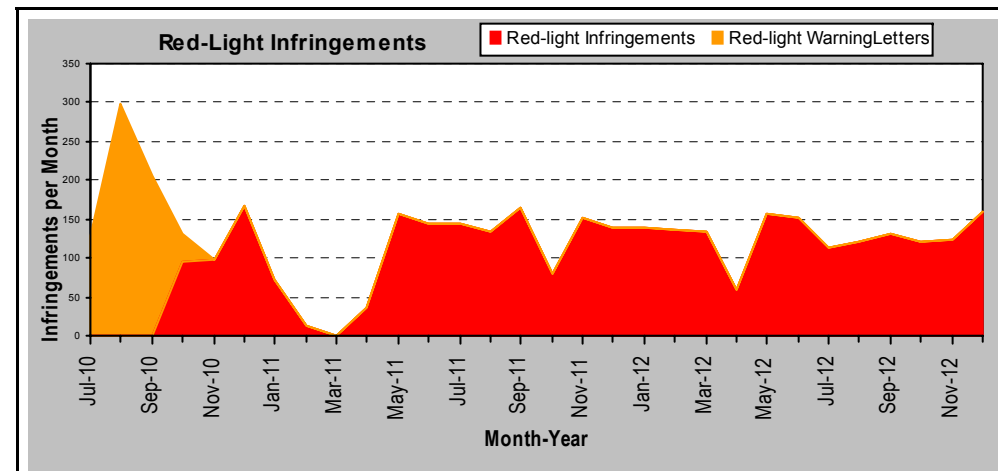
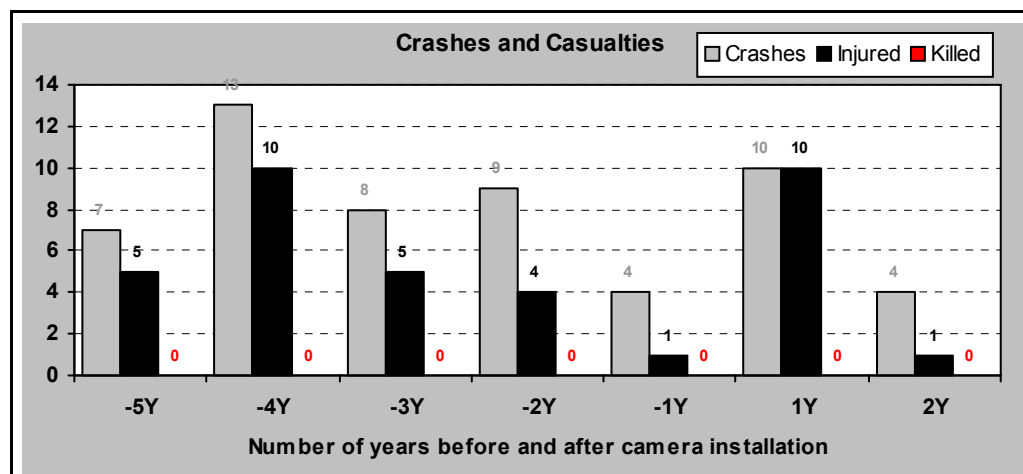
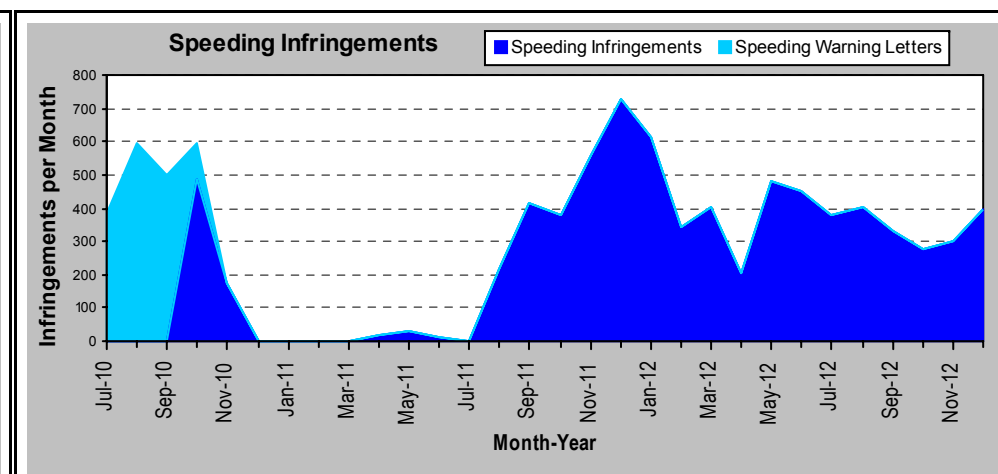
### Infringements at safety camera location

- There is one camera at this intersection.
- The camera at the intersection of Newbridge Rd and Henry Lawson Dr commenced issuing warning letters in September 2010.
- While early results indicate a slight increase in crashes, a more comprehensive analysis over a longer time period is required before making any conclusions about the effectiveness of the camera.
- The infringement graphs show the number of warning letters and infringements issued at this intersection as well as the trend in infringements since the camera began operation. Roadworks and camera maintenance may influence the number of infringements issued.

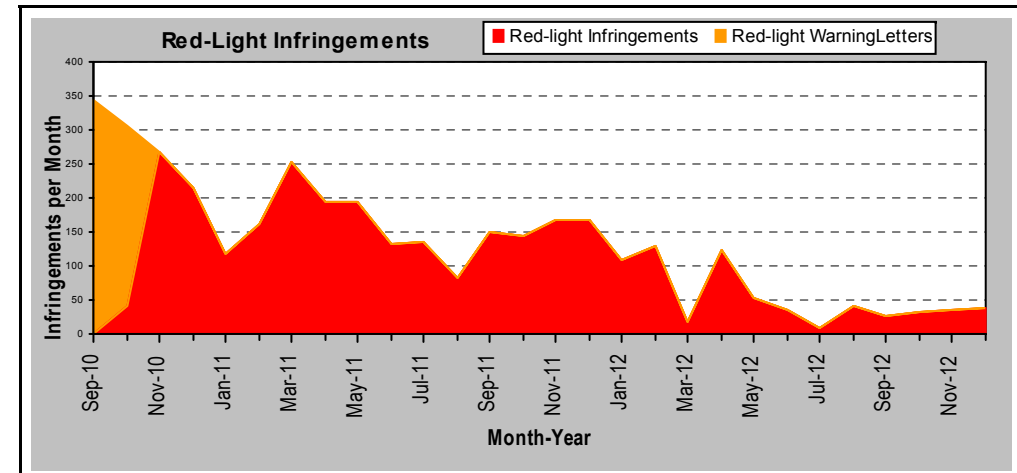
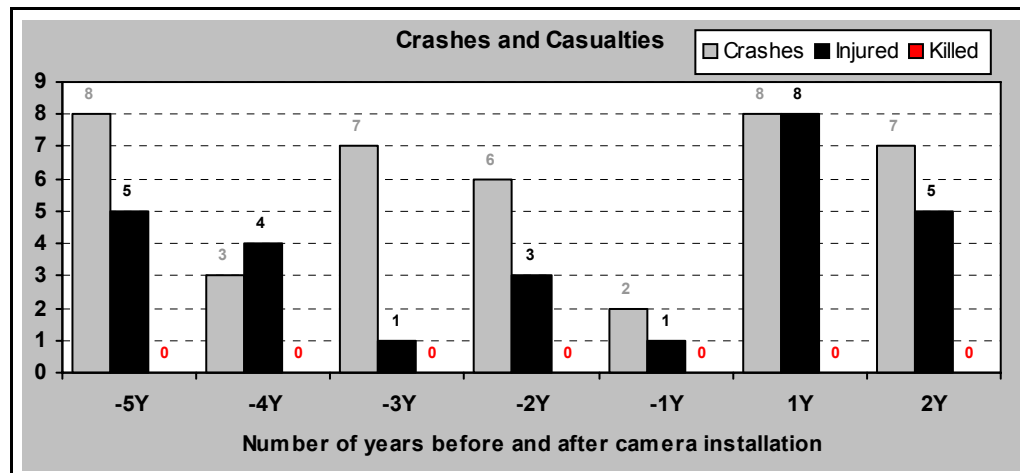
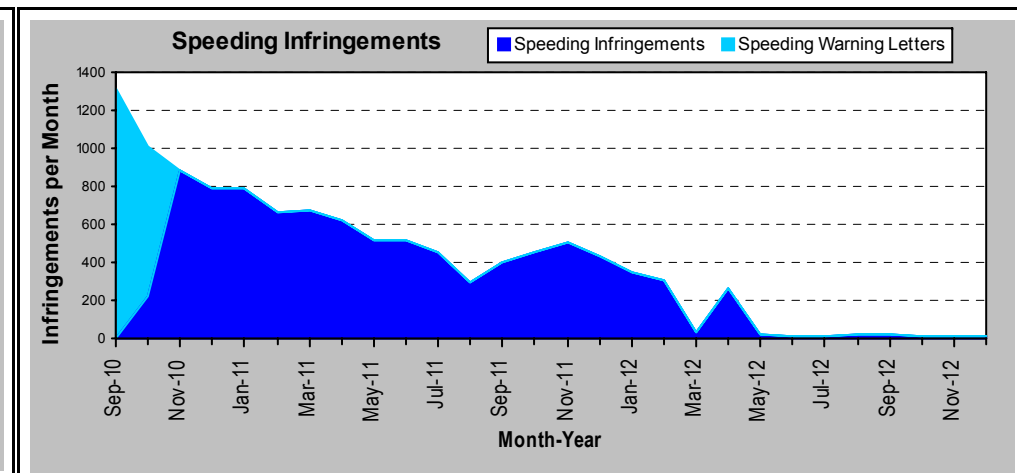
### Infringements at safety camera location

- There is one camera at this intersection.
- The camera at the intersection of Kingsway and Port Hacking Rd commenced issuing warning letters in July 2010.
- While the results available show a decrease in crashes, a more comprehensive analysis over a longer time period is required before making any conclusions about the effectiveness of the camera.
- The infringement graphs show the number of warning letters and infringements issued at this intersection as well as the trend in infringements since the camera began operation. Roadworks and camera maintenance may influence the number of infringements issued.

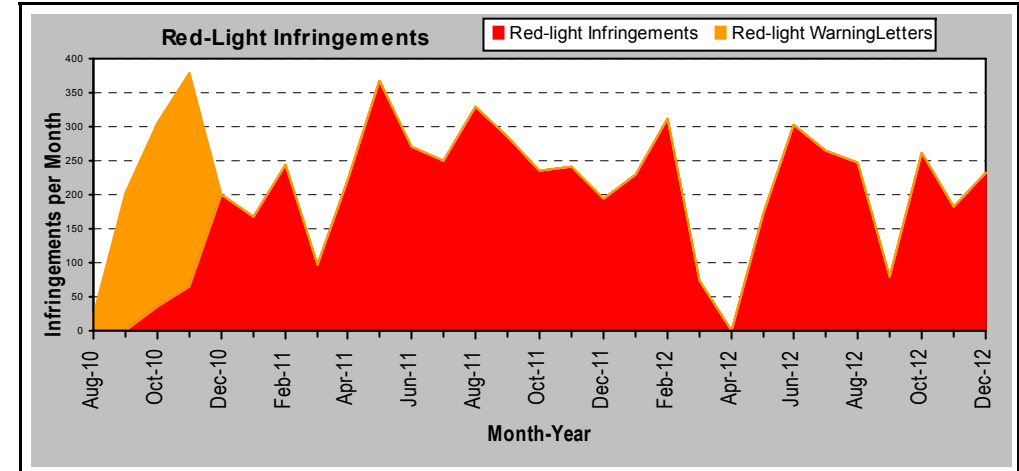
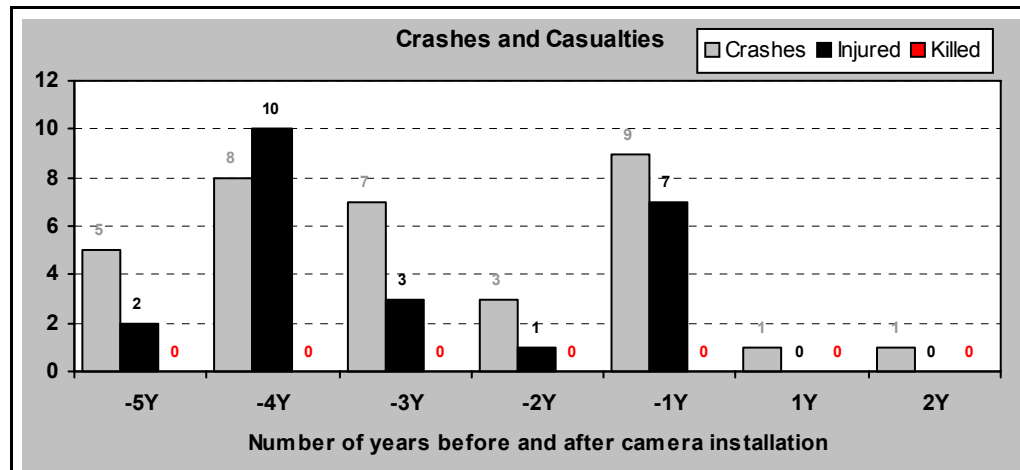
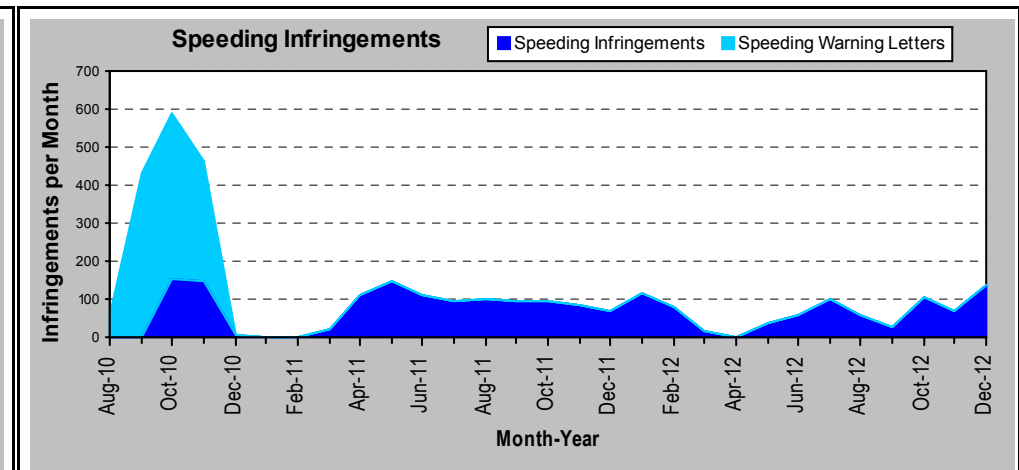
### Infringements at safety camera location

- There is one camera at this intersection. This was previously a wet-film red-light camera location.
- The camera at the intersection of Newbridge Rd and Stockton Av commenced issuing warning letters in December 2010.
- While the results available so far are encouraging, a more comprehensive analysis over a longer time period is required before making any conclusions about the effectiveness of the camera.
- The infringement graphs show the number of warning letters and infringements issued at this intersection as well as the trend in infringements since the camera began operation. Roadworks and camera maintenance may influence the number of infringements issued.

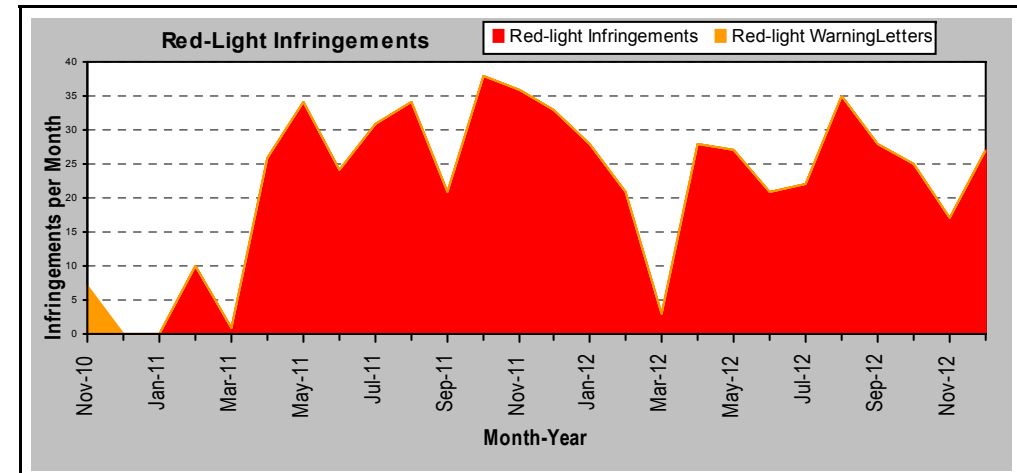
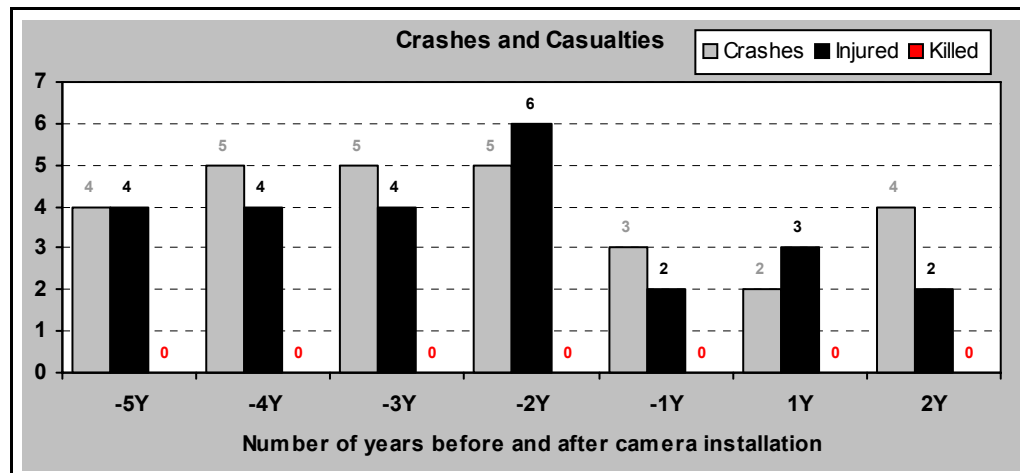
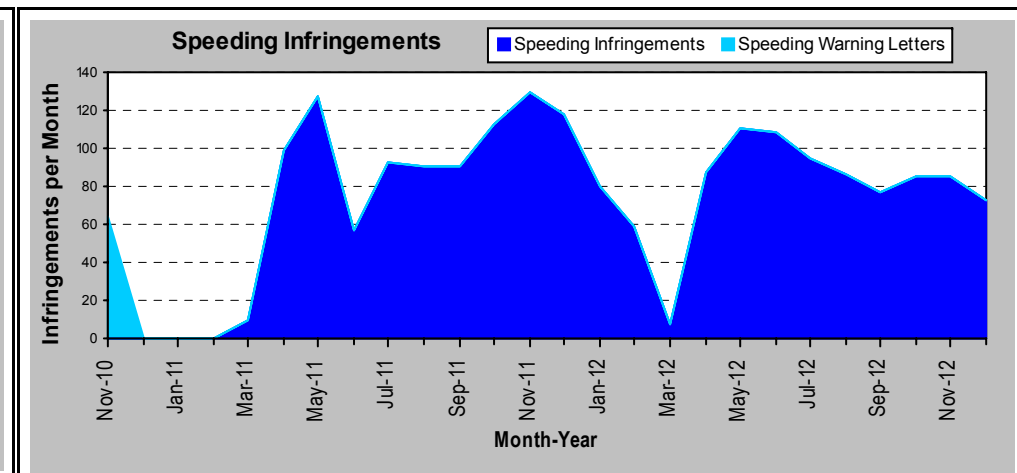
### Infringements at safety camera location

- There is one camera at this intersection. This was previously a wet-film red-light camera location.
- The camera at the intersection of Military Rd and Cowles Rd commenced issuing warning letters in December 2010.
- While early results indicate a slight increase in crashes, a more comprehensive analysis over a longer time period is required before making any conclusions about the effectiveness of the camera.
- The infringement graphs show the number of warning letters and infringements issued at this intersection as well as the trend in infringements since the camera began operation. Roadworks and camera maintenance may influence the number of infringements issued.

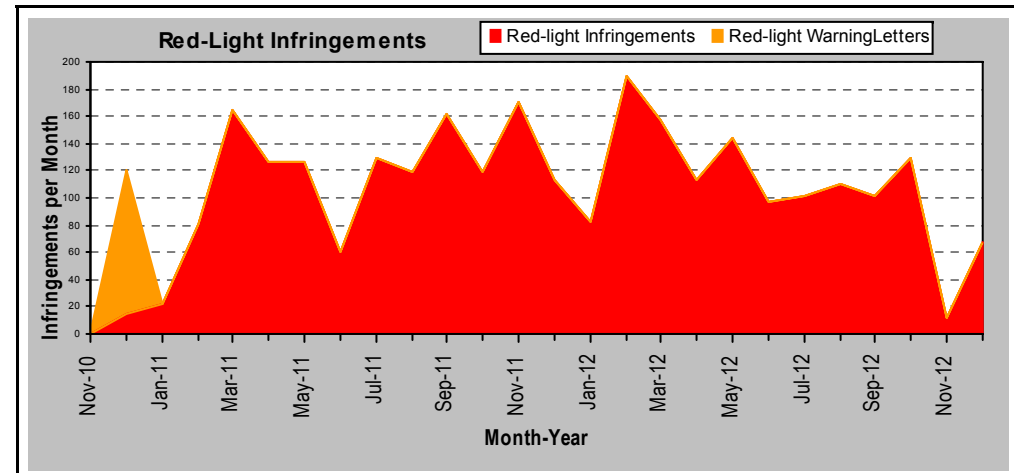
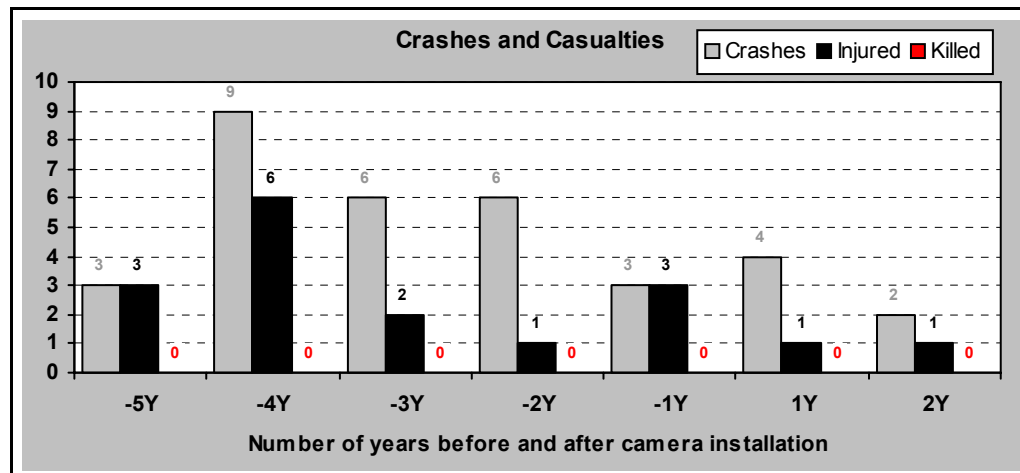
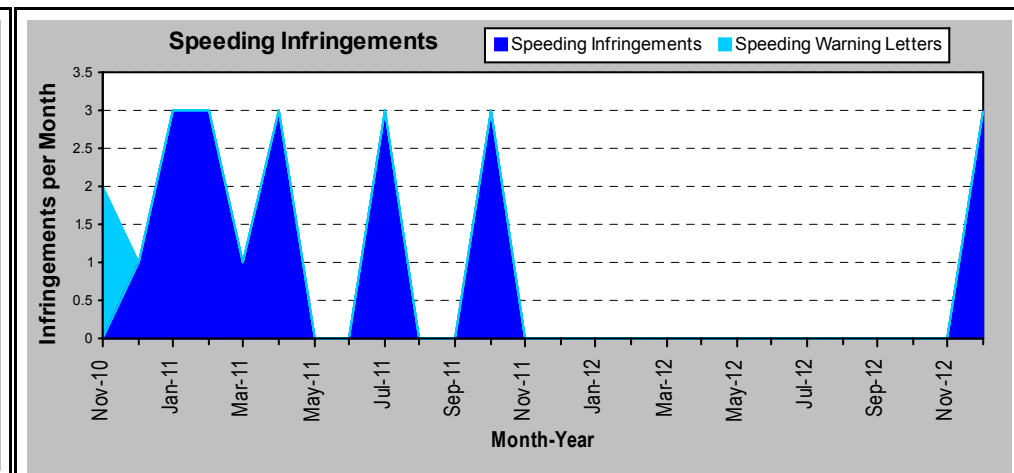
### Infringements at safety camera location

- There is one camera at this intersection. This was previously a wet-film red-light camera location.
- The camera at the intersection of Old Windsor Rd and Cumberland Hwy (Hart Dr) commenced issuing warning letters in December 2010.
- While early results indicate a slight increase in casualties, a more comprehensive analysis over a longer time period is required before making any conclusions about the effectiveness of the camera.
- The infringement graphs show the number of warning letters and infringements issued at this intersection as well as the trend in infringements since the camera began operation. Roadworks and camera maintenance may influence the number of infringements issued.

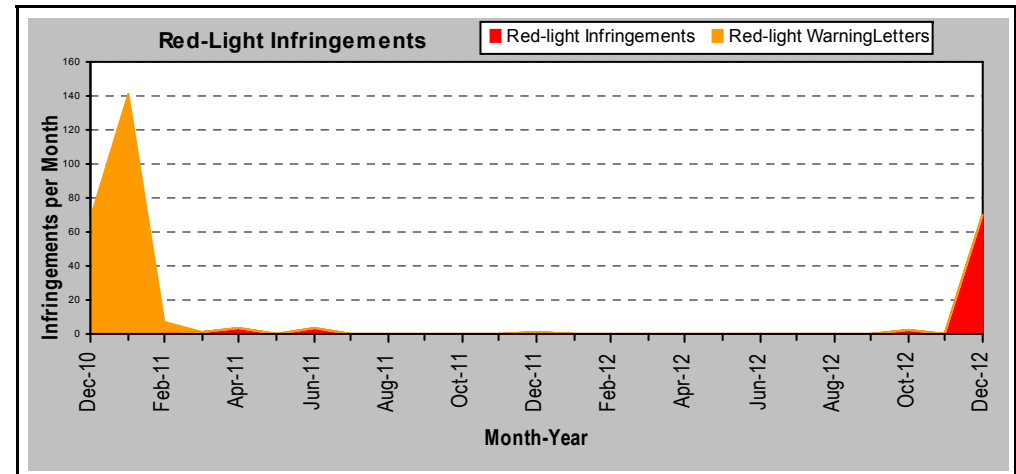
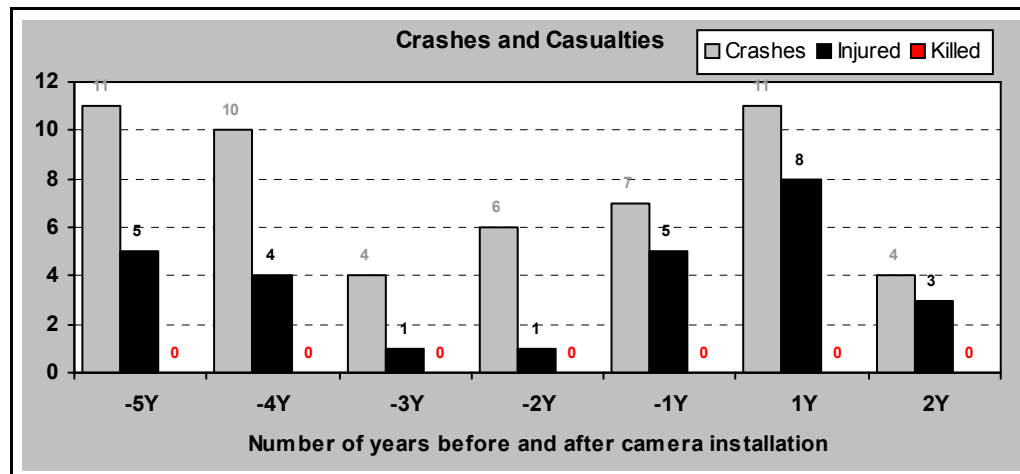
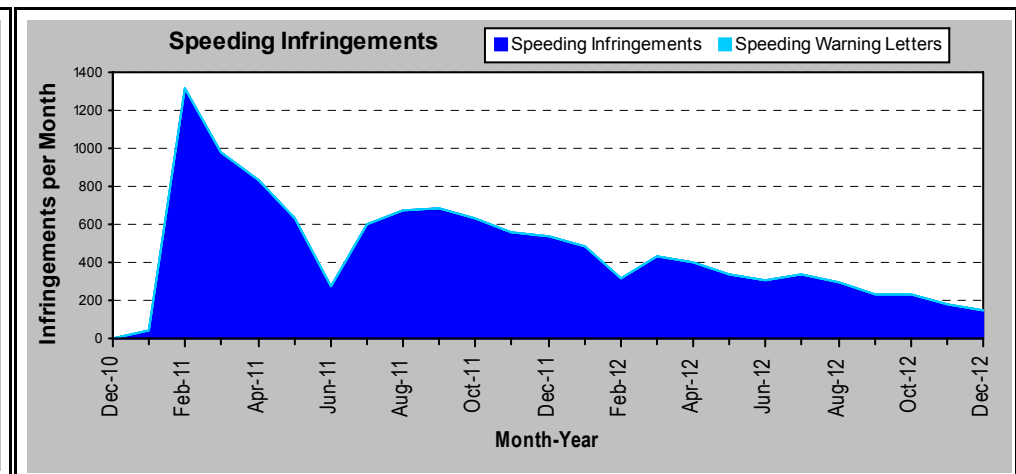
### Infringements at safety camera location

- There is one camera at this intersection. This was previously a wet-film red-light camera location.
- The camera at the intersection of Moore Park Rd and Oxford St commenced issuing warning letters in October 2010.
- While the results available so far are encouraging, a more comprehensive analysis over a longer time period is required before making any conclusions about the effectiveness of the camera.
- The infringement graphs show the number of warning letters and infringements issued at this intersection as well as the trend in infringements since the camera began operation. Roadworks and camera maintenance may influence the number of infringements issued.

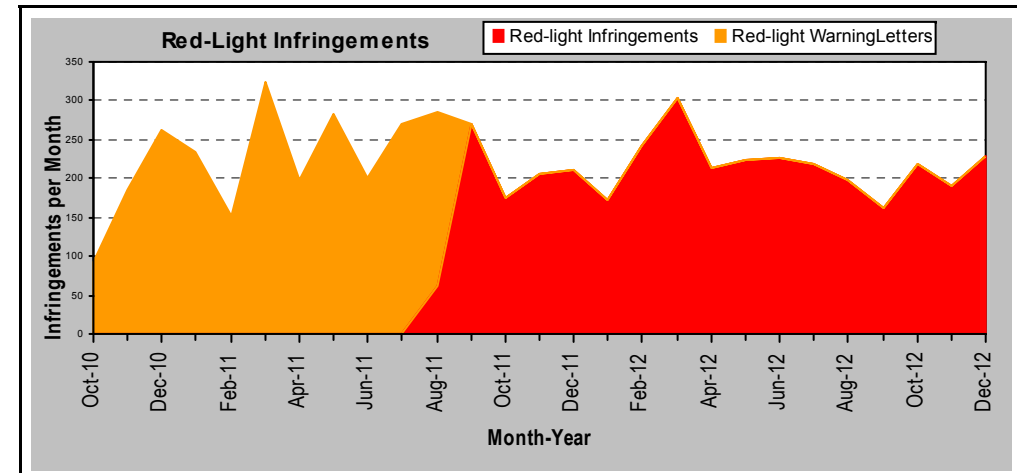
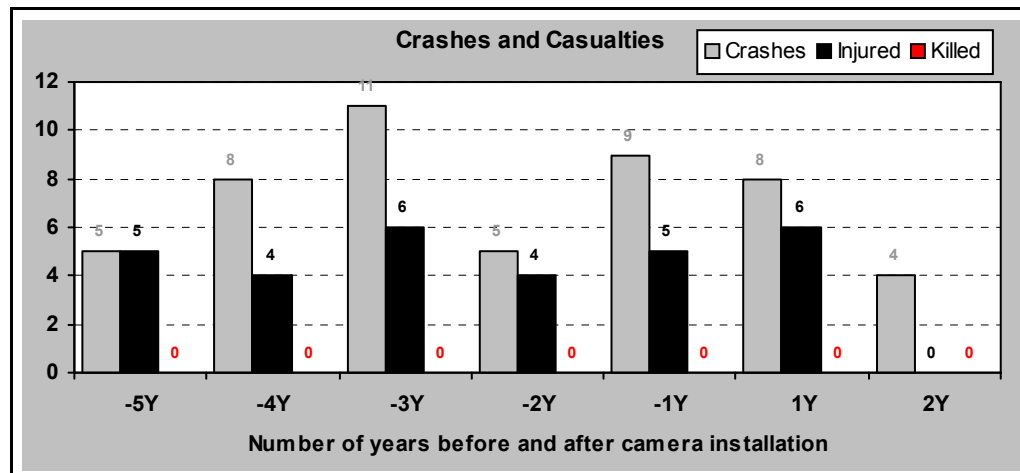
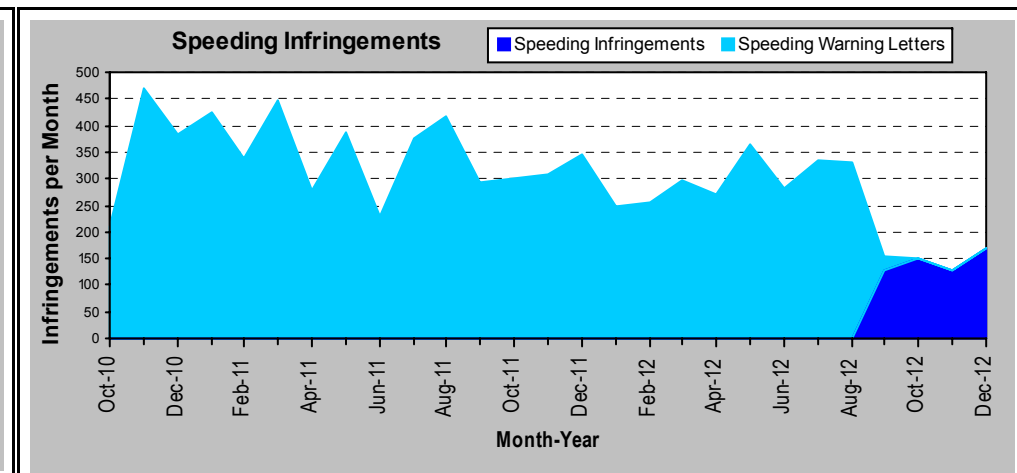
### Infringements at safety camera location

- There are two cameras at this intersection. This was previously a wet-film red-light camera location.
- The camera at the intersection of South Dowling St and Fitzroy St commenced issuing warning letters in June 2010.
- The camera at the intersection of South Dowling St and Moore Park Rd commenced issuing warning letters in June 2010.
- While the results available show a decrease in casualty crashes, a more comprehensive analysis over a longer time period is required before making any conclusions about the effectiveness of the cameras.
- The infringement graphs show the number of warning letters and infringements issued at this intersection as well as the trend in infringements since the camera began operation. Roadworks and camera maintenance may influence the number of infringements issued.

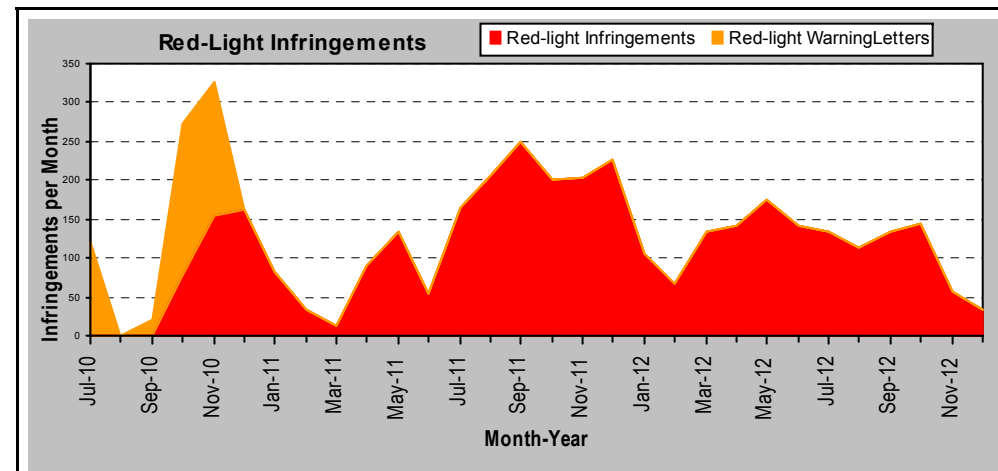
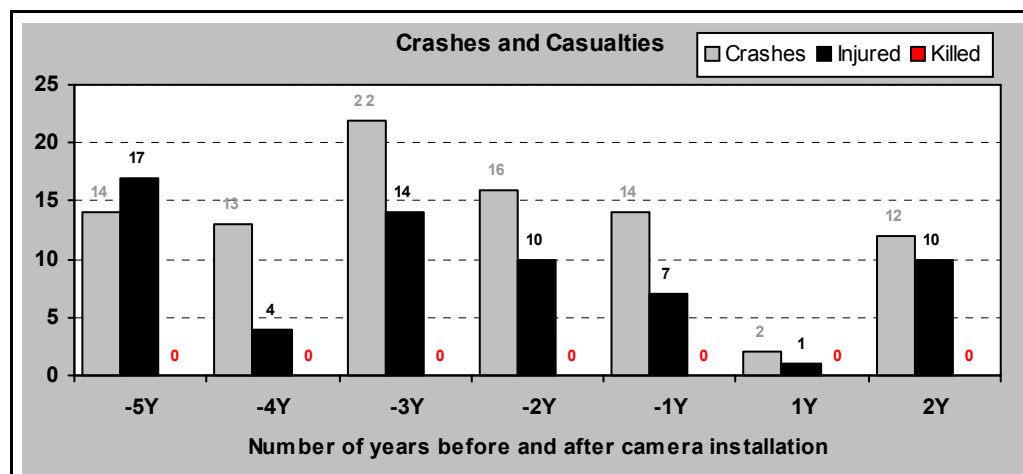
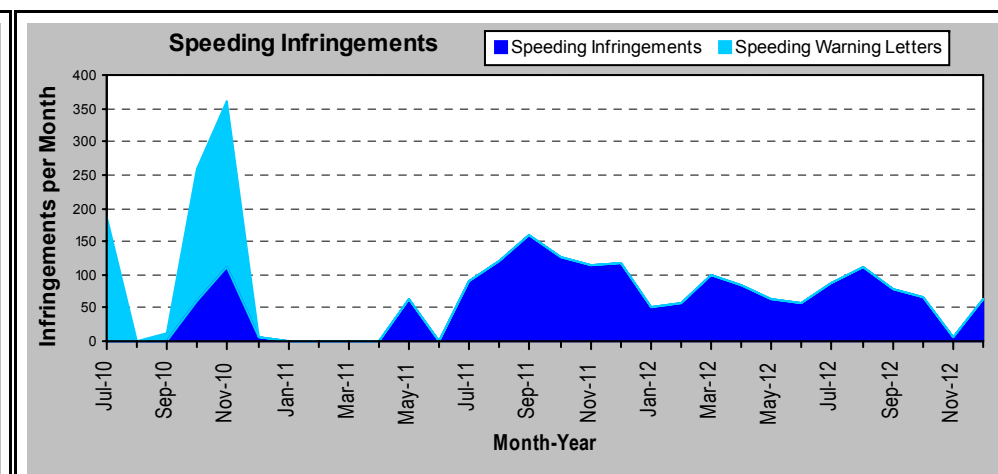
### Infringements at safety camera location

- There is one camera at this intersection. This was previously a wet-film red-light camera location.
- The camera at the intersection of Victoria Rd and Church St commenced issuing warning letters in June 2010.
- While the results available show a decrease in casualty crashes, a more comprehensive analysis over a longer time period is required before making any conclusions about the effectiveness of the camera.
- The infringement graphs show the number of warning letters and infringements issued at this intersection as well as the trend in infringements since the camera began operation. Roadworks and camera maintenance may influence the number of infringements issued.

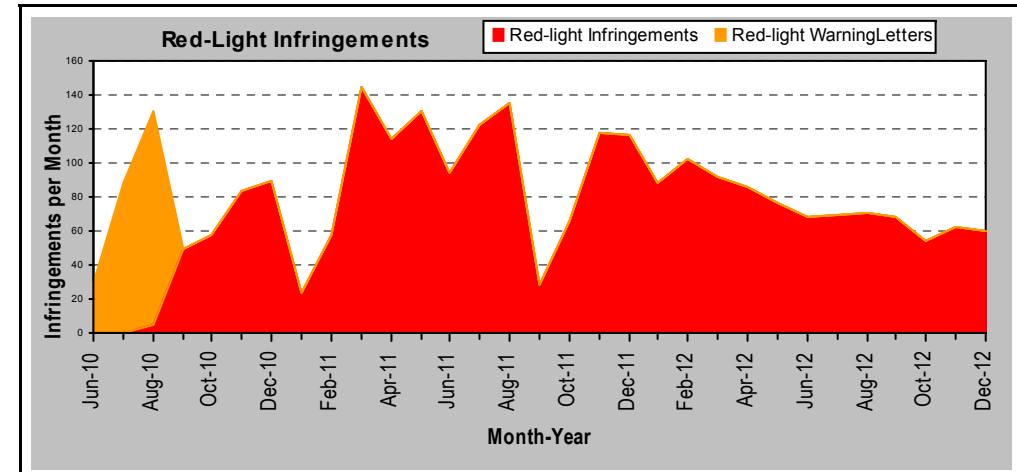
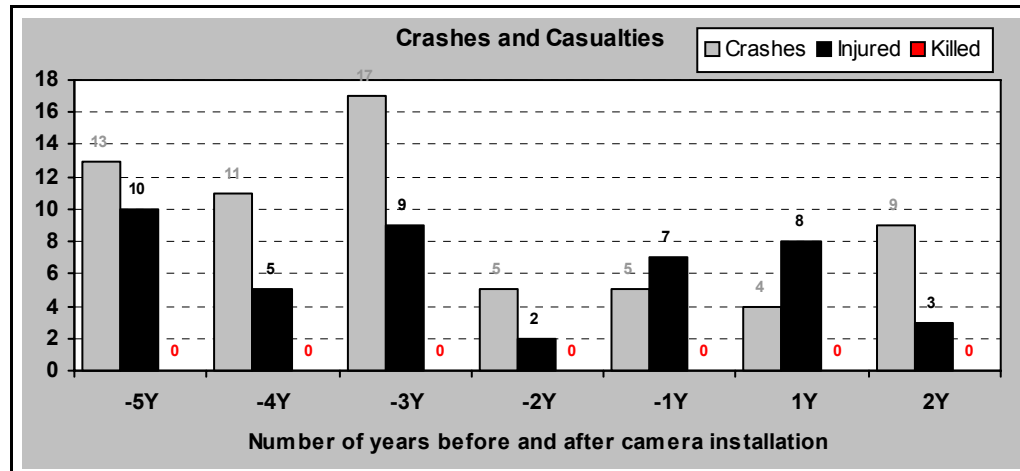
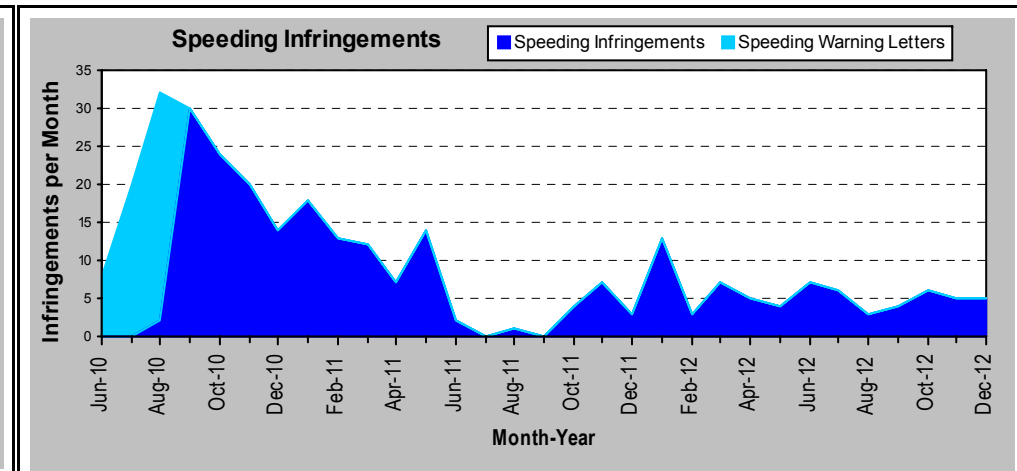
### Infringements at safety camera location

- There is one camera at this intersection. This was previously a wet-film red-light camera location.
- The camera at the intersection of Pennant Hills Rd and Beecroft Rd (W) commenced issuing warning letters in September 2010.
- While the results available so far are encouraging, a more comprehensive analysis over a longer time period is required before making any conclusions about the effectiveness of the camera.
- The infringement graphs show the number of warning letters and infringements issued at this intersection as well as the trend in infringements since the camera began operation. Roadworks and camera maintenance may influence the number of infringements issued.

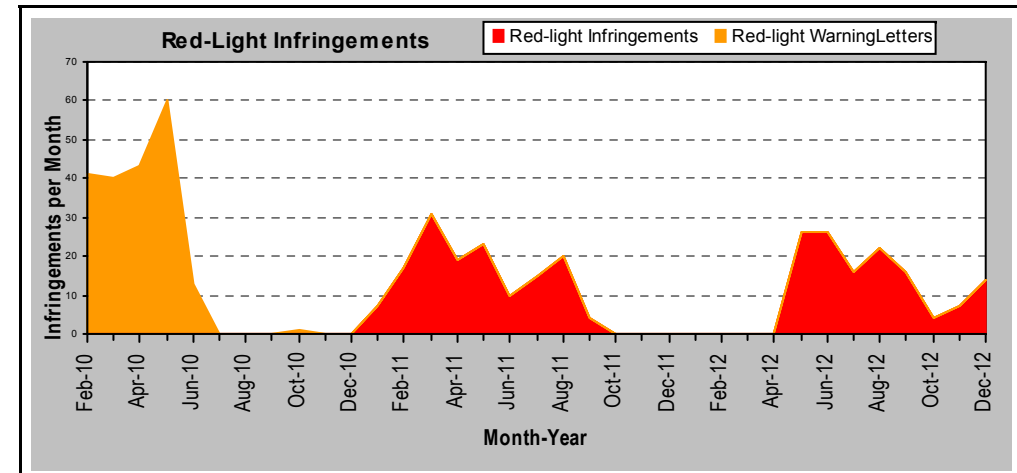
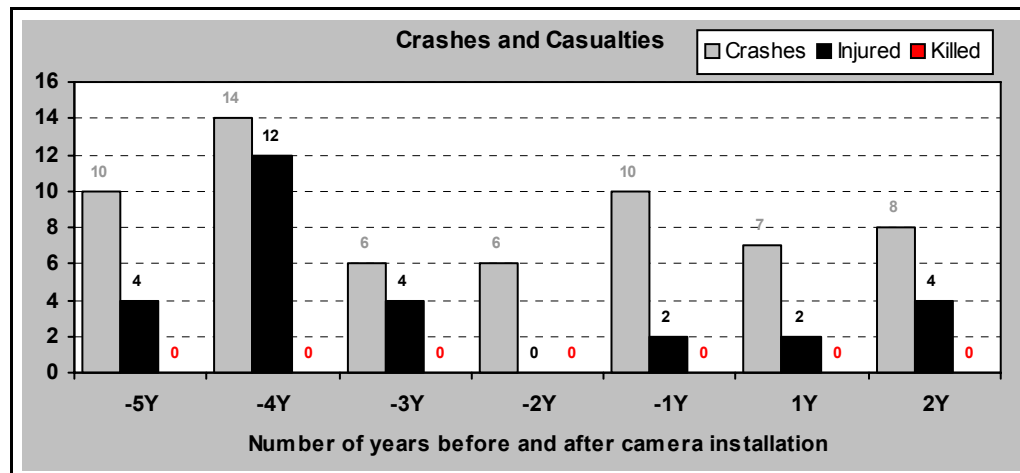
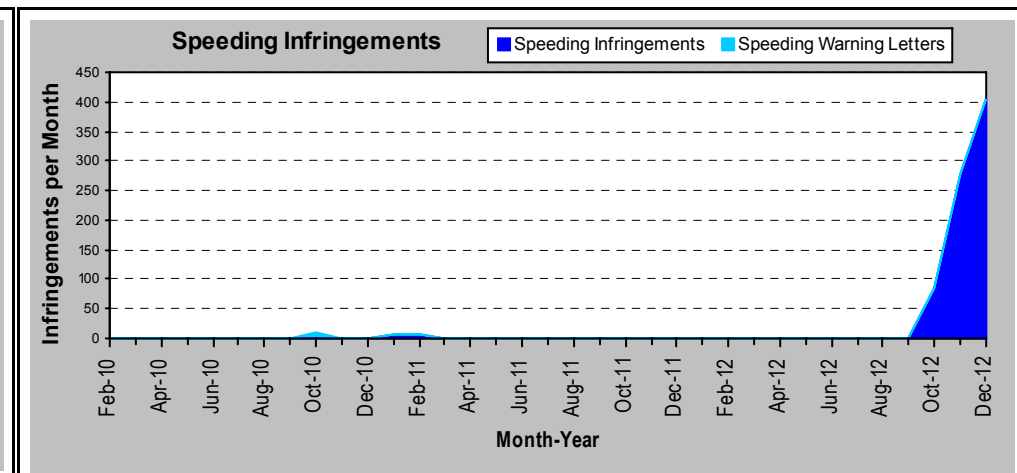
### Infringements at safety camera location

- There is one camera at this intersection. This was previously a wet-film red-light camera location.
- The camera at the intersection of Gordon St and New Canterbury Rd commenced issuing warning letters in November 2010. This camera enforces red-light running only.
- While early results indicate a slight increase in crashes, a more comprehensive analysis over a longer time period is required before making any conclusions about the effectiveness of the camera.
- The infringement graphs show the number of warning letters and infringements issued at this intersection as well as the trend in infringements since the camera began operation. Roadworks and camera maintenance may influence the number of infringements issued.
