Transport  
for NSW

# ANNUAL NSW SPEED CAMERA PERFORMANCE REVIEW

NSW Centre for Road Safety

AUGUST 2013

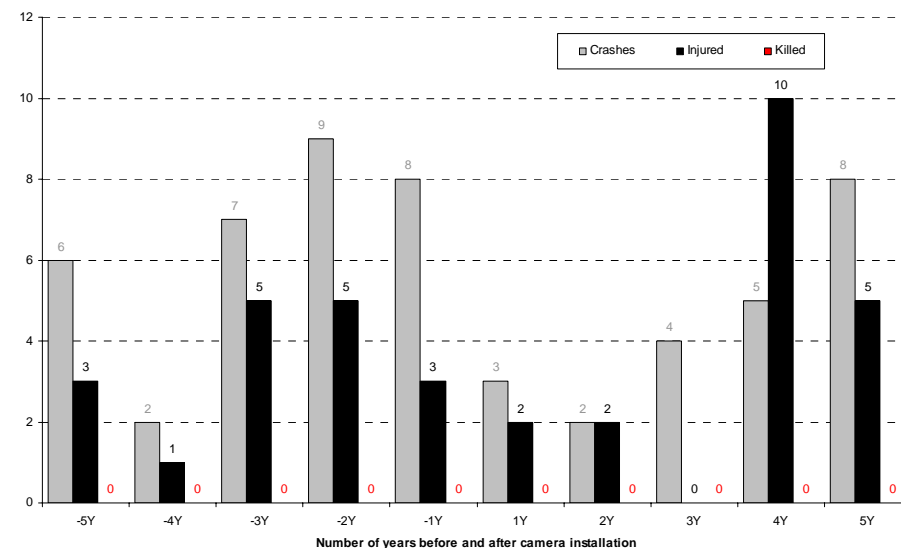
Crashes and casualties

- The current pre and post installation analysis shows that crashes have reduced at this location.
- When comparing the pre installation period to the most recent five year period, there has been a 31 per cent reduction in the annual average number of crashes, however there has been an 18 per cent increase in the annual average number of casualties.
- This location is recommended for comprehensive safety review as there has been an increase in casualties at this location in the most recent five year period.
- The infringement graph details the trend in infringements at this location since the camera began operation. The graph shows there has been a reduction in speeding behaviour at this location over time. Roadworks and camera maintenance may influence the number of infringements issued.

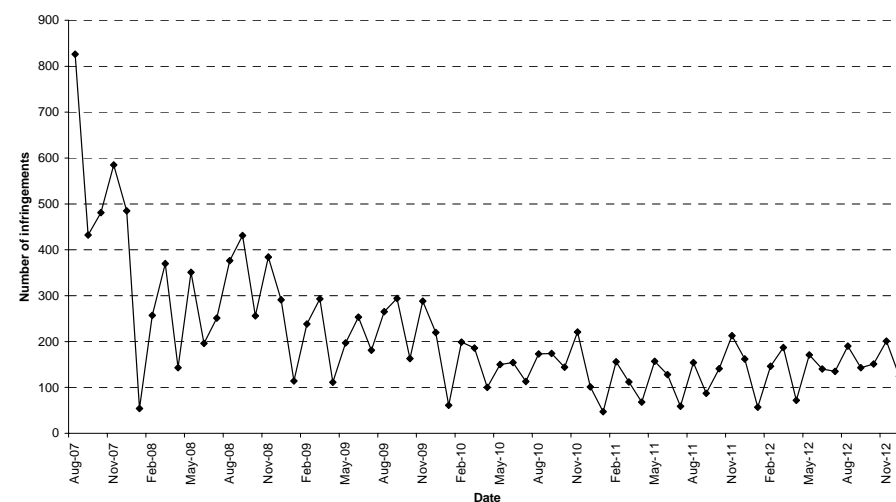
HUME HIGHWAY ASHFIELD

Infringements

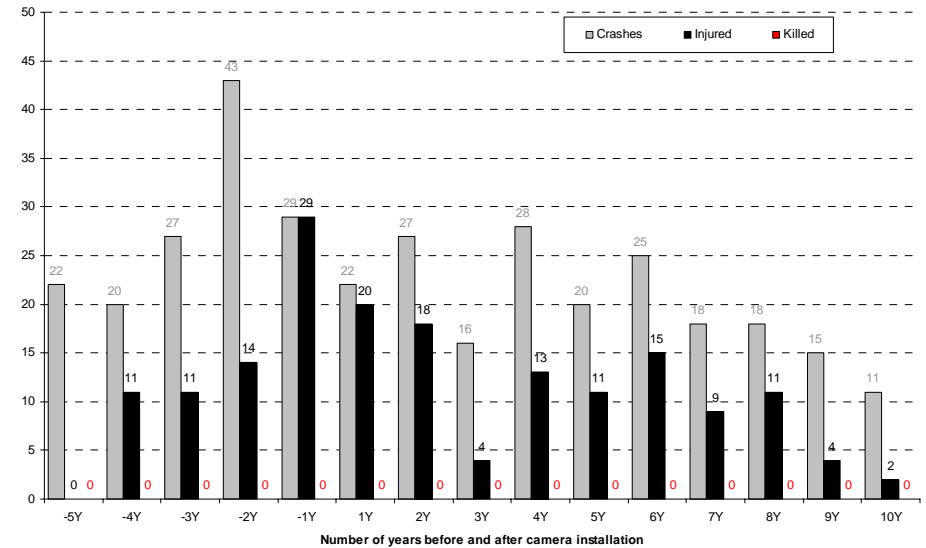
Crashes and casualties

## Trend in road safety performance at camera location

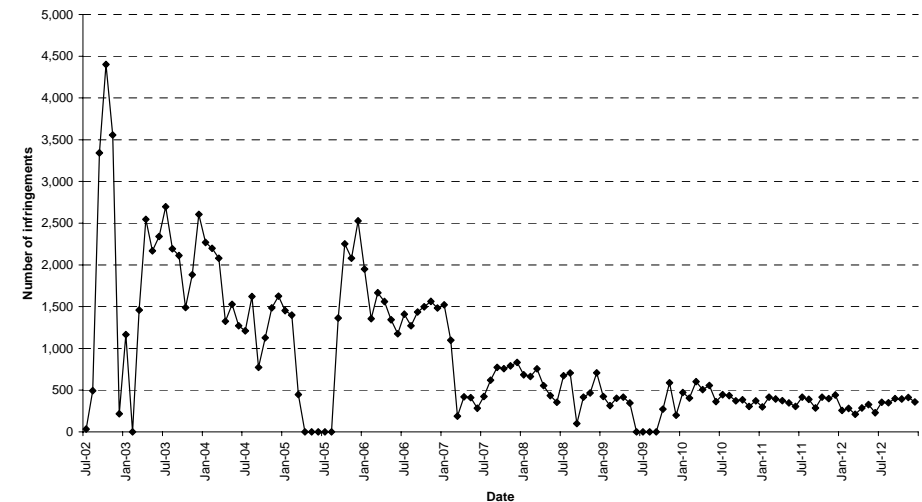
PARRAMATTA ROAD AUBURN

Infringements

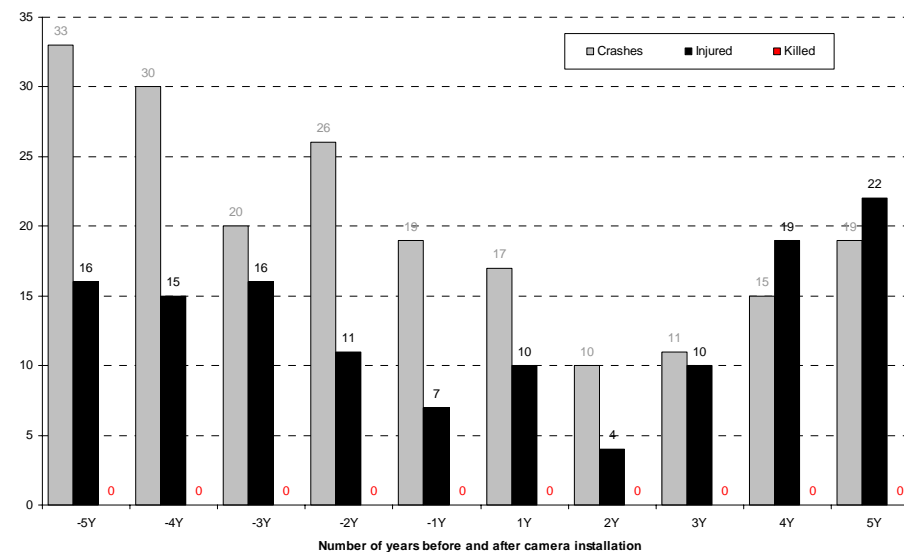
Crashes and casualties

- The current pre and post installation analysis shows that crashes have reduced at this location.
- When comparing the pre installation period to the most recent five year period, there has been a 42 per cent reduction in the annual average number of crashes however there has been a slight increase in the annual average number of casualties.
- This location is recommended for comprehensive safety review as there has been a gradual increase in casualties at this location since the cameras were installed.
- The infringement graph details the trend in infringements at this location since the camera began operation. The graph shows there has been a reduction in speeding behaviour at this location over time. Roadworks and camera maintenance may influence the number of infringements issued.

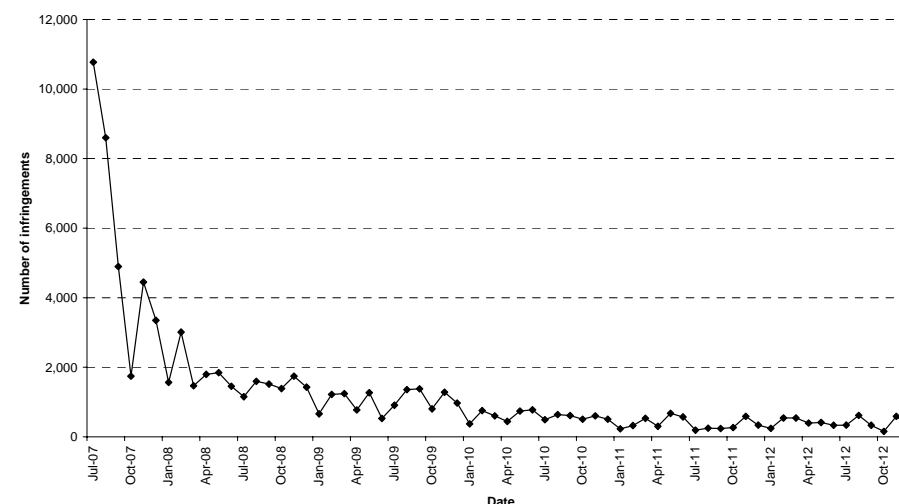
HUME HIGHWAY BANKSTOWN

Infringements

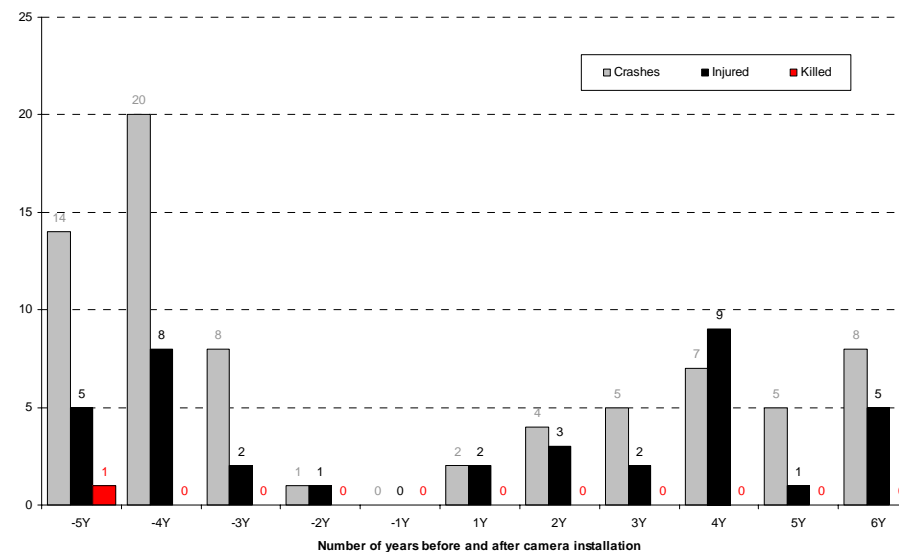
Crashes and casualties

### Trend in road safety performance at camera location

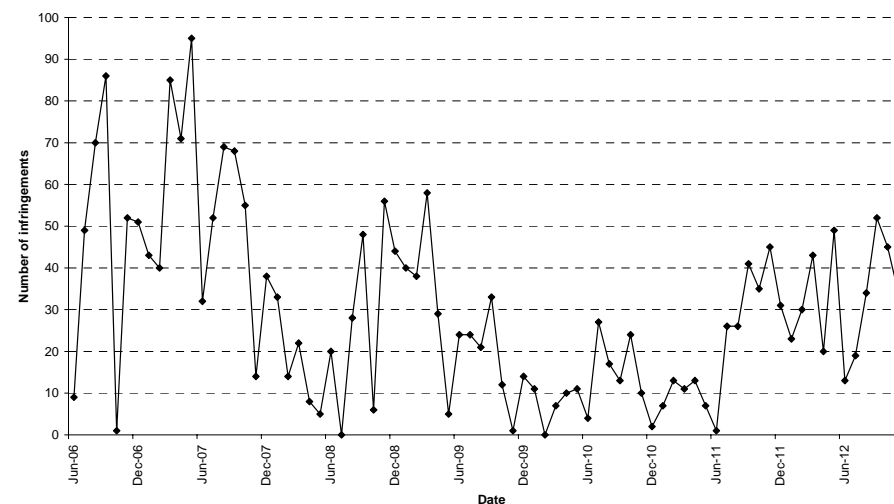
F3 FREEWAY BAR POINT

Infringements

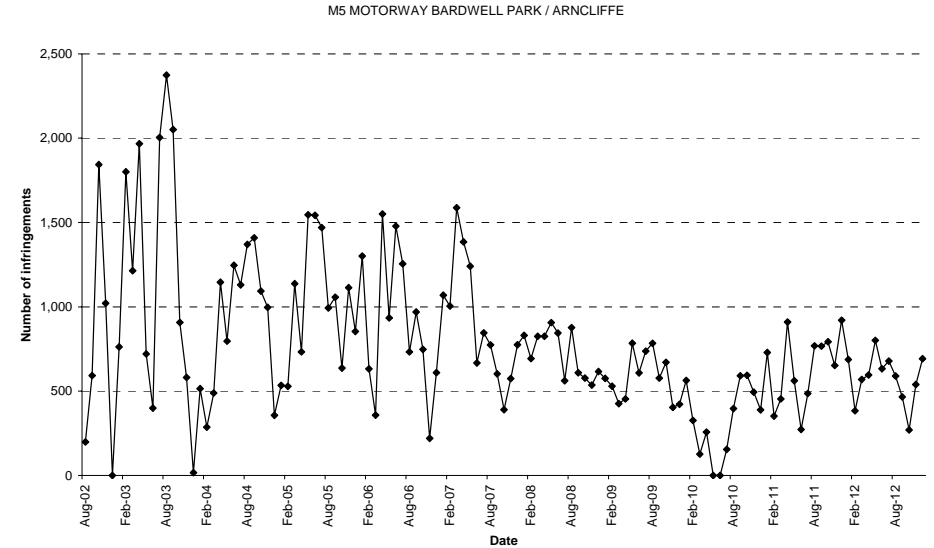
### Infringements at fixed speed camera location

- This location is appropriate for fixed speed camera enforcement as it is a high risk location that is difficult for the NSW Police Force to enforce using traditional methods
- The infringement graph details the trend in infringements at this location since the cameras began operation. The graph shows there has been a reduction in speeding behaviour at this location over time. Roadworks and camera maintenance may influence the number of infringements issued

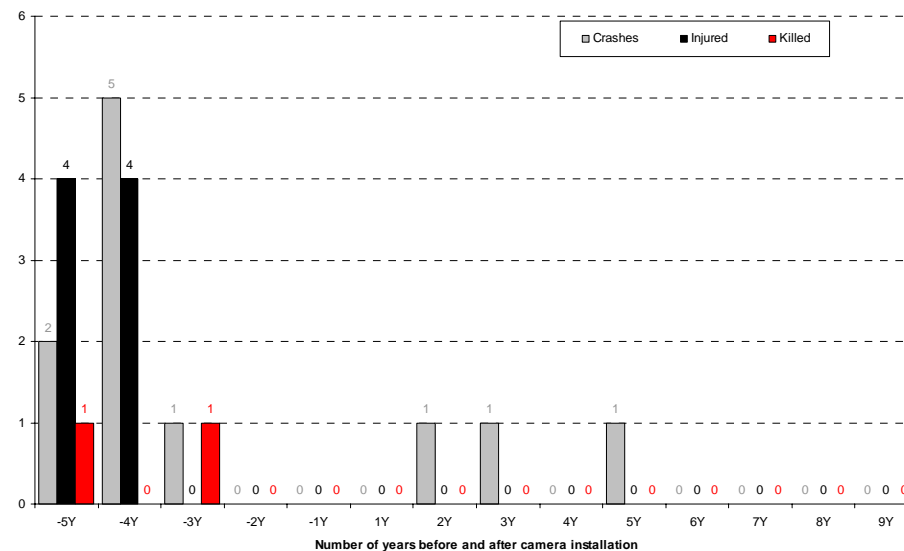
Crashes and casualties

## Trend in road safety performance at camera location

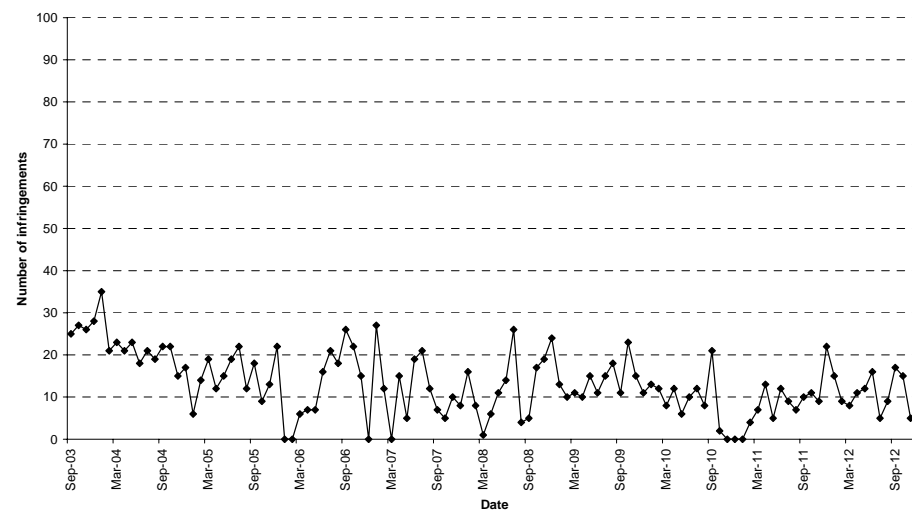
NEW ENGLAND HIGHWAY BEN LOMOND

Infringements

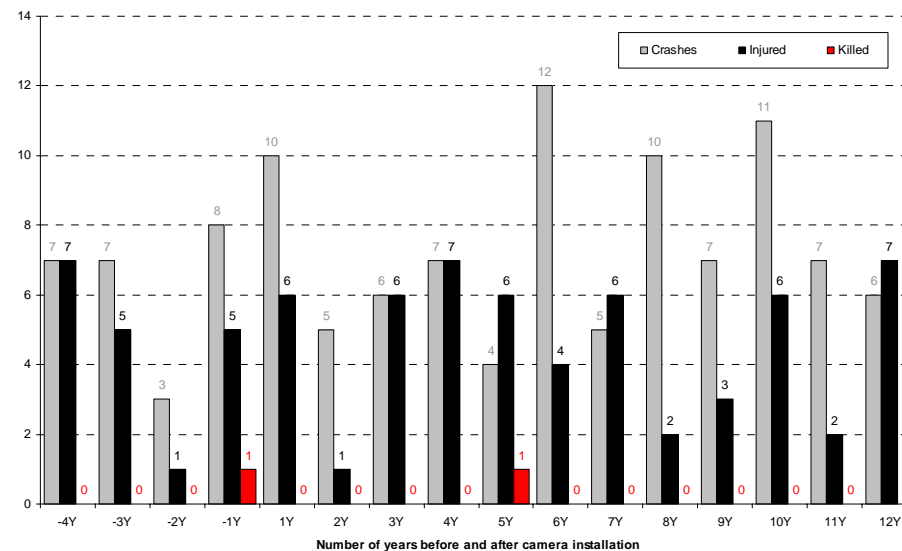
Crashes and casualties

## Trend in road safety performance at camera location

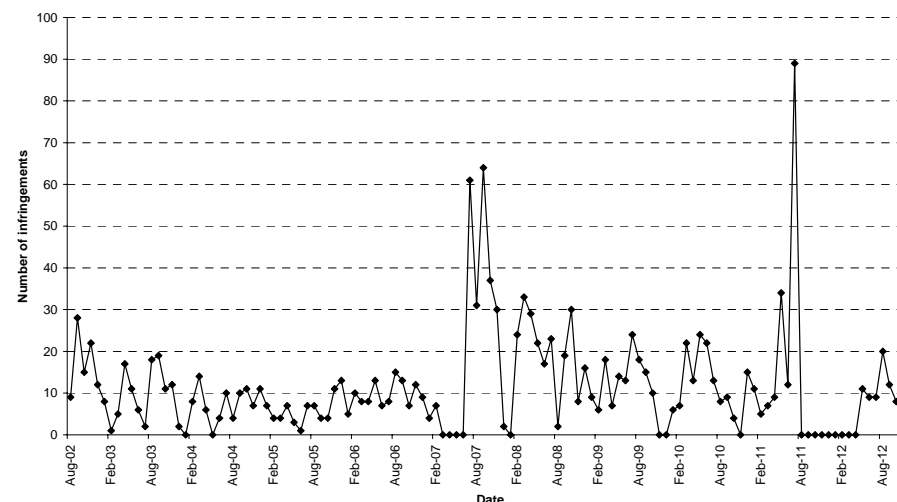
RICHMOND ROAD BERKSHIRE PARK

Infringements

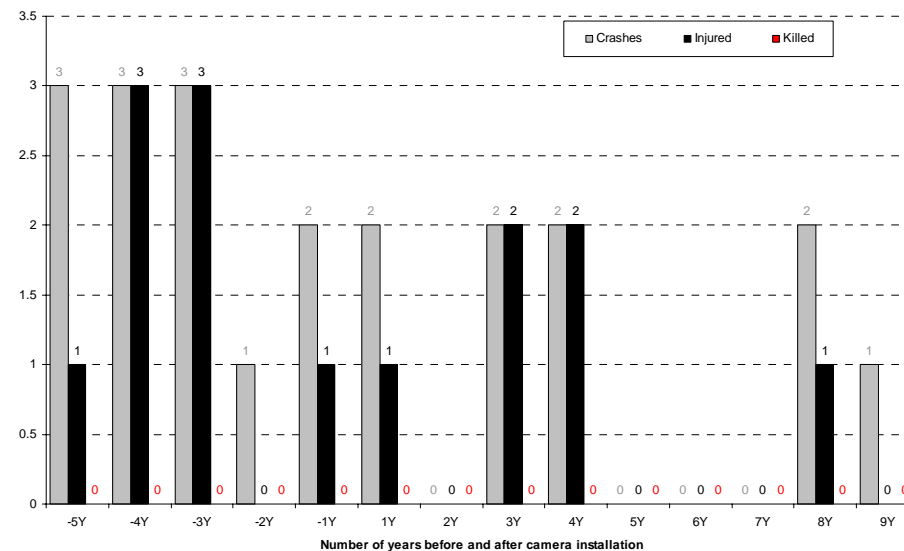
Crashes and casualties

## Trend in road safety performance at camera location

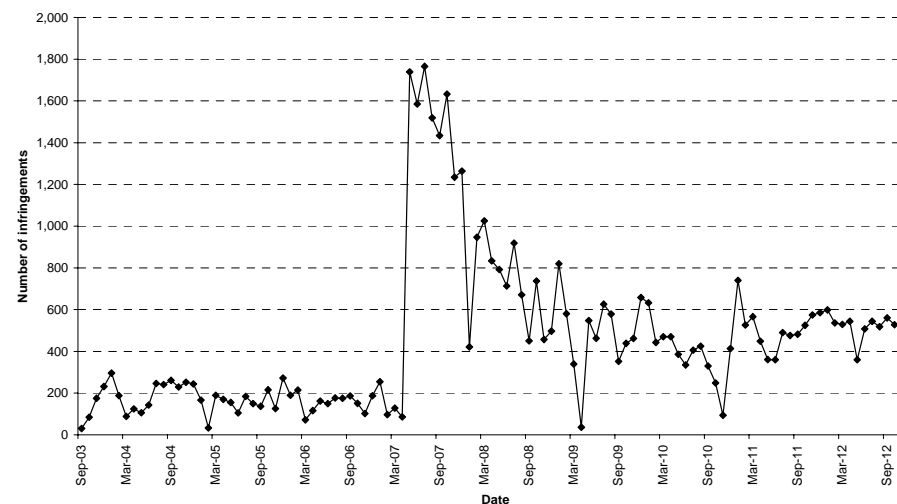
PRINCES HIGHWAY BERRY

Infringements

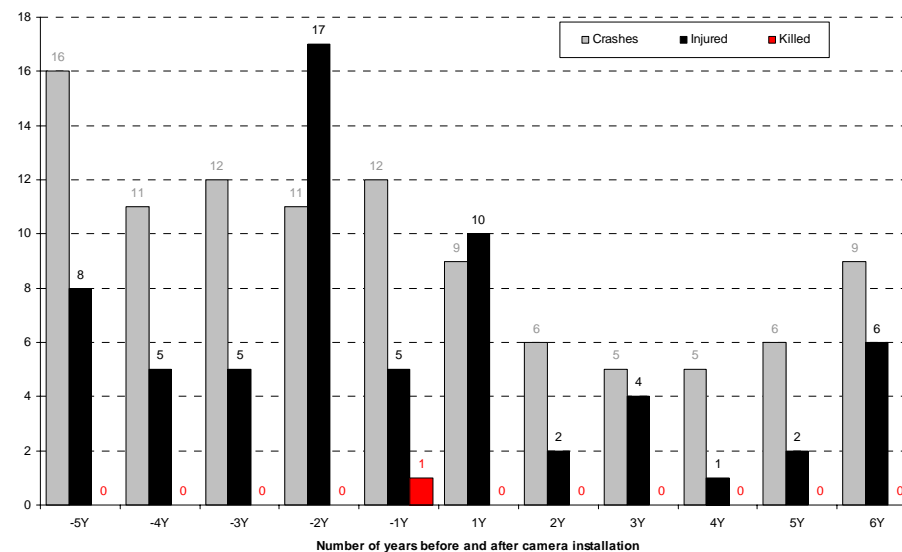
Crashes and casualties

## Trend in road safety performance at camera location

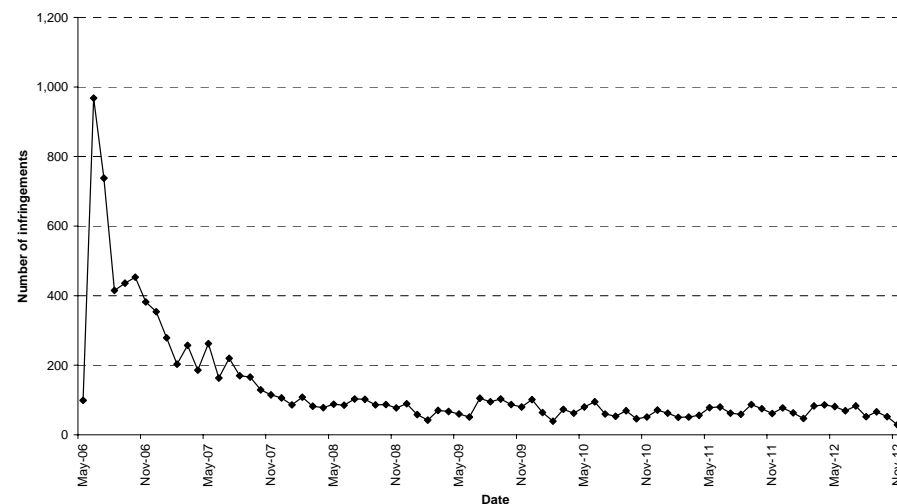
BEXLEY ROAD BEXLEY NORTH

Infringements

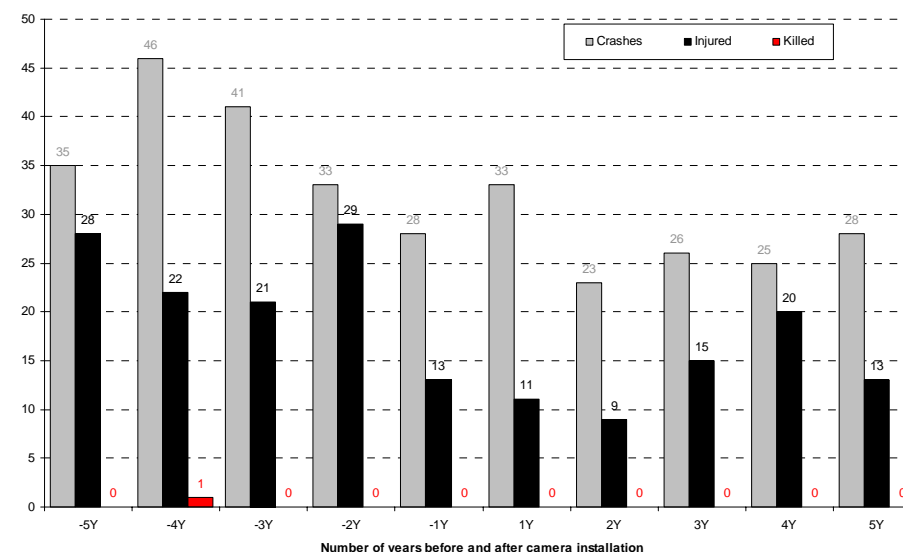
Crashes and casualties

## Trend in road safety performance at camera location

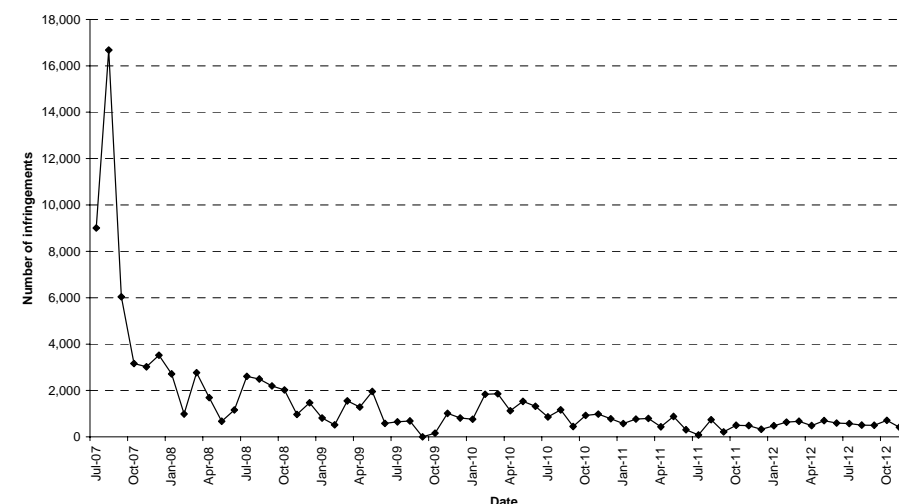
KING GEORGES ROAD BEVERLY HILLS

Infringements

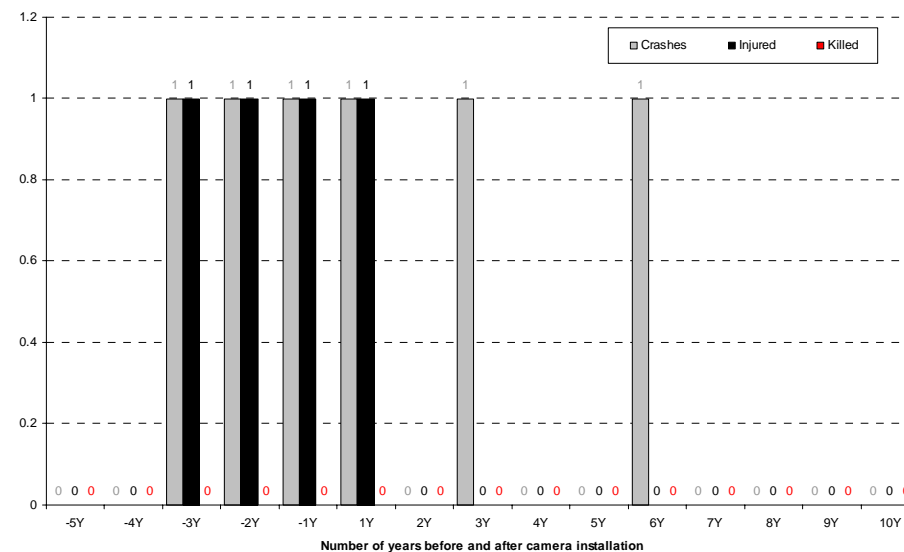
Crashes and casualties

## Trend in road safety performance at camera location

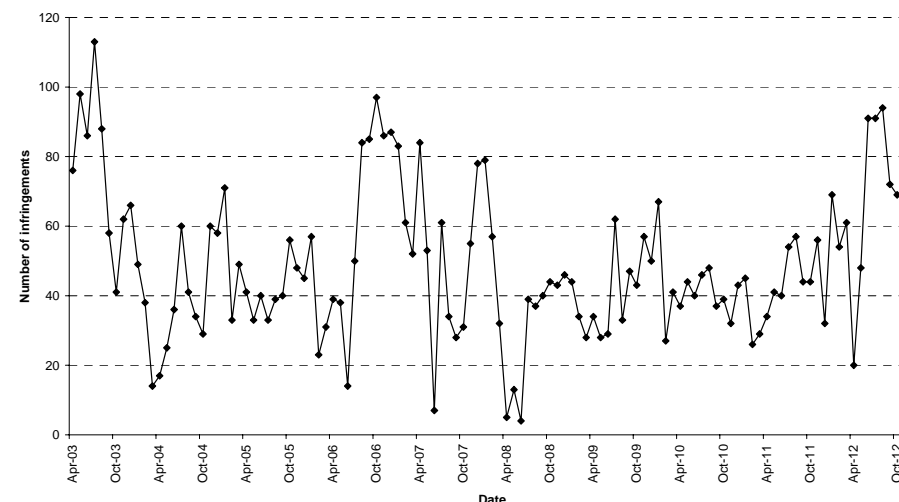
NEW ENGLAND HIGHWAY BLANDFORD

Infringements

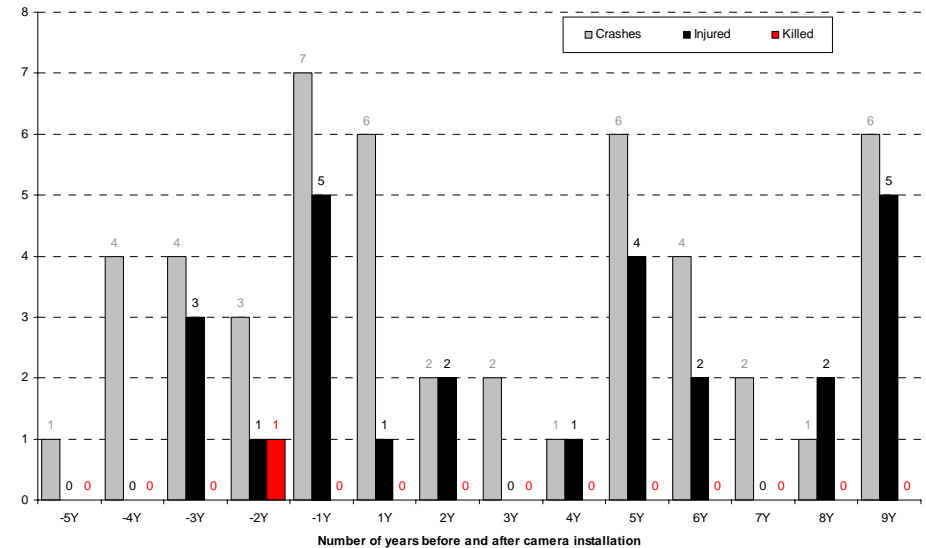
Crashes and casualties

## Trend in road safety performance at camera location

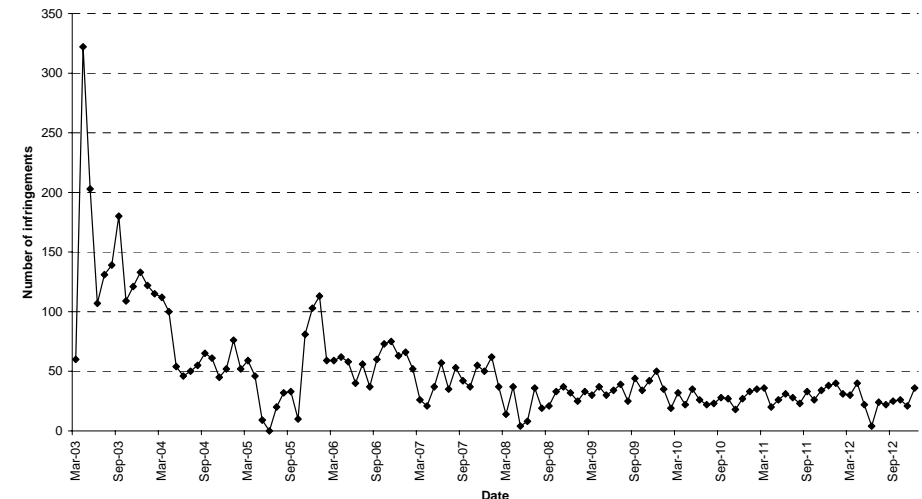
BOLONG ROAD BOMADERRY

Infringements

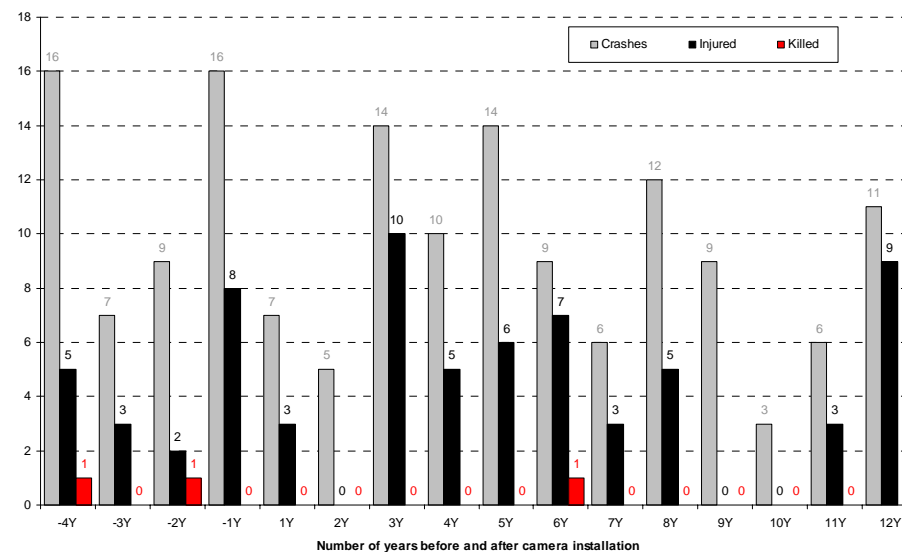
Crashes and casualties

## Trend in road safety performance at camera location

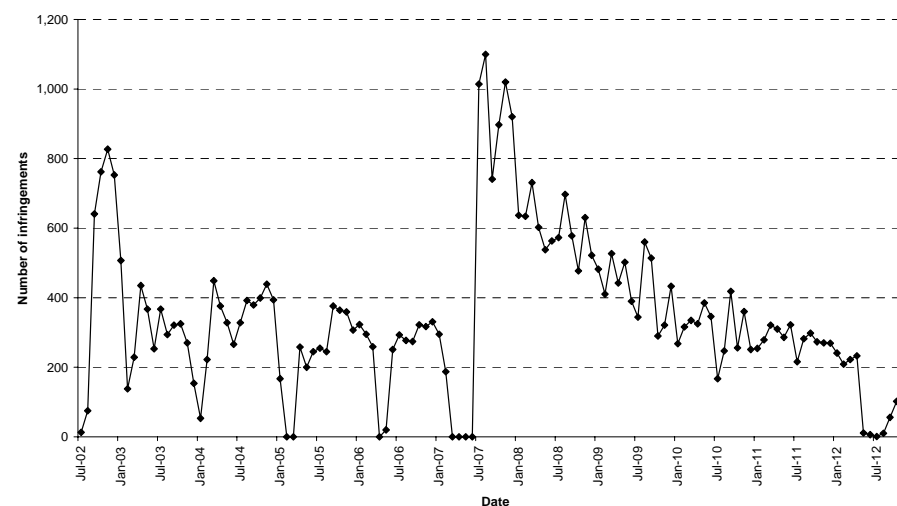
ELIZABETH DRIVE BONNYRIGG

Infringements

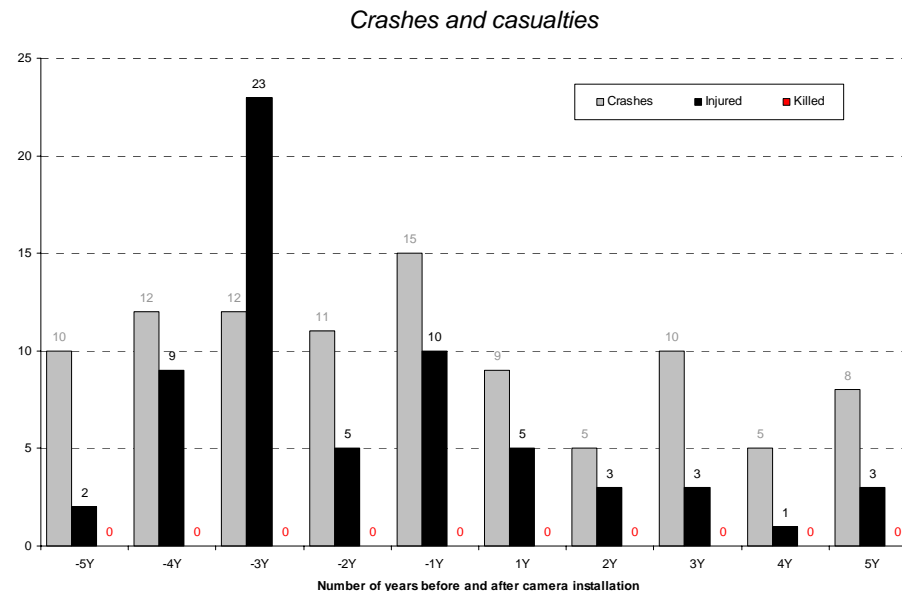
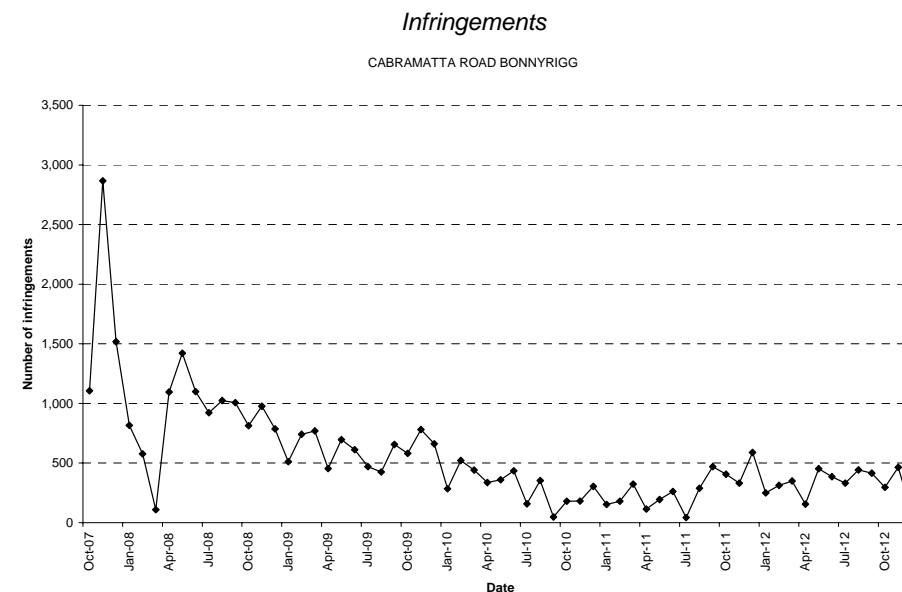
## Trend in road safety performance at camera location

- The current pre and post installation analysis shows that crashes have decreased at this location.
- When comparing the pre installation period to the most recent five year period, there has been a 42 per cent reduction in the annual average number of crashes and a 73 per cent reduction in the annual average number of casualties.
- This has been a saving of \$4.87 million in costs to the community.
- The infringement graph details the trend in infringements at the location since the camera began operation. The graph shows there has been a reduction in speeding behaviour at this location over time. Roadworks and camera maintenance may influence the number of infringements issued.

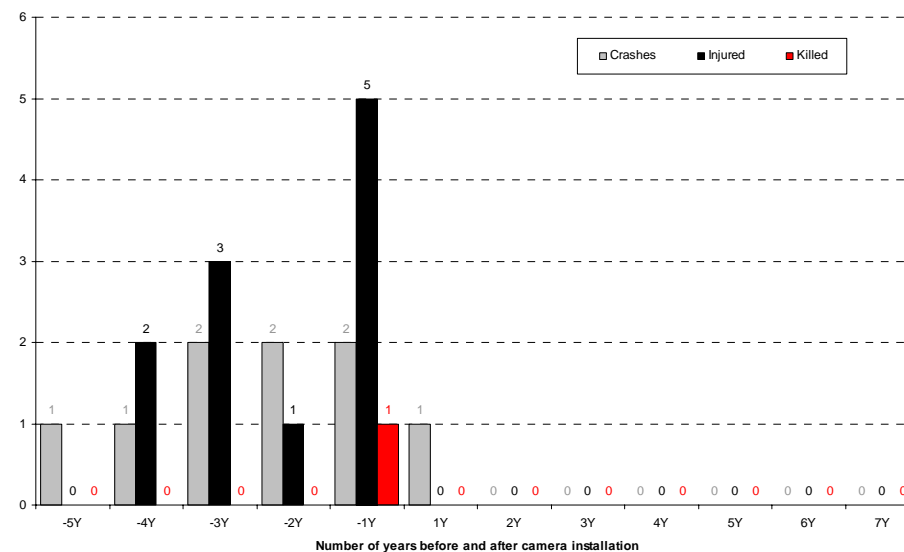
Crashes and casualties

## Trend in road safety performance at camera location

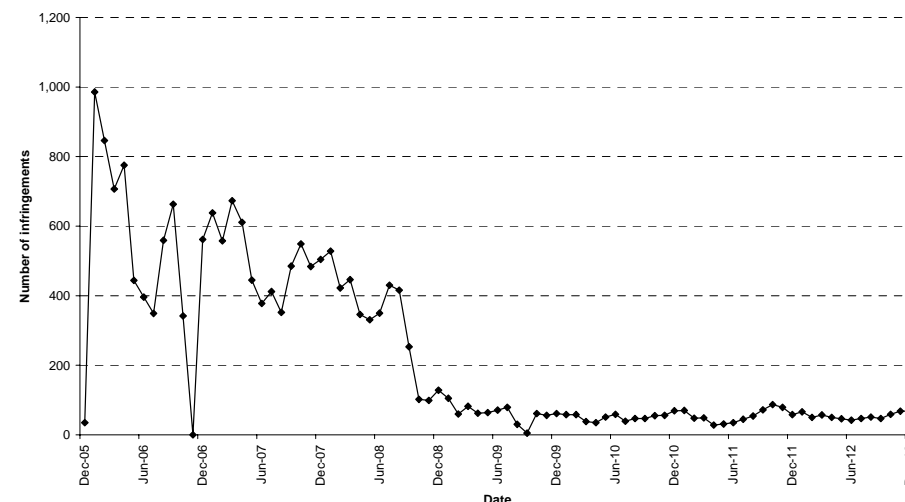
PINE CREEK WAY BONVILLE

Infringements

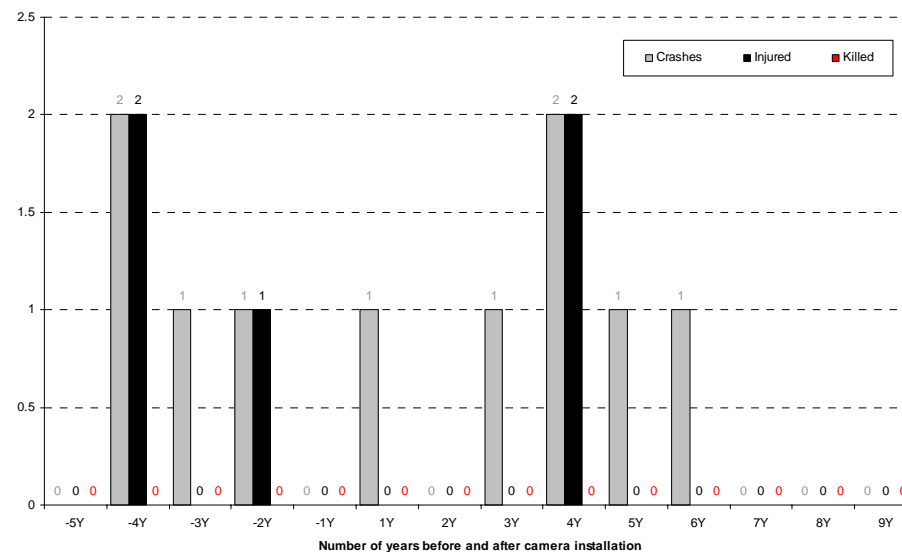
Crashes and casualties

## Trend in road safety performance at camera location

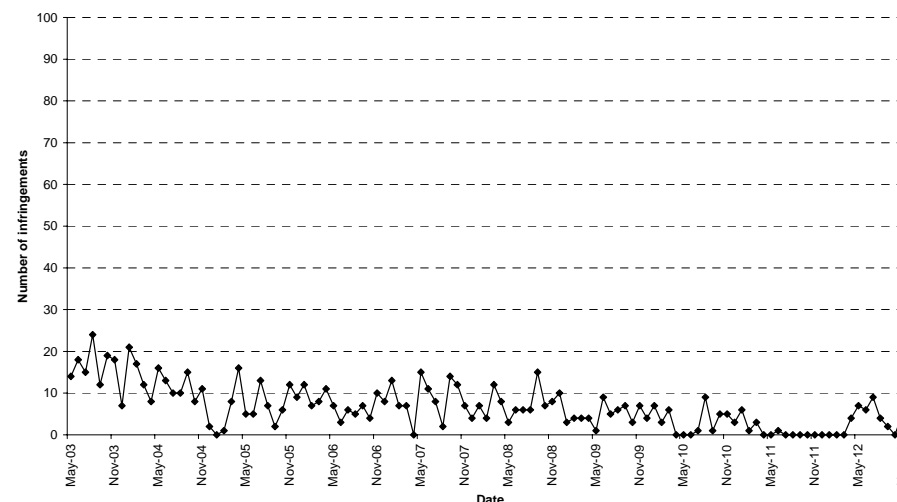
PRINCES HIGHWAY BROGO

Infringements

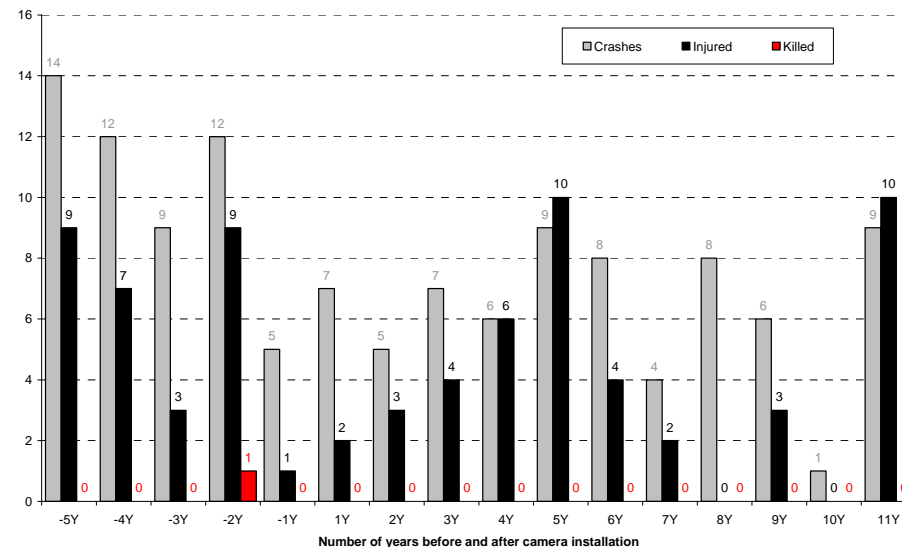
Crashes and casualties

## Trend in road safety performance at camera location

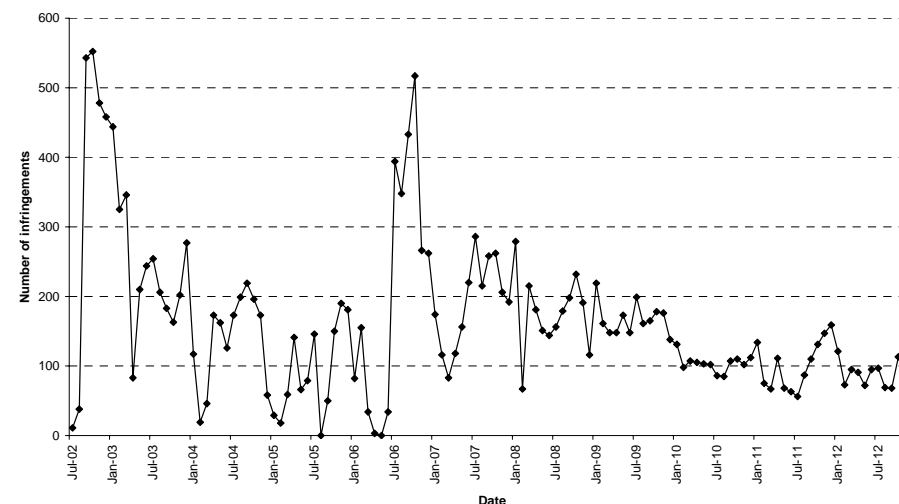
PRINCES HIGHWAY BULLI

Infringements

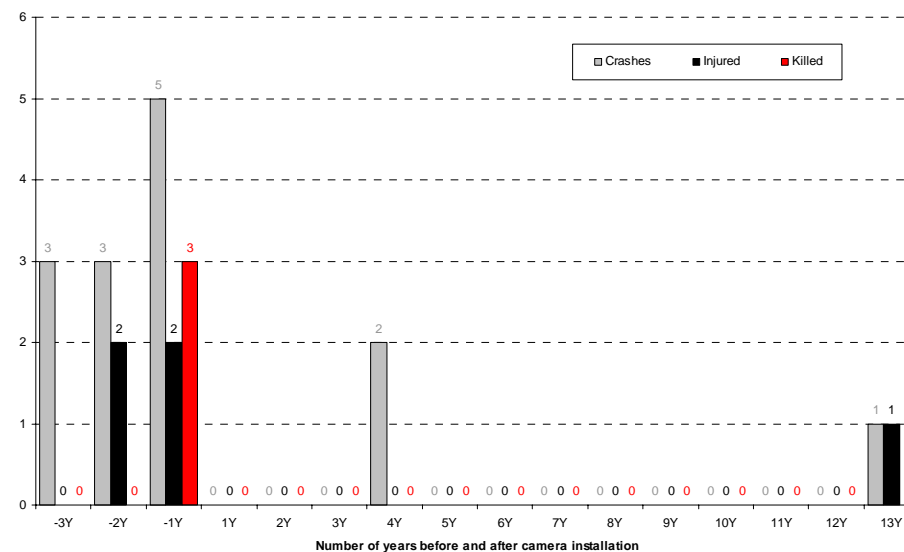
Crashes and casualties

## Trend in road safety performance at camera location

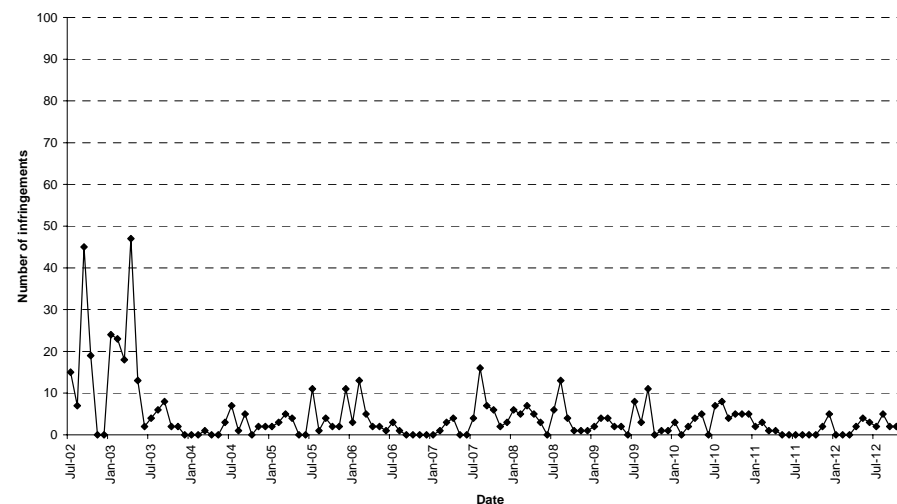
TWEED VALLEY WAY BURRINGBAR

Infringements

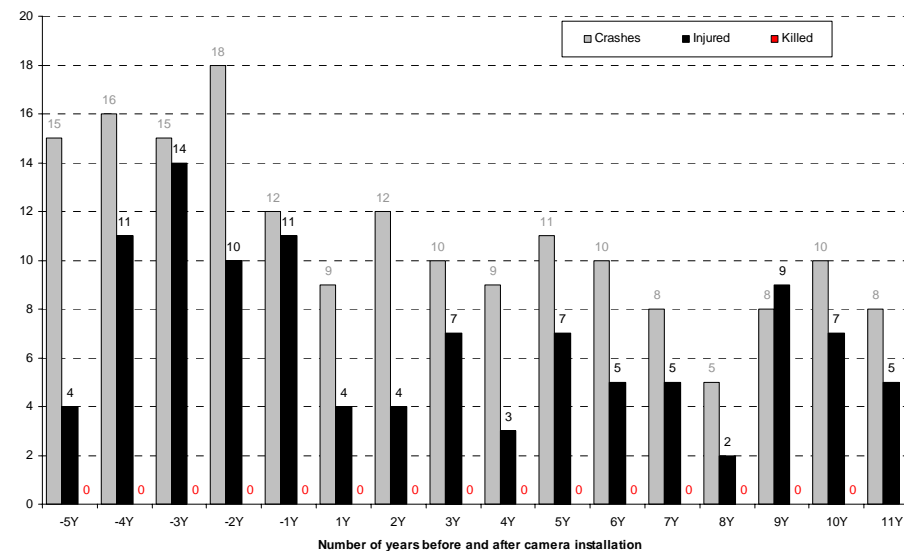
Crashes and casualties

## Trend in road safety performance at camera location

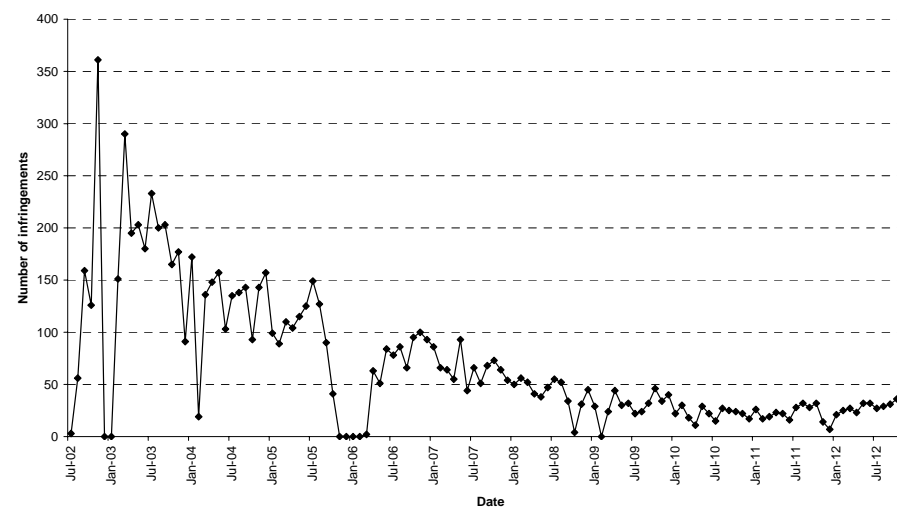
HUME HIGHWAY BURWOOD HEIGHTS

Infringements

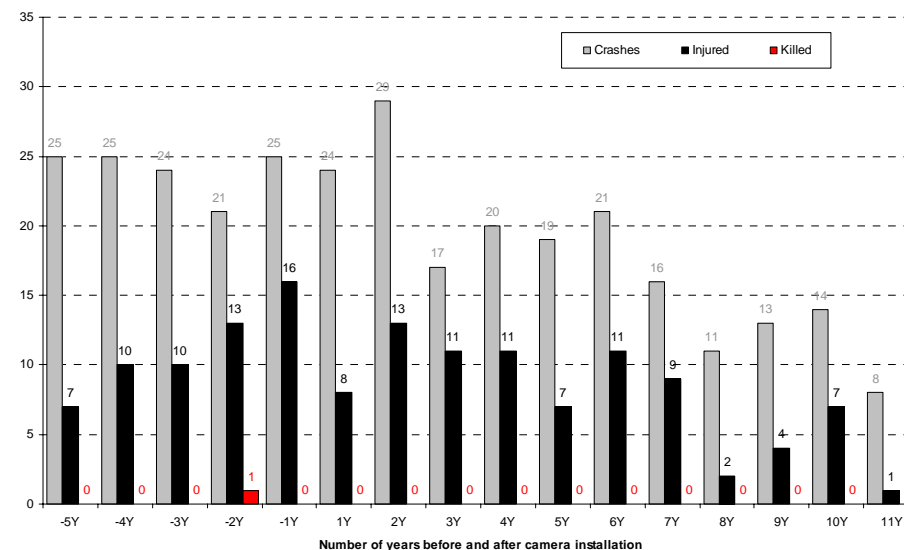
Crashes and casualties

## Trend in road safety performance at camera location

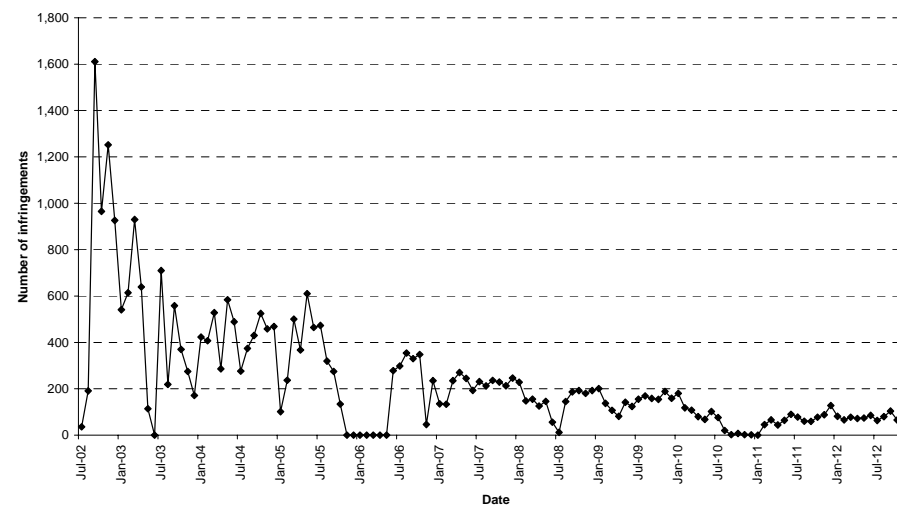
JAMES RUSE DRIVE CAMELLIA

Infringements

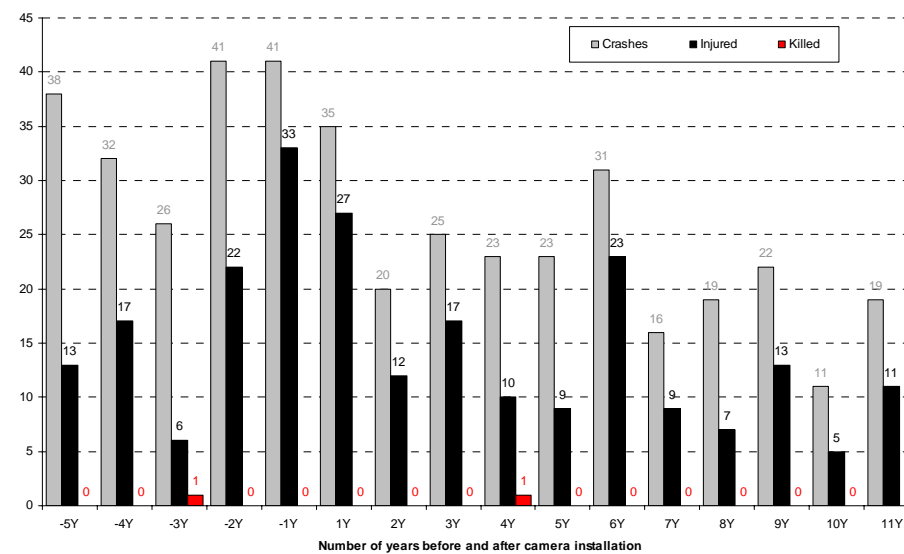
### Crashes and casualties

## Trend in road safety performance at camera location

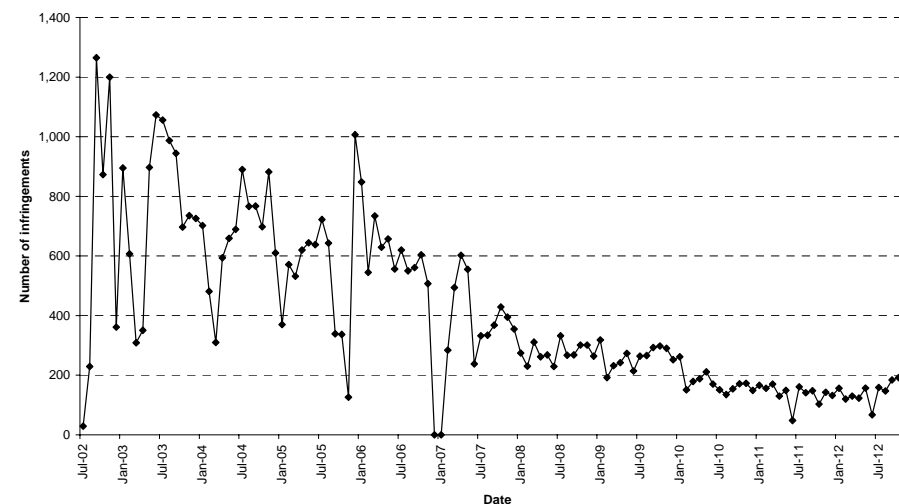
CANTERBURY ROAD CANTERBURY

### Infringements

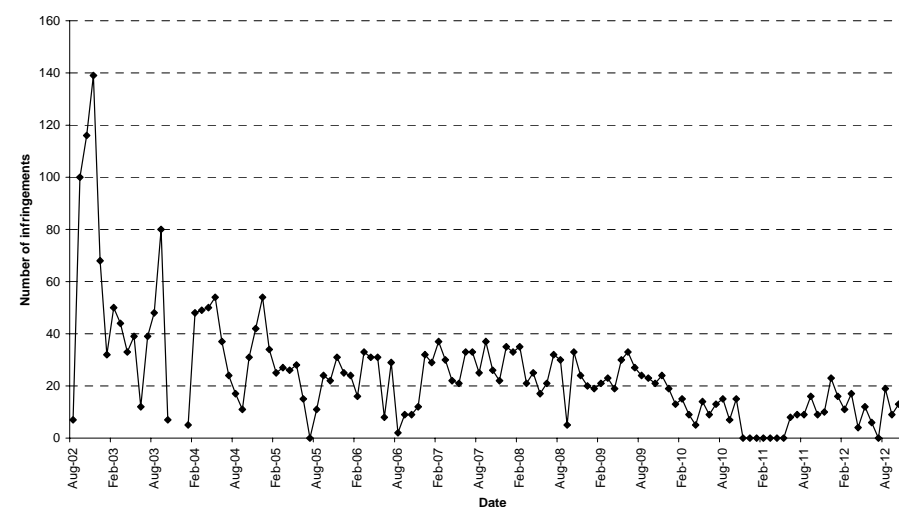
Infringements

CAPTAIN COOK DRIVE CARINGBAH

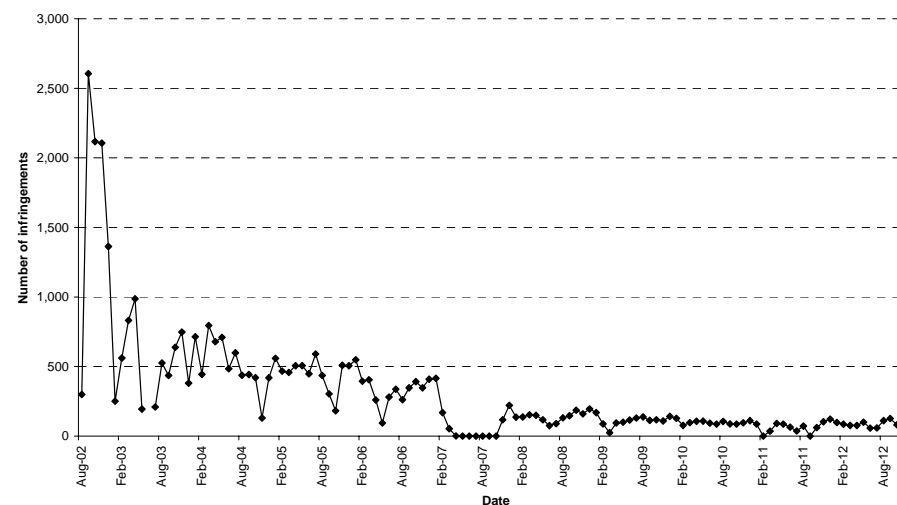
Infringements

PENNANT HILLS ROAD CARLINGFORD

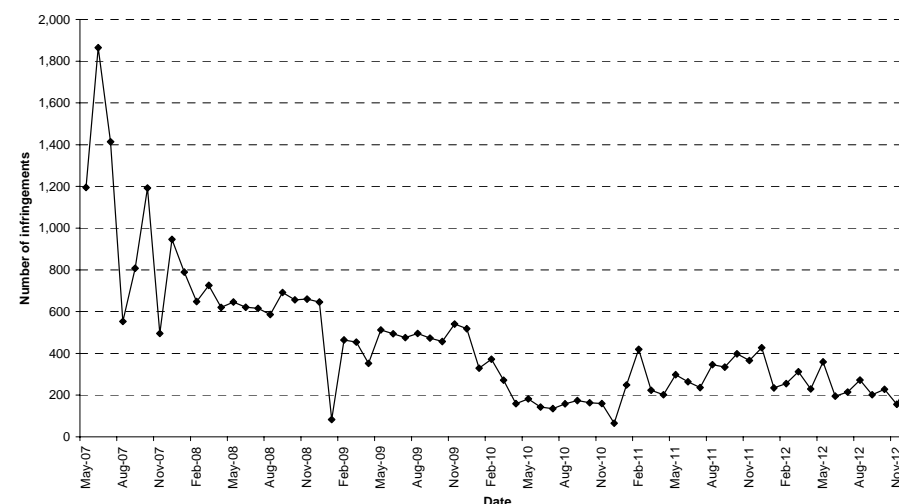
Infringements

OLD NORTHERN ROAD CASTLE HILL

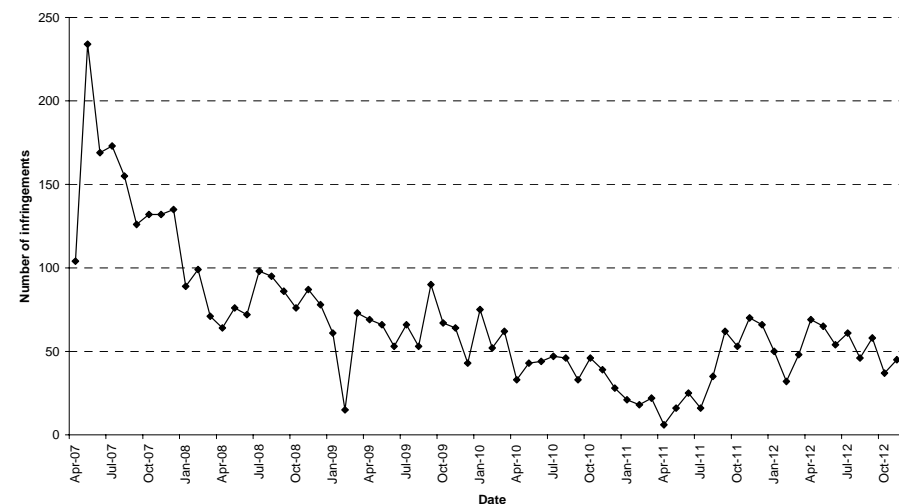
Infringements

PACIFIC HIGHWAY CHARMHAVEN
