Transport  
for NSW

# ANNUAL NSW SPEED CAMERA PERFORMANCE REVIEW

NSW Centre for Road Safety

AUGUST 2013

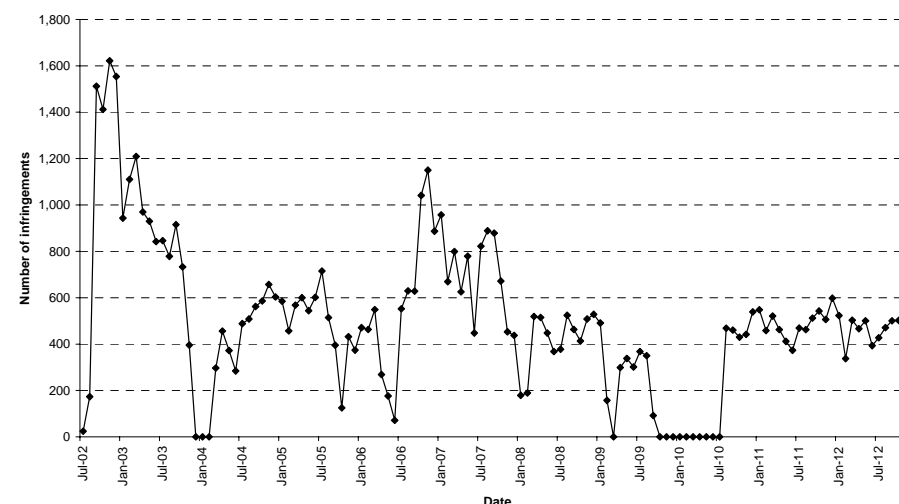
Infringements

CONCORD ROAD CONCORD WEST

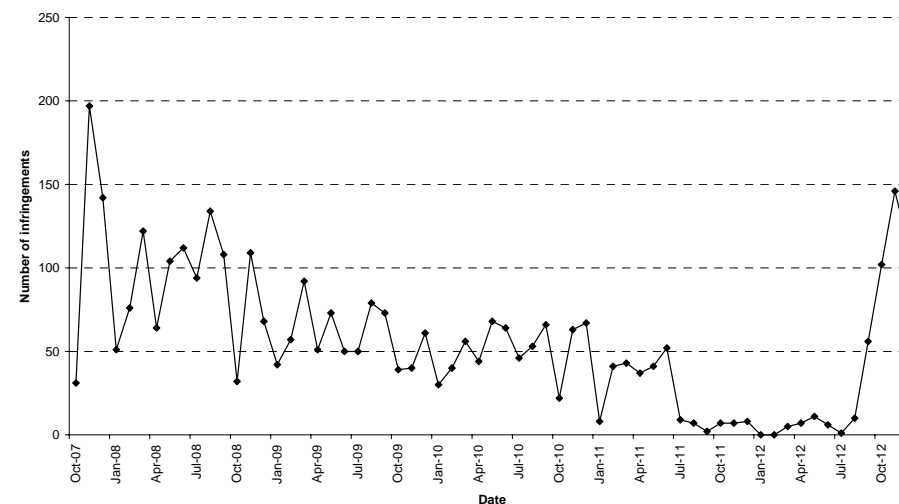
Infringements

EDGAR STREET CONDELL PARK

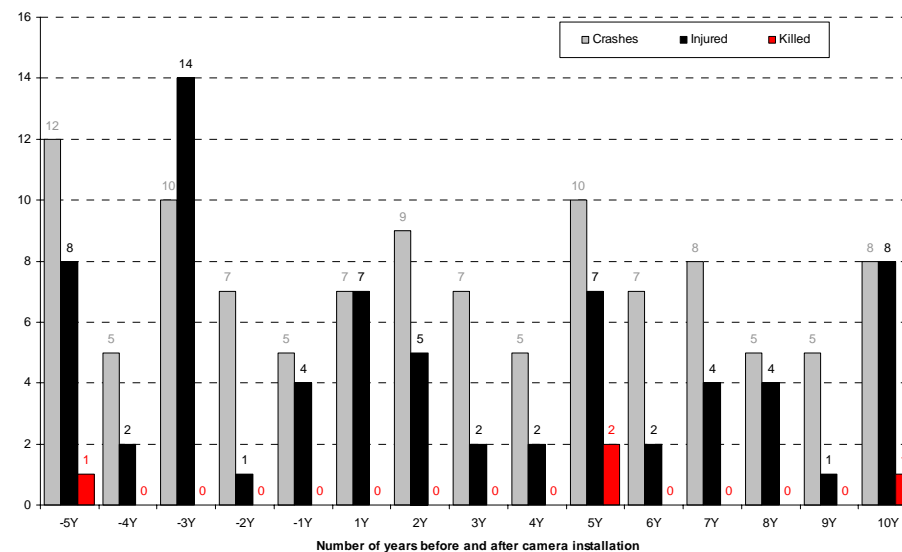
Crashes and casualties

- The current pre and post installation analysis shows that crashes have decreased at this location. This location was reviewed in 2012 due to concerns about the increase in fatalities in recent years. The review found no evidence that the recent fatalities, which occurred at an adjacent intersection, were speed-related and it is unlikely that the speed camera would have reduced these crashes. Further, the 2012 annual review found significant casualty reductions at this location therefore the camera was found to be effective.

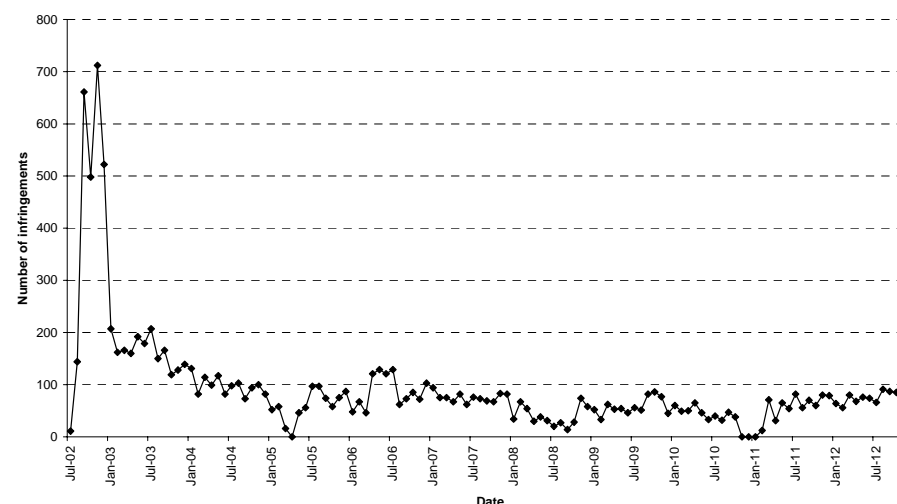
Infringements

NORTHERN DISTRIBUTOR (MEMORIAL DRIVE) CORRIMAL

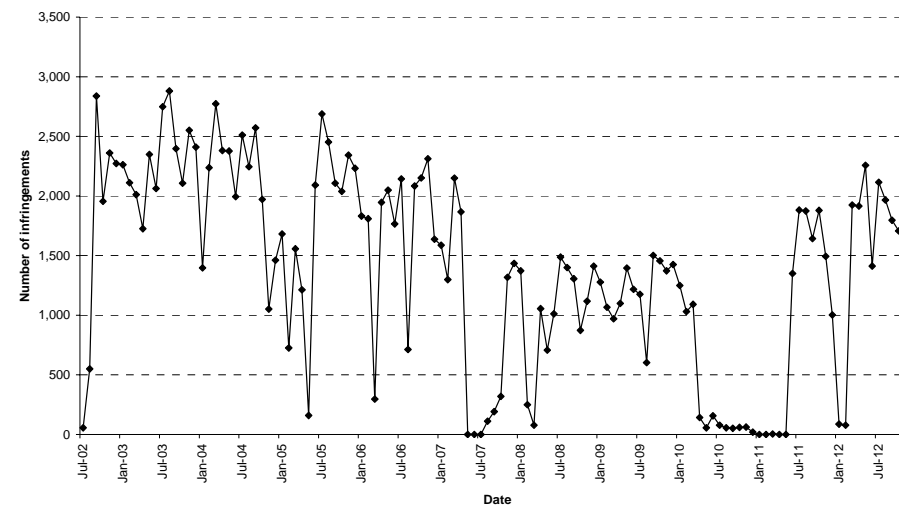
## Infringements at fixed speed camera location

EASTERN DISTRIBUTOR DARLINGHURST

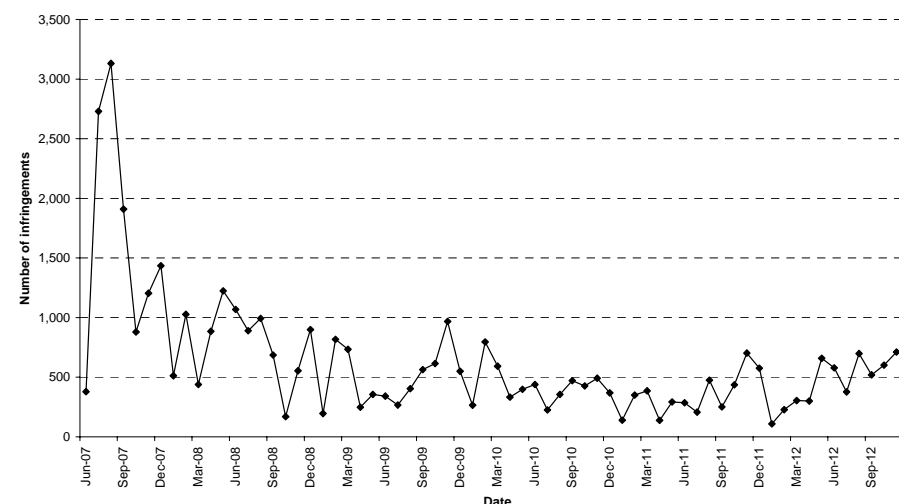
### Infringements

BUNNERONG ROAD EASTGARDENS/MAROUBRA

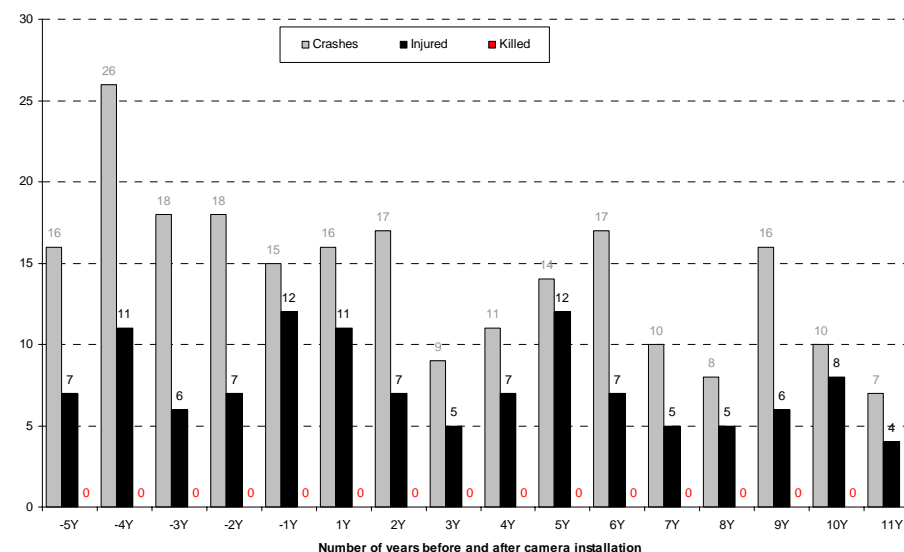
### Crashes and casualties

- The current pre and post installation analysis shows that crashes have decreased at this location. This location was reviewed in 2012 due to concerns that crashes and casualties at this location had increased. The comprehensive review found that the camera only has an impact on the eastbound direction of traffic because the camera only enforces in this direction and there is a very wide median at the camera location. Therefore the camera was found to be effective and this crash analysis looks only at the eastbound carriageway of New South Head Road.

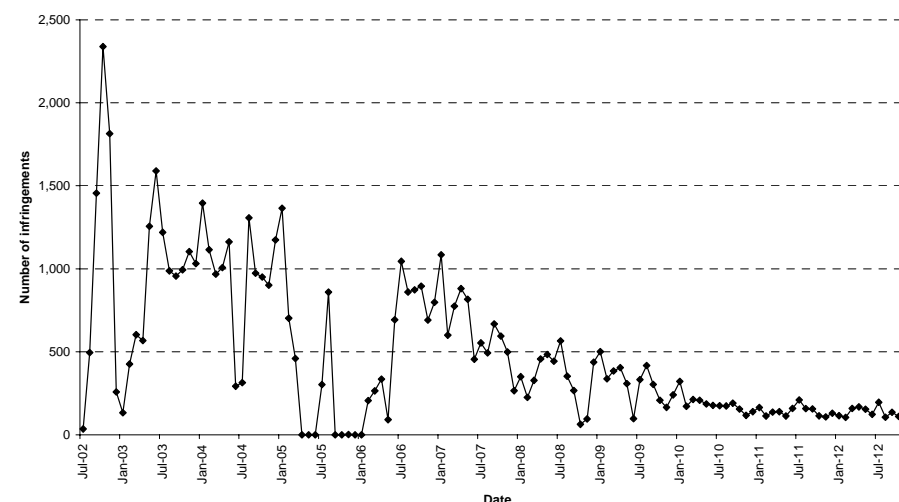
### Infringements

NEW SOUTH HEAD ROAD EDGECLIFF

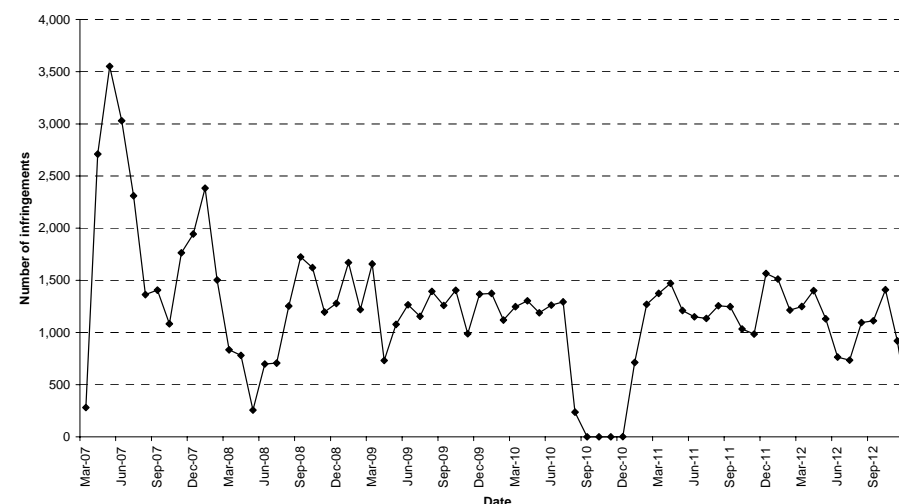
### Infringements

PACIFIC HIGHWAY EWINGSDALE

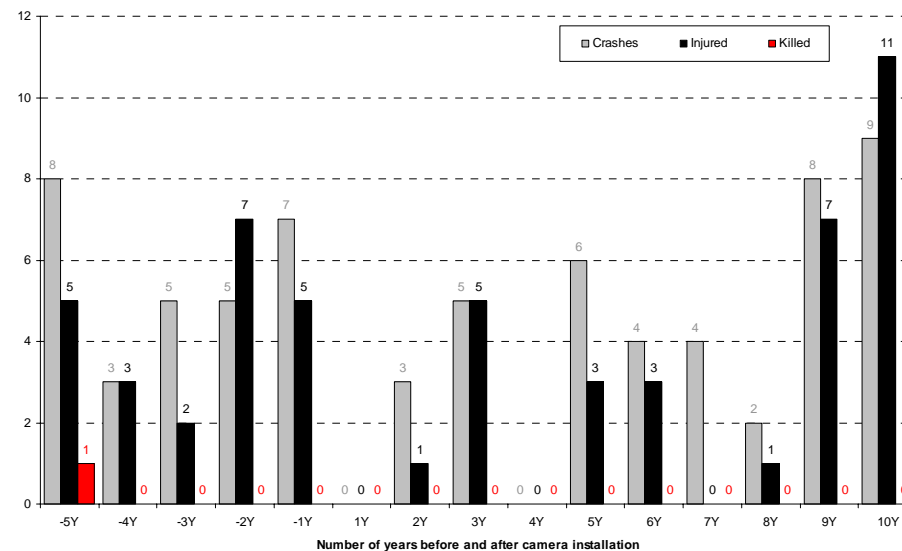
Crashes and casualties

- The current pre and post installation analysis shows that crashes have decreased at this location.
- When comparing the pre installation period to the most recent five year period, there has been an 11 per cent reduction in the annual average number of crashes and a 9 per cent reduction in the annual average number of casualties.
- This has been a saving of \$6.47 million in costs to the community.
- This location is recommended for comprehensive safety review as there has been an increase in casualties at this location in the most recent five year period.
- The infringement graph details the trend in infringements at this location since the camera began operation. The graph shows there has been a reduction in speeding behaviour at this location over time. Roadworks and camera maintenance may influence the number of infringements issued.

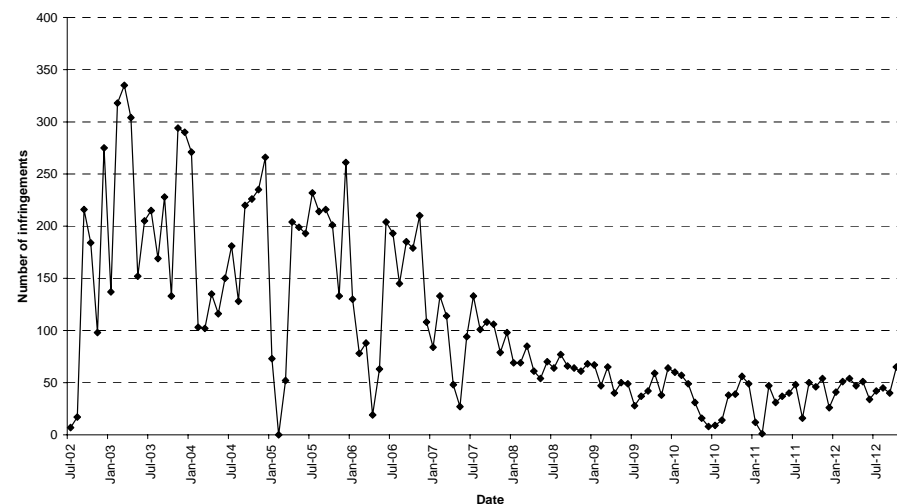
Infringements

FAIRFIELD STREET FAIRFIELD EAST

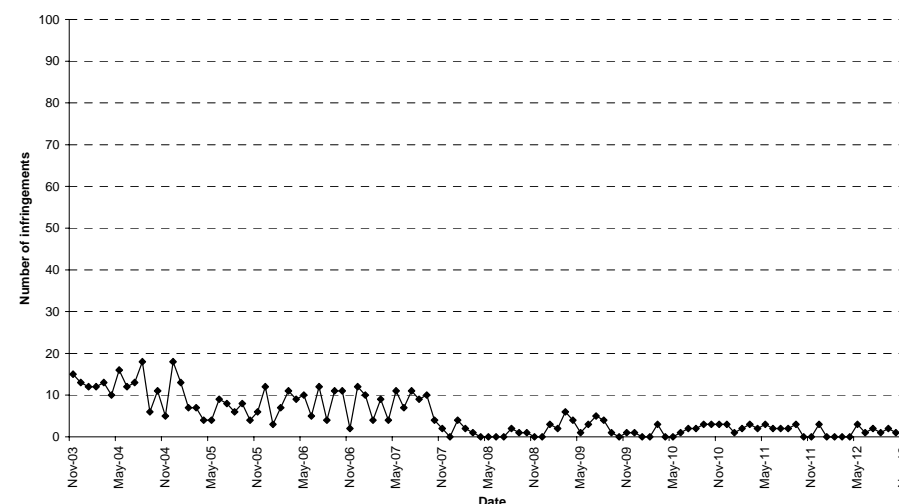
Infringements

PRINCES HIGHWAY FOXGROUND

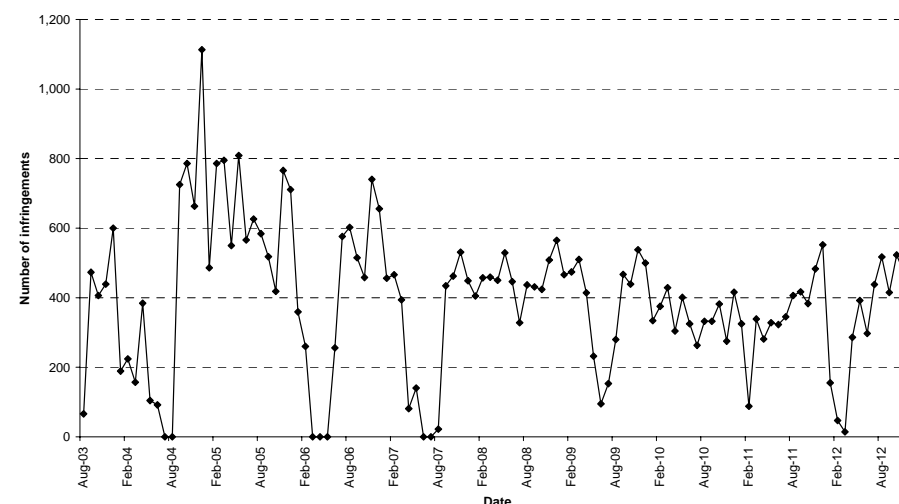
Infringements

PACIFIC HIGHWAY GATESHEAD

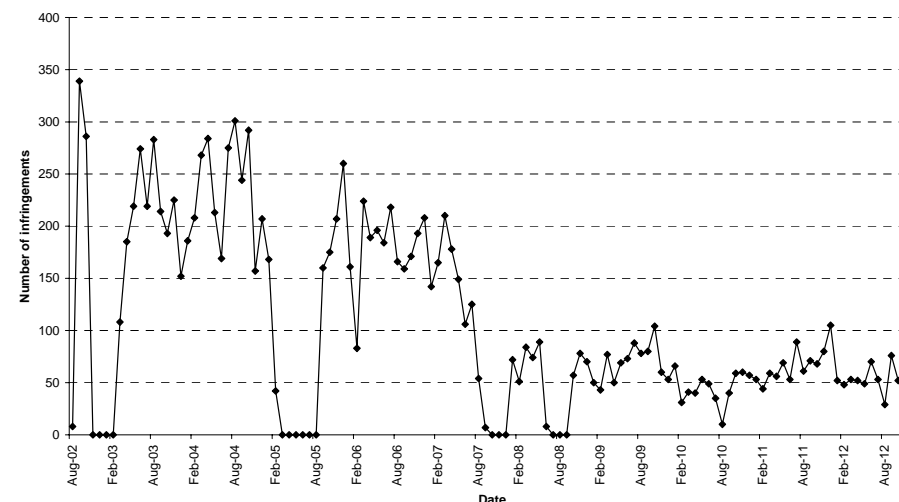
Infringements

GREYSTANES ROAD GREYSTANES

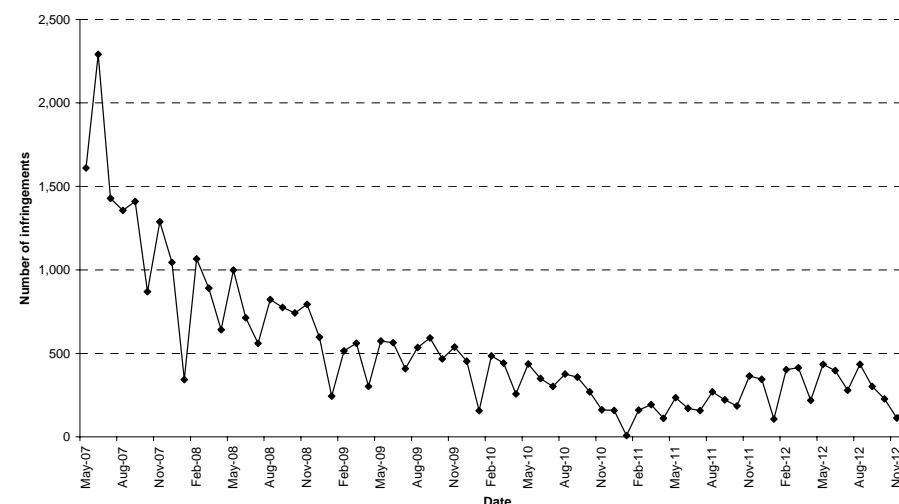
Infringements

WOODVILLE ROAD GUILFORD

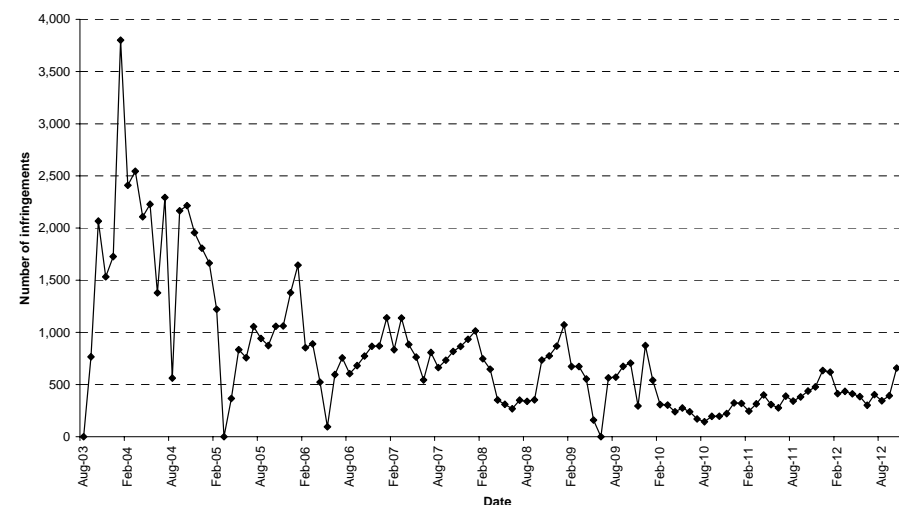
Infringements

F6 SOUTHERN FREEWAY GWYNNEVILLE NORTHBOUND

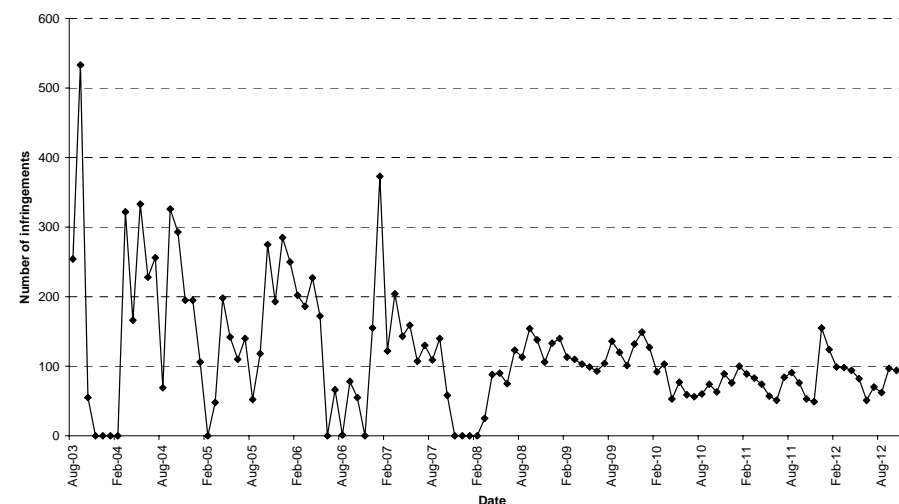
Infringements

F6 SOUTHERN FREEWAY GWYNNEVILLE SOUTHBOUND

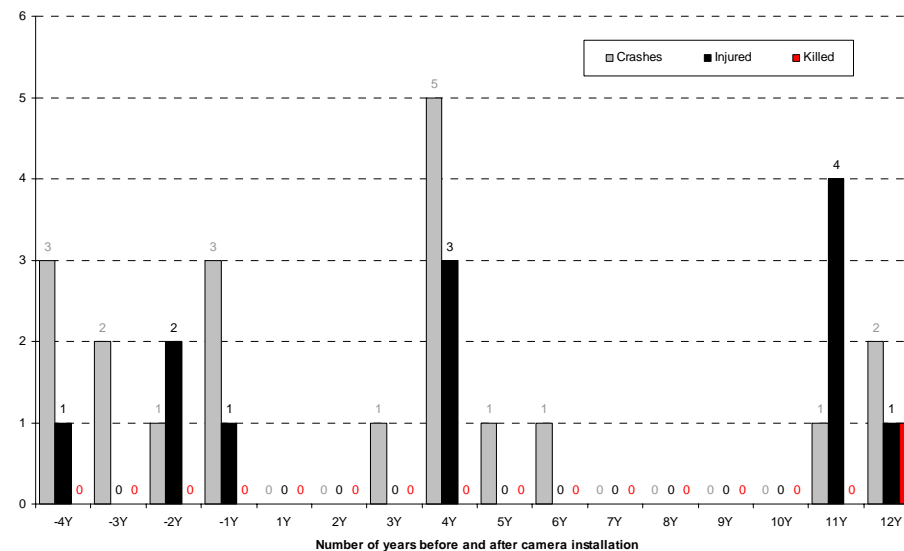
Crashes and casualties

- There was one fatality at this location which occurred in February 2012. Since then, there have been a number of treatments at this location to further improve road safety including a speed limit reduction from 90km/h to 80km/h from July 2012. There is also planned implementation of a point-to-point enforcement length along this section of the Great Western Highway therefore it is recommended that the camera is retained until the length is installed.

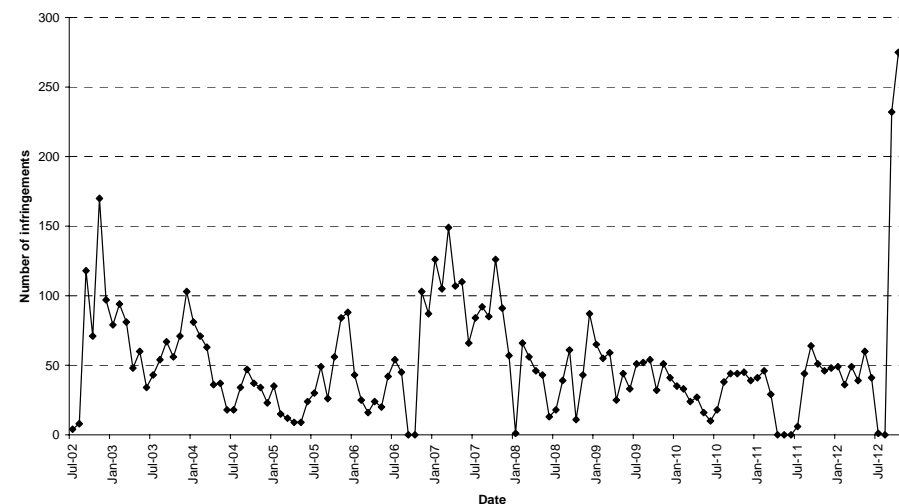
Infringements

GREAT WESTERN HIGHWAY HARTLEY

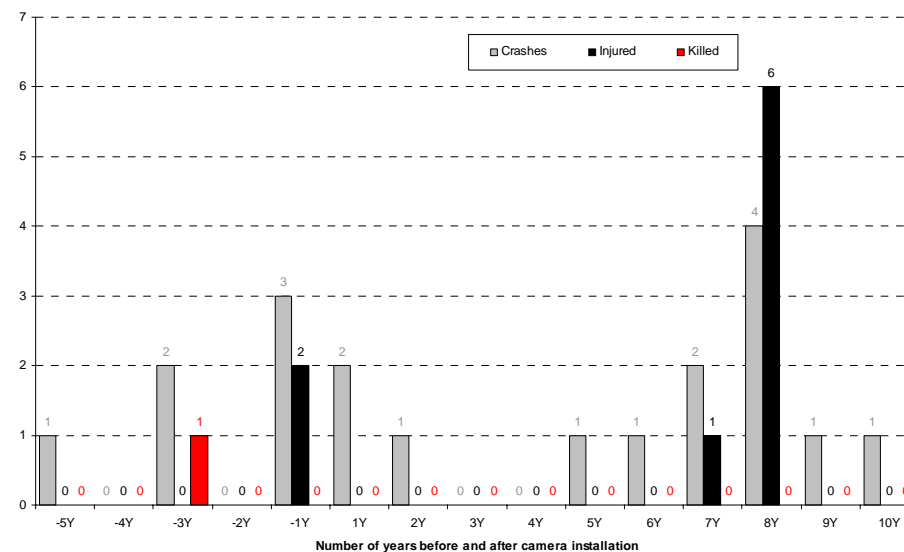
### Crashes and casualties

- As there are difficulties conducting speed enforcement using other means at this location, and to maintain the safety benefits of the wire rope barrier, it was recommended that the camera be retained until the road is bypassed as part of the Pacific Highway upgrade.

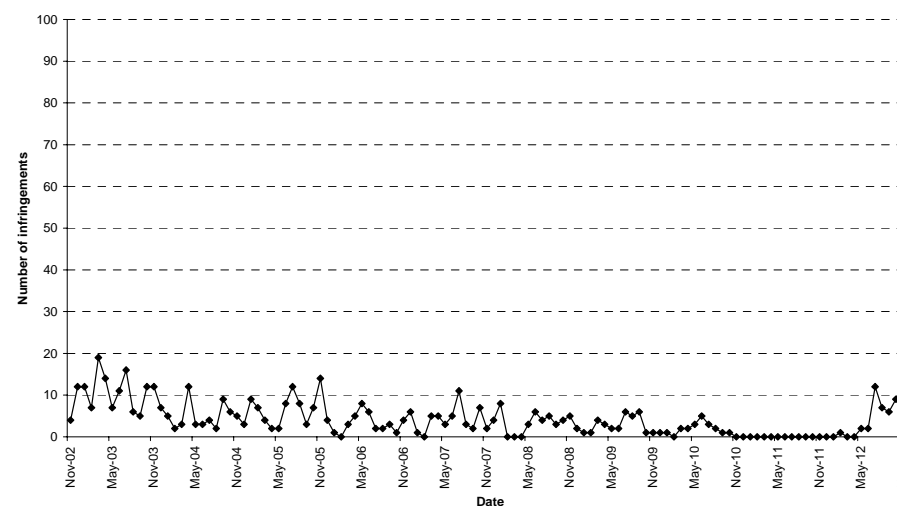
### Infringements

PACIFIC HIGHWAY HUNGRY HEAD (VALLA)

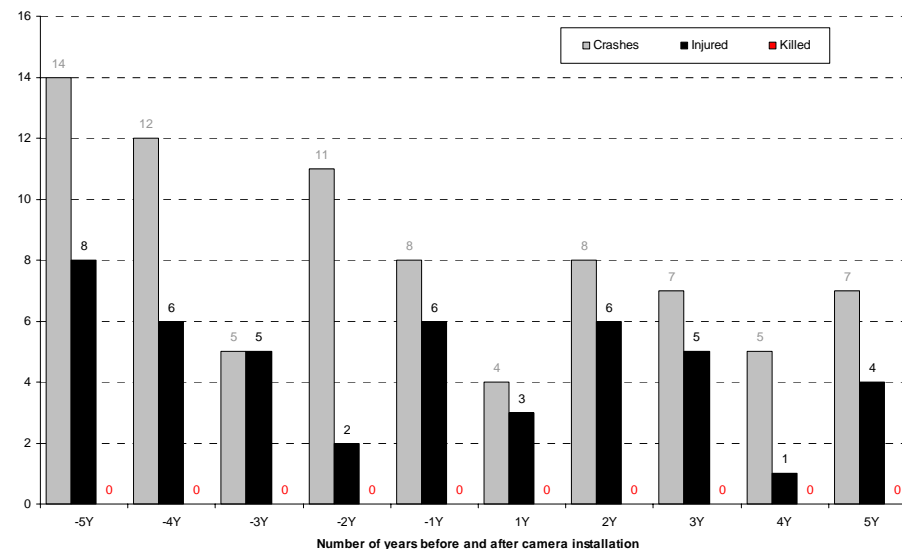
Crashes and casualties

Location: Forest Road, between Lily Street and Cronulla Street  
 School zone: Bethany College, Sydney Technical High School, Hurstville Boys High School and Hurstville Primary School  
 Length description: 190m south to 520m north of camera  
 Total length: 710m (patch to patch)  
 Number of cameras: 1  
 Started infringing: 17/10/2007  
 Status: **Effective**

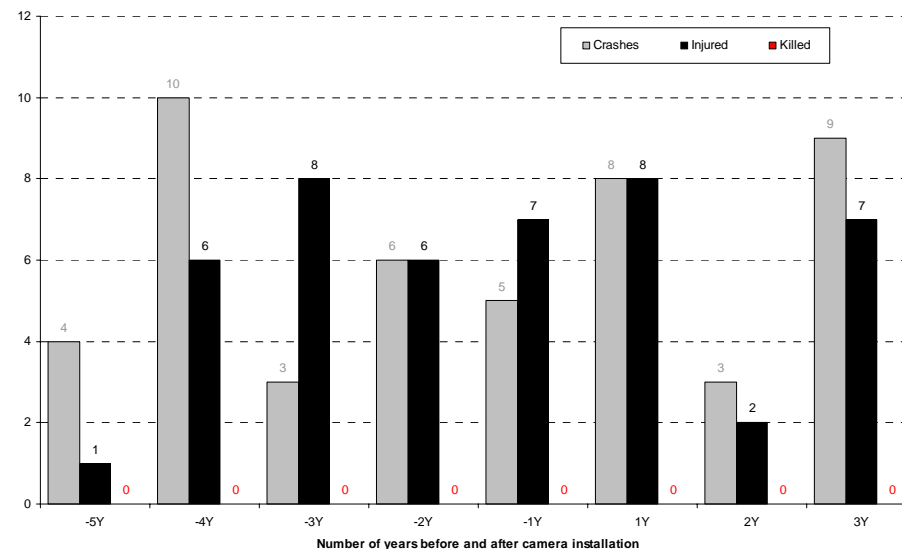
Crashes and casualties

## Trend in road safety performance at camera location

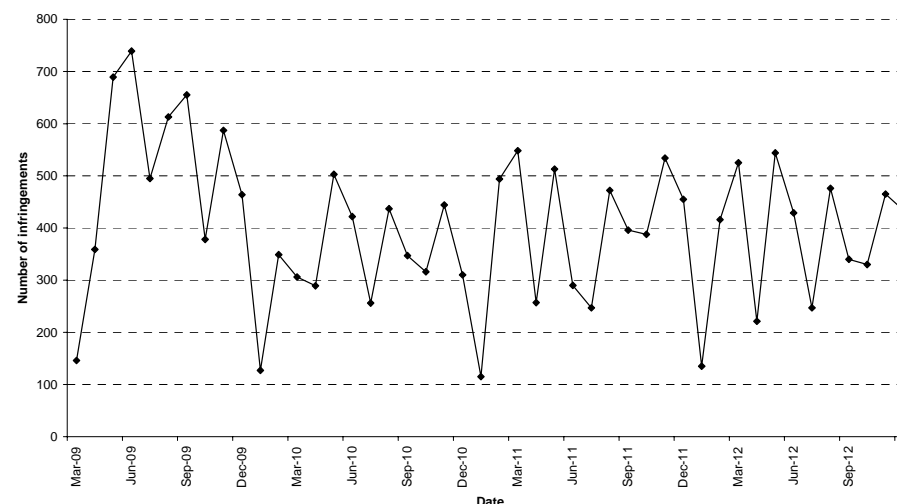
PARKER STREET KINGSWOOD

Infringements

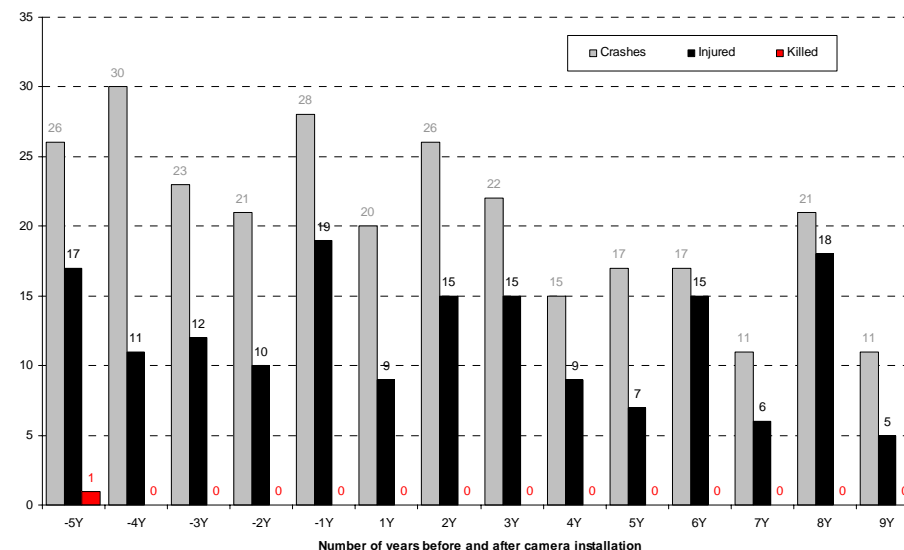
Crashes and casualties

## Trend in road safety performance at camera location

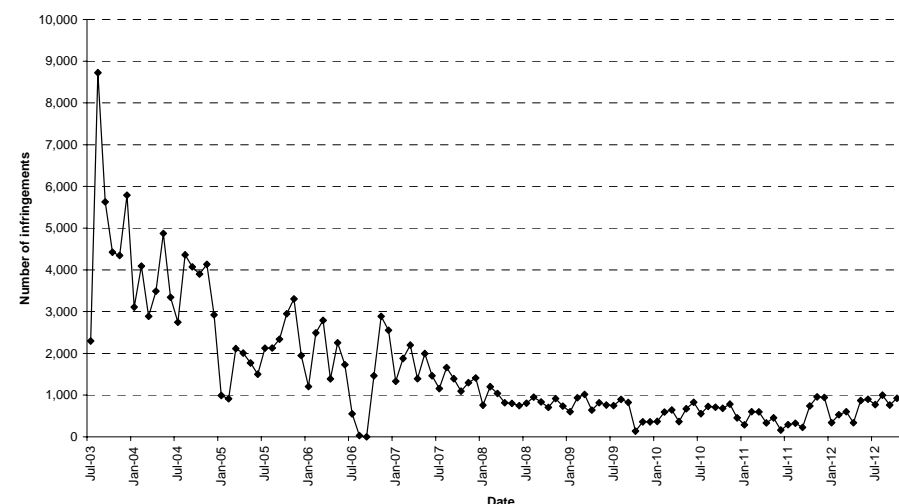
PRINCES HIGHWAY KOGARAH

Infringements

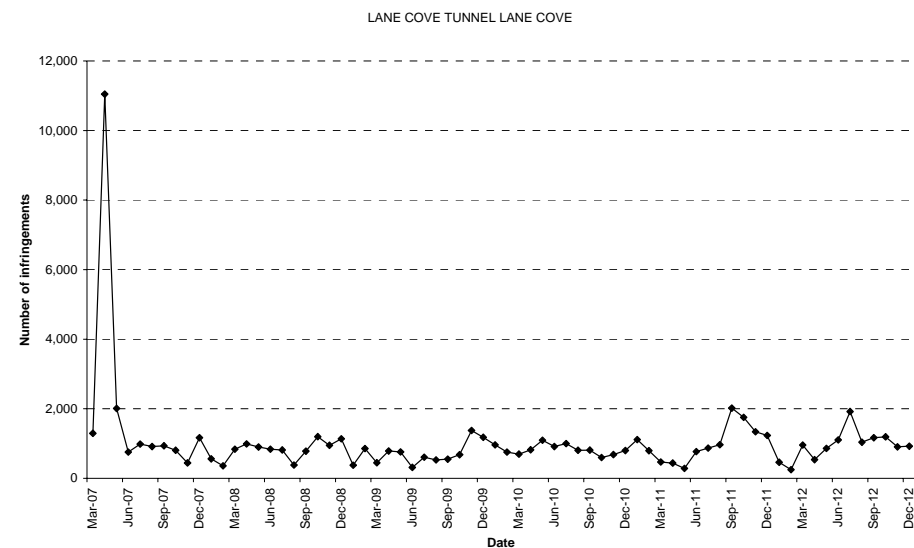
## Infringements at fixed speed camera location

- This location is appropriate for fixed speed camera enforcement as it is a high risk location that is difficult for the NSW Police Force to enforce using traditional methods.
- The infringement graph details the trend in infringements at this location since the cameras began operation. Roadworks and camera maintenance may influence the number of infringements issued.

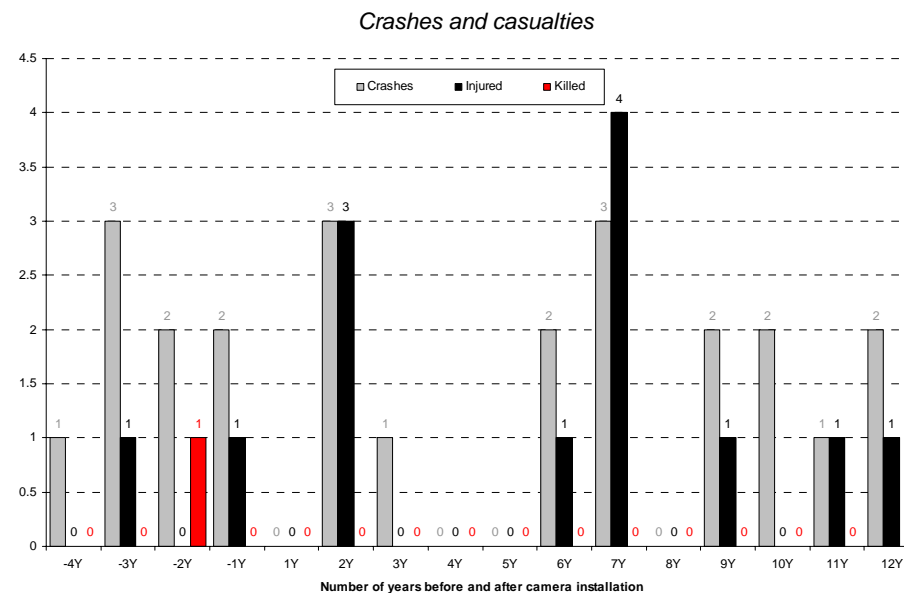
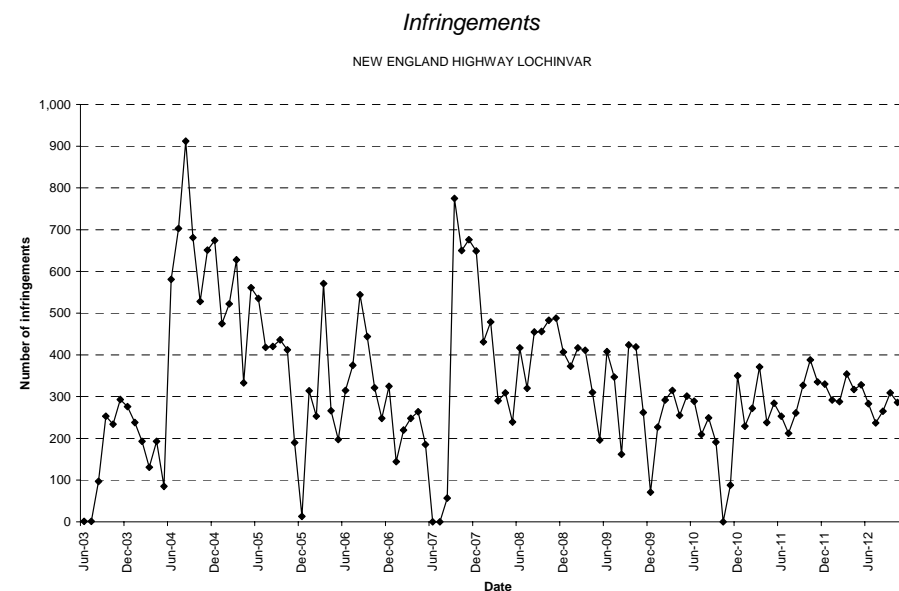
## Trend in road safety performance at camera location

- The current adjusted five year pre installation and post installation analysis shows that crashes have decreased at this location. This location was reviewed in 2012 due to concerns that casualties had increased slightly. The comprehensive safety review found that since the speed camera was installed, traffic volumes had increased significantly due to mining activities in the Hunter region. Given the increase in traffic volume, the adjusted casualty rate indicated that the speed camera has been effective in reducing casualties. Further, there was strong community support for the retention of the speed camera due to its location in a school zone where safety is a high priority. Therefore the speed camera at this location was found to be effective.

- The infringement graph details the trend in infringements at this location since June 2003. Infringement data before this date are not available. The spike in infringements from September 2007 was due to the camera commencing speed enforcement of both directions of traffic where it previously enforced one direction.

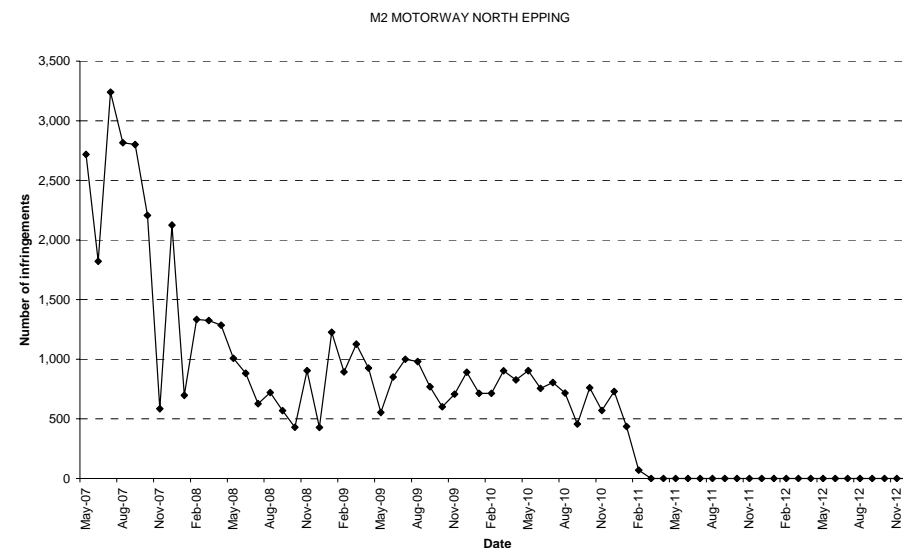
## Infringements at fixed speed camera location

- The fixed speed camera in the M2 Tunnel, M2 Motorway was installed in May 2007 however the camera is not currently installed due to roadworks.
- This location is appropriate for fixed speed camera enforcement as it is a high risk location that is difficult for the NSW Police Force to enforce using traditional methods.
- The infringement graph details the trend in infringements at this location since the camera began operation. The graph shows there has been a reduction in speeding behaviour at this location over time. Roadworks and camera maintenance may influence the number of infringements issued.

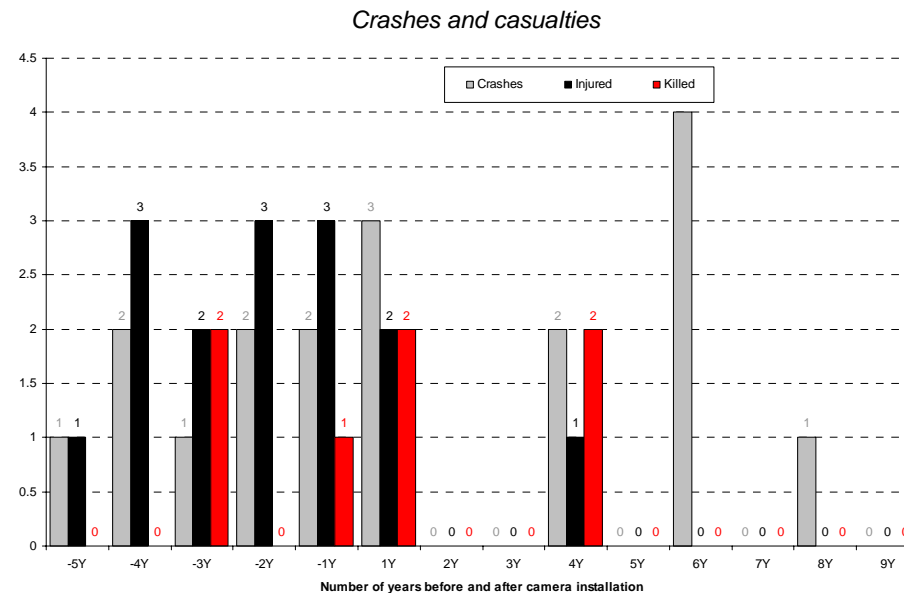
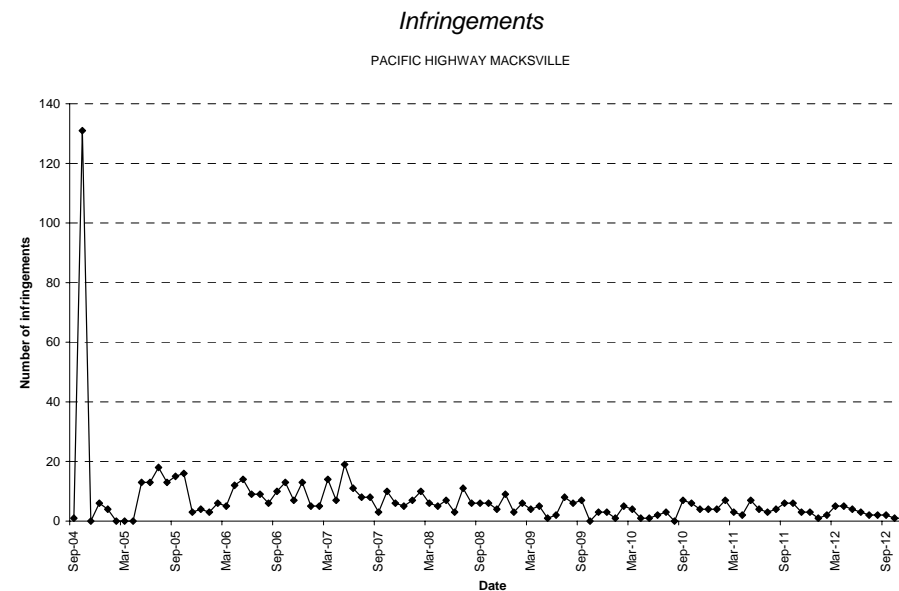
## Trend in road safety performance at camera location

- The current pre and post installation analysis shows that crashes have decreased at this location.
- When comparing the pre installation period to the most recent five year period, there has been a 38 per cent reduction in the annual average number of crashes and a 100 per cent reduction in the annual average number of casualties.
- This has been a saving of \$20.64 million in costs to the community.
- The infringement graph details the trend in infringements at this location since September 2004. Infringement data before this date are not available. The graph shows there has been a reduction in speeding behaviour at this location over time. Roadworks and camera maintenance may influence the number of infringements issued.

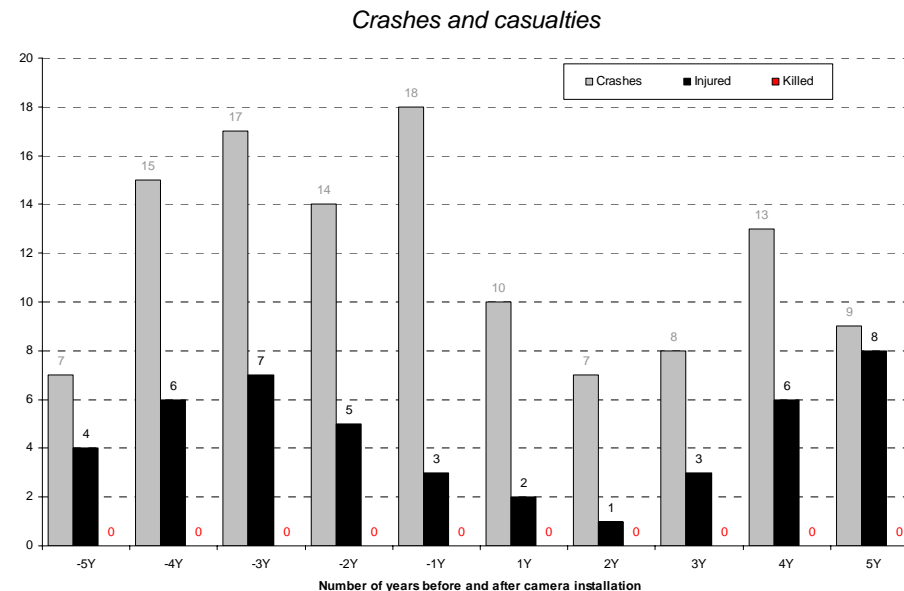
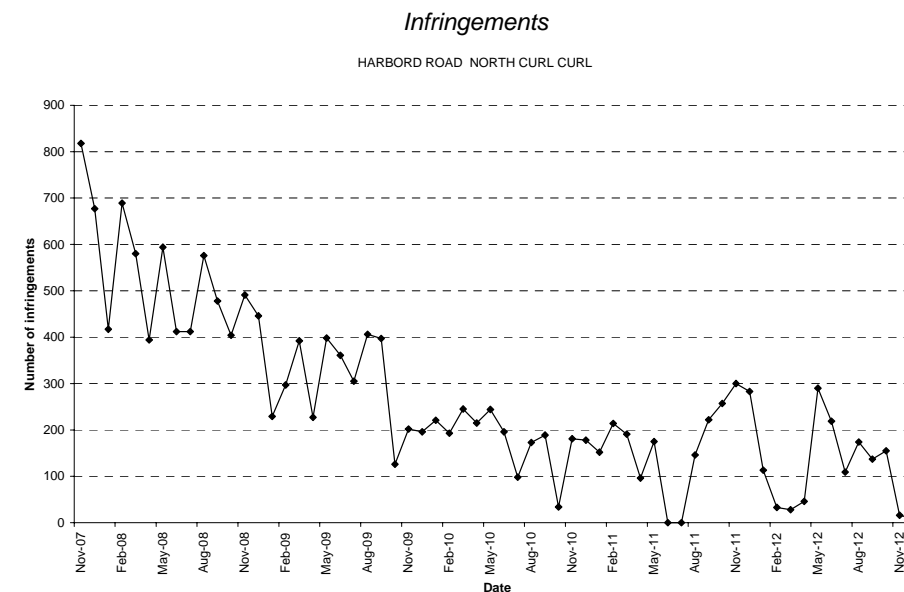
## Trend in road safety performance at camera location

- The current pre and post installation analysis shows that crashes have decreased at this location.
- When comparing the pre installation period to the most recent five year period, there has been a 34 per cent reduction in the annual average number of crashes and a 20 per cent reduction in the annual average number of casualties.
- This has been a saving of \$680,000 in costs to the community.
- The infringement graph details the trend in infringements at this location since the cameras began operation. The graph shows there has been a reduction in speeding behaviour at this location over time. Roadworks and camera maintenance may influence the number of infringements issued.

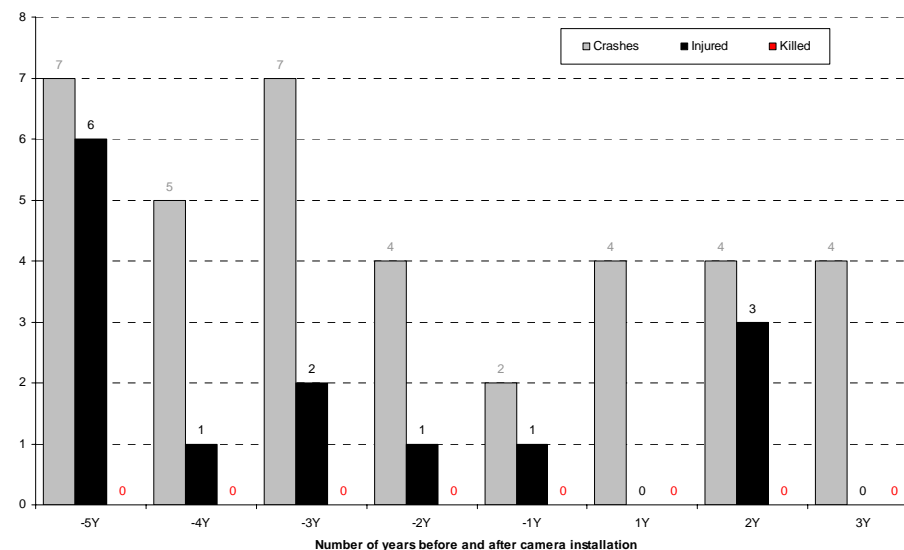
### Crashes and casualties

## Trend in road safety performance at camera location

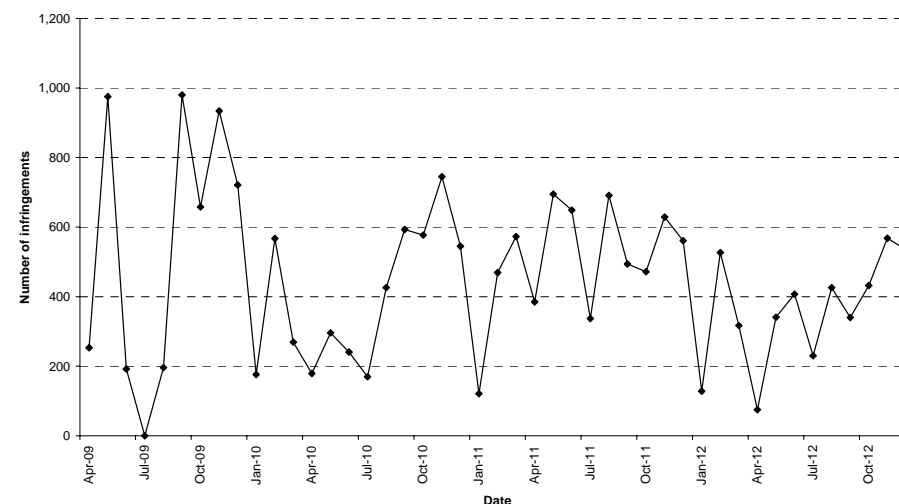
PITTWATER ROAD NORTH NARRABEEN

### Infringements

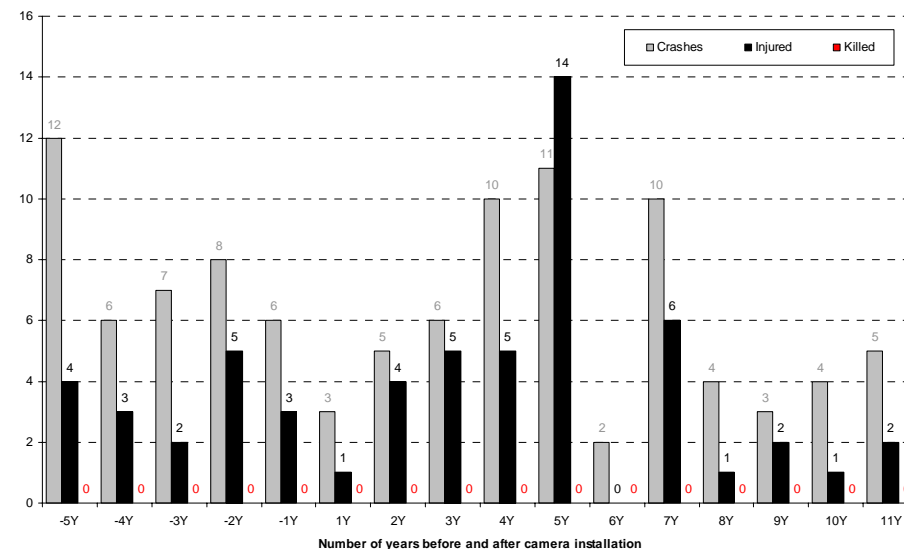
Crashes and casualties

## Trend in road safety performance at camera location

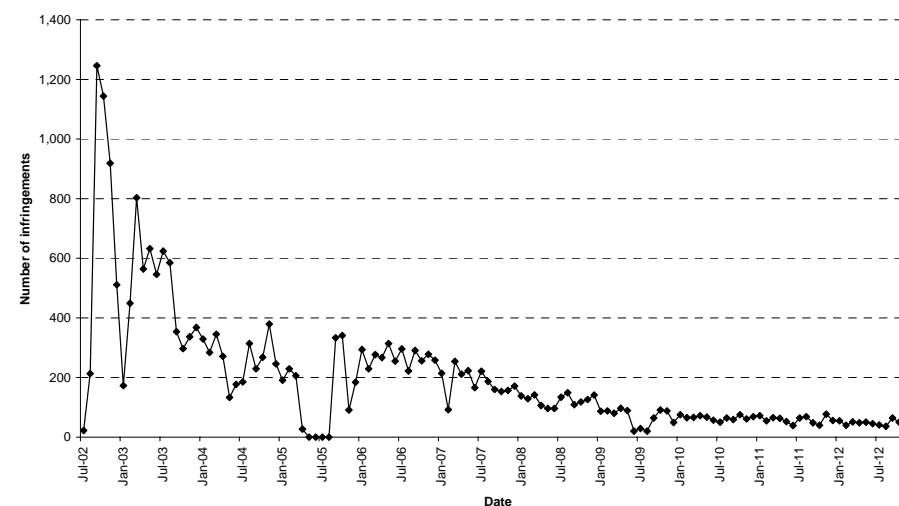
PENNANT HILLS RD NORTH PARRAMATTA

Infringements

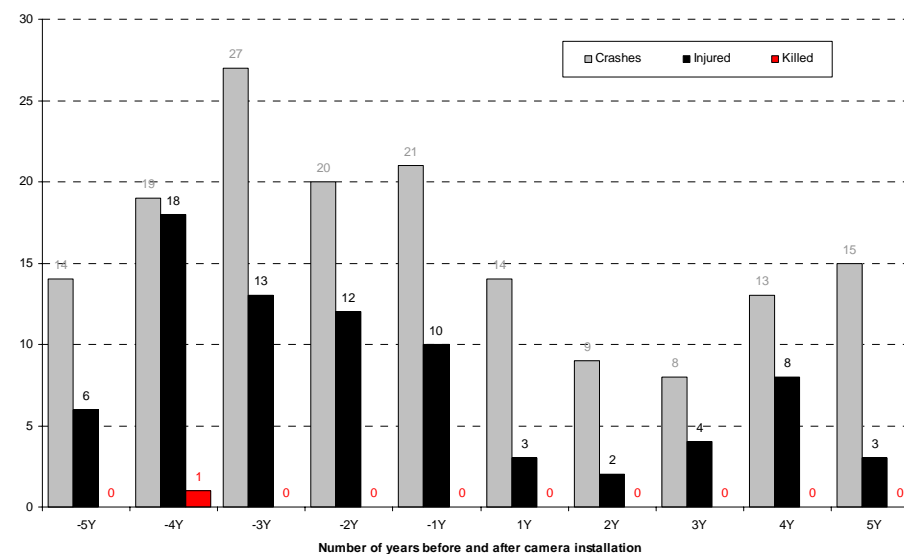
### Crashes and casualties

## Trend in road safety performance at camera location

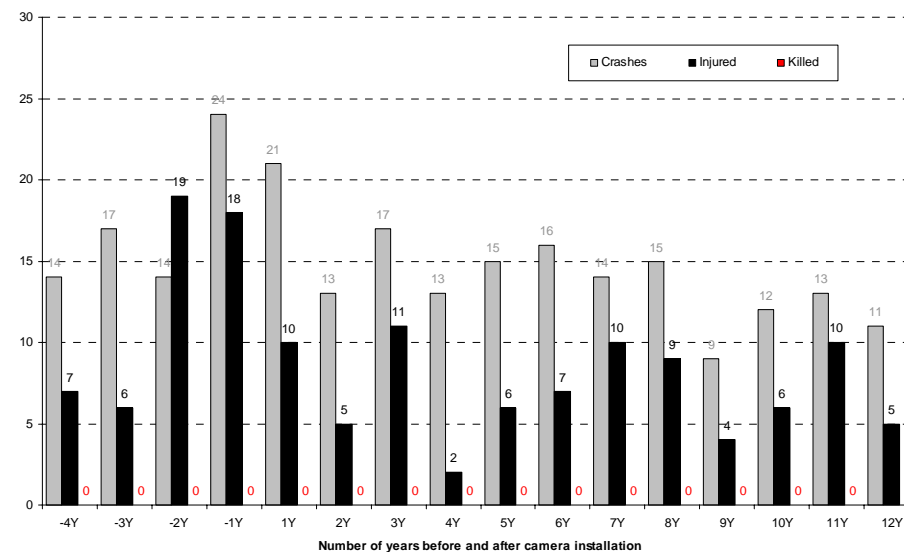
Crashes and casualties

## Trend in road safety performance at camera location

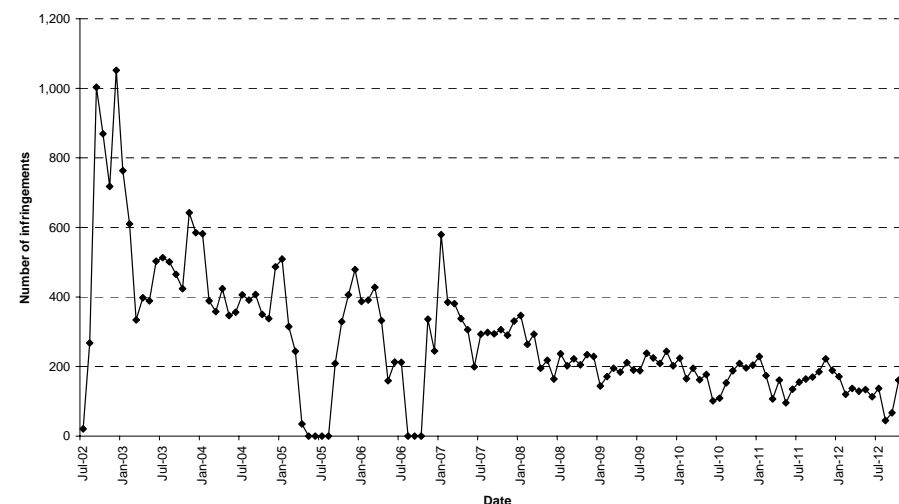
PRINCES HIGHWAY NORTH WOLLONGONG

Infringements

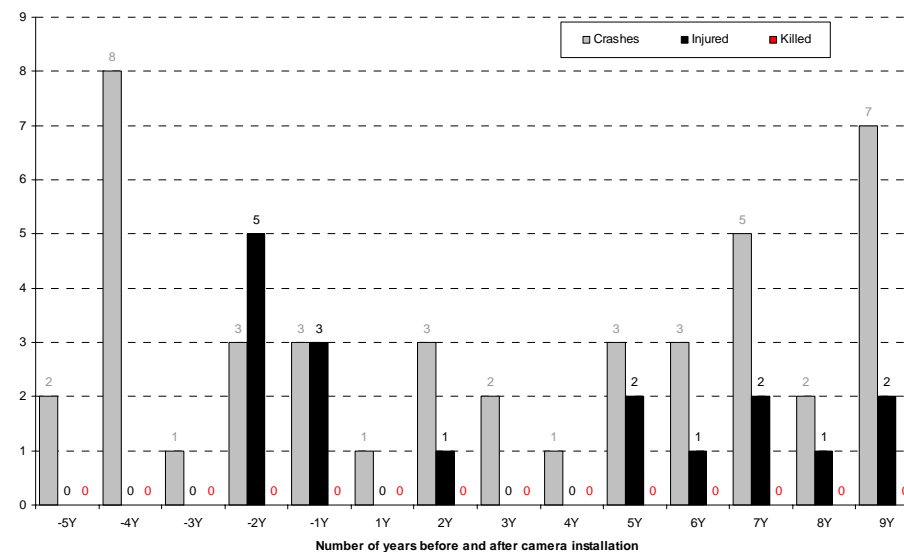
Crashes and casualties

## Trend in road safety performance at camera location

- The current pre and post installation analysis shows that crashes and casualties have increased at this location.
- When comparing the pre installation period to the most recent five year period, there has been an 18 per cent increase in the annual average number of crashes and a 25 per cent increase in the annual average number of casualties. In June 2012, there was one crash that resulted in 3 injuries.
- This location is recommended for comprehensive safety review as there has been an increase in crashes and casualties at this location in the most recent five year period.
- The infringement graph details the trend in infringements at this location since the camera began operation. The graph shows there has been reduction in speeding behaviour at this location over time. Roadworks and camera maintenance may influence the number of infringements issued.
