Transport  
for NSW

# ANNUAL NSW SPEED CAMERA PERFORMANCE REVIEW

NSW Centre for Road Safety

AUGUST 2013

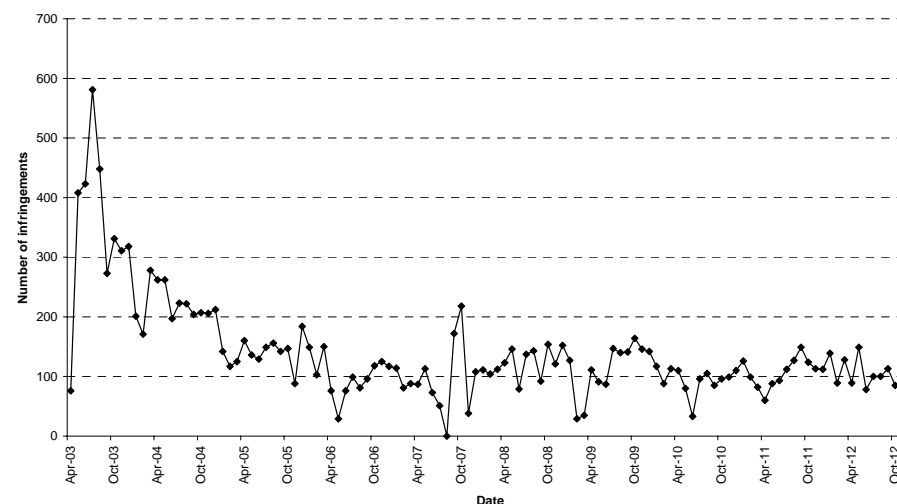
MCCAFFREY DRIVE RANKIN PARK

Infringements

- The current pre and post installation analysis shows that crashes and casualties have increased at this location.
- When comparing the pre installation period to the most recent five year period, there has been an 18 per cent increase in the annual average number of crashes and a 25 per cent increase in the annual average number of casualties. In June 2012, there was one crash that resulted in 3 injuries.
- This location is recommended for comprehensive safety review as there has been an increase in crashes and casualties at this location in the most recent five year period.
- The infringement graph details the trend in infringements at this location since the camera began operation. The graph shows there has been reduction in speeding behaviour at this location over time. Roadworks and camera maintenance may influence the number of infringements issued.

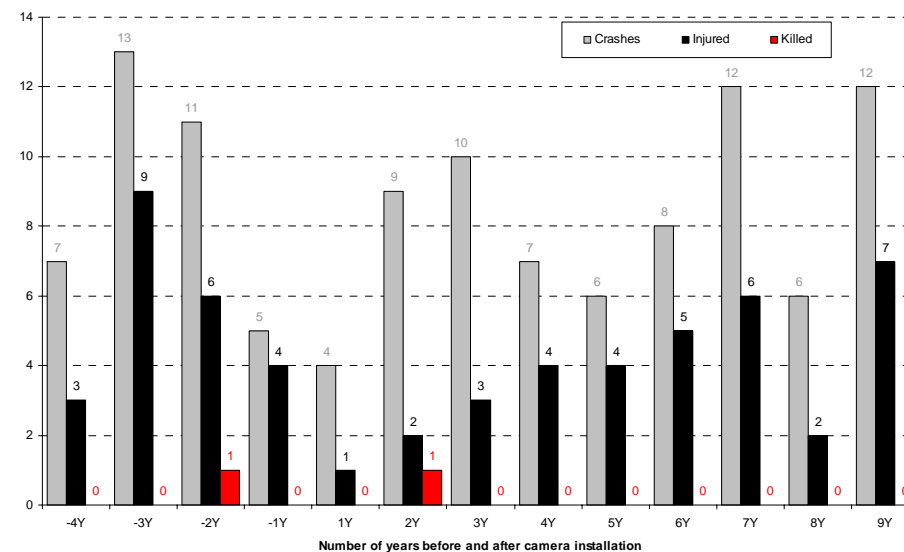
Crashes and casualties

## Trend in road safety performance at camera location

- This has been a saving of \$6.61 million in costs to the community.
- This location is recommended for comprehensive safety review as there has been a gradual increase in casualties at this location since the cameras were installed.

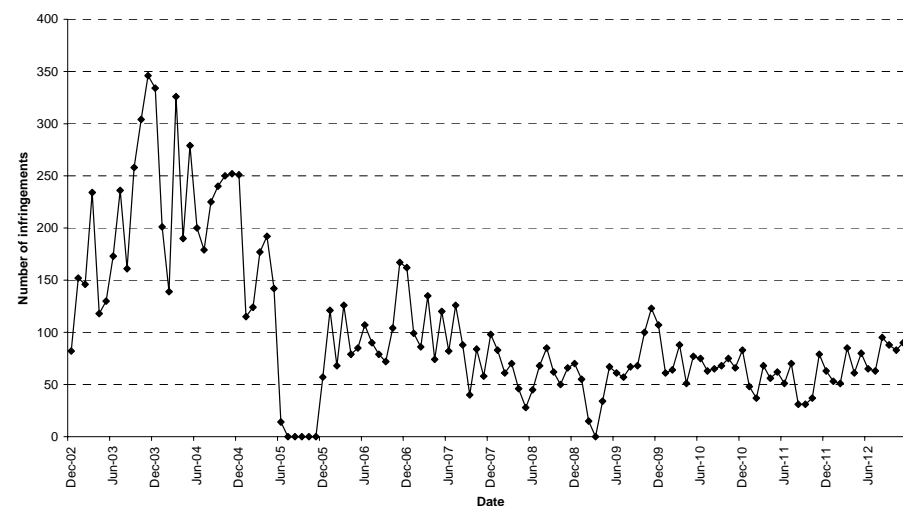
PACIFIC HIGHWAY SANDGATE

Infringements

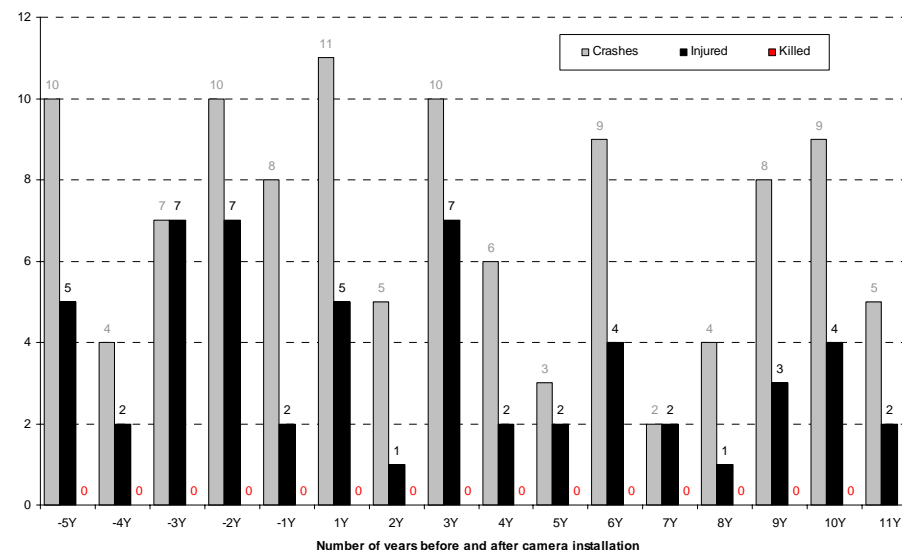
## Trend in road safety performance at camera location

Crashes and casualties

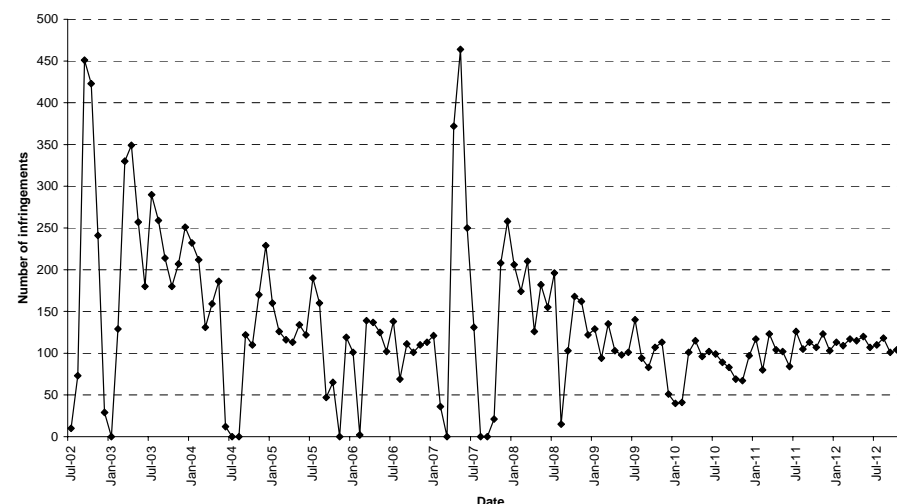
GEORGE STREET SOUTH WINDSOR

Infringements

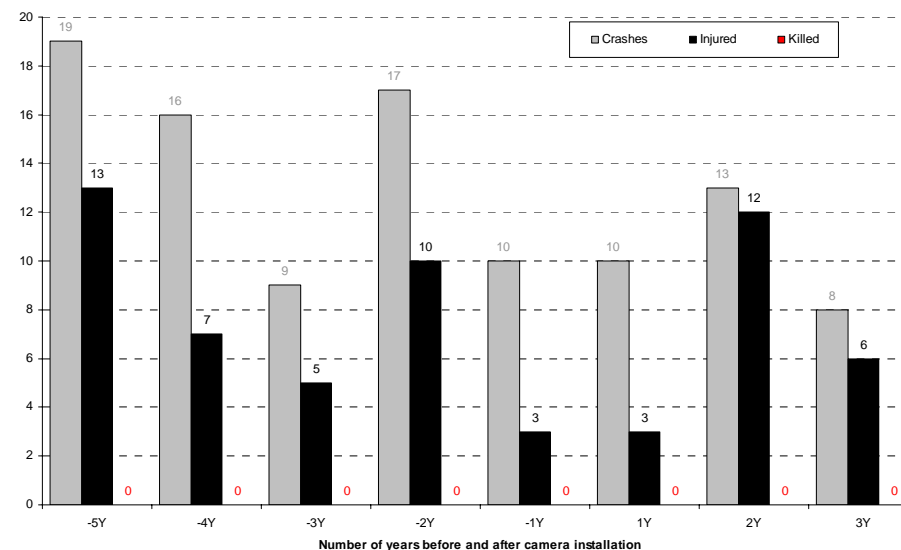
## Trend in road safety performance at camera location

Crashes and casualties

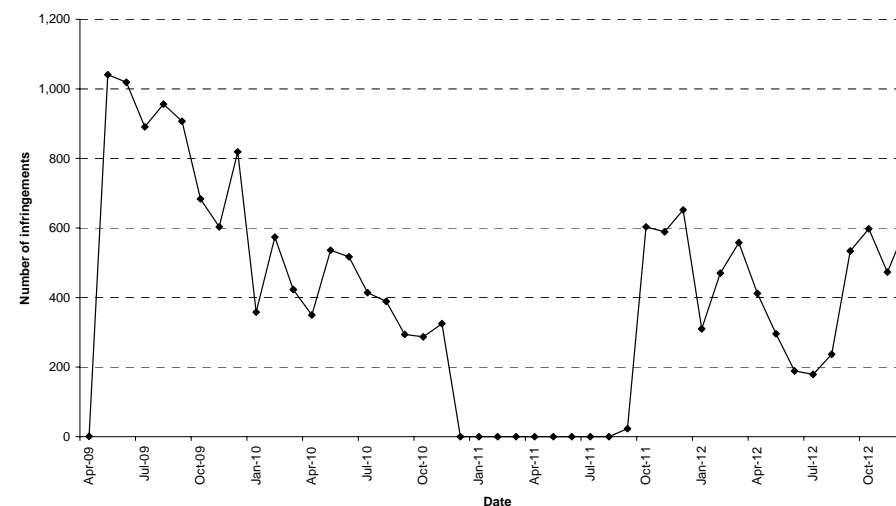
THE BOULEVARDE STRATHFIELD

Infringements

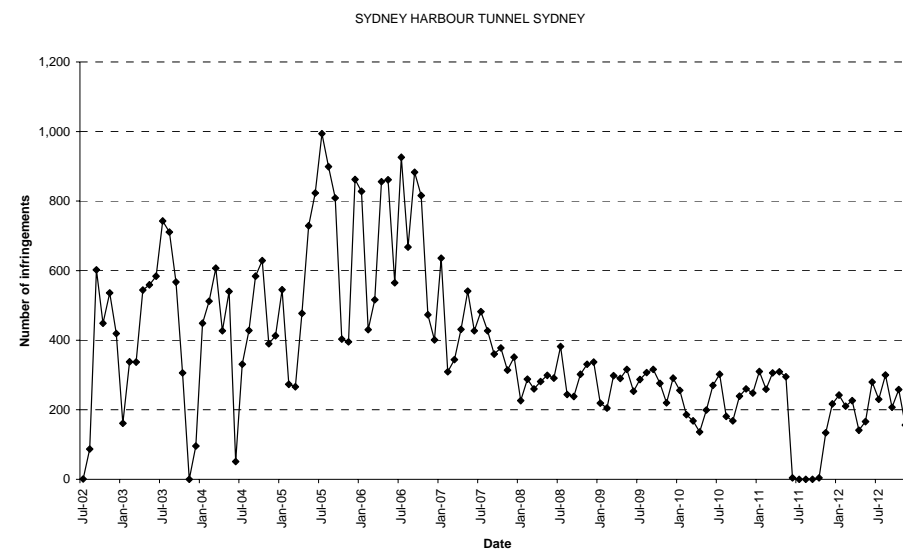
## Infringements at fixed speed camera location

- This location is appropriate for fixed speed camera enforcement as it is a high risk location that is difficult for the NSW Police Force to enforce using traditional methods.
- The infringement graph details the trend in infringements at this location since the cameras began operation. The extended period of camera downtime from June 2011 to October 2011 was due to camera maintenance requirements and difficulties accessing the tunnel site.

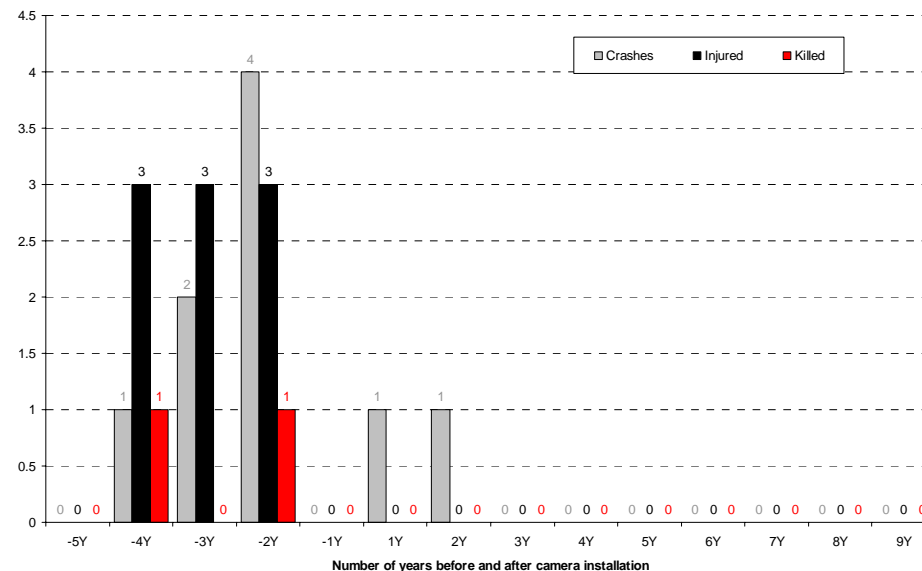
## Trend in road safety performance at camera location

Crashes and casualties

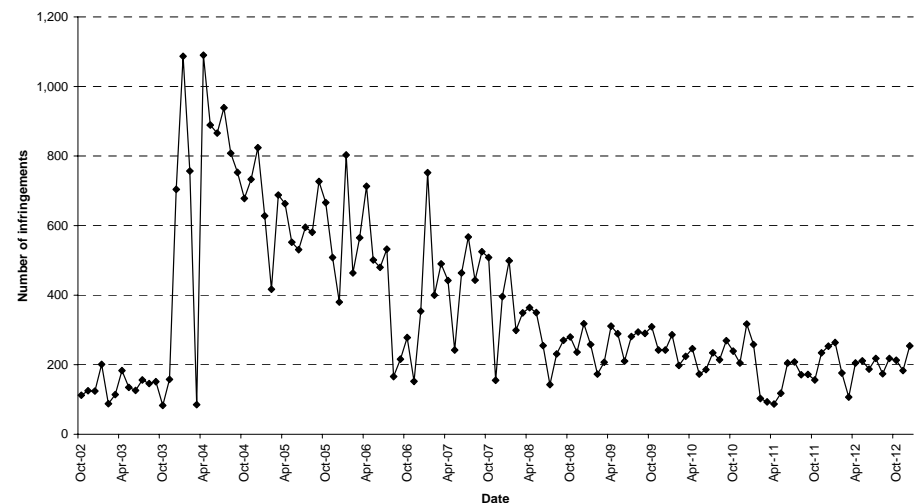
NEW ENGLAND HIGHWAY TENTERFIELD

Infringements

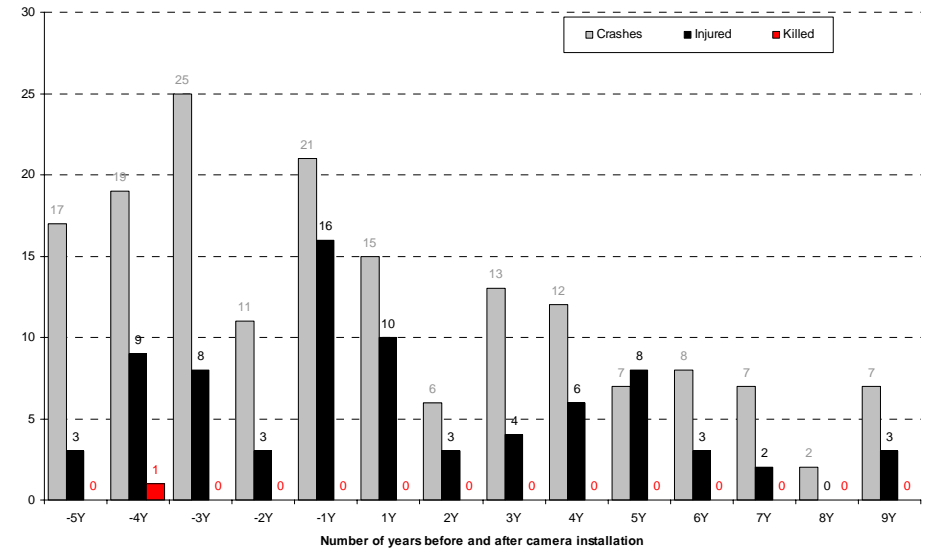
## Trend in road safety performance at camera location

Crashes and casualties

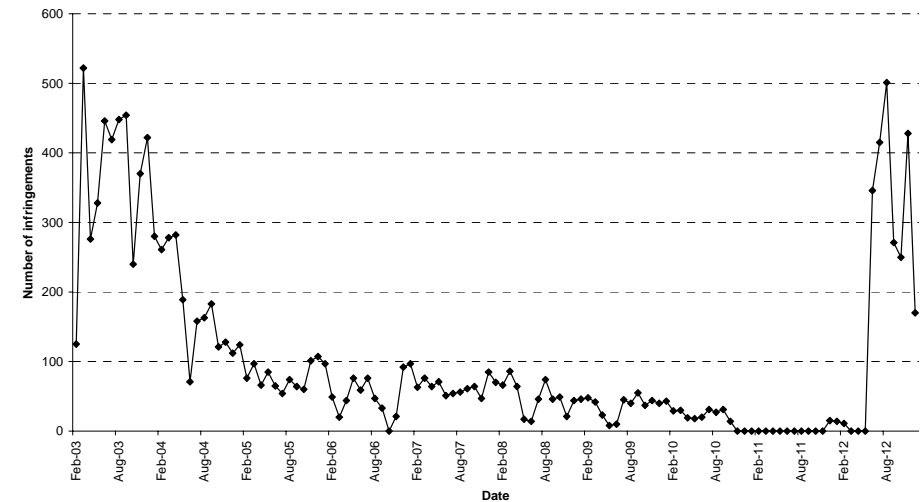
TERRIGAL DRIVE TERRIGAL

Infringements

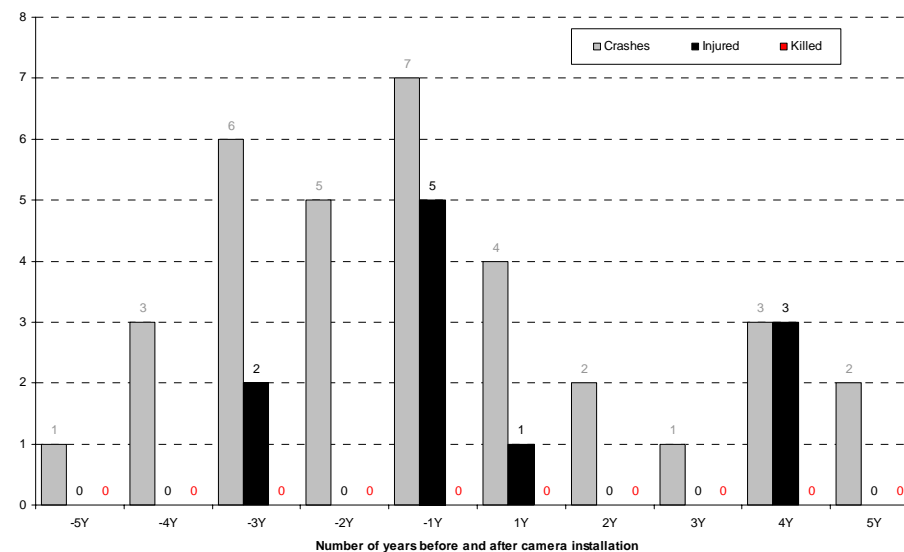
## Trend in road safety performance at camera location

Crashes and casualties

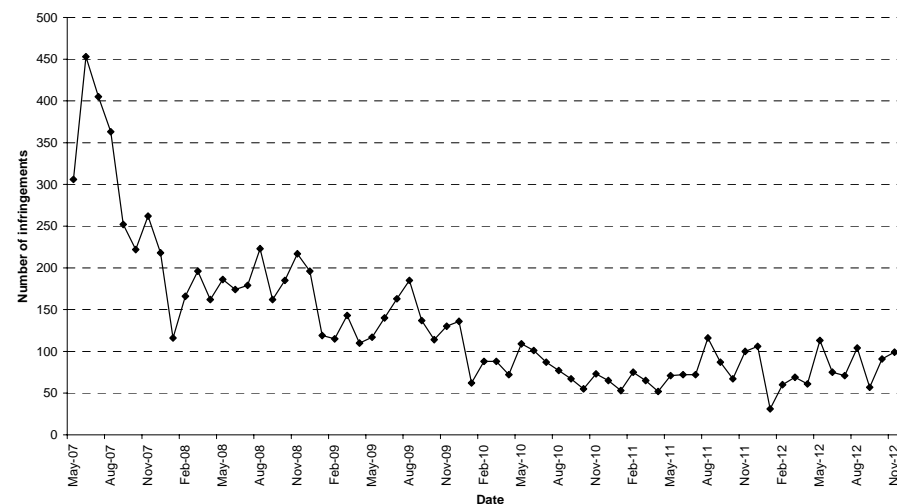
FITZWILLIAM ROAD OLD TOONGABBIE

Infringements

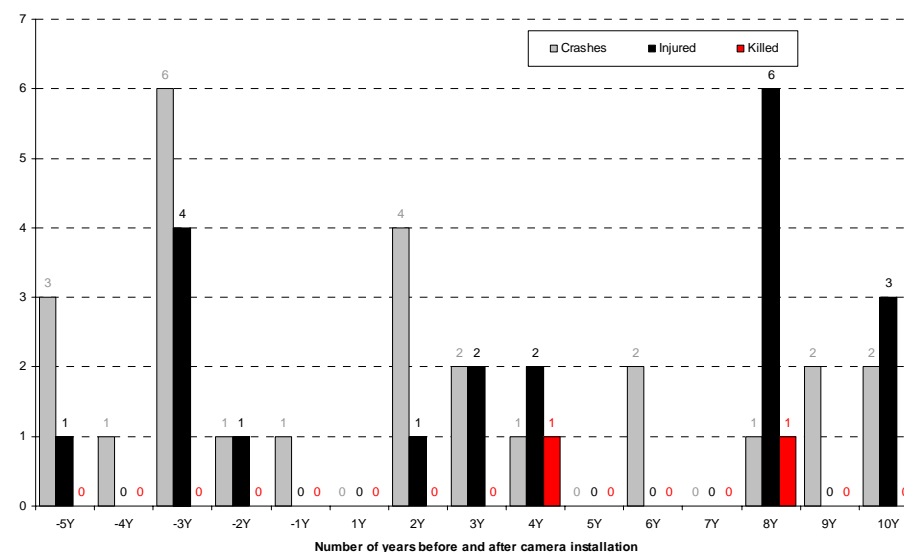
## Trend in road safety performance at camera location

Crashes and casualties

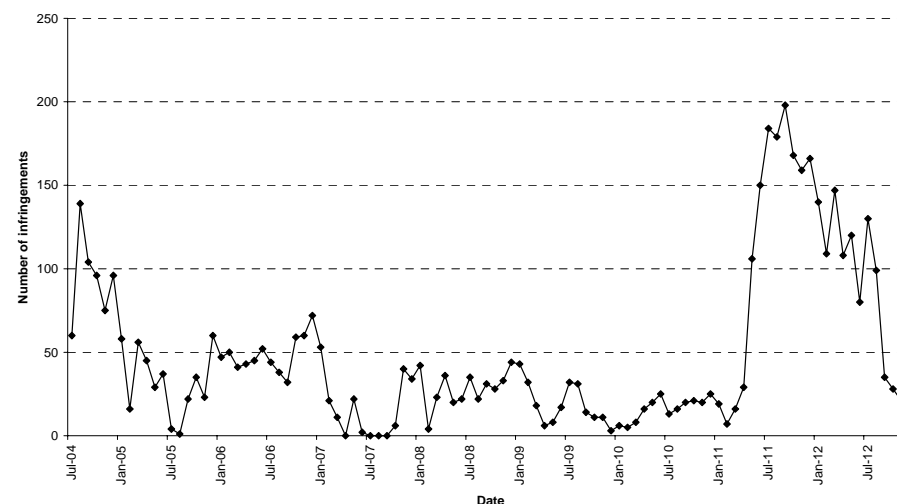
PACIFIC HIGHWAY VALLA BEACH

Infringements

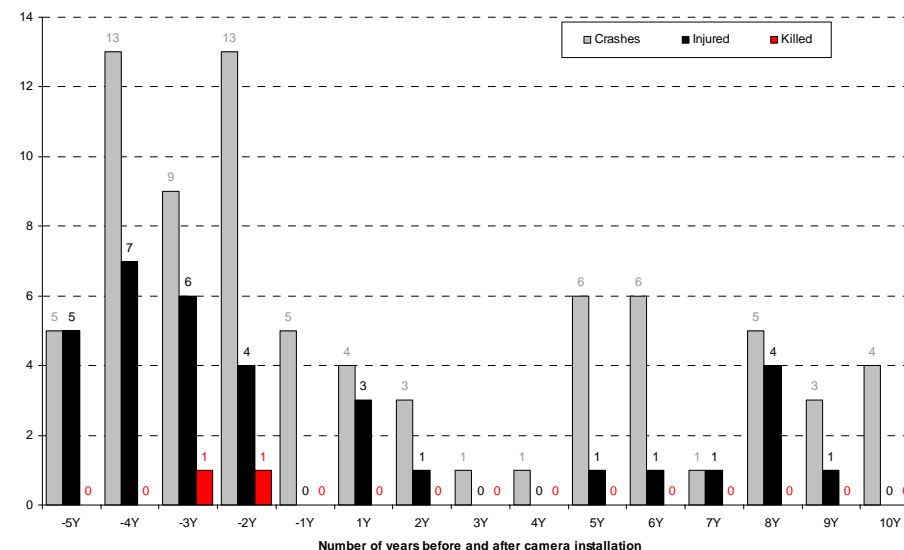
## Trend in road safety performance at camera location

Crashes and casualties

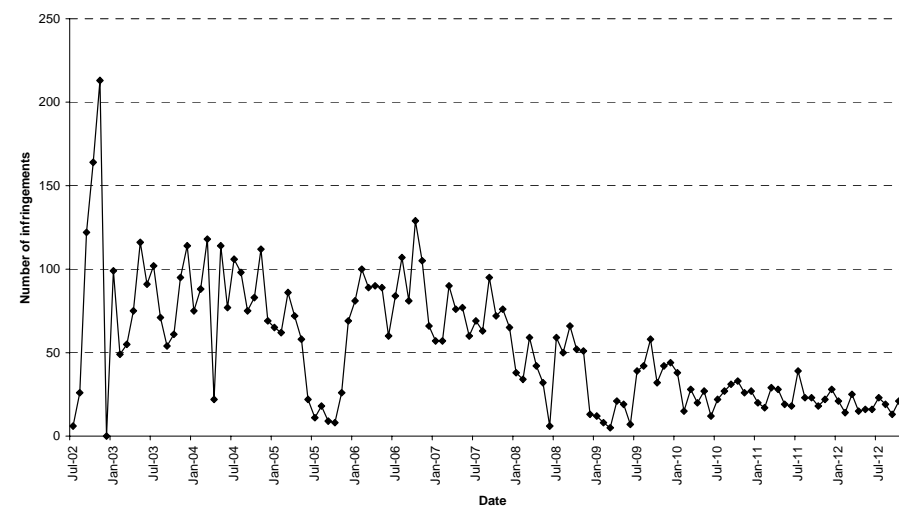
GREAT WESTERN HIGHWAY VALLEY HEIGHTS

Infringements

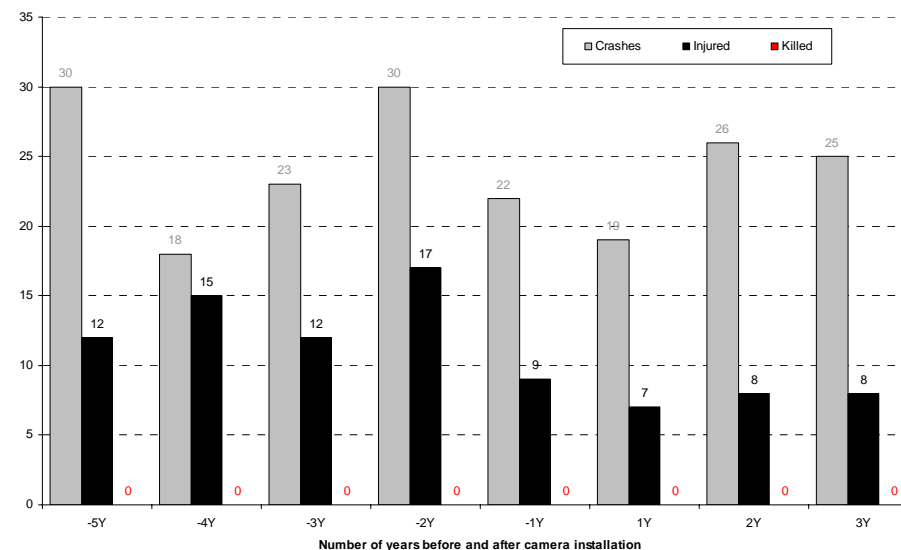
## Trend in road safety performance at camera location

Crashes and casualties

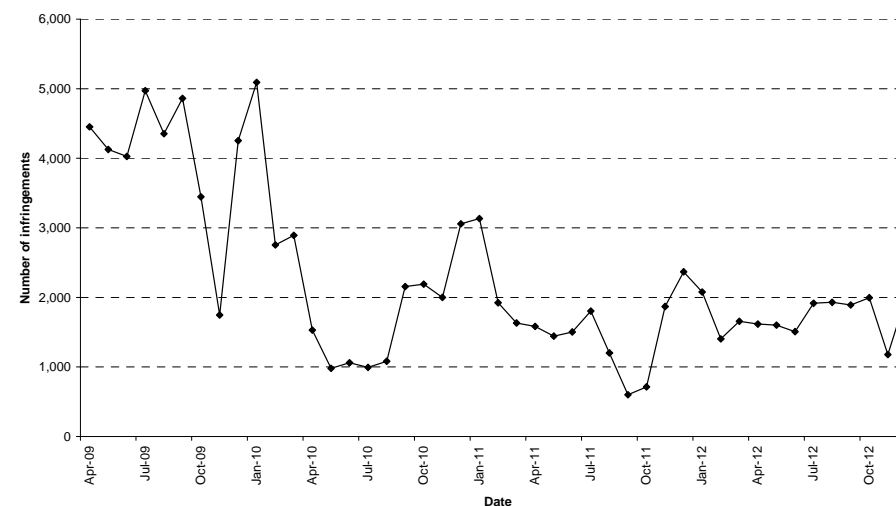
PACIFIC HIGHWAY WAHROONGA

Infringements

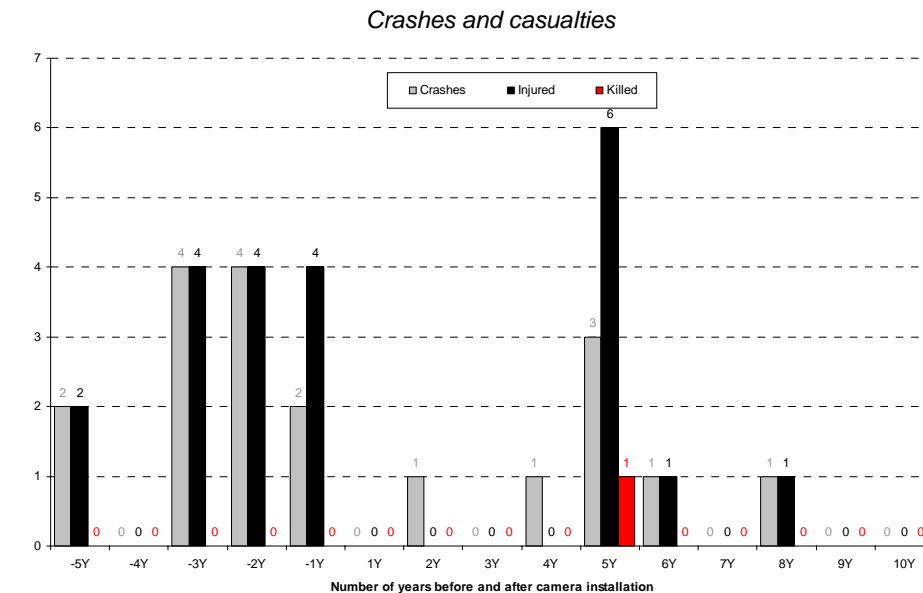
- The current pre and post installation analysis shows that crashes have decreased at this location.
- When comparing the pre installation period to the most recent five year period, there has been a 75 per cent reduction in the annual average number of crashes and a 79 per cent reduction in the annual average number of casualties.
- This has been a saving of \$1.49 million in costs to the community.
- The infringement graph details the trend in infringements at this location since the camera began operation. The spike in infringements in September 2009 can be attributed to the speed limit changing from 100km/h to 80km/h. Roadworks and camera maintenance may influence the number of infringements issued.

## Trend in road safety performance at camera location

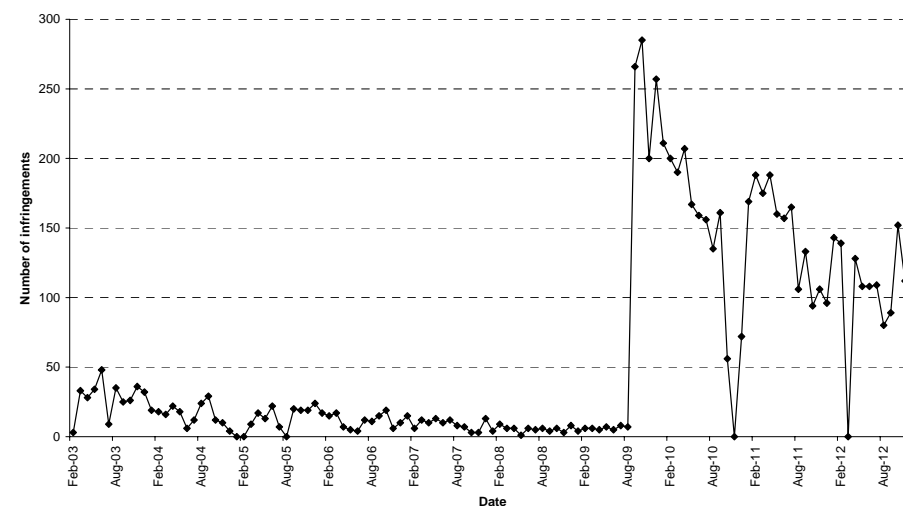
PACIFIC HIGHWAY WARDELL

### Infringements

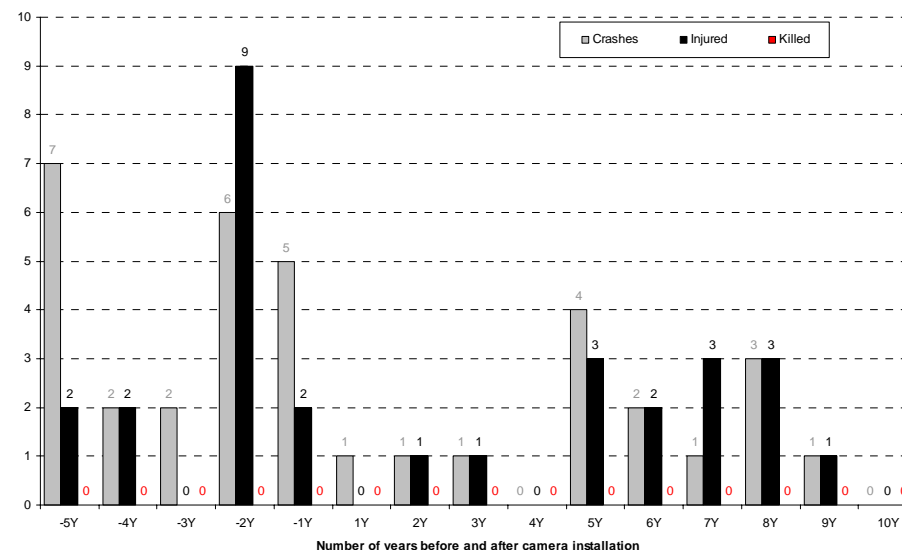
## Trend in road safety performance at camera location

Crashes and casualties

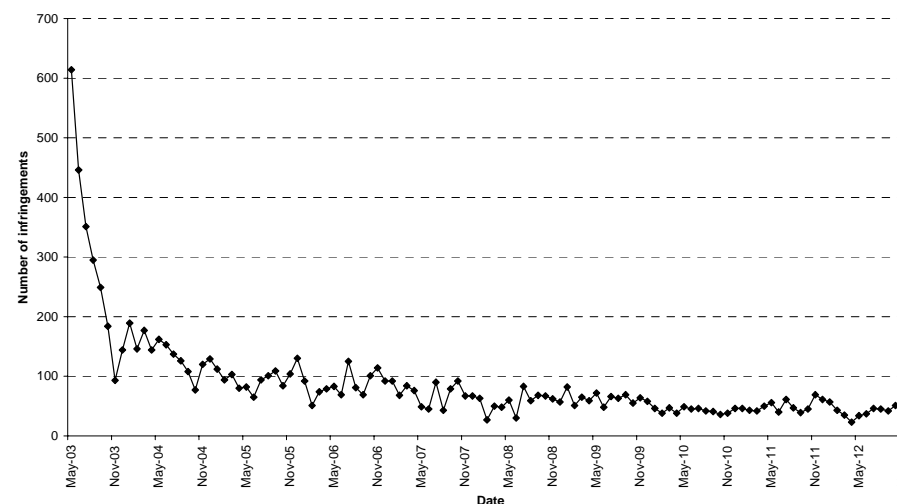
NORTHCLIFFE DRIVE WARRAWONG

Infringements

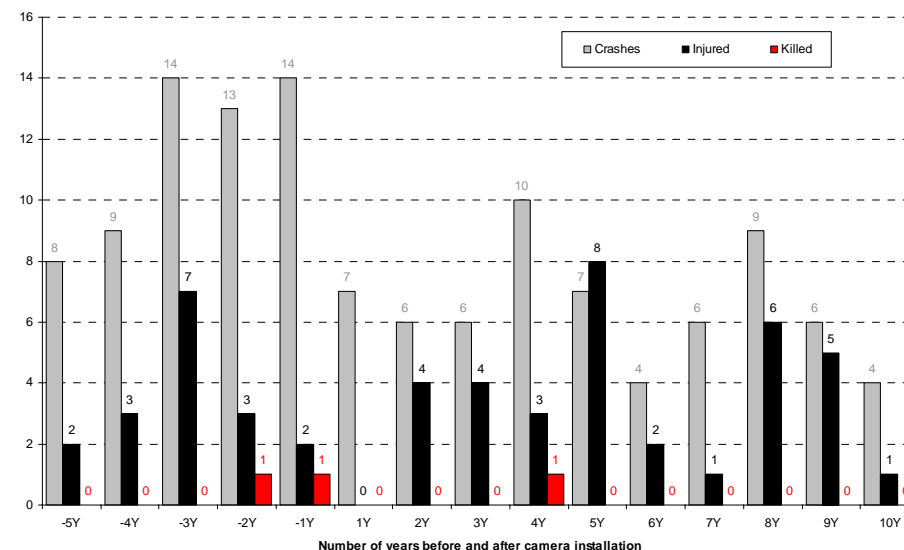
## Trend in road safety performance at camera location

Crashes and casualties

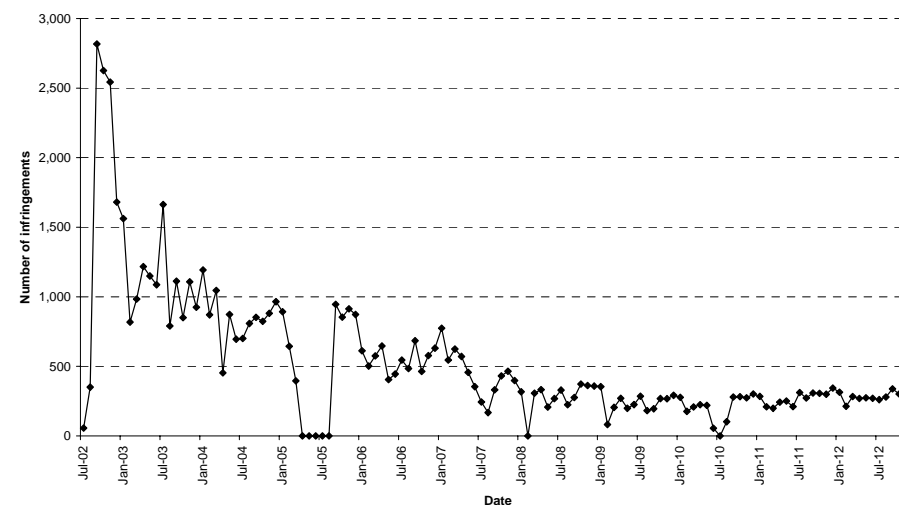
CASTLE HILL ROAD WEST PENNANT HILLS

Infringements

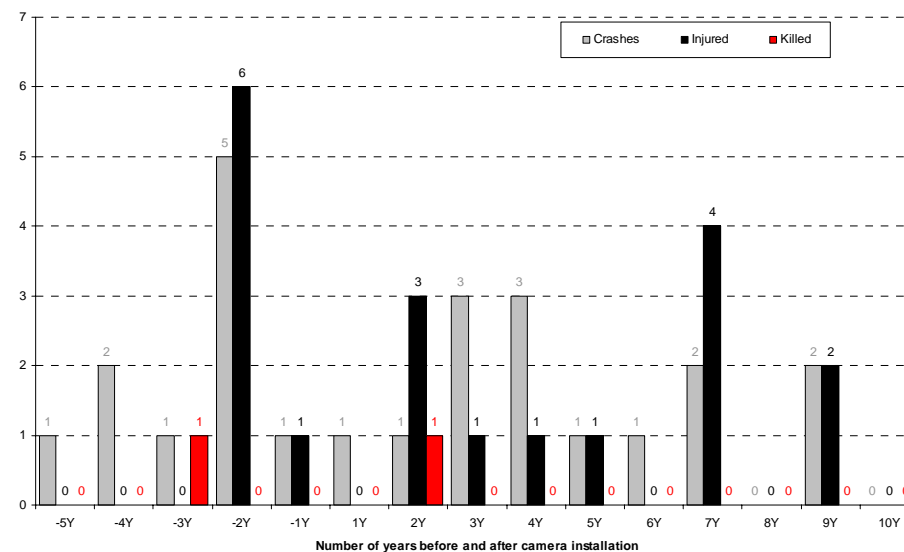
## Trend in road safety performance at camera location

Crashes and casualties

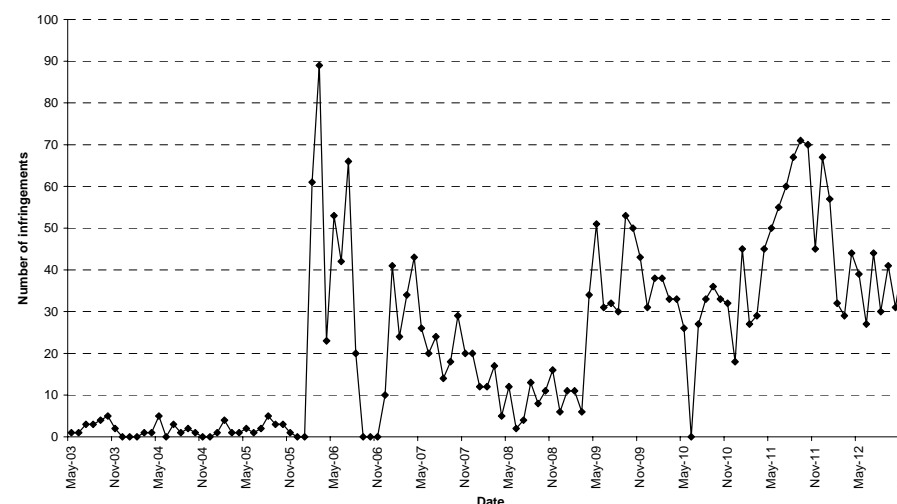
BRUXNER HWY WOLLONGBAR

Infringements

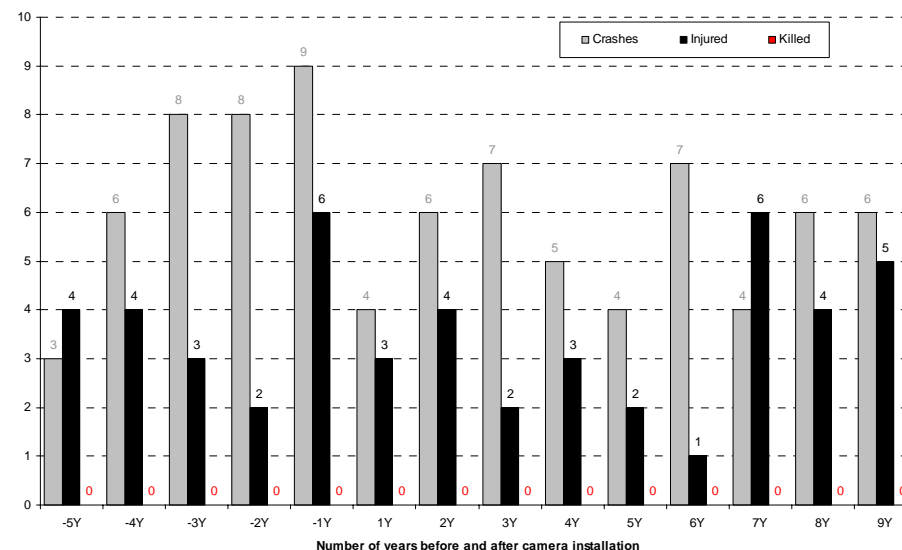
## Trend in road safety performance at camera location

Crashes and casualties

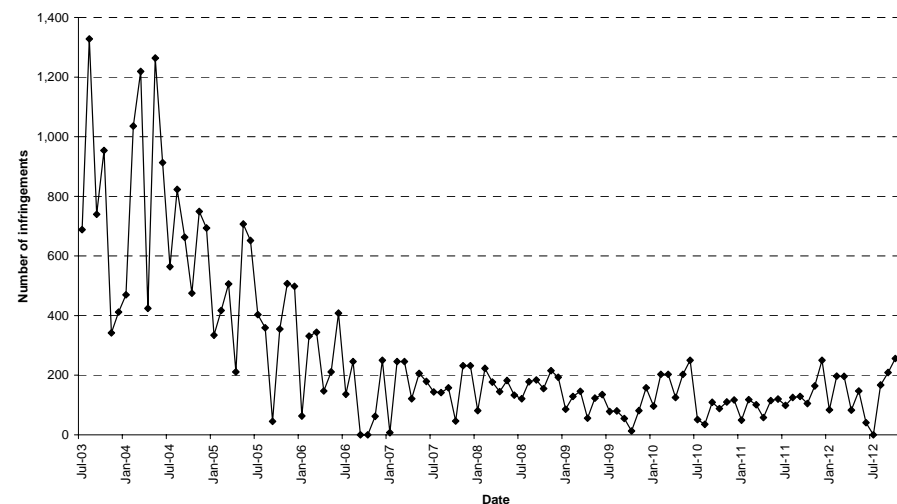
PRINCES HIGHWAY WEST WOLLONGONG

Infringements

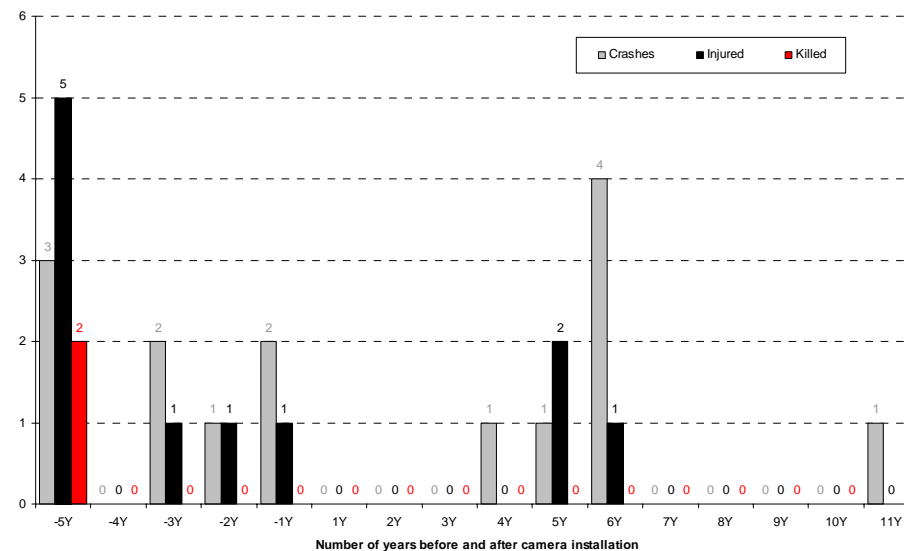
## Trend in road safety performance at camera location

Crashes and casualties

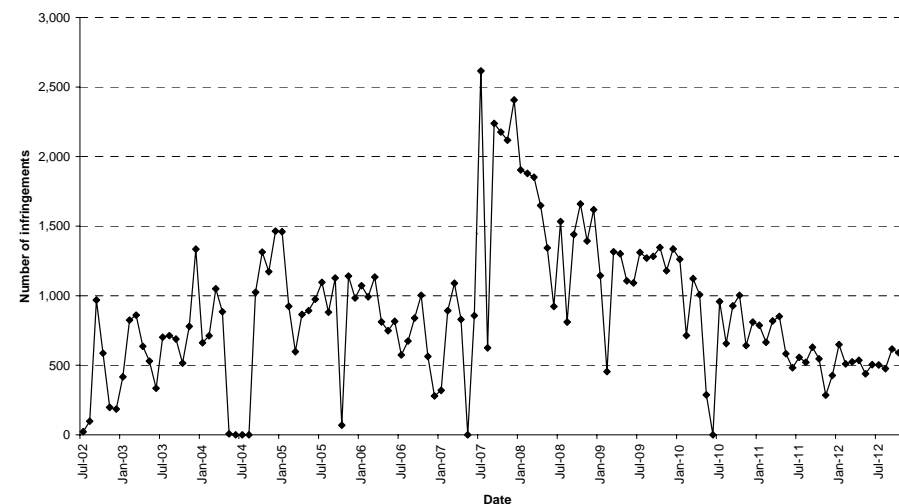
PACIFIC HIGHWAY WOODBURN

Infringements

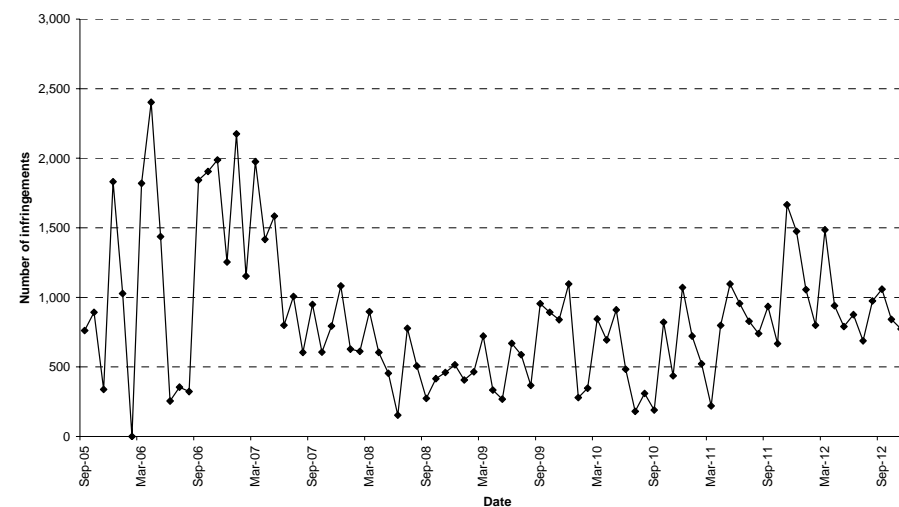
CROSS CITY TUNNEL WOOLLOOMOOLOO EAST SYDNEY

## Infringements at fixed speed camera location

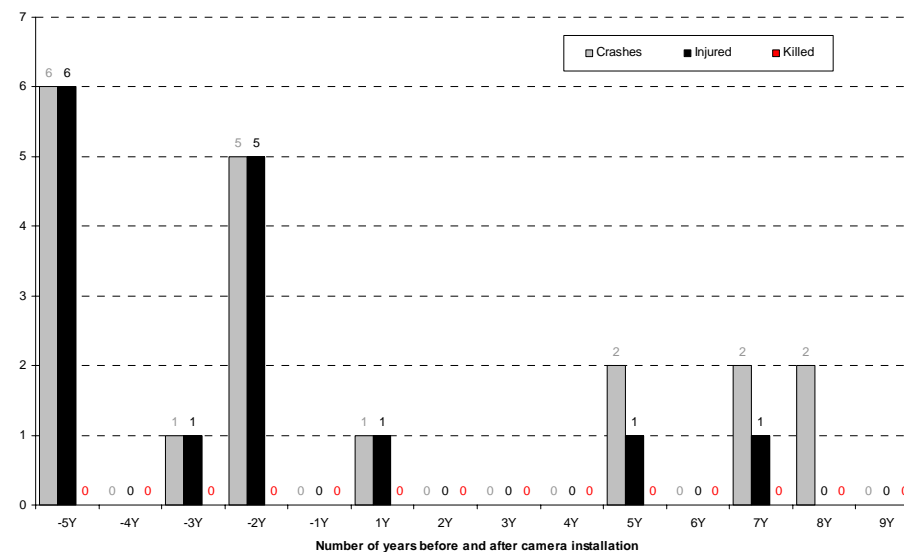
## Trend in road safety performance at camera location

Crashes and casualties

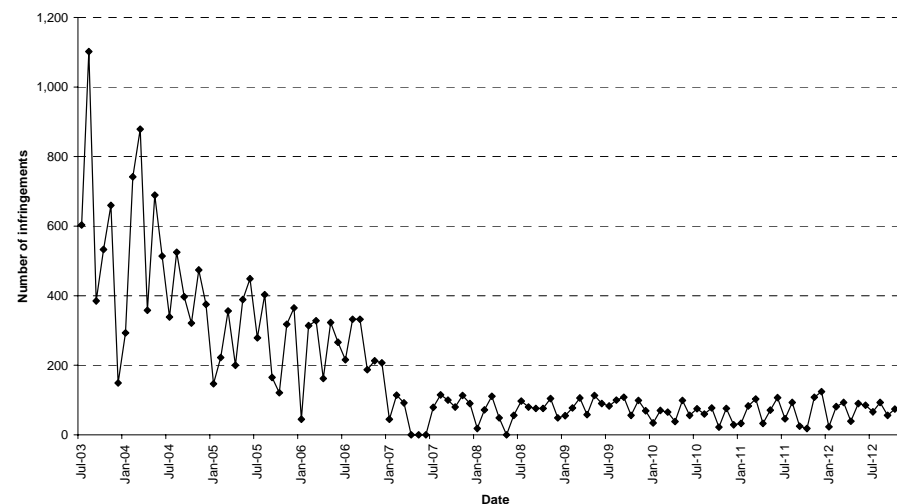
HENRY PARRY DRIVE WYOMING

Infringements

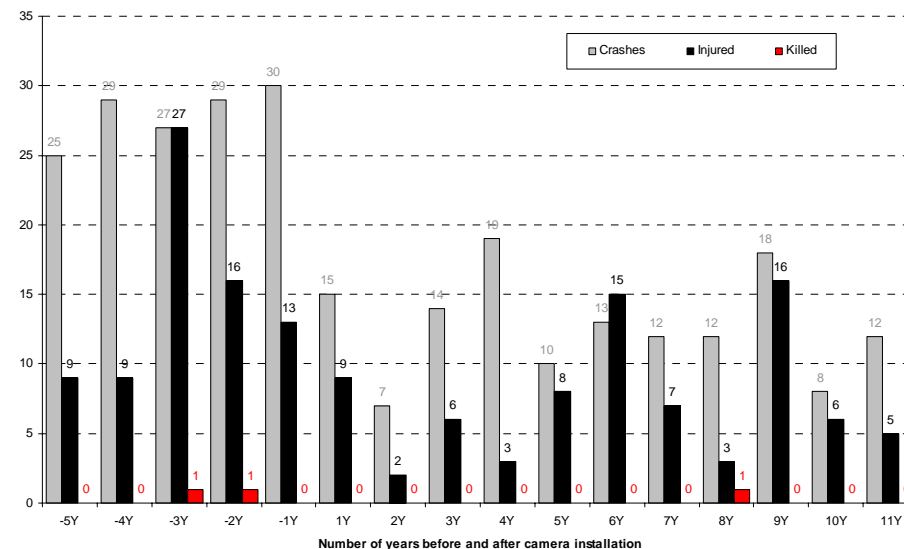
## Trend in road safety performance at camera location

Crashes and casualties

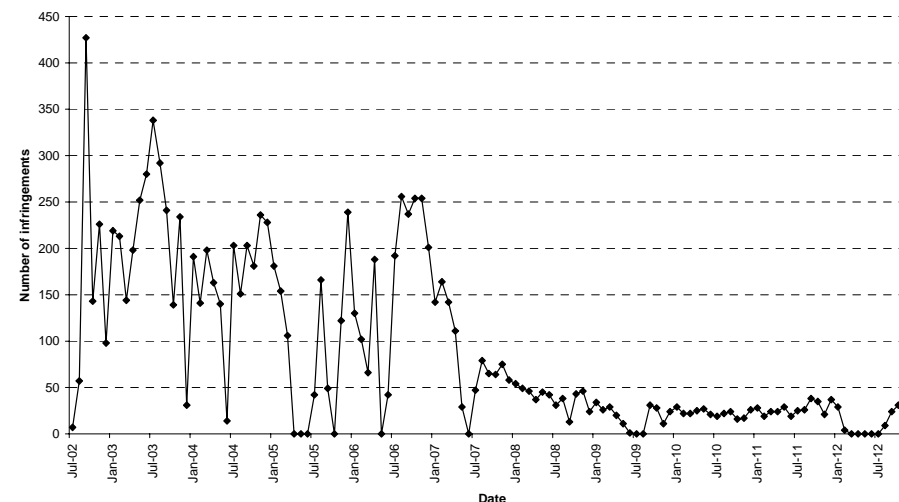
HUME HIGHWAY YAGOONA

Infringements

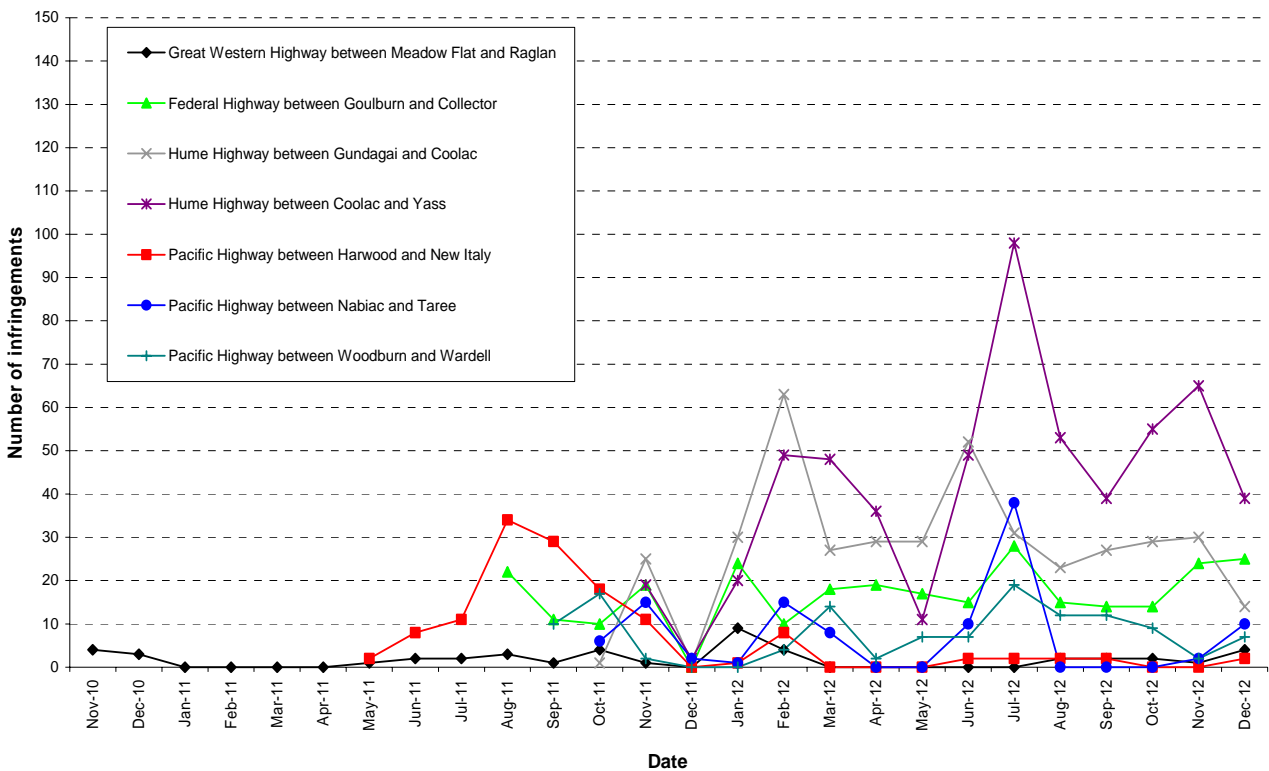
**Point-to-point speed infringements to December 2012**

A total of 1,617 speeding infringements were issued at point-to-point lengths in 2012. The low number of infringements issued within each of these lengths shows that there has been a high level of compliance with the speed limit. Roadworks and camera maintenance may influence the number of infringements issued.
