Transport
for NSW

ANNUAL NSW SPEED CAMERA PERFORMANCE REVIEW

NSW Centre for Road Safety

OCTOBER 2014

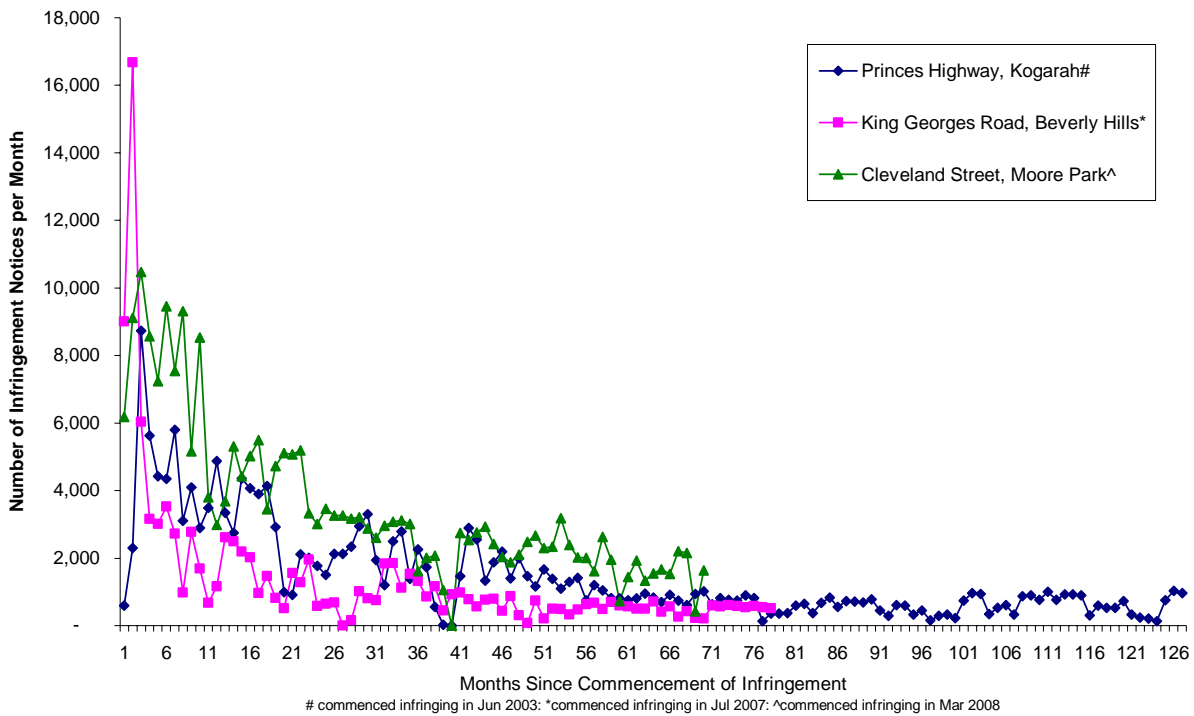
Figure 1: Example of trend in speed camera infringements over time.

Speed cameras are used to change driver behaviour, which can be measured by changes in infringements over time. An example of this trend is illustrated in Figure 1 that depicts the number of infringements per month since the commencement of enforcement at three of the highest infringing fixed speed camera locations. This pattern shows an initial high number of infringements followed by a rapid and sustained decrease in infringements as drivers modify their behaviour which is reflected in a reduction in crashes over time. Appendix C contains this type of infringement graph for every fixed speed camera location.

Number of Fixed Speed Camera Infringement Notices per Month for Sample of Cameras

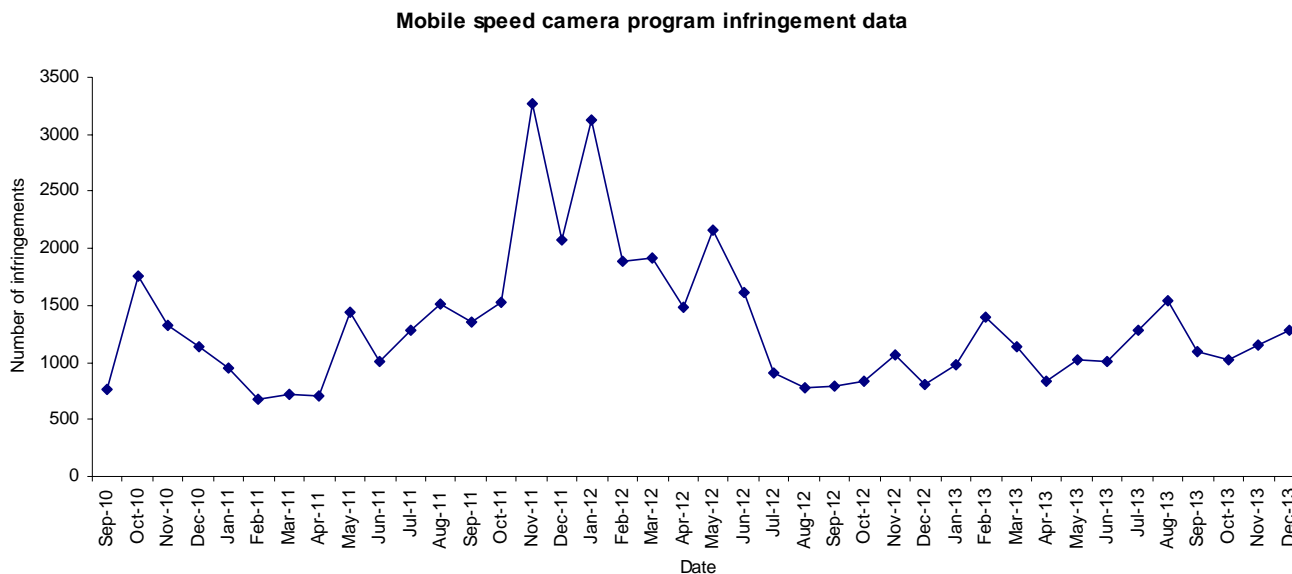
Mobile speed camera infringements

In 2013 there were a total of 13,766 infringements issued from mobile speed camera enforcement resulting in a total fines of \$2.59 million. The total number of infringements in 2013 reduced by 21 per cent compared to the total number of infringements in 2012.

Since the program commenced, the number of sites available for use and the number of sites used each month has increased over time as ongoing assessments to identify suitable enforcement sites are completed. The total number of approved sites is 640 with all selected sites published on the Centre for Road Safety website. The above graph depicting the mobile speed camera program infringement data shows that in 2011 there were two months where there were peaks in infringement volumes. An increase in infringements usually comes when mobile speed cameras are enforcing in less frequently used locations or locations that have not been used before. In both May 2011 and November 2011 there were increases in the number of sites used for enforcement in those months. In the months following the use of new sites, the number of infringements decreased or stabilised. This trend is to be anticipated; for example fixed speed enforcement follows the same type of pattern, with the difference being that fixed speed cameras remain in the same place and continually enforce meaning that reductions in infringements are more consistent.

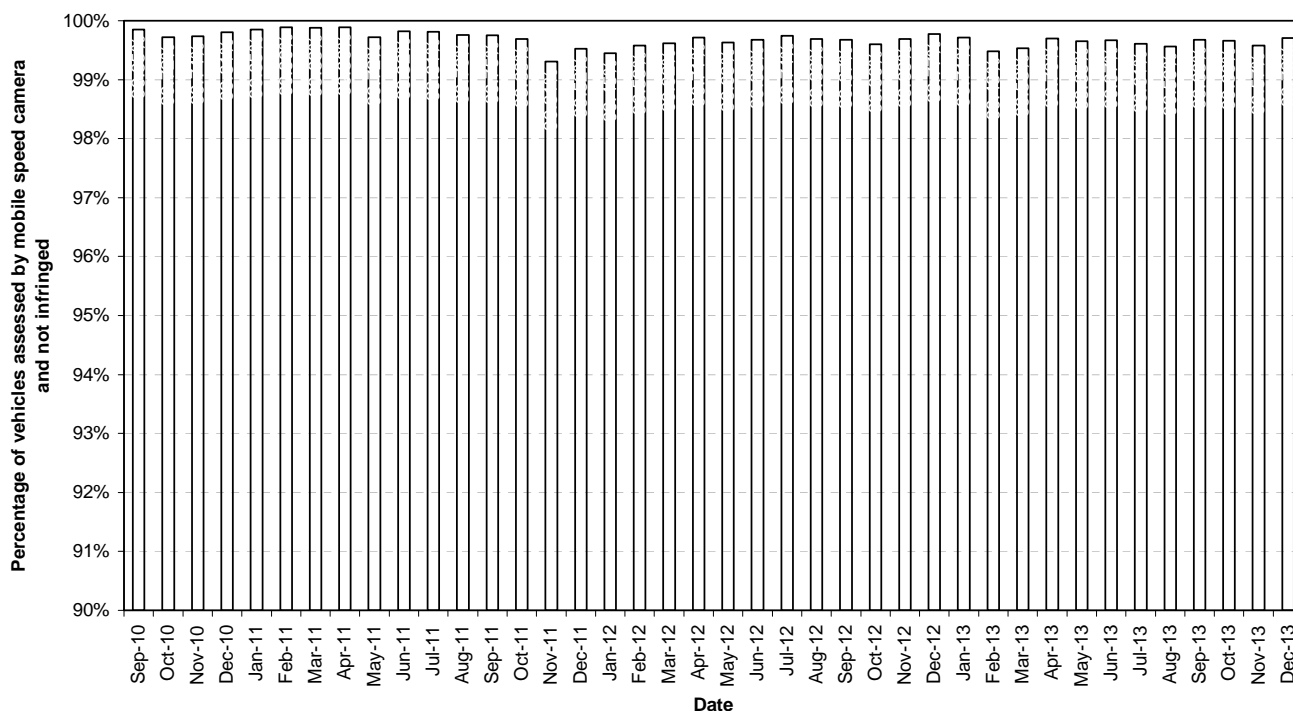
Compliance rate of vehicles at mobile speed camera locations

The figure below shows the compliance rate of vehicles at mobile speed camera locations. Compliance data compares the number of vehicles that pass a camera with the number of fines detected by the camera. As can be seen below, over 99 per cent of vehicles passing mobile cameras are not infringed for speeding. This high rate of compliance has remained consistent since 2010 when the program was reintroduced.

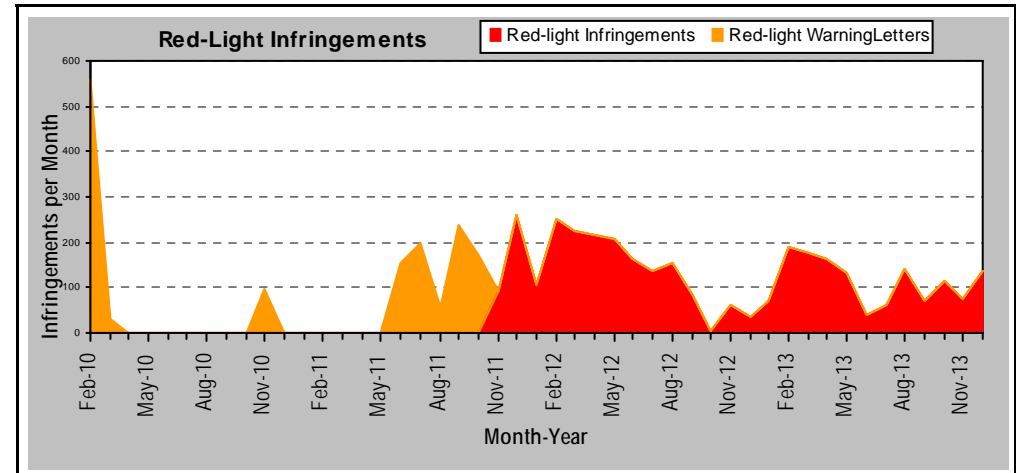
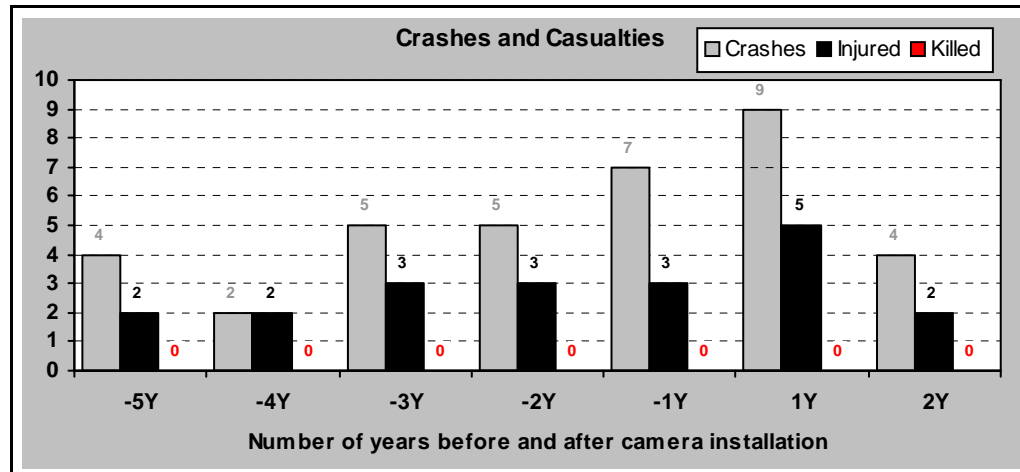
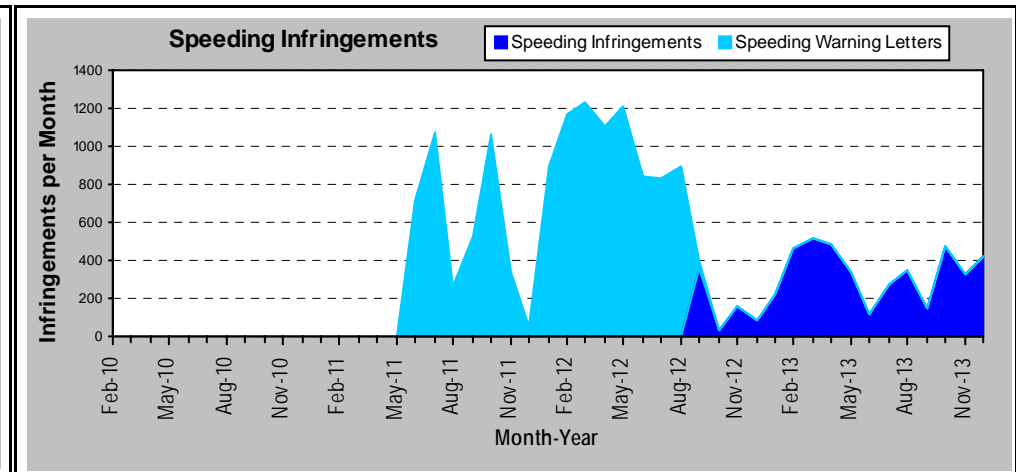
Infringements at enforced intersection

- There is one camera at this intersection. This was previously a wet-film red-light camera location.
- The camera at the intersection of Parramatta Road and Sloane Street commenced issuing warning letters in June 2011.
- While early results indicate a slight increase in casualties and crashes, a more comprehensive analysis over a longer time period is required before making any conclusions about the effectiveness of the camera.
- The infringement graphs show the number of warning letters and infringements issued at this intersection as well as the trend in infringements since the camera began operation. Roadworks and camera maintenance may influence the number of infringements issued.

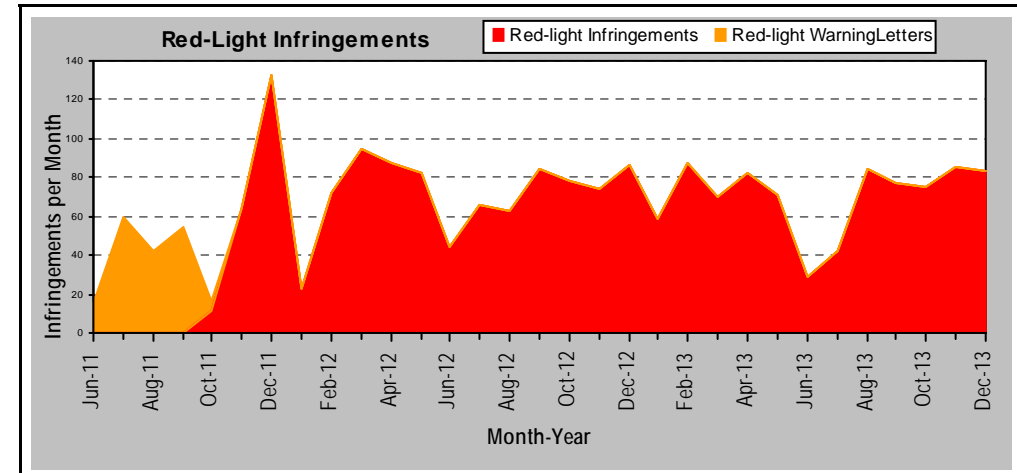
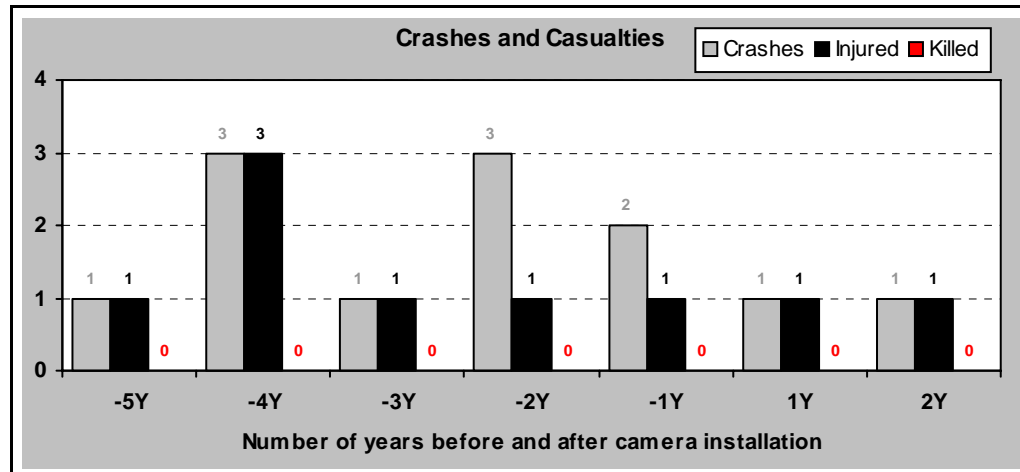
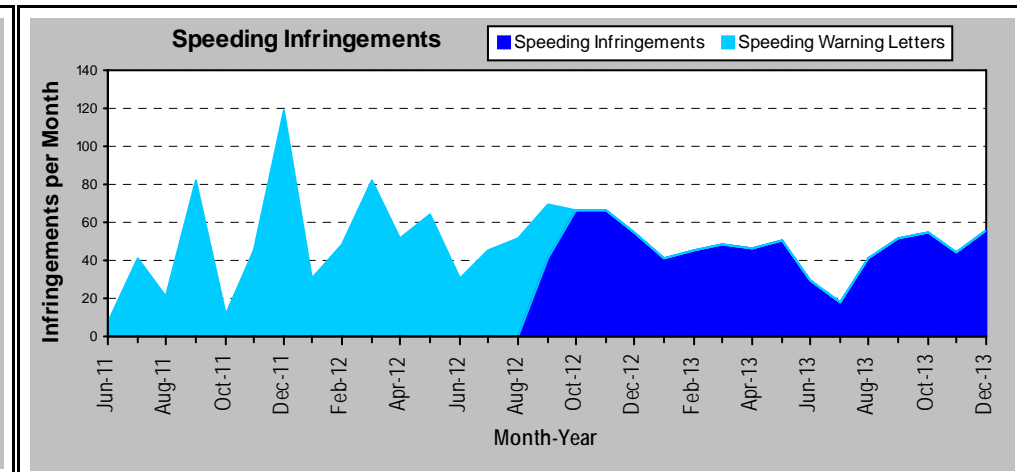
Infringements at enforced intersection

- There is one camera at this intersection.
- The camera at the intersection of Pacific Highway and Parry Street commenced issuing warning letters in June 2011.
- While the results available so far are encouraging, a more comprehensive analysis over a longer time period is required before making any conclusions about the effectiveness of the camera.
- The infringement graphs show the number of warning letters and infringements issued at this intersection as well as the trend in infringements since the camera began operation. Roadworks and camera maintenance may influence the number of infringements issued.

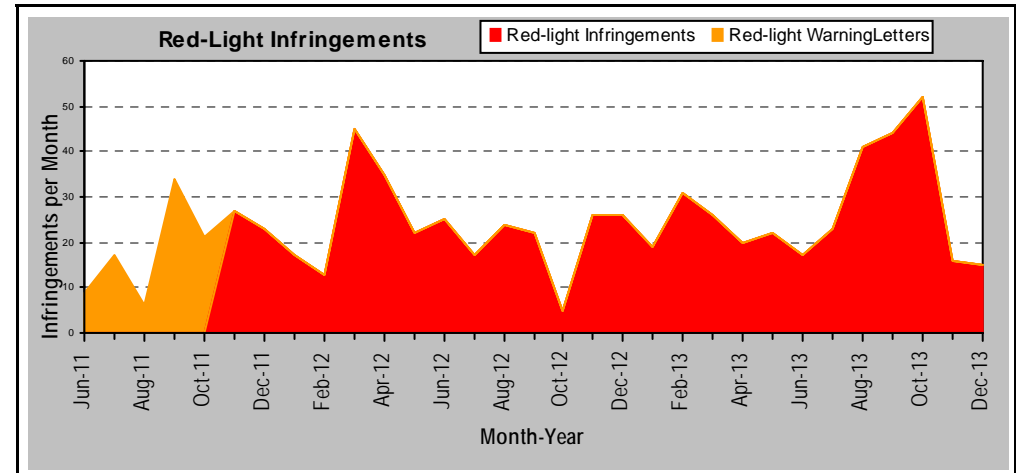
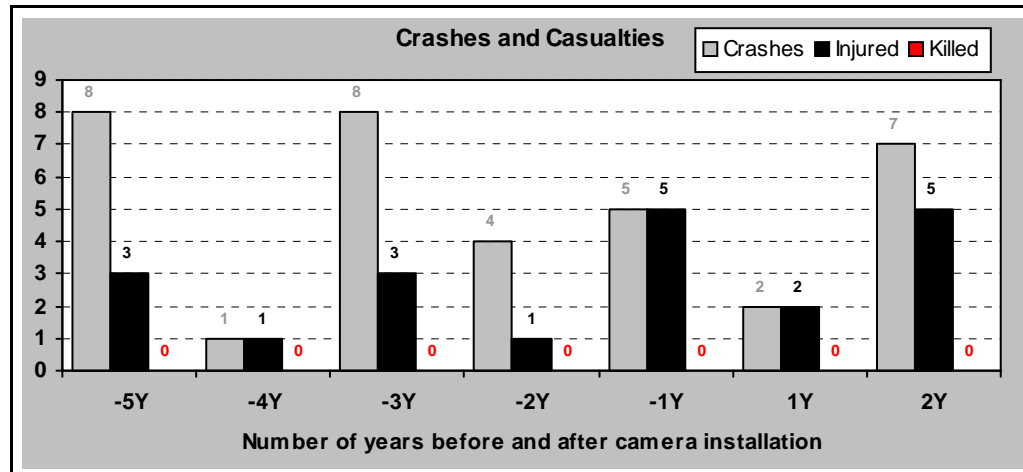
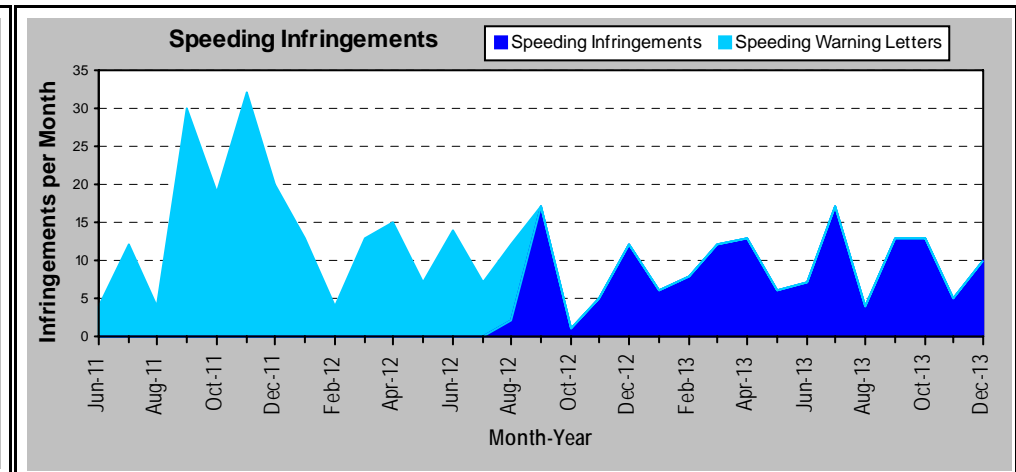
Mascot - O'Riordan Street at Coward Street

Infringements at enforced intersection

- There is one camera at this intersection. This was previously a wet-film red-light camera location.
- The camera at the intersection of O'Riordan Street and Coward Street commenced issuing warning letters in April 2011.
- While the results available show a decrease in casualty crashes, a more comprehensive analysis over a longer time period is required before making any conclusions about the effectiveness of the camera.
- The infringement graphs show the number of warning letters and infringements issued at this intersection as well as the trend in infringements since the camera began operation. Roadworks and camera maintenance may influence the number of infringements issued.

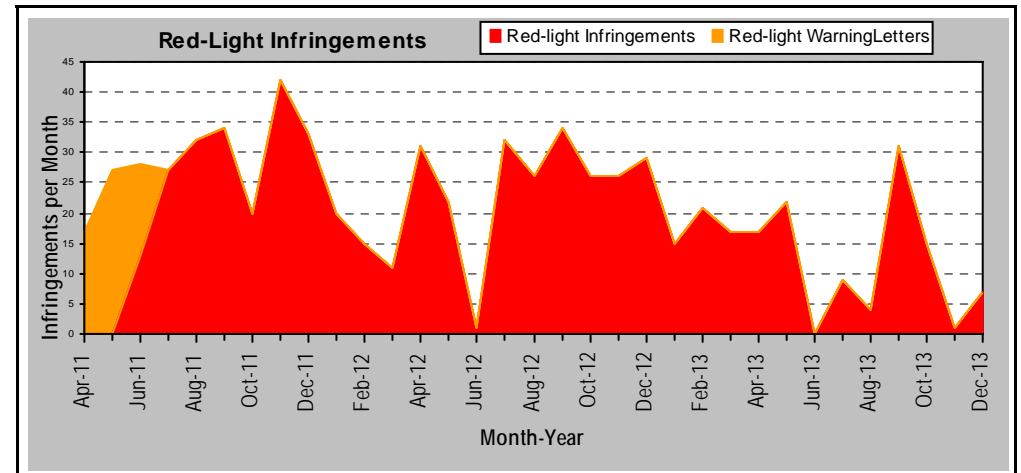
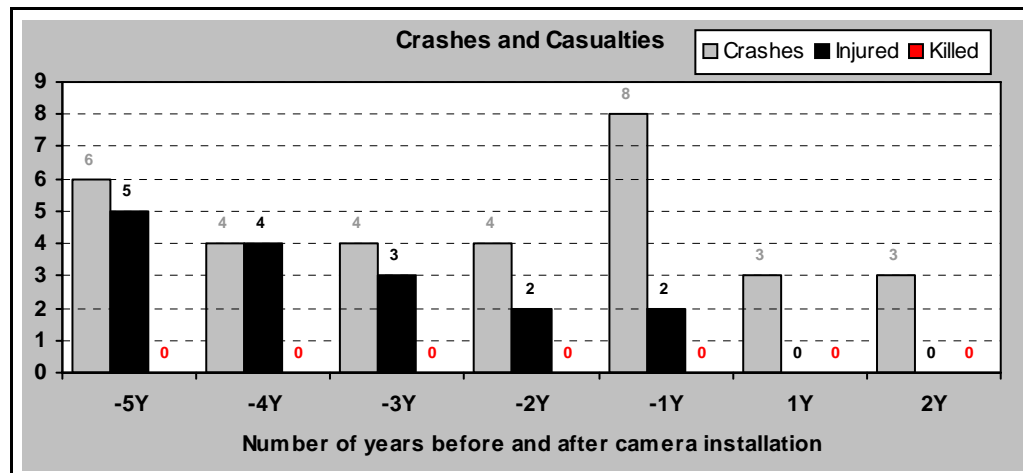
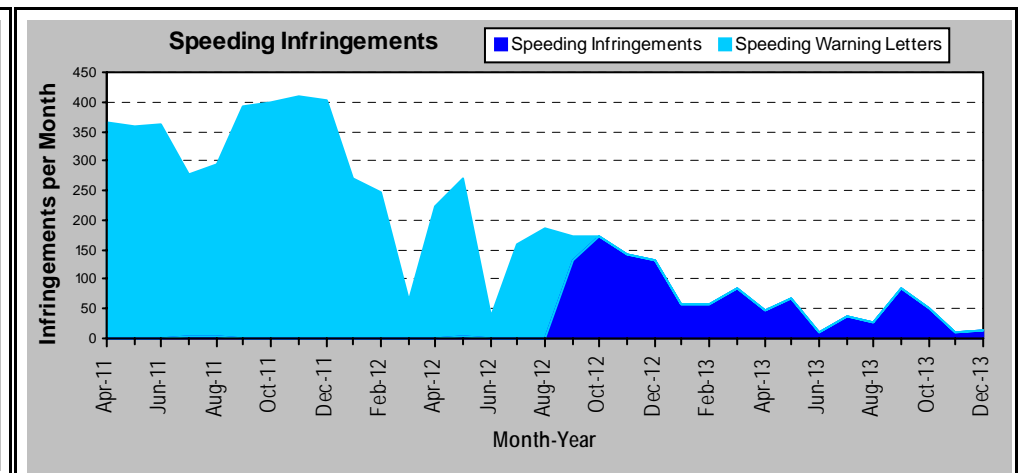
Infringements at enforced intersection

- There is one camera at this intersection. This was previously a wet-film red-light camera location.
- The camera at the intersection of O'Riordan Street and Gardeners Road commenced issuing warning letters in October 2010.
- While early results indicate a slight increase in crashes, a more comprehensive analysis over a longer time period is required before making any conclusions about the effectiveness of the camera.
- The infringement graphs show the number of warning letters and infringements issued at this intersection as well as the trend in infringements since the camera began operation. Roadworks and camera maintenance may influence the number of infringements issued.

The investigation at O’Riordan Street and Gardeners Road, Mascot identified no safety deficiencies, and revealed the intersection will be upgraded in the near future as part of re-development work associated with Green Square. No safety deficiencies were also identified at the intersection at Anzac Parade and Lang Road, Moore Park.

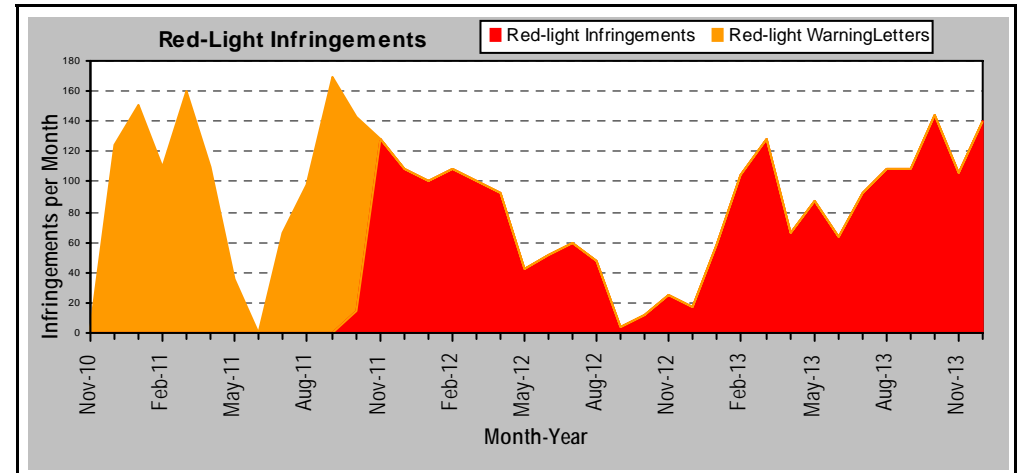
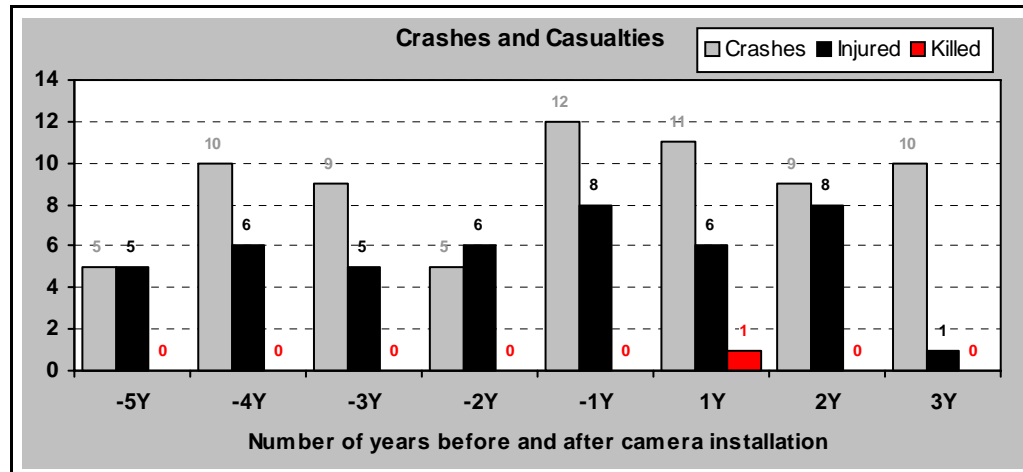
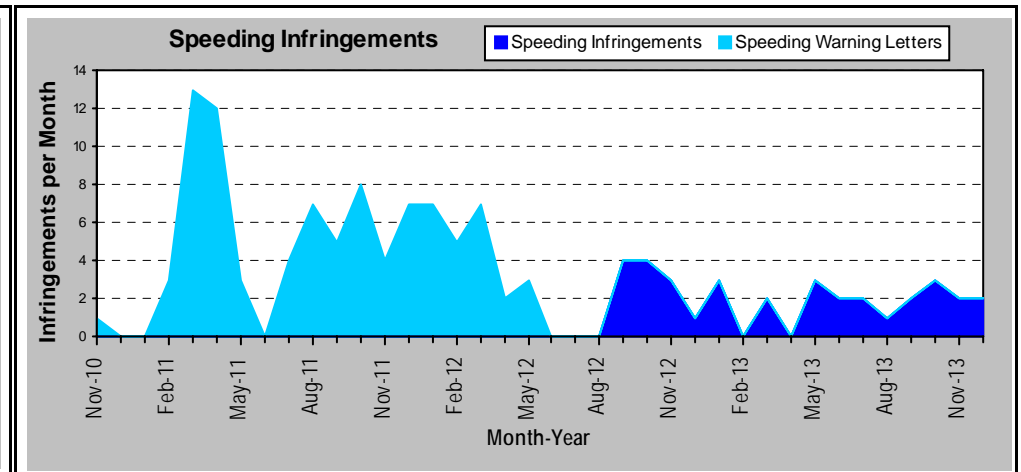
Infringements at enforced intersection

- There is one camera at this intersection. This was previously a wet-film red-light camera location.
- The camera at the intersection of Pacific Highway and Maud Street commenced issuing warning letters in May 2011.
- While early results indicate a slight increase in casualties and crashes, a more comprehensive analysis over a longer time period is required before making any conclusions about the effectiveness of the camera.
- The infringement graphs show the number of warning letters and infringements issued at this intersection as well as the trend in infringements since the camera began operation. Roadworks and camera maintenance may influence the number of infringements issued.

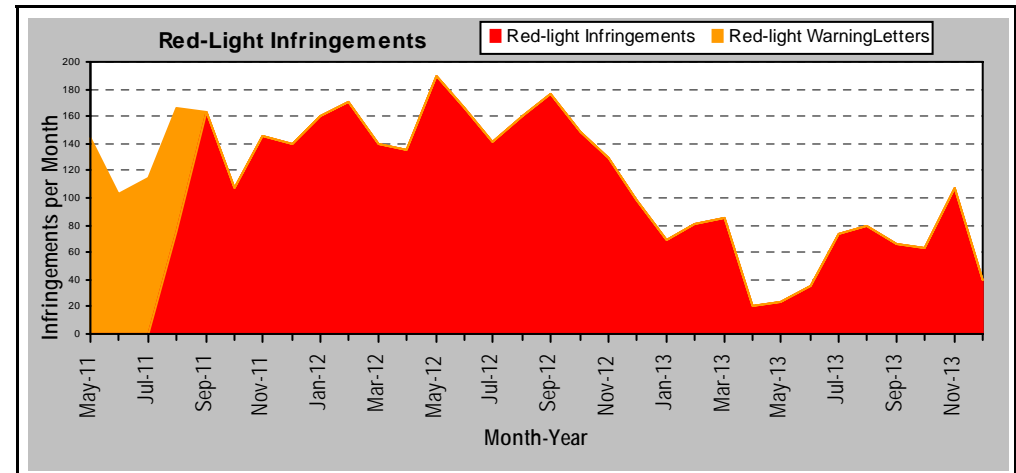
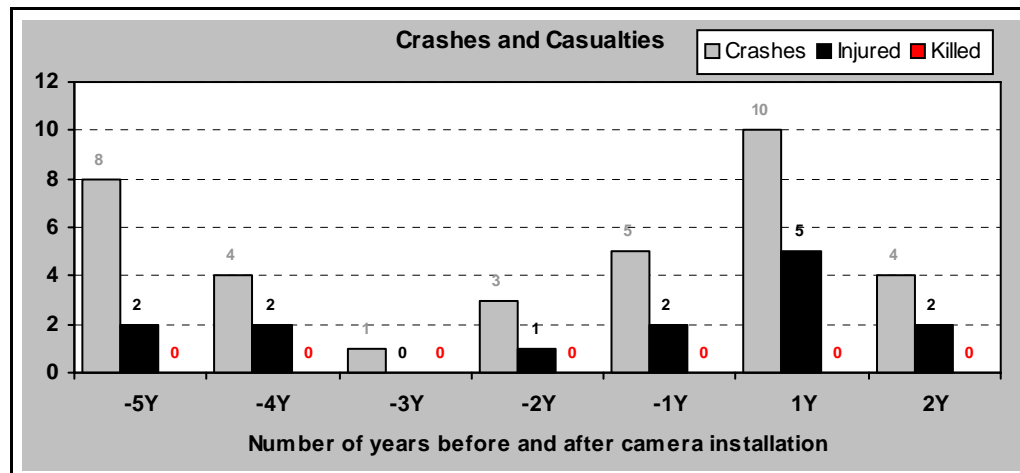
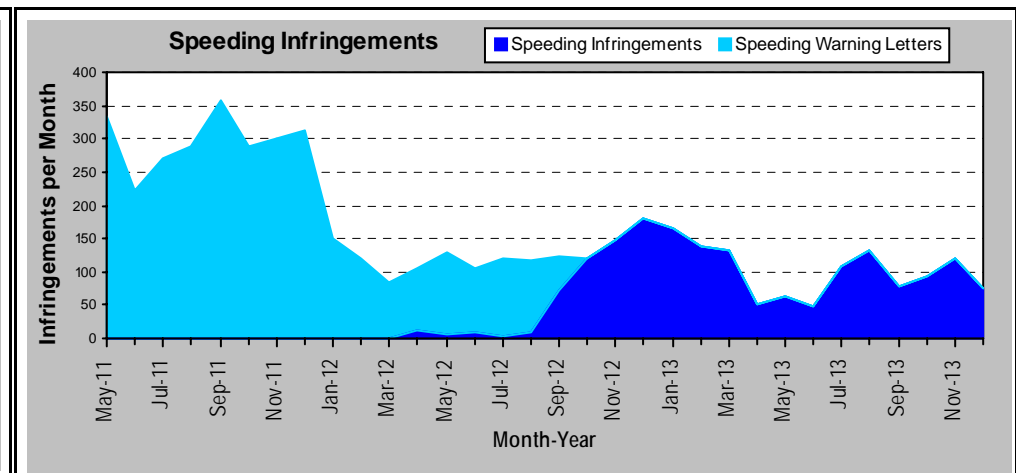
Infringements at enforced intersection

- There are two cameras at this intersection.
- The camera at the intersection of Great Western Highway and Coleman Street commenced issuing warning letters in July 2010.
- The camera at the intersection of Great Western Highway and Hawkesbury Road commenced issuing warning letters in July 2010.
- While the results available so far are encouraging, a more comprehensive analysis over a longer time period is required before making any conclusions about the effectiveness of the cameras.
- The infringement graphs show the number of warning letters and infringements issued at this intersection as well as the trend in infringements since the camera began operation. Roadworks and camera maintenance may influence the number of infringements issued.

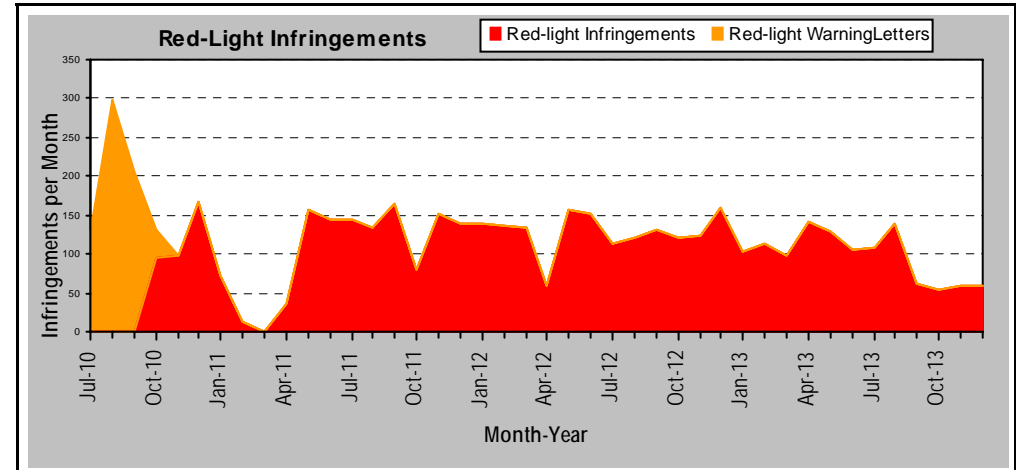
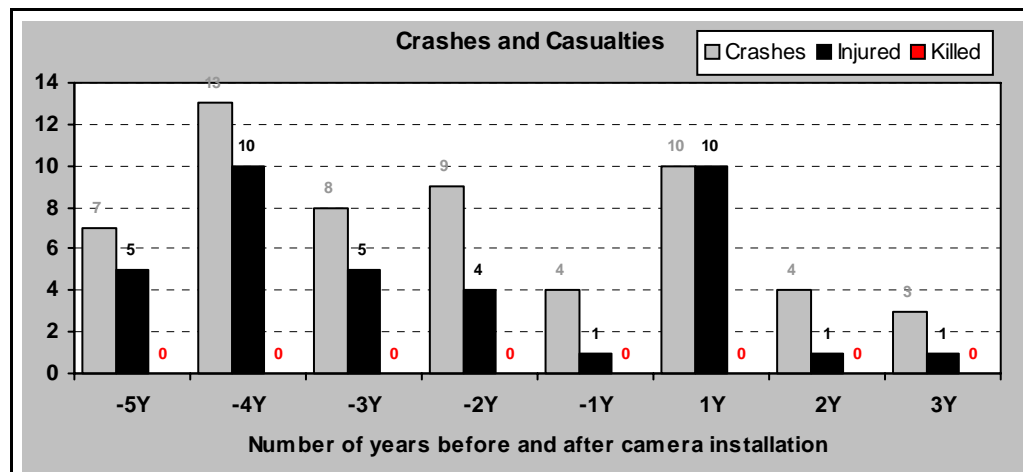
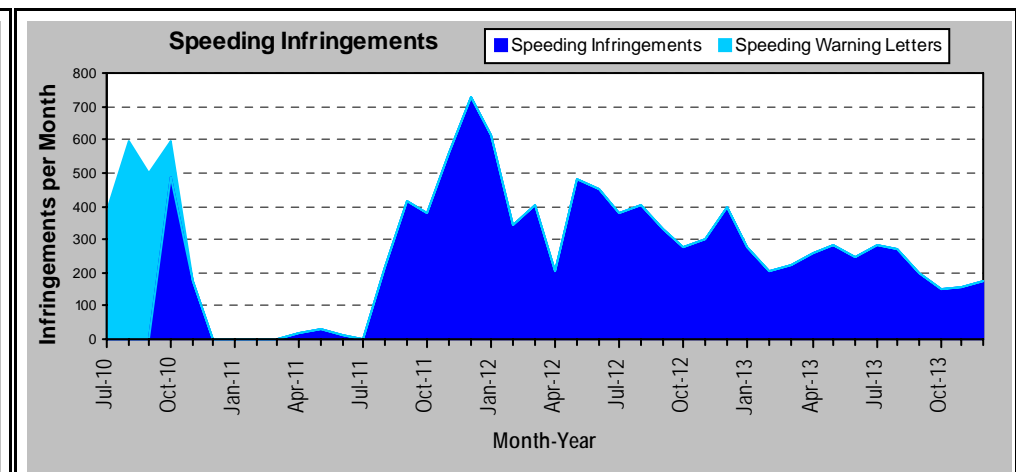
Infringements at enforced intersection

- There is one camera at this intersection.
- The camera at the intersection of Newbridge Road and Henry Lawson Drive commenced issuing warning letters in September 2010.
- While early results indicate a slight increase in casualties and crashes, a more comprehensive analysis over a longer time period is required before making any conclusions about the effectiveness of the camera.
- The infringement graphs show the number of warning letters and infringements issued at this intersection as well as the trend in infringements since the camera began operation. In May 2012, the speed limit was changed from 60 km/h to 70 km/h. Roadworks and camera maintenance may influence the number of infringements issued.

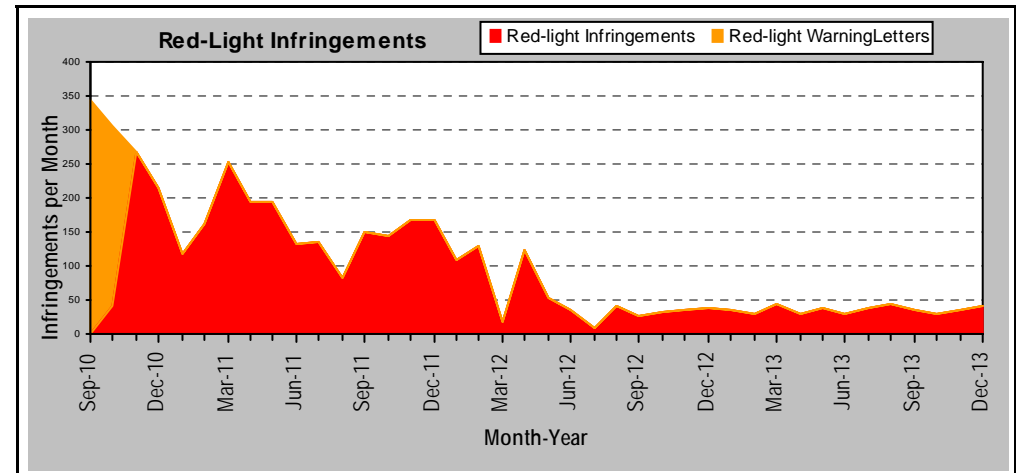
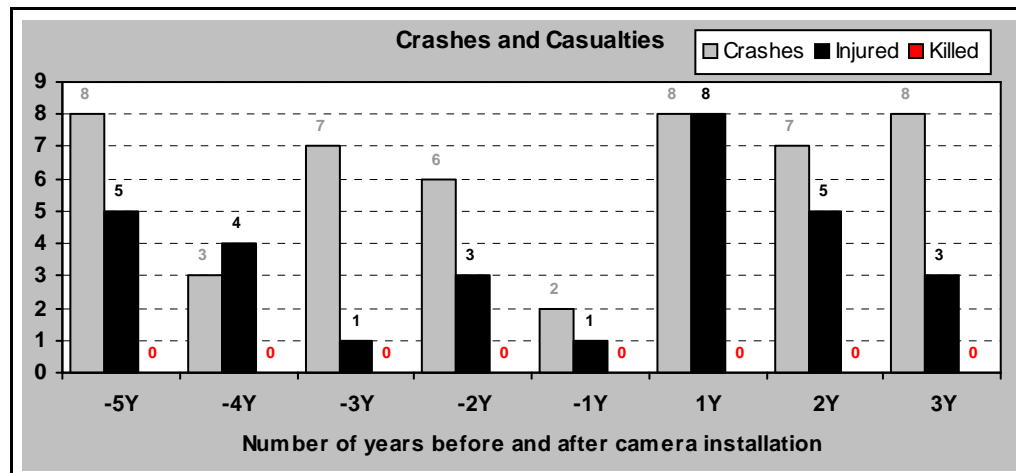
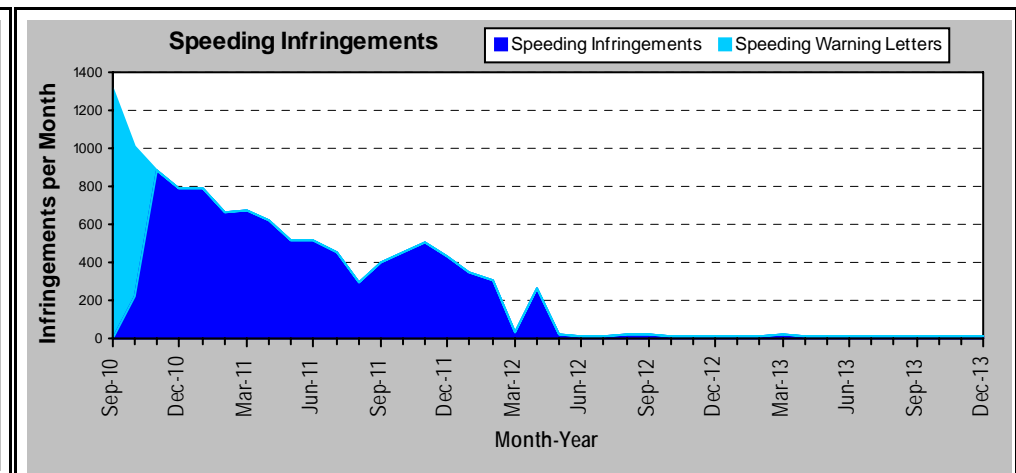
Infringements at enforced intersection

- There is one camera at this intersection.
- The camera at the intersection of Kingsway and Port Hacking Road commenced issuing warning letters in July 2010.
- While the results available show a decrease in casualty crashes, a more comprehensive analysis over a longer time period is required before making any conclusions about the effectiveness of the camera.
- The infringement graphs show the number of warning letters and infringements issued at this intersection as well as the trend in infringements since the camera began operation. Roadworks and camera maintenance may influence the number of infringements issued.

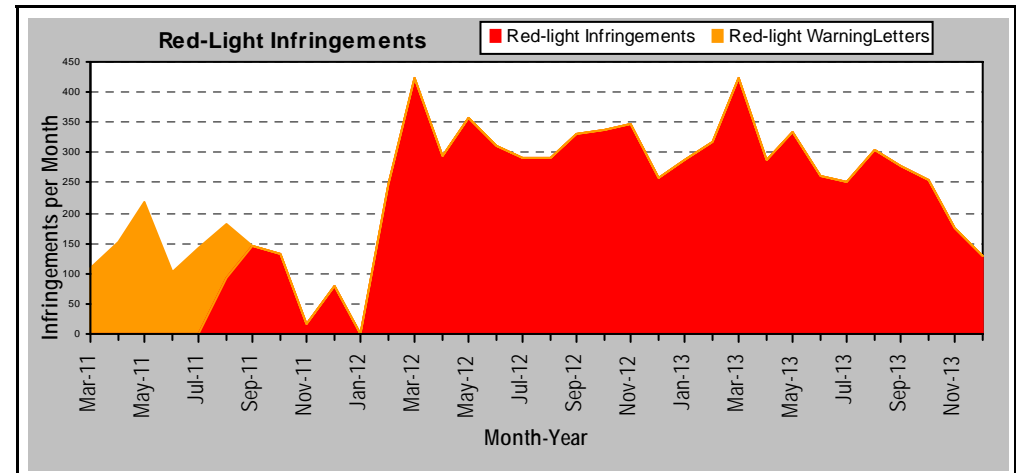
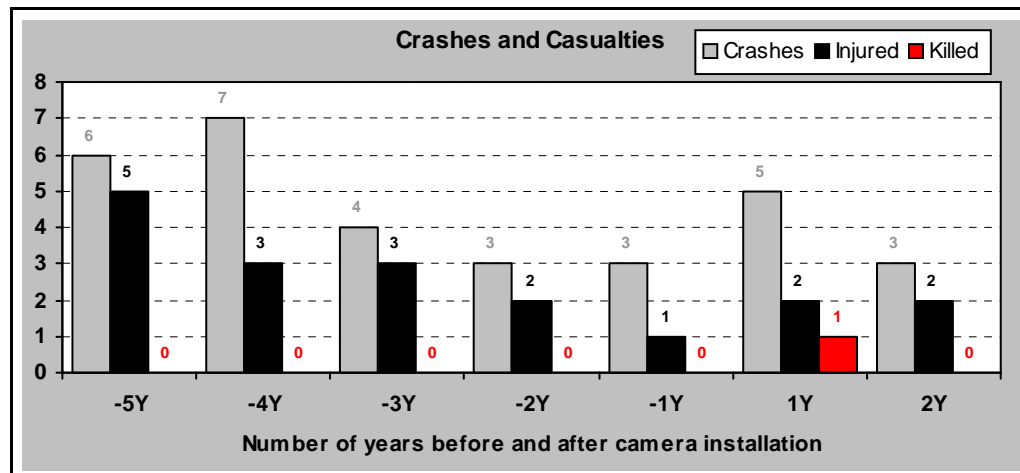
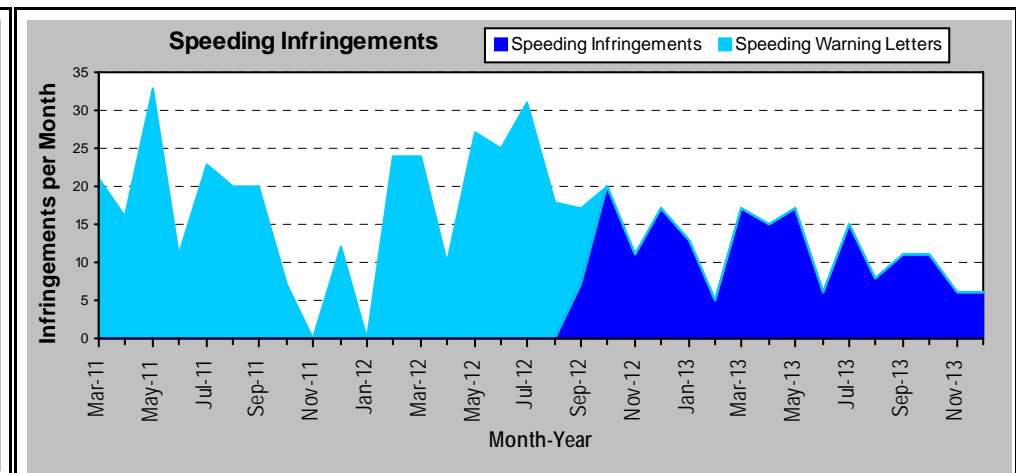
Infringements at enforced intersection

- There are two cameras at this intersection.
- The camera at the intersection of Anzac Parade and Moore Park Road commenced issuing warning letters in August 2010.
- The camera at the intersection of Flinders Street and Moore Park Road commenced issuing warning letters in August 2010.
- While the results available show a decrease in crashes, a more comprehensive analysis over a longer time period is required before making any conclusions about the effectiveness of the cameras.
- The infringement graphs show the number of warning letters and infringements issued at this intersection as well as the trend in infringements since the camera began operation. Roadworks and camera maintenance may influence the number of infringements issued.

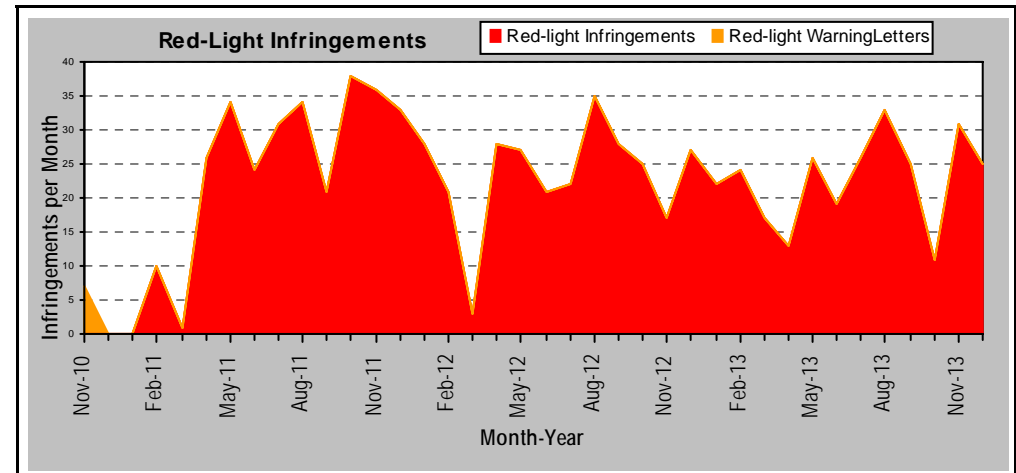
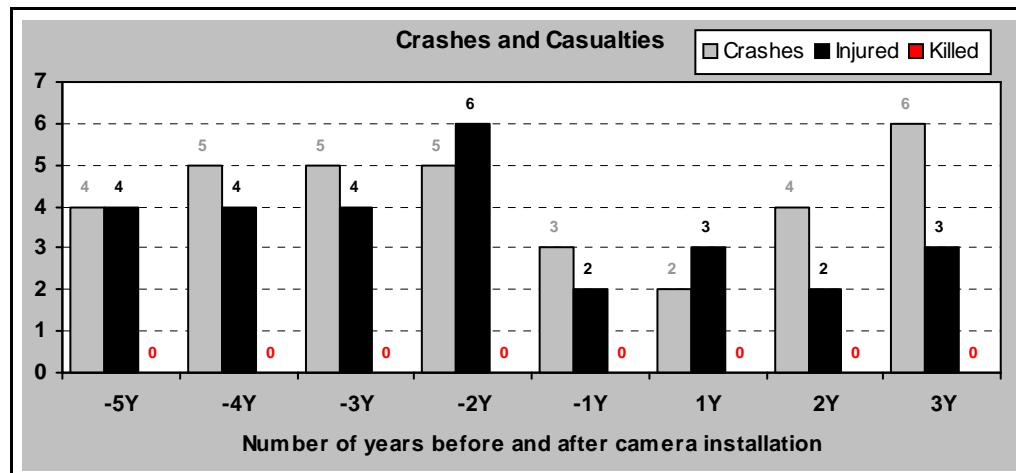
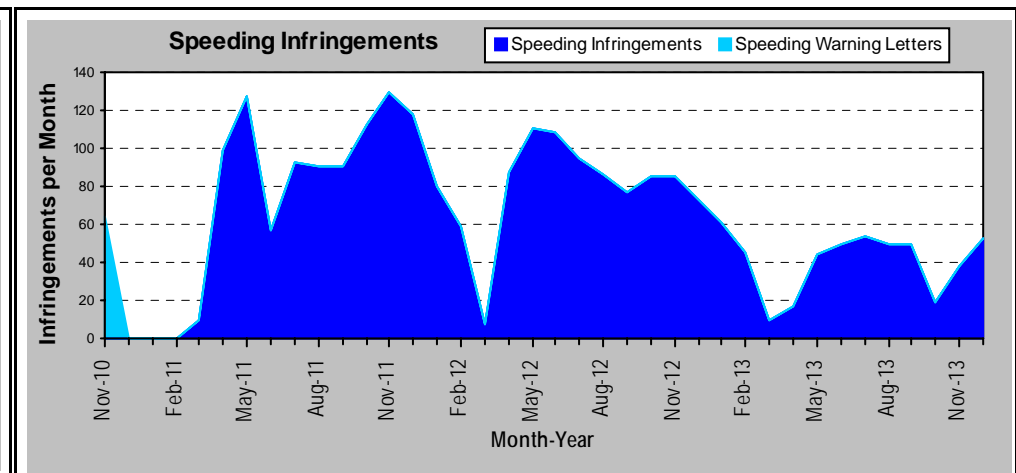
Infringements at enforced intersection

- There is one camera at this intersection. This was previously a wet-film red-light camera location.
- The camera at the intersection of Military Road and Cowles Road commenced issuing warning letters in December 2010.
- While early results indicate a slight increase in crashes, a more comprehensive analysis over a longer time period is required before making any conclusions about the effectiveness of the camera.
- The infringement graphs show the number of warning letters and infringements issued at this intersection as well as the trend in infringements since the camera began operation. Roadworks and camera maintenance may influence the number of infringements issued.

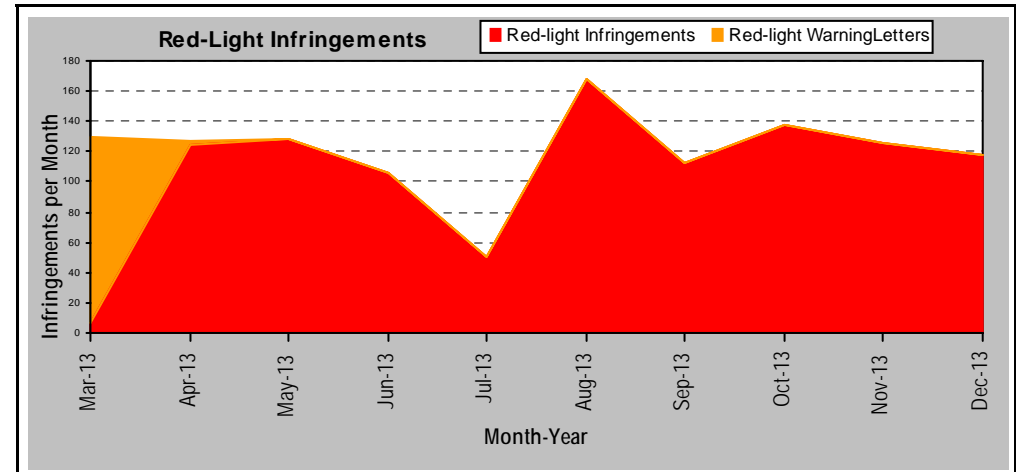
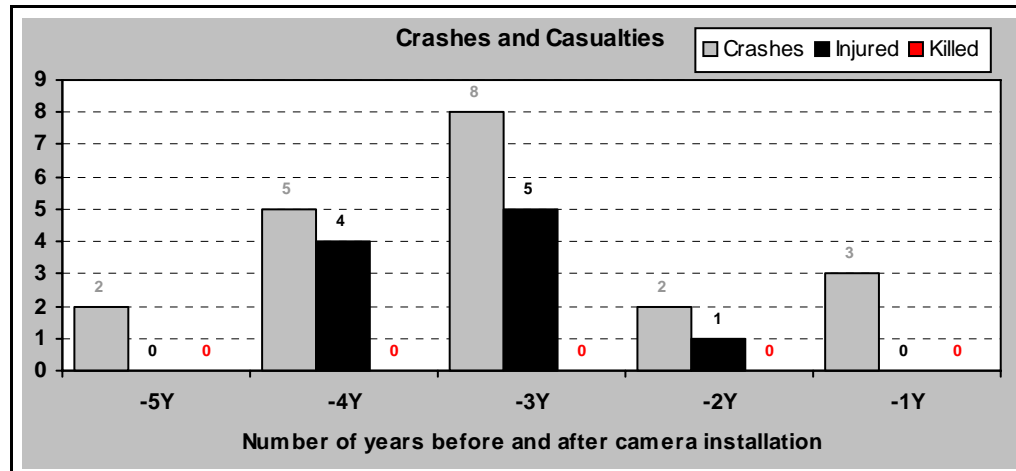
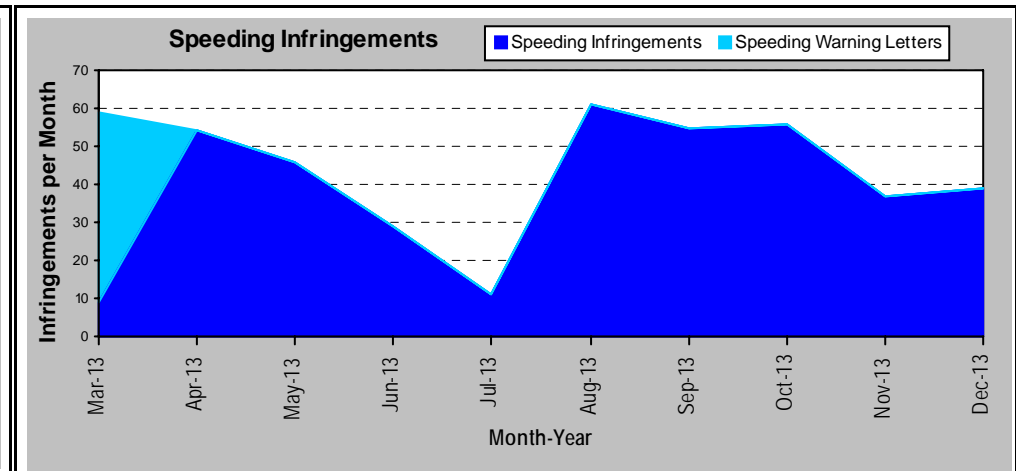
Infringements at enforced intersection

- There are three cameras at this intersection.
- The camera at the intersection of Cox's Road and Lane Cove Road commenced issuing warning letters in April 2013. This camera enforces red-light running only.
- The camera at the intersection of Lane Cove Road (Northbound) and Cox's Road commenced issuing warning letters in April 2013.
- The camera at the intersection of Lane Cove Road (Southbound) and Cox's Road commenced issuing warning letters in April 2013.
- While the results available show a decrease in crashes, a more comprehensive analysis over a longer time period is required before making any conclusions about the effectiveness of the cameras.
- The infringement graphs show the number of warning letters and infringements issued at this intersection since the camera began operation. Roadworks and camera maintenance may influence the number of infringements issued.
