Transport
for NSW

ANNUAL NSW SPEED CAMERA PERFORMANCE REVIEW

NSW Centre for Road Safety

OCTOBER 2014

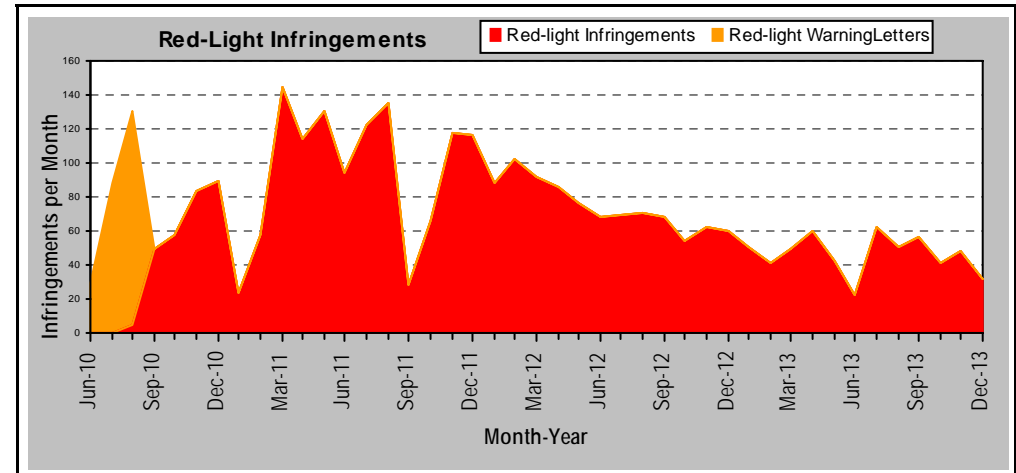
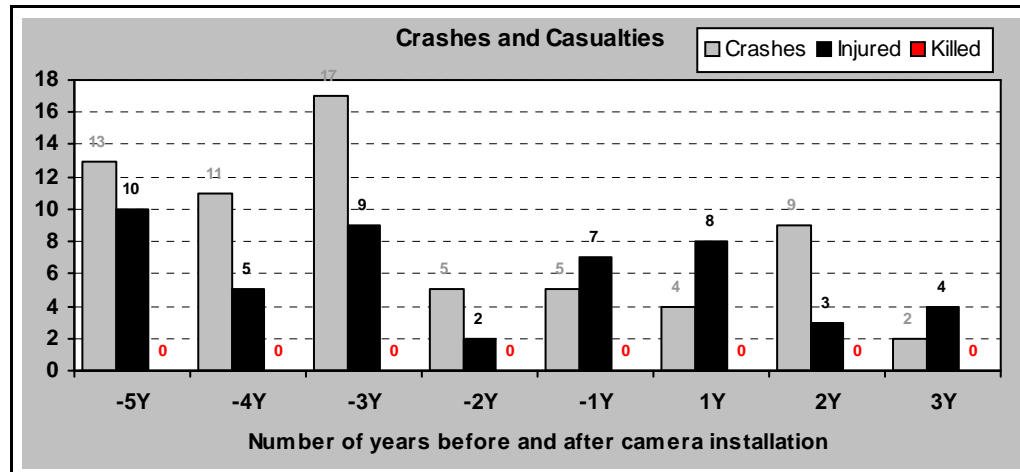
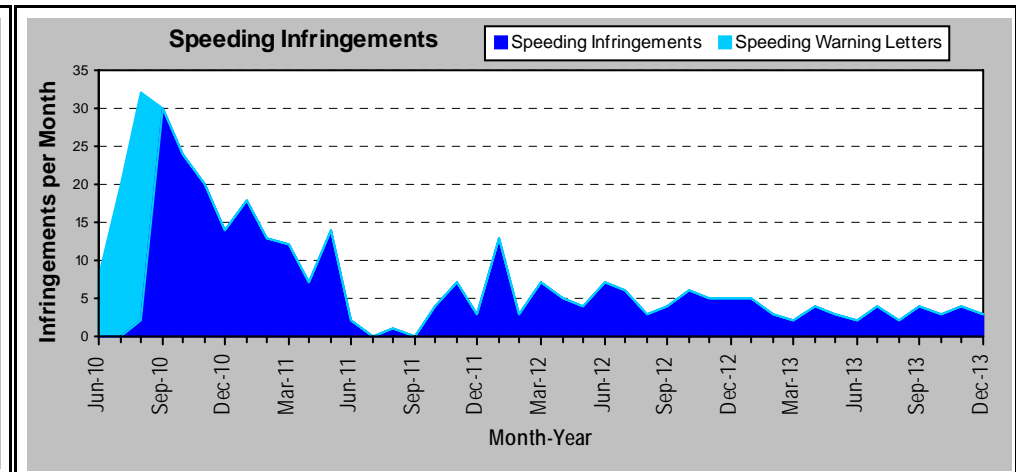
Infringements at enforced intersection

Pennant Hills - Pennant Hills Road at Beecroft Road (School Zone)

- There is one camera at this intersection. This was previously a wet-film red-light camera location.
- The camera at the intersection of Pennant Hills Road and Beecroft Road commenced issuing warning letters in September 2010.
- While the results available so far are encouraging, a more comprehensive analysis over a longer time period is required before making any conclusions about the effectiveness of the camera.
- The infringement graphs show the number of warning letters and infringements issued at this intersection as well as the trend in infringements since the camera began operation. Roadworks and camera maintenance may influence the number of infringements issued.

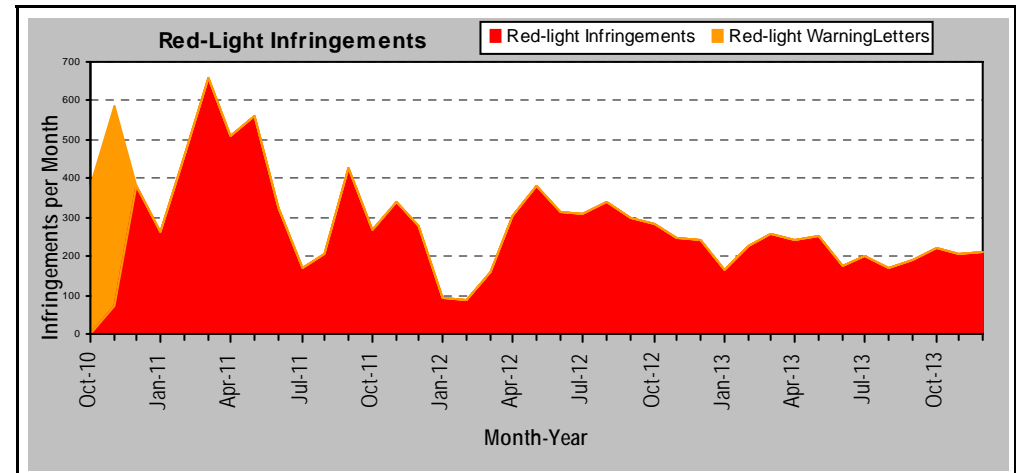
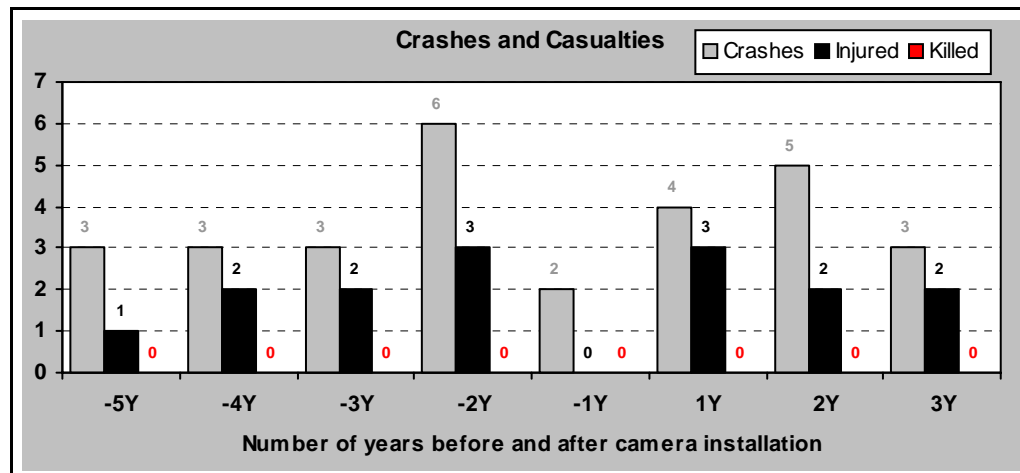
Infringements at enforced intersection

Petersham - Parramatta Road at West Street

- There is one camera at this intersection. This was previously a wet-film red-light camera location.
- The camera at the intersection of Parramatta Road and West Street commenced issuing warning letters in September 2010.
- While the results available so far are encouraging, a more comprehensive analysis over a longer time period is required before making any conclusions about the effectiveness of the camera.
- The infringement graphs show the number of warning letters and infringements issued at this intersection as well as the trend in infringements since the camera began operation. Roadworks and camera maintenance may influence the number of infringements issued.

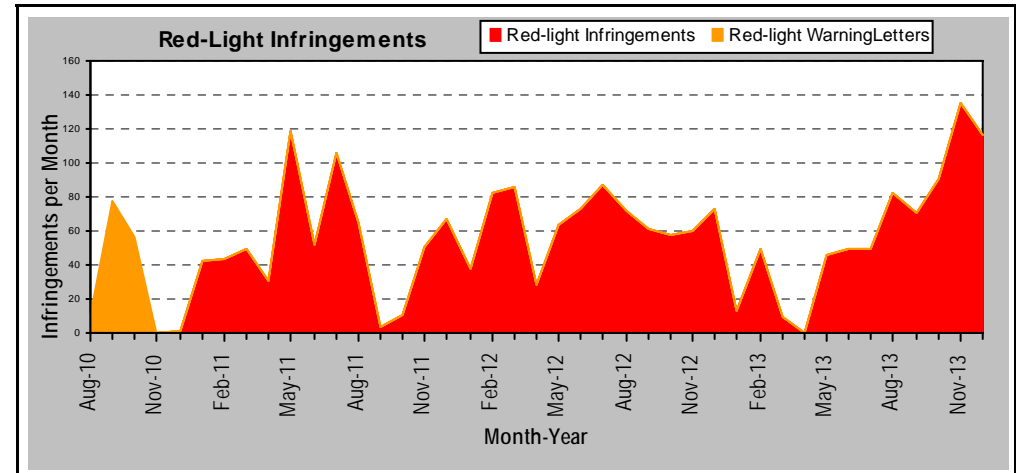
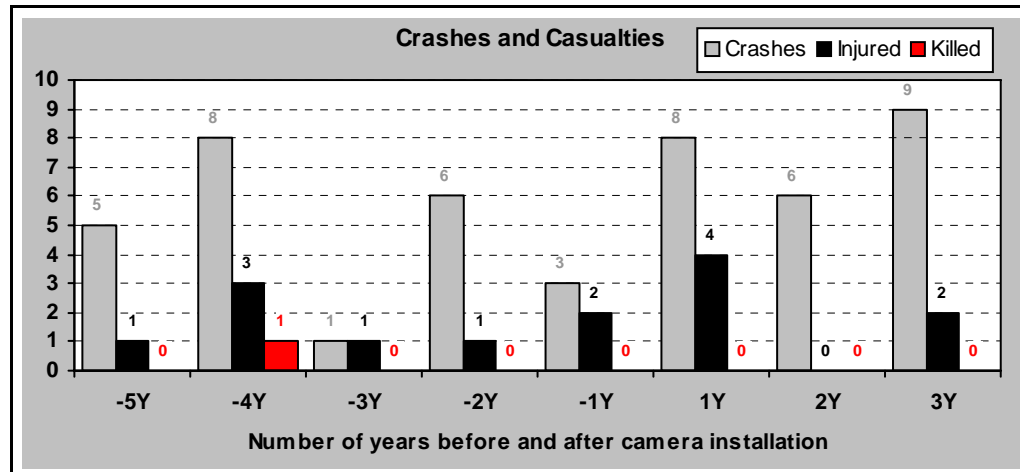
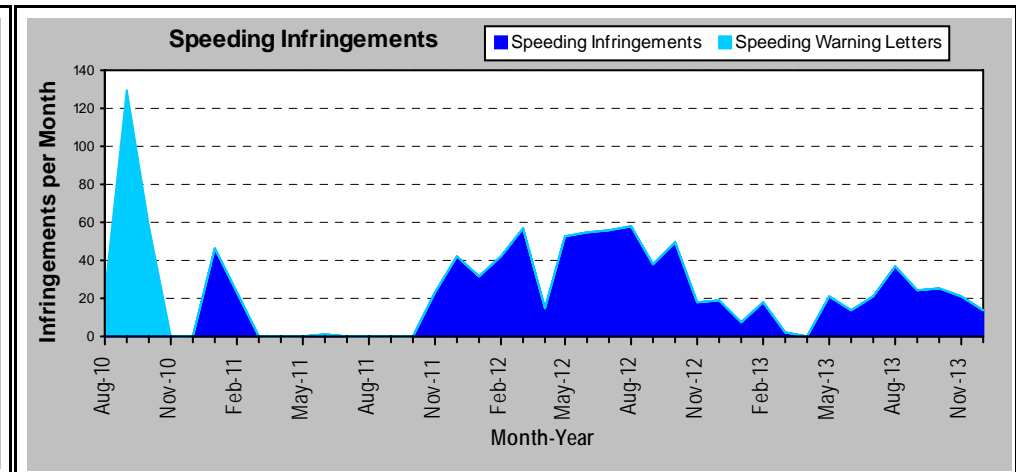
Infringements at enforced intersection

- There is one camera at this intersection. This was previously a wet-film red-light camera location.
- The camera at the intersection of Ryde Road and Lady Game Drive commenced issuing warning letters in December 2010.
- While the results available show a decrease in casualty crashes, a more comprehensive analysis over a longer time period is required before making any conclusions about the effectiveness of the camera.
- The infringement graphs show the number of warning letters and infringements issued at this intersection as well as the trend in infringements since the camera began operation. Roadworks and camera maintenance may influence the number of infringements issued.

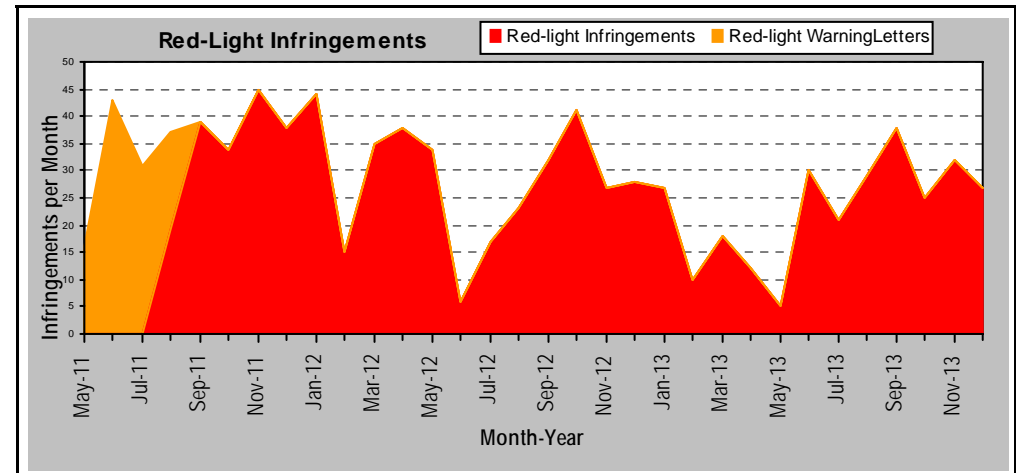
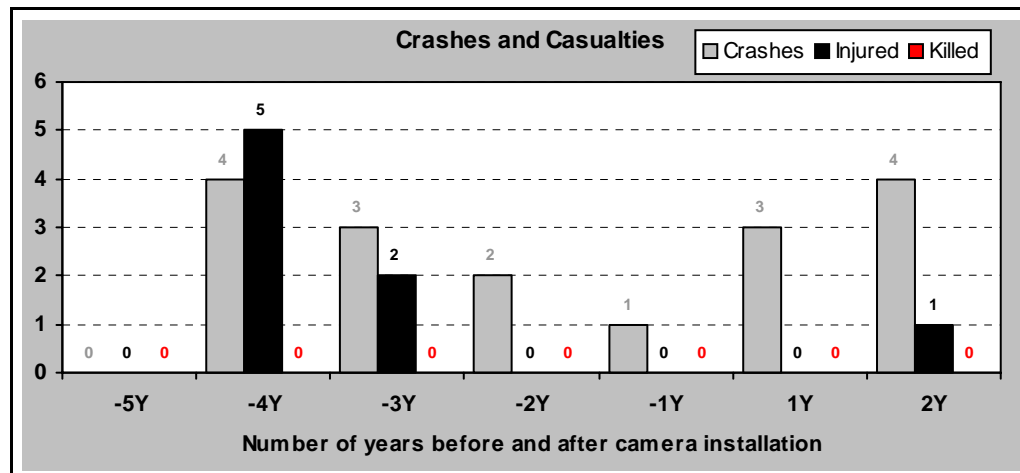
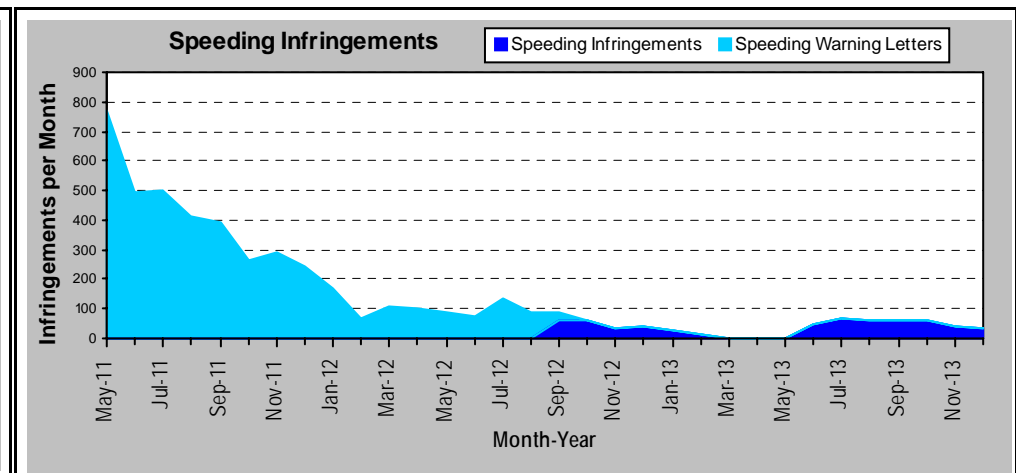
Infringements at enforced intersection

- There is one camera at this intersection. This was previously a wet-film red-light camera location.
- The camera at the intersection of Corrimal Street and Burelli Street commenced issuing warning letters in April 2011.
- While the results available so far are encouraging, a more comprehensive analysis over a longer time period is required before making any conclusions about the effectiveness of the camera.
- The infringement graphs show the number of warning letters and infringements issued at this intersection as well as the trend in infringements since the camera began operation. Roadworks and camera maintenance may influence the number of infringements issued.

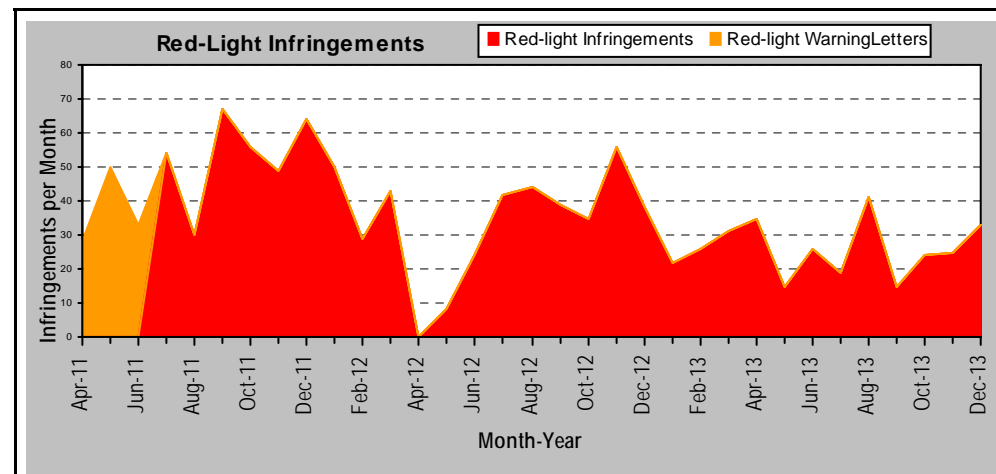
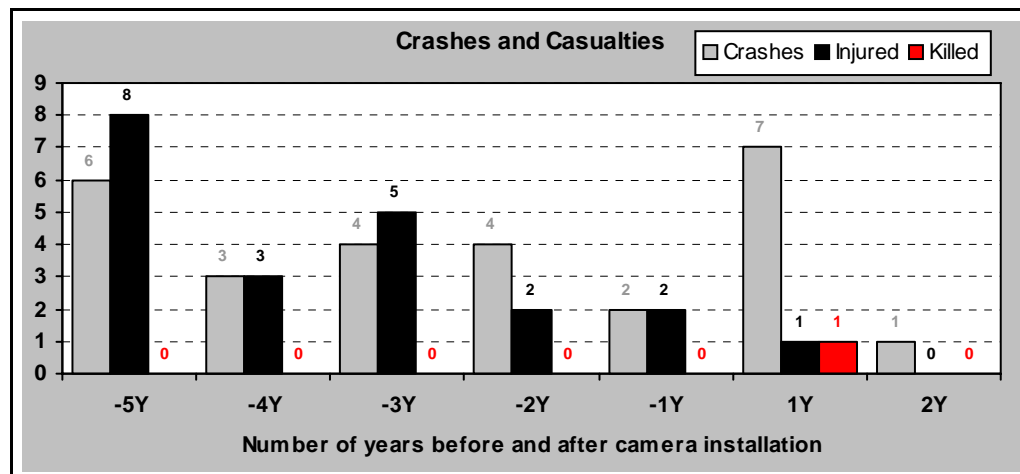
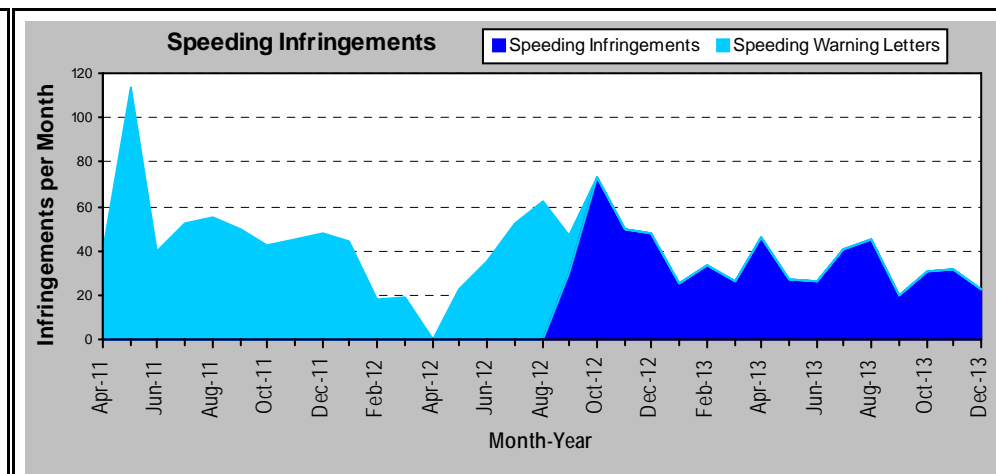
Infringements at enforced intersection

- There is one camera at this intersection.
- The camera at the intersection of Gladstone Avenue and Princes Highway commenced issuing warning letters in June 2011.
- While the results available so far are encouraging, a more comprehensive analysis over a longer time period is required before making any conclusions about the effectiveness of the camera.
- The infringement graphs show the number of warning letters and infringements issued at this intersection as well as the trend in infringements since the camera began operation. Roadworks and camera maintenance may influence the number of infringements issued.

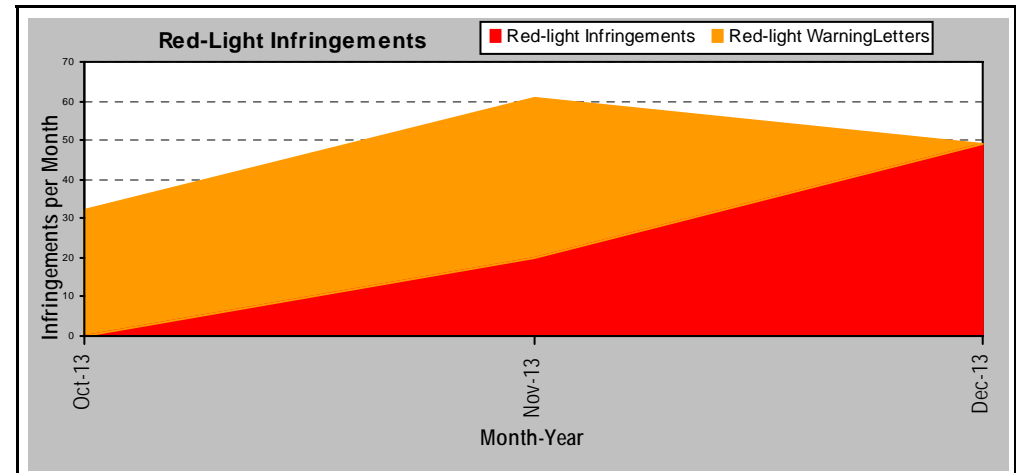
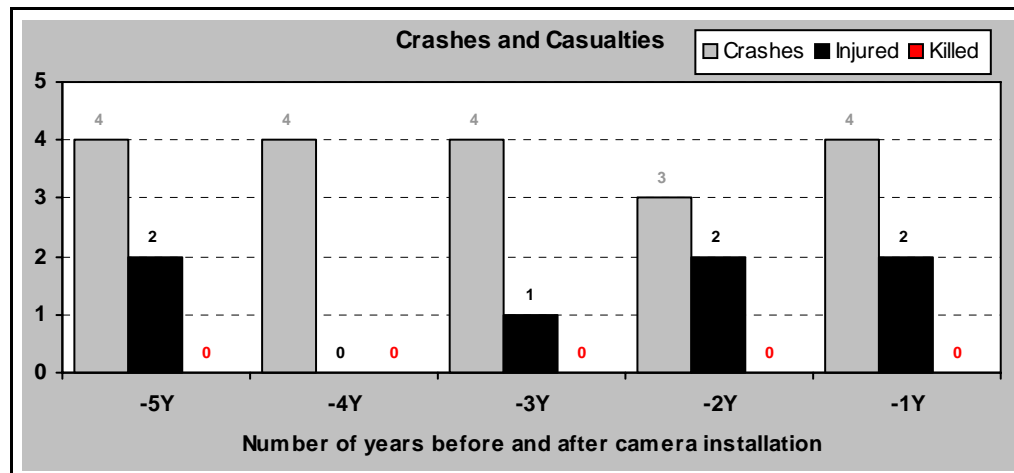
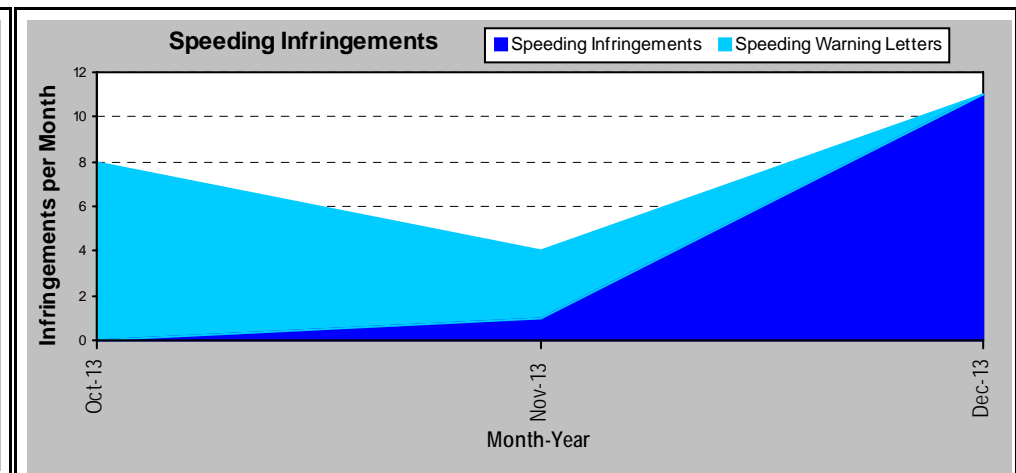
Infringements at enforced intersection

- There is one camera at this intersection. This was previously a wet-film red-light camera location.
- The camera at the intersection of Bourke Street and Botany Road commenced issuing warning letters in June 2010.
- While the results available show a decrease in casualty crashes, a more comprehensive analysis over a longer time period is required before making any conclusions about the effectiveness of the camera.
- The infringement graphs show the number of warning letters and infringements issued at this intersection as well as the trend in infringements since the camera began operation. Roadworks and camera maintenance may influence the number of infringements issued.

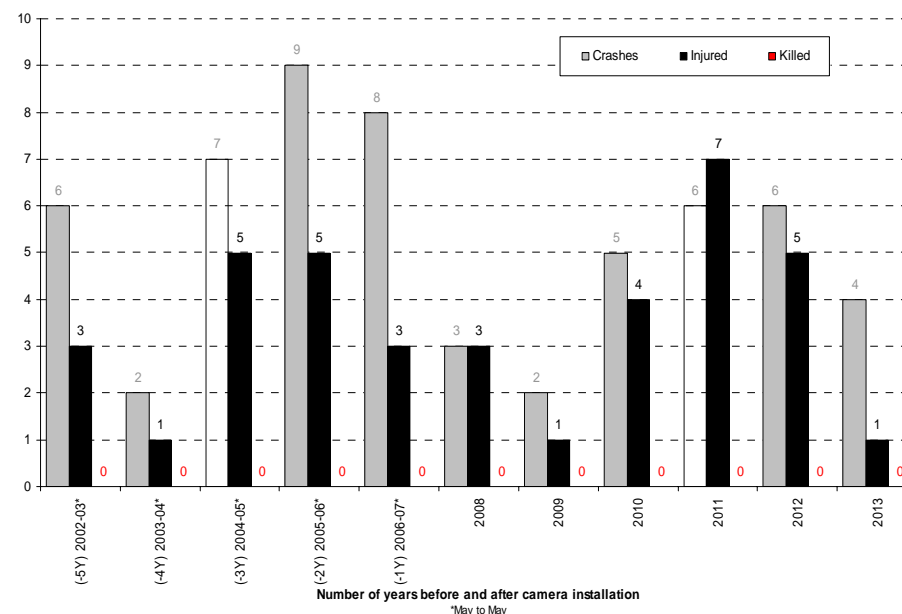
Crashes and casualties

Trend in road safety performance at camera location

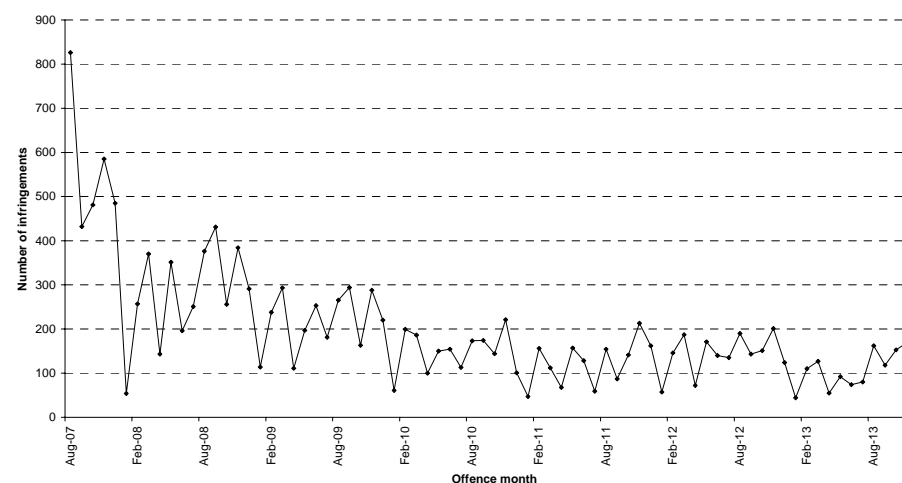
HUME HIGHWAY ASHFIELD

Infringements

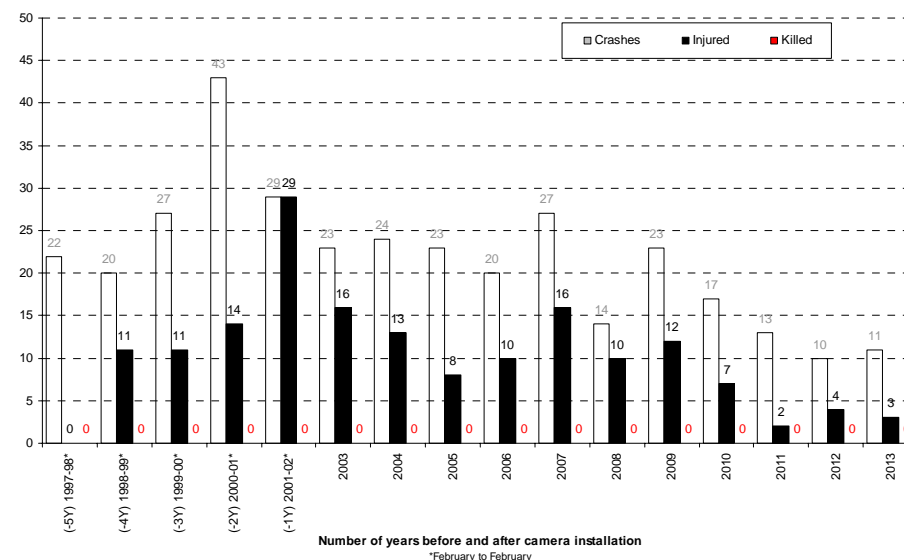
Crashes and casualties

Trend in road safety performance at camera location

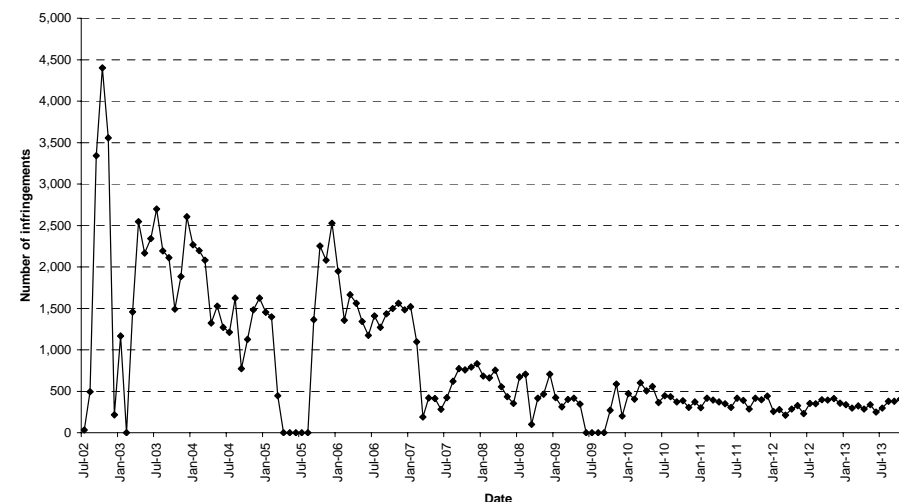
PARRAMATTA ROAD AUBURN

Infringements

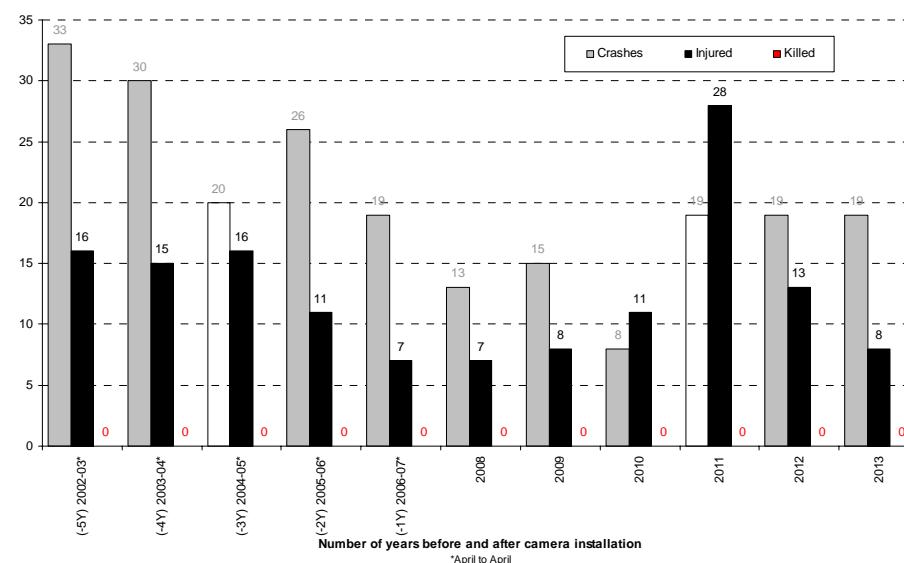
Crashes and casualties

Trend in road safety performance at camera location

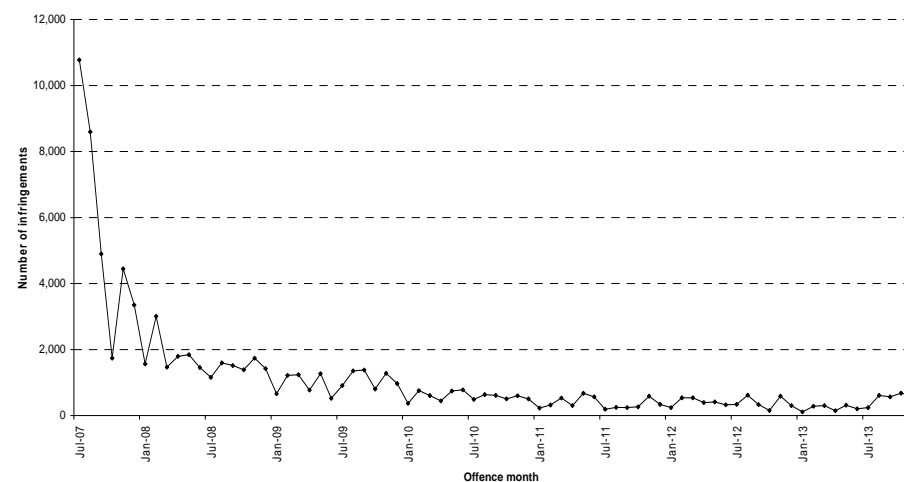
HUME HIGHWAY BANKSTOWN

Infringements

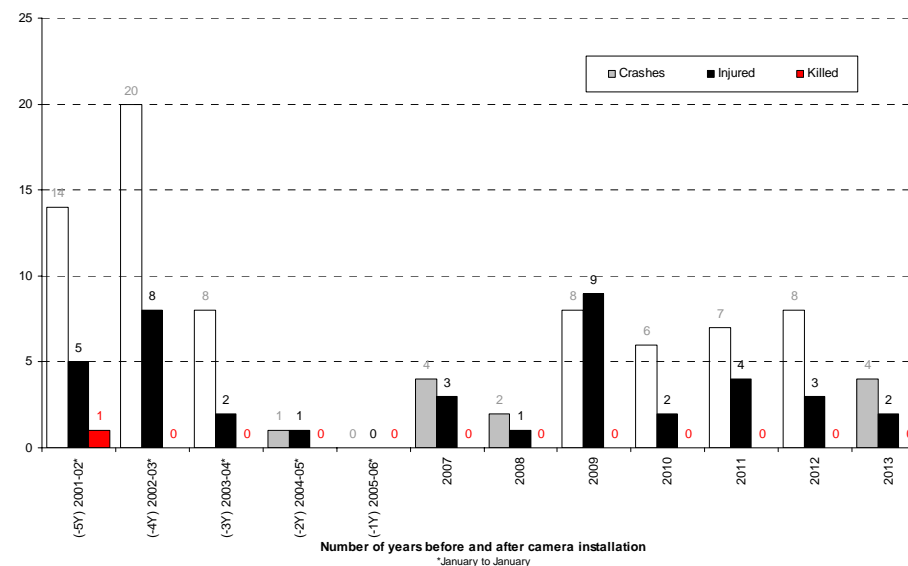
Crashes and casualties

Trend in road safety performance at camera location

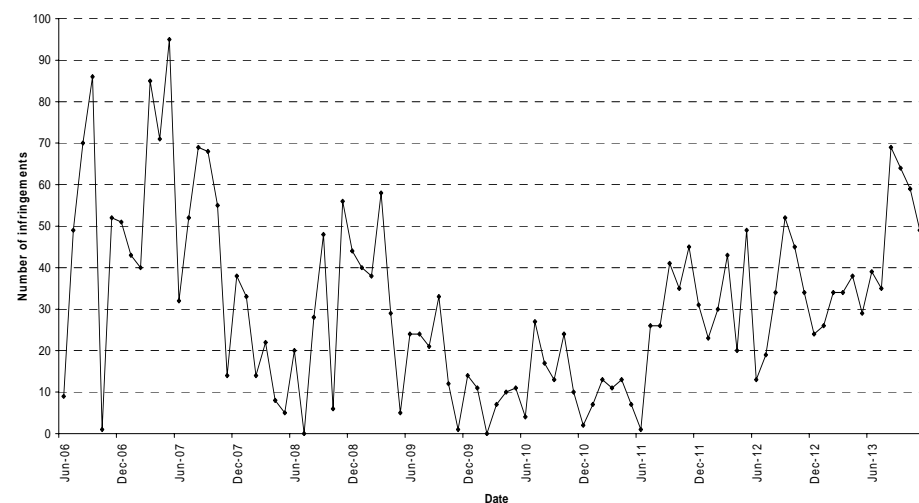
F3 FREEWAY BAR POINT

Infringements

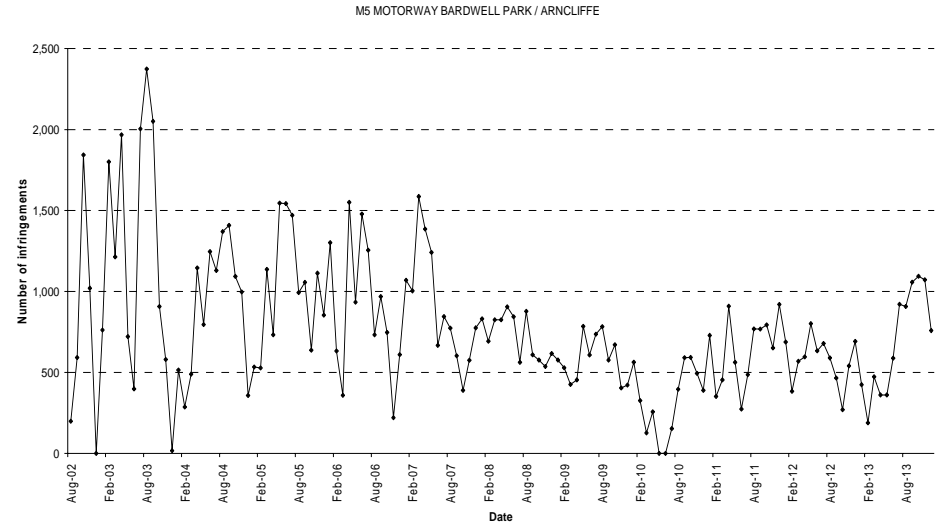
Infringements at fixed speed camera location

- This location is appropriate for fixed speed camera enforcement as it is a high risk location that is difficult for the NSW Police Force to enforce using traditional methods.
- The infringement graph details the trend in infringements at this location since the cameras began operation. The graph shows there has been a reduction in speeding behaviour at this location over time. Roadworks and camera maintenance may influence the number of infringements issued.

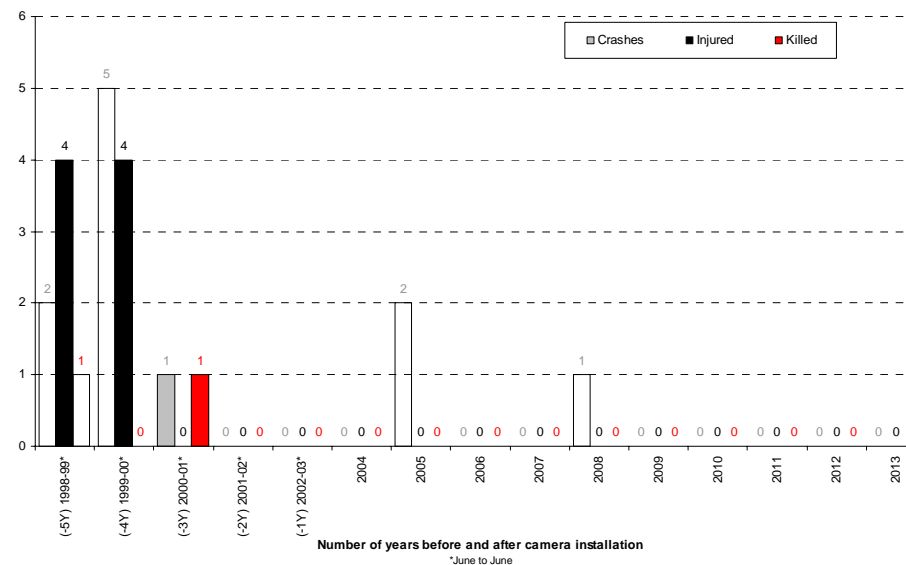
Crashes and casualties

Trend in road safety performance at camera location

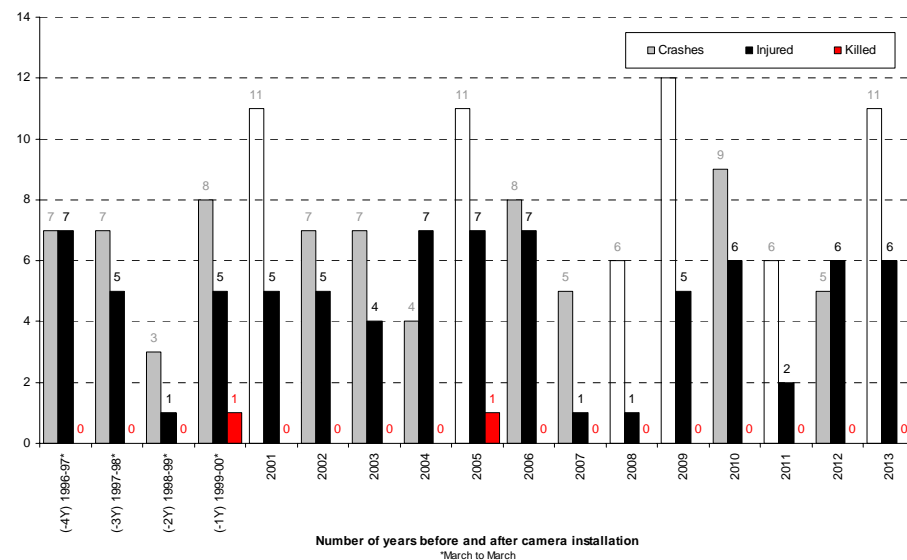
Crashes and casualties

Trend in road safety performance at camera location

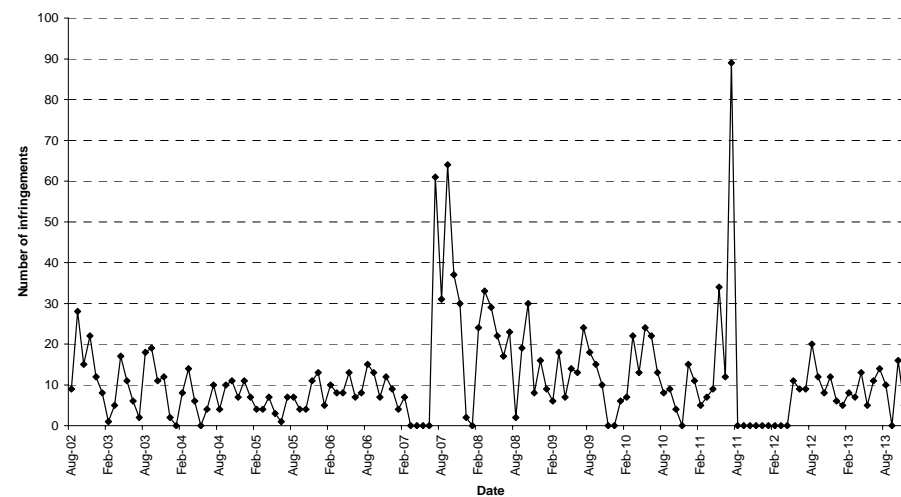
RICHMOND ROAD BERKSHIRE PARK

Infringements

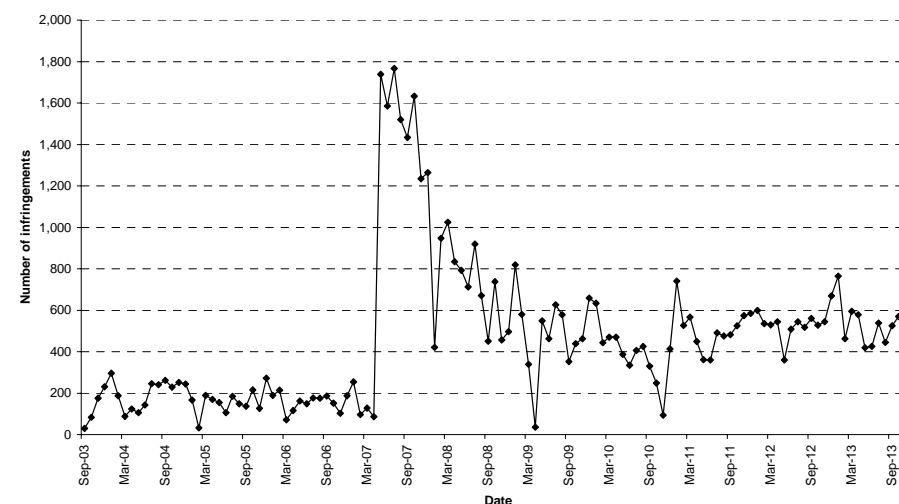
PRINCES HIGHWAY BERRY

Infringements

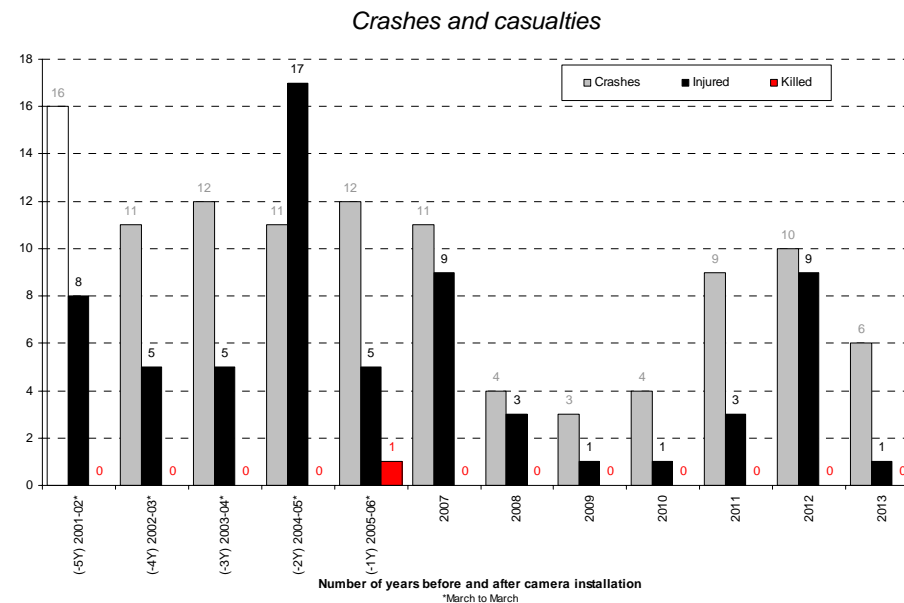
Trend in road safety performance at camera location

- The current pre and post installation analysis shows that crashes have decreased at this location.
- When comparing the pre installation period to the most recent five year period, there has been a 48 per cent reduction in the annual average number of crashes and a 63 per cent reduction in the annual average number of casualties.
- This has been a saving of \$9.34 million in costs to the community.
- The infringement graph details the trend in infringements at this location since the camera began operation. The graph show there has been a reduction in speeding behaviour at this location over time. Roadworks and camera maintenance may influence the number of infringements issued. These data

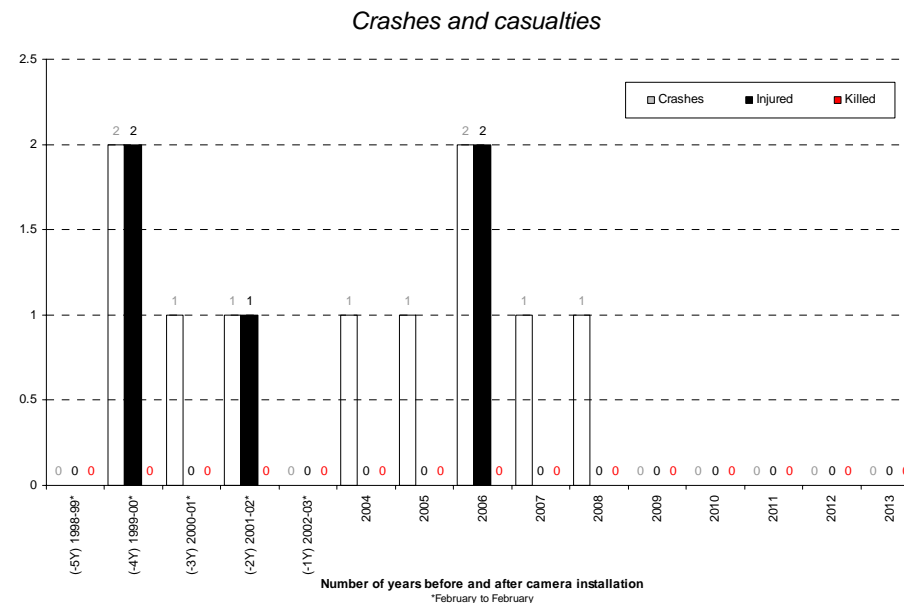
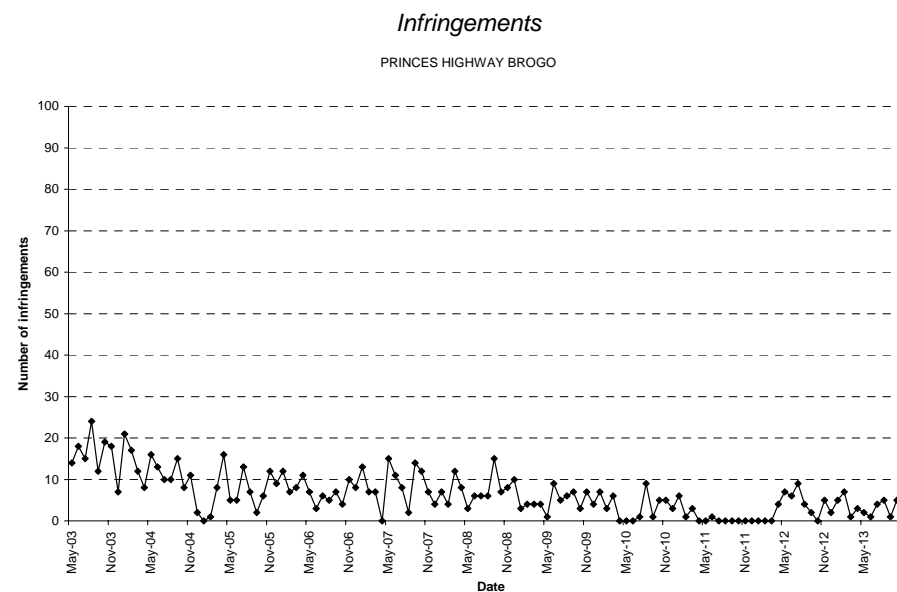
Trend in road safety performance at camera location

- The current pre and post installation analysis shows that crashes have decreased at this location.
- When comparing the pre installation period to the most recent five year period, there has been a 100 per cent reduction in the annual average number of crashes and a 100 per cent reduction in the annual average number of casualties.
- This has been a saving of \$350,000 in costs to the community.
- The infringement graph details the trend in infringements at the location since the camera began operation. The graph shows there has been a reduction in speeding behaviour at this location over time. Roadworks and camera maintenance may influence the number of infringements issued.

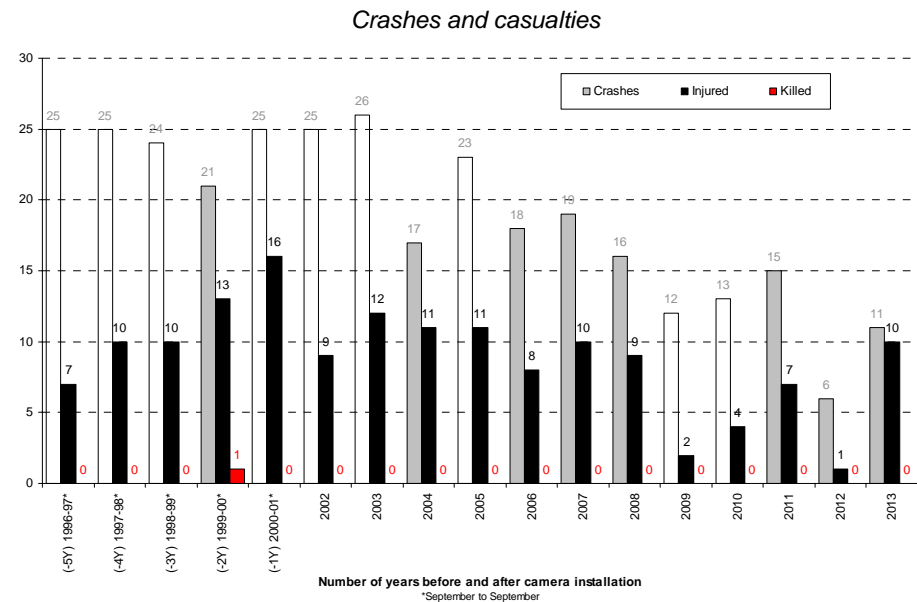
Trend in road safety performance at camera location

- The current pre and post installation analysis shows that crashes have decreased at this location.
- When comparing the pre installation period to the most recent five year period, there has been a 53 per cent reduction in the annual average number of crashes and a 58 per cent reduction in the annual average number of casualties.
- This has been a saving of \$10.15 million in costs to the community.
- The infringement graph details the trend in infringements at this location since July 2002. Infringement data before this date are not available. These graph shows there has been a reduction in speeding behaviour at this location over time. Roadworks and camera maintenance may influence the number of infringements issued.

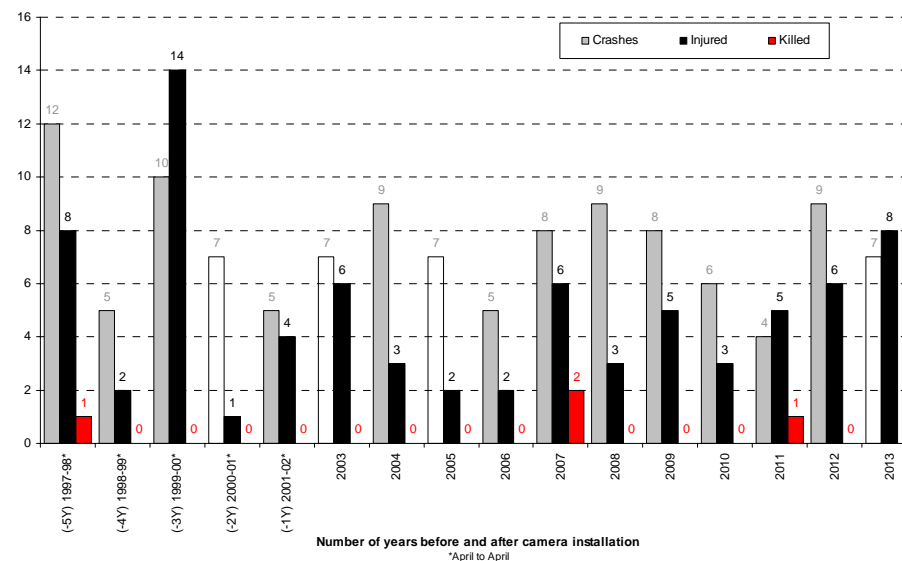
Crashes and casualties

Trend in road safety performance at camera location

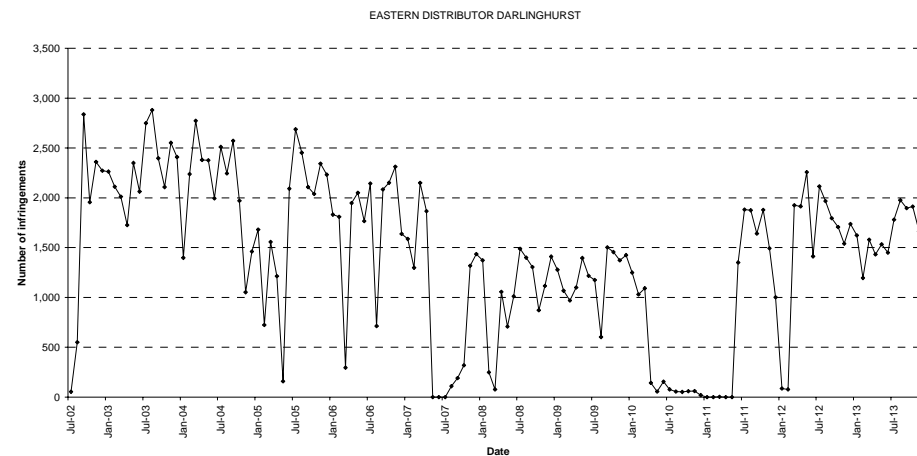
Infringements at fixed speed camera location

- This location is appropriate for fixed speed camera enforcement as it is a high risk location that is difficult for the NSW Police Force to enforce using traditional methods.
- The infringement graph details the trend in infringements at this location since July 2002. Infringement data before this date are not available. Roadworks and camera maintenance may influence the number of infringements issued.

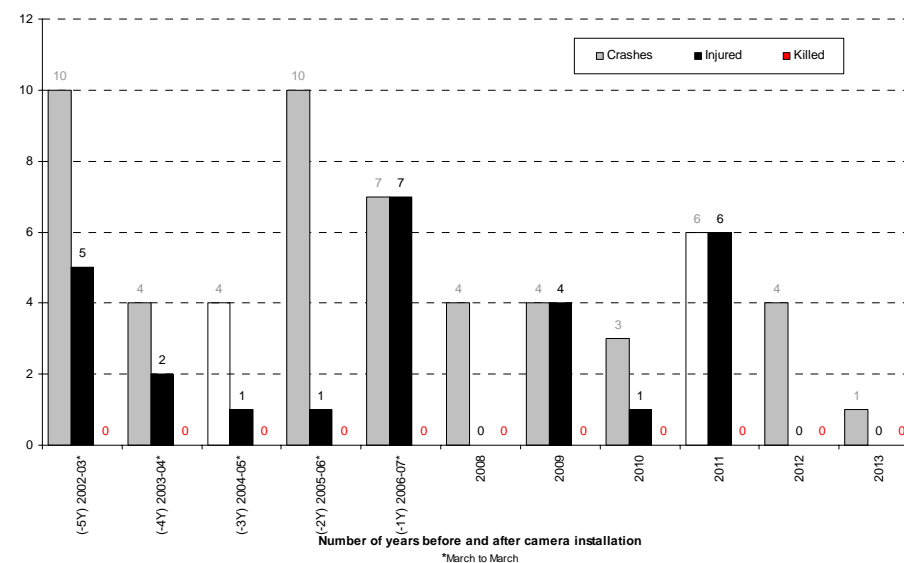
Crashes and casualties

Trend in road safety performance at camera location

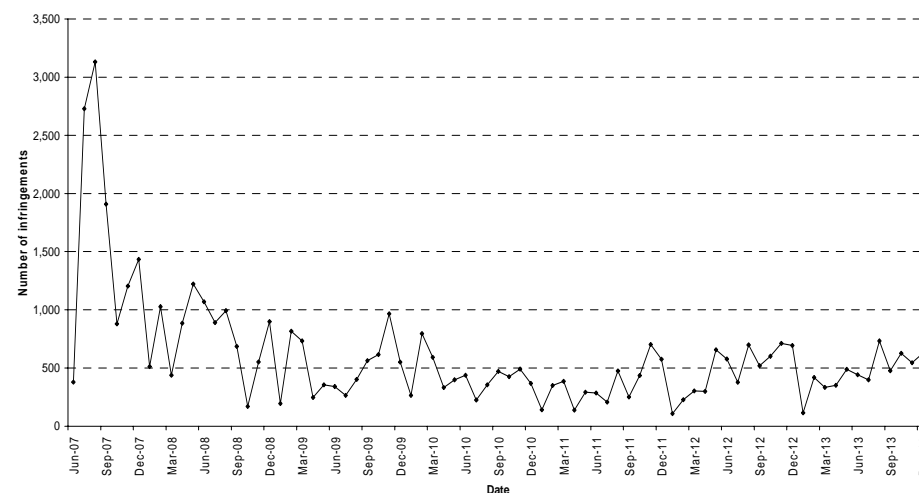
BUNNERONG ROAD EASTGARDENS/MAROUBRA

Infringements

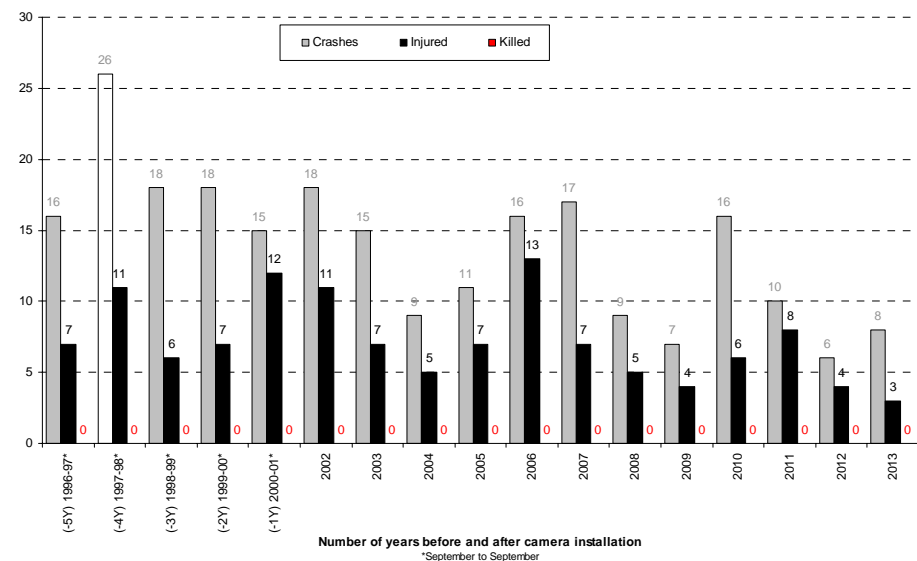
Crashes and casualties

Trend in road safety performance at camera location

- The current pre and post installation analysis shows that crashes have decreased at this location. This location was reviewed in 2012 due to concerns that crashes and casualties at this location had increased. The comprehensive review found that the camera only has an impact on the eastbound direction of traffic because the camera only enforces in this direction and there is a very wide median at the camera location. Therefore the camera was found to be effective and this crash analysis looks only at the eastbound carriageway of New South Head Road.

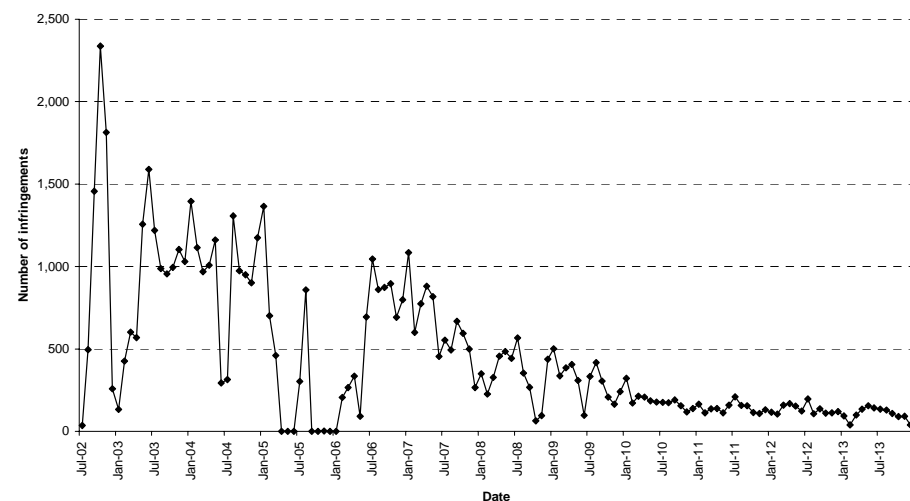
NEW SOUTH HEAD ROAD EDGECLIFF

Infringements

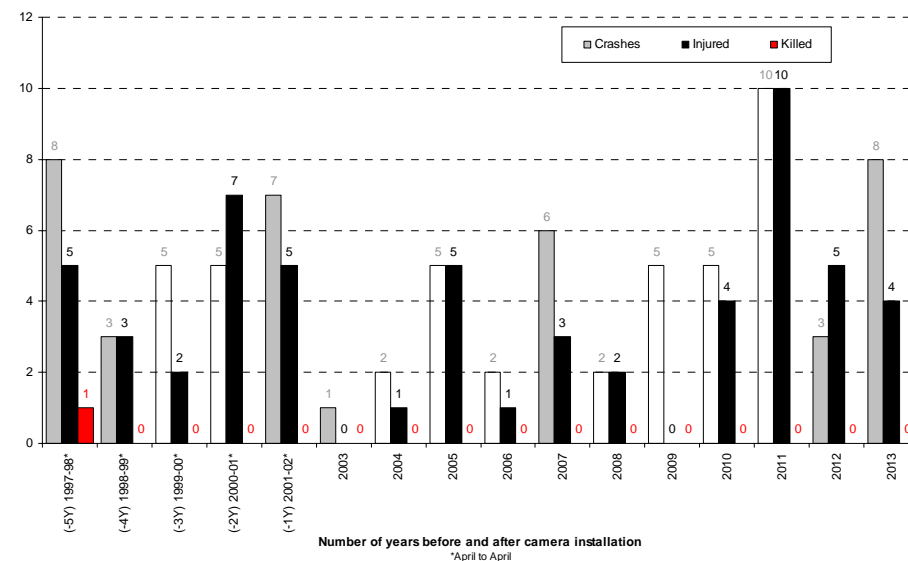
Crashes and casualties

Trend in road safety performance at camera location

- This location was reviewed in 2013 due to concerns about the increase in crashes and casualties in recent years. The 2013 review found that since the speed camera was installed, the number of crashes per year has decreased. The review also found that the number of injury crashes per year decreased. While there was one fatal crash with one fatality prior to the installation of the speed camera, there have been no fatalities since the camera has been in operation. Therefore based on this information, the speed camera is considered to be providing road safety benefits and it is recommended that the speed camera be retained.

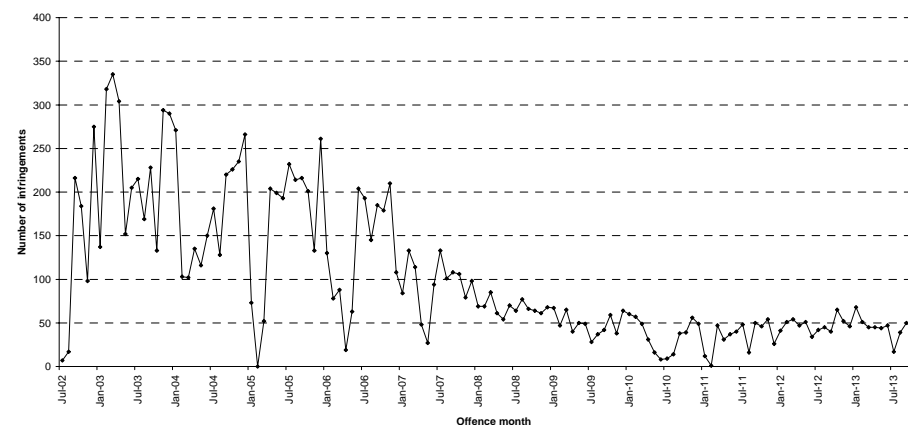
FAIRFIELD STREET FAIRFIELD EAST

Infringements
