Transport
for NSW

ANNUAL NSW SPEED CAMERA PERFORMANCE REVIEW

NSW Centre for Road Safety

OCTOBER 2014

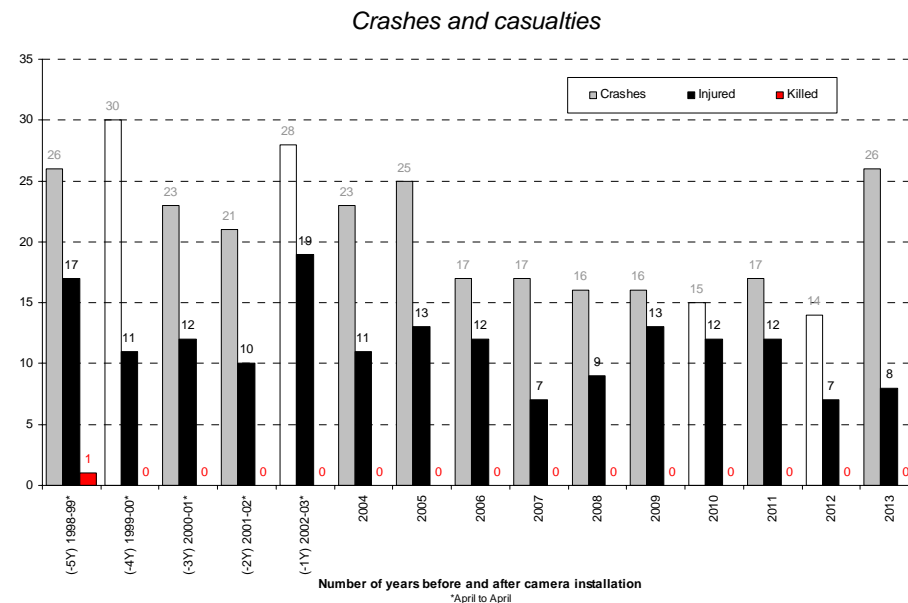
Trend in road safety performance at camera location

- This has been a saving of \$8.42 million in costs to the community.
- This location has been identified as one of the highest infringing sites in 2013. The infringement graph details the trend in infringements at this location since the cameras began operation. Despite the high numbers of infringements issued compared to other NSW locations, the graph shows there has been a reduction in speeding behaviour at this location over time. Roadworks and camera maintenance may influence the number of infringements issued.

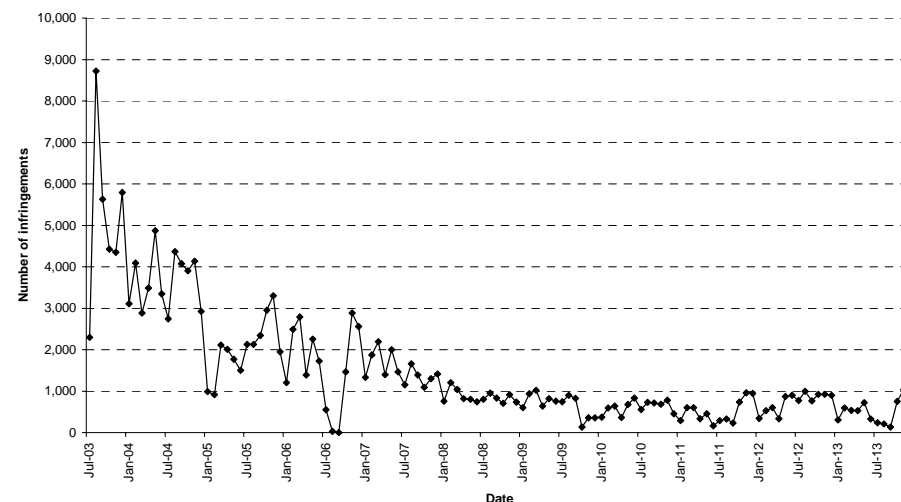
PRINCES HIGHWAY KOGARAH

Infringements

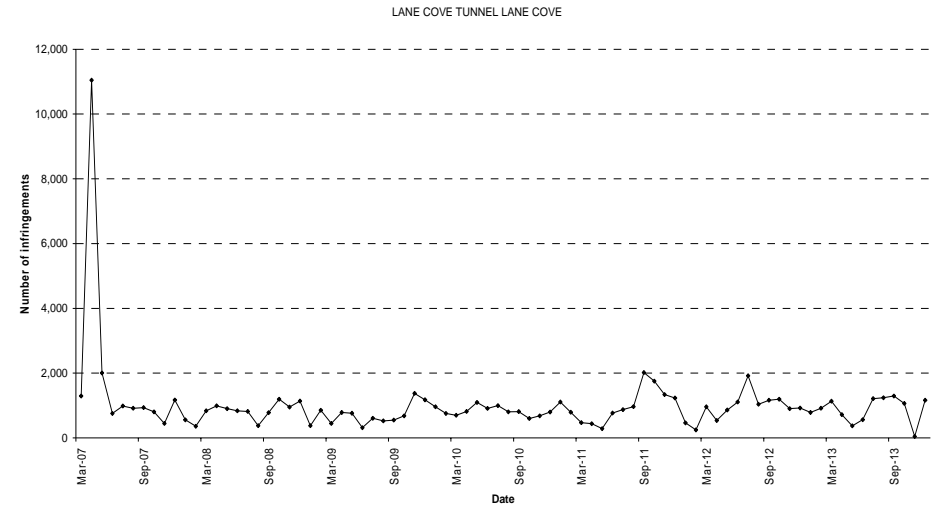
Infringements at fixed speed camera location

- This location is appropriate for fixed speed camera enforcement as it is a high risk location that is difficult for the NSW Police Force to enforce using traditional methods.
- The infringement graph details the trend in infringements at this location since the cameras began operation. Roadworks and camera maintenance may influence the number of infringements issued.

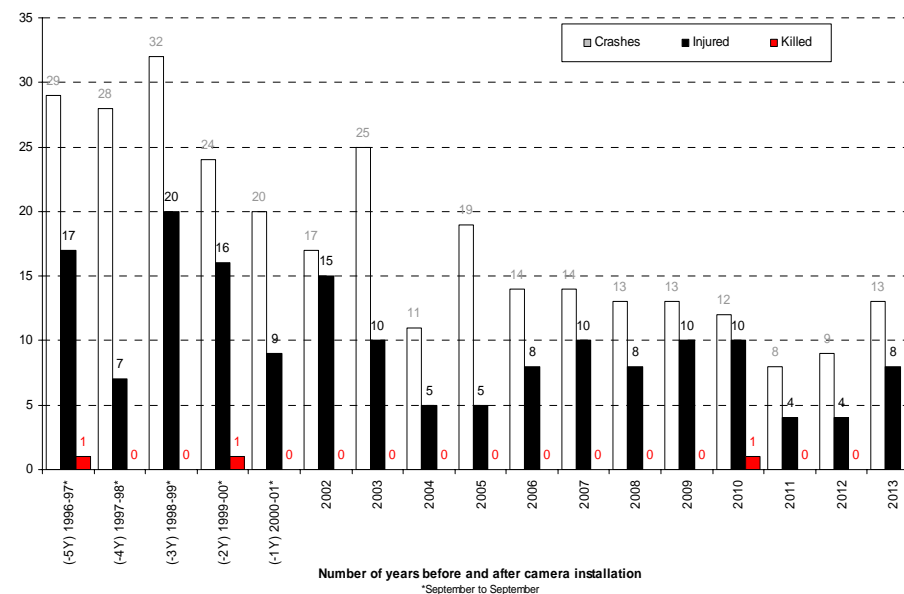
Crashes and casualties

Trend in road safety performance at camera location

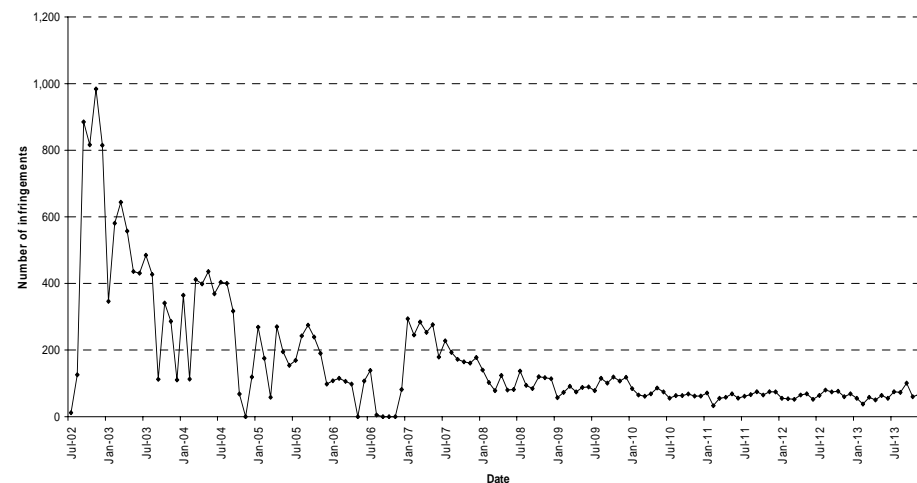
HUME HIGHWAY LANSVALE

Infringements

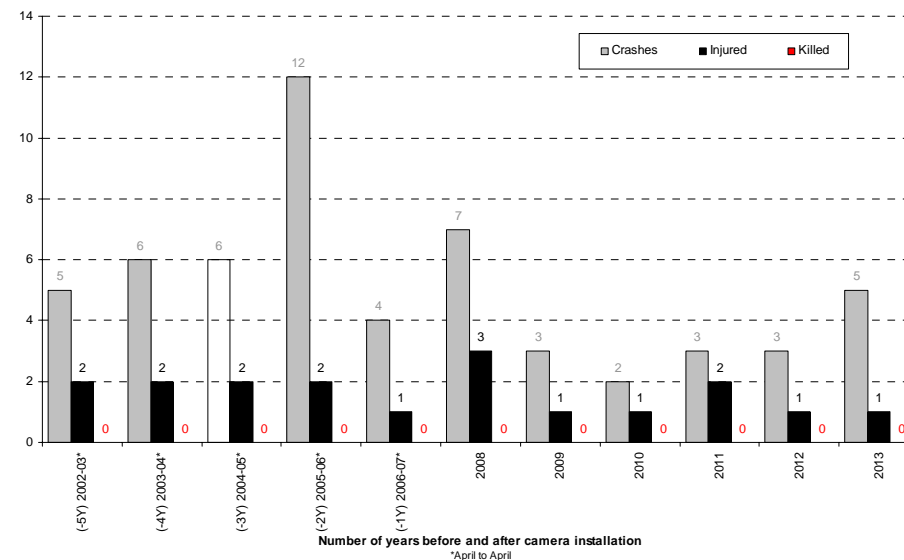
Crashes and casualties

Trend in road safety performance at camera location

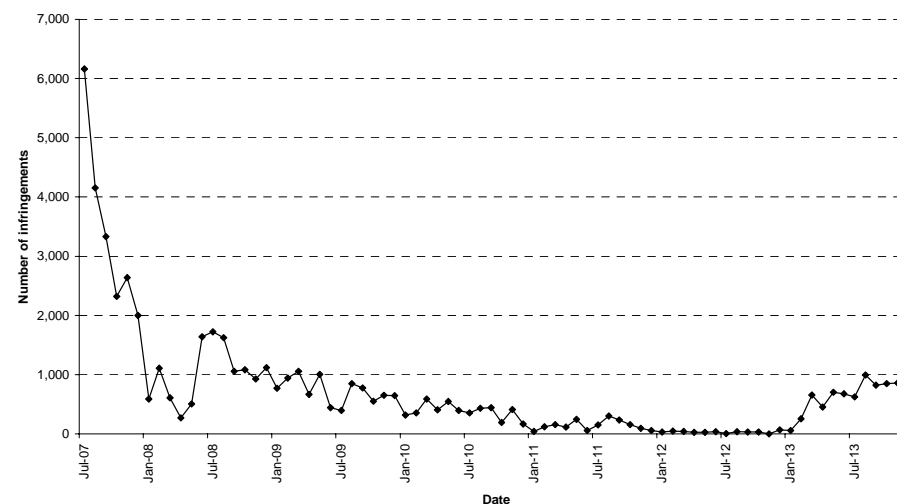
PACIFIC HIGHWAY LINDFIELD

Infringements

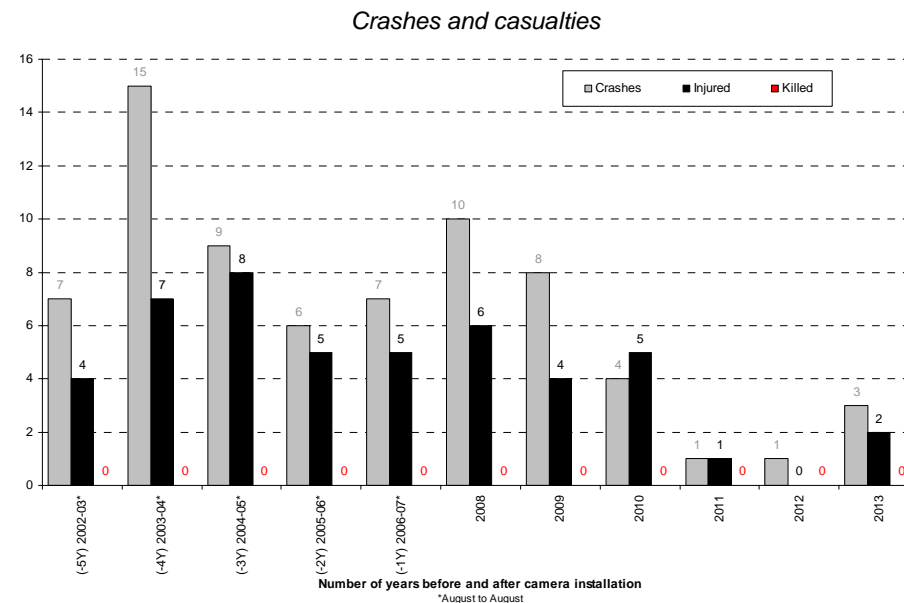
- The current pre and post installation analysis shows that crashes have decreased at this location.
- When comparing the pre installation period to the most recent five year period, there has been a 59 per cent reduction in the annual average number of crashes and a 61 per cent reduction in the annual average number of casualties.
- This has been a saving of \$1.96 million in costs to the community.
- The infringement graph details the trend in infringements at this location since the cameras began operation. The graph shows there has been a reduction in speeding behaviour at this location over time. Roadworks and camera maintenance may influence the number of infringements issued.

Trend in road safety performance at camera location

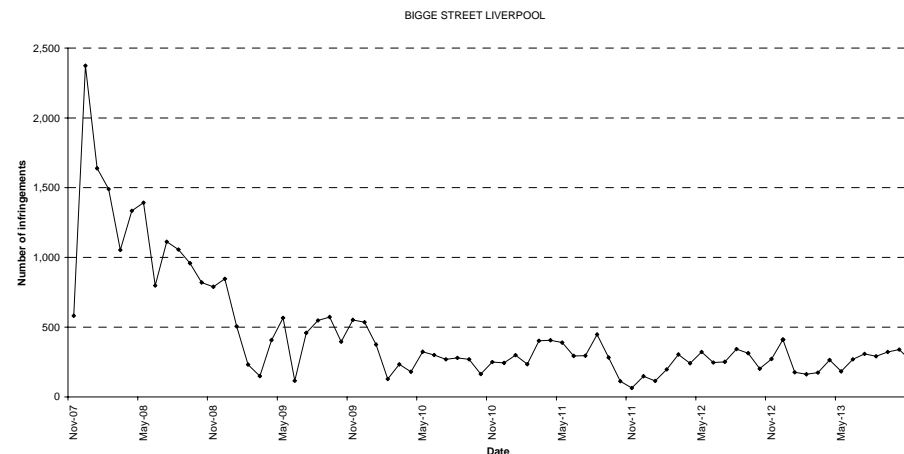
Infringements

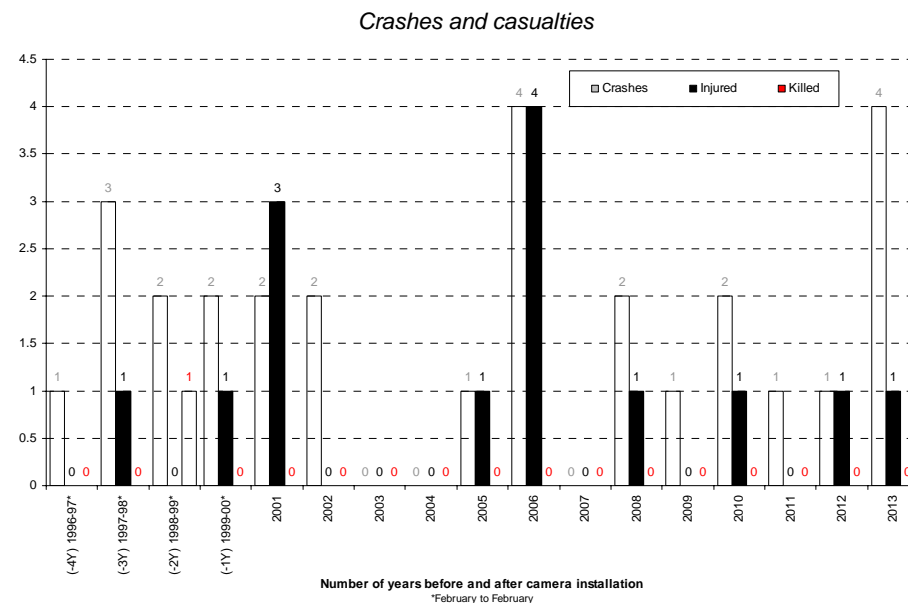
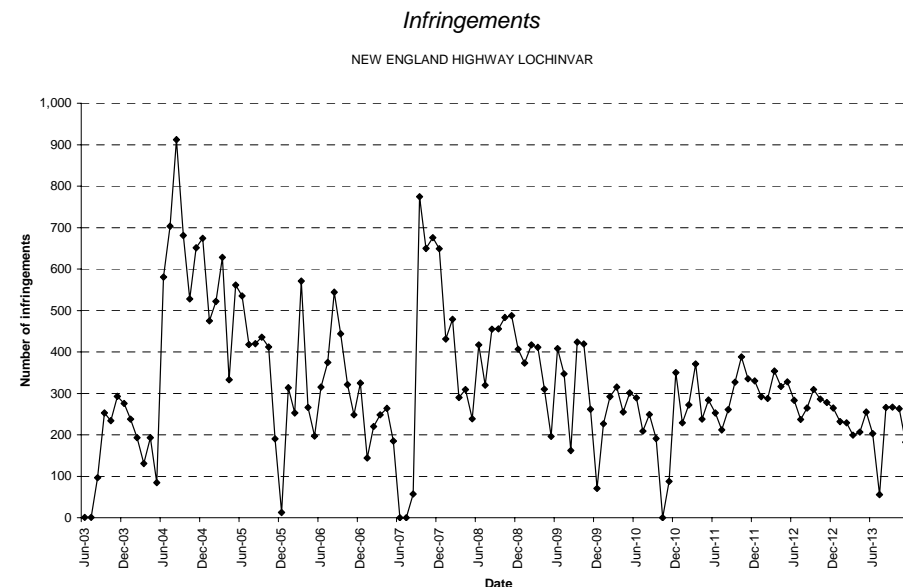
- The current adjusted five year pre installation and post installation analysis shows that crashes and casualties have decreased at this location.
- This location was reviewed in 2012 due to concerns that casualties had increased slightly. The comprehensive safety review found that since the speed camera was installed, traffic volumes had increased significantly due to mining activities in the Hunter region. Given the increase in traffic volume, the adjusted casualty rate indicated that the speed camera has been effective in reducing casualties. Further, there was strong community support for the retention of the speed camera due to its location in a school zone where safety is a high priority. Therefore the speed camera at this location was found to be effective.

- The infringement graph details the trend in infringements at this location since June 2003. Infringement data before this date are not available. The spike in infringements from September 2007 was due to the camera commencing speed enforcement of both directions of traffic where it previously enforced one direction.

Trend in road safety performance at camera location

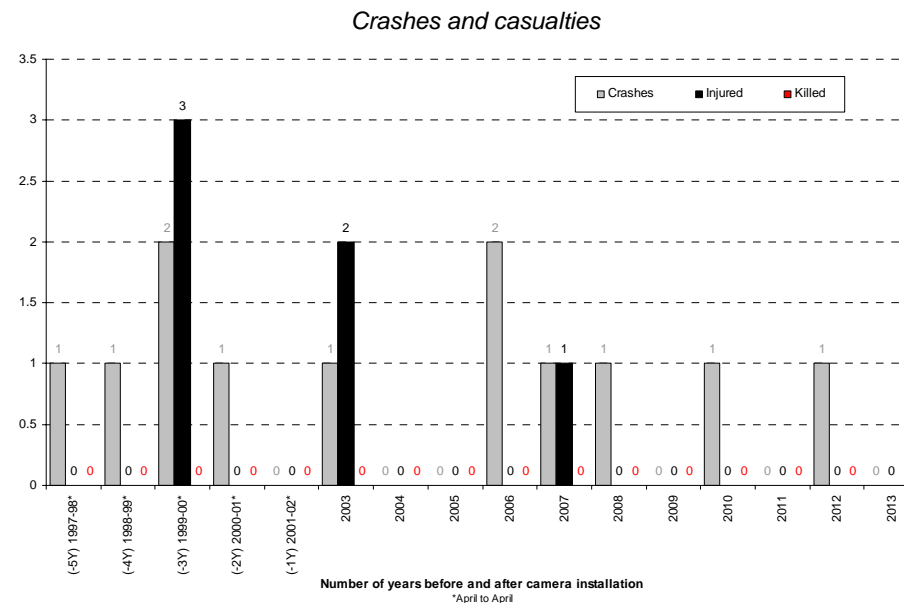
- The current pre and post installation analysis shows that crashes have decreased at this location.
- When comparing the pre installation period to the most recent five year period, there has been a 60 per cent reduction in the annual average number of crashes and a 100 per cent reduction in the annual average number of casualties.
- This has been a saving of \$350,000 in costs to the community.
- The infringement graph details the trend in infringements at this location since the cameras began operation. The graph shows there has been a reduction in speeding behaviour at this location over time. Roadworks and camera maintenance may influence the number of infringements issued.

Trend in road safety performance at camera location

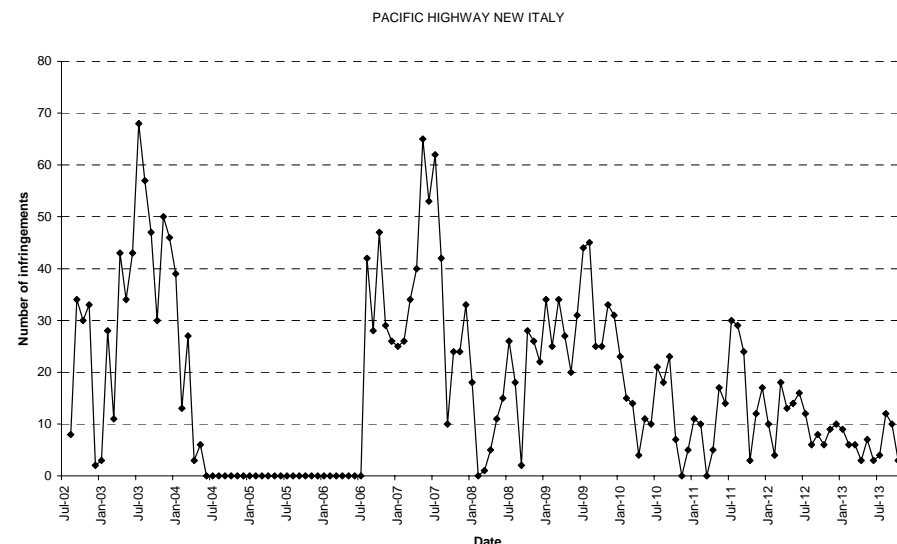
Infringements

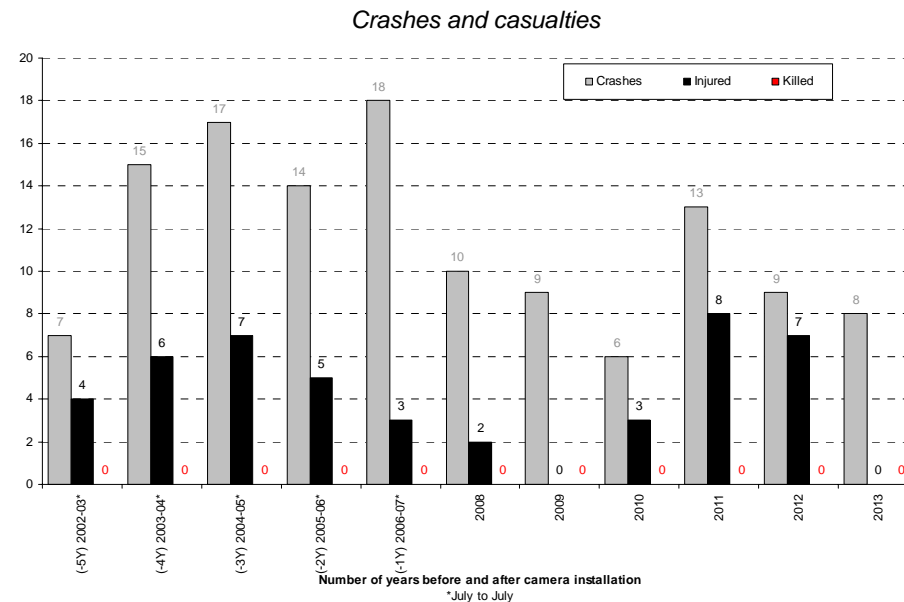
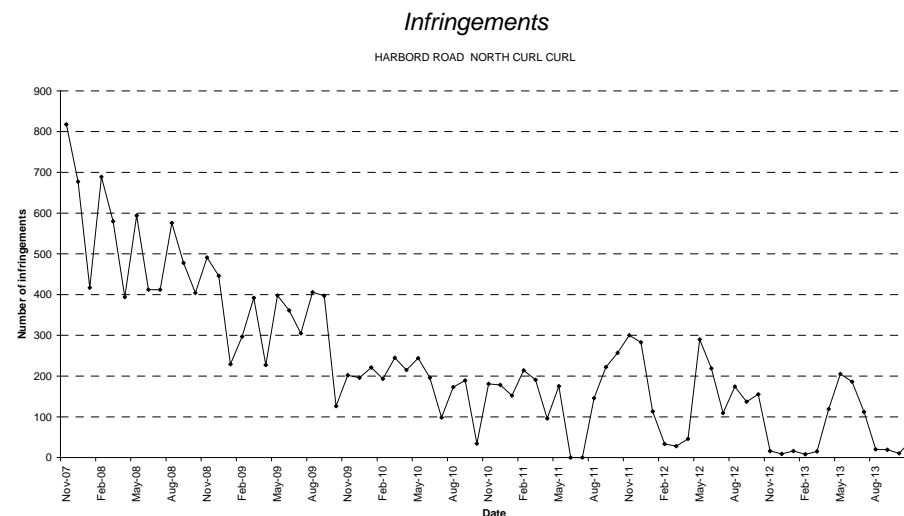
- The current pre and post installation analysis shows that crashes have decreased at this location.
- When comparing the pre installation period to the most recent five year period, there has been a 37 per cent reduction in the annual average number of crashes and a 28 per cent reduction in the annual average number of casualties.
- This has been a saving of \$810,000 in costs to the community.
- The infringement graph details the trend in infringements at this location since the cameras began operation. The graph shows there has been a reduction in speeding behaviour at this location over time. Roadworks and camera maintenance may influence the number of infringements issued.

Trend in road safety performance at camera location

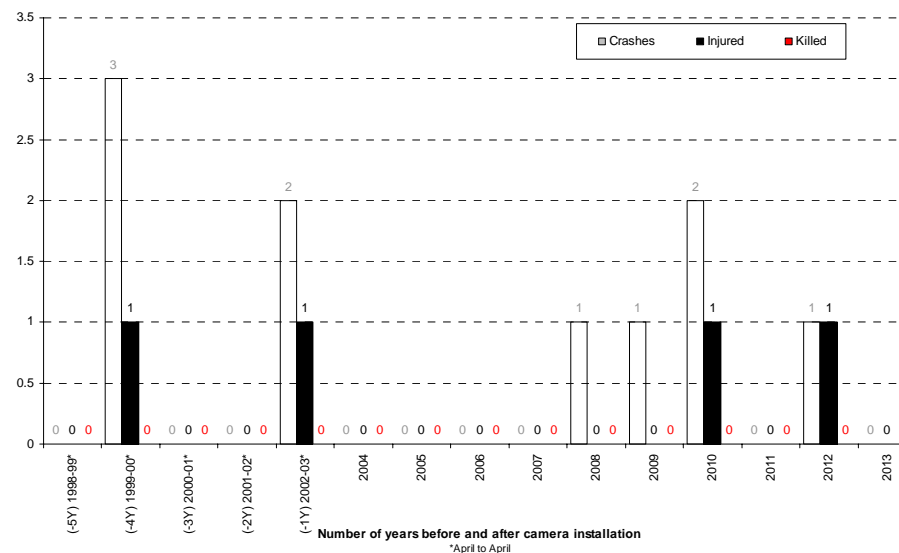
Crashes and casualties

Trend in road safety performance at camera location

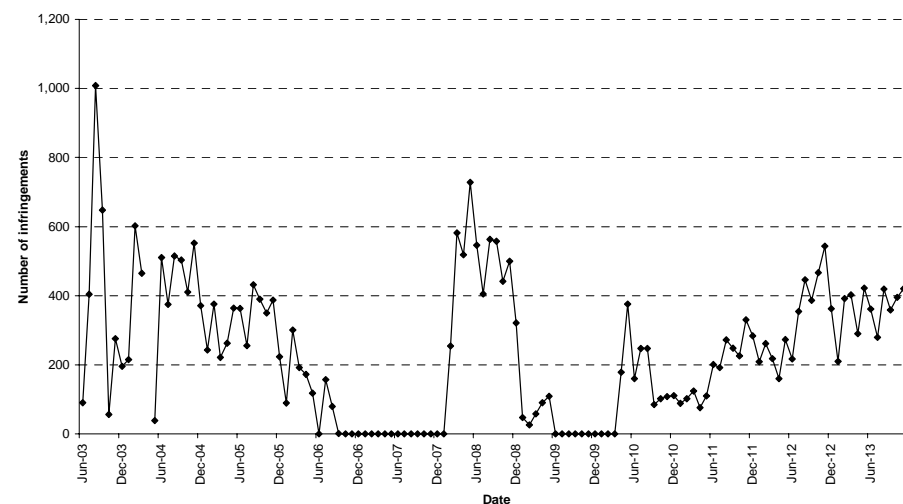
Infringements

PACIFIC HIGHWAY OURIMBAH

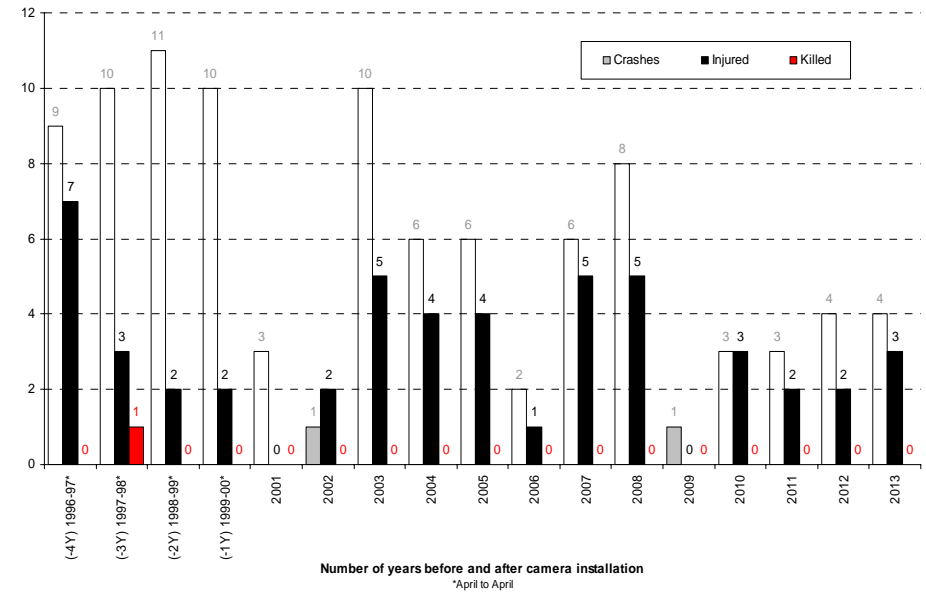
Crashes and casualties

Trend in road safety performance at camera location

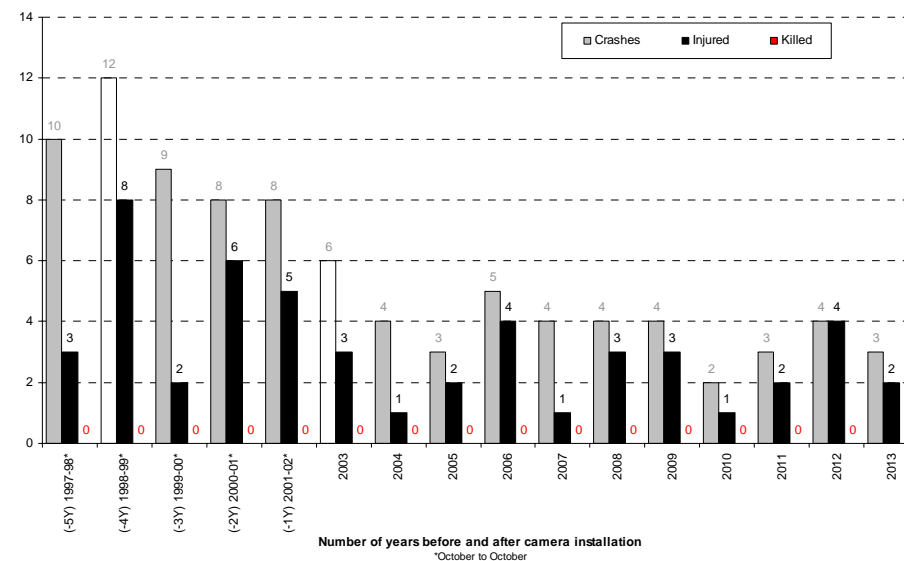
Crashes and casualties

Trend in road safety performance at camera location

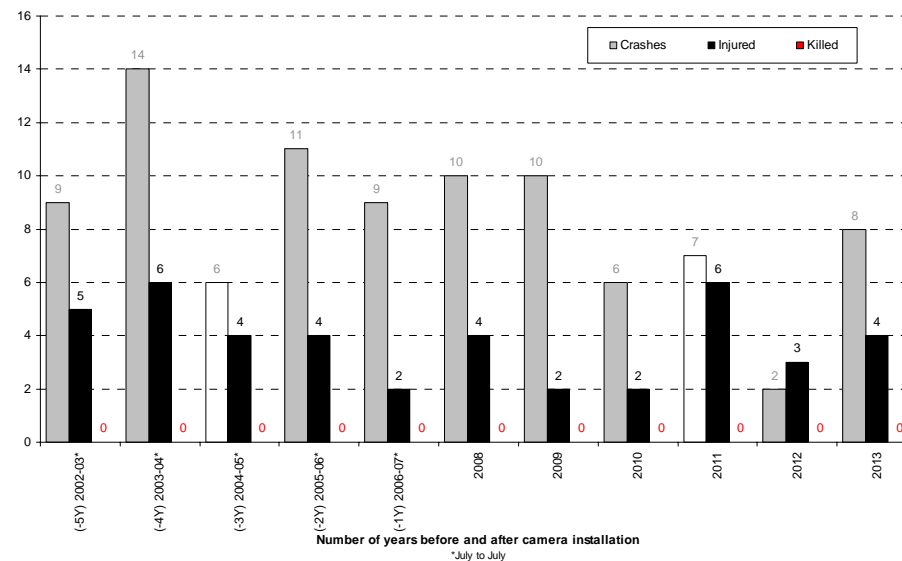
Crashes and casualties

Trend in road safety performance at camera location

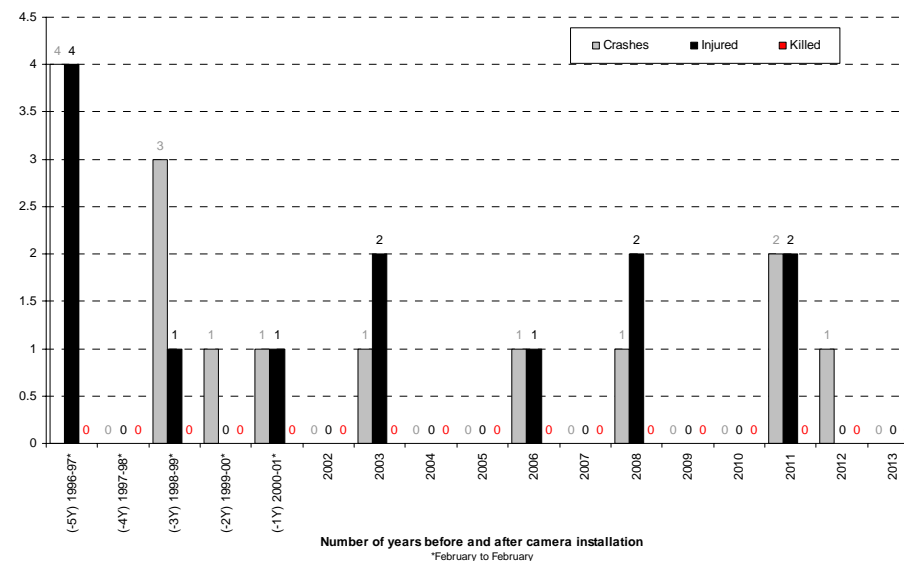
Crashes and casualties

Trend in road safety performance at camera location

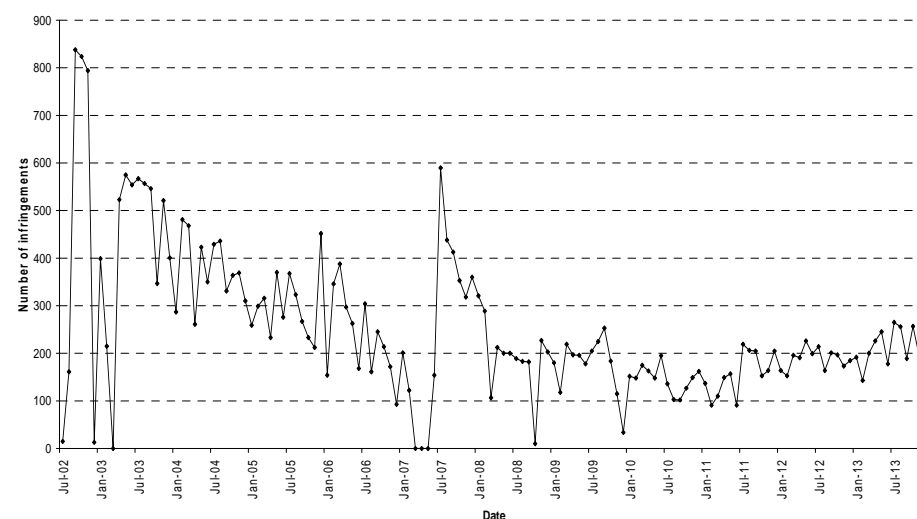
Infringements

HENRY LAWSON DRIVE PICNIC POINT

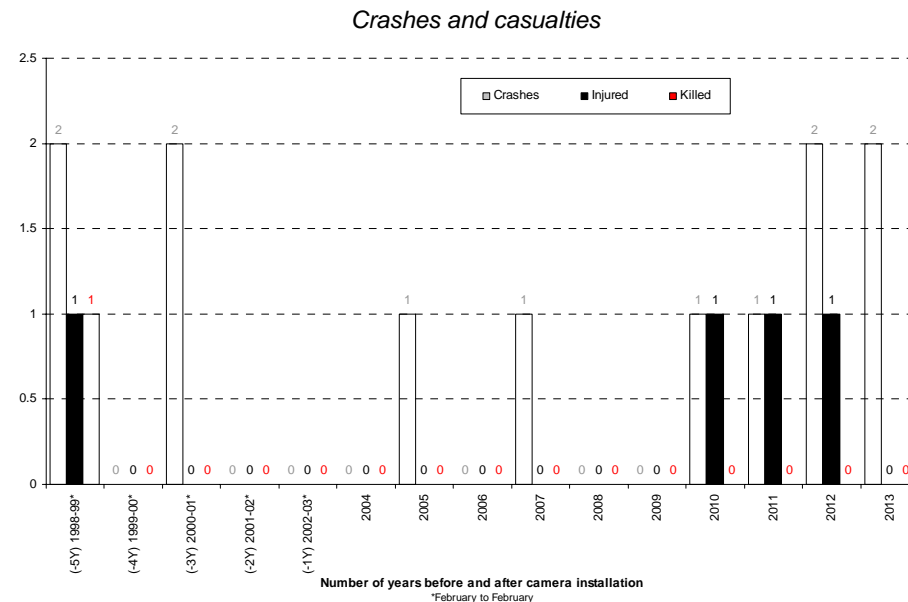
- The current pre and post installation analysis shows that crashes have increased at this location.
- When comparing the pre installation period to the most recent five year period, there has been a slight increase in crashes from four to six at this location, and in casualties from two to three. The high percentage increase is due to the low number of crashes at this location. However there has been a reduction in fatalities from one to zero at this location. Therefore this camera is delivering the expected road safety benefits.
- This has been a saving of \$6.23 million in costs to the community.
- The infringement graph details the trend in infringements at this location since the camera began operation. The graph shows there has been reduction in speeding behaviour at this location over time. Roadworks and camera maintenance may influence the number of infringements issued.

Trend in road safety performance at camera location

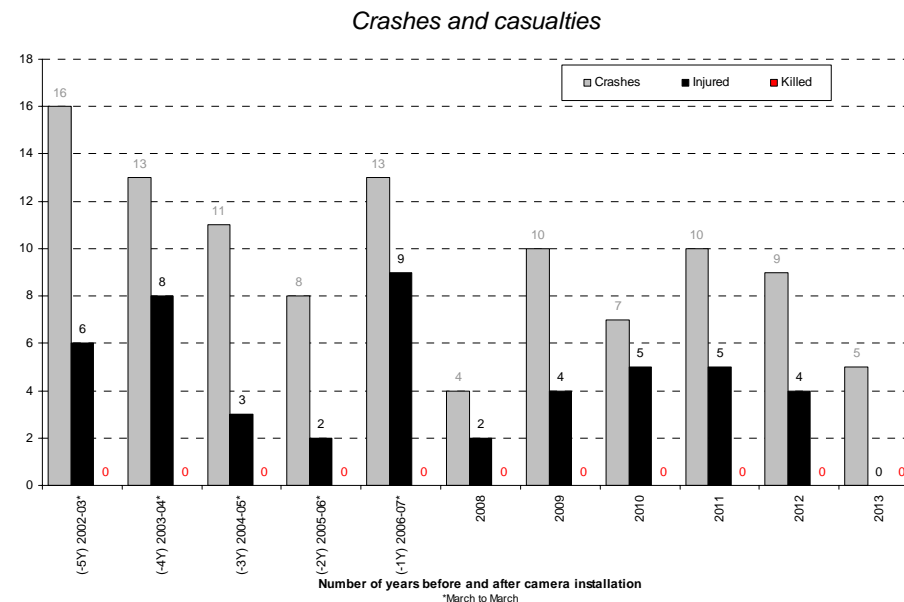
- The current pre and post installation analysis shows that crashes have decreased at this location.
- When comparing the pre installation period to the most recent five year period, there has been a 33 per cent reduction in the annual average number of crashes and a 25 per cent reduction in the annual average number of casualties.
- This has been a saving of \$820,000 in costs to the community.
- The infringement graph details the trend in infringements at this location since the camera began operation. The graph shows there has been reduction in speeding behaviour at this location over time. Roadworks and camera maintenance may influence the number of infringements issued.

Trend in road safety performance at camera location

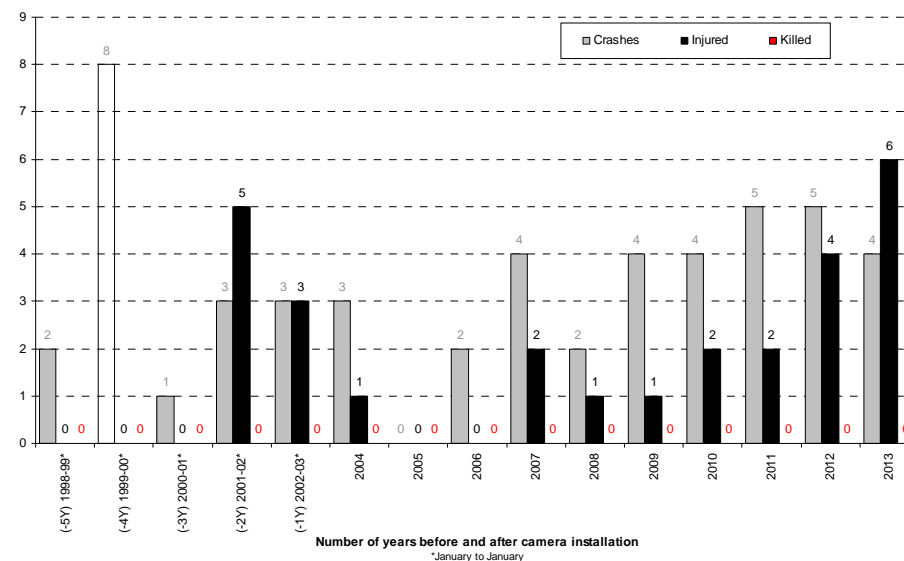
Crashes and casualties

Trend in road safety performance at camera location

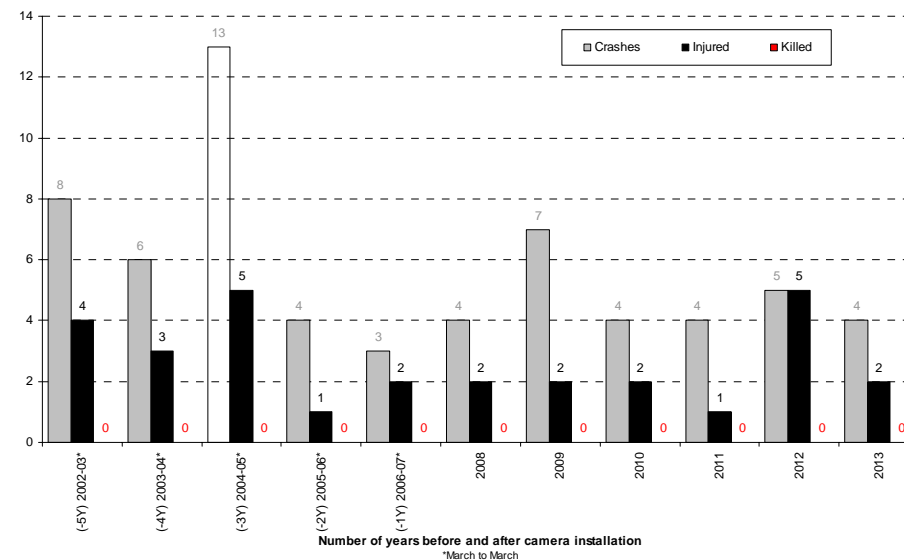
Crashes and casualties

Trend in road safety performance at camera location

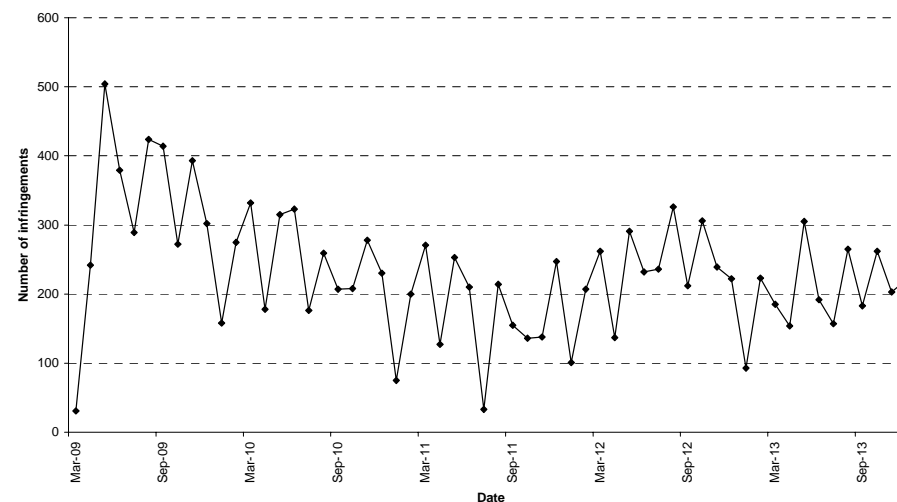
Infringements

VICTORIA ROAD RYDALMERE

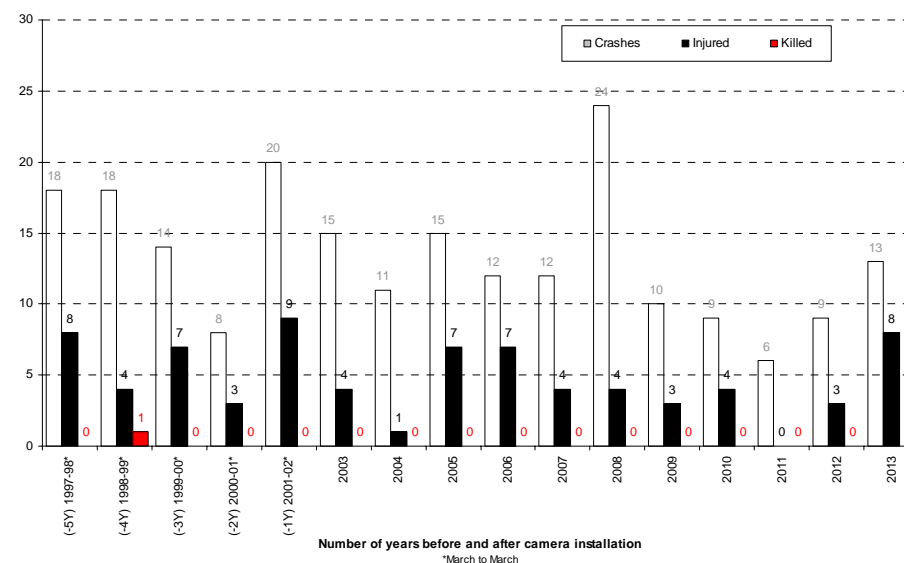
Crashes and casualties

Trend in road safety performance at camera location

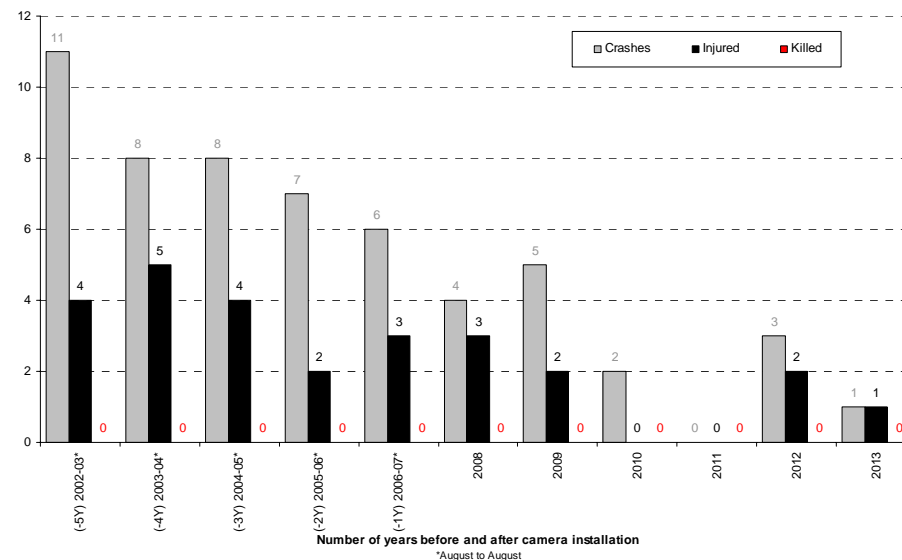
Crashes and casualties

Trend in road safety performance at camera location

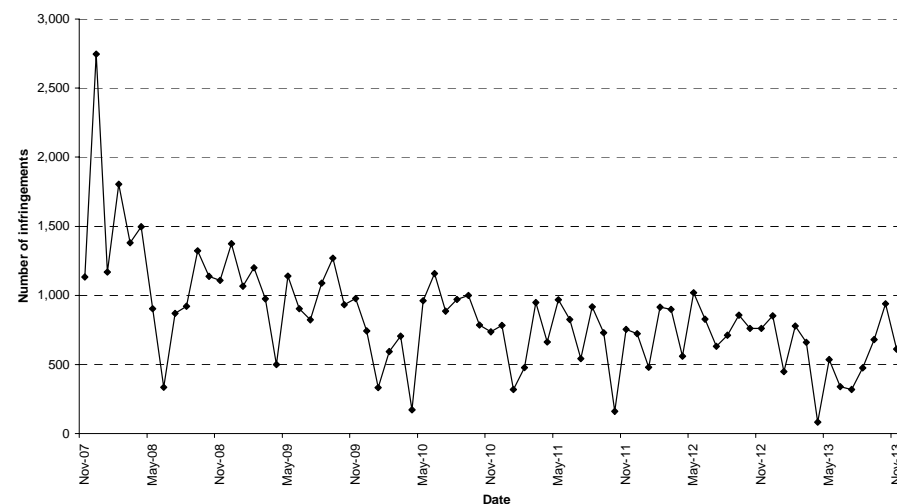
Infringements

VICTORIA ROAD RYDE

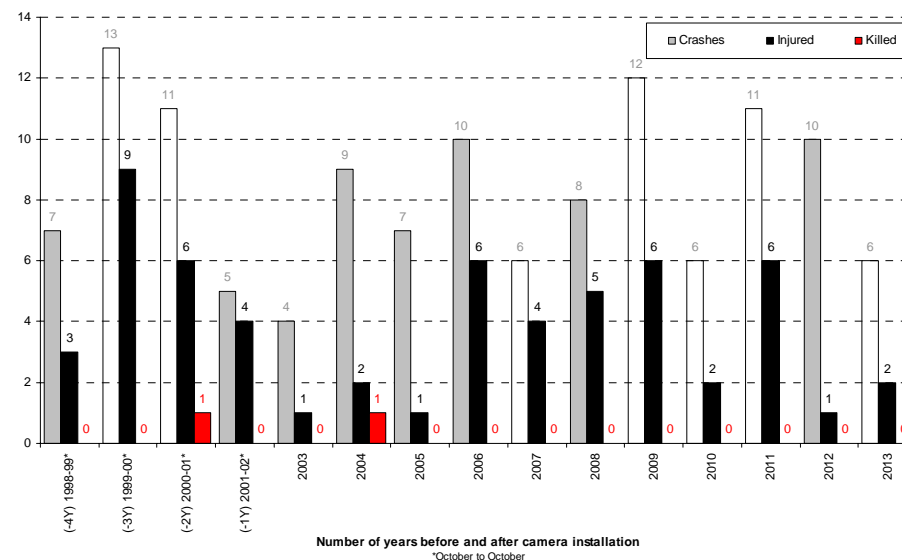
Crashes and casualties

Trend in road safety performance at camera location

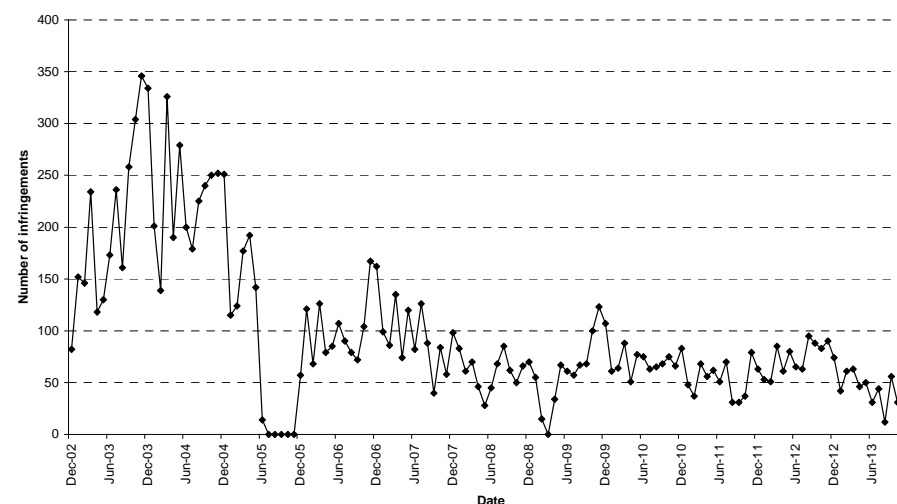
Infringements

PACIFIC HIGHWAY SANDGATE

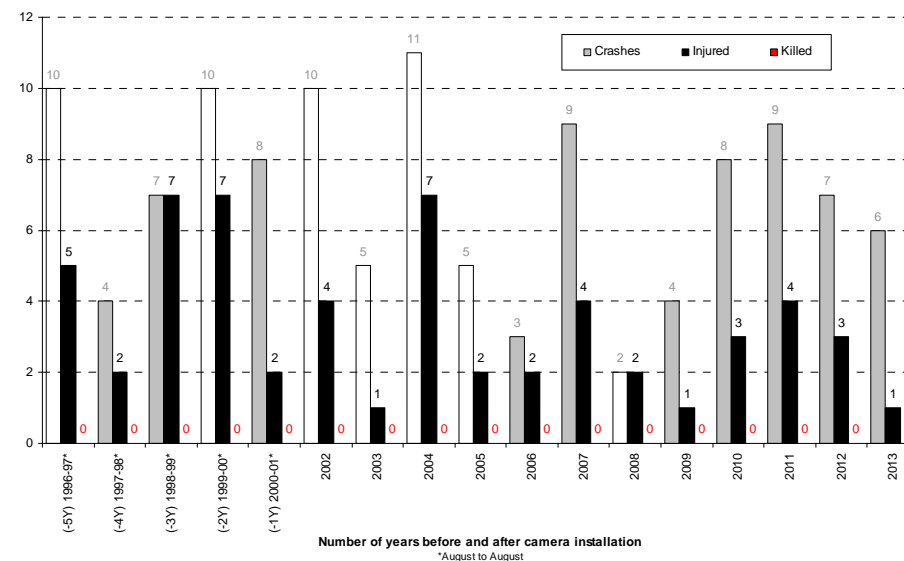
Crashes and casualties

Trend in road safety performance at camera location

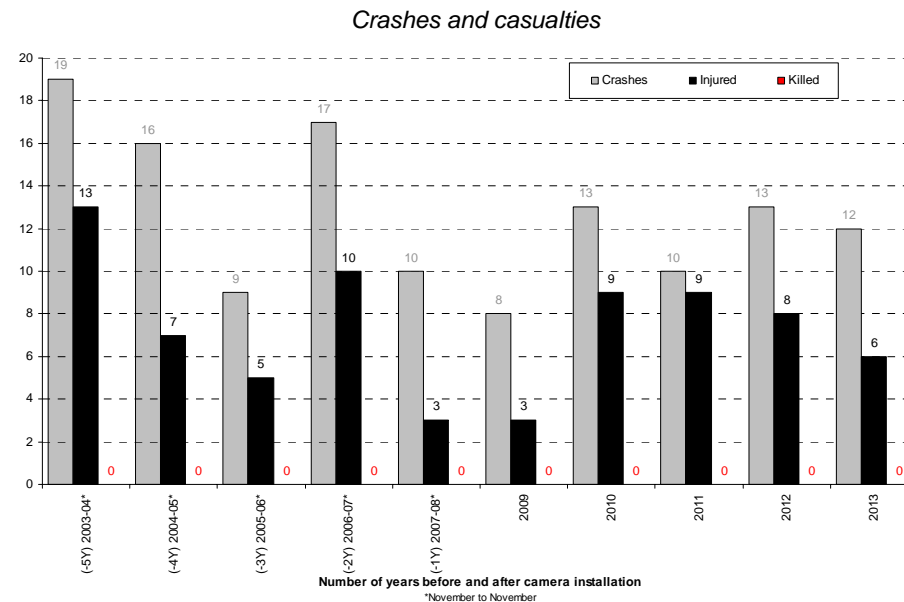
- The current pre and post installation analysis shows that crashes have decreased at this location.
- When comparing the pre installation period to the most recent three years and 331 day period, there has been a 20 per cent reduction in the annual average number of crashes and a 6 per cent reduction in the annual average number of casualties.
- This has been a saving of \$340,000 in costs to the community.
- The infringement graph details the trend in infringements at this location since the camera began operation. Roadworks and camera maintenance may influence the number of infringements issued.
- With less than five years of post installation data, it is too early to assess the effectiveness of the cameras at this location however early results indicate they are delivering the expected road safety benefits.

Trend in road safety performance at camera location

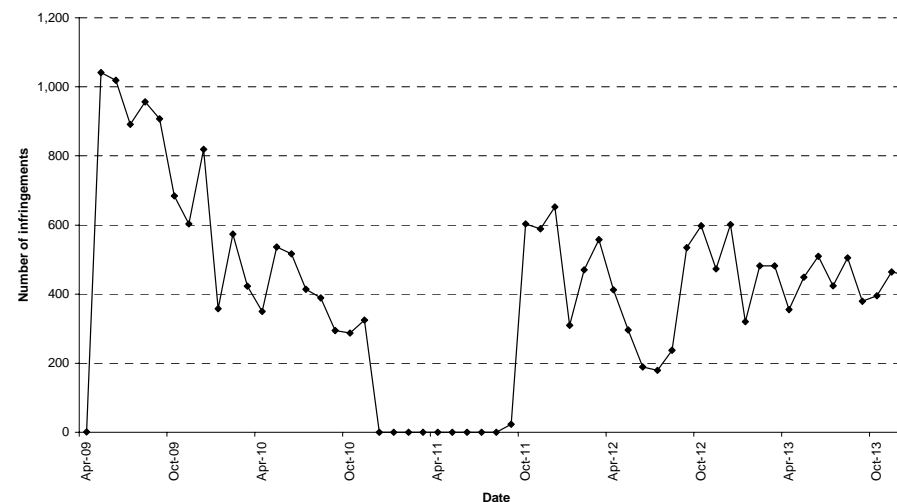
Infringements

THE BOULEVARDE STRATHFIELD

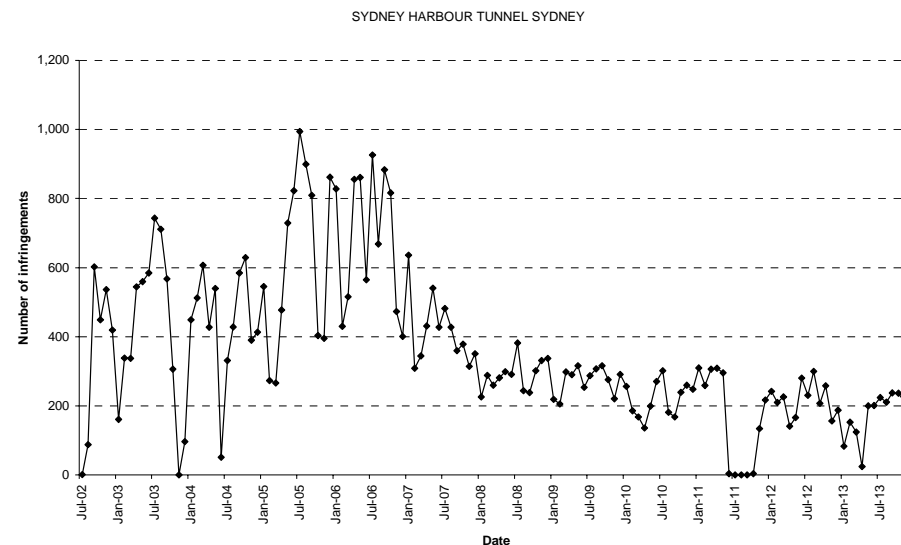
- This location is appropriate for fixed speed camera enforcement as it is a high risk location that is difficult for the NSW Police Force to enforce using traditional methods.
- The infringement graph details the trend in infringements at this location since the cameras began operation. The extended period of camera downtime from June 2011 to October 2011 was due to camera maintenance requirements and difficulties accessing the tunnel site.

Infringements at fixed speed camera location

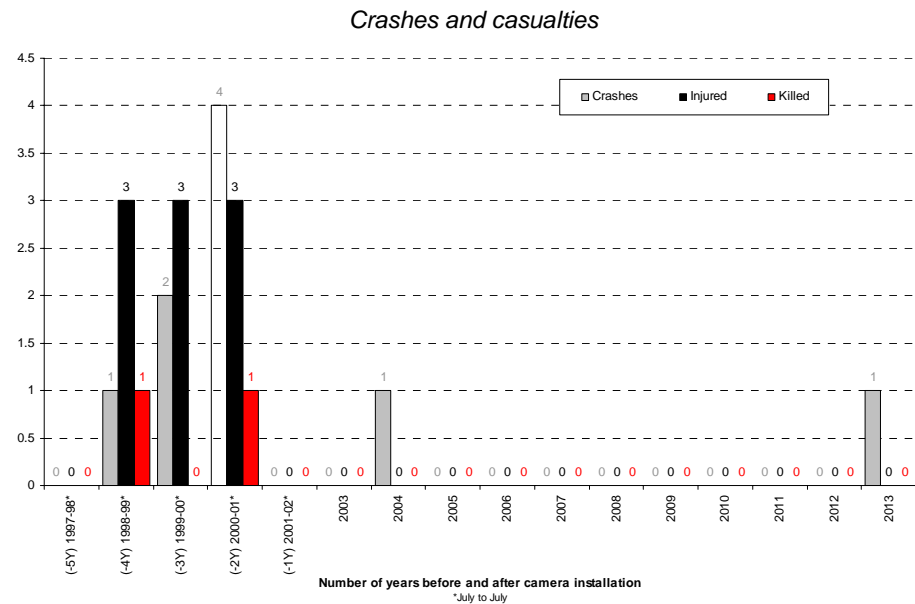
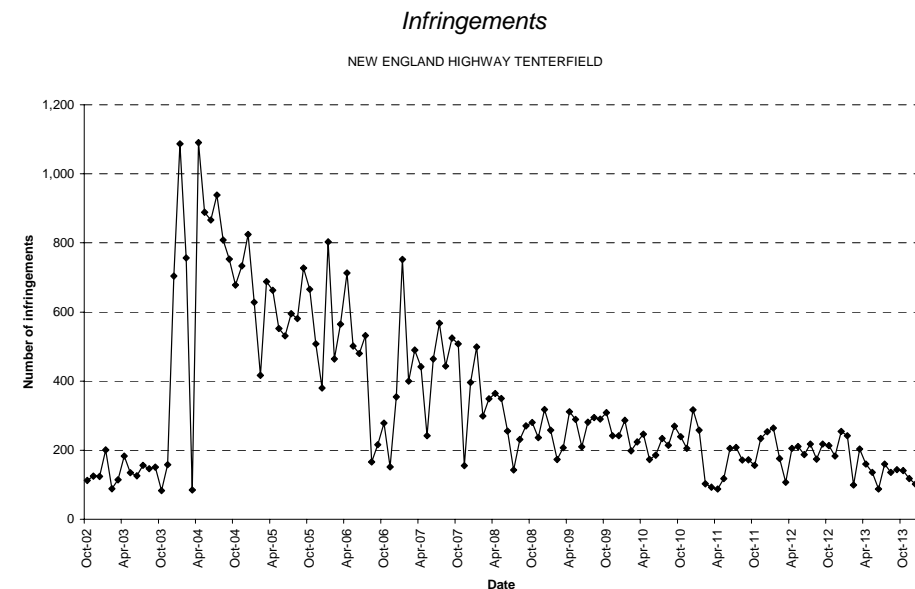
- The current pre and post installation analysis shows that crashes have decreased at this location.
- When comparing the pre installation period to the most recent five year period, there has been an 86 per cent reduction in the annual average number of crashes and a 100 per cent reduction in the annual average number of casualties.
- This has been a saving of \$13.97 million in costs to the community.
- The infringement graph details the trend in infringements at this location since the camera began operation. The graph shows there has been reduction in speeding behaviour at this location over time. Roadworks and camera maintenance may influence the number of infringements issued.

Trend in road safety performance at camera location

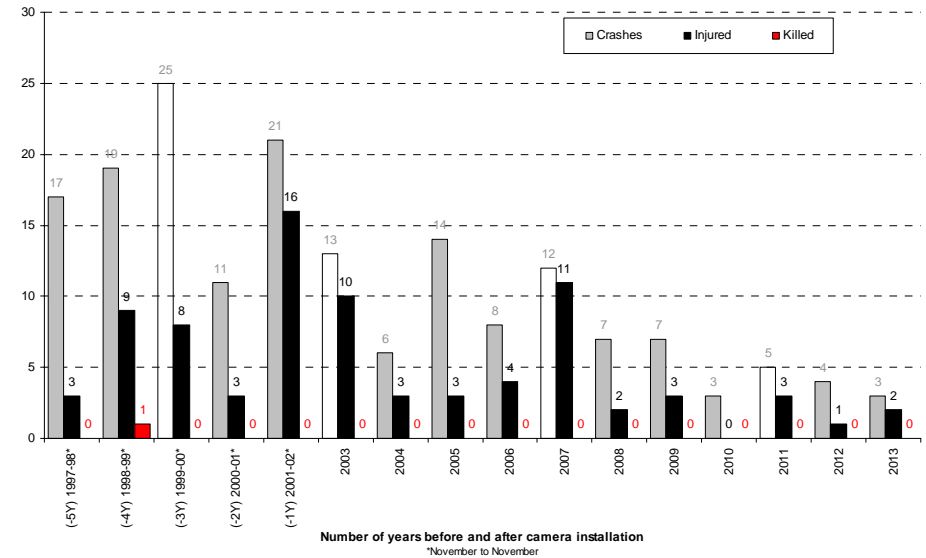
Crashes and casualties

Trend in road safety performance at camera location

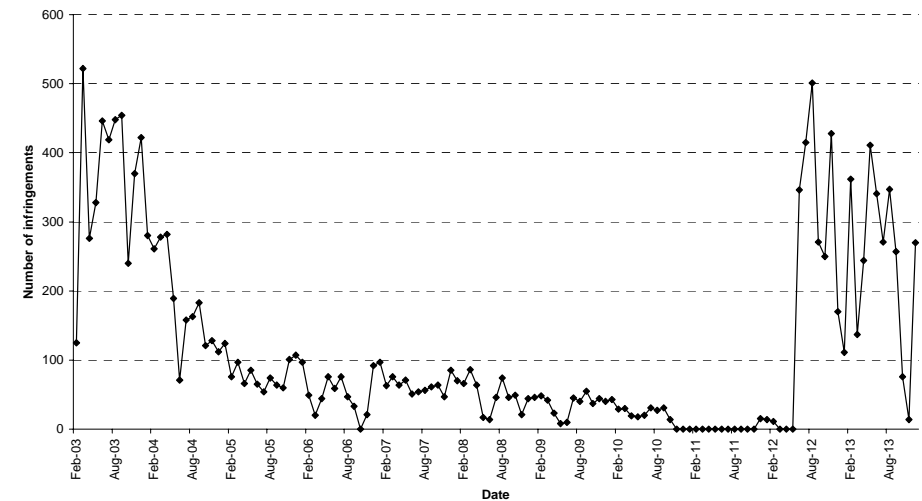
Infringements

TERRIGAL DRIVE TERRIGAL
