Transport
for NSW

ANNUAL NSW SPEED CAMERA PERFORMANCE REVIEW

NSW Centre for Road Safety

OCTOBER 2014

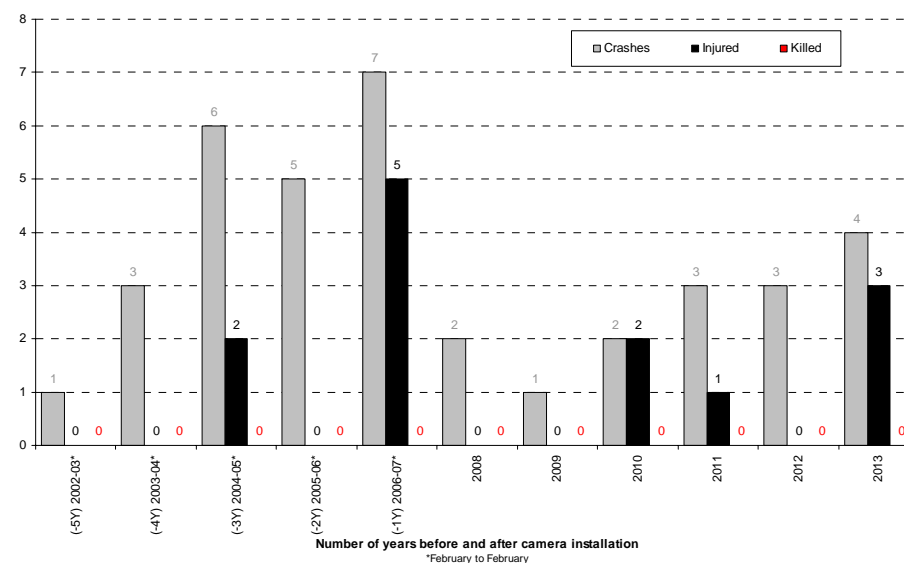
Crashes and casualties

Trend in road safety performance at camera location

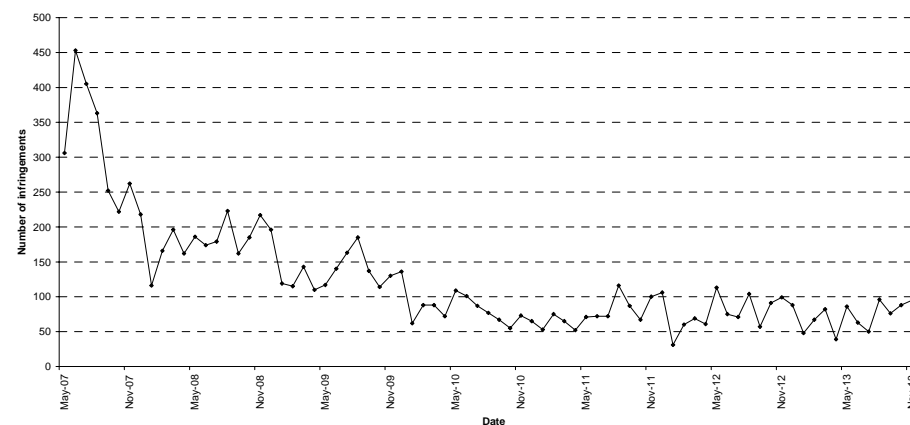
Infringements

FITZWILLIAM ROAD OLD TOONGABBIE

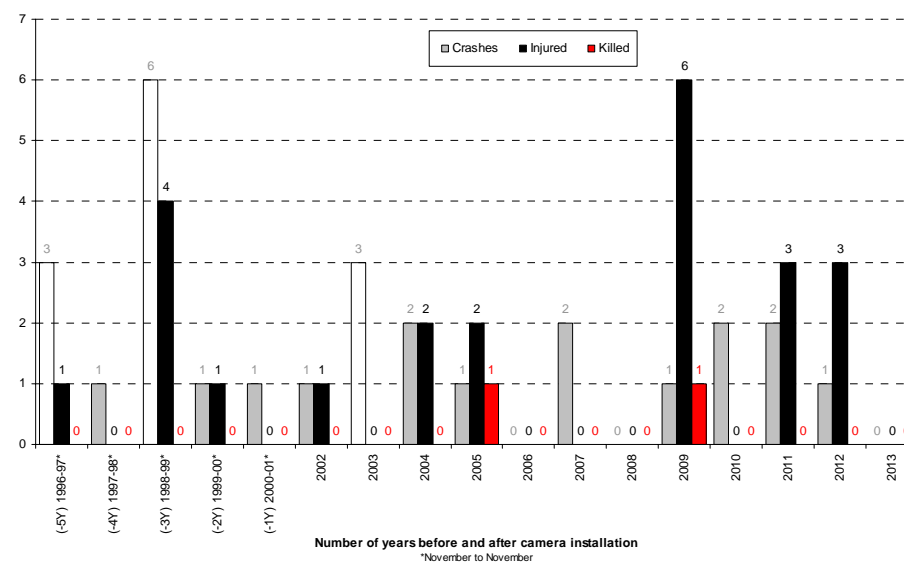
Crashes and casualties

Trend in road safety performance at camera location

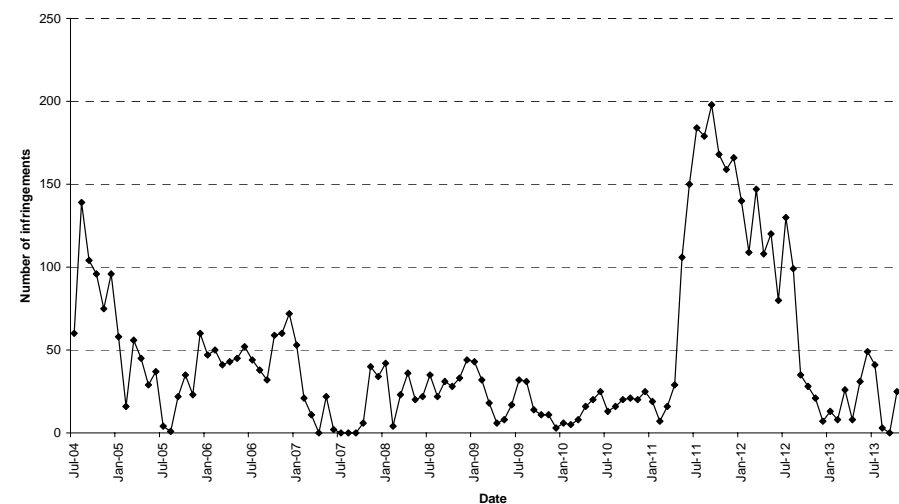
Infringements

PACIFIC HIGHWAY VALLA BEACH

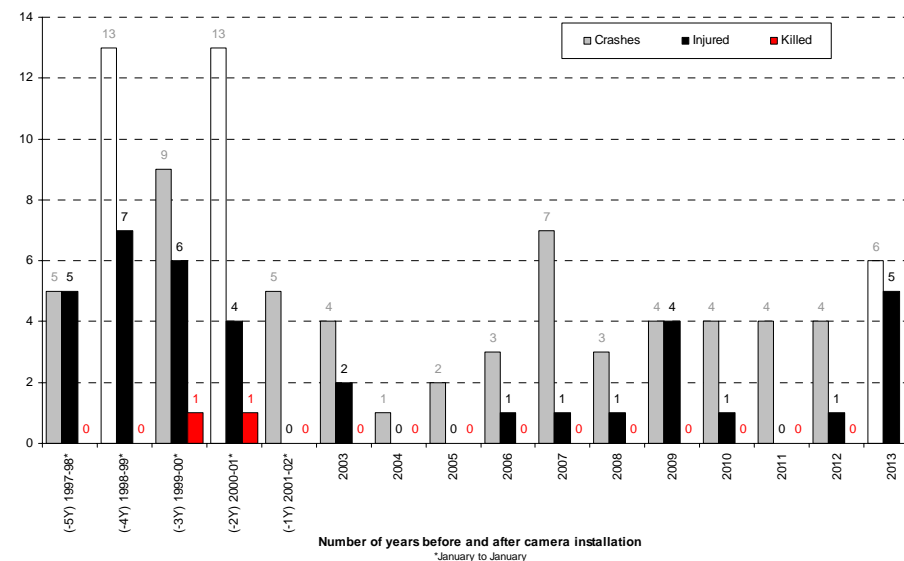
Crashes and casualties

Trend in road safety performance at camera location

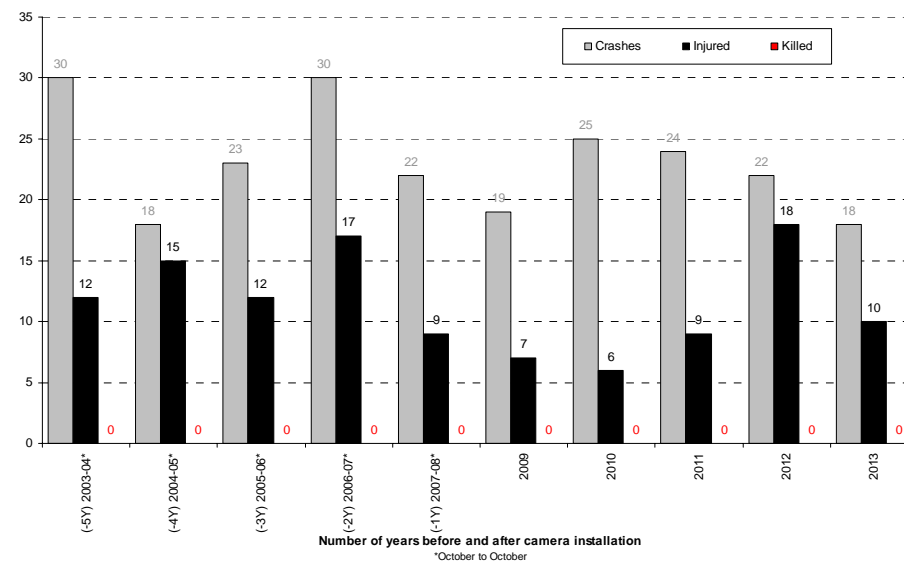
Crashes and casualties

Location: Pacific Highway, between Gilda Avenue and Woodville Avenue
 School zone: Warrawee Public School, Knox Grammar, Abbotsleigh Senior Campus
 Length description: 1080m south to 880m north of camera
 Total length: 1960m (patch to patch)
 Number of cameras: 2
 Started infringing: 28/01/2009
 Status: **Effective**

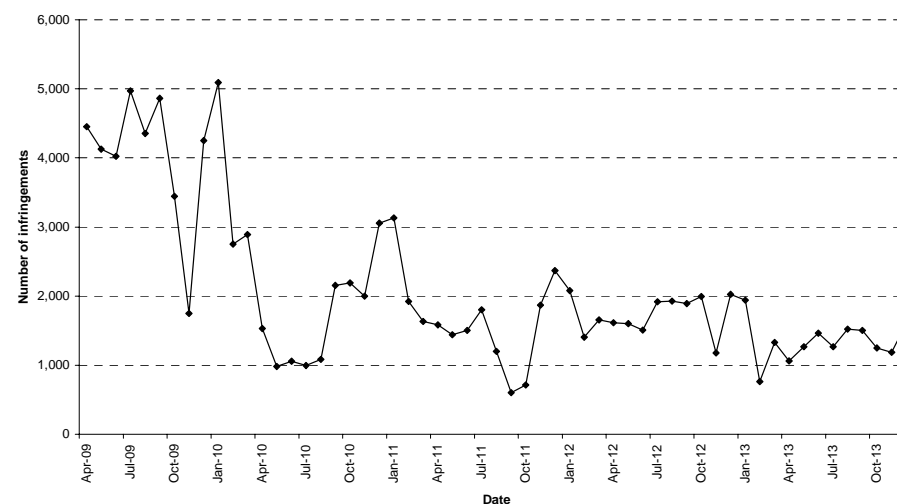
PACIFIC HIGHWAY WAHROONGA

Infringements

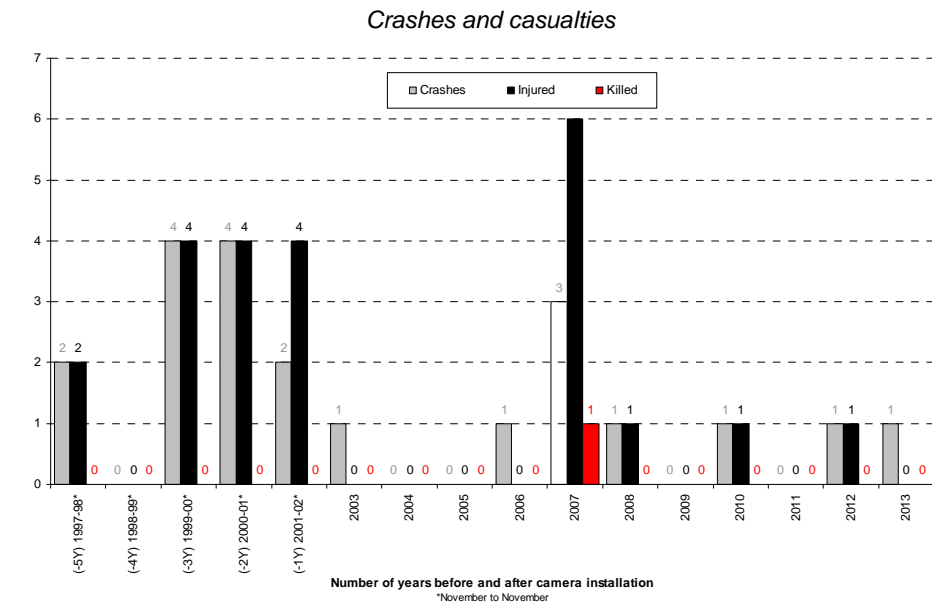
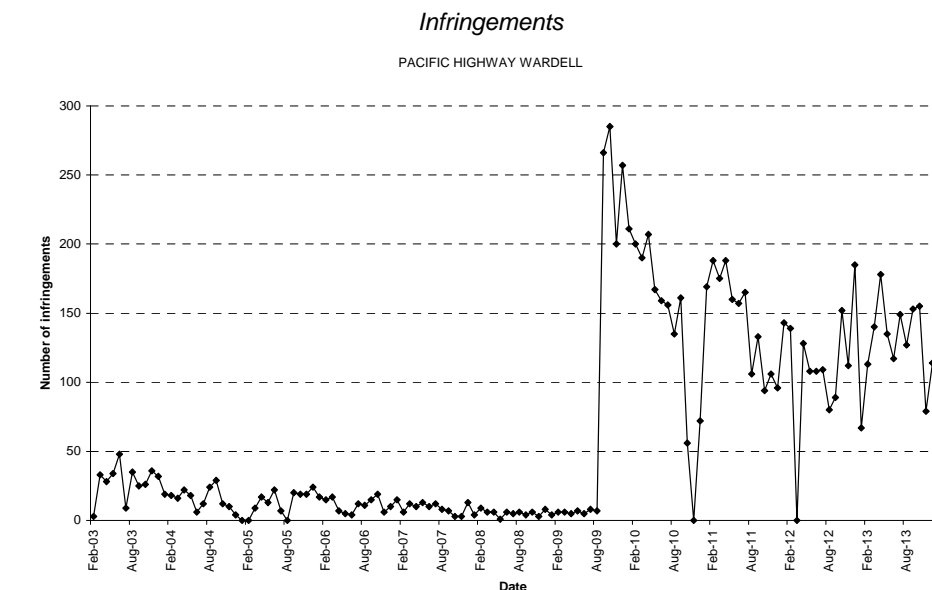
Trend in road safety performance at camera location

- The current pre and post installation analysis shows that crashes have decreased at this location.
- When comparing the pre installation period to the most recent five year period, there has been a 75 per cent reduction in the annual average number of crashes and an 86 per cent reduction in the annual average number of casualties.
- This has been a saving of \$1.38 million in costs to the community.
- The infringement graph details the trend in infringements at this location since the camera began operation. The spike in infringements in September 2009 can be attributed to the speed limit changing from 100km/h to 80km/h. Roadworks and camera maintenance may influence the number of infringements issued.

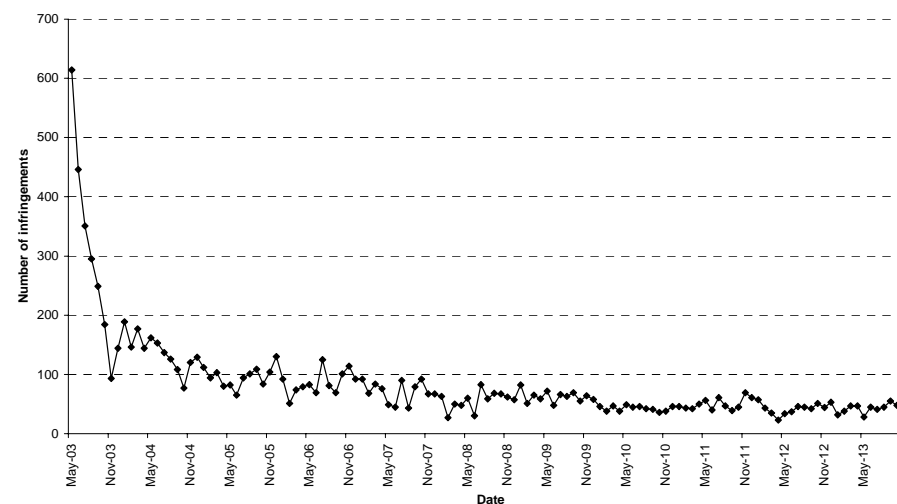
NORTHCLIFFE DRIVE WARRAWONG

Infringements

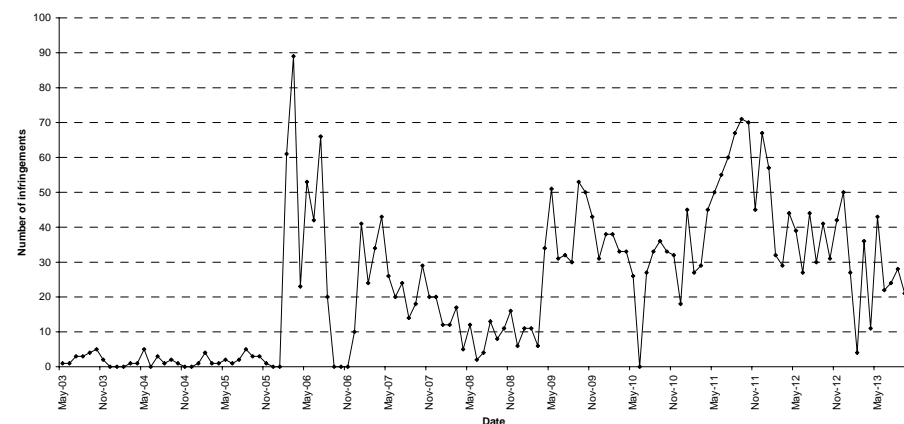
BRUXNER HWY WOLLONGBAR

Infringements

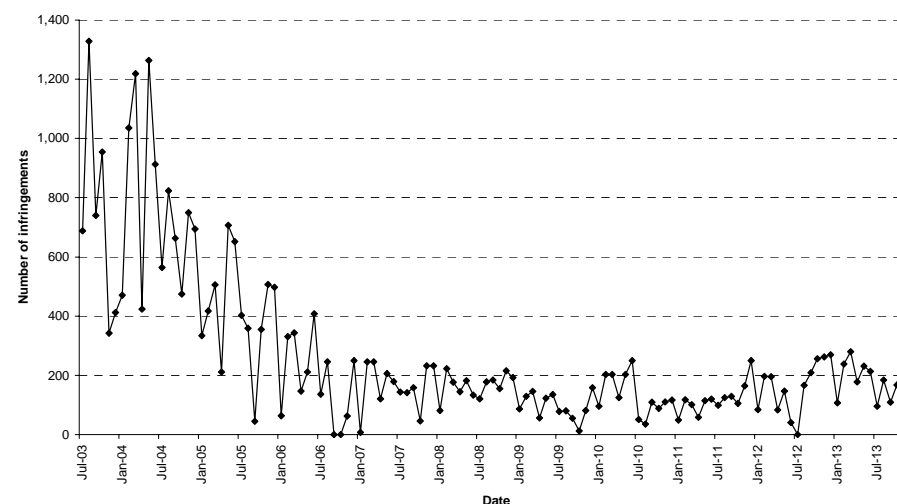
PRINCES HIGHWAY WEST WOLLONGONG

Infringements

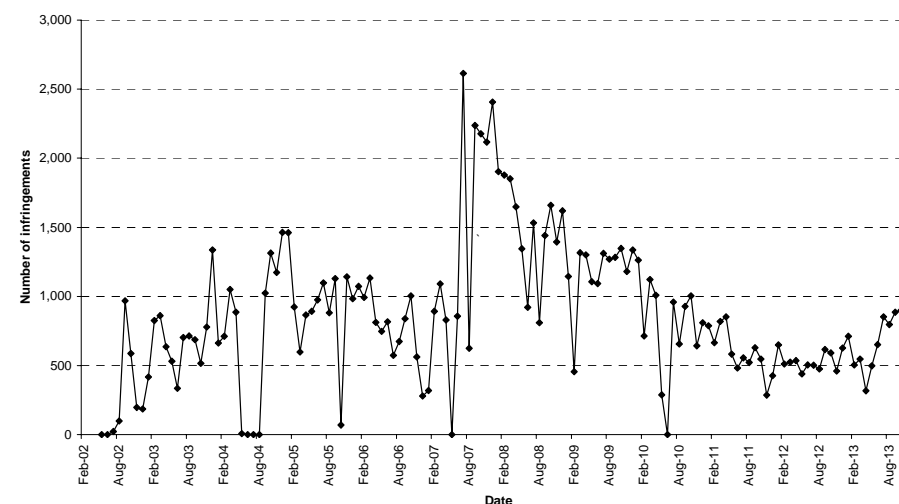
PACIFIC HIGHWAY WOODBURN

Infringements

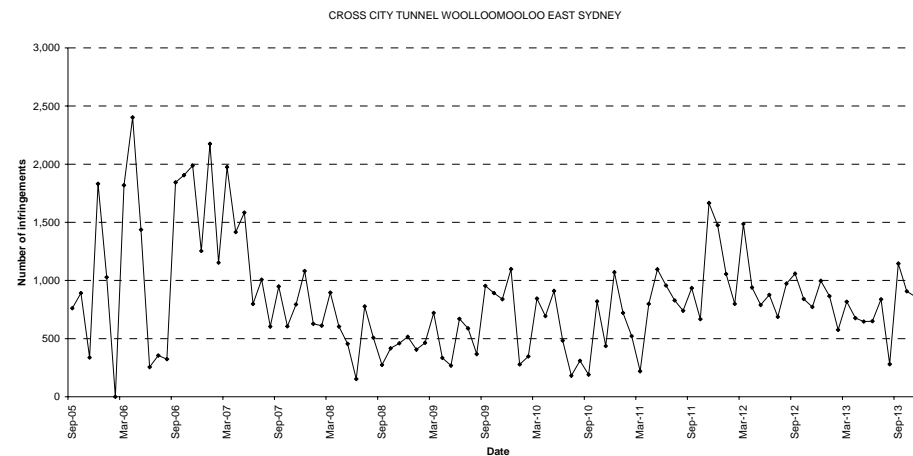
Infringements at fixed speed camera location

- This location is appropriate for fixed speed camera enforcement as it is a high risk location that is difficult for the NSW Police Force to enforce using traditional methods.
- The infringement graph details the trend in infringements at this location since the cameras began operating. Roadworks and camera maintenance may influence the number of infringements issued.

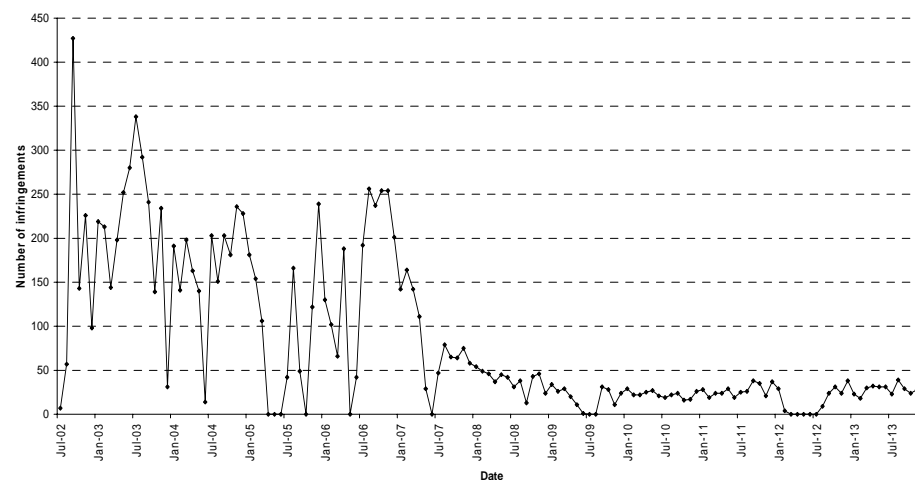
HUME HIGHWAY YAGOONA

Infringements

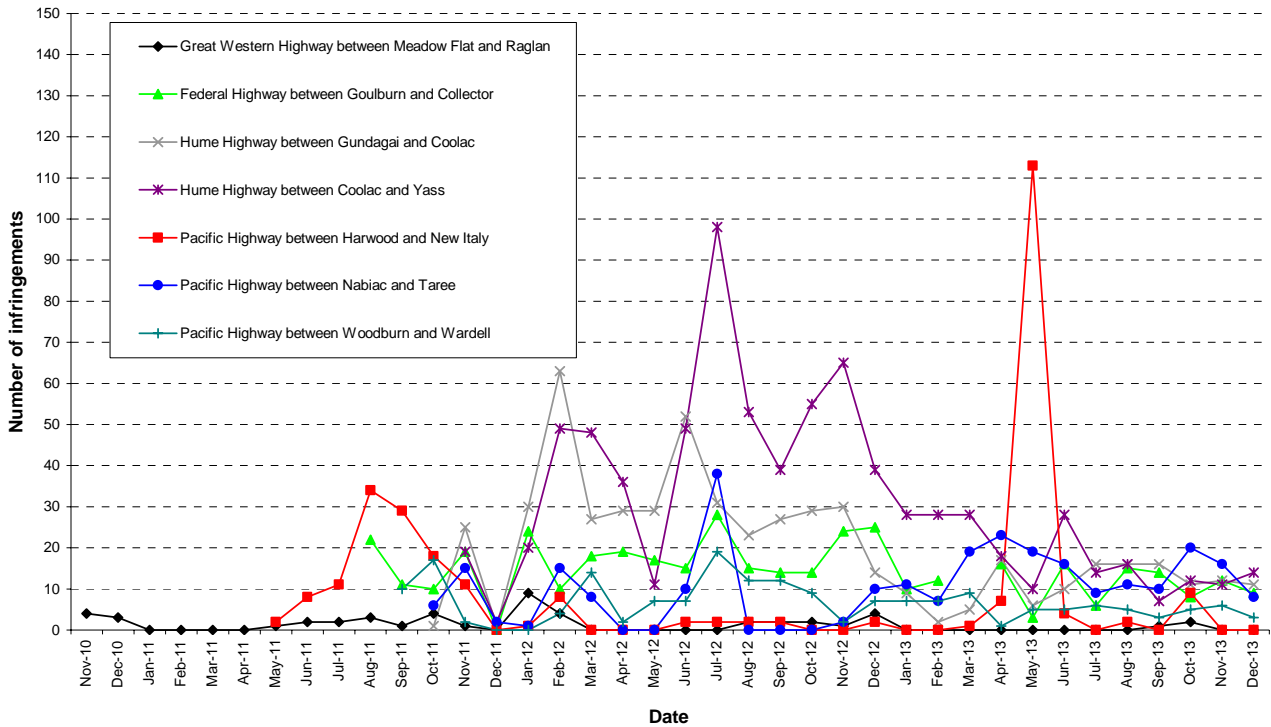
Point-to-point speed infringements to December 2013

The infringement data for these lengths are detailed in the graph below. The low number of infringements issued within each of these lengths shows that there has been a high level of compliance with the speed limit. The graph also shows there has been a reduction in speeding behaviour at these lengths over time. Roadworks and camera maintenance may influence the number of infringements issued.

The spike in infringements at the Pacific Highway between Harwood and New Italy length in May 2013 can be attributed to a reduction in speed limit due to road works that commenced in April 2013. The reduced average speed commenced infringing in May 2013 at this length.

A total of 1,267 speeding infringements were issued resulting in total fines of \$501,776 at point-to-point lengths in 2013.
