Transport  
for NSW

Centre for Road Safety

# Annual NSW Speed Camera Performance Review 2015

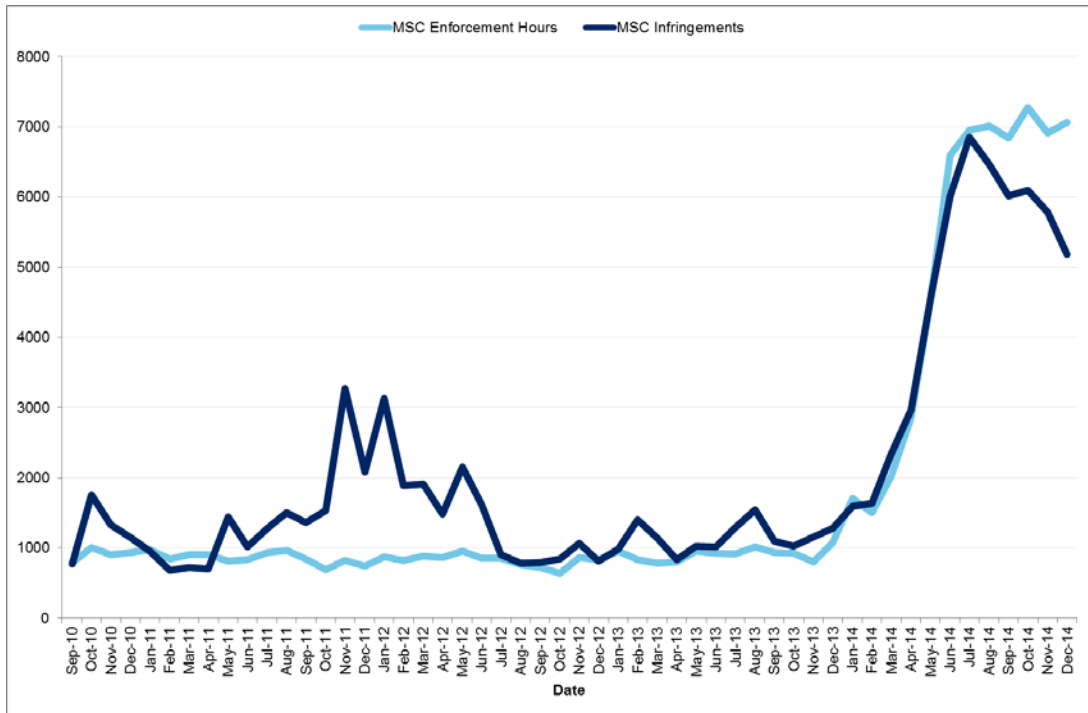
Figure A3: Speeding infringements issued and number of enforcement hours conducted by mobile speed cameras by month

The below graph depicting the mobile speed camera program infringement data and the number of enforcement hours per months shows that in 2014 there was a steady increase in infringements as the amount of enforcement per month increased until July, when the program reached 7,000 hours of enforcement for the month. Since then the number of infringements has decreased each month as motorists have changed their behaviour at the locations where mobile speed cameras enforce.

In 2014 there were a total of 55,467 infringements issued from mobile speed camera enforcement resulting in \$10.54 million of fines. The cost of conducting the mobile speed camera program in 2014 was \$17.4 million. The total number of infringements in 2014 increased four fold compared to 2013, however this increase was lower than expected as the total number of enforcement hours increased more than five fold from 11,106 hours of enforcement in 2013 to 61,256 in 2014.

The significant decrease in infringements from June 2012 can be attributed to the enhanced visibility of mobile speed camera vehicles as well as additional signage being placed before a mobile speed camera to ensure drivers see and recognised the enforcement activity. At the same time, mobile speed cameras also switched from enforcing in both directions to single direction enforcement, further contributing to the lower volume of infringements.
