Transport
for NSW

Centre for Road Safety

Speed Camera Programs: 2016 Annual Review

Author: Centre for Road Safety
Date: March 2017
Version: 1.0
Division: Freight, Strategy and Planning

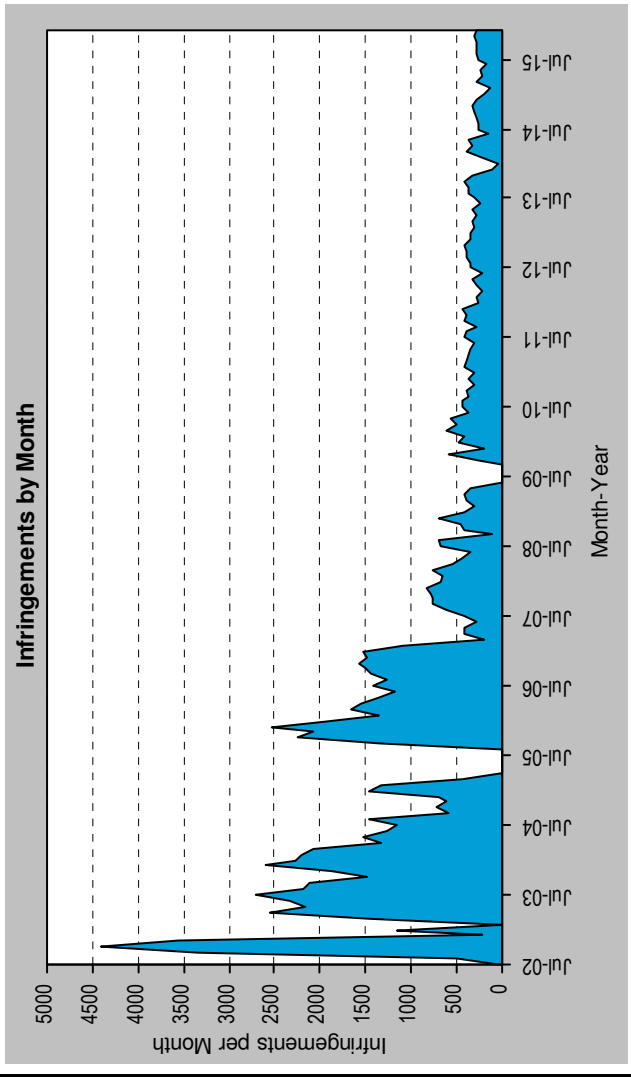
Auburn - Parramatta Road, between Harbord Street and Duck Street

This location is 1000m in length, and is enforced with one camera. The camera commenced operating on 15 May 2002.

• When comparing the pre installation period to the most recent five year period, there has been a 51% decrease in casualty crashes at this fixed speed camera location. The data presented do not account for the prevailing statewide trend.

• The infringement graph details the trend in infringements at this location since July 2002. Infringement data before this date is not available. Roadworks and camera maintenance may influence the number of infringements issued.

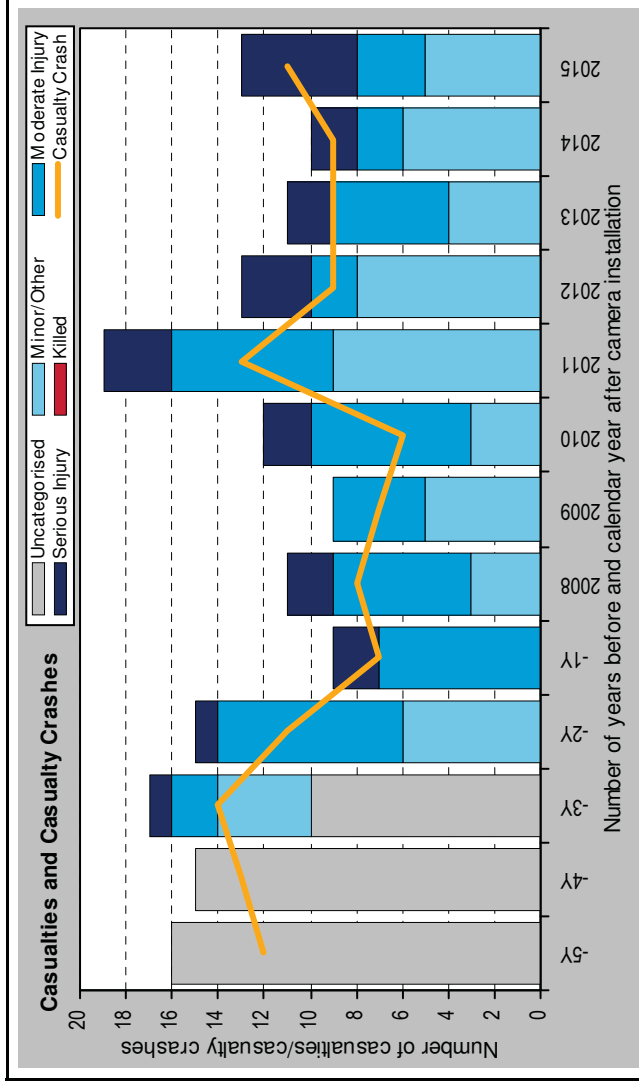
Bankstown - Hume Highway, between Rookwood Road and Stacey Street

• The infringement graph details the trend in infringements at this location since the camera began operating. Roadworks and camera maintenance may influence the number of infringements issued.

• This location was reviewed in 2013 due to concerns about the increase in casualties in recent years. The review found that during 2011 there were 28 casualties. This significant increase in the number of casualties included one crash involving a bus, resulting in 11 casualties. The number of casualty crashes has reduced in the following years. Speeding infringements were also found to have significantly reduced following the introduction of the speed cameras. It was recommended that the speed cameras be retained.

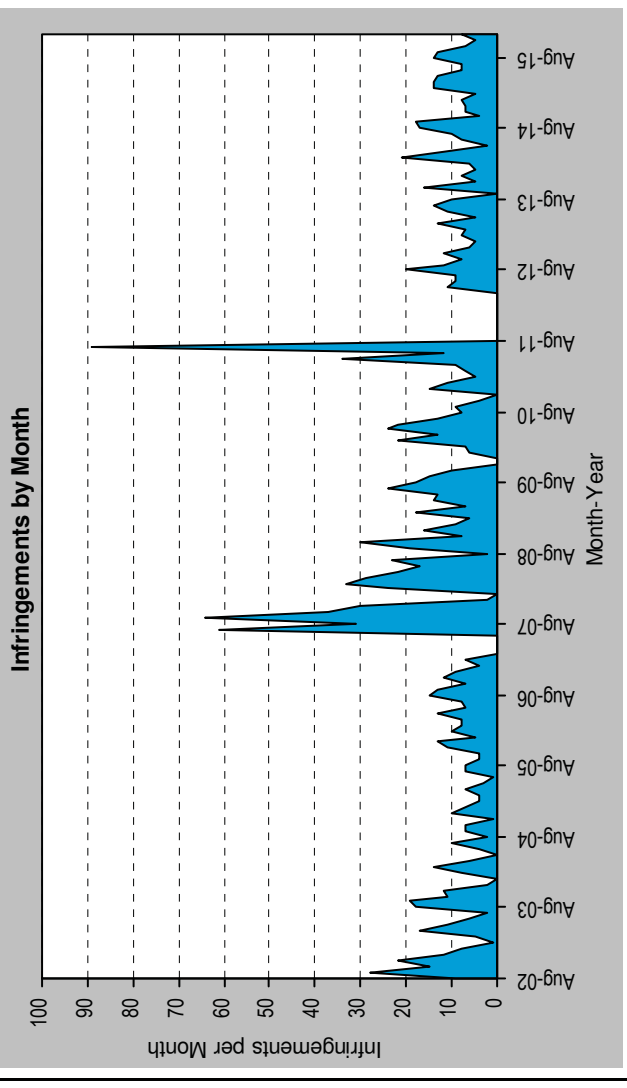
Berkshire Park - Richmond Road, between Liandilo Road and Sanctuary Drive

This location is 1000m in length, and is enforced with one camera. The camera commenced operating on 30 June 2000.

(There has been an increase in casualty crashes at this location, but the increase is not statistically significant. This location has previously been reviewed.)

- When comparing the pre installation period to the most recent five year period, there has been a 17% increase in casualty crashes at this fixed speed camera location. The increase in casualty crashes is not statistically significant. The data presented do not account for the prevailing statewide trend.
- The infringement graph details the trend in infringements at this location since July 2002. Infringement data before this date is not available. Roadworks and camera maintenance may influence the number of infringements issued.
- This location was reviewed in 2014. The safety review found that the speed camera continues to provide safety benefits and it was recommended that the speed camera be retained.

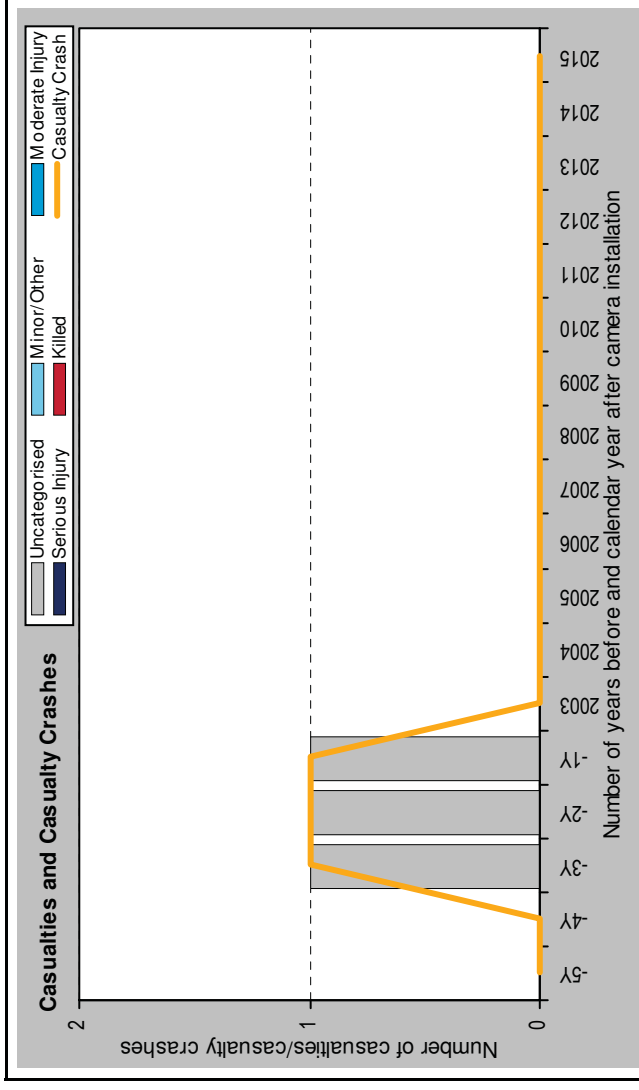
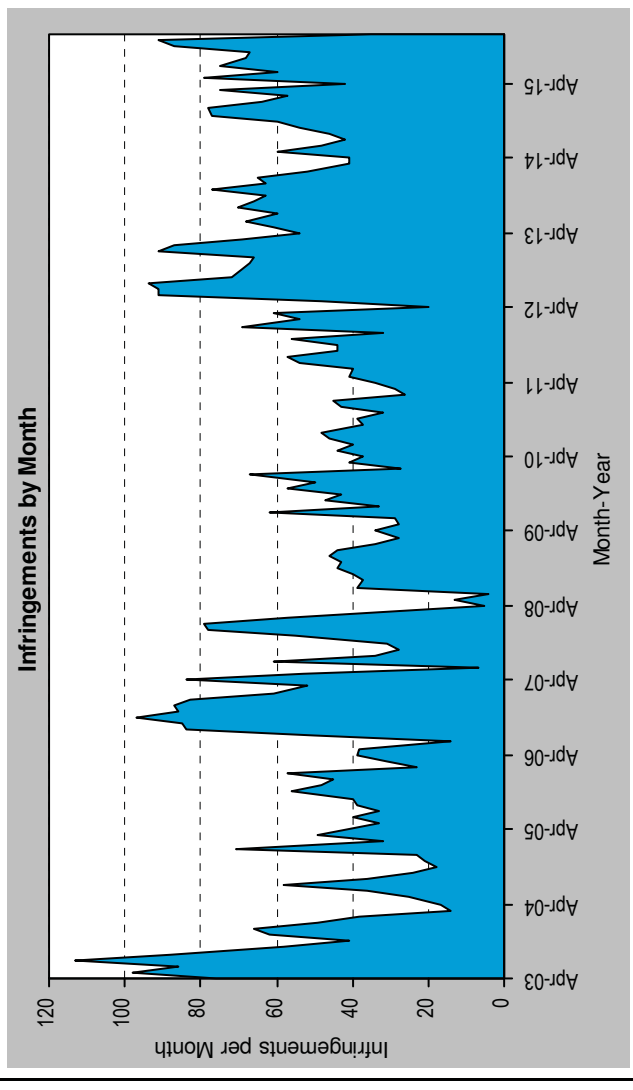
Blandford - New England Highway, between Hayles Street and Mills Street

This location is 1000m in length, and is enforced with one camera. The camera commenced operating on 10 April 2002.

• When comparing the pre installation period to the most recent five year period, there has been a 100% decrease in casualty crashes at this fixed speed camera location. The data presented do not account for the prevailing statewide trend.

• The infringement graph details the trend in infringements at this location since July 2002. Infringement data before this date is not available. Roadworks and camera maintenance may influence the number of infringements issued.

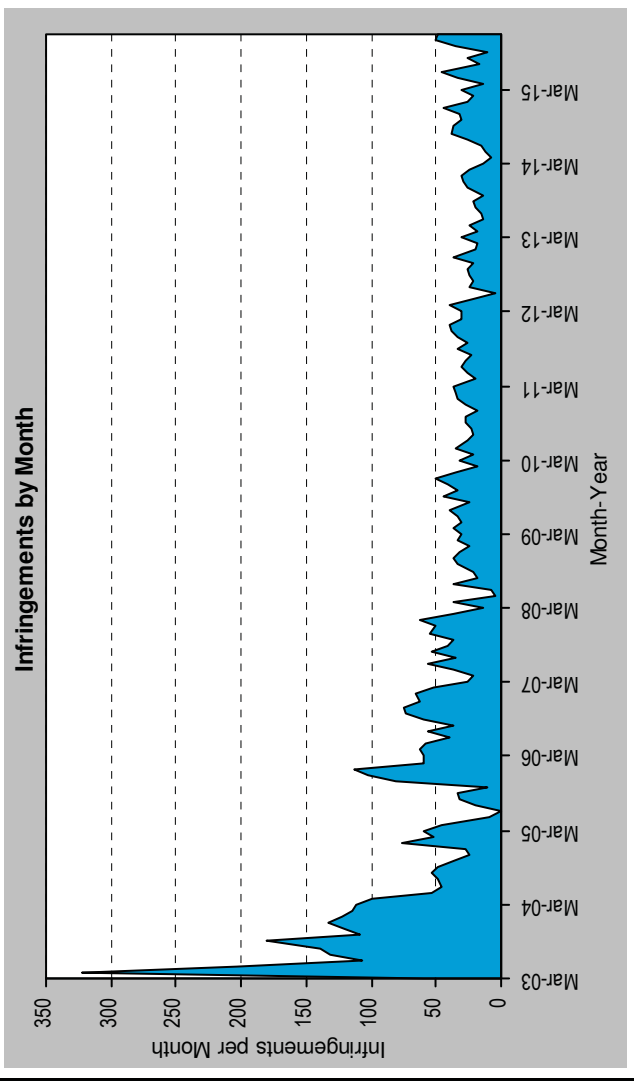
Bomaderry - Bolong Road, between Beinda Street and Coomea Street

This location is 1000m in length, and is enforced with one camera. The camera commenced operating on 31 March 2003.

• When comparing the pre installation period to the most recent five year period, there has been a 129% increase in casualty crashes at this fixed speed camera location. The increase in casualty crashes is statistically significant. The data presented do not account for the prevailing statewide trend.

• The infringement graph details the trend in infringements at this location since the camera began operating. Roadworks and camera maintenance may influence the number of infringements issued.

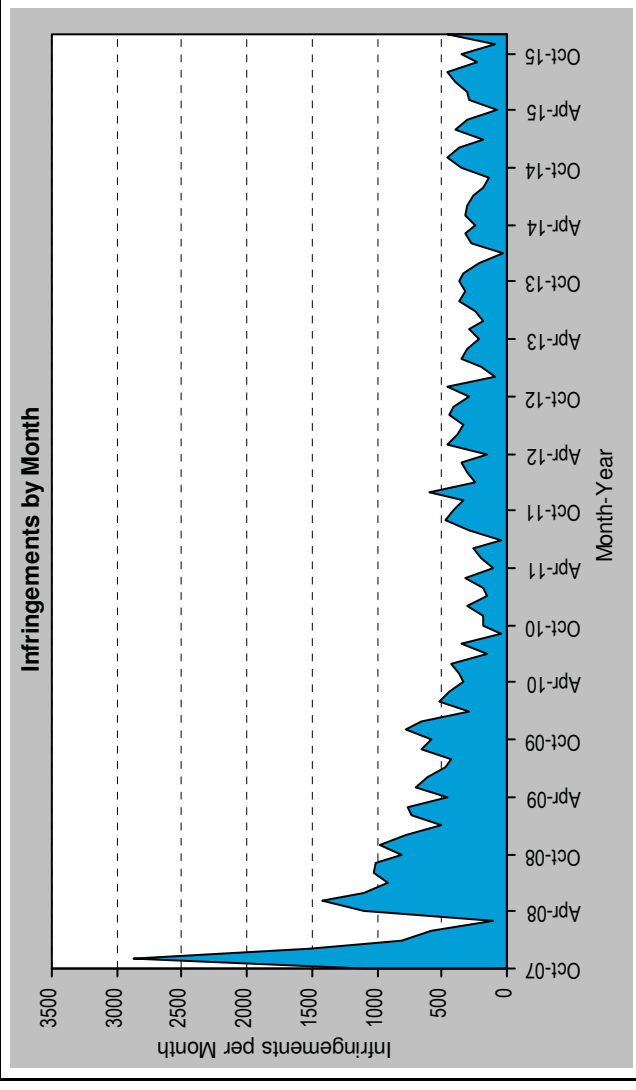
Bonnyrigg - Cabramatta Road, between Katinka Street and Tarlington Parade

• When comparing the pre installation period to the most recent five year period, there has been a 4% decrease in casualty crashes at this fixed speed camera location. The data presented do not account for the prevailing statewide trend.

• The infringement graph details the trend in infringements at this location since the camera began operating. Roadworks and camera maintenance may influence the number of infringements issued.

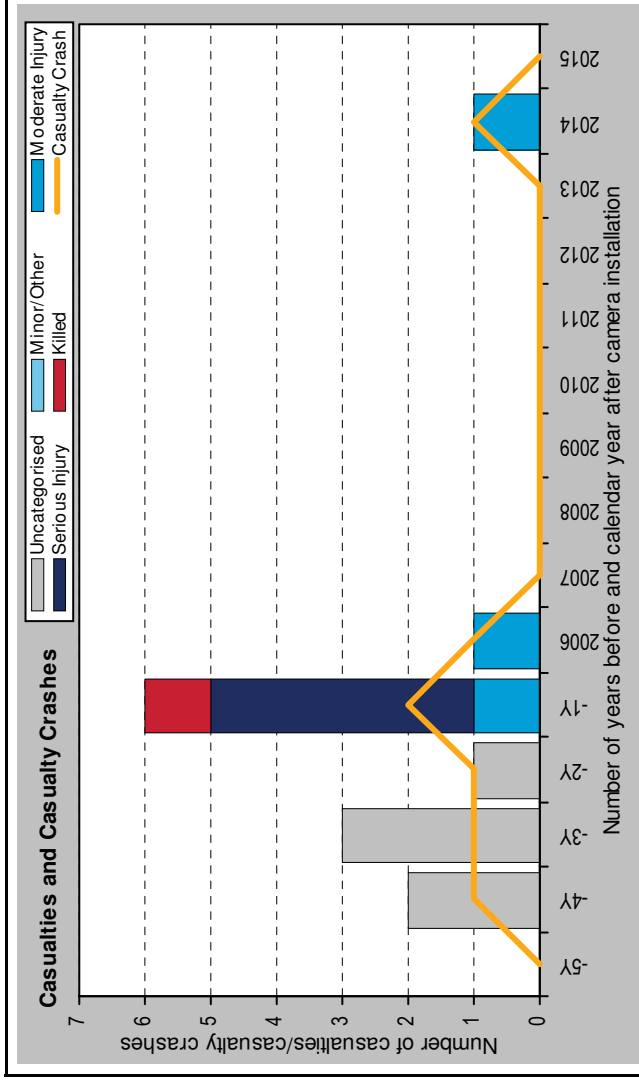
Bonville - Pine Creek Way, between Bonville Creek and Bonville Station Road

This location is 1000m in length, and is enforced with one camera. The camera commenced operating on 16 December 2005.

• The infringement graph details the trend in infringements at this location since the camera began operating. Roadworks and camera maintenance may influence the number of infringements issued.

• This camera was in operation for all of 2015, but was decommissioned in early 2016 as result of the 2015 annual speed camera review.

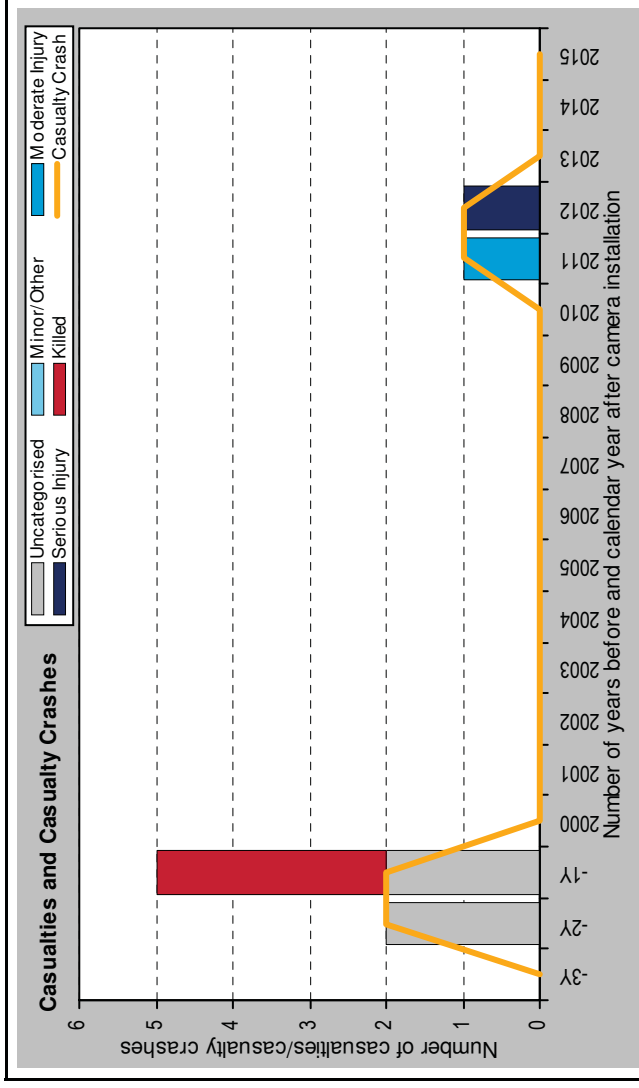
Burringbar - Tweed Valley Way, between Blakeney Road and Cooradilla Road

This location is 1000m in length, and is enforced with one camera. The camera commenced operating on 2 April 1999.

(There is currently a review underway at this location.)

- When comparing the pre installation period to the most recent five year period, there has been a 70% decrease in casualty crashes at this fixed speed camera location. The data presented do not account for the prevailing statewide trend.
- The infringement graph details the trend in infringements at this location since July 2002. Infringement data before this date is not available. Roadworks and camera maintenance may influence the number of infringements issued.
- This camera is located on a section of road that was formerly the Pacific Highway, that has been bypassed. While there is a low level of speeding infringements at this location, the review will help determine whether there are road safety risks that require ongoing speed enforcement at this location.

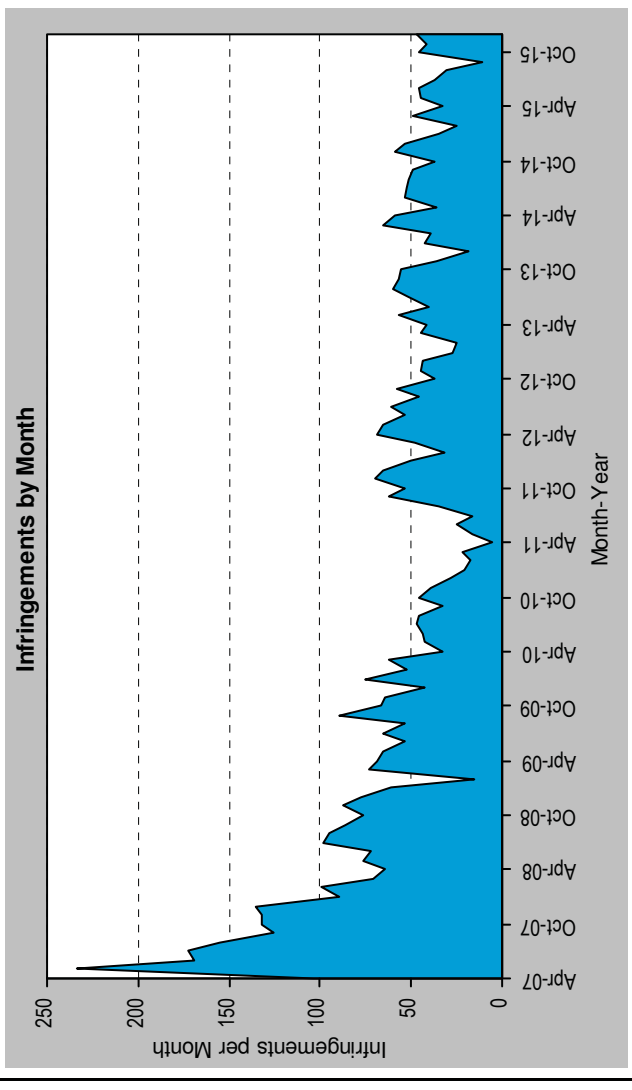
Charmhaven - Pacific Highway, between Wallarah Creek and Lowana Avenue

• When comparing the pre installation period to the most recent five year period, there has been a 39% decrease in casualty crashes at this fixed speed camera location. The data presented do not account for the prevailing statewide trend.

• The infringement graph details the trend in infringements at this location since the camera began operating. Roadworks and camera maintenance may influence the number of infringements issued.

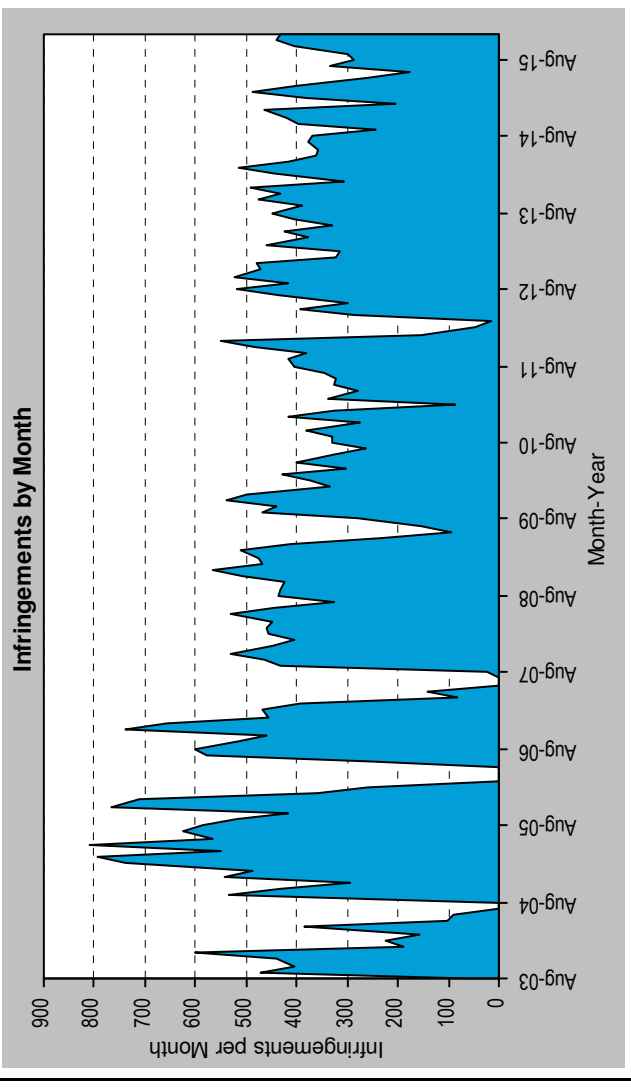
Gateshead - Pacific Highway, between Sydney Street and Macquarie Avenue

• When comparing the pre installation period to the most recent five year period, there has been a 60% decrease in casualty crashes at this fixed speed camera location. The data presented do not account for the prevailing statewide trend.

• The infringement graph details the trend in infringements at this location since July 2002. Infringement data before this date is not available. Roadworks and camera maintenance may influence the number of infringements issued.

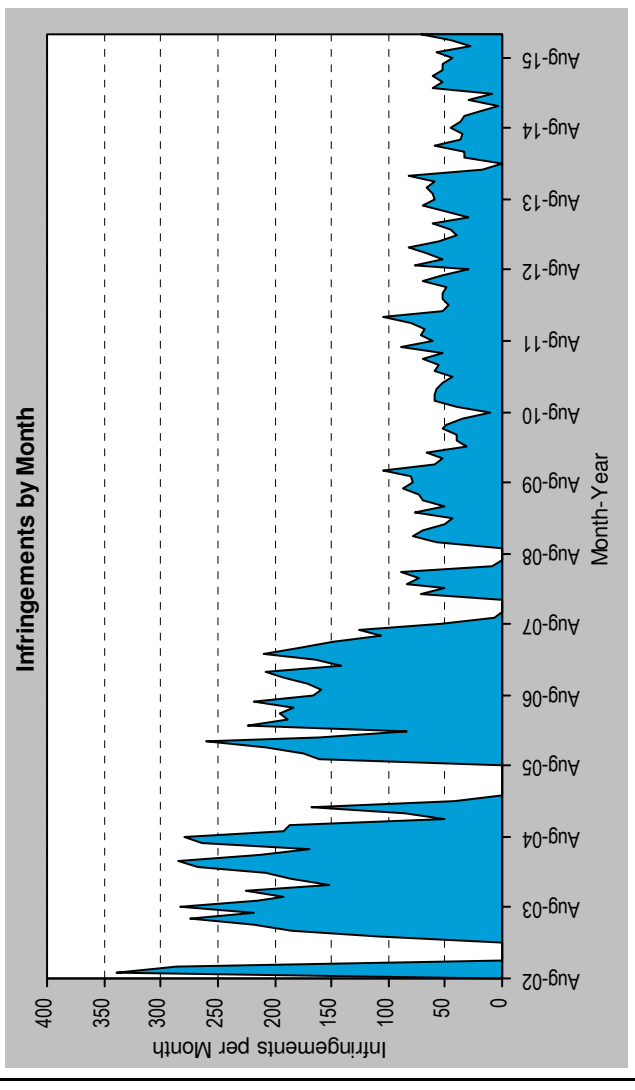
Greystanes - Greystanes Road, between Merrylands Road and Old Prospect Road

• When comparing the pre installation period to the most recent five year period, there has been a 46% decrease in casualty crashes at this fixed speed camera location. The data presented do not account for the prevailing statewide trend.

• The infringement graph details the trend in infringements at this location since July 2002. Infringement data before this date is not available. Roadworks and camera maintenance may influence the number of infringements issued.

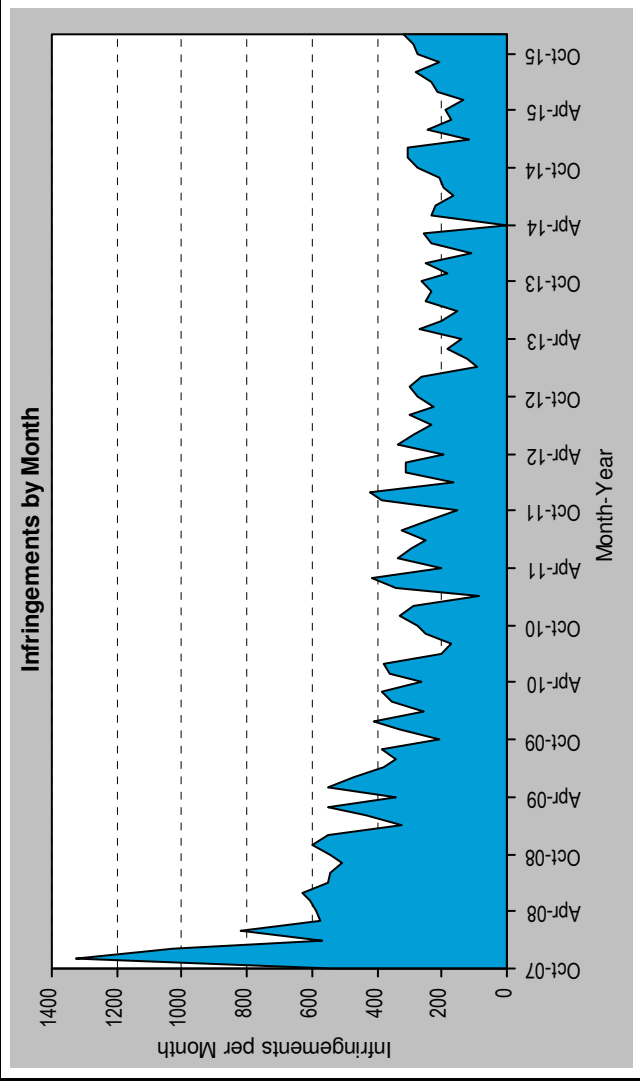
• When comparing the pre installation period to the most recent five year period, there has been a 6% decrease in casualty crashes at this fixed speed camera location. The data presented do not account for the prevailing statewide trend.

• The infringement graph details the trend in infringements at this location since the camera began operating. Roadworks and camera maintenance may influence the number of infringements issued.

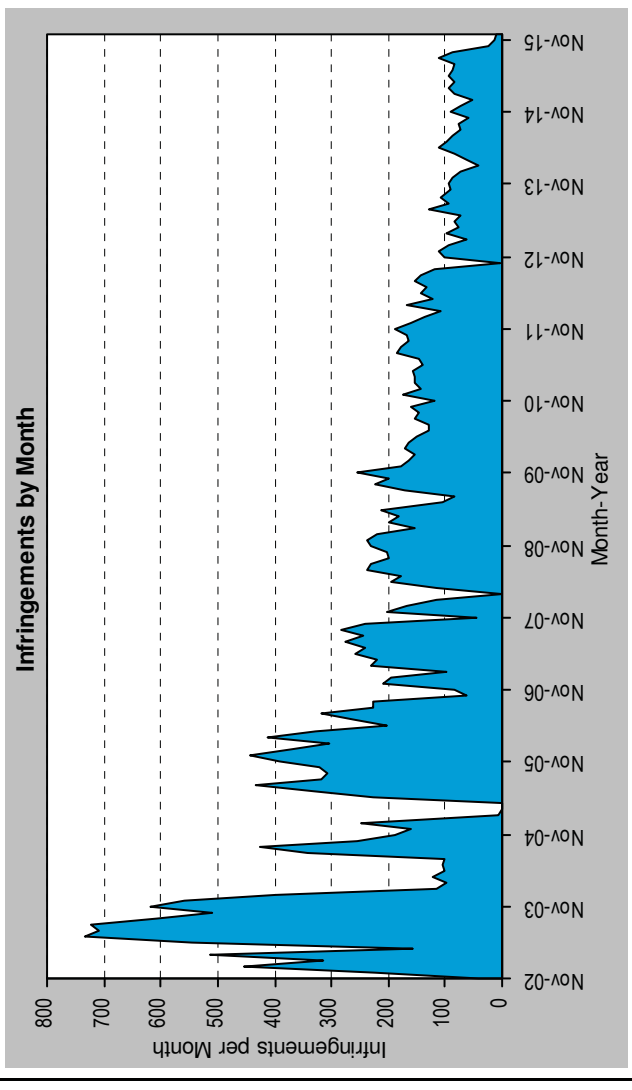
• When comparing the pre installation period to the most recent five year period, there has been a 21% decrease in casualty crashes at this fixed speed camera location. The data presented do not account for the prevailing statewide trend.

• The infringement graph details the trend in infringements at this location since the camera began operating. Roadworks and camera maintenance may influence the number of infringements issued.

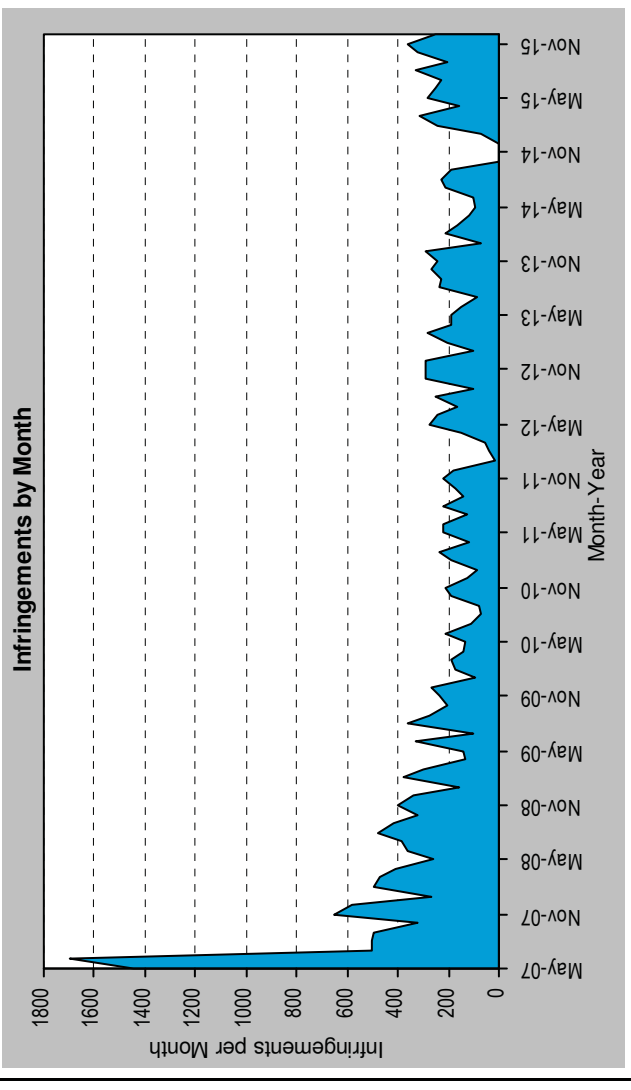
• When comparing the pre installation period to the most recent five year period, there has been a 40% decrease in casualty crashes at this fixed speed camera location. The data presented do not account for the prevailing statewide trend.

• The infringement graph details the trend in infringements at this location since the camera began operating. Roadworks and camera maintenance may influence the number of infringements issued.

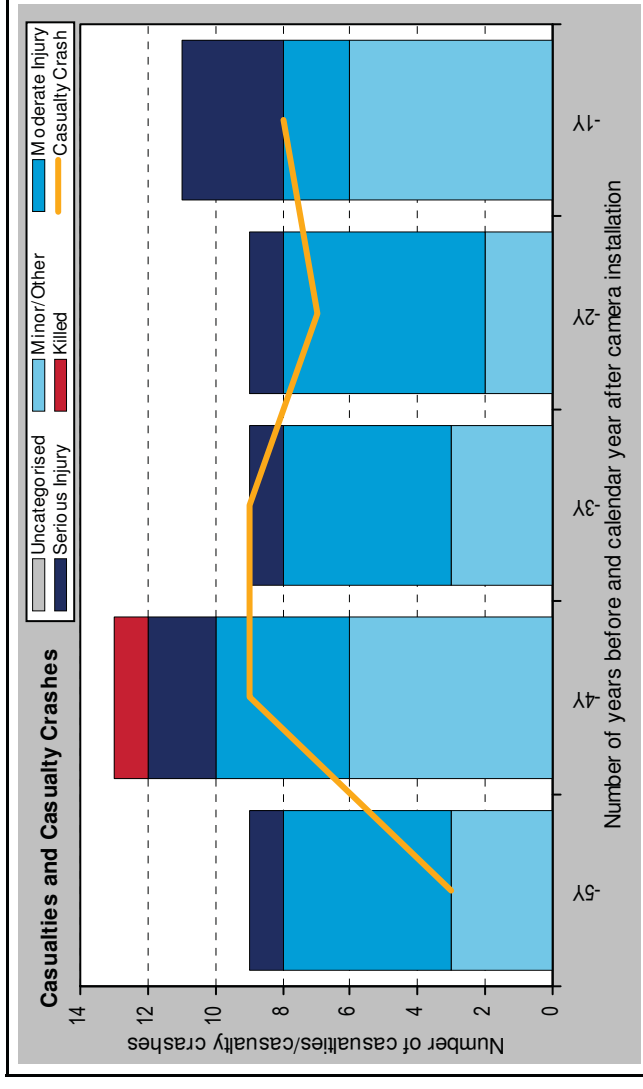
Status : [Insufficient data](#)

- CRS will develop further commentary when there is additional data available for this location in the future.
- The infringement graph details the trend in infringements at this location since the camera began operating. Roadworks and camera maintenance may influence the number of infringements issued.

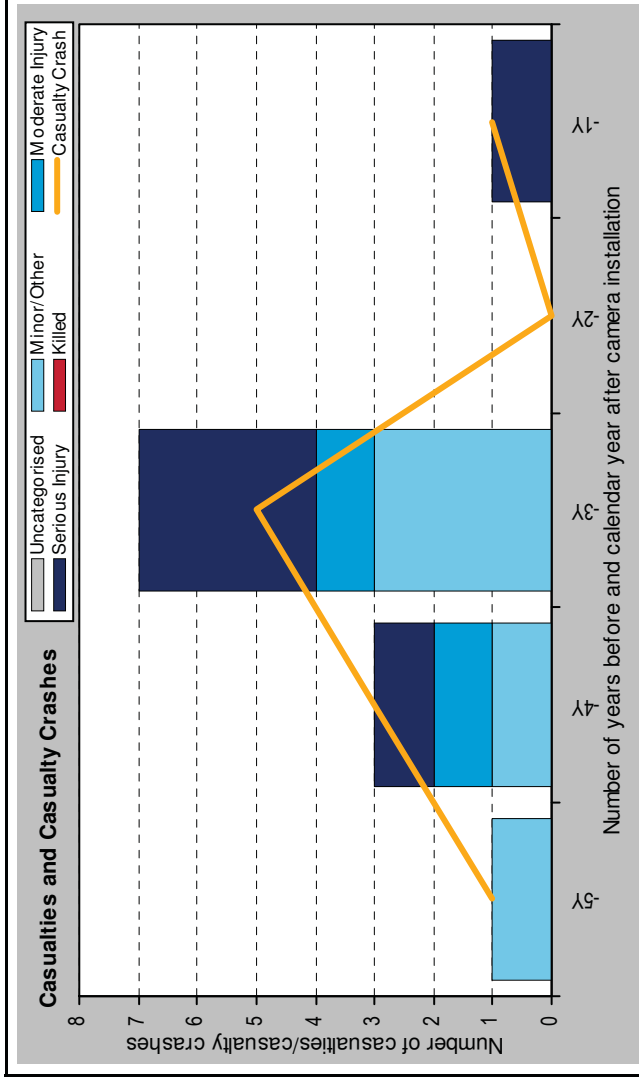
North Macksville - Pacific Highway, North Macksville

- CRS will develop further commentary when there is additional data available for this location in the future.
- The infringement graph details the trend in infringements at this location since the camera began operating. Roadworks and camera maintenance may influence the number of infringements issued.

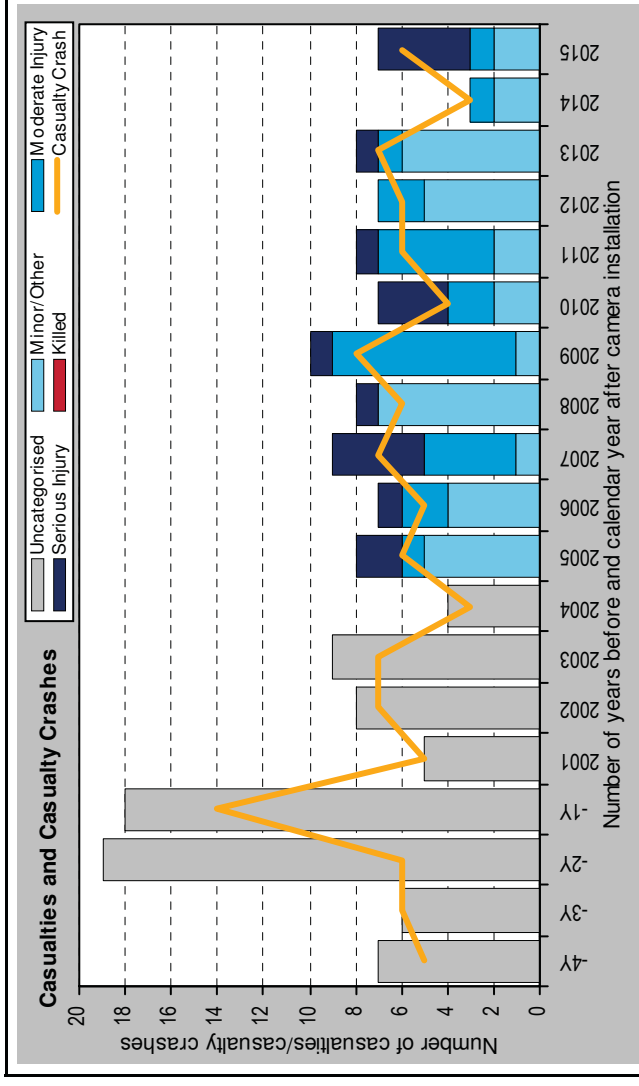
North Wollongong - Princes Highway, between Ajax Avenue and Exeter Avenue

• When comparing the pre installation period to the most recent five year period, there has been a 28% decrease in casualty crashes at this fixed speed camera location. The data presented do not account for the prevailing statewide trend.

• The infringement graph details the trend in infringements at this location since July 2002. Infringement data before this date is not available. Roadworks and camera maintenance may influence the number of infringements issued.

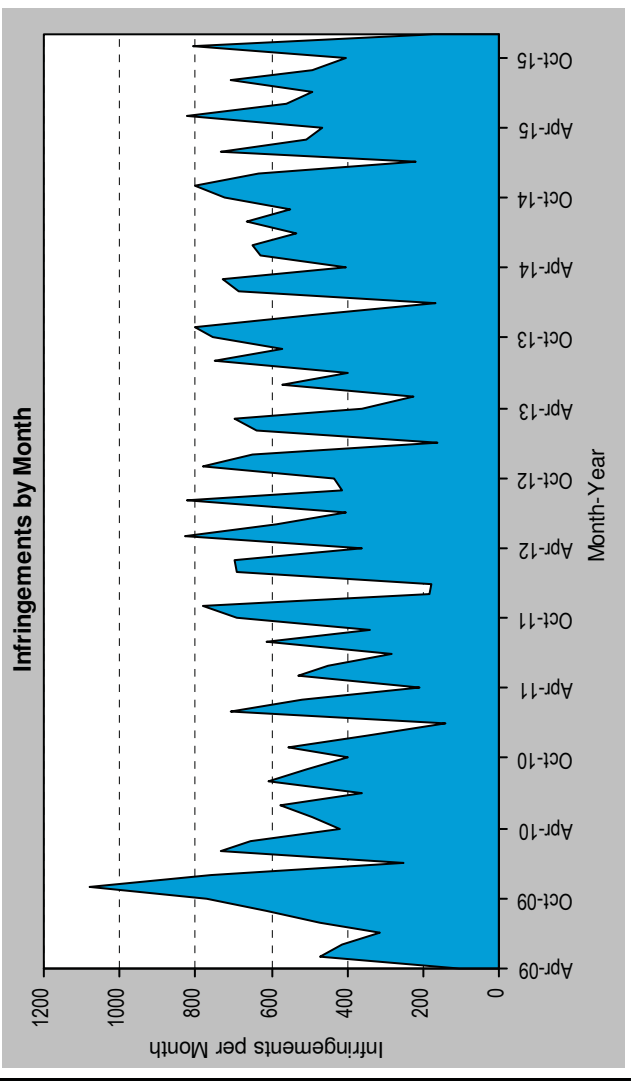
Old Guildford - Woodville Road, between Orchardleigh Street and Middleton Road

• When comparing the pre installation period to the most recent five year period, there has been a 53% decrease in casualty crashes at this fixed speed camera location. The data presented do not account for the prevailing statewide trend.

• The infringement graph details the trend in infringements at this location since the camera began operating. Roadworks and camera maintenance may influence the number of infringements issued.

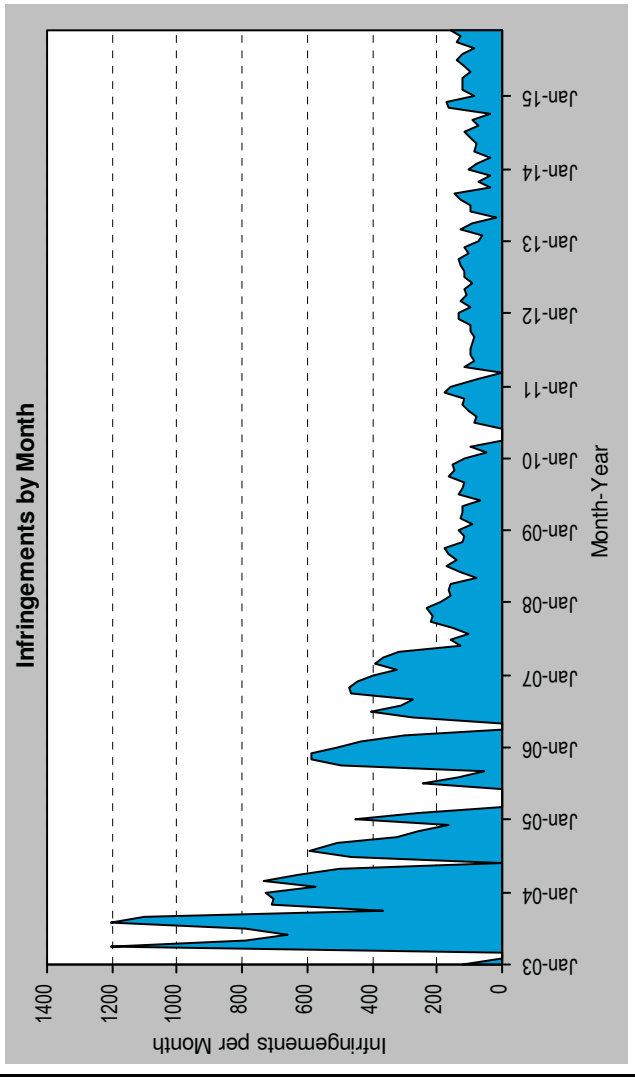
Peakhurst - Henry Lawson Drive, between Belmont Road and Ogilvy Street

• When comparing the pre installation period to the most recent five year period, there has been an 18% decrease in casualty crashes at this fixed speed camera location. The data presented do not account for the prevailing statewide trend.

• The infringement graph details the trend in infringements at this location since the camera began operating. Roadworks and camera maintenance may influence the number of infringements issued.

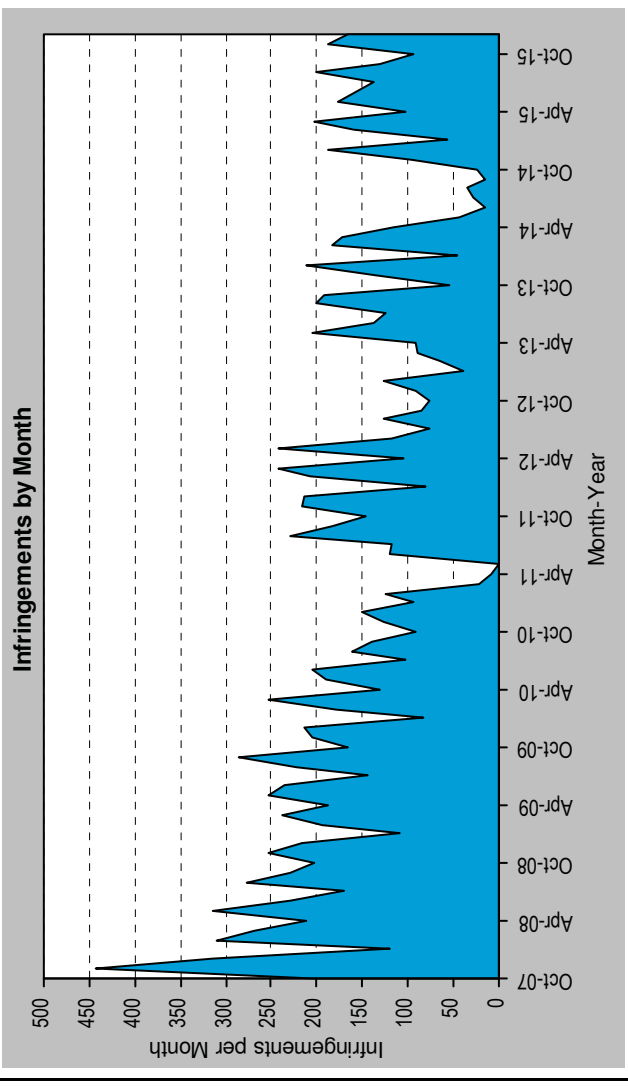
Penshurst - Forest Road, between Penshurst Street and St Georges Street

• When comparing the pre installation period to the most recent five year period, there has been a 35% decrease in casualty crashes at this fixed speed camera location. The data presented do not account for the prevailing statewide trend.

• The infringement graph details the trend in infringements at this location since the camera began operating. Roadworks and camera maintenance may influence the number of infringements issued.

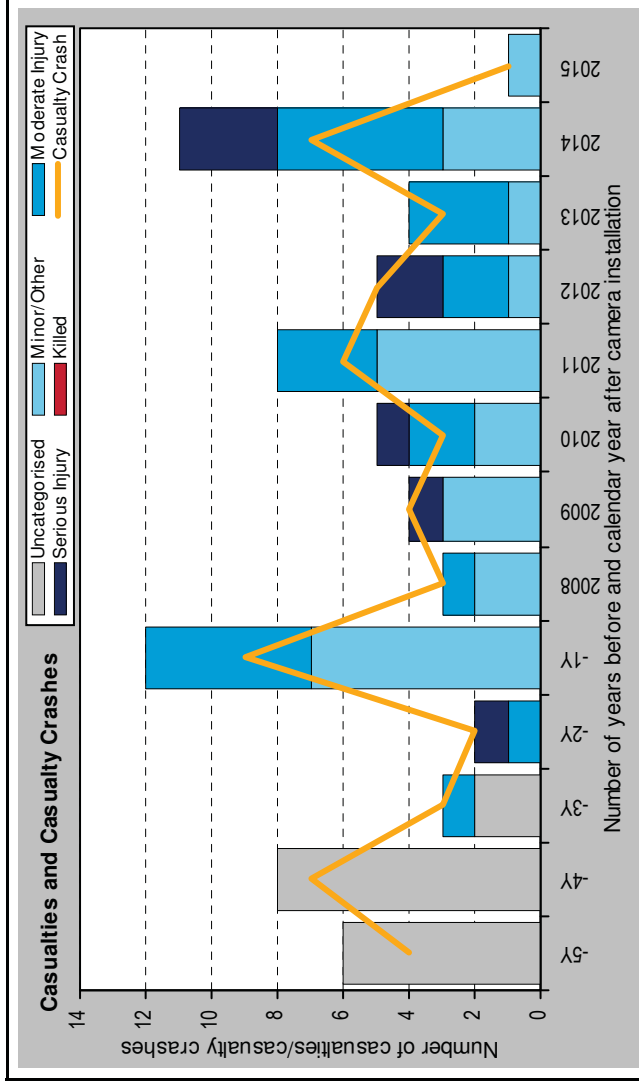
Randwick - Avoca Street, between Howard Street and Barker Road

- When comparing the pre installation period to the most recent five year period, there has been an 8% decrease in casualty crashes at this fixed speed camera location. The data presented do not account for the prevailing statewide trend.
- The infringement graph details the trend in infringements at this location since the camera began operating. Roadworks and camera maintenance may influence the number of infringements issued.

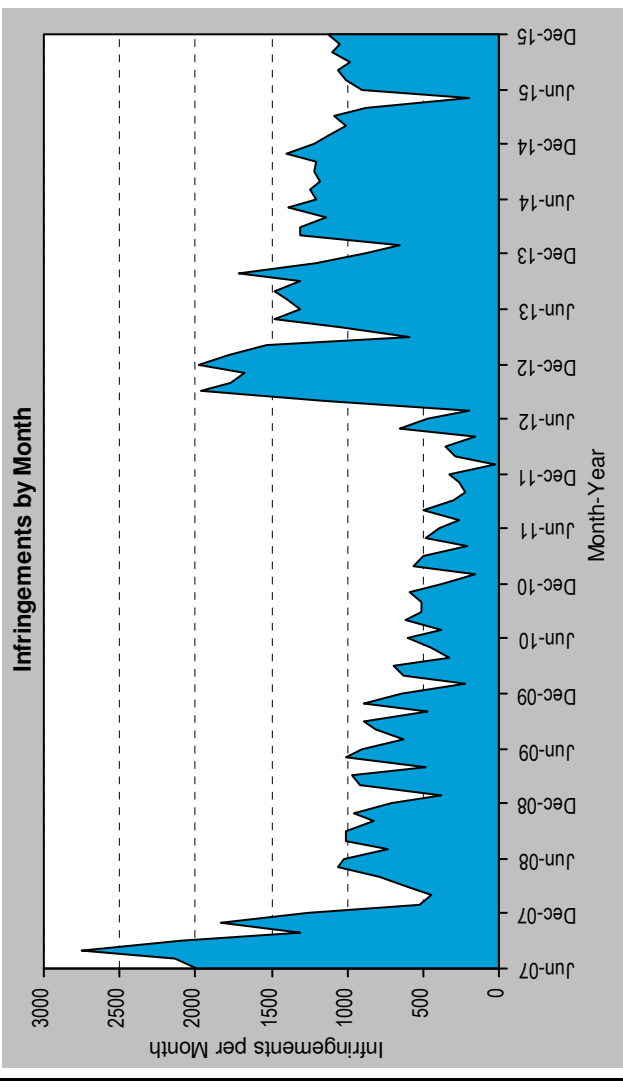
Rosebery/Alexandria - Botany Road, between Gardeners Road and Gillespie Street

• When comparing the pre installation period to the most recent five year period, there has been a 6% decrease in casualty crashes at this fixed speed camera location. The data presented do not account for the prevailing statewide trend.

• The infringement graph details the trend in infringements at this location since the camera began operating. The spike in infringements after July 2012 can be attributed to a change in speed limit from 60km/h to 50km/h. Roadworks and camera maintenance may influence the number of infringements issued.

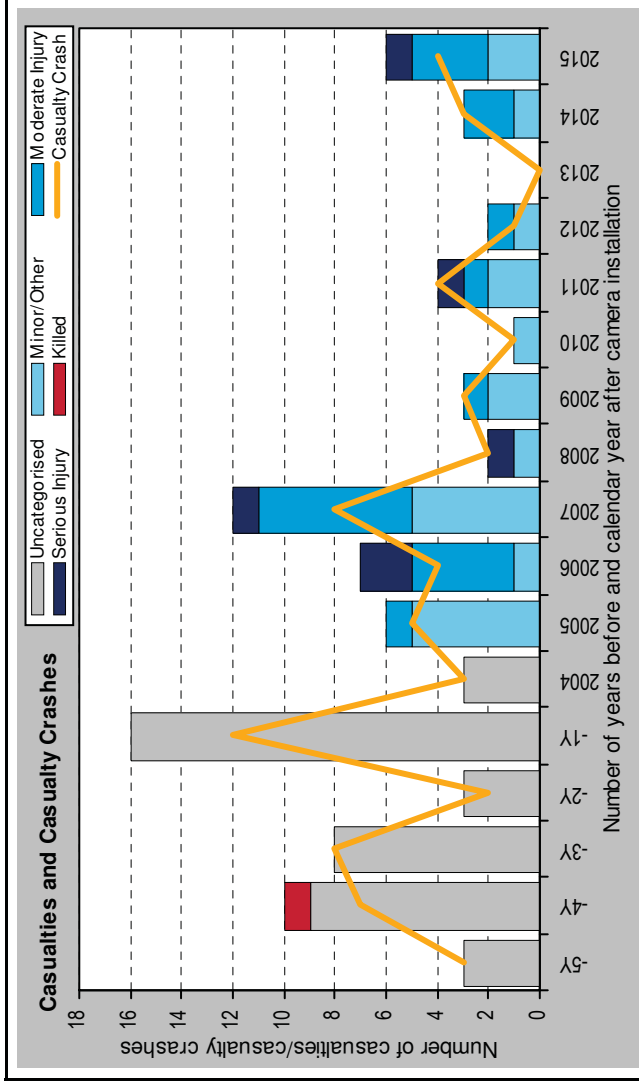
- The infringement graph details the trend in infringements at this location since the camera began operating. The extended period of camera downtime from December 2010 to June 2012 was due to road works. The subsequent spike in infringements in June 2012 may be attributed to a change in speed limit as the area became a school zone in March 2012. Roadworks and camera maintenance may influence the number of infringements issued.

- In 2014, major road safety and traffic works commenced at this location. The camera and accompanying signage has been removed. The location will be reviewed now that works are complete and a final decision will be made about the need for ongoing enforcement.

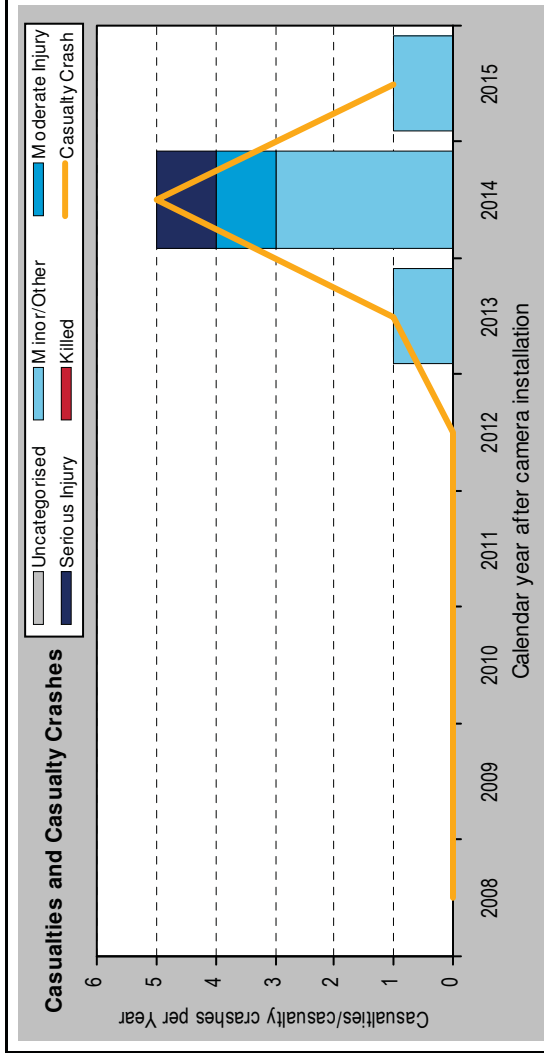
Camera 1 Eastbound

- In the eastbound direction, there was 1 casualty crash in the 2015 data. This resulted in 1 minor injury.
- In the westbound direction, there were 2 casualty crashes in the 2015 data. This resulted in 1 moderate injury, and 1 minor injury.
- The infringement graphs show the number of infringements issued at this location by direction, as well as the trend in infringements. Roadworks and camera maintenance may influence the number of infringements issued.

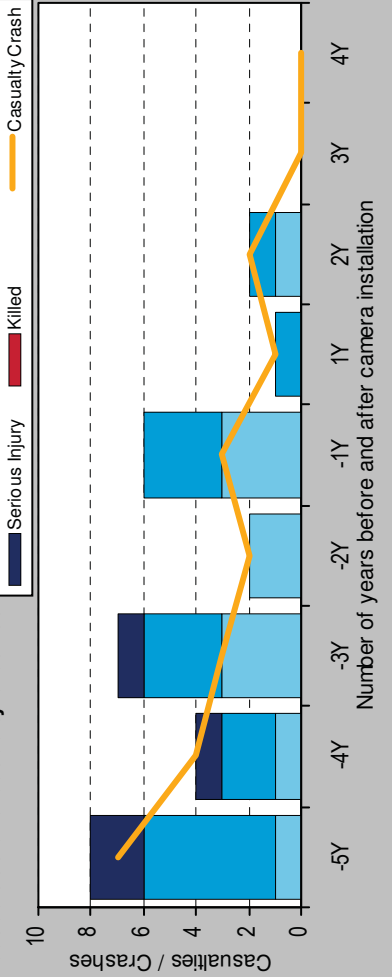
Casualties and Casualty Crashes

³ The percentage change is based on annualised crash data to allow for a direct comparison between the pre and post installation time periods. Red values indicate an increase.

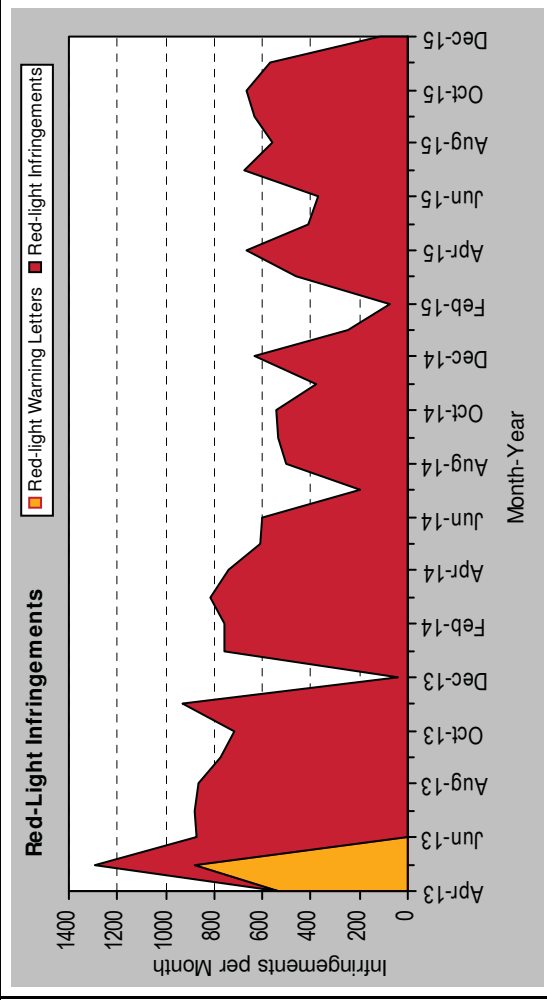
Infringements at enforced intersection

Speeding Infringements

Casualties and Casualty Crashes

Status: Insufficient data (<5 years) to reliably assess.

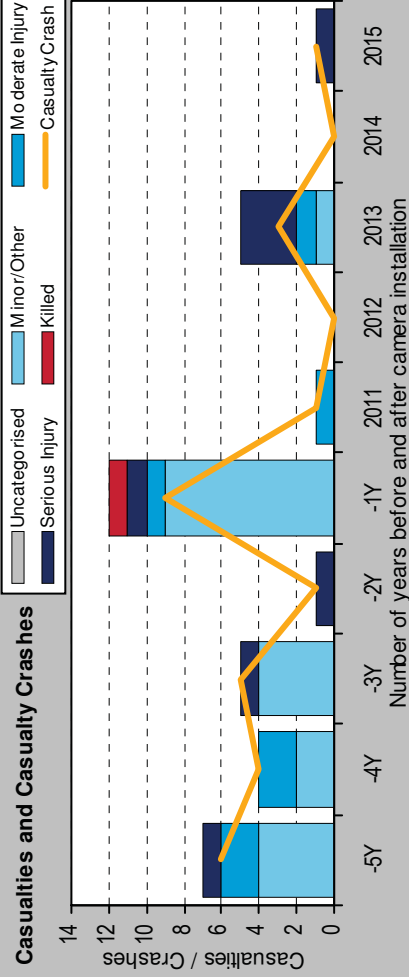
Infringements at enforced intersection

Speeding Infringements

Casualties and Casualty Crashes

Status: Retain.
