Transport
for NSW

Centre for Road Safety

Speed Camera Programs: 2016 Annual Review

Author: Centre for Road Safety
Date: March 2017
Version: 1.0
Division: Freight, Strategy and Planning

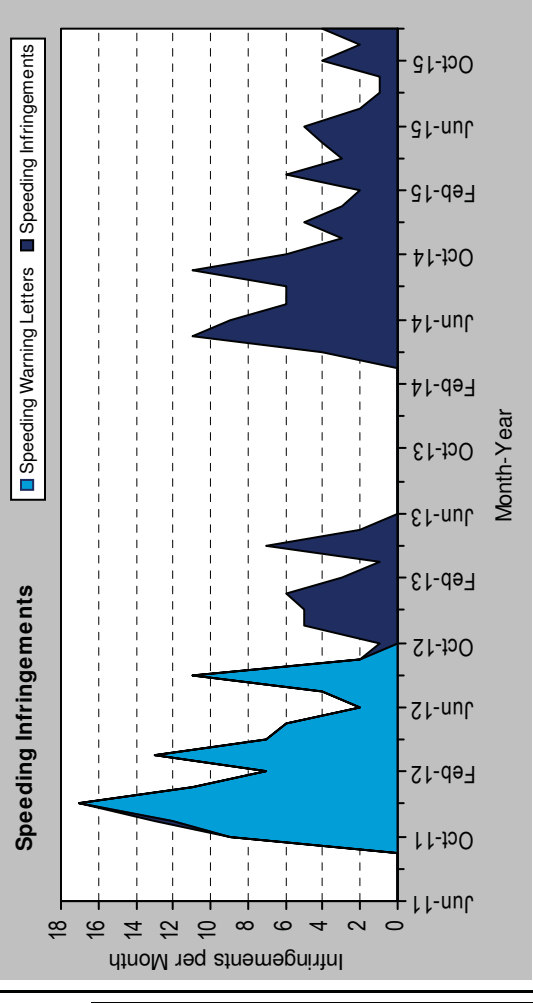
Infringements at enforced intersection

Speeding Infringements

Casualties and Casualty Crashes

Status: Insufficient data (<5 years) to reliably assess.

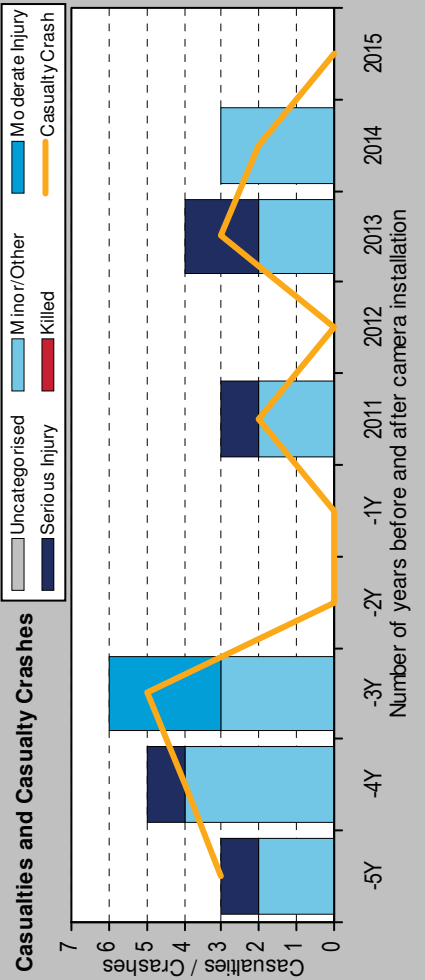
Infringements at enforced intersection

Speeding Infringements

Casualties and Casualty Crashes

Status: Retain and Monitor. The previous wet-film red light camera may have influenced the before period data. Annual traffic counts have increased at this location.

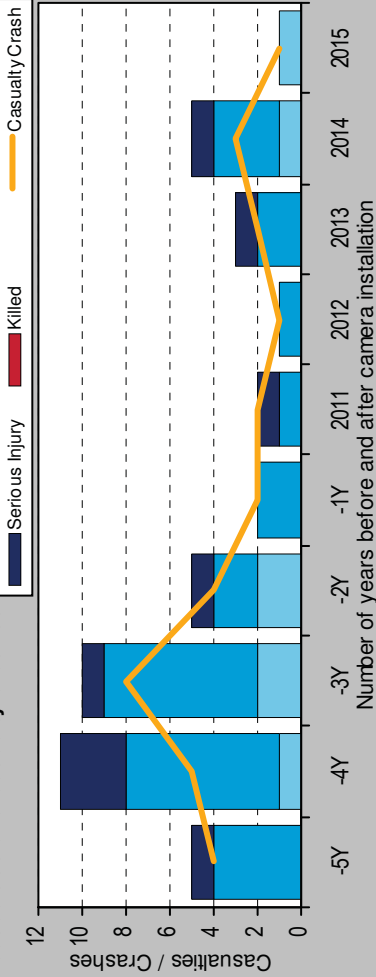
Casualties and Casualty Crashes

Status: Retain.

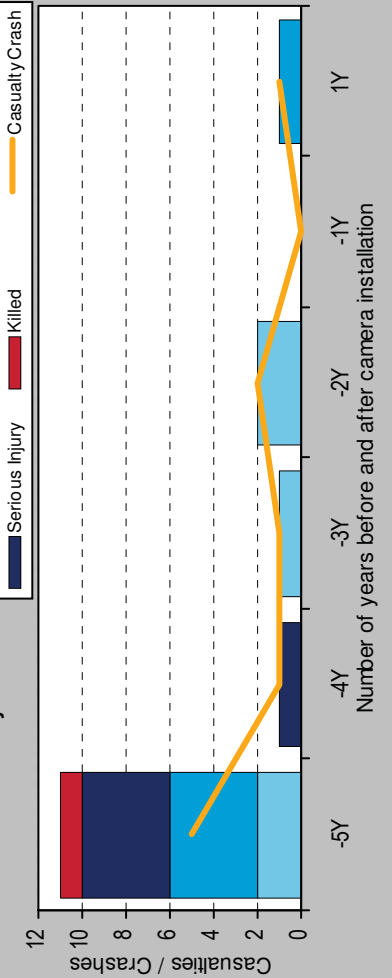
Casualties and Casualty Crashes

Status: Insufficient data (<5 years) to reliably assess.

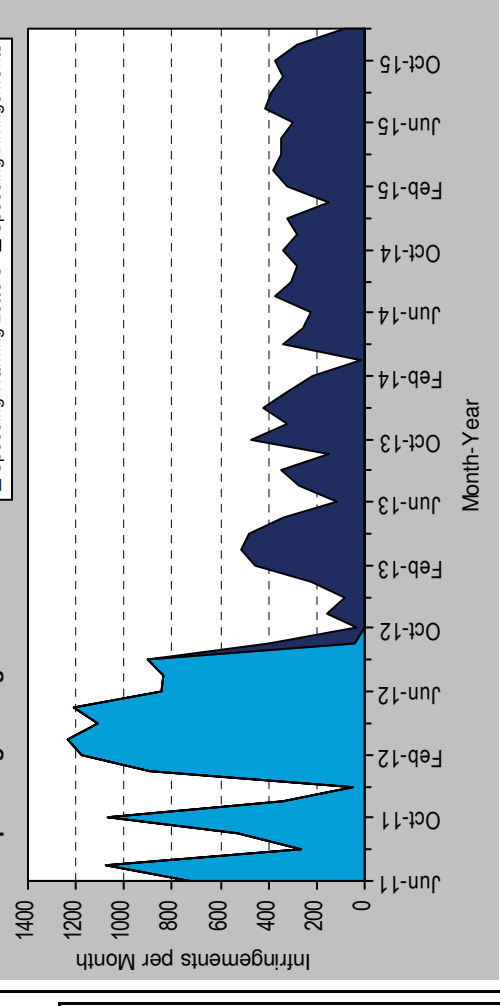
Haberfield - Dobroyd Parade at Mortley Avenue

Infringements at enforced intersection

Speeding Infringements

Casualties and Casualty Crashes

Status: Insufficient data (<5 years) to reliably assess.

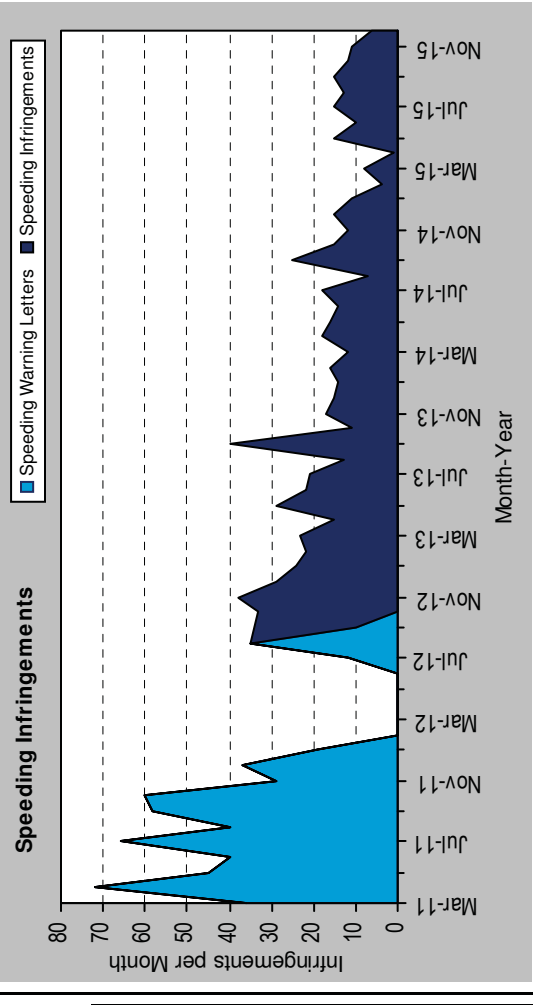
Hunters Hill - Ryde Road at Pittwater Road

Infringements at enforced intersection

Speeding Infringements

Casualties and Casualty Crashes

Status: Insufficient data (<5 years) to reliably assess.

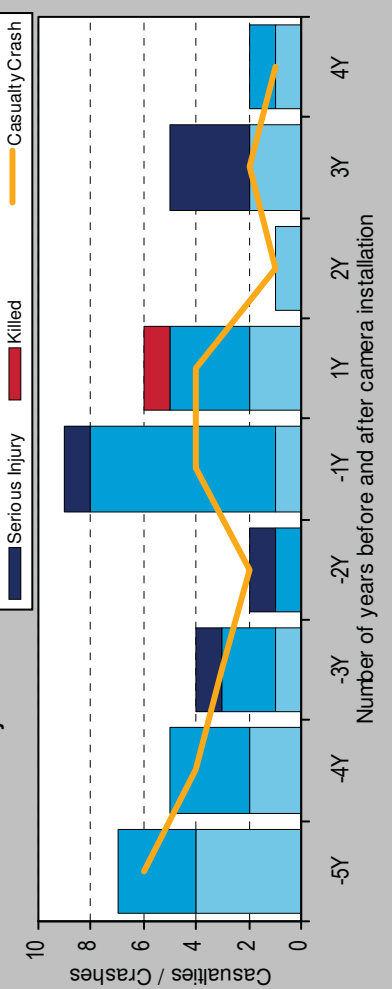
Casualties and Casualty Crashes

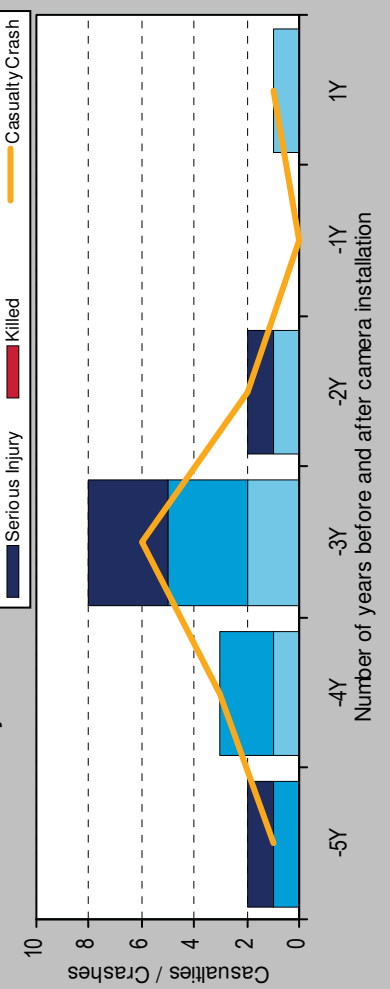
Casualties and Casualty Crashes

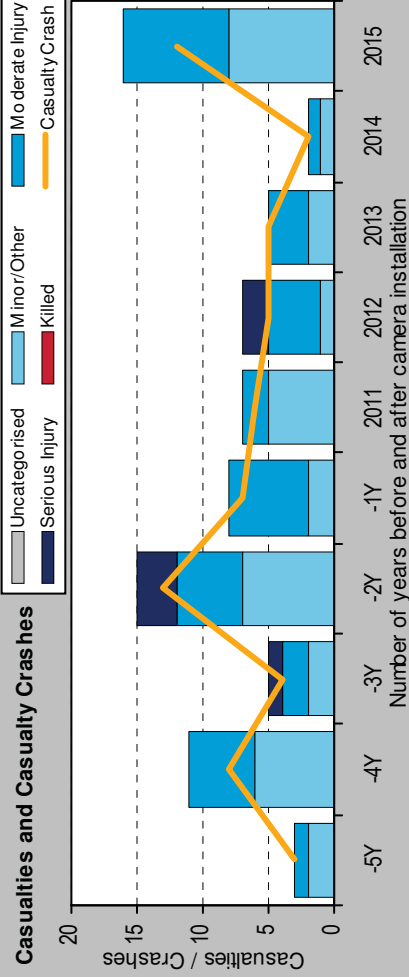
Casualties and Casualty Crashes

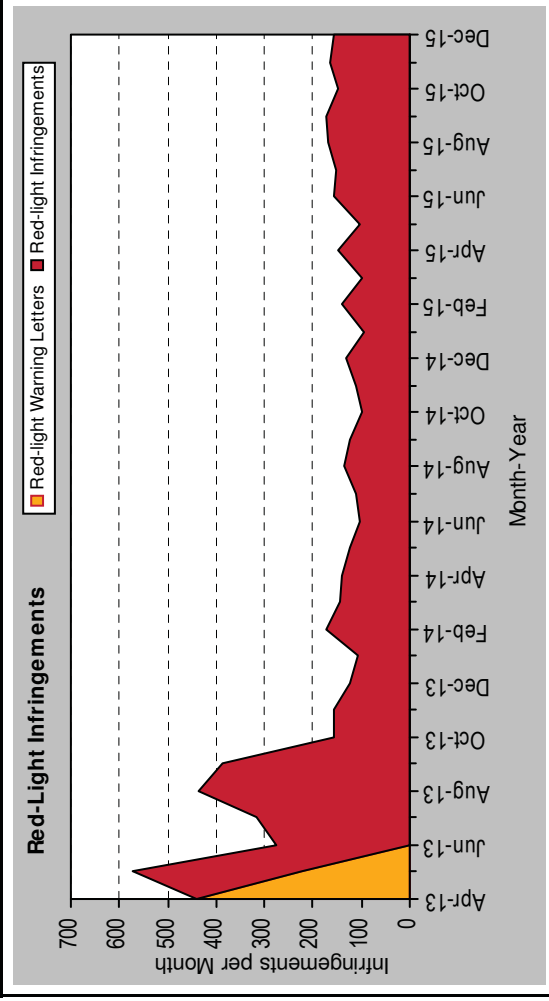
Infringements at enforced intersection

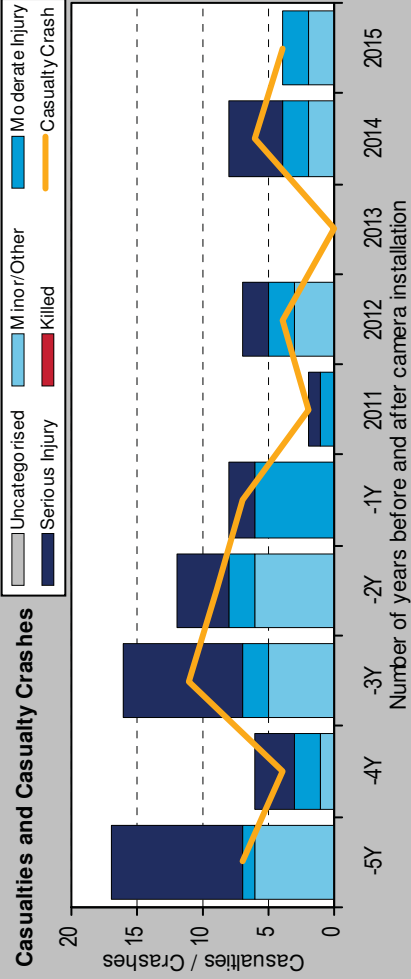
Casualties and Casualty Crashes

Status: Retain.

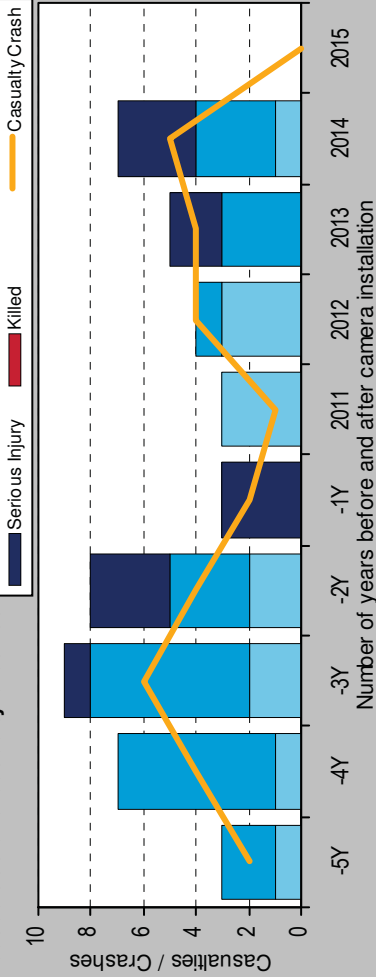
Casualties and Casualty Crashes

Status: Retain.

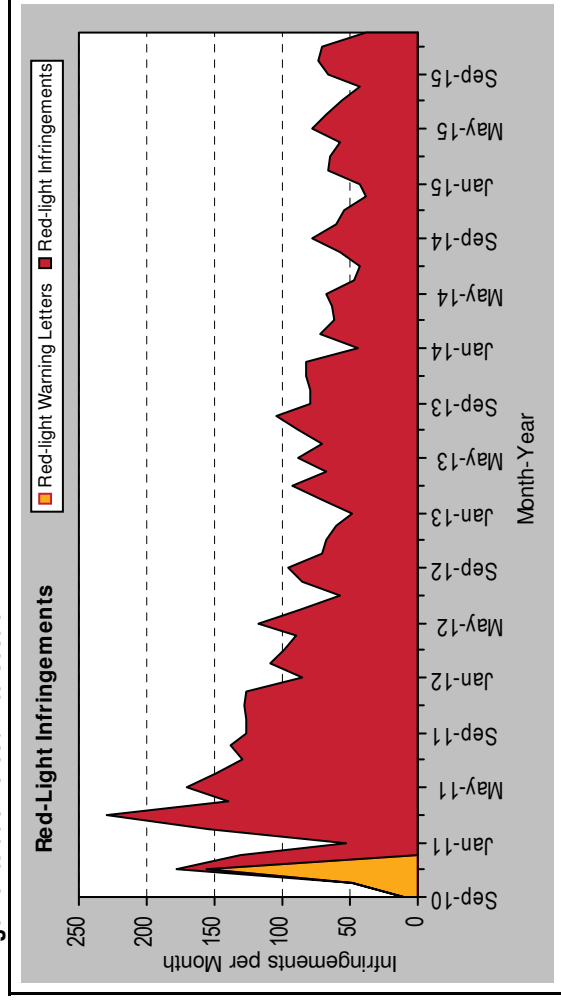
Infringements at enforced intersection

Status: Retain.

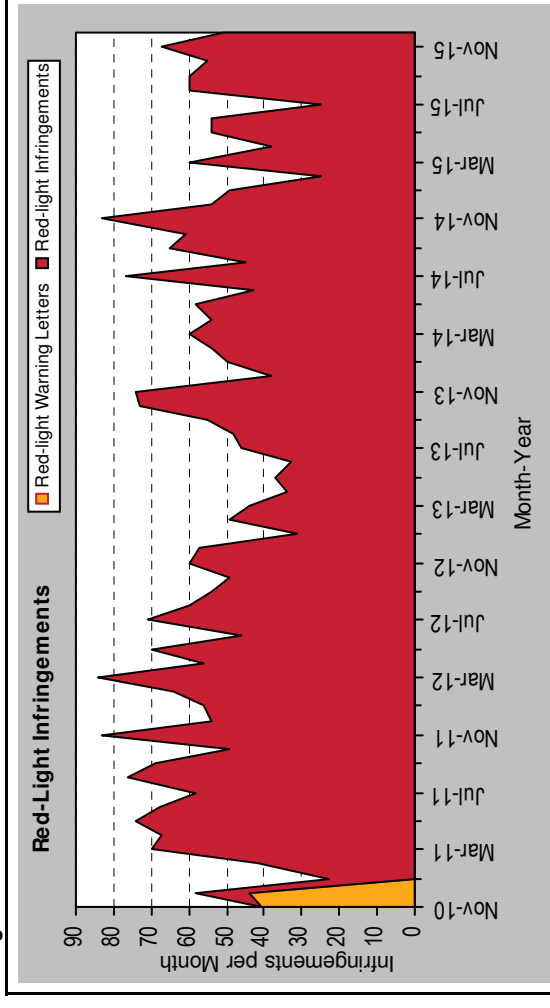
Infringements at enforced intersection

Status: Retain and Monitor. The previous wet-film red light camera may have influenced the before period data. Annual traffic counts have increased at this location.

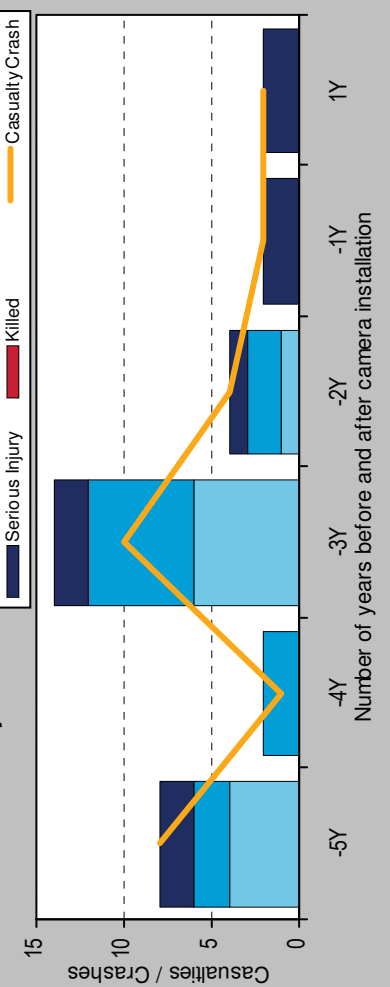
Casualties and Casualty Crashes

³ The percentage change is based on annualised crash data to allow for a direct comparison between the pre and post installation time periods. Red values indicate an increase.

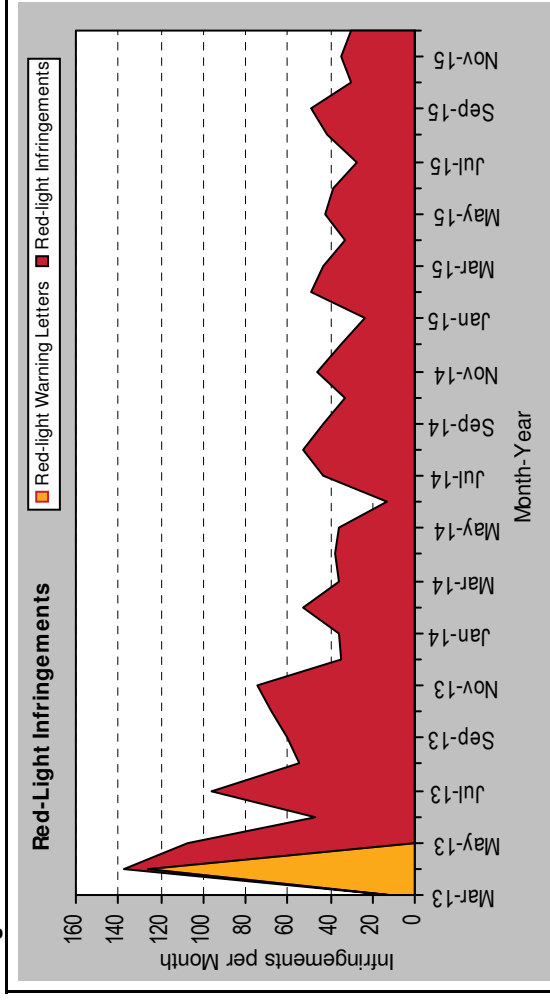
Infringements at enforced intersection

Wiley Park - The Boulevard at King Georges Road (school zone)

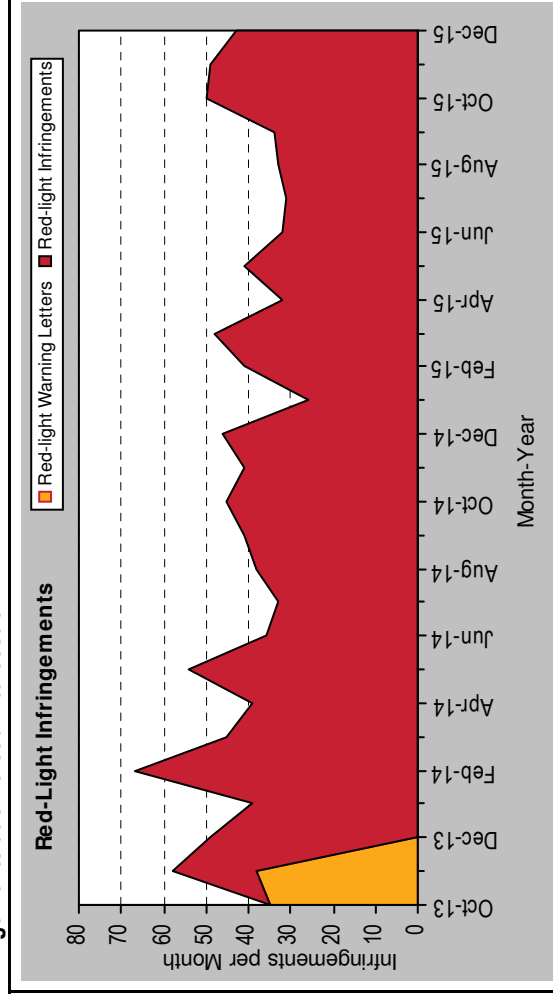
Infringements at enforced intersection

Woolahra - Queen Street at Ocean Street

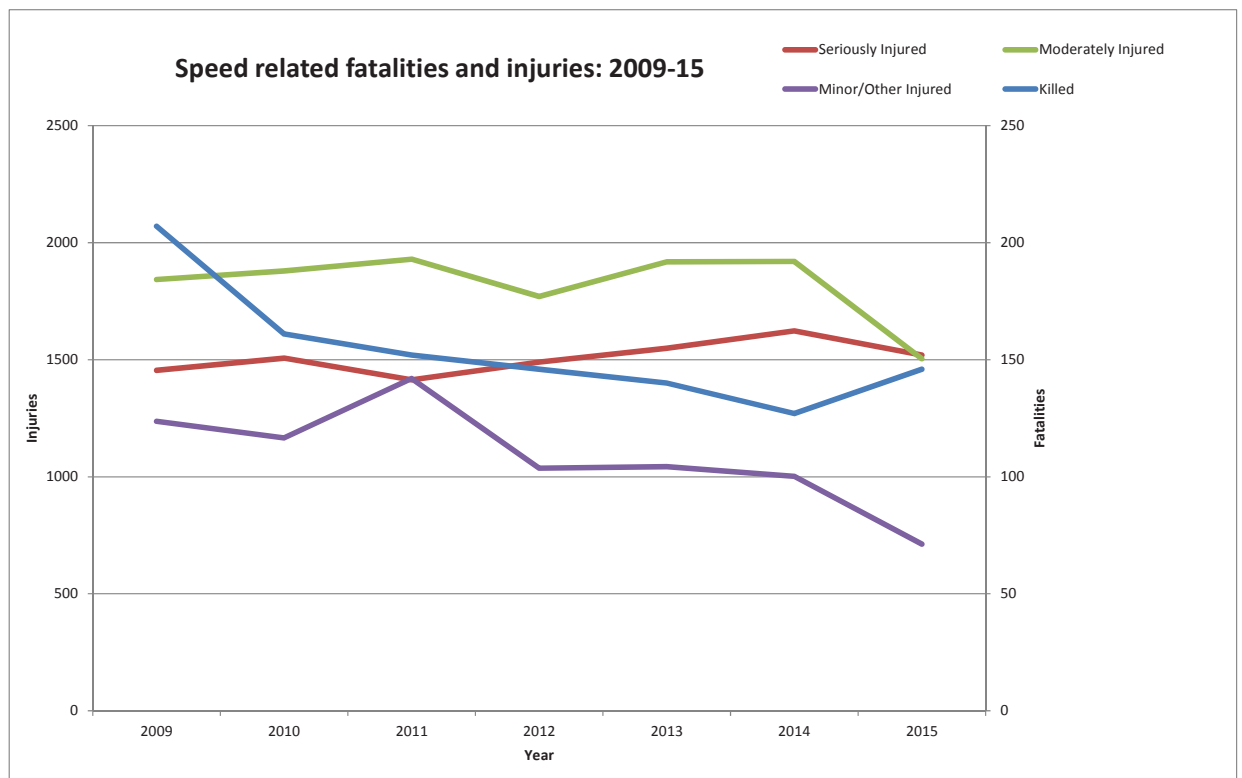
Figure C1: Speed-related fatalities and injuries, 2009-2014

There were 146 fatalities from speed related crashes in 2015. This represents a 29 per cent reduction on 2009 figures (before the mobile speed camera program was reintroduced in NSW).

There were 1,520 serious injuries from speed related crashes in 2015. This represents a 4 per cent increase on 2009 figures:

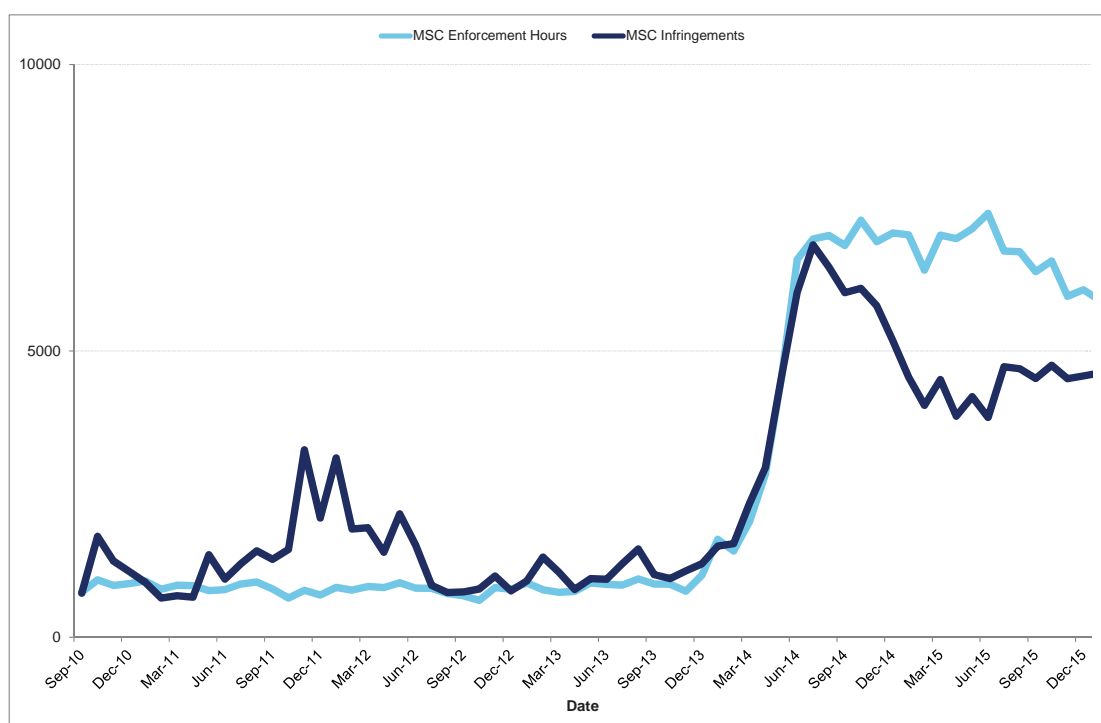
Figure C3: Speeding infringements issued and number of enforcement hours conducted by mobile speed cameras by month

The below graph shows the mobile speed camera program infringement data and the number of enforcement hours per months. The graph shows that there was a marked decrease in the number of infringements issued from the end of June 2014 onwards. At that time, the number of enforcement hours reached 7,000 per month, and have not increased over and above that point. It can be seen that the number of monthly infringements has decreased since that time, as motorists have changed their behaviour at the locations where mobile speed cameras enforce.

The above graph depicts some peaks in infringement numbers when new sites are in use more frequently. In the months following the use of new sites, the number of infringements decreased or stabilised. This trend is to be anticipated; for example fixed speed enforcement follows the same type of pattern, with the difference being that fixed speed cameras remain in the same place and continually enforce meaning that reductions in infringements are more consistent.

The total number of mobile speed camera infringements issued in 2015 decreased by 11 per cent compared to 2014.
