Transport
for NSW

Centre for Road Safety

Speed Camera Programs: 2017 Annual Review

Author: Centre for Road Safety
Date: May 2018
Version: 0.6
Division: Freight, Strategy and Planning

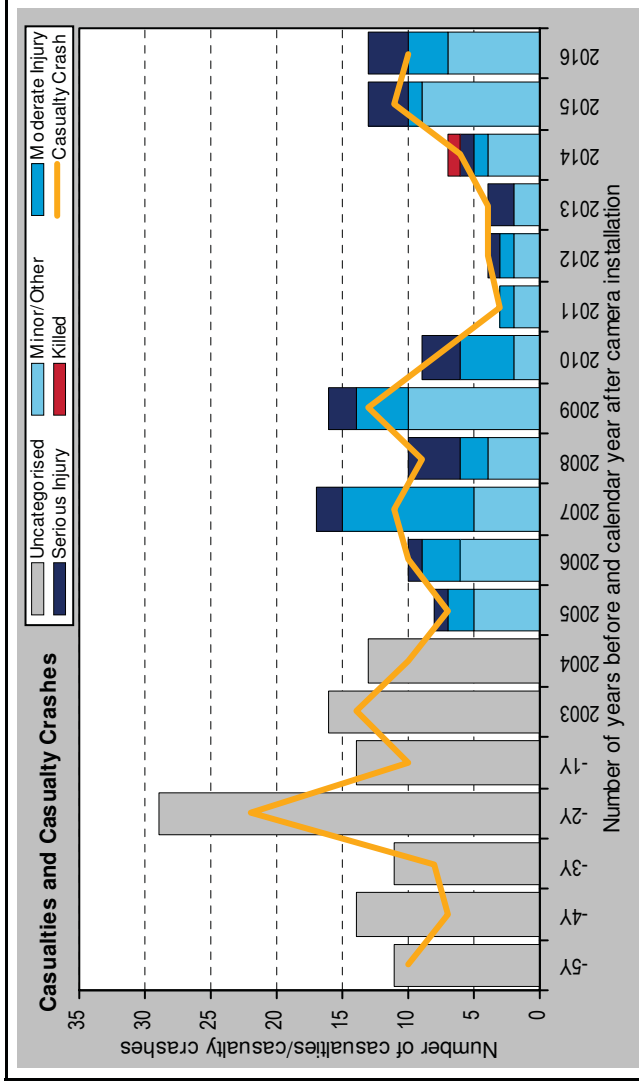
9534: Auburn - Parramatta Road, between Harbord Street and Duck Street

This location is 1000m in length, and is enforced with one camera. The camera commenced operating on 15 May 2002.

• When comparing the pre installation period to the most recent five year period, there has been a 39% decrease in casualty crashes at this fixed speed camera location. The data presented do not account for the prevailing statewide trend.

• The infringement graph details the trend in infringements at this location since July 2002. Infringement data before this date is not available. Roadworks and camera maintenance may influence the number of infringements issued.

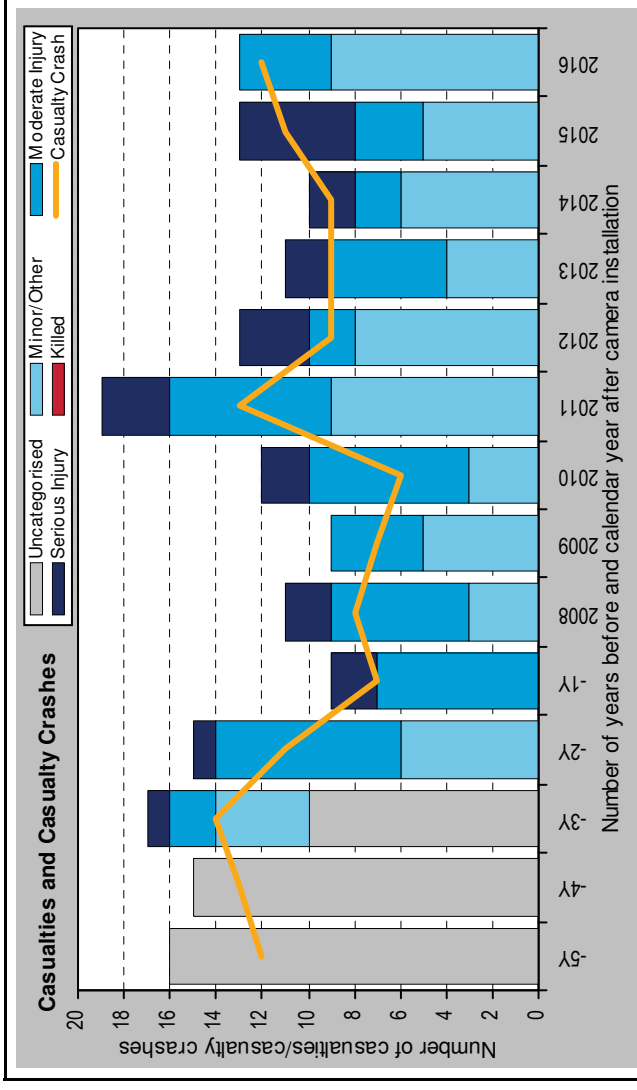
9818|9819: Bankstown - Hume Highway, between Rookwood Road and Stacey Street

• The infringement graph details the trend in infringements at this location since the camera began operating. Roadworks and camera maintenance may influence the number of infringements issued.

• This location was reviewed in 2013 due to concerns about the increase in casualties in recent years. The review found that during 2011 there were 28 casualties. This significant increase in the number of casualties included one crash involving a bus, resulting in 11 casualties. The number of casualty crashes has reduced in the following years. Speeding infringements were also found to have significantly reduced following the introduction of the speed cameras. It was recommended that the speed cameras be retained.

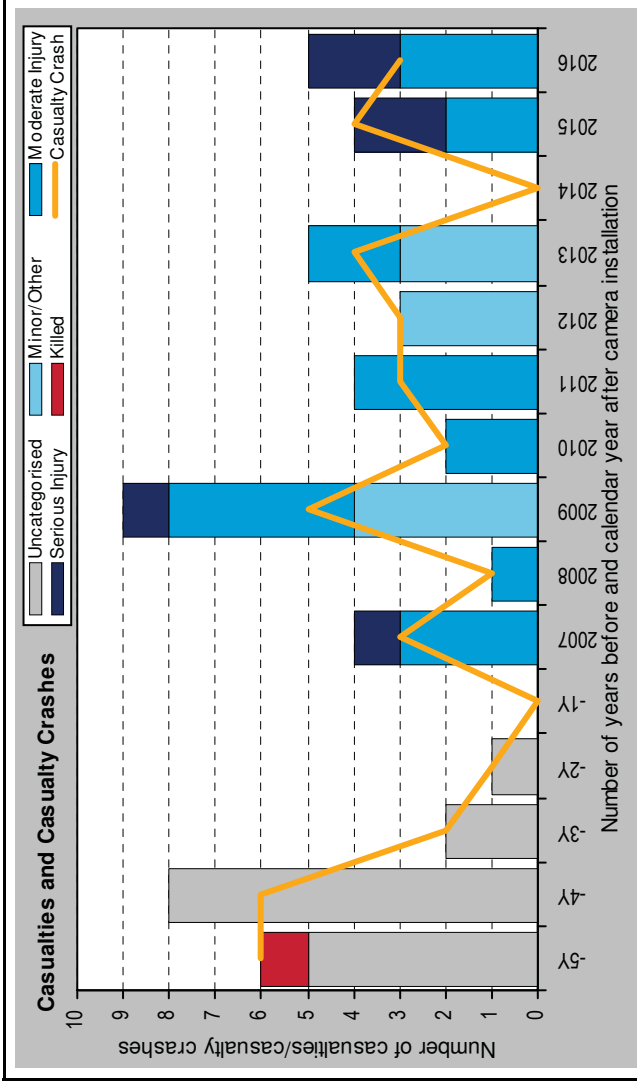
9616: Bar Point - M1 Pacific Motorway, between Jolls Bridge and Mt White Exit Ramp

This location is 1000m in length, and is enforced with one camera. The camera commenced operating on 10 April 2006.

• When comparing the pre installation period to the most recent five year period, there has been a 7% decrease in casualty crashes at this fixed speed camera location. The data presented do not account for the prevailing statewide trend.

• The infringement graph details the trend in infringements at this location since the camera began operating. Roadworks and camera maintenance may influence the number of infringements issued.

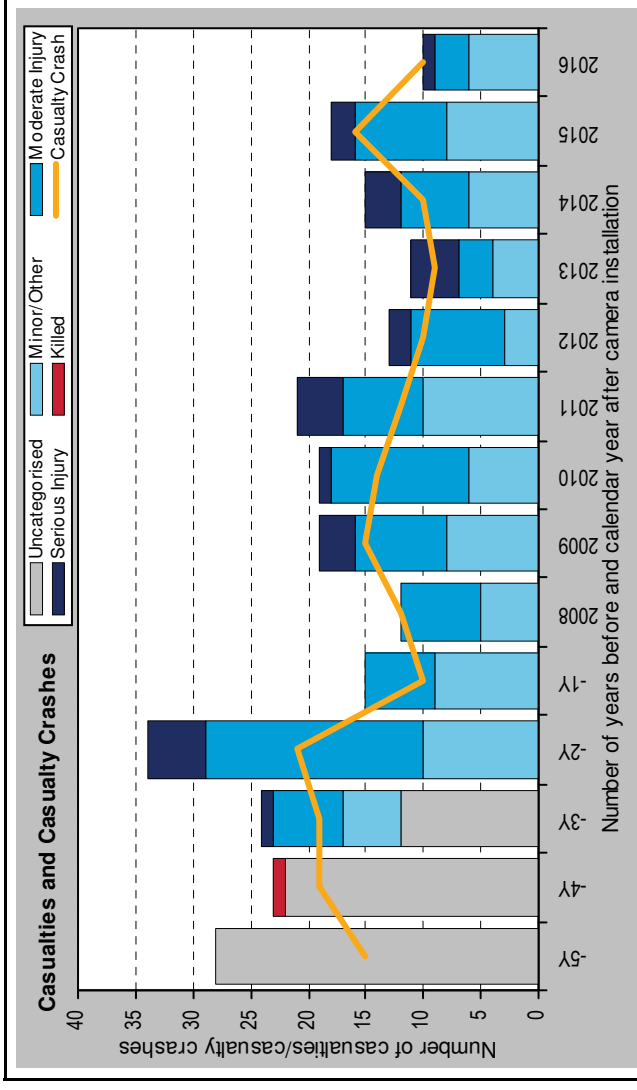
982219823: Beverly Hills - King Georges Road, between Stoney Creek Road and Edgbaston Road

- When comparing the pre installation period to the most recent five year period, there has been a 35% decrease in casualty crashes at this fixed speed camera location. The data presented do not account for the prevailing statewide trend.

- The infringement graph details the trend in infringements at this location since the camera began operating. Roadworks and camera maintenance may influence the number of infringements issued.

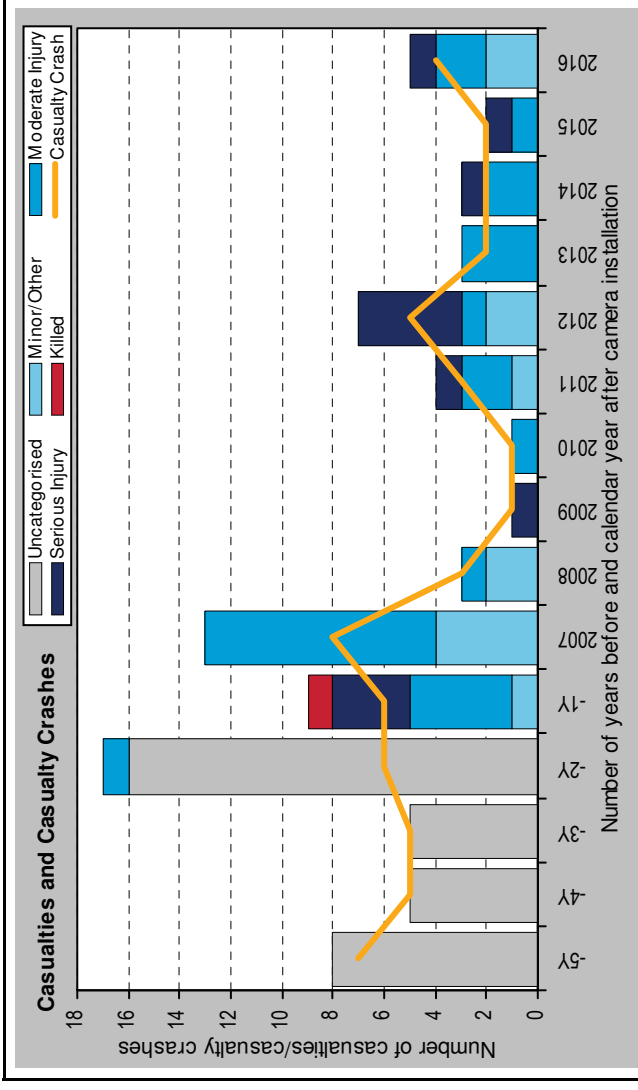
9617: Bexley North - Bexley Road, between Kingsland Road North and Miller Avenue

This location is 1000m in length, and is enforced with one camera. The camera commenced operating on 29 May 2006.

• When comparing the pre installation period to the most recent five year period, there has been a 48% decrease in casualty crashes at this fixed speed camera location. The data presented do not account for the prevailing statewide trend.

• The infringement graph details the trend in infringements at this location since the camera began operating. Roadworks and camera maintenance may influence the number of infringements issued.

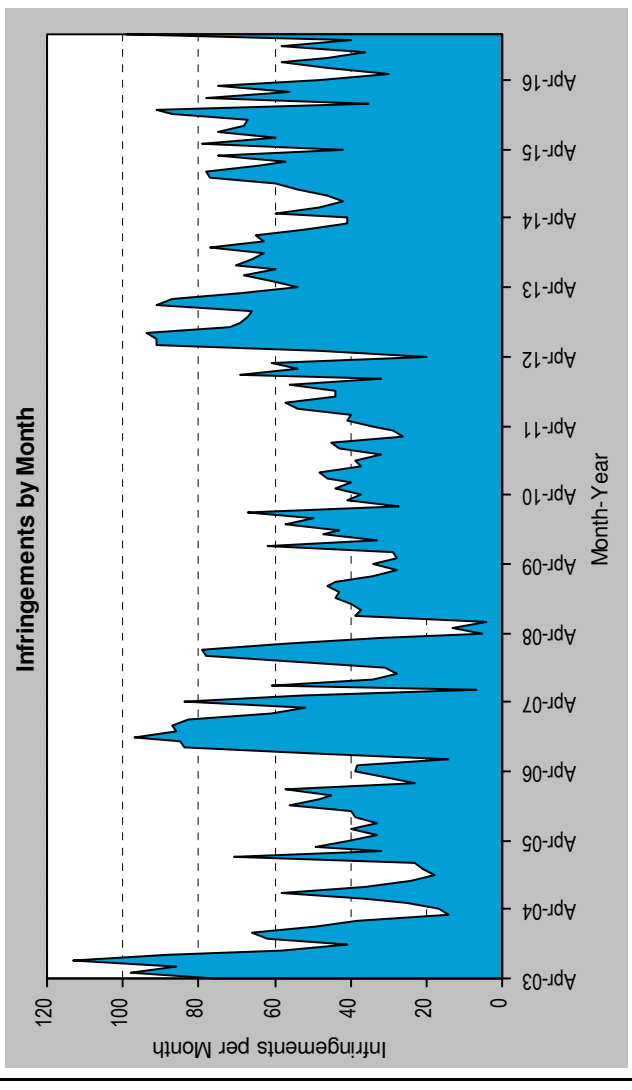
9579: Blandford - New England Highway, between Hayles Street and Mills Street

This location is 1000m in length, and is enforced with one camera. The camera commenced operating on 10 April 2002.

• When comparing the pre installation period to the most recent five year period, there has been a 100% decrease in casualty crashes at this fixed speed camera location. The data presented do not account for the prevailing statewide trend.

• The infringement graph details the trend in infringements at this location since July 2002. Infringement data before this date is not available. Roadworks and camera maintenance may influence the number of infringements issued.

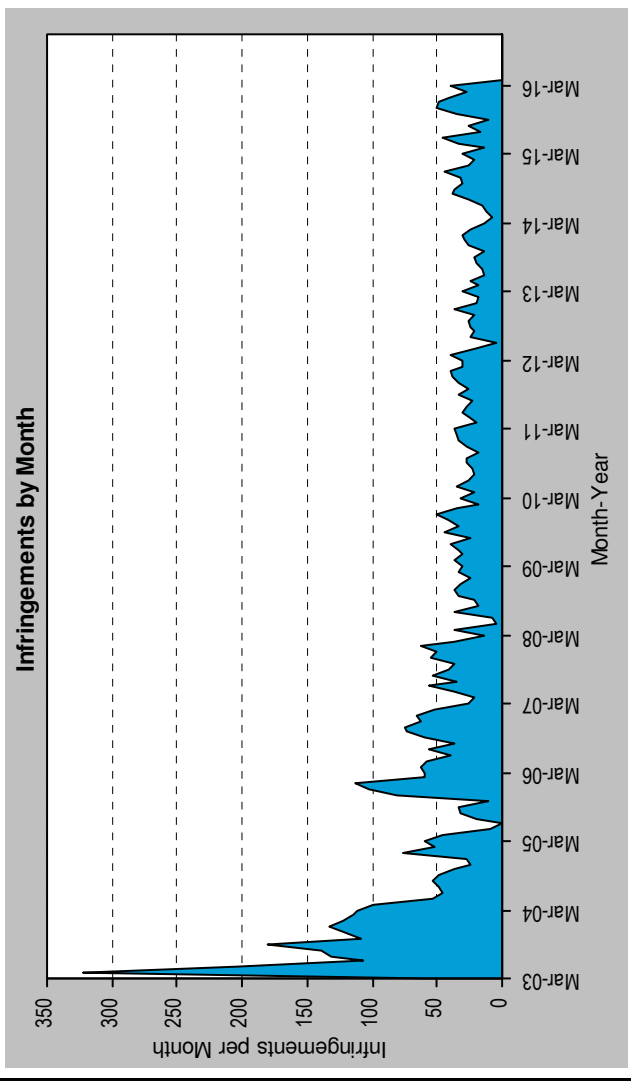
9594: Bomaderry - Bolong Road, between Beinda Street and Coomea Street

This location is 1000m in length, and is enforced with one camera. The camera commenced operating on 31 March 2003.

• When comparing the pre installation period to the most recent five year period, there has been an 86% increase in casualty crashes at this fixed speed camera location. The increase in casualty crashes is not statistically significant. The data presented do not account for the prevailing statewide trend.

• The infringement graph details the trend in infringements at this location since the camera began operating. Roadworks and camera maintenance may influence the number of infringements issued.

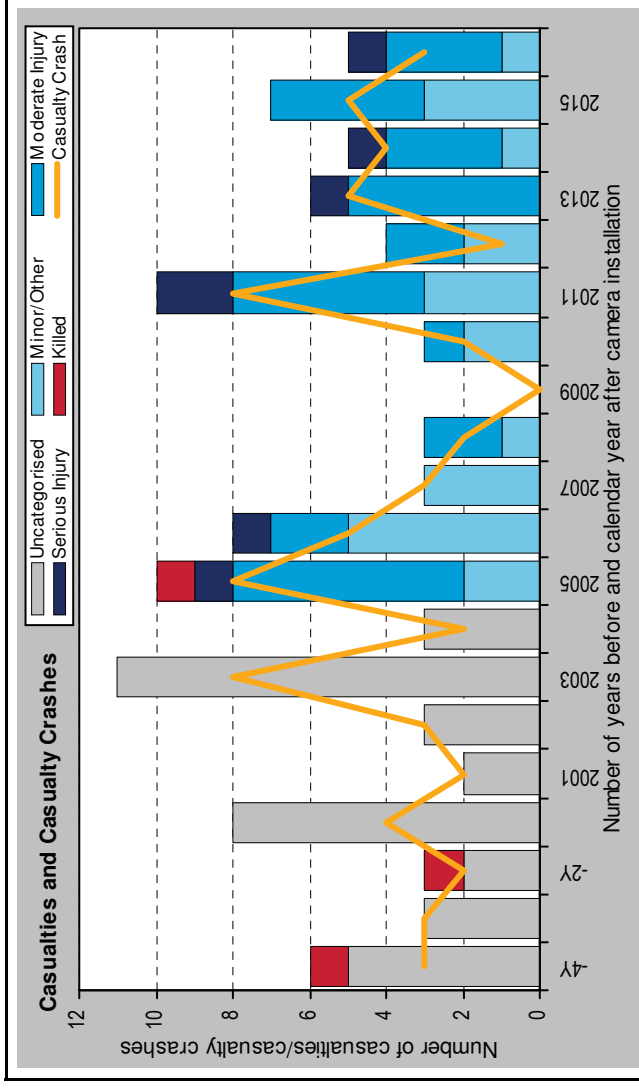
9645: Bonnyrigg - Elizabeth Drive, between Brown Road and Humphries Road

This location is 1000m in length, and is enforced with one camera. The camera commenced operating on 7 July 2000.

(There has been an increase in casualty crashes at this location, but the increase is not statistically significant. This location has not previously identified for review.)

- When comparing the pre installation period to the most recent five year period, there has been a 20% increase in casualty crashes at this fixed speed camera location. The increase in casualty crashes is not statistically significant. The data presented do not account for the prevailing statewide trend.
- The infringement graph details the trend in infringements at this location since July 2002. Infringement data before this date is not available. The spike in infringements from July 2007 can be attributed to the camera commencing speed enforcement of both directions of traffic where it previously enforced one direction. Since then, there has been a reduction in speeding behaviour at this location over time. Roadworks and camera maintenance may influence the number of infringements issued.
- A desktop review of this location was undertaken in 2015.

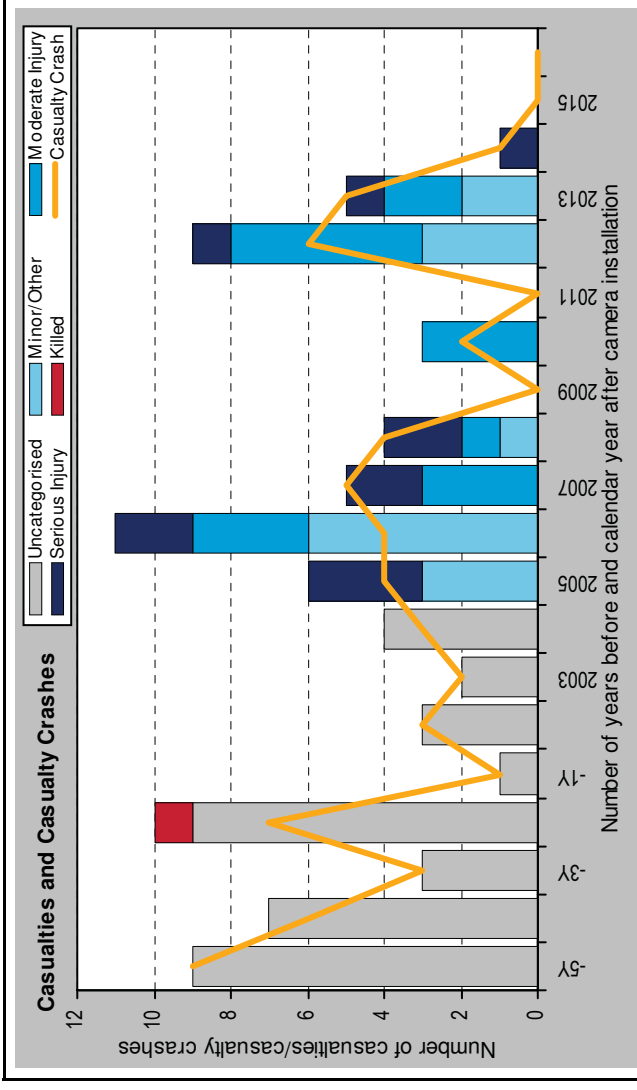
9509: Bulli - Princes Highway, between Grevillea Park Road and Black Diamond Place

This location is 1000m in length, and is enforced with one camera. The camera commenced operating on 4 December 2001.

• When comparing the pre installation period to the most recent five year period, there has been a 54% decrease in casualty crashes at this fixed speed camera location. The data presented do not account for the prevailing statewide trend.

• The infringement graph details the trend in infringements at this location since July 2002. Infringement data before this date is not available. The spike in infringements from July 2006 may be attributed to the camera commencing speed enforcement of both directions of traffic where it previously enforced one direction. Since then, there has been a reduction in speeding behaviour at this location over time. Roadworks and camera maintenance may influence the number of infringements issued.

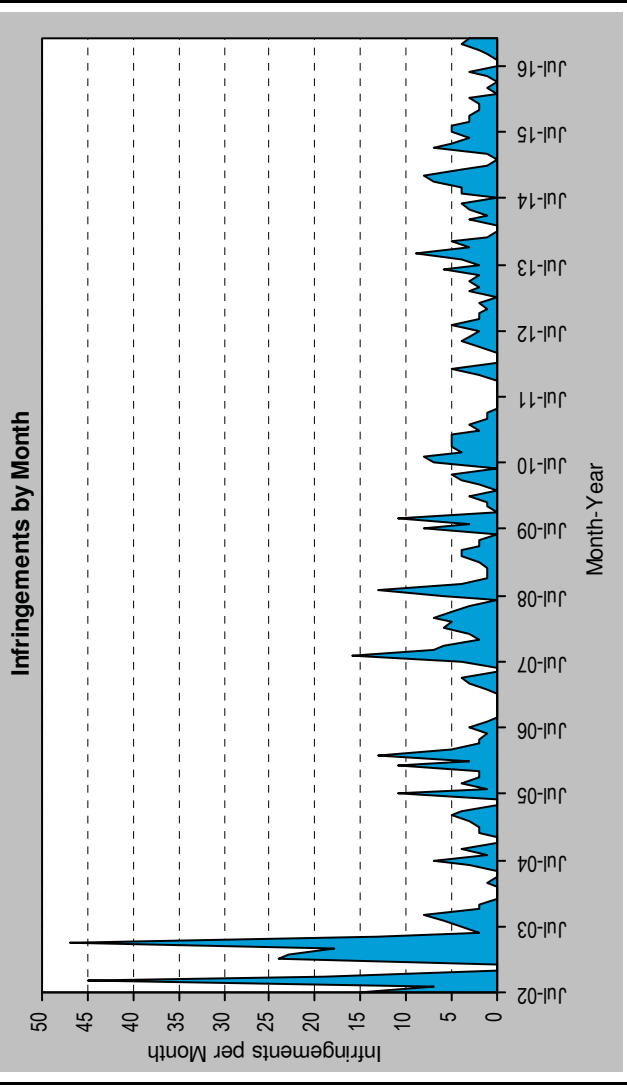
9652: Burringbar - Tweed Valley Way, between Blakeney Road and Cooradilla Road

This location is 1000m in length, and is enforced with one camera. The camera commenced operating on 2 April 1999.

(There is currently a review underway at this location.)

- When comparing the pre installation period to the most recent five year period, there has been a 70% decrease in casualty crashes at this fixed speed camera location. The data presented do not account for the prevailing statewide trend.
- The infringement graph details the trend in infringements at this location since July 2002. Infringement data before this date is not available. Roadworks and camera maintenance may influence the number of infringements issued.
- This camera is located on a section of road that was formerly the Pacific Highway, that has been bypassed. While there is a low level of speeding infringements at this location, the review will help determine whether there are road safety risks that require ongoing speed enforcement at this location.

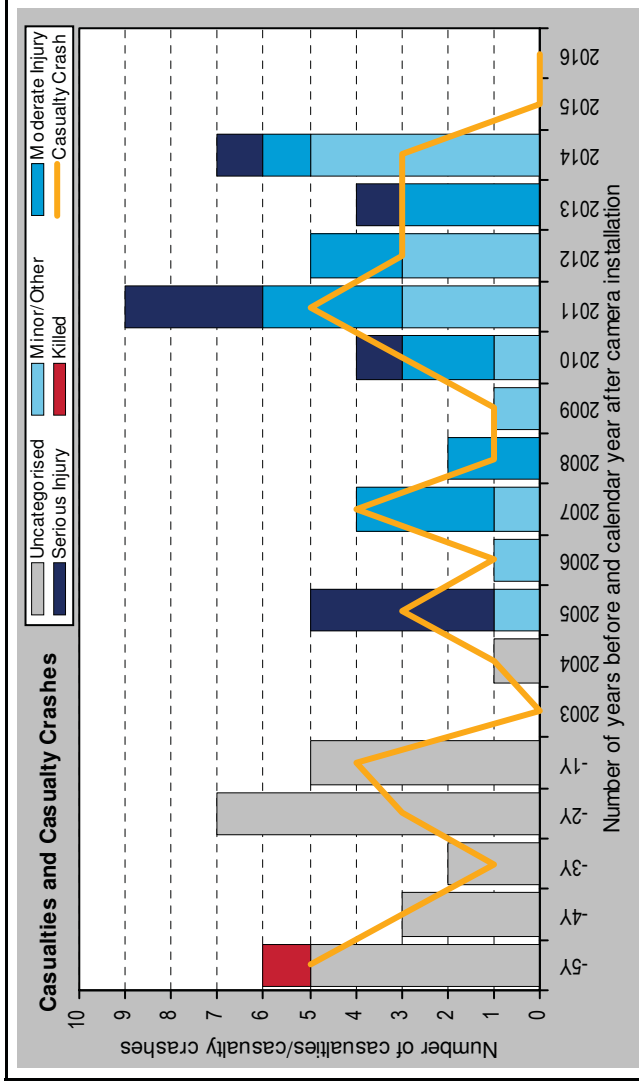
- The infringement graph details the trend in infringements at this location since the camera began operating. Roadworks and camera maintenance may influence the number of infringements issued.

- This location was reviewed in 2013 due to concerns about the increase in crashes and casualties in recent years. The 2013 review found that since the speed camera was installed, the number of crashes per year had decreased. The review also found that the number of injury crashes per year decreased. While there was one fatal crash with one fatality prior to the installation of the speed camera, there have been no fatalities since the camera has been in operation. Therefore based on this information, the speed camera has been retained.

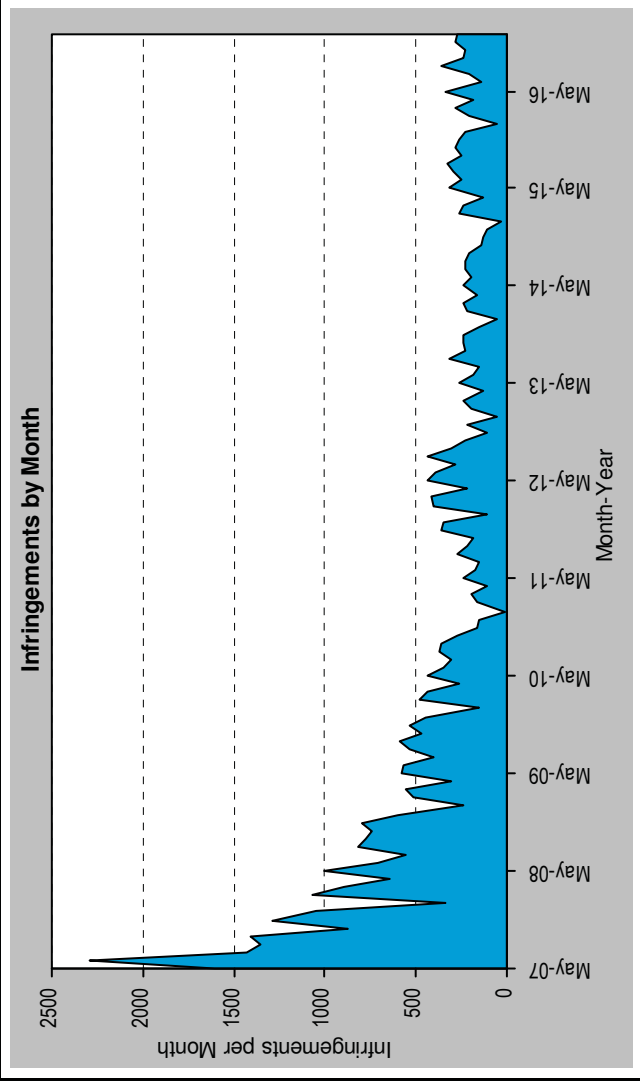
- When comparing the pre installation period to the most recent five year period, there has been a 34% decrease in casualty crashes at this fixed speed camera location. The data presented do not account for the prevailing statewide trend.
- The infringement graph details the trend in infringements at this location since the camera began operating. Roadworks and camera maintenance may influence the number of infringements issued.

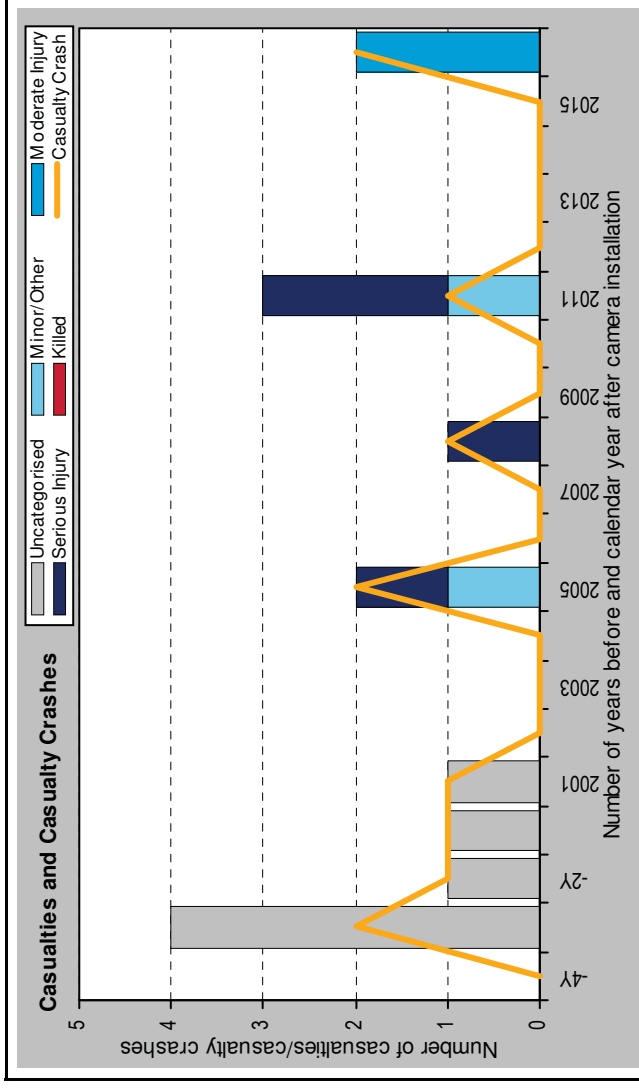
• When comparing the pre installation period to the most recent five year period, there has been a 60% decrease in casualty crashes at this fixed speed camera location. The data presented do not account for the prevailing statewide trend.

• The infringement graph details the trend in infringements at this location since July 2002. Infringement data before this date is not available. Roadworks and camera maintenance may influence the number of infringements issued.

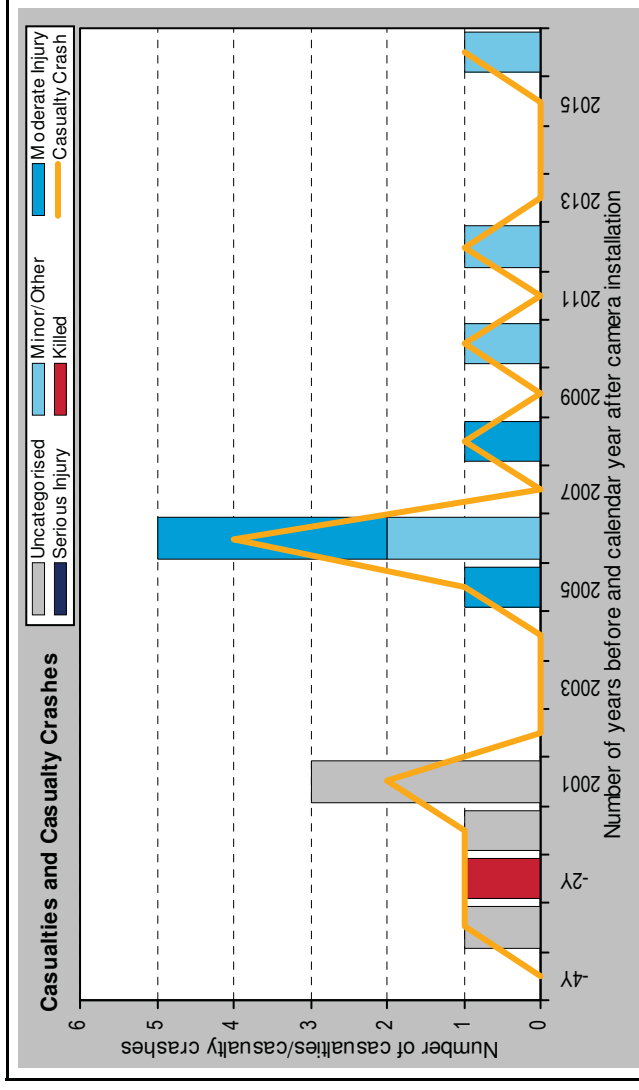
- The infringement graph details the trend in infringements at this location since July 2002. Infringement data before this date is not available. The spike in infringements from September 2007 was due to the camera commencing speed enforcement of both directions of traffic where it previously enforced one direction. Roadworks and camera maintenance may influence the number of infringements issued.

- This location was reviewed in 2012 due to concerns that casualties had increased slightly. The comprehensive safety review found that since the speed camera was installed, traffic volumes had increased significantly due to mining activities in the Hunter region. Given the increase in traffic volume, the adjusted casualty rate indicated that the speed camera has been effective in reducing casualties. Further, there was strong community support for the retention of the speed camera due to its location in a school zone where safety is a high priority. Therefore the speed camera at this location was retained.

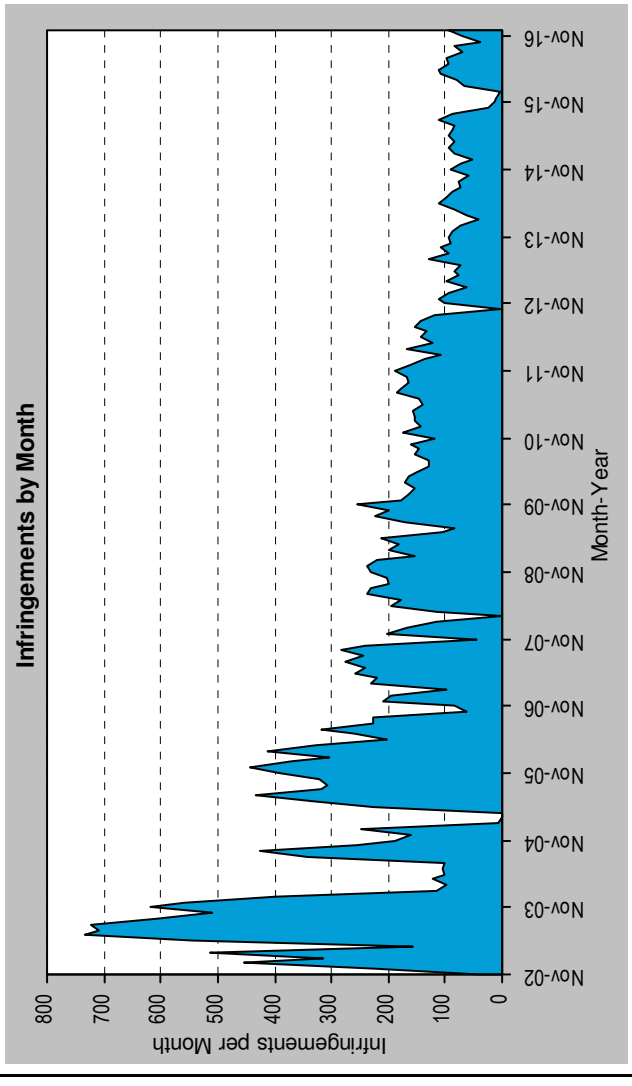
• When comparing the pre installation period to the most recent five year period, there has been a 34% decrease in casualty crashes at this fixed speed camera location. The data presented do not account for the prevailing statewide trend.

• The infringement graph details the trend in infringements at this location since the camera began operating. Roadworks and camera maintenance may influence the number of infringements issued.

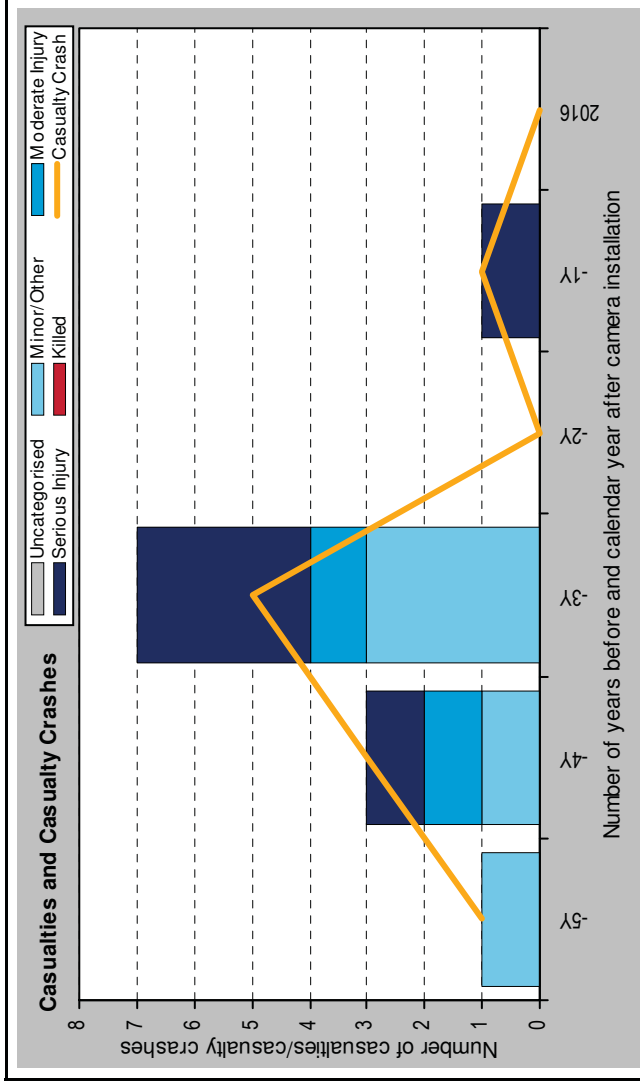
9665: North Macksville - Pacific Highway, between Bellview Drive and Ferry Street

Status : [Insufficient data](#)

- CRS will develop further commentary when there is additional data available for this location in the future.
- The infringement graph details the trend in infringements at this location since the camera began operating. Roadworks and camera maintenance may influence the number of infringements issued.

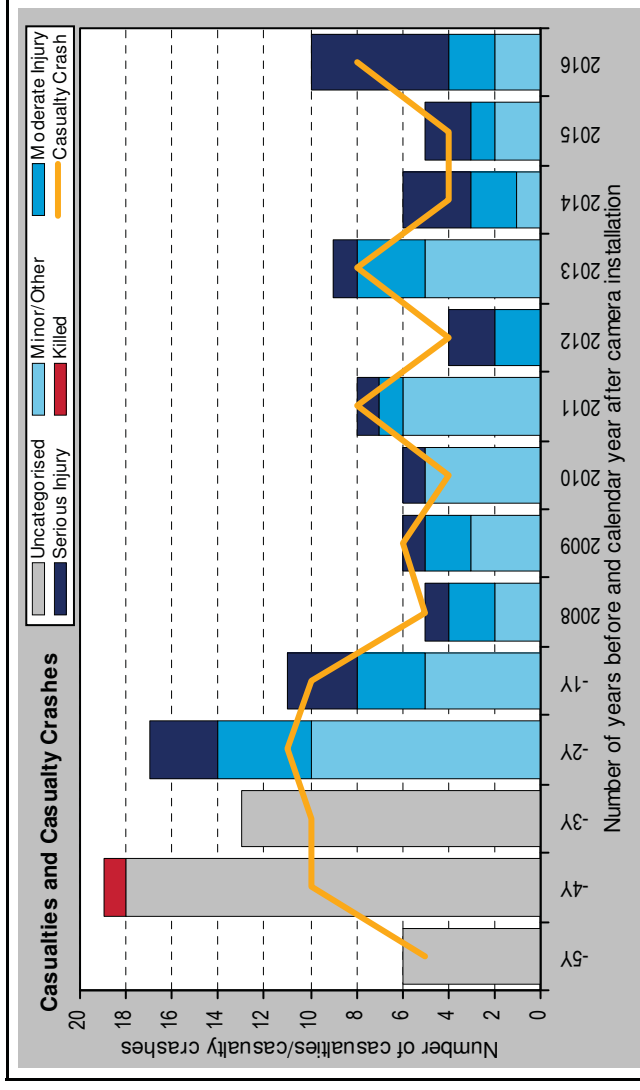
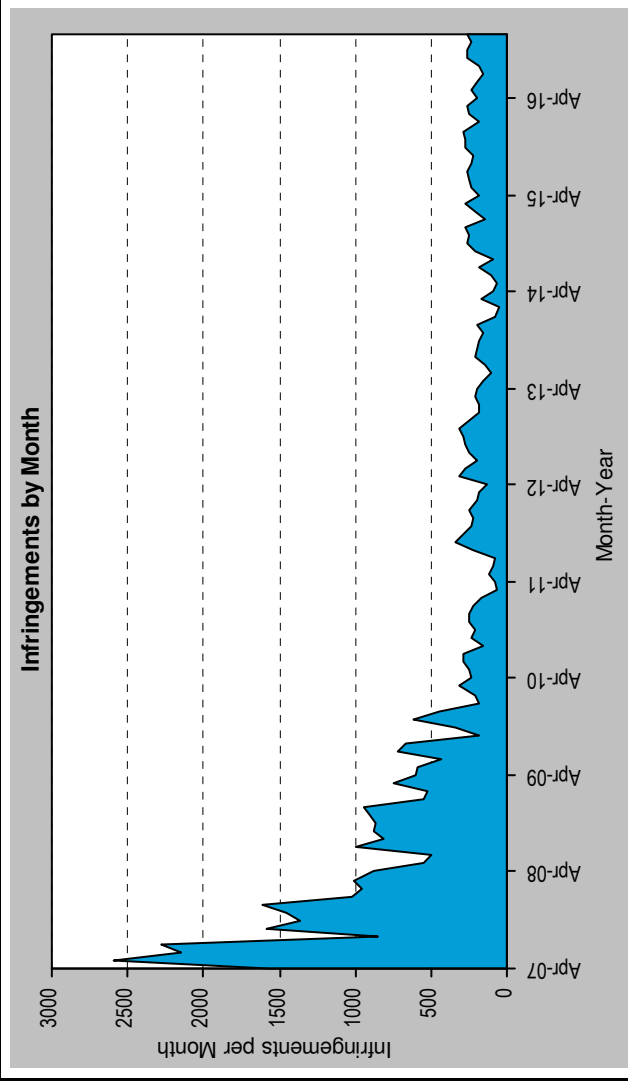
965719658: North Parramatta / Oatlands - Pennant Hills Road, between Masons Drive and Suttor Avenue

• When comparing the pre installation period to the most recent five year period, there has been a 39% decrease in casualty crashes at this fixed speed camera location. The data presented do not account for the prevailing statewide trend.

• The infringement graph details the trend in infringements at this location since the camera began operating. Roadworks and camera maintenance may influence the number of infringements issued.

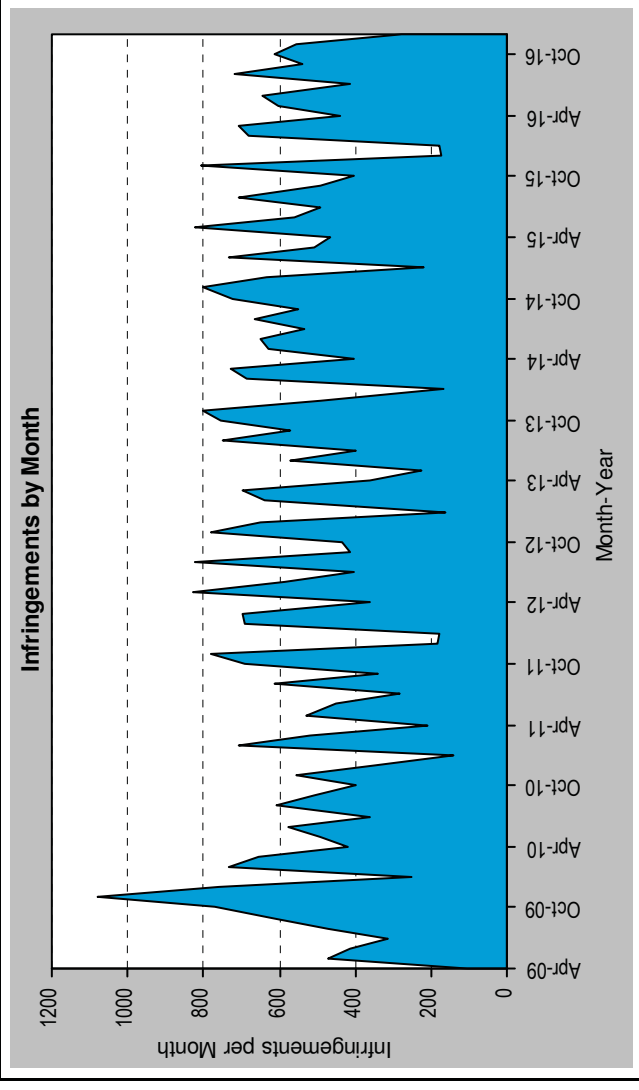
984119842: Old Guildford - Woodville Road, between Orchardleigh Street and Middleton Road

• When comparing the pre installation period to the most recent five year period, there has been a 47% decrease in casualty crashes at this fixed speed camera location. The data presented do not account for the prevailing statewide trend.

• The infringement graph details the trend in infringements at this location since the camera began operating. Roadworks and camera maintenance may influence the number of infringements issued.

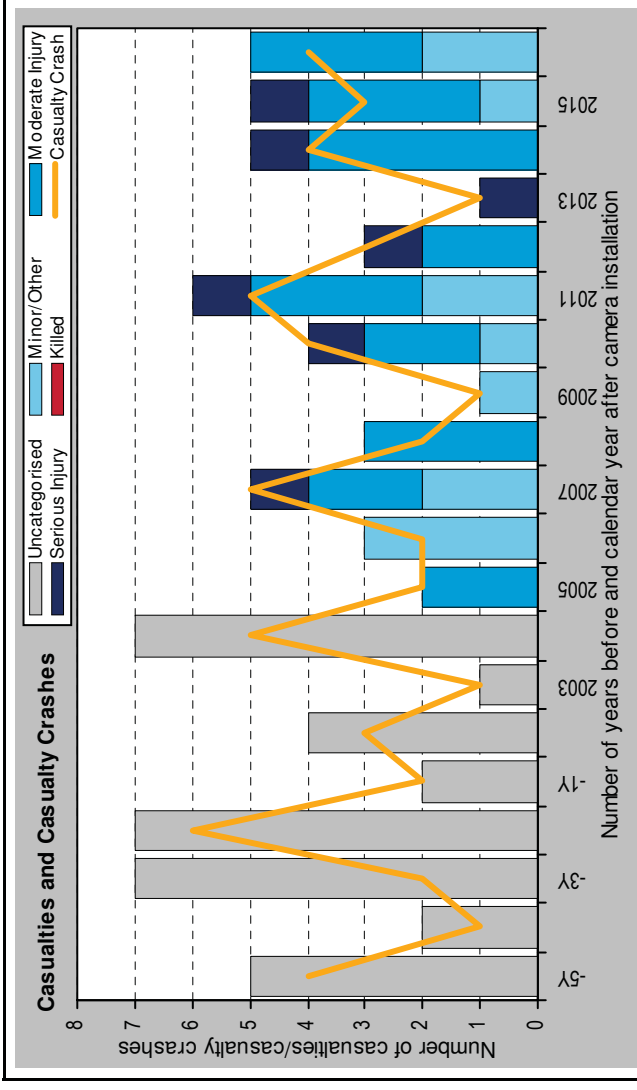
• When comparing the pre installation period to the most recent five year period, there has been no change in casualty crashes at this fixed speed camera location. The change in casualty crashes is not statistically significant. The data presented do not account for the prevailing statewide trend.

• The infringement graph details the trend in infringements at this location since July 2002. Infringement data before this date is not available. The spike in infringements in April 2007 may be attributed to the camera commencing speed enforcement of both directions of traffic where it previously enforced one direction only. Roadworks and camera maintenance may influence the number of infringements issued.

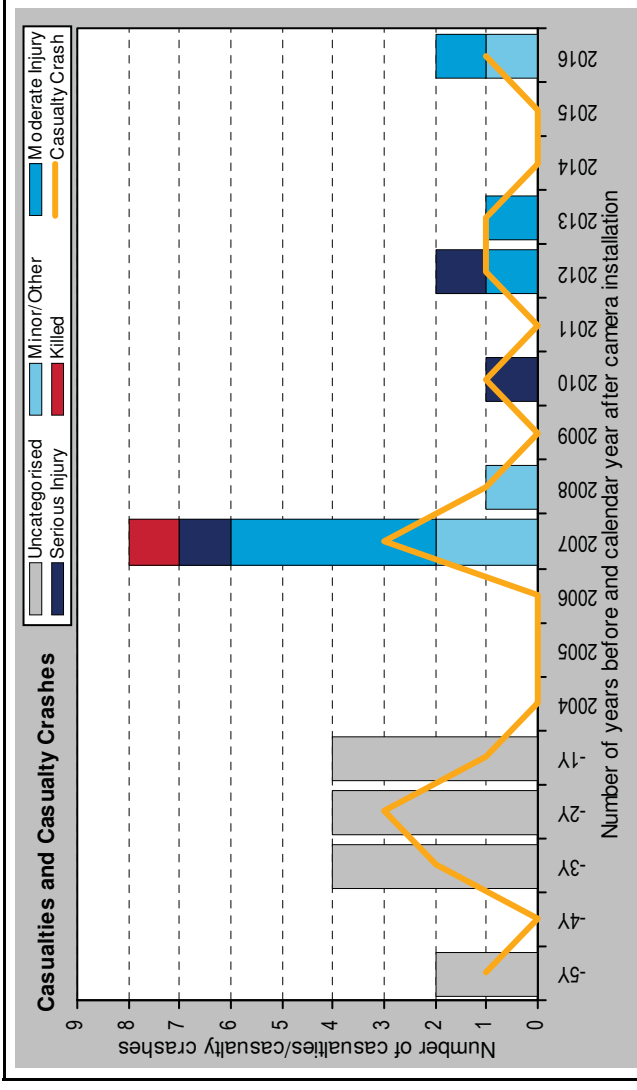
• When comparing the pre installation period to the most recent five year period, there has been a 57% decrease in casualty crashes at this fixed speed camera location. The data presented do not account for the prevailing statewide trend.

• The infringement graph details the trend in infringements at this location since the camera began operating. The spike in infringements in September 2009 can be attributed to the speed limit changing from 100km/h to 80km/h. Roadworks and camera maintenance may influence the number of infringements issued.

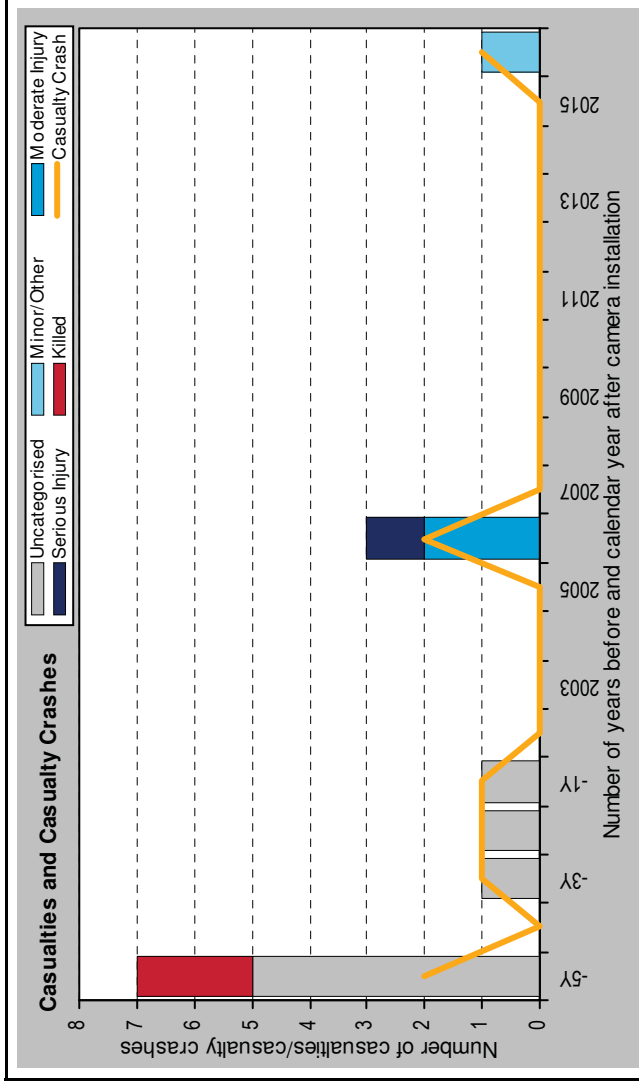
• When comparing the pre installation period to the most recent five year period, there has been an 80% decrease in casualty crashes at this fixed speed camera location. The data presented do not account for the prevailing statewide trend.

• The infringement graph details the trend in infringements at this location since July 2002. Infringement data before this date is not available. The spike in infringements in June 2007 may be attributed to the speed limit changing from 60km/h to 50km/h. Following this spike, infringements again reduced and have remained at a consistent level at this location. Roadworks and camera maintenance may influence the number of infringements issued.

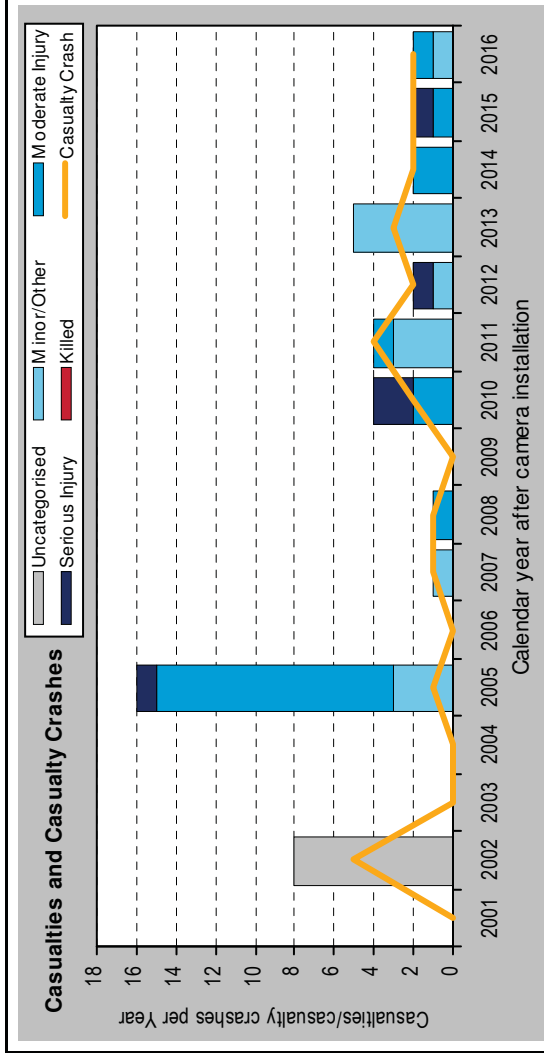
Camera 1 Northbound

- In the northbound direction, there were 2 casualty crashes in the 2016 data. This resulted in 1 moderate injury, and 1 minor injury.
- In the southbound direction, there were 5 casualty crashes in the 2016 data. This resulted in 2 moderate injuries, and 3 minor injuries.
- The infringement graphs show the number of infringements issued at this location by direction, as well as the trend in infringements. Roadworks and camera maintenance may influence the number of infringements issued.

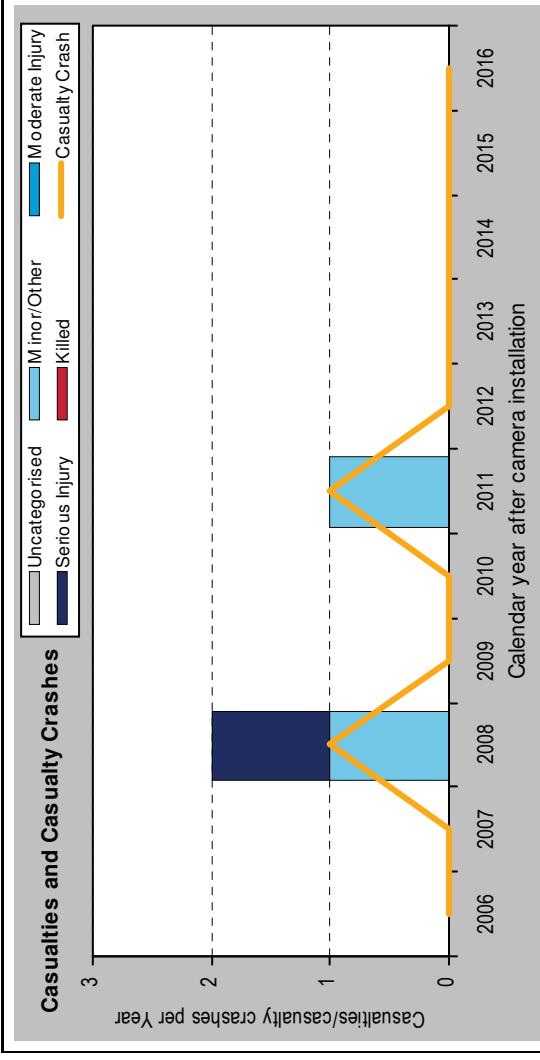
Camera 1 Eastbound

- In the eastbound direction, there were no casualty crashes in the 2016 data.
- In the westbound direction, there were no casualty crashes in the 2016 data.
- The infringement graphs show the number of infringements issued at this location by direction, as well as the trend in infringements. Roadworks and camera maintenance may influence the number of infringements issued.

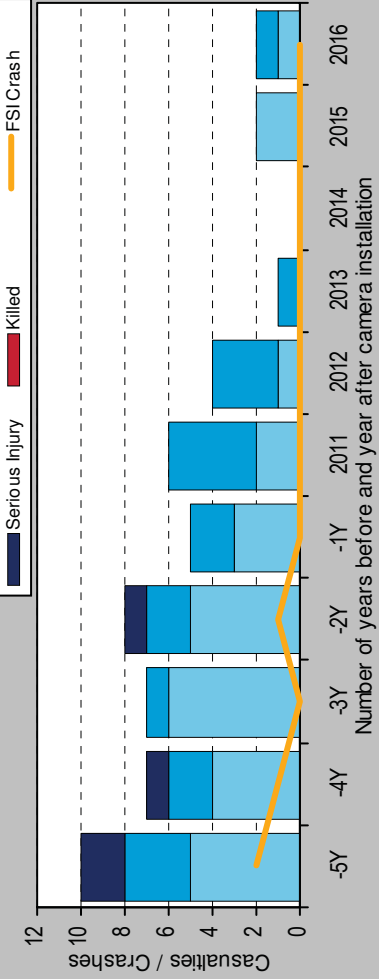
Casualties and FSI Crashes

Status: Retain.

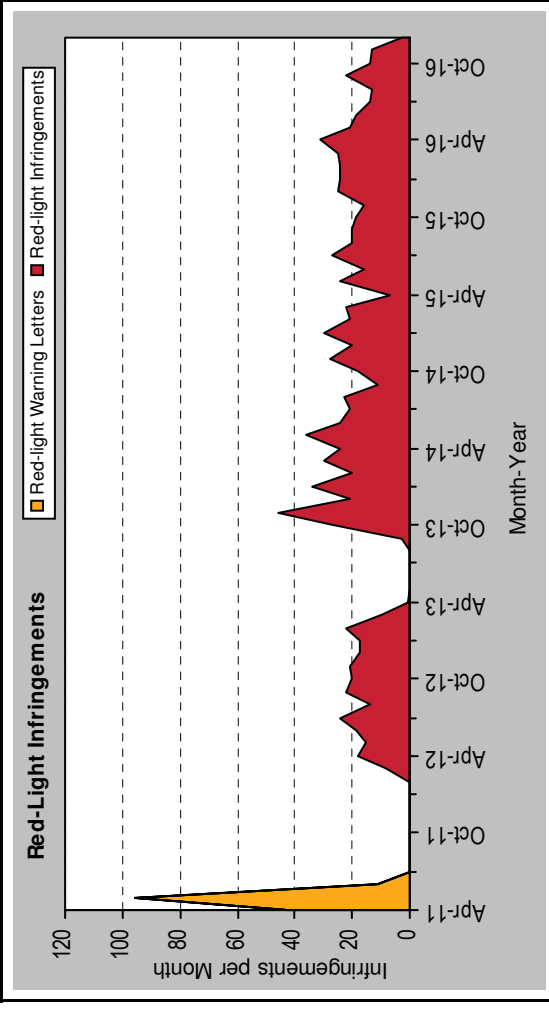
Infringements at enforced intersection

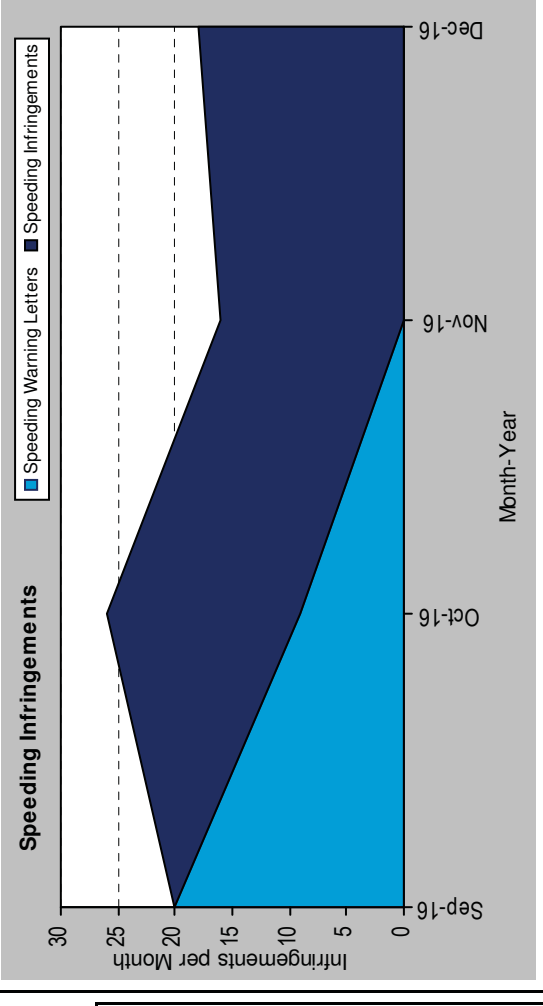
Infringements at enforced intersection

Status: Insufficient data (<5 years) to reliably assess.

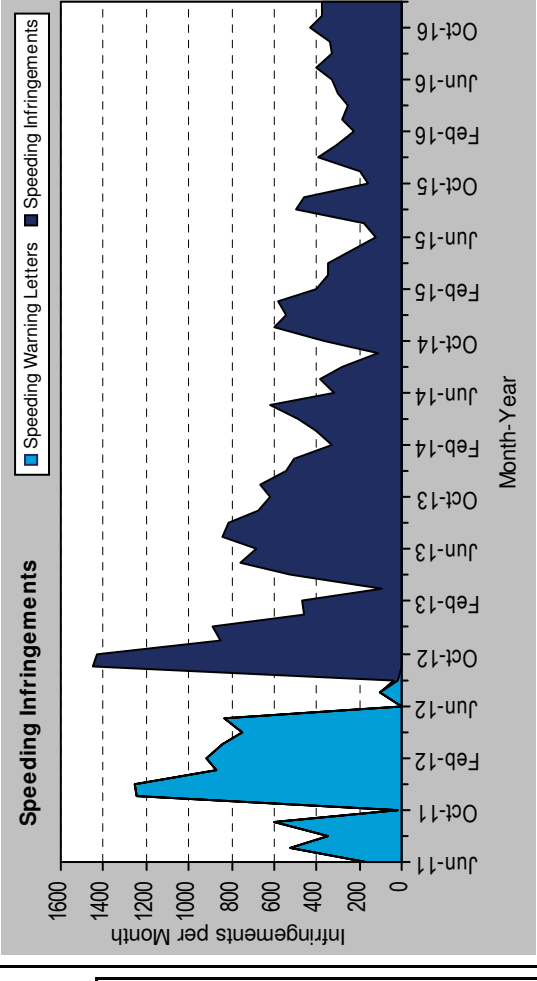
Infringements at enforced intersection

Status: Retain.
