Transport
for NSW

Centre for Road Safety

Speed Camera Programs: 2017 Annual Review

Author: Centre for Road Safety
Date: May 2018
Version: 0.6
Division: Freight, Strategy and Planning

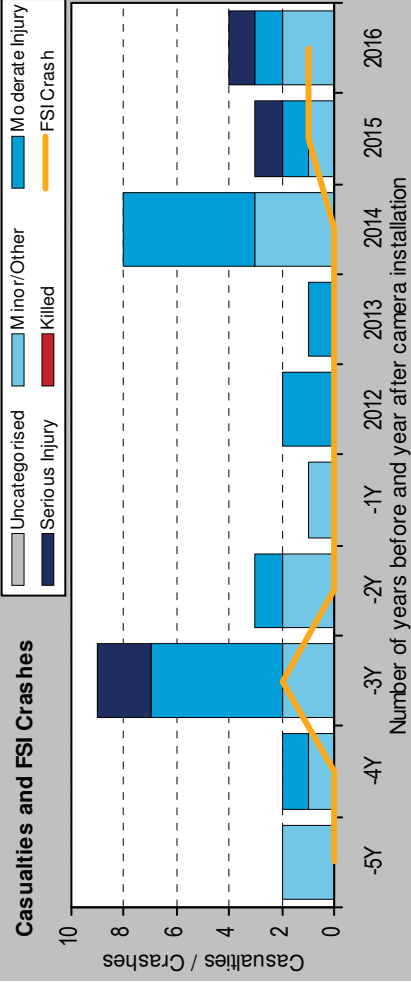
7198 Kirrawee - Acacia Road at President Avenue

Infringements at enforced intersection

Speeding Infringements

Casualties and FSI Crashes

Status: Retain.

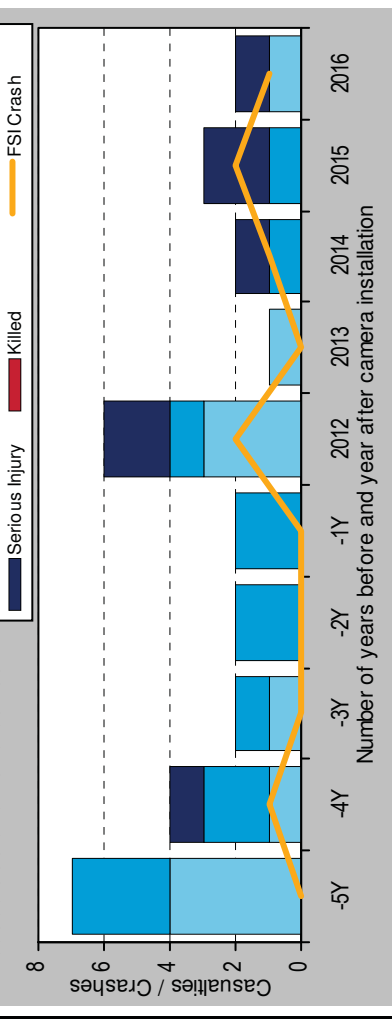
7195 Kogarah Bay - Park Road at Princes Highway

Infringements at enforced intersection

Speeding Infringements

Casualties and FSI Crashes

Status: Retain and Monitor. The previous wet-film red light camera may have influenced the before period data. Annual traffic counts have increased across NSW.

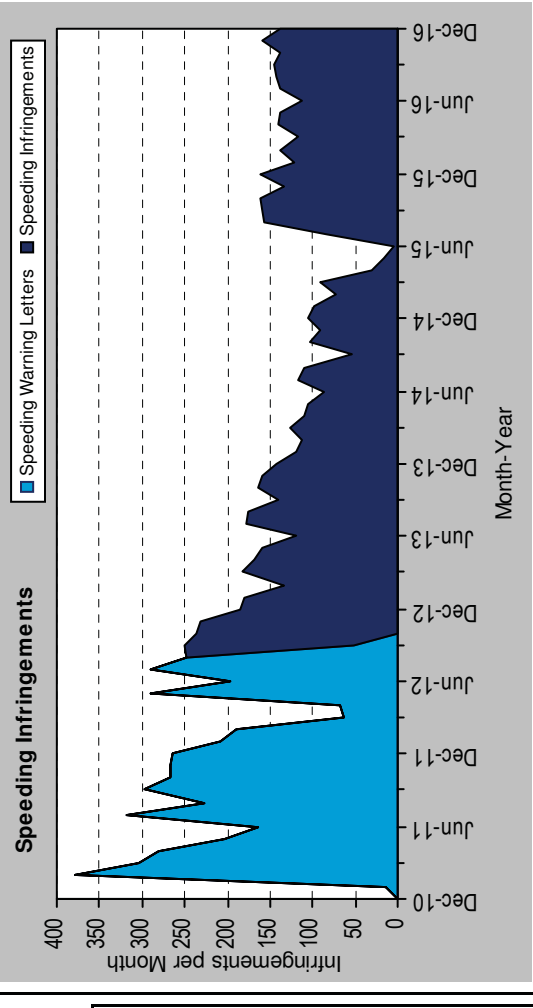
7205 Mosman - Military Road at Cowles Road

Infringements at enforced intersection

Speeding Infringements

Casualties and FSI Crashes

Status: Retain and Monitor. The previous wet-film red light camera may have influenced the before period data. Annual traffic counts have increased across NSW.

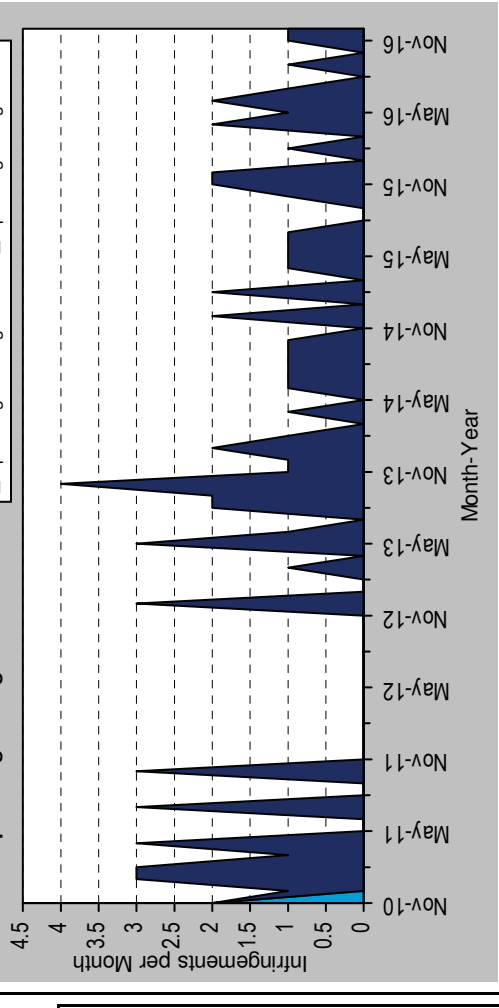
7185 North Ryde - Wicks Road at Epping Road

Infringements at enforced intersection

Speeding Infringements

Casualties and FSI Crashes

Status: Retain and Monitor. The previous wet-film red light camera may have influenced the before period data. Annual traffic counts have increased across NSW.

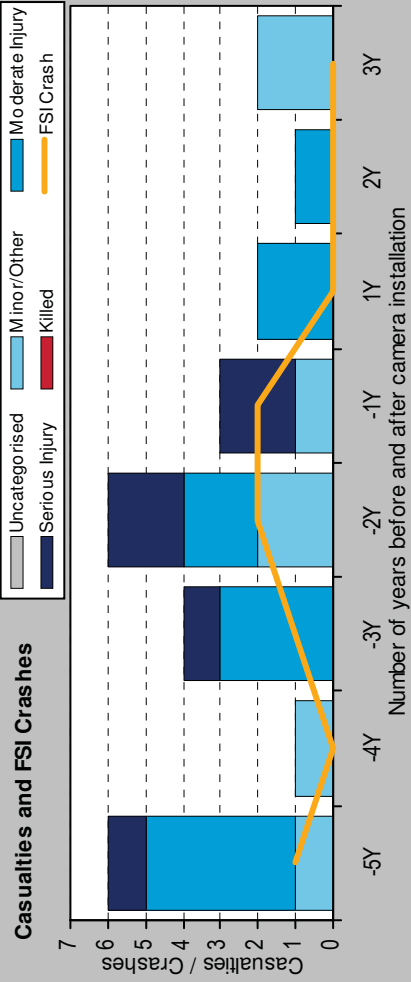
7283 Northmead - Briens Road at Redbank Road

Infringements at enforced intersection

Speeding Infringements

Casualties and FSI Crashes

Status: Insufficient data (<5 years) to reliably assess.

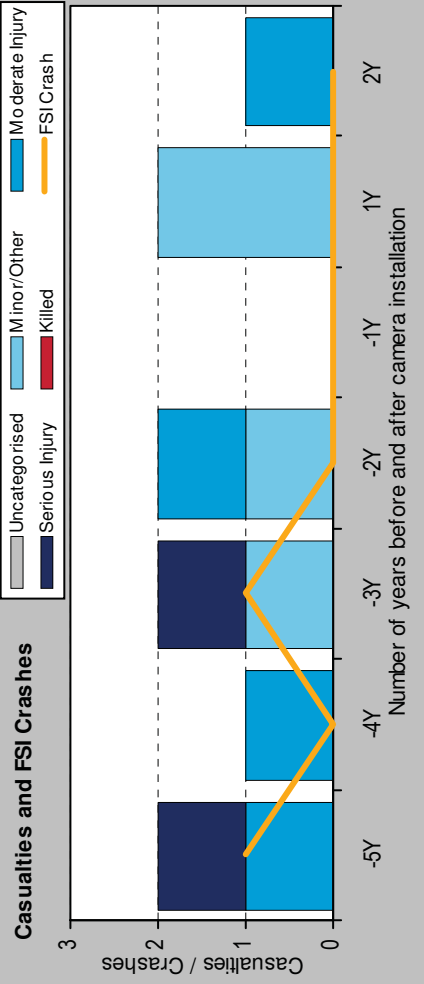
Casualties and FSI Crashes

Status: Insufficient data (<5 years) to reliably assess.

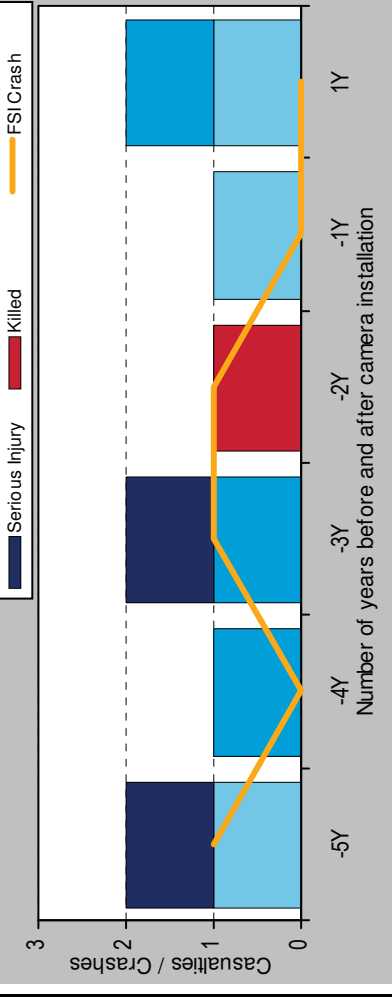
Casualties and FSI Crashes

Status: Insufficient data (<5 years) to reliably assess.

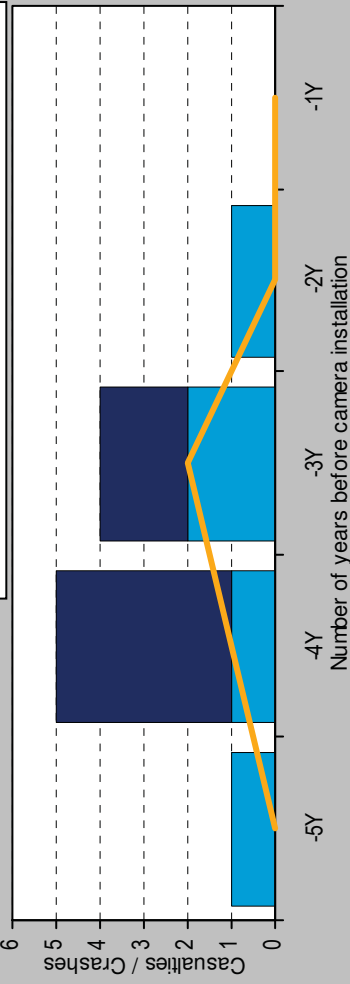
Casualties and FSI Crashes

Status: Insufficient data (<5 years) to reliably assess.

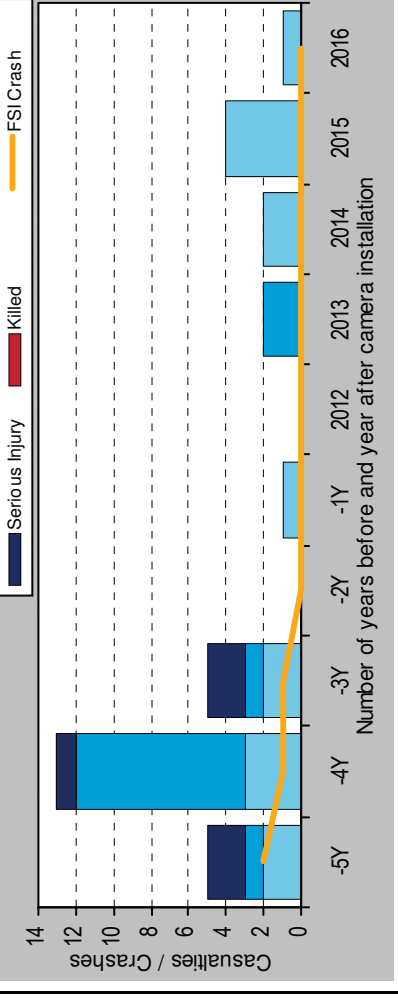
Casualties and FSI Crashes

Status: Retain.

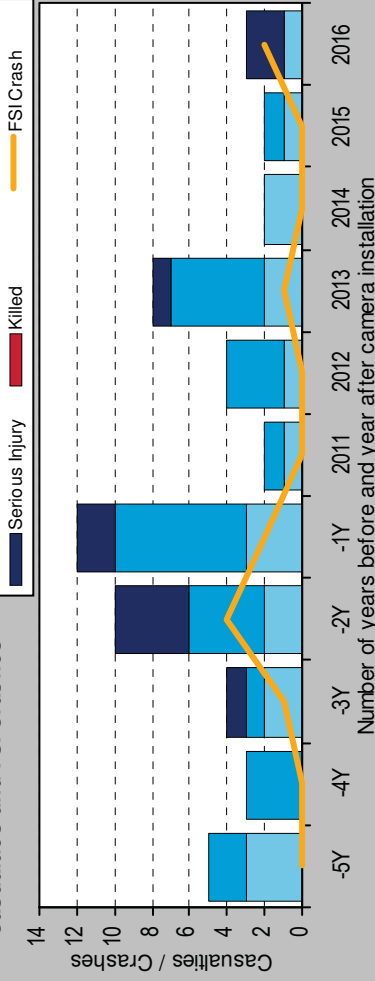
Casualties and FSI Crashes

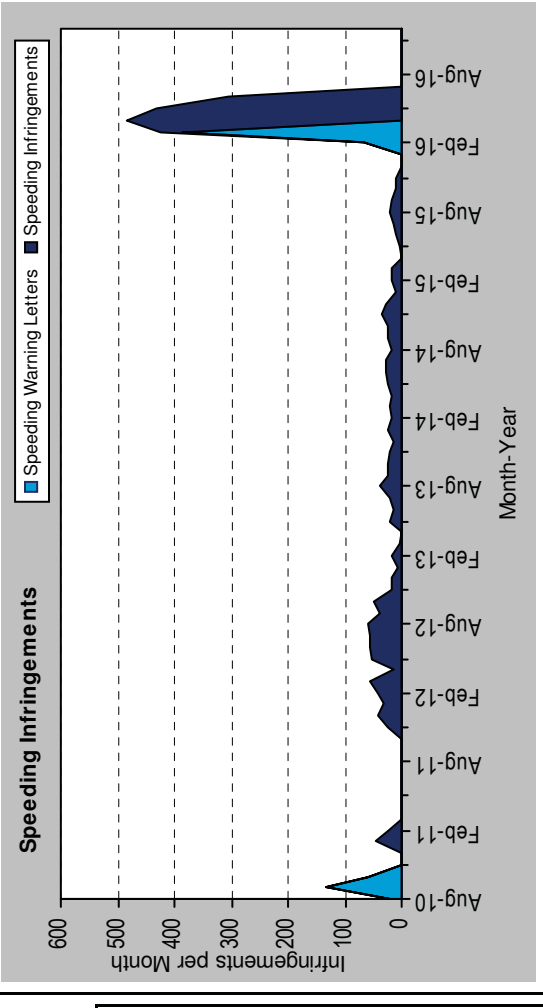
Speeding Infringements

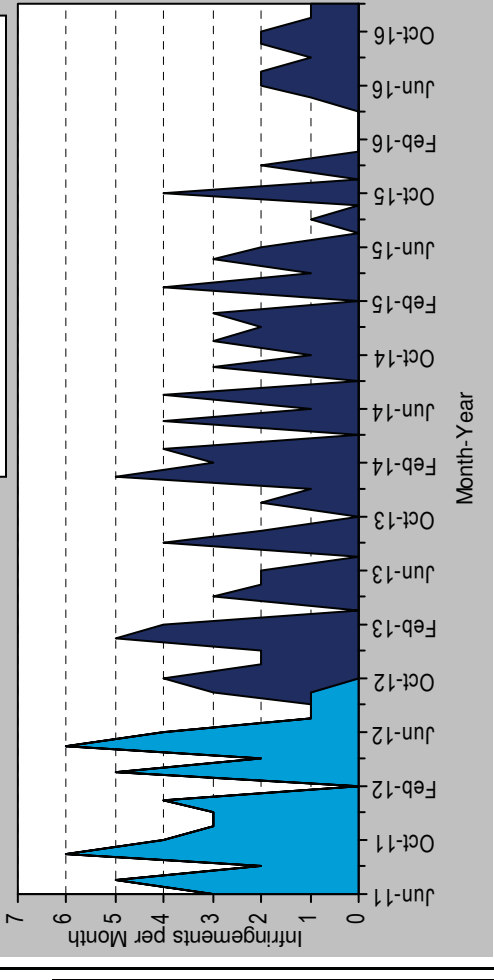
Speeding Infringements

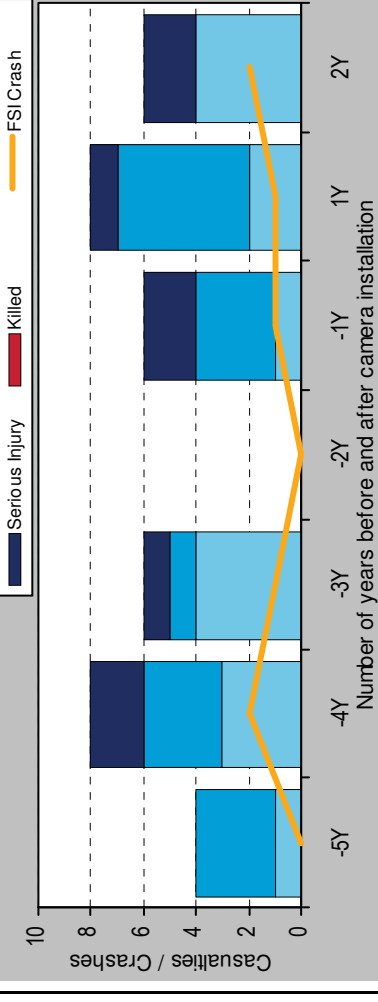
7106 Zetland - Bourke Street at Botany Road

Infringements at enforced intersection

Speeding Infringements

Casualties and FSI Crashes

Status: Insufficient data (<5 years) to reliably assess.

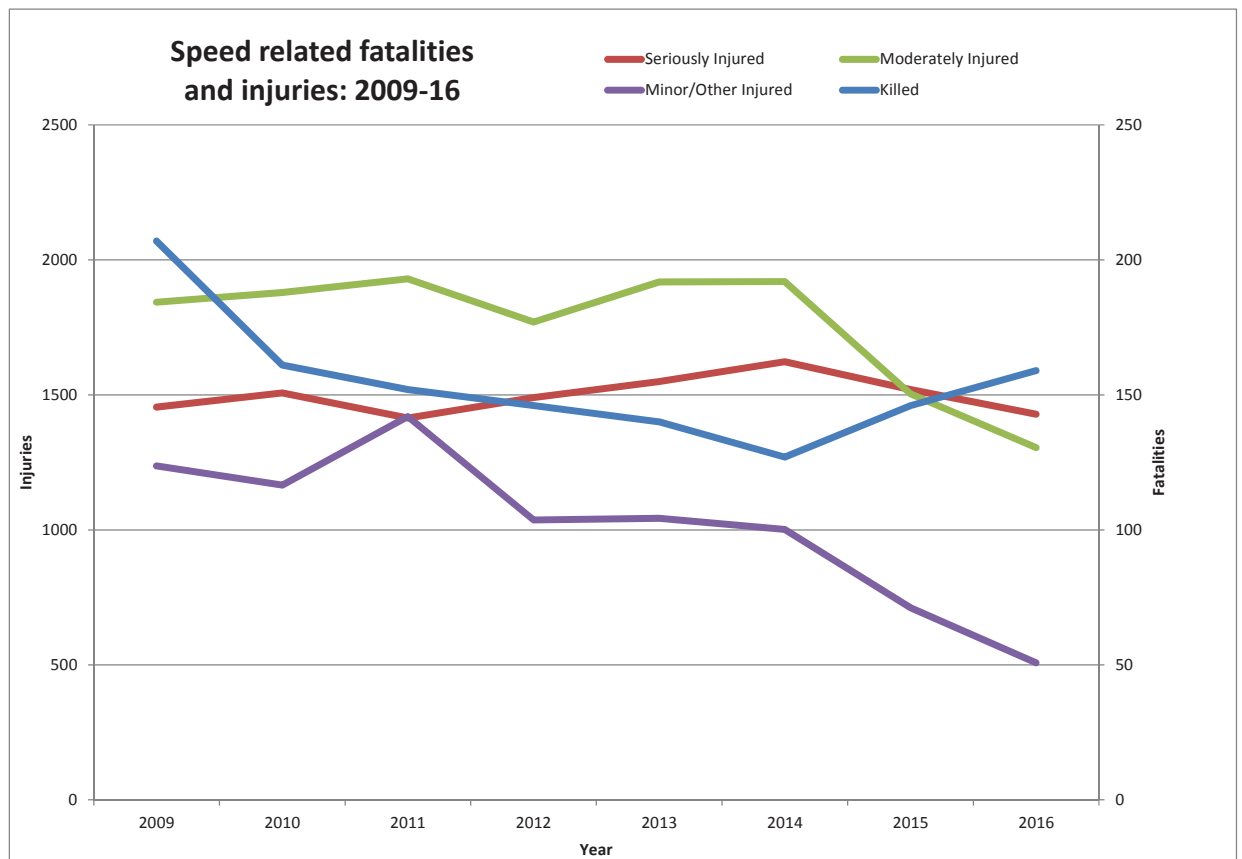
Figure C1: Speed-related fatalities and injuries, 2009-2016

There were 159 fatalities from excessive speed in 2016. This represents a 23 per cent reduction on 2009 figures (before the mobile speed camera program was reintroduced in NSW).

There were 1,428 serious injuries from speed related crashes in 2016. This represents a 2 per cent decrease on 2009 figures:
