Transport
for NSW

Centre for Road Safety

Speed Camera Programs: 2018 Annual Review

Author: Centre for Road Safety
Date: February 2019
Version: 1.0
Division: Safety, Environment & Regulation

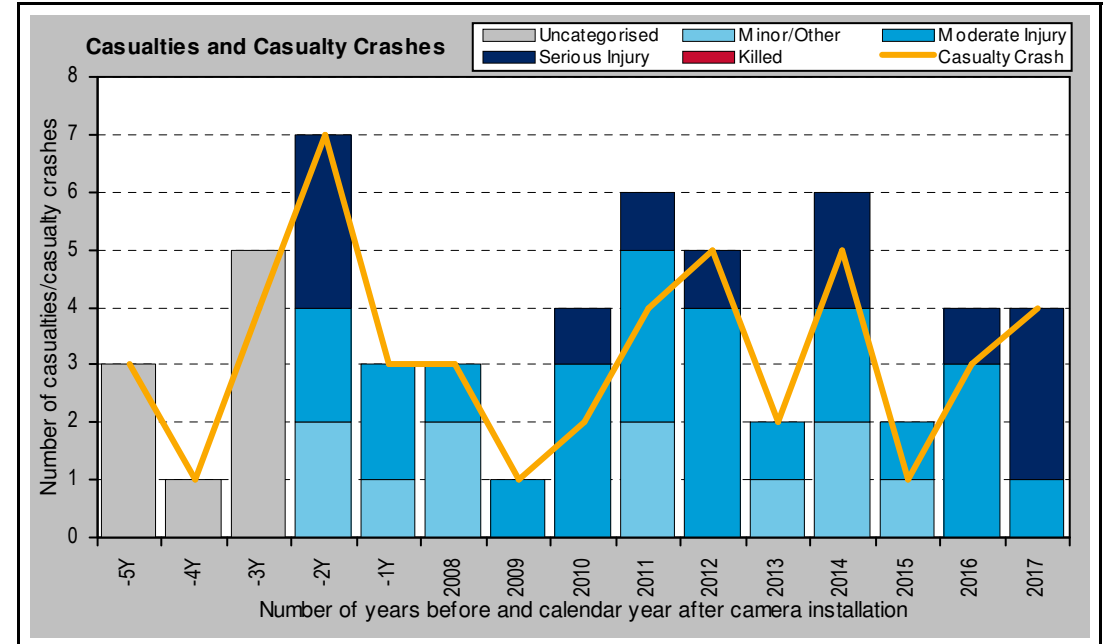
- When comparing the pre installation period to the most recent five year period, there has been a 17% decrease in casualty crashes at this fixed speed camera location. The data presented do not account for the prevailing statewide trend.
- The infringement graph details the trend in infringements at this location since the camera began operating. Roadworks and camera maintenance may influence the number of infringements issued.
- This location was reviewed in 2013 due to concerns about the increase in casualties in recent years. In the 2013 review it was recommended that the speed camera be retained.

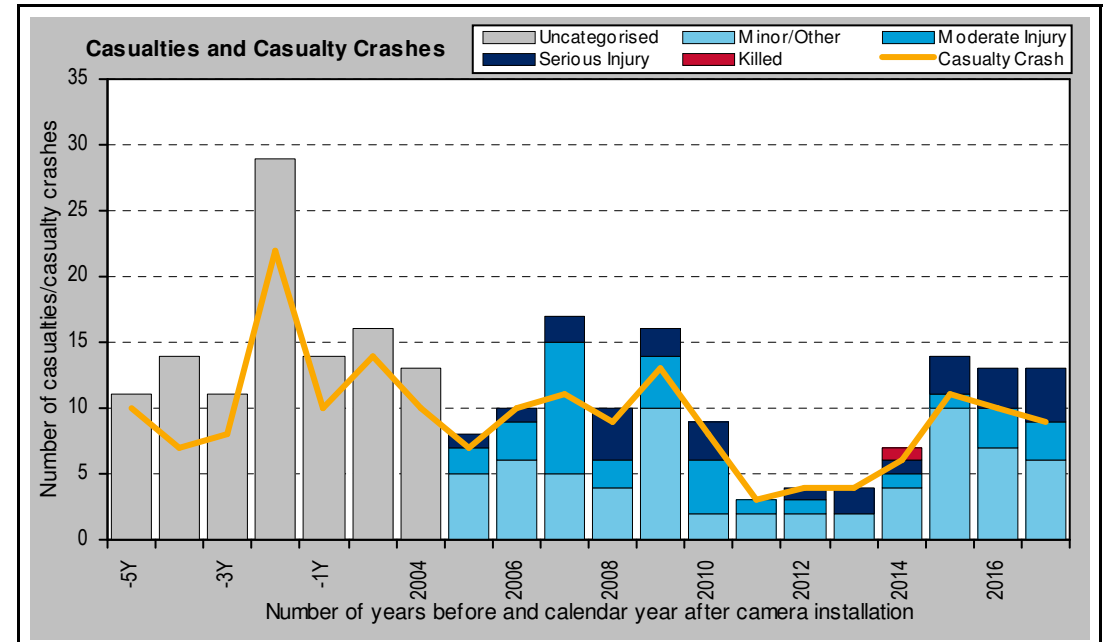
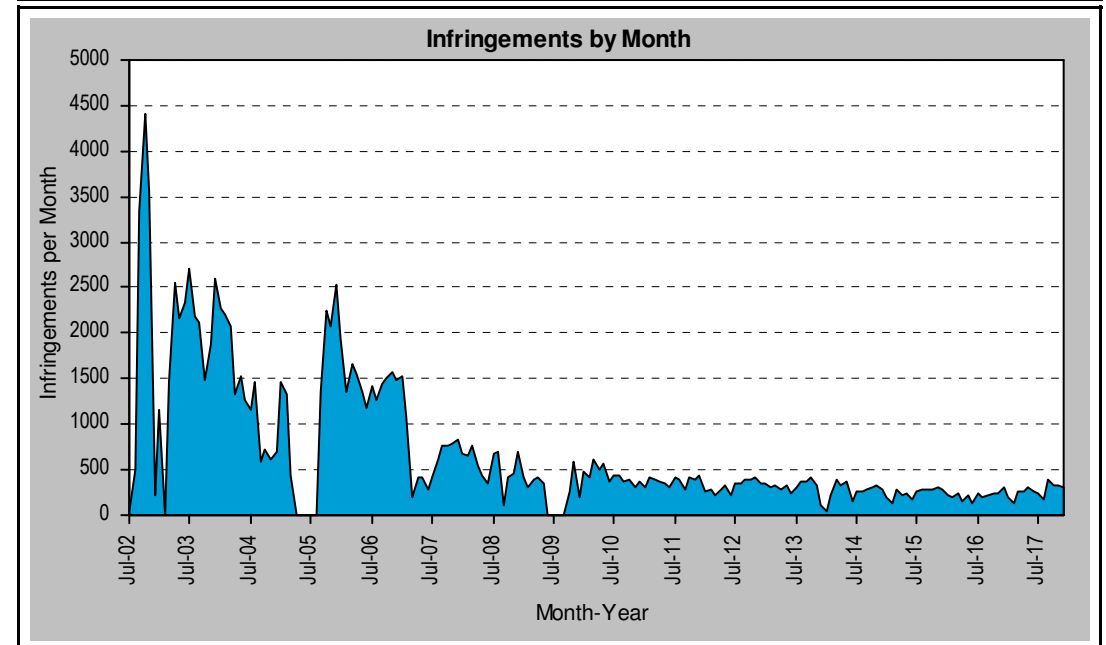
9534: Auburn - Parramatta Road, between Harbord Street and Duck Street

This location is 1000m in length, and is enforced with one camera.
The camera commenced operating on 15 May 2002.

- When comparing the pre installation period to the most recent five year period, there has been a 30% decrease in casualty crashes at this fixed speed camera location. The data presented do not account for the prevailing statewide trend.

- The infringement graph details the trend in infringements at this location since July 2002. Infringement data before this date is not available. Roadworks and camera maintenance may influence the number of infringements issued.

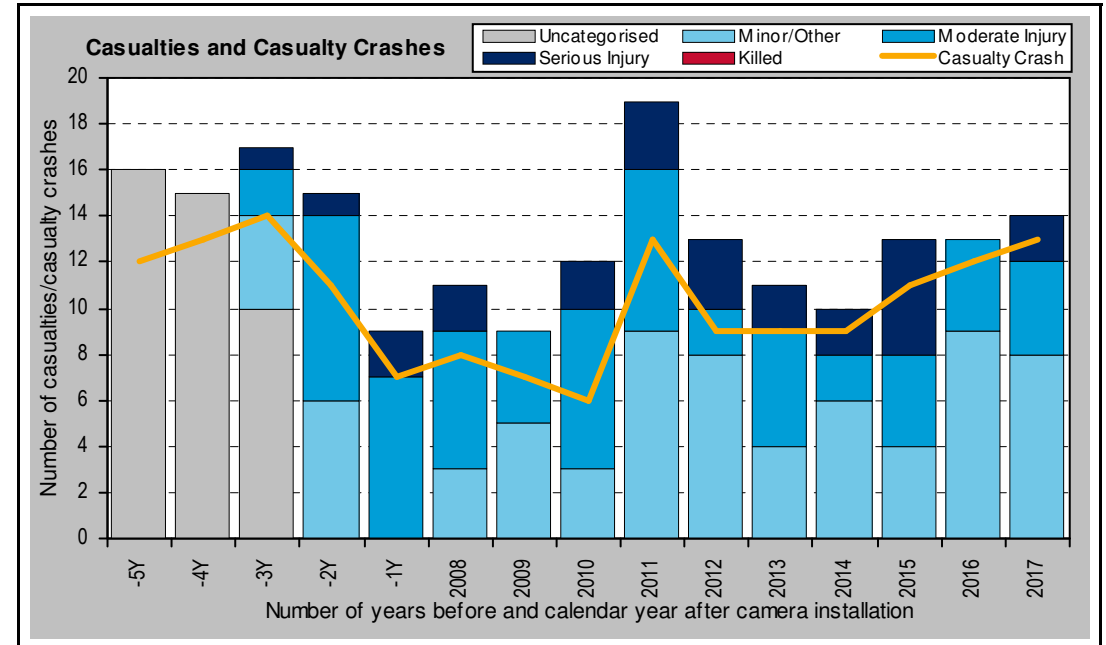
9818|9819: Bankstown - Hume Highway, between Rookwood Road and Stacey Street

- The infringement graph details the trend in infringements at this location since the camera began operating. Roadworks and camera maintenance may influence the number of infringements issued.

- This location was reviewed in 2013 due to concerns about the increase in casualties in recent years. The review found that during 2011 there were 28 casualties. This significant increase in the number of casualties included one crash involving a bus, resulting in 11 casualties. The number of casualty crashes has reduced in the following years. Speeding infringements were also found to have significantly reduced following the introduction of the speed cameras. It was recommended that the speed cameras be retained.

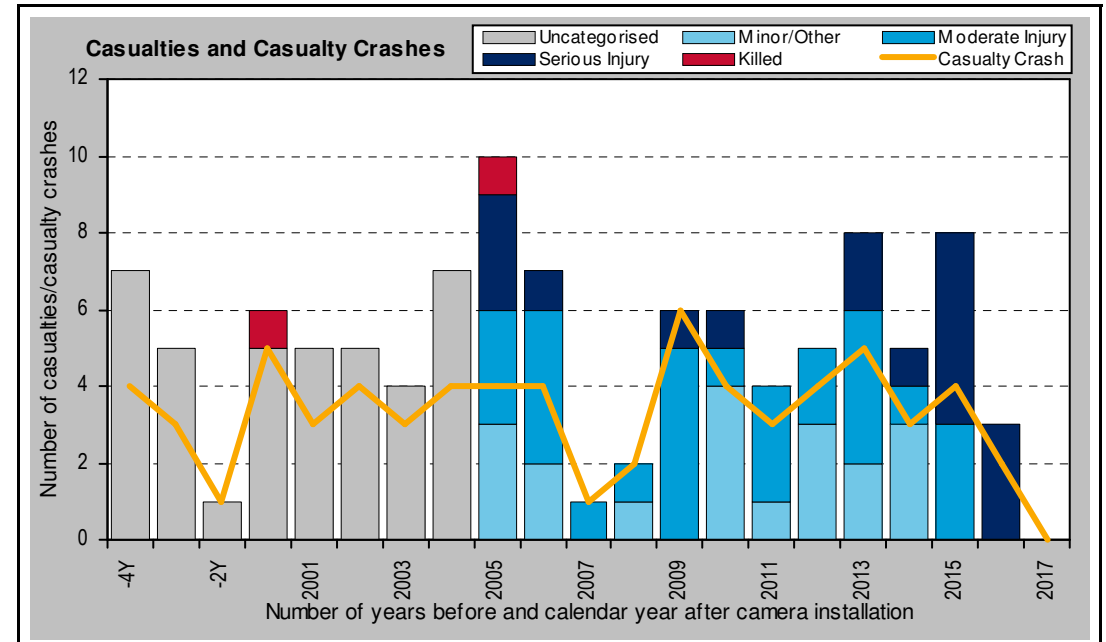
9643: Berkshire Park - Richmond Road, between Llandilo Road and Sanctuary Drive

This location is 1000m in length, and is enforced with one camera.
The camera commenced operating on 30 June 2000.

- When comparing the pre installation period to the most recent five year period, there has been a 14% decrease in casualty crashes at this fixed speed camera location. The data presented do not account for the prevailing statewide trend.
- The infringement graph details the trend in infringements at this location since July 2002. Infringement data before this date is not available. Roadworks and camera maintenance may influence the number of infringements issued.
- This location was reviewed in 2014. The safety review found that the speed camera continues to provide safety benefits and it was recommended that the speed camera be retained.

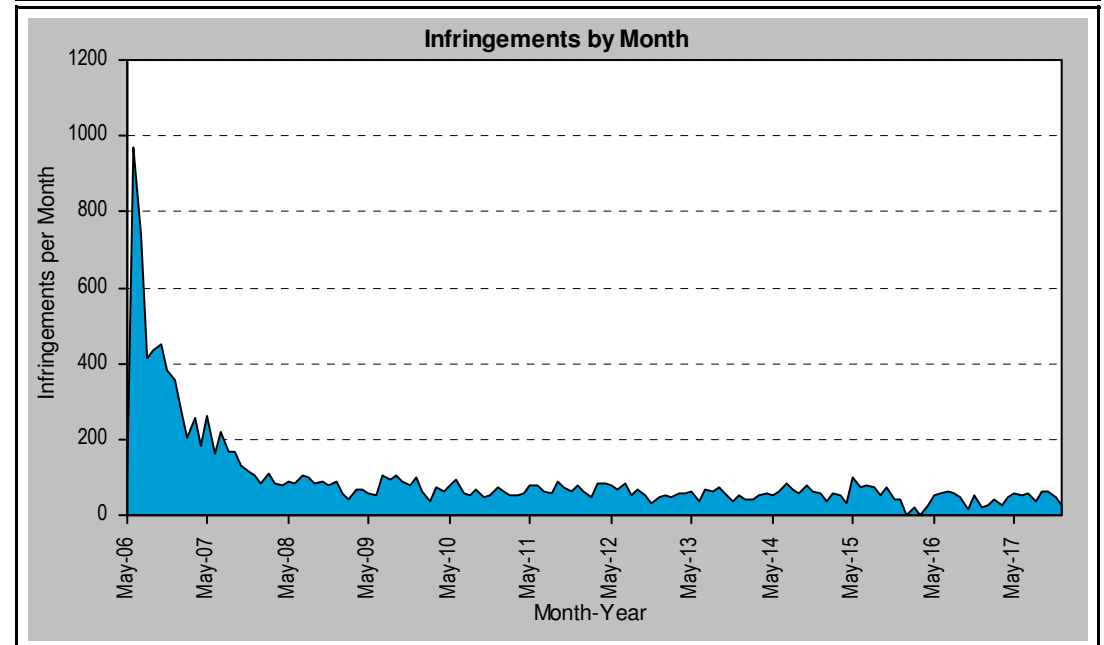
9617: Bexley North - Bexley Road, between Kingsland Road North and Miller Avenue

This location is 1000m in length, and is enforced with one camera.
The camera commenced operating on 29 May 2006.

- When comparing the pre installation period to the most recent five year period, there has been a 55% decrease in casualty crashes at this fixed speed camera location. The data presented do not account for the prevailing statewide trend.
- The infringement graph details the trend in infringements at this location since the camera began operating. Roadworks and camera maintenance may influence the number of infringements issued.

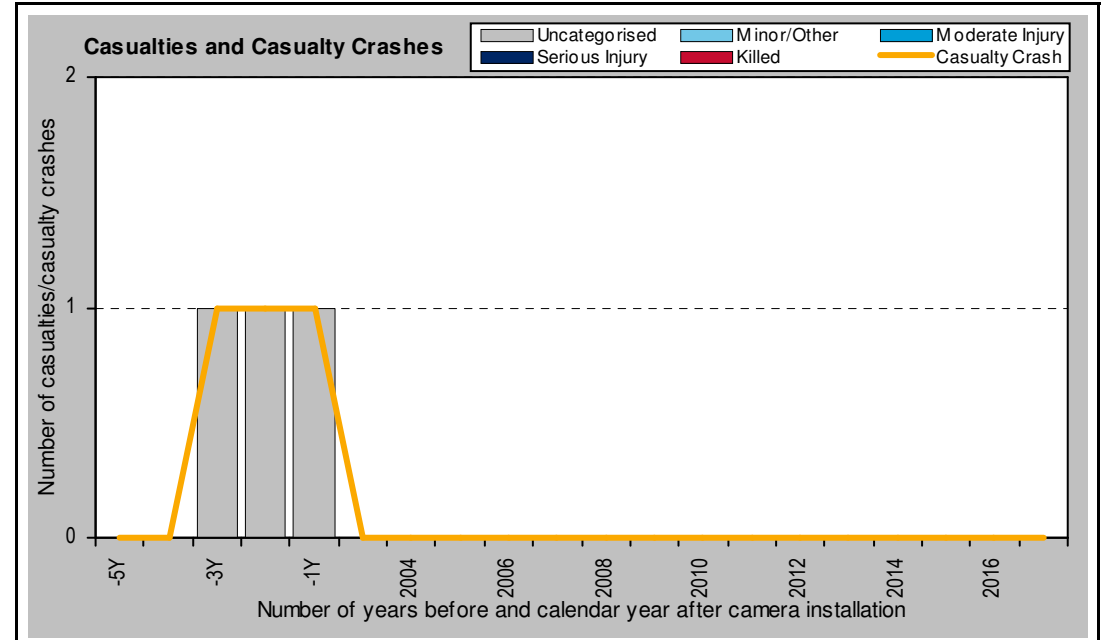
9579: Blandford - New England Highway, between Hayles Street and Mills Street

This location is 1000m in length, and is enforced with one camera.
The camera commenced operating on 10 April 2002.

- When comparing the pre installation period to the most recent five year period, there has been a 100% decrease in casualty crashes at this fixed speed camera location. The data presented do not account for the prevailing statewide trend.

- The infringement graph details the trend in infringements at this location since July 2002. Infringement data before this date is not available. Roadworks and camera maintenance may influence the number of infringements issued.

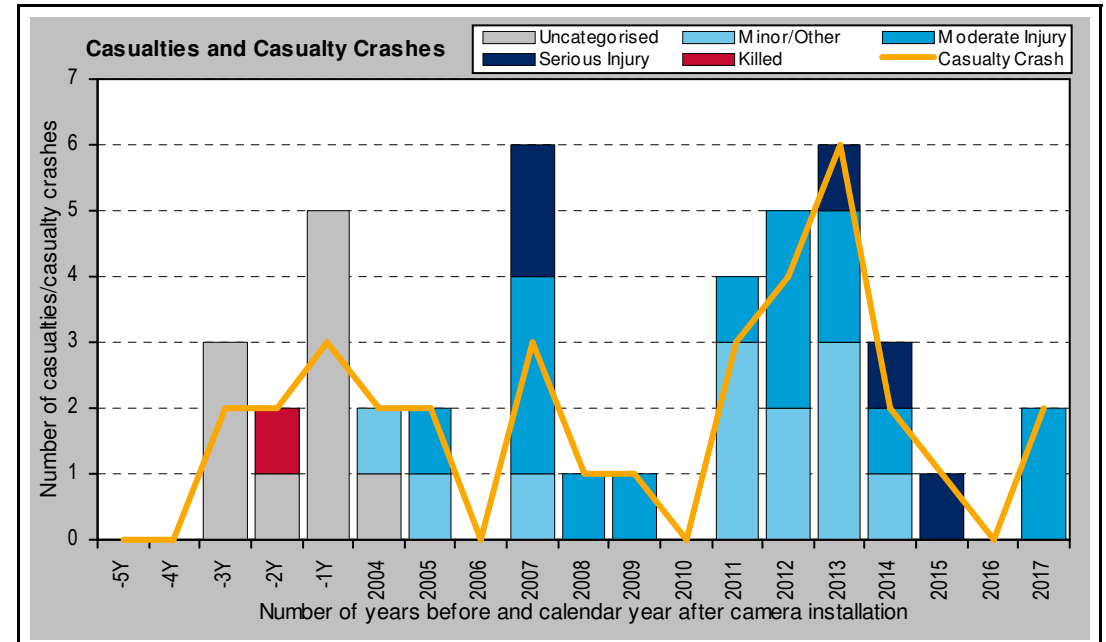
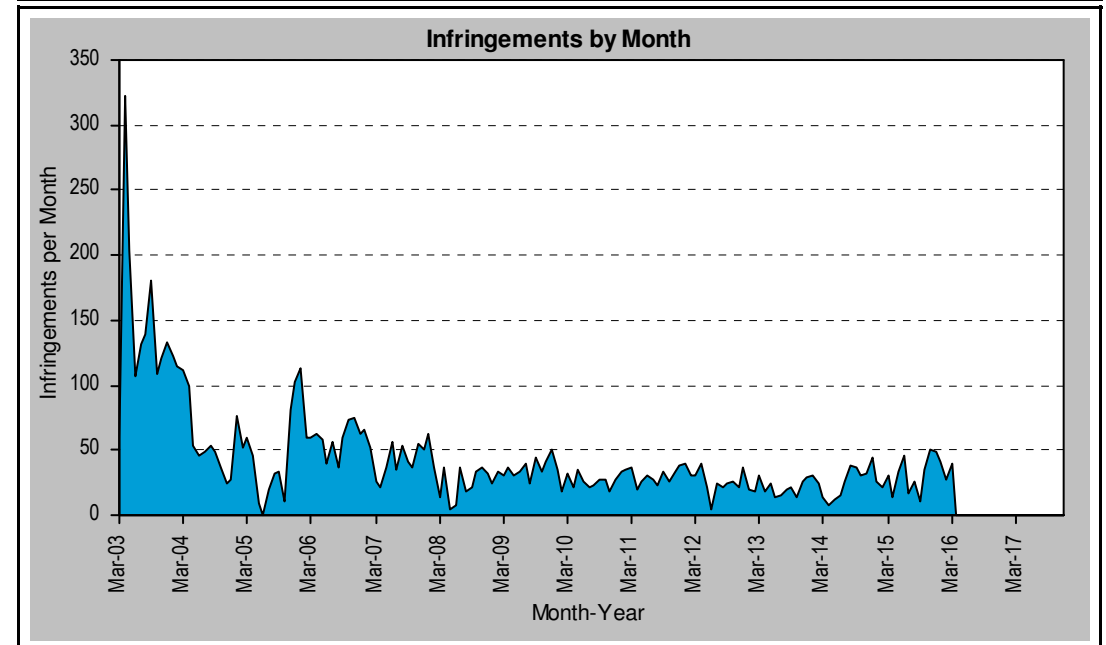
9594: Bomaderry - Bolong Road, between Beinda Street and Coomea Street

This location is 1000m in length, and is enforced with one camera.
The camera commenced operating on 31 March 2003.

- When comparing the pre installation period to the most recent five year period, there has been a 57% increase in casualty crashes at this fixed speed camera location. The increase in casualty crashes is not statistically significant. The data presented do not account for the prevailing statewide trend.
- The infringement graph details the trend in infringements at this location since the camera began operating. Roadworks and camera maintenance may influence the number of infringements issued.

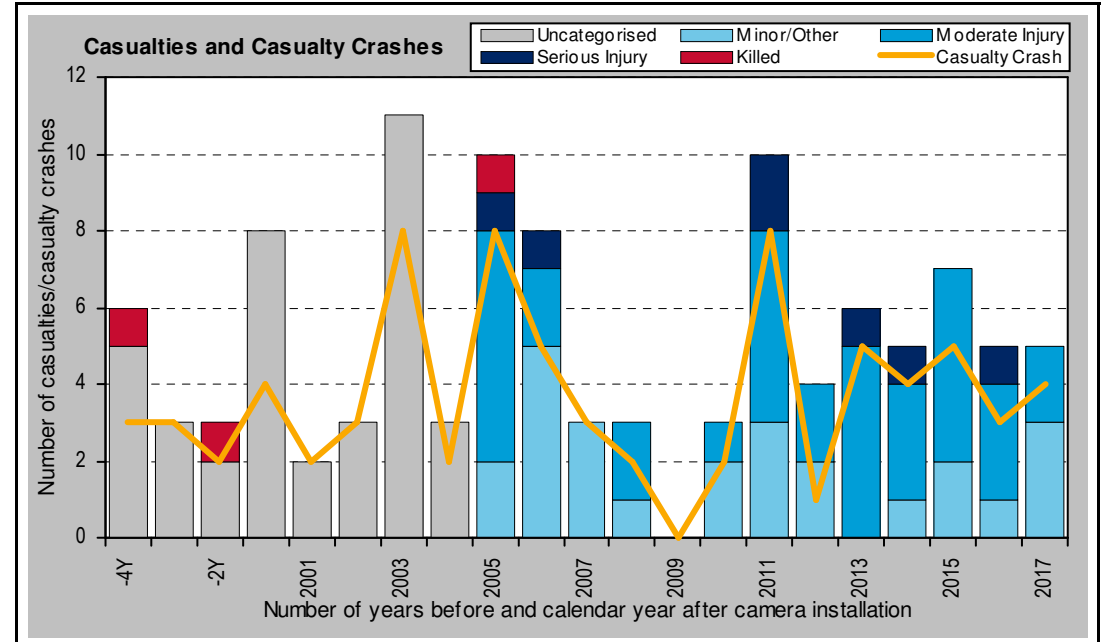
9645: Bonnyrigg - Elizabeth Drive, between Brown Road and Humphries Road

This location is 1000m in length, and is enforced with one camera.
The camera commenced operating on 7 July 2000.

- When comparing the pre installation period to the most recent five year period, there has been a 40% increase in casualty crashes at this fixed speed camera location. The increase in casualty crashes is not statistically significant. The data presented do not account for the prevailing statewide trend.
- The infringement graph details the trend in infringements at this location since July 2002. Infringement data before this date is not available. The spike in infringements from July 2007 can be attributed to the camera commencing speed enforcement of both directions of traffic where it previously enforced one direction. Since then, there has been a reduction in speeding behaviour at this location over time. Roadworks and camera maintenance may influence the number of infringements issued.
- A desktop review of this location was undertaken in 2015.

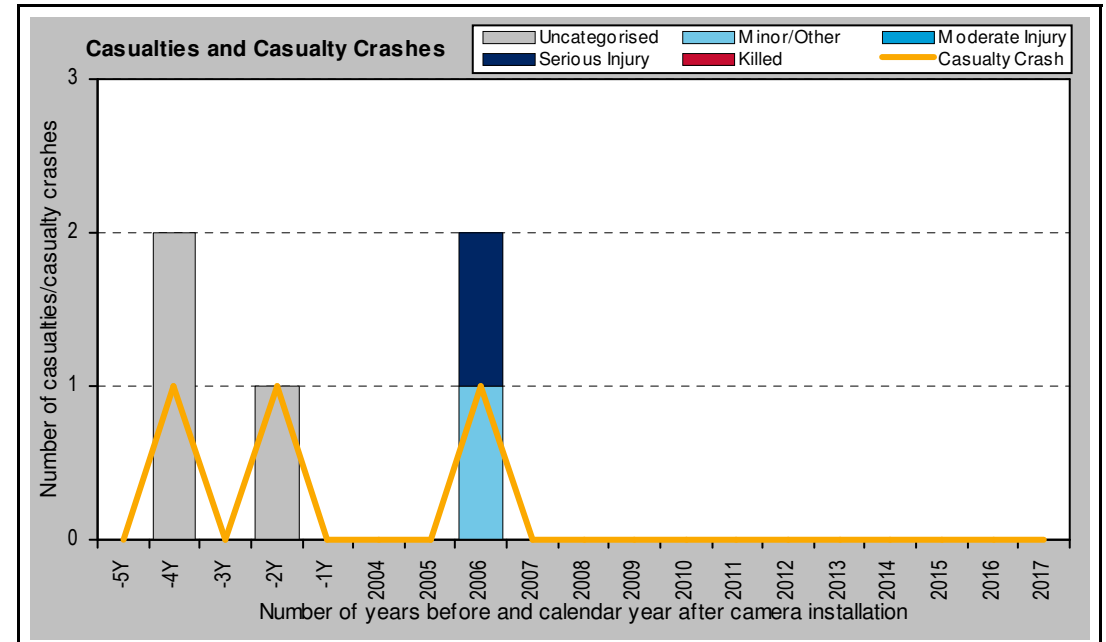
9612: Brogo - Princes Highway, between Pioneer Close and Brogo River

This location is 1000m in length, and is enforced with one camera.
The camera commenced operating on 2 May 2003.

- When comparing the pre installation period to the most recent five year period, there has been a 100% decrease in casualty crashes at this fixed speed camera location. The data presented do not account for the prevailing statewide trend.
- The infringement graph details the trend in infringements at this location since the camera began operating. Roadworks and camera maintenance may influence the number of infringements issued.

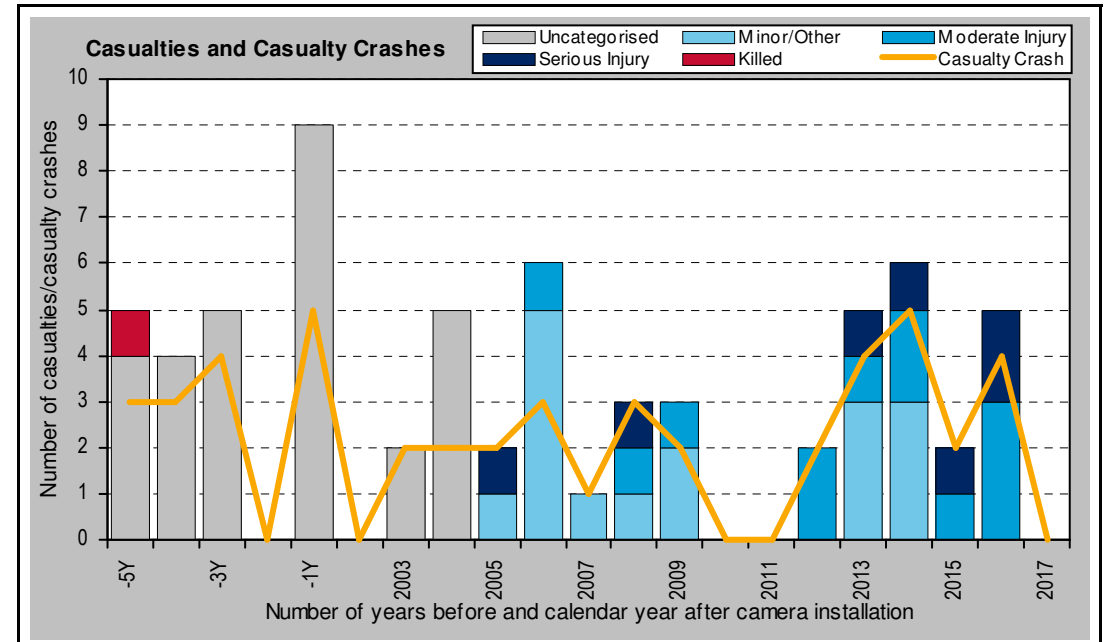
9626: Caringbah - Captain Cook Drive, between Cawarra Road and Gannons Road

- When comparing the pre installation period to the most recent five year period, there has been no change in casualty crashes at this fixed speed camera location. The change in casualty crashes is not statistically significant. The data presented do not account for the prevailing statewide trend.
- The infringement graph details the trend in infringements at this location since July 2002. Infringement data before this date is not available. No infringements were recorded at this location from November 2010 to May 2011 as a replacement camera was installed. Roadworks and camera maintenance may influence the number of infringements issued.

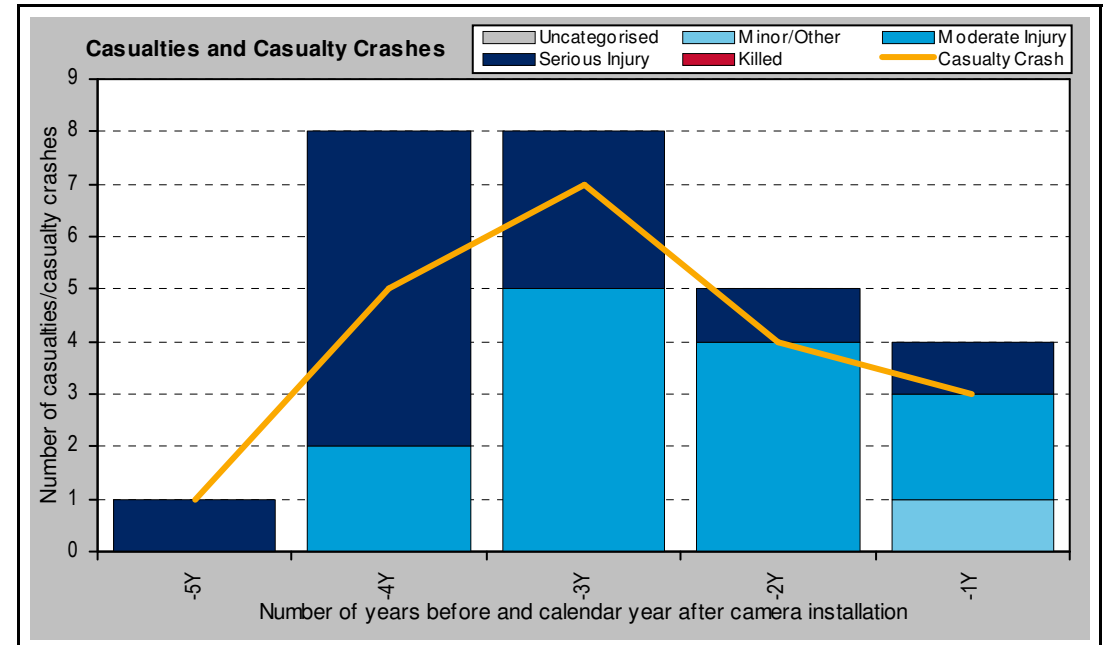
9669: Engadine - Heathcote Road, between Forum Drive and New Illawarra Road

- CRS will develop further commentary when there is additional data available for this location in the future.
- The infringement graph details the trend in infringements at this location since the camera began operating. Roadworks and camera maintenance may influence the number of infringements issued.

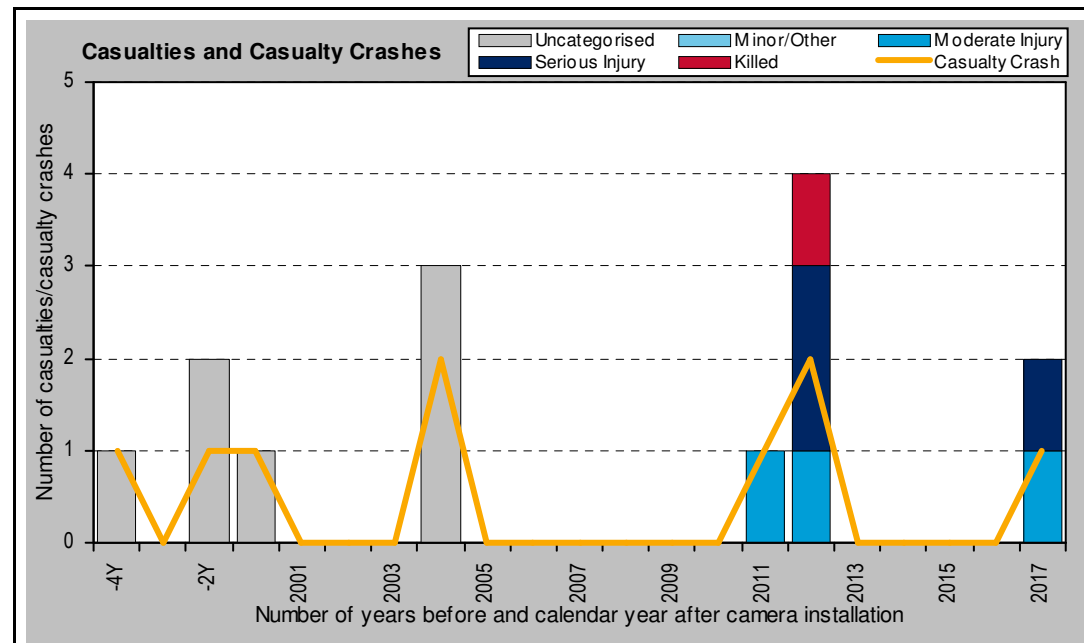
- When comparing the pre installation period to the most recent five year period, there has been a 73% decrease in casualty crashes at this fixed speed camera location. The data presented do not account for the prevailing statewide trend.
- The infringement graph details the trend in infringements at this location since July 2002. Infringement data before this date is not available. Roadworks and camera maintenance may influence the number of infringements issued.
- This location was recommended for review in the 2014 annual speed camera review.

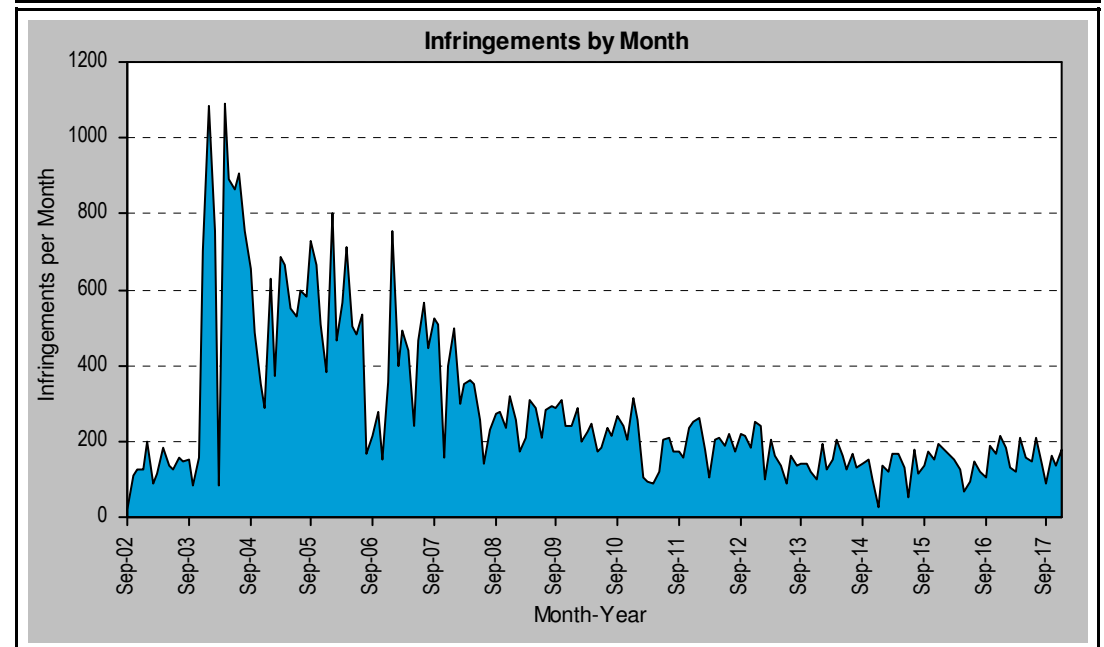
- When comparing the pre installation period to the most recent five year period, there has been a 100% decrease in casualty crashes at this fixed speed camera location. The data presented do not account for the prevailing statewide trend.
- The infringement graph details the trend in infringements at this location since the camera began operating. Roadworks and camera maintenance may influence the number of infringements issued.

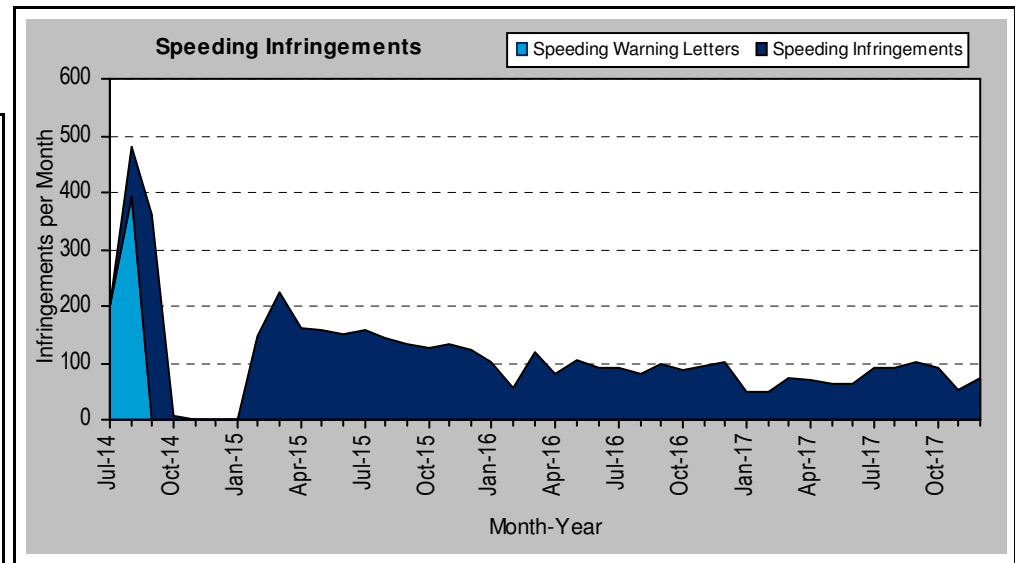
Infringements at enforced intersection

- There is one camera at this intersection.
- The camera at the intersection of Rookwood Road and Bruncker Road commenced issuing warning letters in July 2014.
- The infringement graphs show the number of warning letters and infringements issued at this intersection as well as the trend in infringements since the camera began operation. Roadworks and camera maintenance may influence the number of infringements issued.
