Transport
for NSW

Centre for Road Safety

Speed Camera Programs: 2019 Annual Review

Author: Centre for Road Safety
Date: March 2021
Version: 1.0
Division: Safety, Environment & Regulation

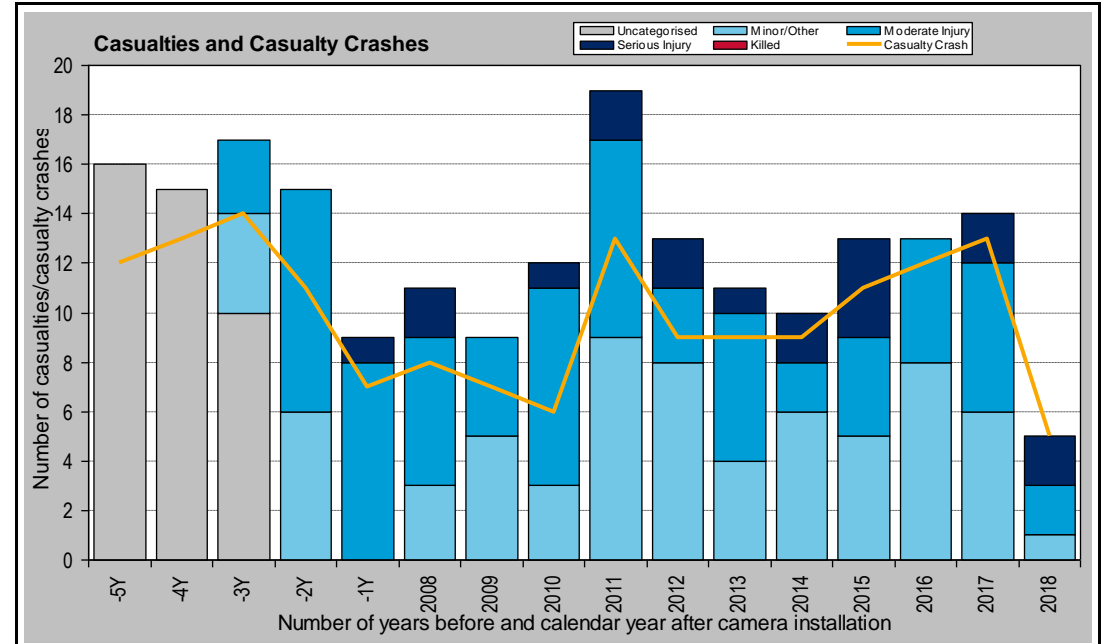
9818|9819: Bankstown - Hume Highway, between Rookwood Road and Stacey Street

- The infringement graph details the trend in infringements at this location since the camera began operating. Roadworks and camera maintenance may influence the number of infringements issued.

- This location was reviewed in 2013 due to concerns about the increase in casualties in recent years. The review found that during 2011 there were 28 casualties. This significant increase in the number of casualties included one crash involving a bus, resulting in 11 casualties. The number of casualty crashes has reduced in the following years. Speeding infringements were also found to have significantly reduced following the introduction of the speed cameras. It was recommended that the speed cameras be retained.

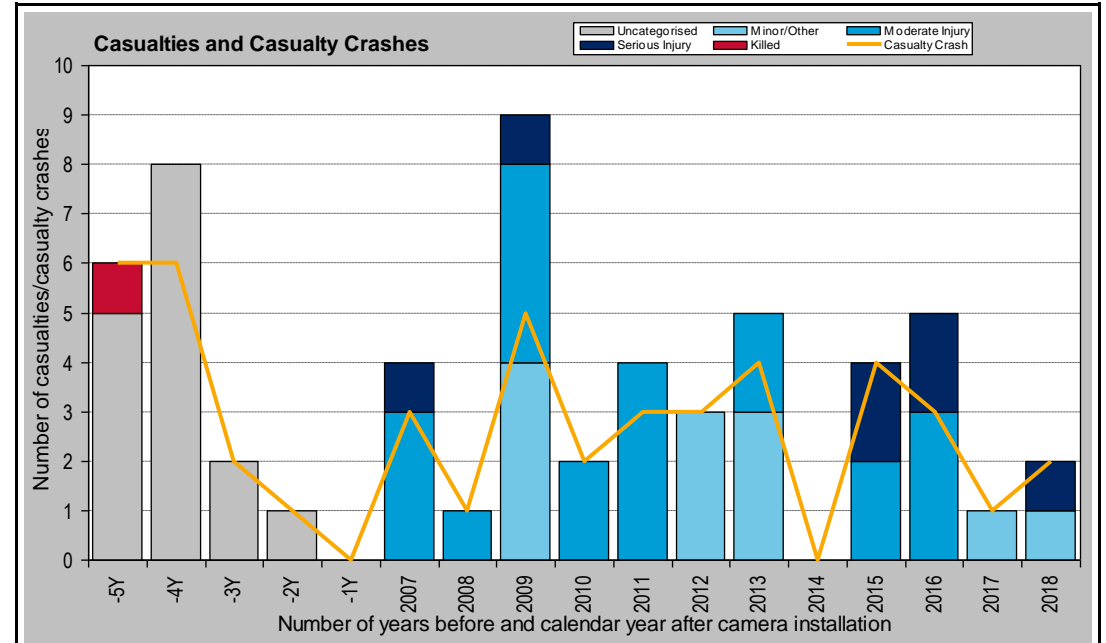
9616: Bar Point - M1 Pacific Motorway, between Jolls Bridge and Mt White Exit Ramp

This location is 1000m in length, and is enforced with one camera.
The camera commenced operating on 10 April 2006.

- When comparing the pre installation period to the most recent five year period, there has been a 33% decrease in casualty crashes at this fixed speed camera location. The data presented do not account for the prevailing statewide trend.
- The infringement graph details the trend in infringements at this location since the camera began operating. Roadworks and camera maintenance may influence the number of infringements issued.

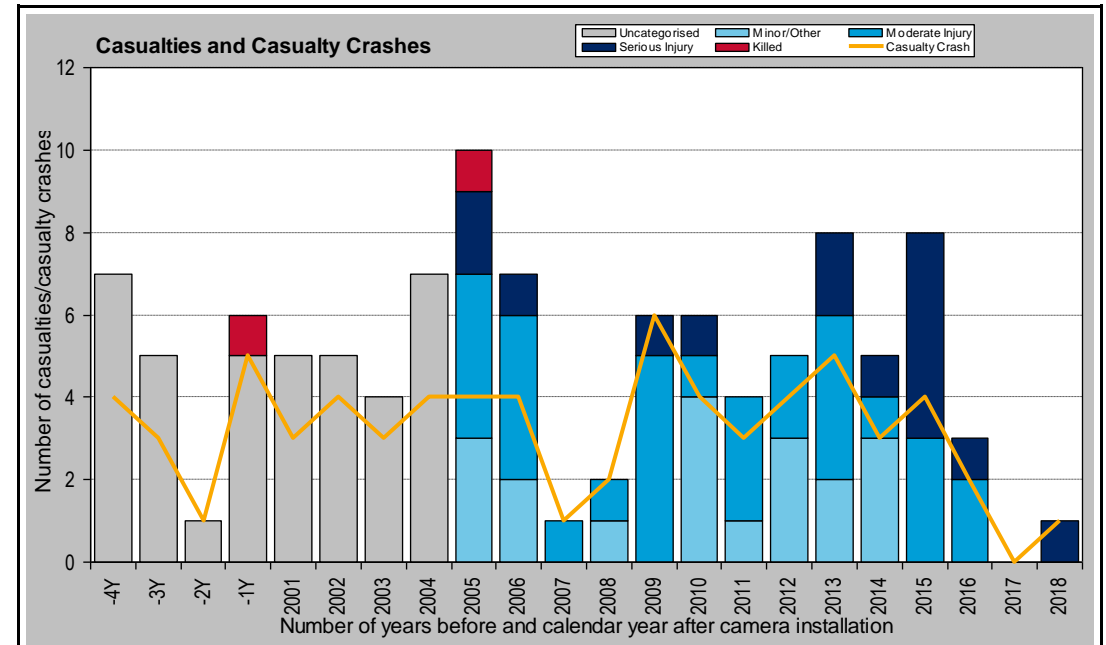
9643: Berkshire Park - Richmond Road, between Llandilo Road and Sanctuary Drive

This location is 1000m in length, and is enforced with one camera.
The camera commenced operating on 30 June 2000.

- When comparing the pre installation period to the most recent five year period, there has been a 38% decrease in casualty crashes at this fixed speed camera location. The data presented do not account for the prevailing statewide trend.
- The infringement graph details the trend in infringements at this location since July 2002. Infringement data before this date is not available. Roadworks and camera maintenance may influence the number of infringements issued.
- This location was reviewed in 2014. The safety review found that the speed camera continues to provide safety benefits and it was recommended that the speed camera be retained.

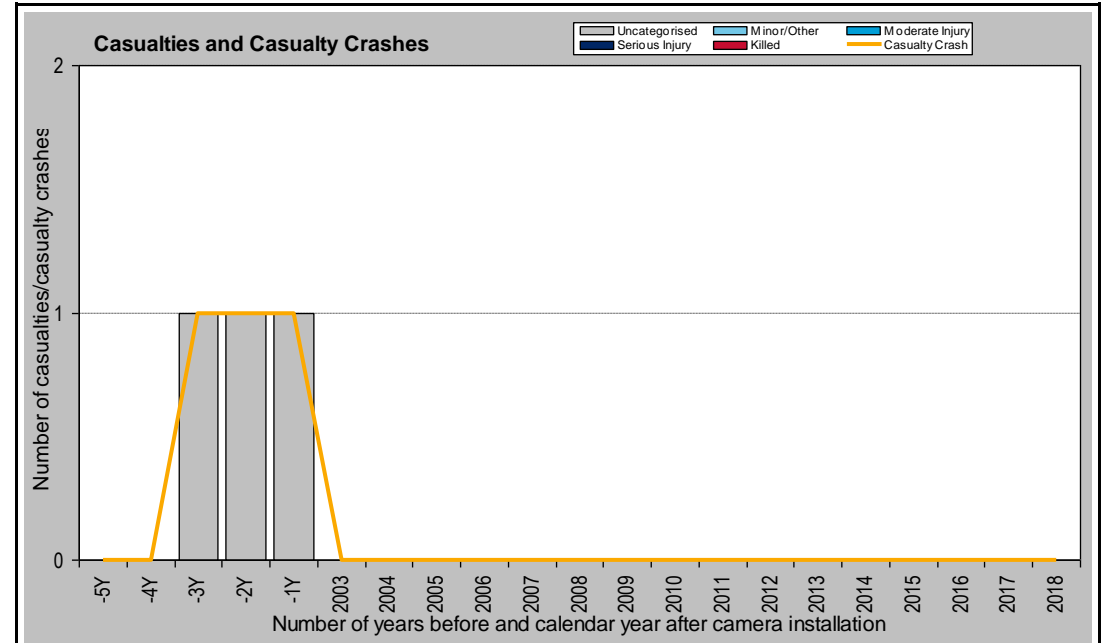
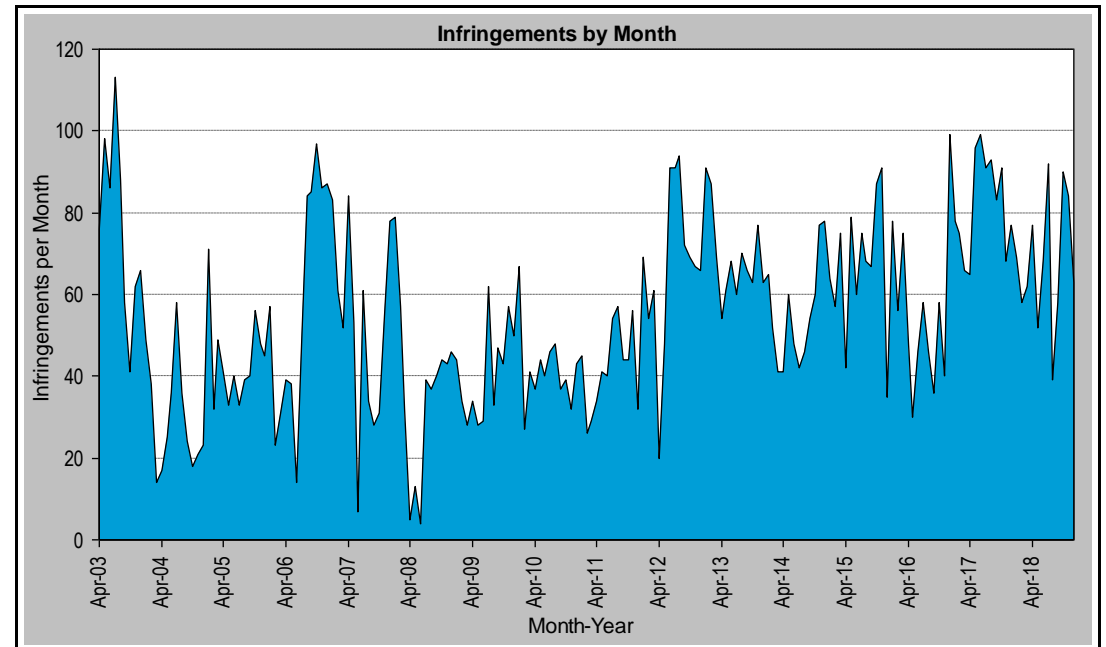
9579: Blandford - New England Highway, between Hayles Street and Mills Street

This location is 1000m in length, and is enforced with one camera.
The camera commenced operating on 10 April 2002.

- When comparing the pre installation period to the most recent five year period, there has been a 100% decrease in casualty crashes at this fixed speed camera location. The data presented do not account for the prevailing statewide trend.

- The infringement graph details the trend in infringements at this location since July 2002. Infringement data before this date is not available. Roadworks and camera maintenance may influence the number of infringements issued.

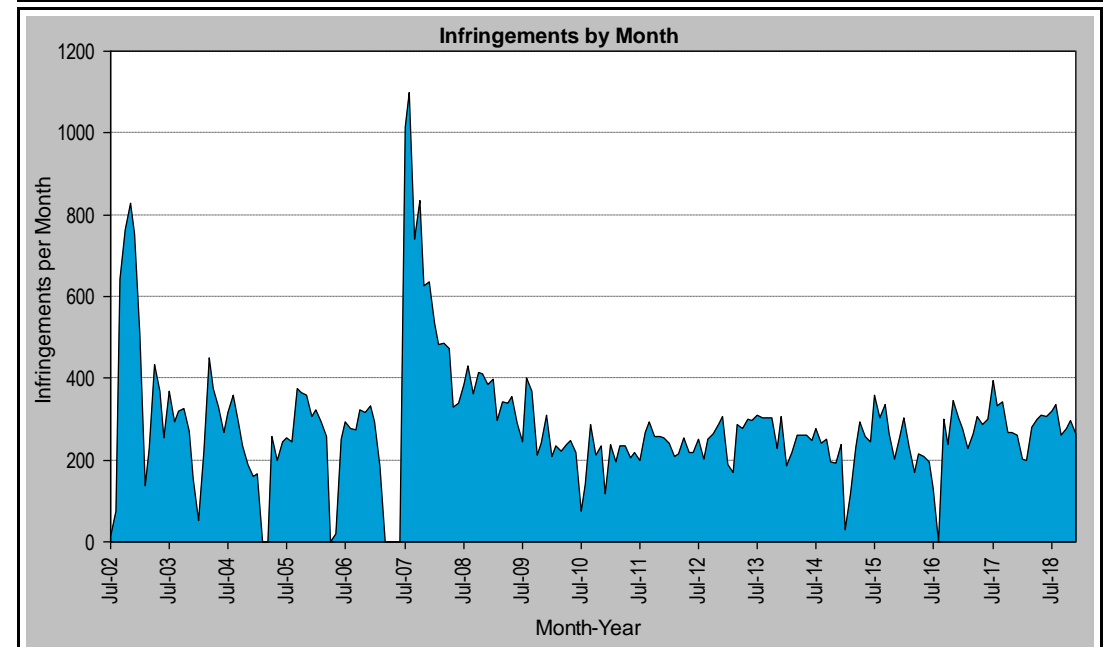
9645: Bonnyrigg - Elizabeth Drive, between Brown Road and Humphries Road

This location is 1000m in length, and is enforced with one camera.
The camera commenced operating on 7 July 2000.

- When comparing the pre installation period to the most recent five year period, there has been a 20% increase in casualty crashes at this fixed speed camera location. The increase in casualty crashes is not statistically significant. The data presented do not account for the prevailing statewide trend.
- The infringement graph details the trend in infringements at this location since July 2002. Infringement data before this date is not available. The spike in infringements from July 2007 can be attributed to the camera commencing speed enforcement of both directions of traffic where it previously enforced one direction. Since then, there has been a reduction in speeding behaviour at this location over time. Roadworks and camera maintenance may influence the number of infringements issued.
- A desktop review of this location was undertaken in 2015.

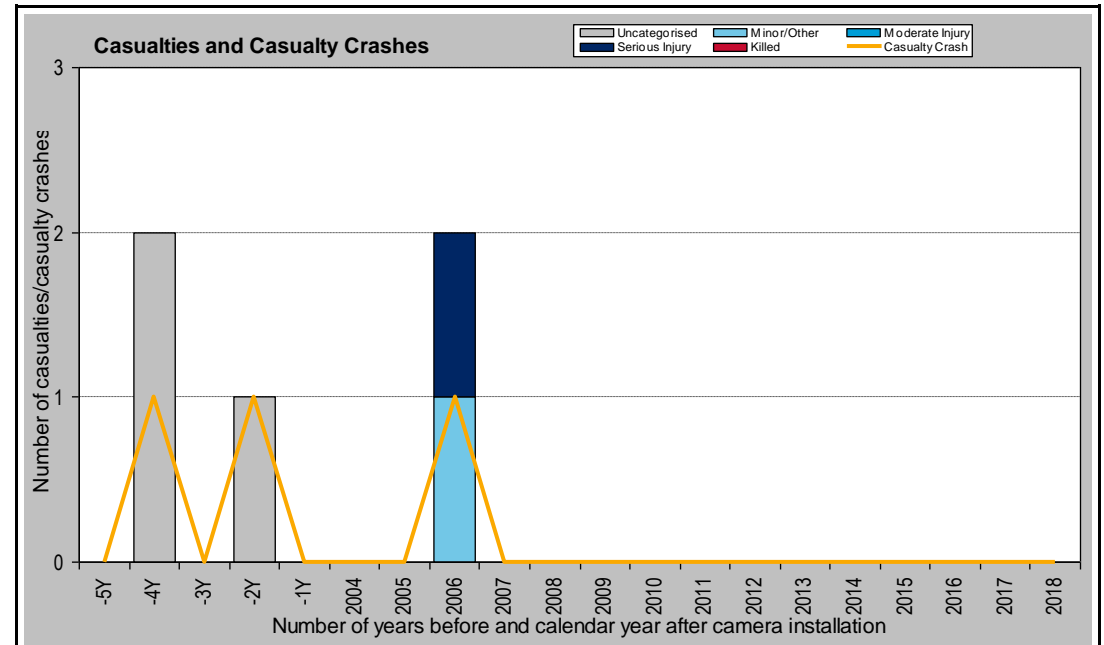
9612: Brogo - Princes Highway, between Pioneer Close and Brogo River

This location is 1000m in length, and is enforced with one camera.
The camera commenced operating on 2 May 2003.

- When comparing the pre installation period to the most recent five year period, there has been a 100% decrease in casualty crashes at this fixed speed camera location. The data presented do not account for the prevailing statewide trend.
- The infringement graph details the trend in infringements at this location since the camera began operating. Roadworks and camera maintenance may influence the number of infringements issued.

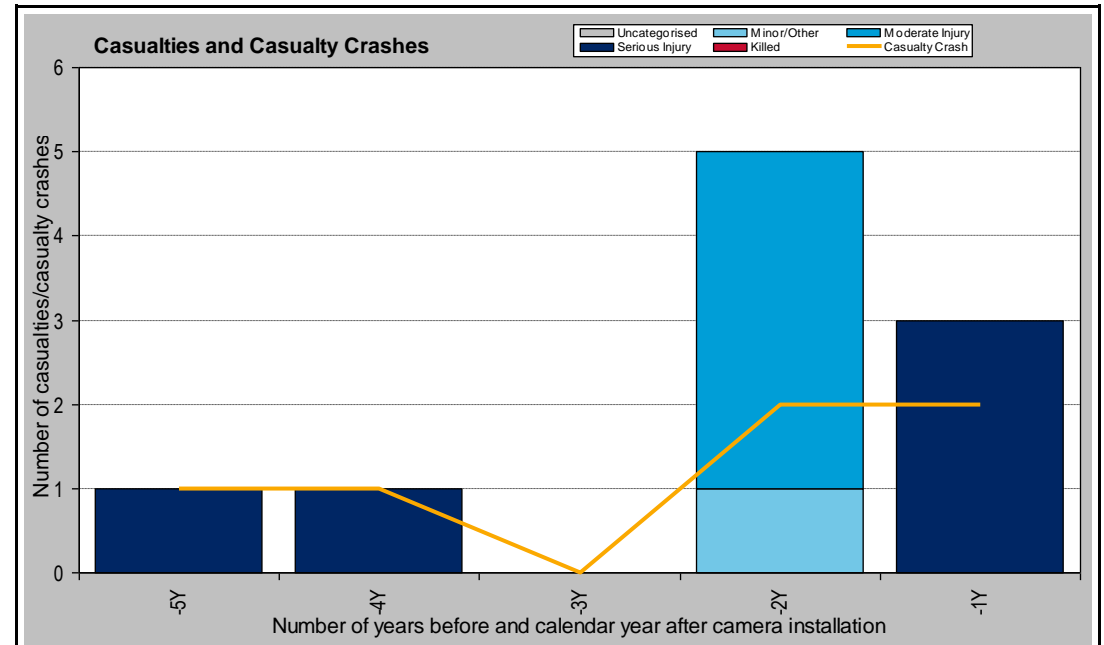
Status : [Insufficient data](#)

- CRS will develop further commentary when there is additional data available for this location in the future.
- The infringement graph details the trend in infringements at this location since the camera began operating. Infringement graph includes warning letters issued during November and December 2018. Roadworks and camera maintenance may influence the number of infringements issued.

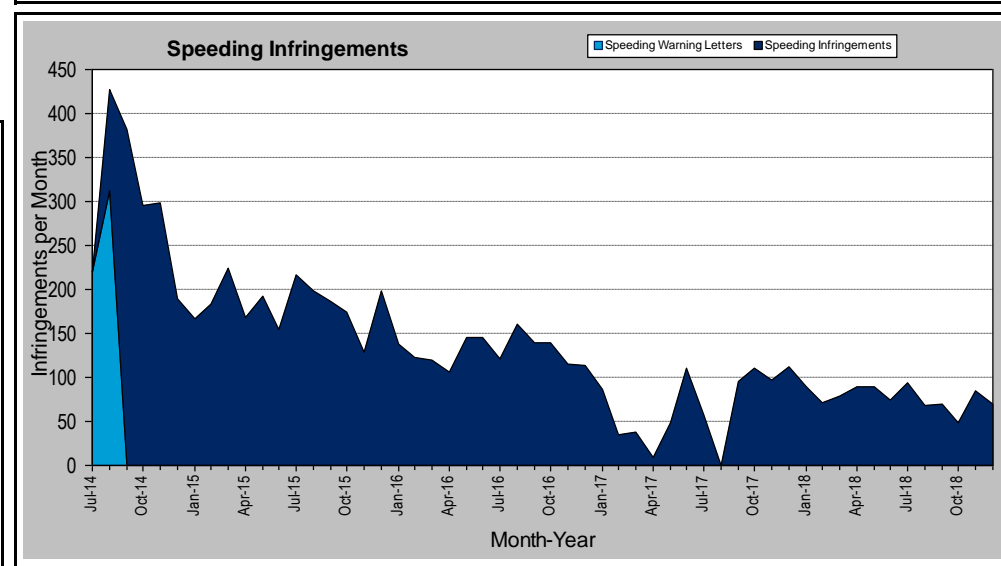
7254|7269|7270 North Ryde - Cox's Road at Lane Cove Road (school zone)

- There are three cameras at this intersection.
- The camera at the intersection of Cox's Road and Lane Cove Road (westbound) commenced issuing warning letters in April 2013. This camera enforces red-light running only.
- Both cameras at the intersection of Lane Cove Road and Cox's Road commenced issuing warning letters in April 2013.
- The infringement graphs show the number of warning letters and infringements issued at this intersection as well as the trend in infringements since the camera began operation. Roadworks and camera maintenance may influence the number of infringements issued.
