Transport
for NSW

Centre for Road Safety

Speed Camera Programs: 2020 Annual Review

Author: Centre for Road Safety
Date: September 2021
Version: 1.0
Division: Safety, Environment & Regulation

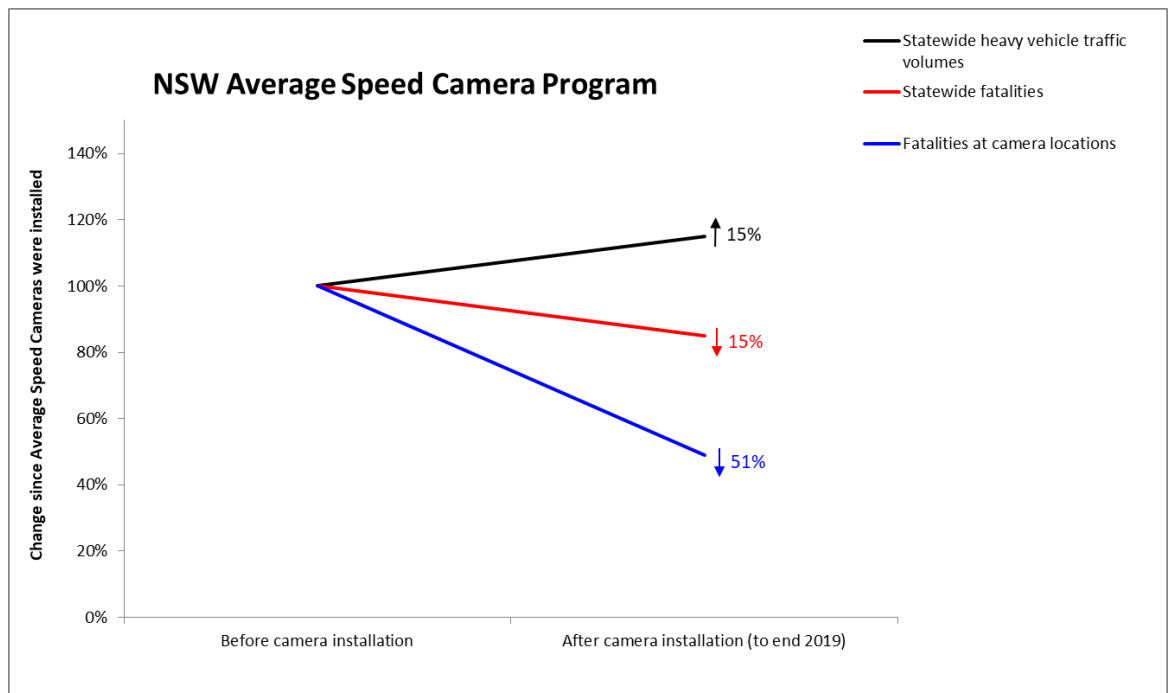
It should also be noted, alongside the crash data outlined above, that there has been a notable increase in heavy vehicle traffic volumes. Over the periods that average speed enforcement lengths have been reviewed within this report, there has been a 15 per cent increase in heavy vehicle volumes across NSW.⁵

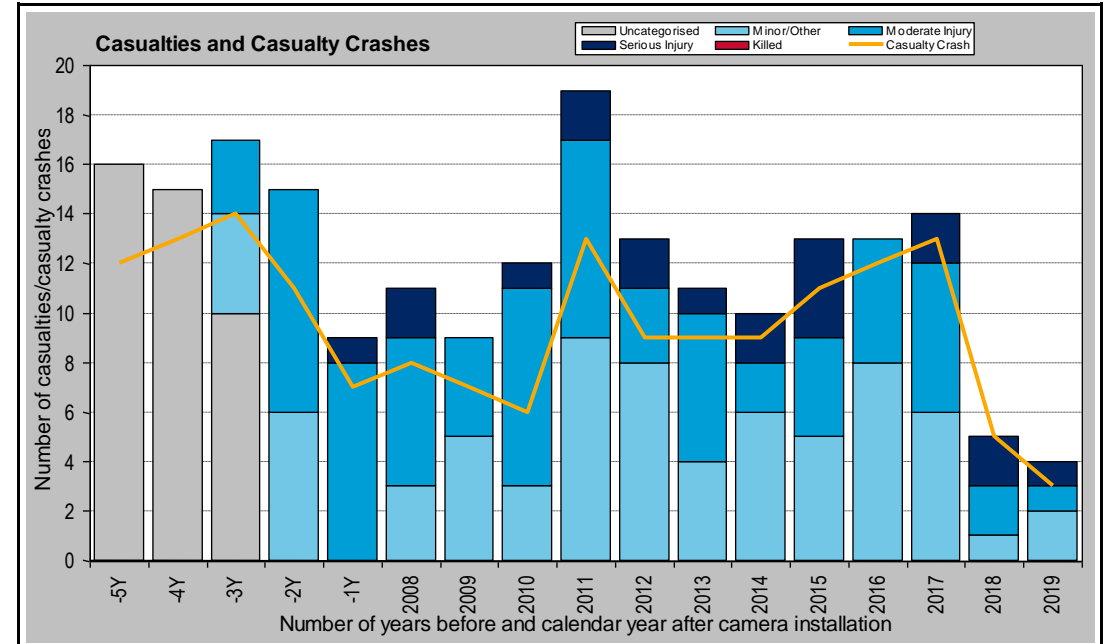
9818|9819: Bankstown - Hume Highway, between Rookwood Road and Stacey Street

- The infringement graph details the trend in infringements at this location since the camera began operating. Roadworks and camera maintenance may influence the number of infringements issued.

- This location was reviewed in 2013 due to concerns about the increase in casualties in recent years. The review found that during 2011 there were 28 casualties. This significant increase in the number of casualties included one crash involving a bus, resulting in 11 casualties. The number of casualty crashes has reduced in the following years. Speeding infringements were also found to have significantly reduced following the introduction of the speed cameras. It was recommended that the speed cameras be retained.

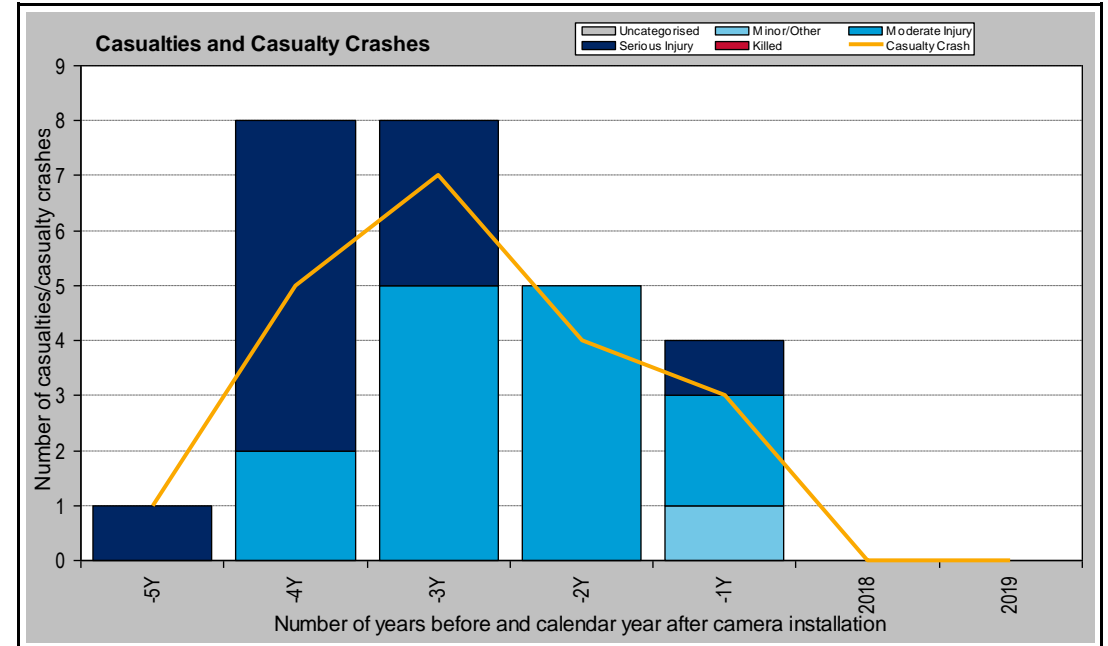
9669: Engadine - Heathcote Road, between Forum Drive and New Illawarra Road

- CRS will develop further commentary when there is additional data available for this location in the future.
- The infringement graph details the trend in infringements at this location since the camera began operating. Roadworks and camera maintenance may influence the number of infringements issued.

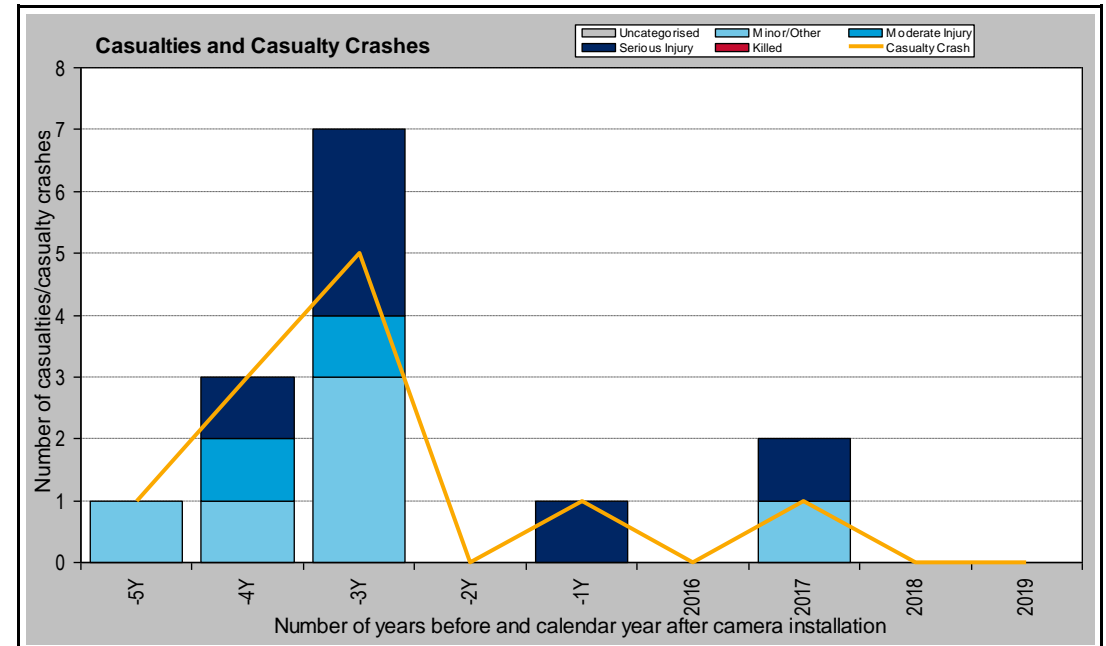
9665: North Macksville - Pacific Highway, between Bellview Drive and Ferry Street

This location is 1000m in length, and is enforced with one camera.
The camera commenced operating on 10 January 2015.

Status : [Insufficient data](#)

- CRS will develop further commentary when there is additional data available for this location in the future.
- The infringement graph details the trend in infringements at this location since the camera began operating. Roadworks and camera maintenance may influence the number of infringements issued.

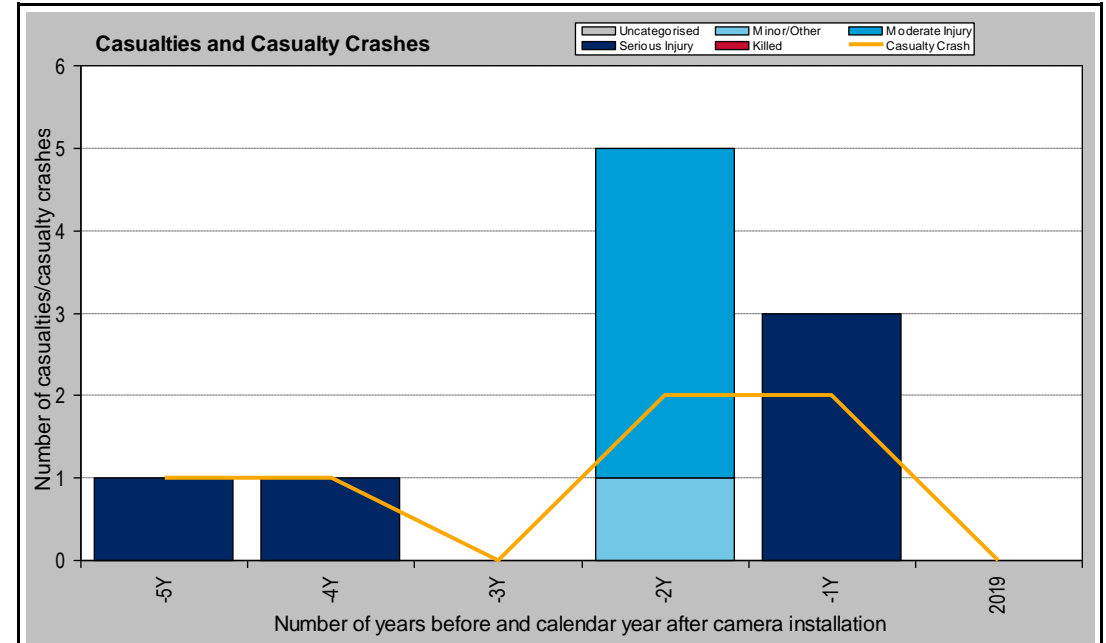
9670: Ulmarra - Pacific Highway, between River Street and George Street

- CRS will develop further commentary when there is additional data available for this location in the future.
- The infringement graph details the trend in infringements at this location since the camera began operating. Roadworks and camera maintenance may influence the number of infringements issued.

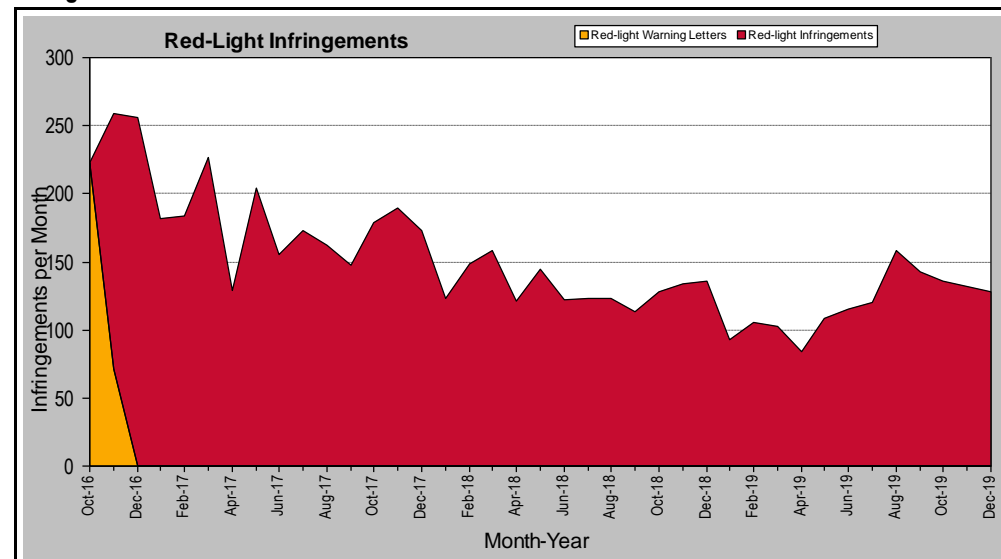
7319 Eastern Creek - Great Western Highway at Rooty Hill Road South

Infringements at enforced intersection

- There is one camera at this intersection.
- The camera at the intersection of Great Western Highway and Rooty Hill Road South commenced issuing warning letters in October 2015.
- The infringement graphs show the number of warning letters and infringements issued at this intersection as well as the trend in infringements since the camera began operation. Roadworks and camera maintenance may influence the number of infringements issued.

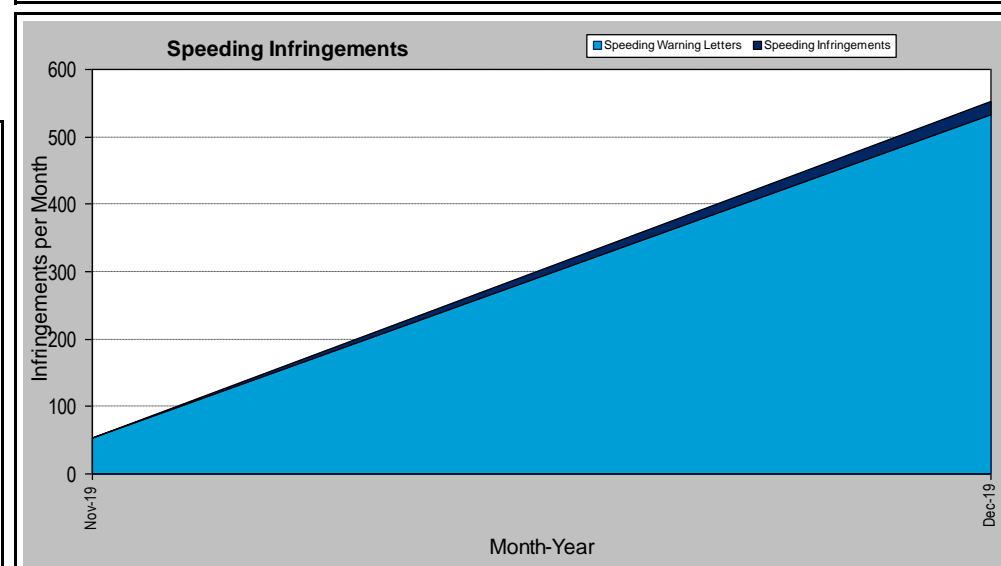
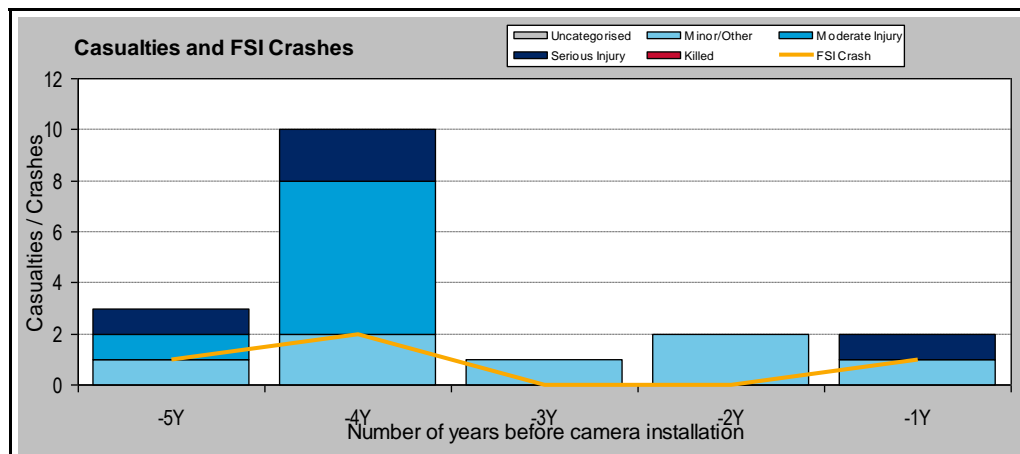
Infringements at enforced intersection

Status: Insufficient data (<5 years) to reliably assess.

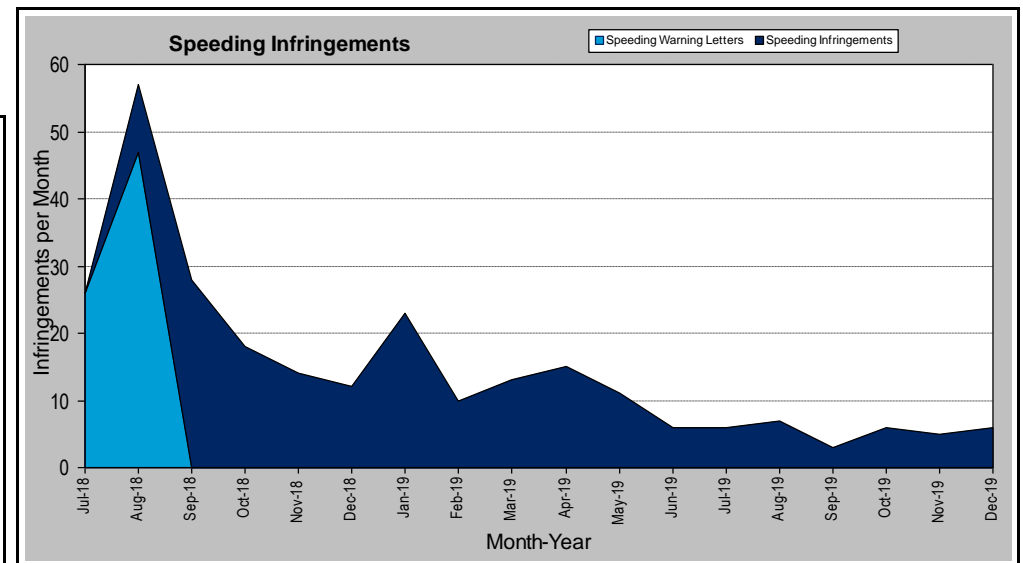
7299 Merrylands West - Merrylands Road at Sherwood Road

- There is one camera at this intersection.
- The camera at the intersection of Merrylands Road and Sherwood Road commenced issuing warning letters in October 2014.
- The infringement graphs show the number of warning letters and infringements issued at this intersection as well as the trend in infringements since the camera began operation. Roadworks and camera maintenance may influence the number of infringements issued.

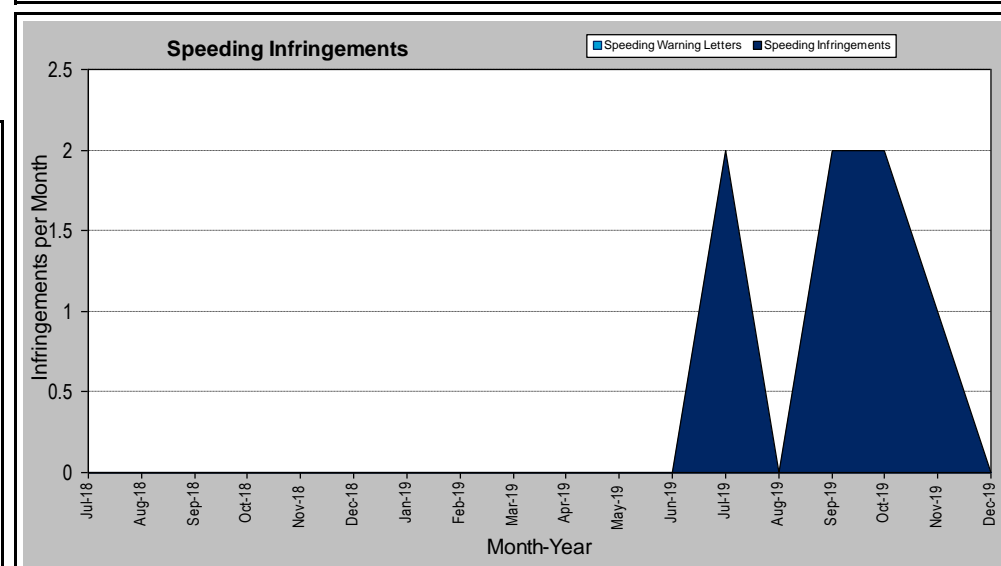
Infringements at enforced intersection

- There is one camera at this intersection.
- The camera at the intersection of Woodstock Avenue and M7 Northbound off ramp (Northbound) commenced issuing warning letters in July 2015.
- The infringement graphs show the number of warning letters and infringements issued at this intersection as well as the trend in infringements since the camera began operation. Roadworks and camera maintenance may influence the number of infringements issued.

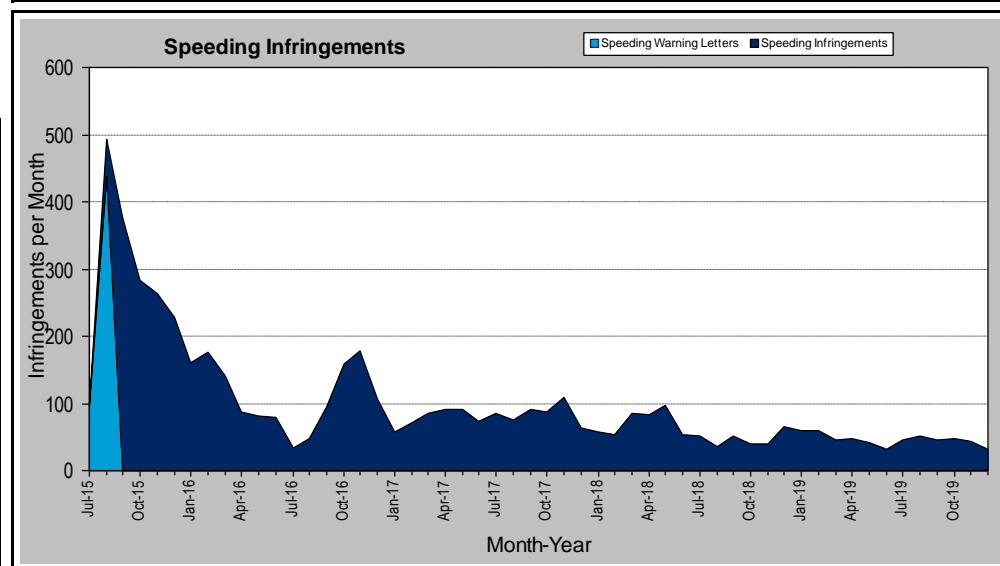
Infringements at enforced intersection

- There is one camera at this intersection. This was previously a wet-film red-light camera location.
- The camera at the intersection of King Georges Road and Moorefields Road commenced issuing warning letters in October 2010.
- The infringement graphs show the number of warning letters and infringements issued at this intersection as well as the trend in infringements since the camera began operation. Roadworks and camera maintenance may influence the number of infringements issued. The speed limit at this location changed from 70 km/h to 60 km/h in October 2011.
