Document type  
**FINAL**

# **106 GOULBURN STREET, TARAGO INTERIM ENVIRONMENTAL MANAGEMENT PLAN**

Project name **106 Goulburn Street, Tarago, Interim Environmental Management Plan**  
Project no. **318001376**  
Recipient **Transport for New South Wales**  
Document type **Environmental Management Plan**  
Report ref. **318001376-T2**  
Description **The report describes environmental management procedures to minimise risks from contaminated soil, dust and paint at the former Station Masters Cottage located at 106 Goulburn Street, Tarago.**

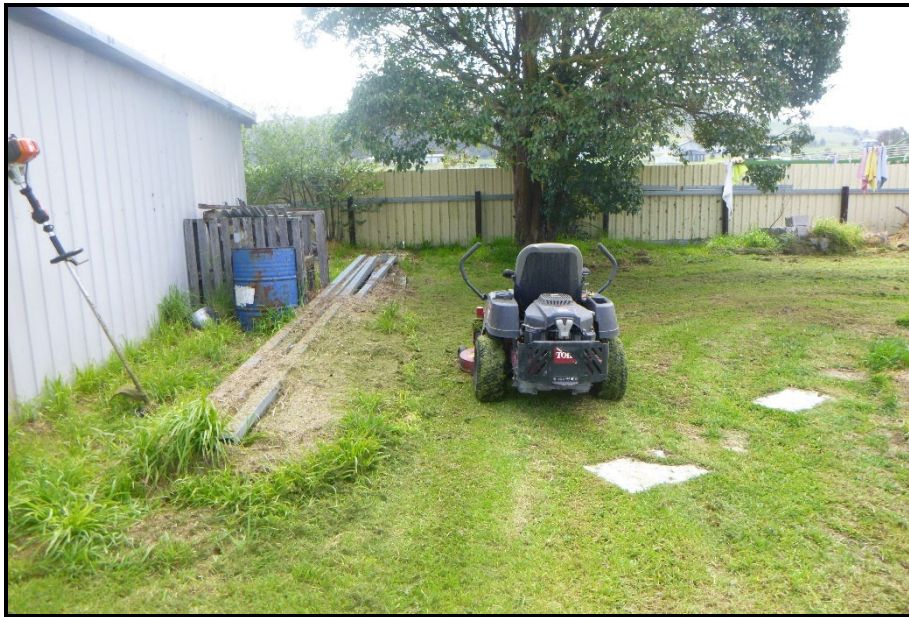
Photo 1: Backyard of FSMC showing grassed area and shed

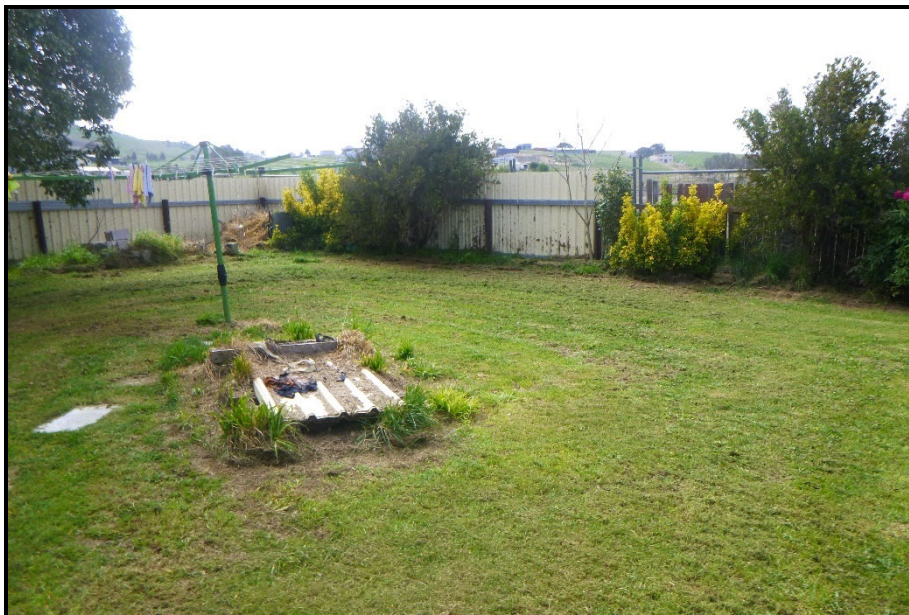
Photo 2: Backyard of FMSC showing grassed area, some small piles of stokcpiles and clothesline.

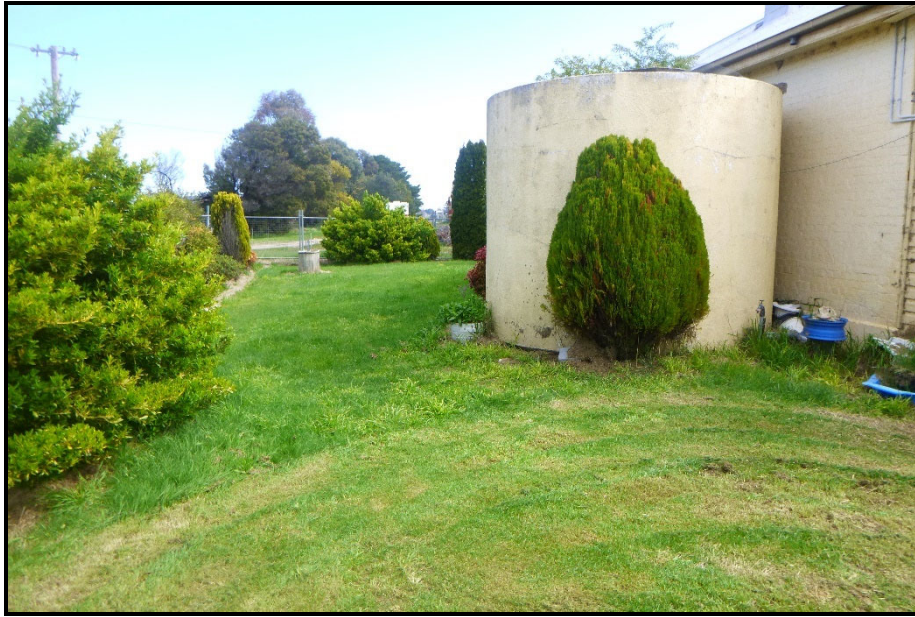
Photo 3: Side of FSMC showing grassed area, shrubs and rainwater tank.

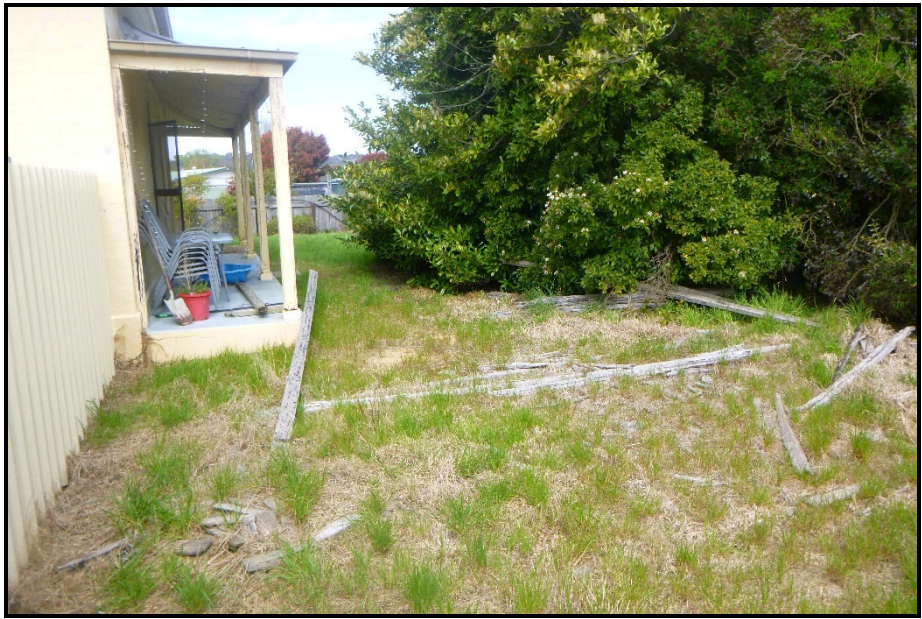
Photo 5: Side of FMSC showing sparse grass, timber pieces, large tree and porch of FMSC.

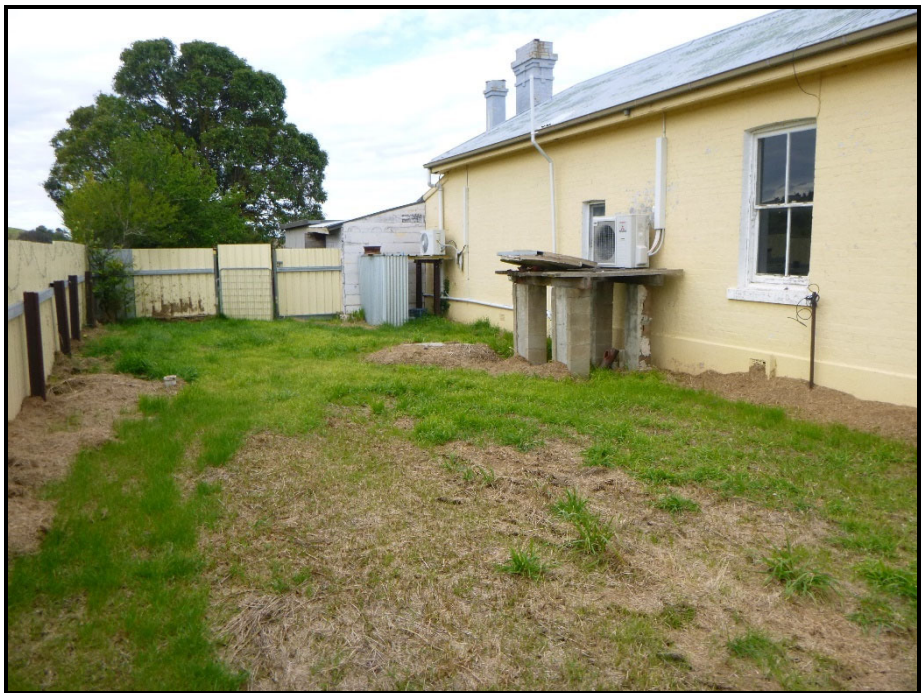
Photo 6: Side of FMSC showing sparse grass and fence line

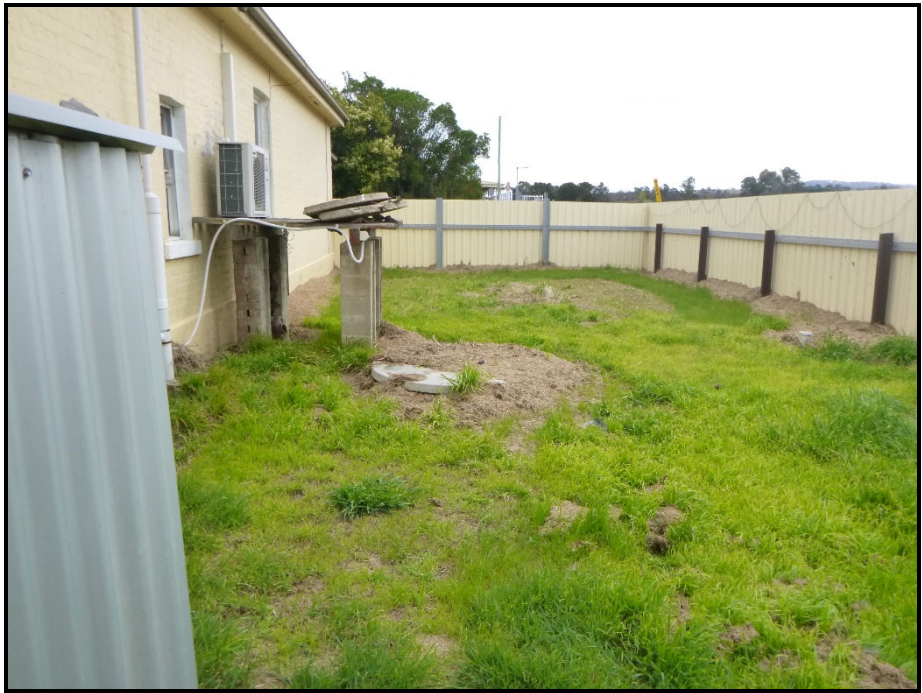
Photo 7: Side of FMSC showing sparse grass and fence line

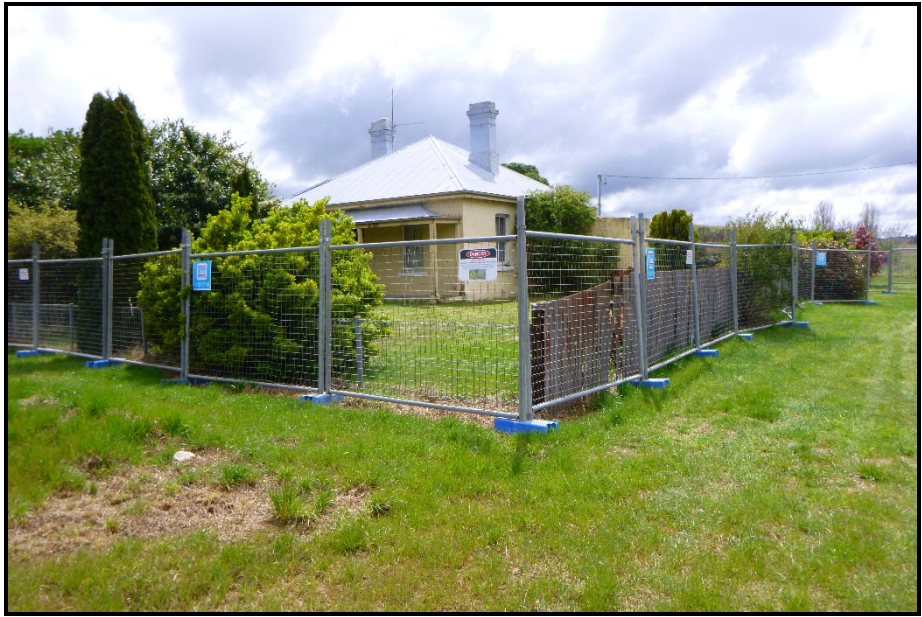
Photo 8: Front of FSMC site showing the site is fenced off with temporary fencing.

The principal hazard mitigation measure is to restrict access to the contaminated area by creating an exclusion zone until such time as the area is remediated and risks are documented to be acceptable. Existing fencing around the site should be inspected to ensure site security and limit access. Where access is required, strict management controls are to be implemented.

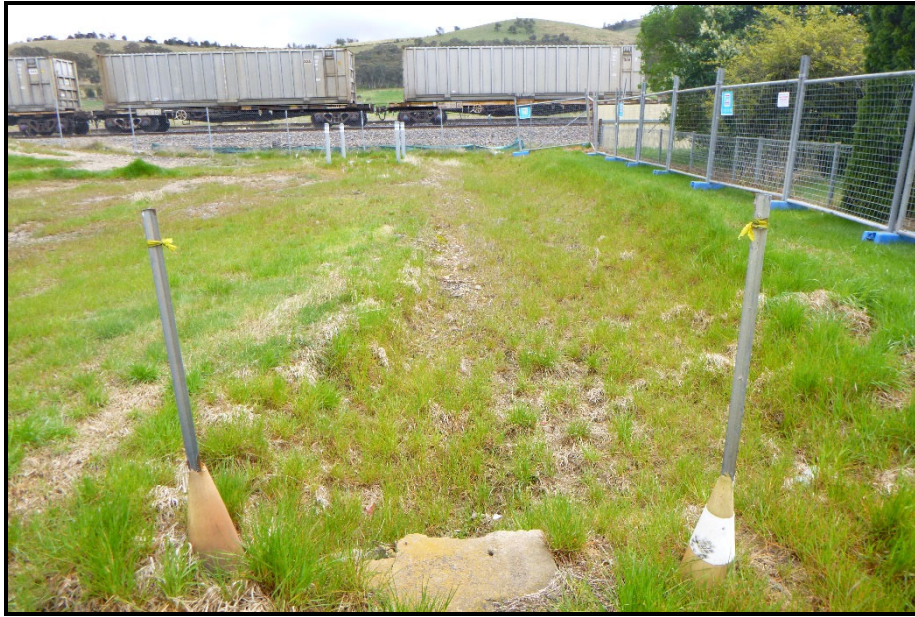
Photo 9: Site adjacent to FSMC showing temporary fencing around the site and the railway line behind the site.

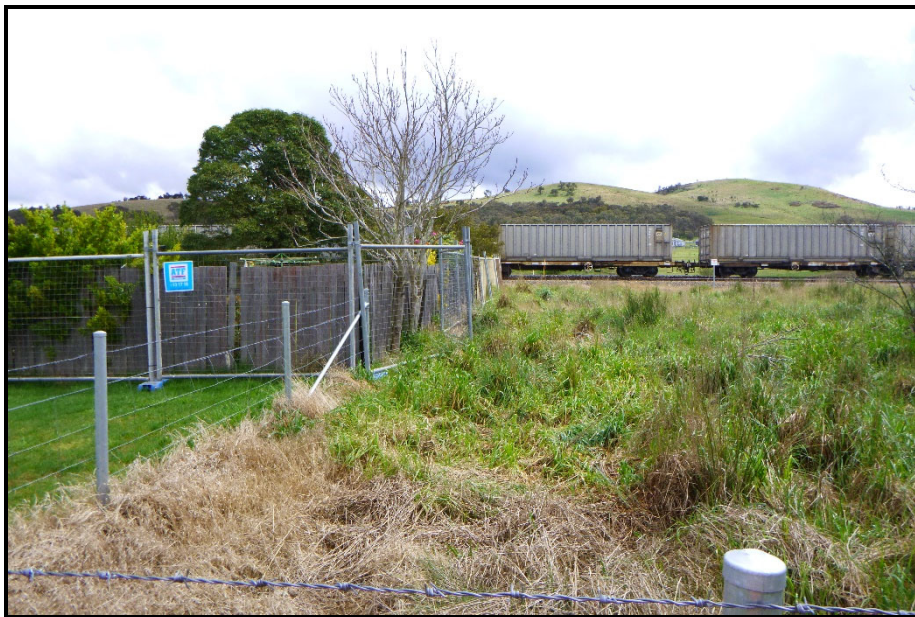
Photo 10: Site adjacent to FSMC showing temporary fencing around the site and the railway line behind the site.
