TfNSW Natural Disaster Pavement Saturation Damage Assessment Guide

June 2023

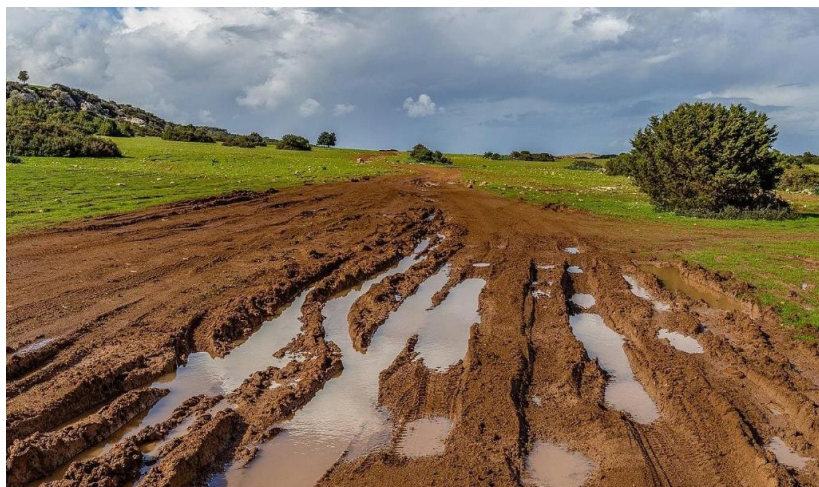
6.1.1 Example only – not actual evidence

- An unsealed road is inundated by floodwater for 3 days.
- The council provides evidence of the inundation (such as photos).
- The road is opened just before all floodwater has receded.
- Traffic damages the saturated pavement by heavily rutting the surface.
- The council claims a 100mm re-sheet for a 200m length. However, the evidence shows that only 50m has rut depths between 75mm and 100mm and the remaining section has an average rut depth of 40mm.
- The pre-disaster evidence shows that the road was re-sheeted six months prior to the flooding.
- The eligible claim is therefore a 100mm re-sheet for 50m and a 40mm gravel allowance for 150m.

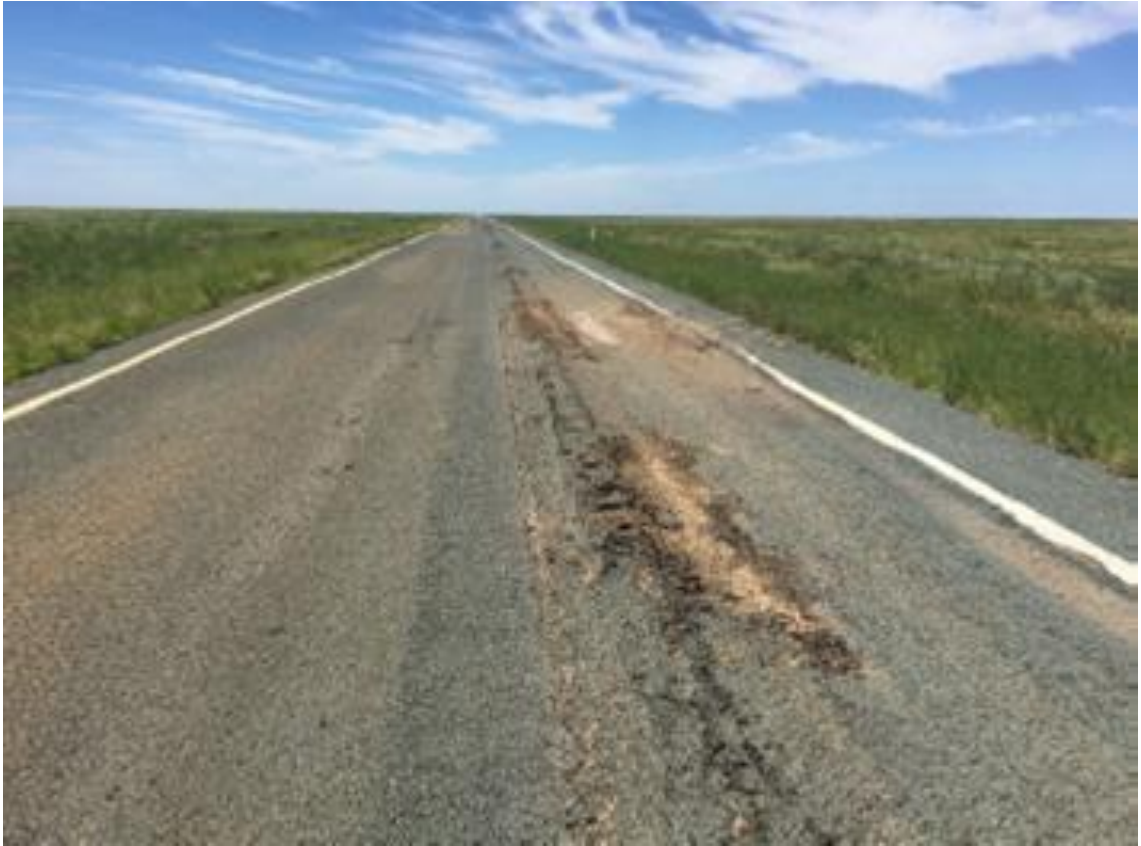
6.3.1 Rutting after saturation

- A 6m sealed road is inundated for 3 weeks.
- The council provides evidence of inundation.
- The road is opened just as floodwater has receded from the travel lanes.
- There is no “immediate” damage evident and the council monitors the road, daily.
- After four days, rutting appears in the outer wheel path.
- After 10 days, rutting also appears in the inner wheel path.
- The council claims full width (9m) ripping, re-compaction and sealing as the required restoration treatment.
- The pre-disaster evidence was a laser profilometer survey undertaken 12 months before the flooding. The survey recorded minor rutting (<3mm) and negligible cracking and other defects.
- It was accepted that the ‘fresh’ rutting was caused by traffic on a saturated pavement so that the proposed treatment is eligible for funding, except for the additional 3m of sealing which would require complementary funding.
