Guide for Natural Disaster Slope Damage Restoration Requirements

September 2023

The purpose of this document is to assist Transport for NSW and Local Government in complying with the Natural Disaster Framework of the Australian and New South Wales Governments as it relates to the restoration of slope damage impacting Essential Public Assets.

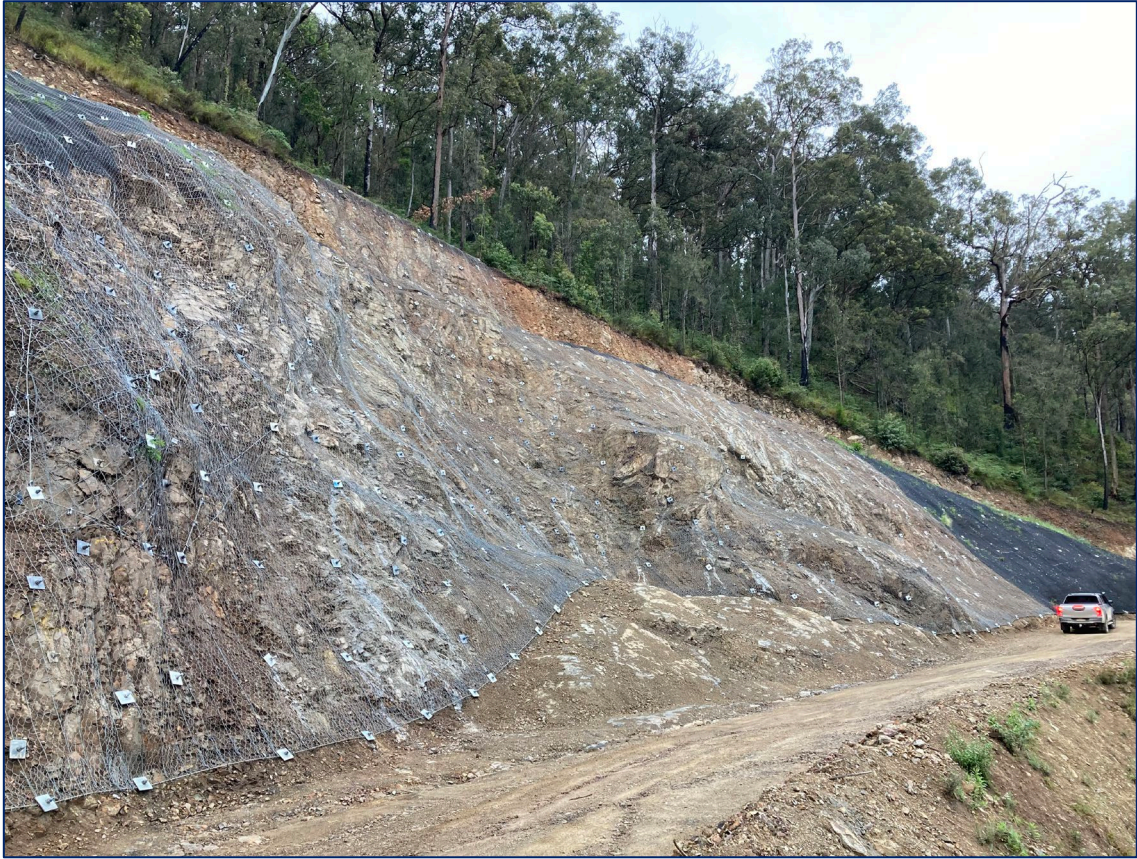
Big Hill Slip - Photo of rock bolts and mesh as well as bolts and matting (far right)

An example of a significant upslope failure is shown in Appendix B – Example 2 Big Hill Slip on Kempsey to Armidale Road, where the rock slope is rated ARL 1 in terms of risk assessment. The slope was broken up into three geological areas for treatment with combination of rock anchors and mesh or matting.

- Width of existing is about 5 metres.
- Road connection between Kempsey and Armidale
- Upslope assessed as ARL 1 and about 30 metres high.
- Slip containing debris and rock.
- The rock upslope is divided into 3 areas for treatment based on geological characteristics.
- Treatment includes a combination of rock anchors with mesh or matting.

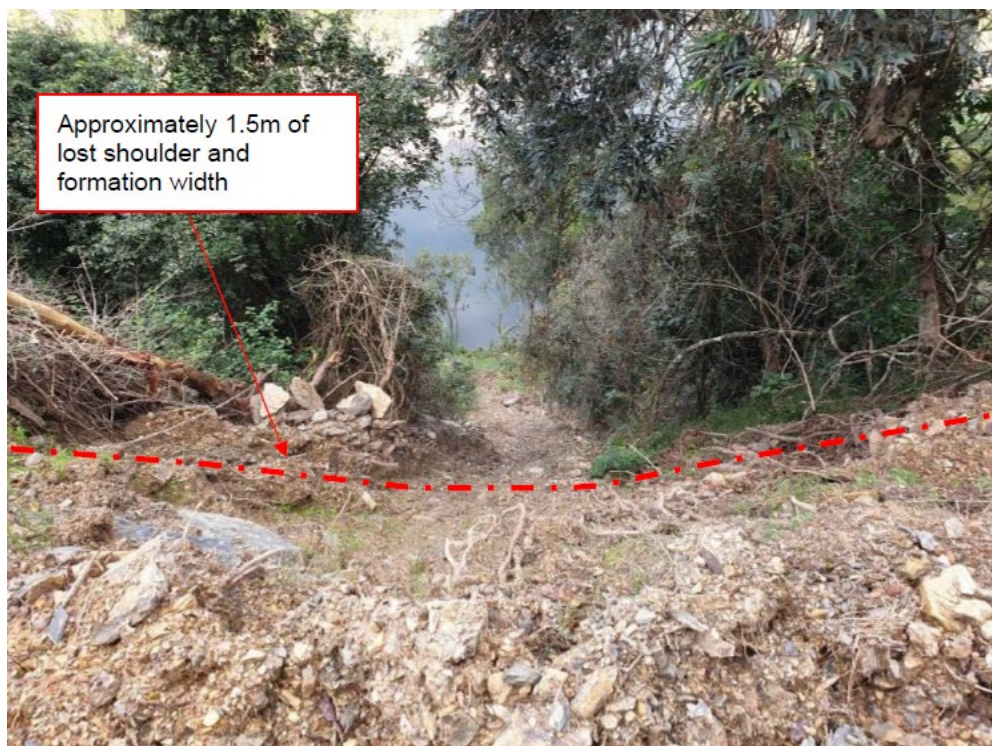
Figure 4.1 DM00231 – Downslope failure extends >100m downslope

Photo of slip site

- Traffic Volumes are 50 to 100 AADT (estimated)
- Existing pre-disaster road width about 5 metres
- Downslope failure causing loss of structural integrity of batter resulting in reduction of road width.
- ARL risk rating of 1
- Steep terrain with no obvious foundation to build up from to recover missing downslope batter support.

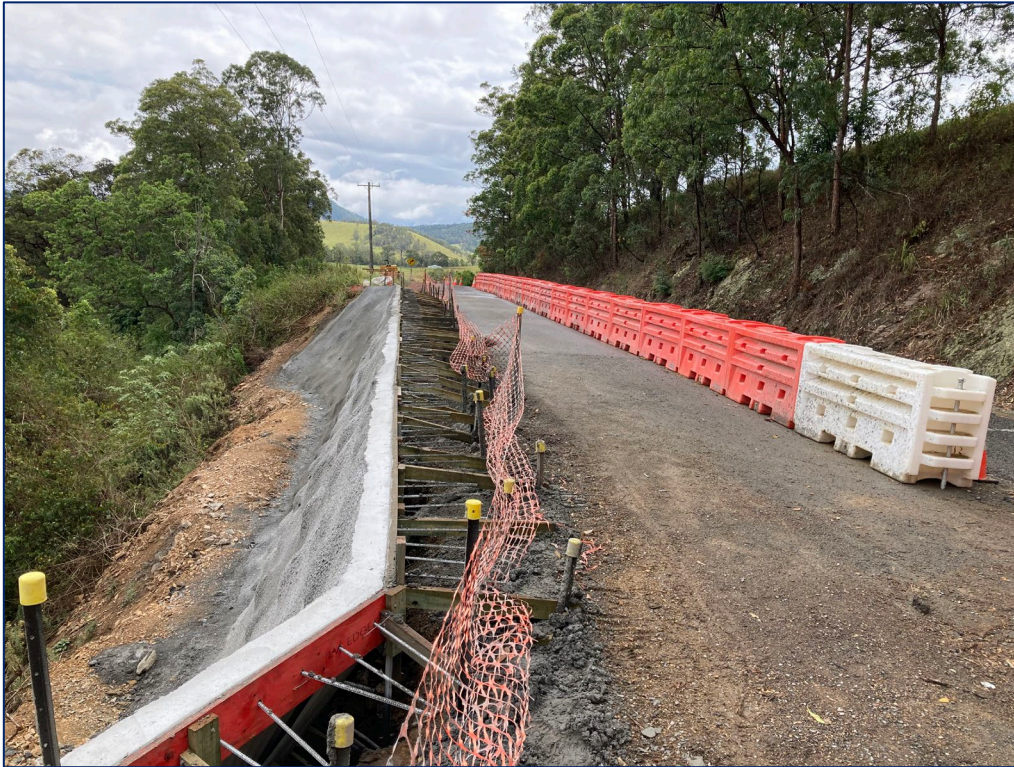
Typical proposed solution of soil nails and shotcrete face

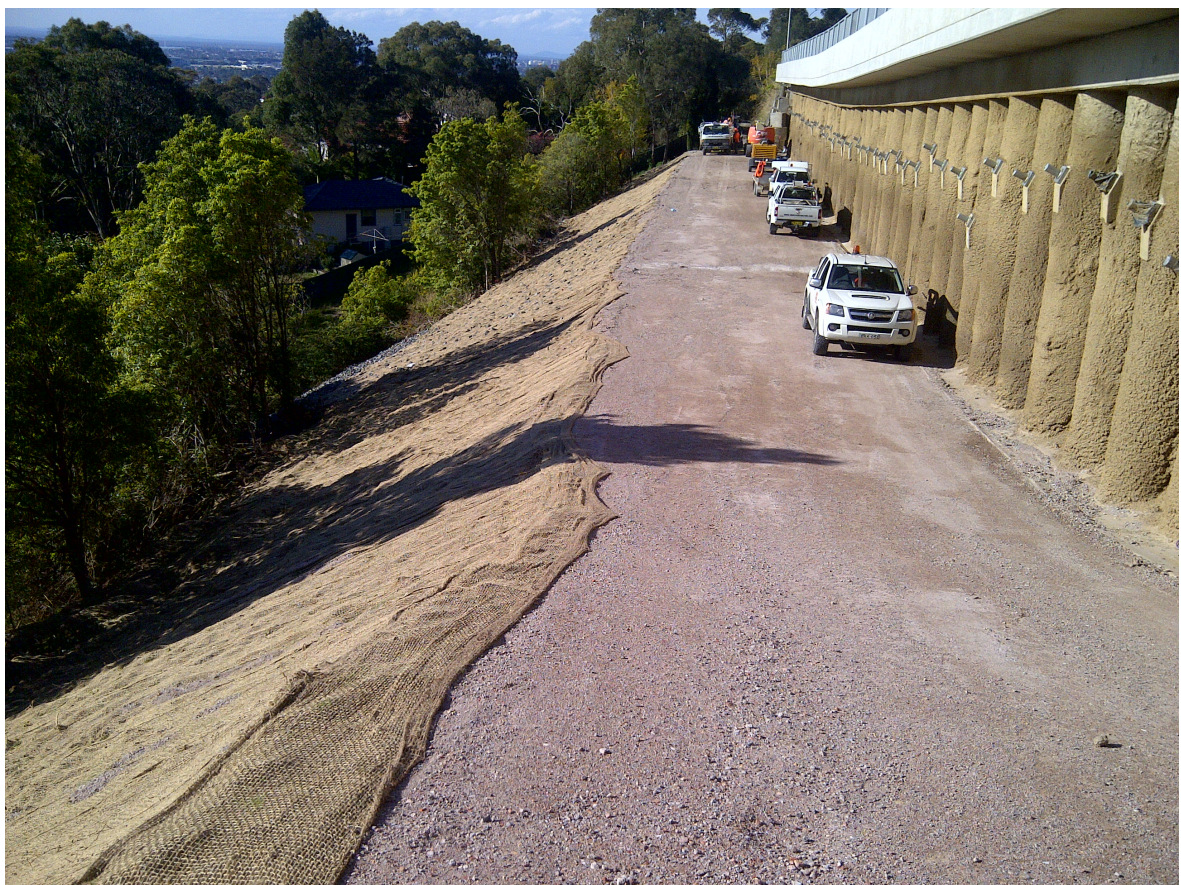
Typical piled solution – Pacific Highway Newcastle
