## 8. Swing span bridges

### 8.1 Description of swing bridges

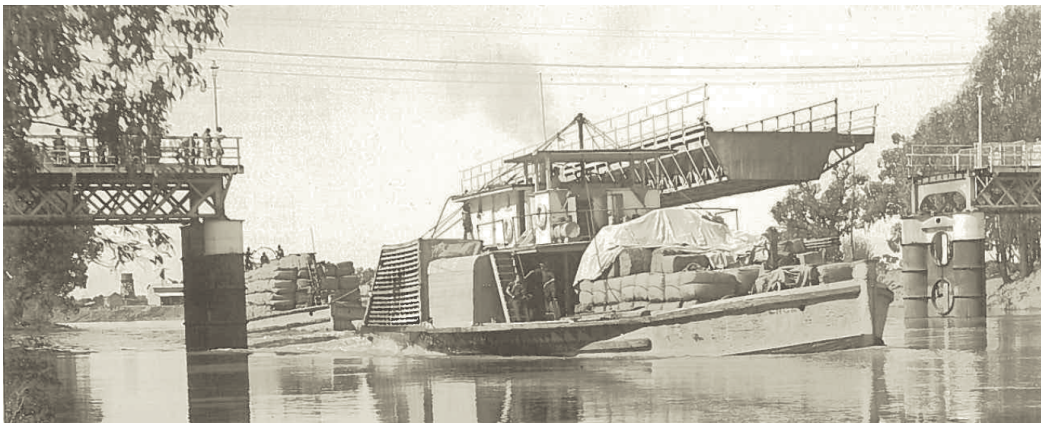
**Figure 8.2 Hay Bridge opened to allow passage of the steamer Ulonga with barge in tow in 1932 (Source: Brown Collection, Hay Historical Society)**

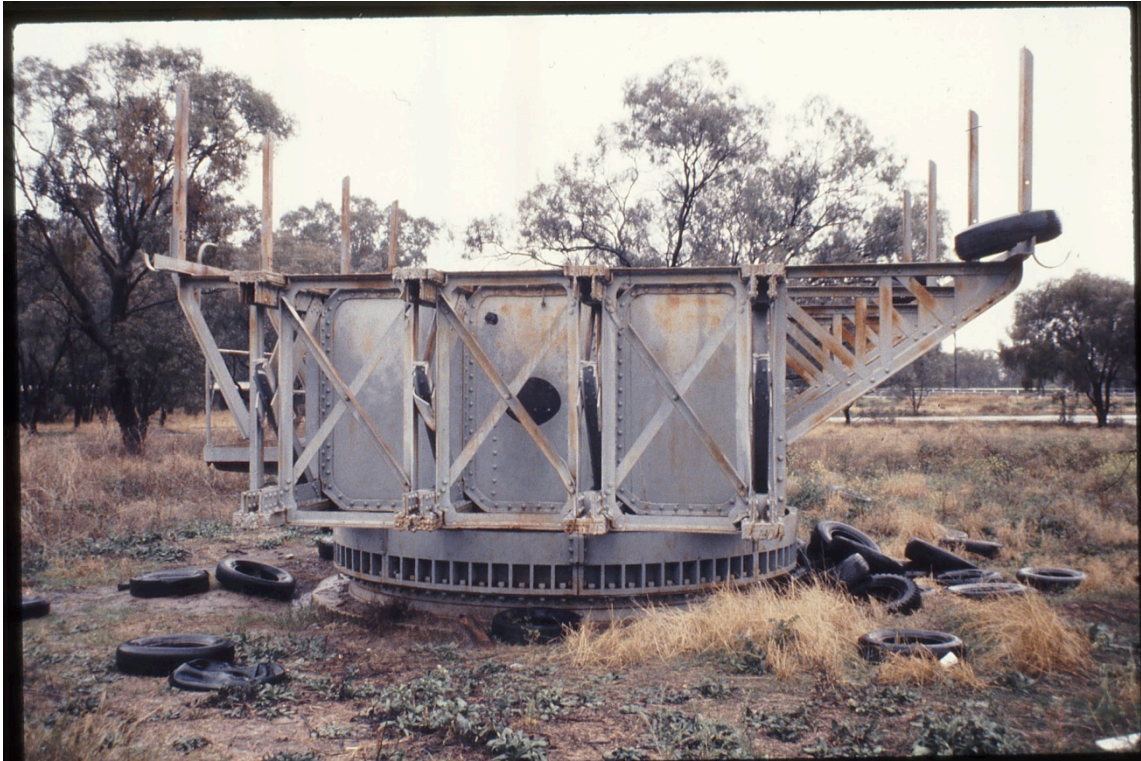
**Figure 8.9 Turntable from demolished Hay Bridge shown with footway on right. This forms part of the Bidgee Riverside Trail near Lions Park, Hay**

The next development in swing bridge design was apparent on the Hay Bridge completed in 1873. The design consisted of lattice girder span supporting timber decking and the bridge was operated by hand. The drum was a composite of cast and wrought iron that was finally founded on a centre pier. It was noted by Mr G. S. Mullen, past Resident Engineer, that the Hay Bridge was operating satisfactorily with the frequency of openings being over times per annum in the 1880s (*Main Roads*, 1973). The swing span was locked shut in 1937 and the bridge was demolished in 1973 with the turntable relocated to Lions Park, Hay.

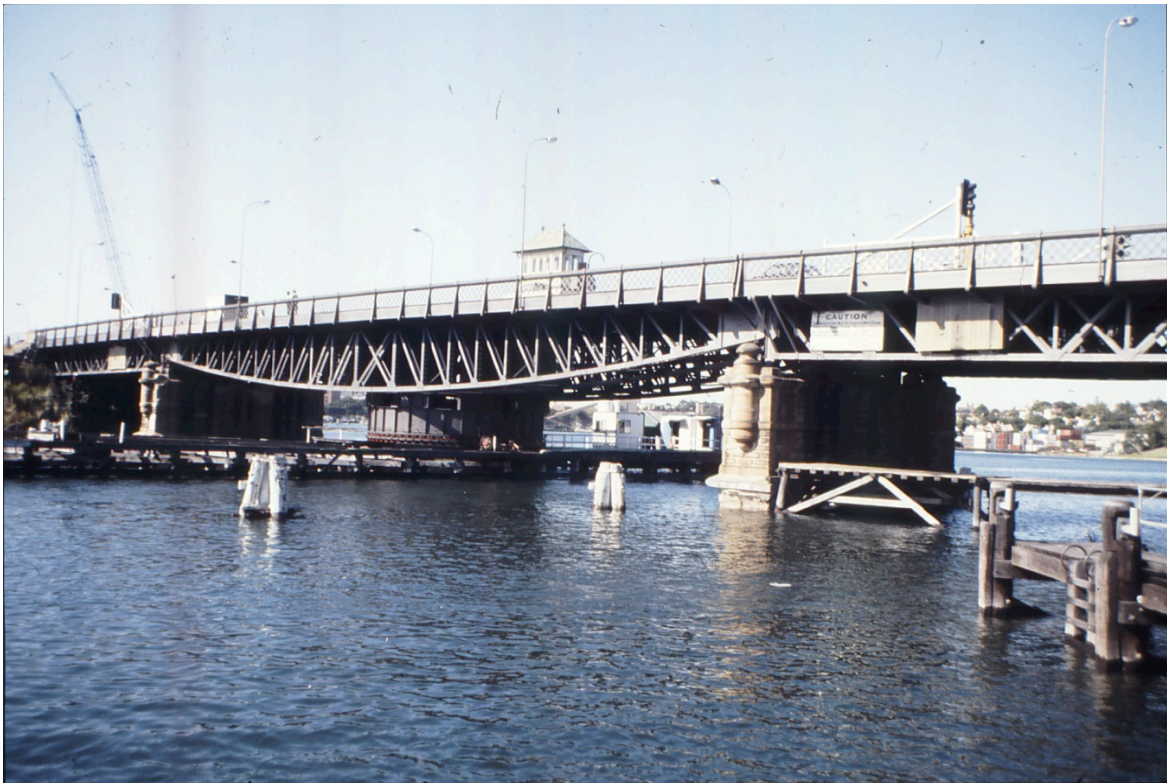
**Figure 9.1** General view of Glebe Island Bridge in 1993 (Source: RMS)

The bridge over Johnston Bay at Glebe Island is a swing type bridge which consists of a rotating centre span with length 191 ft., two fixed approach spans with lengths 81 ft. and two substantial stone causeways.

The swing span of the bridge generally consists of a steel Howe deck truss with curved bottom cord. This deck is mounted on a steel drum that is designed to rotate on the centre pivot pier. The pivot pier is a concrete and stone cylinder founded on 97 timber piles. The separate components that make up the bridge are shown in Figure 9.1.

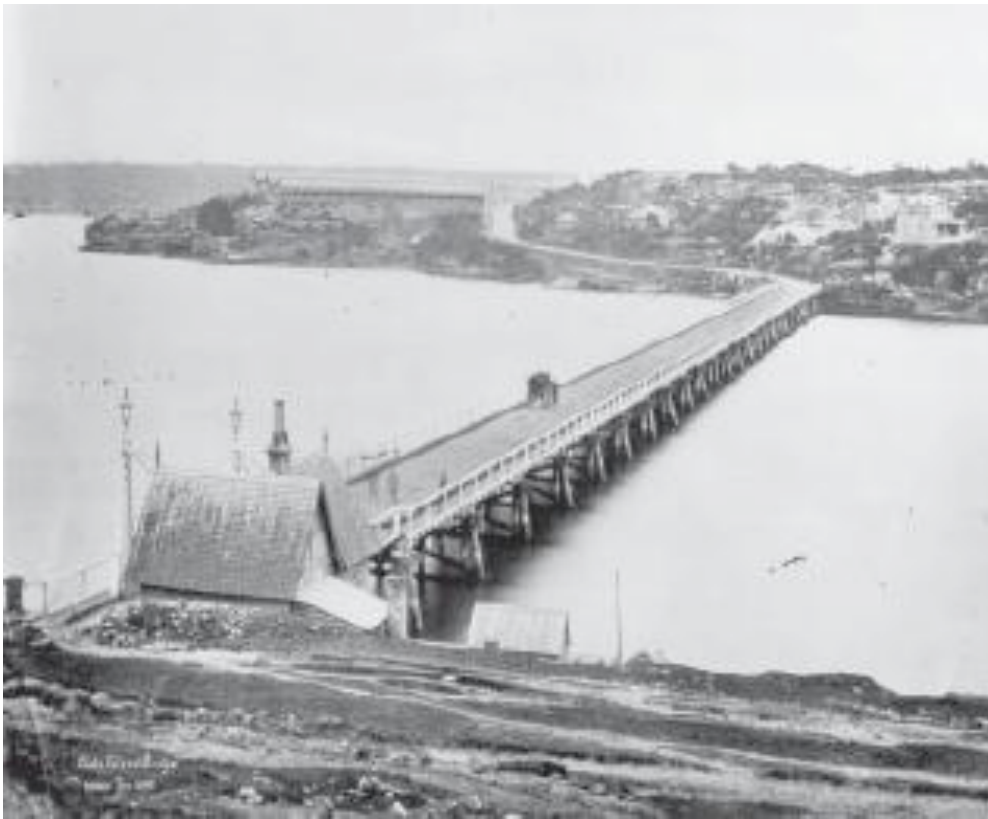
**Figure 9.3 1862 Glebe Island Bridge taken in 1870 (Source: Government Printer No.SH620, RTA No.32108)**

Figure 9.3 above is looking north from Pymont. The single sided swing span with counterweight is on the lower left and the abattoirs are on the upper left. Glebe Island is yet to be cut down for the causeway and for reclamation.

The first Glebe Island Bridge was opened in 1862 and consisted of a primarily timber structure which was fitted with a one sided swing span (Figure 9.3). After 41 years of service the old Glebe Island Bridge was deemed as having excessive deterioration by E. M. De Burgh, due to damage caused by white ants and underwater worm borers. It was also noted that repairs would only slightly lengthen the life expectancy of the bridge hence it was decided in 1894 by the Public Works Committee to replace the bridge as soon as possible (Glebe Island Bridge CMP, 2004).

The first Glebe Island Bridge, which opened in 1862, was Government built and had a one sided swing span balanced by a counterweight next to the Pyrmont side. These two swing bridges (Pyrmont and Glebe Island) were followed by two more, the 1881 Bridge over the Parramatta River from Drummoyne to Gladesville and the Figtree Bridge of 1885 over the Lane Cove River, these completed the roads to Ryde and beyond and to the North Shore. The Pyrmont and Glebe Island swing bridges were replaced in 1902 and 1903, and new Gladesville and Figtree Bridges were completed in the 1960s (Fraser, 1985; Main Roads, September 1951). Thus the Glebe Island Bridge played an important role within the northern and western Sydney bridge networks as part of several transport arteries. This in turn had a significant bearing on the economic and social development of greater Sydney.

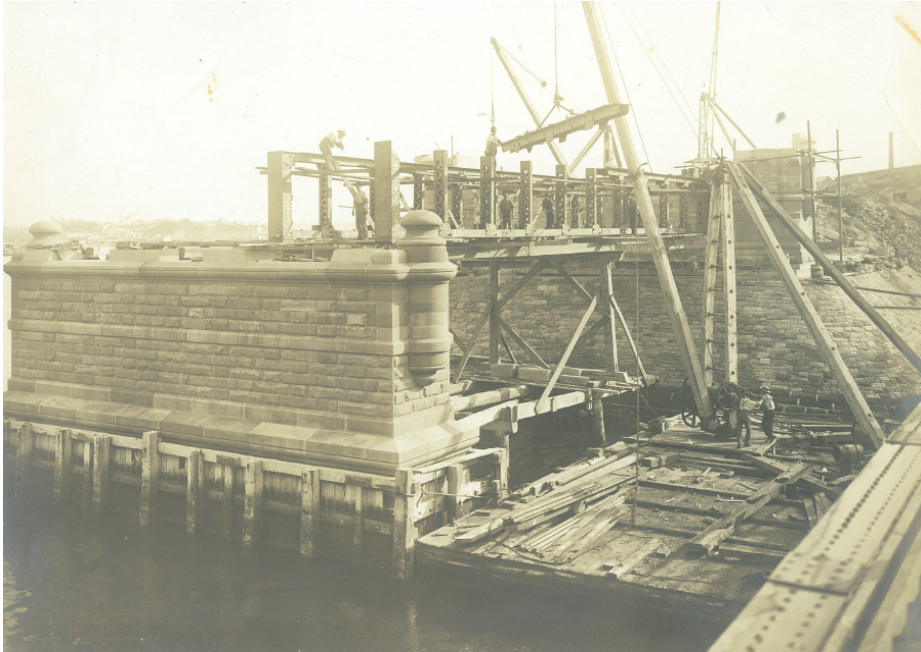
**Figure 9.5 Rozelle side rest pier and approach span under construction in 1902 (Source: RMS photographic archives)**

The rest piers at either end of the swing-span were constructed on the monolithic principle with the concrete being deposited through the water with specially designed skips, continuously day and night, until the work was completed. They are faced with sandstone and capped with trachyte. They are each equipped with timber fenders and 4 dolphins.

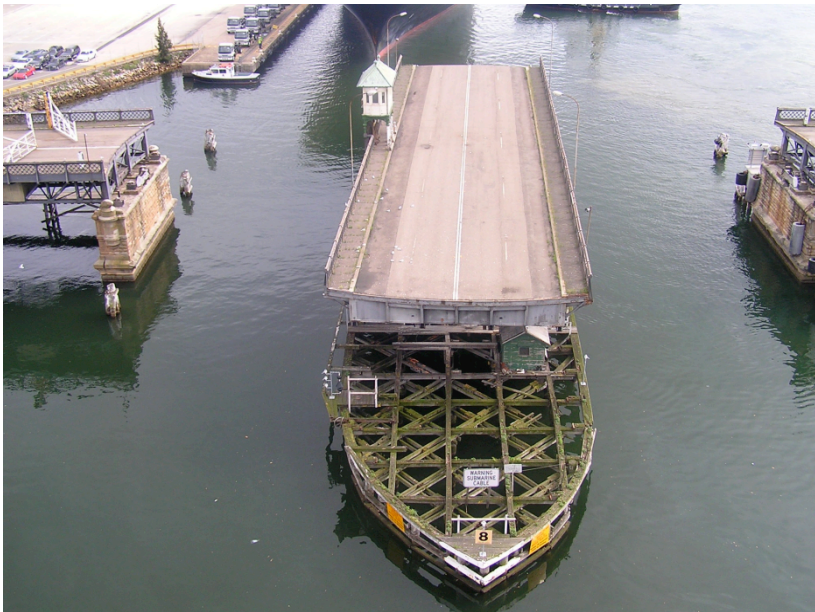
**Figure 9.8** View looking north of the bridge with swing span in open position, fender in foreground and rest piers lining the channels to each side

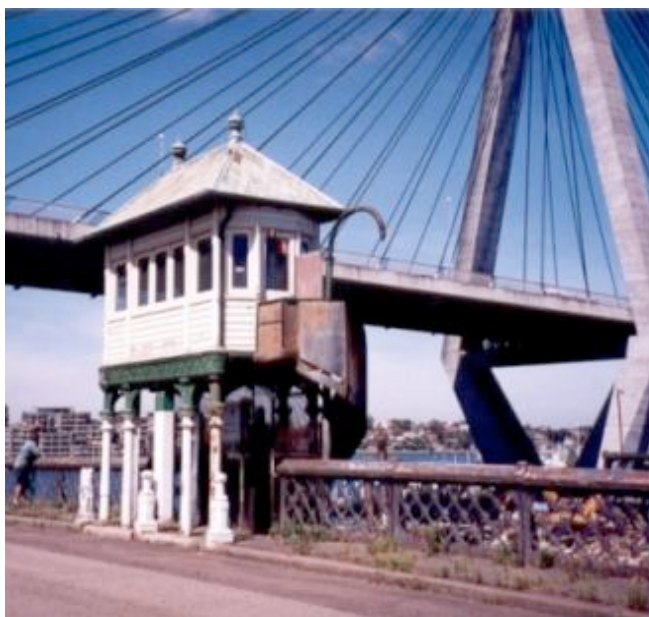
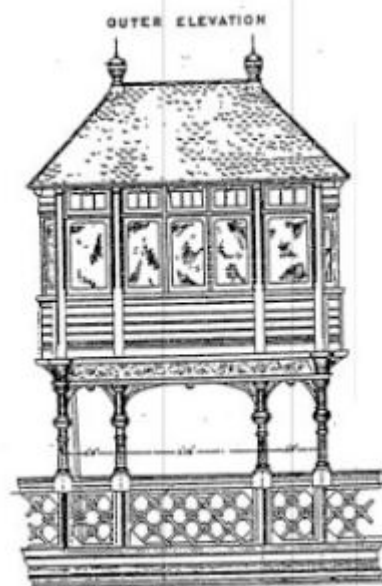
**Figure 9.9 Glebe Island Bridge control cabin (Source: DPWS, 2000)**

The Glebe Island Bridge consists of the interaction of a number of mechanisms however a feature of the bridge is that it can be operated by a single individual. The operator is positioned in the control cabin mounted at the centre of the swing span (Figure 9.9).

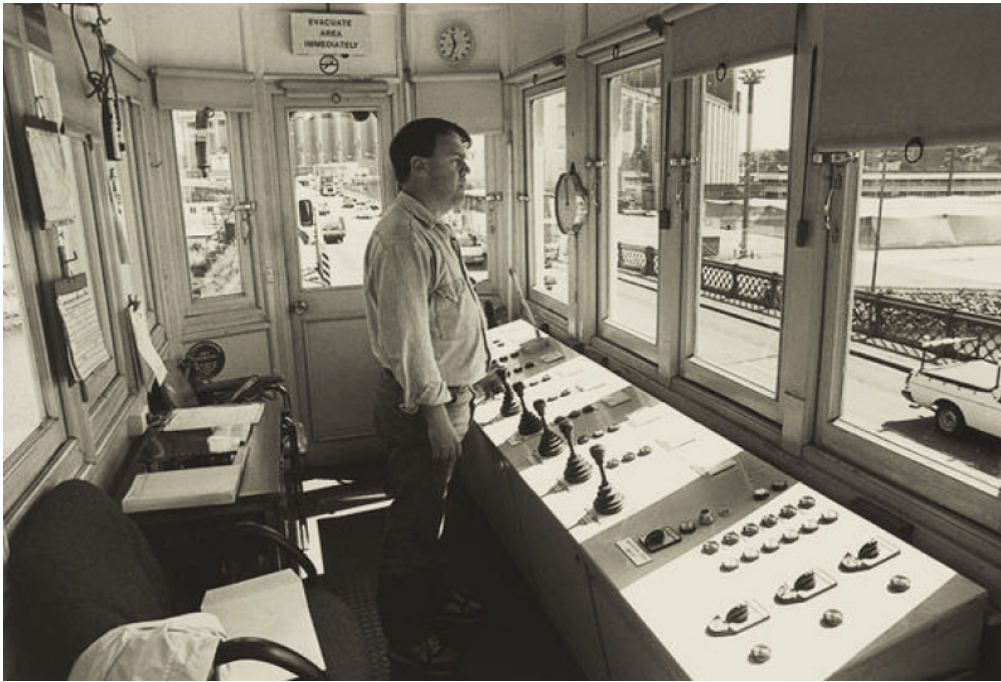
**Figure 9.10 View inside the control cabin in 1995 (Source: RMS photographic archives)**

The only innovations were the introduction of a split system air conditioner for operator comfort and modern electrical equipment fitted into a control panel along the north side of the cabin for the bridge opening mechanism utilising crane type joy sticks was installed.

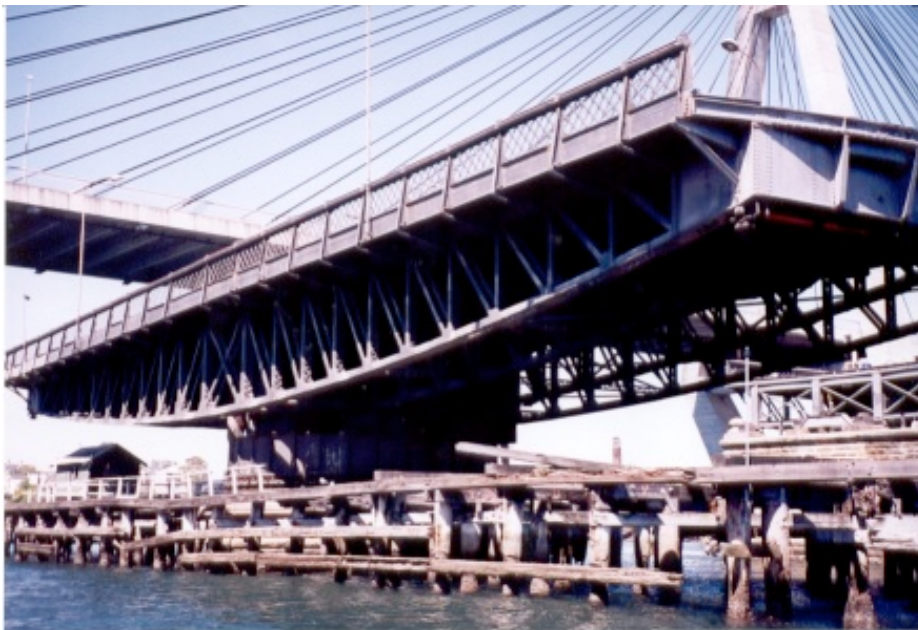
**Figure 9.11 Detail of swing span in open position**

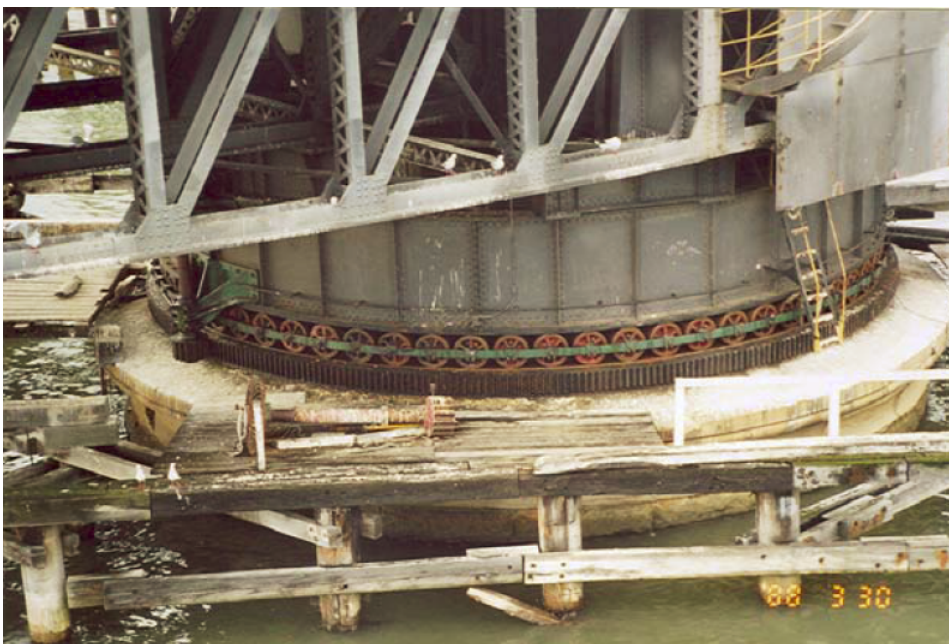
The bearing of the drum on the pier is achieved by steel conical rollers which are contained between a track fixed to the underside of the drum and a second track fixed to the pier. As the drum rotates, the rollers allow for the smooth continuous bearing during motion. These components are shown in Figure 9.17 to Figure 9.18 below.

**Figure 9.17 Glebe Island Bridge swing span drum. The main girders rest on the distributing girders and the drum pivots on the cast steel rollers**

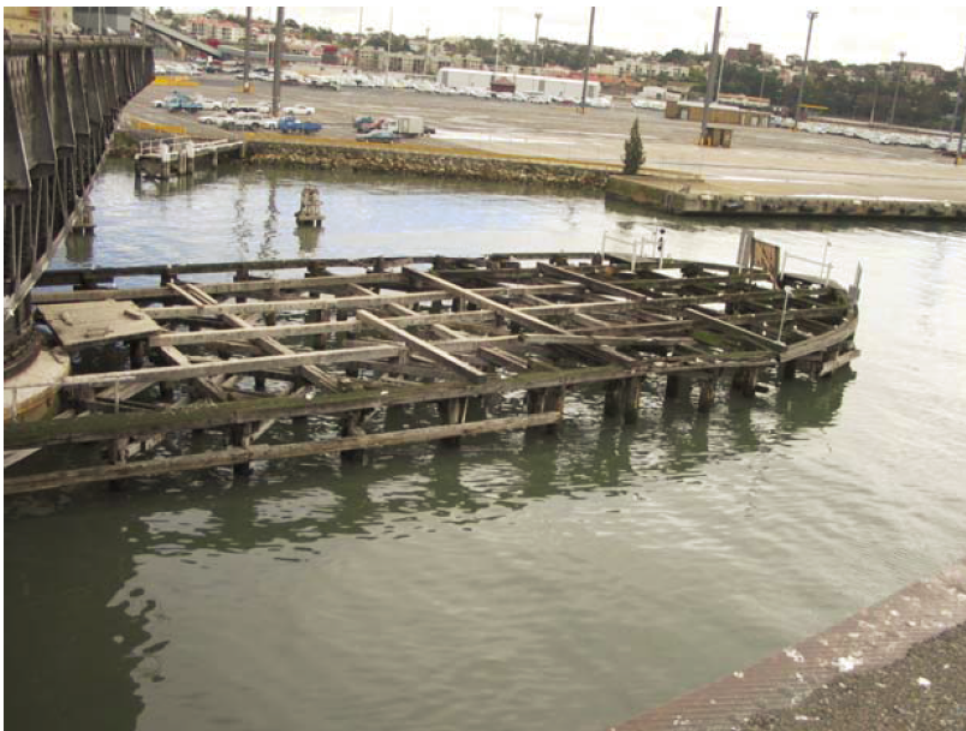
Figure 9.21 View of the southern end of the fender in 2012 prior to repair works

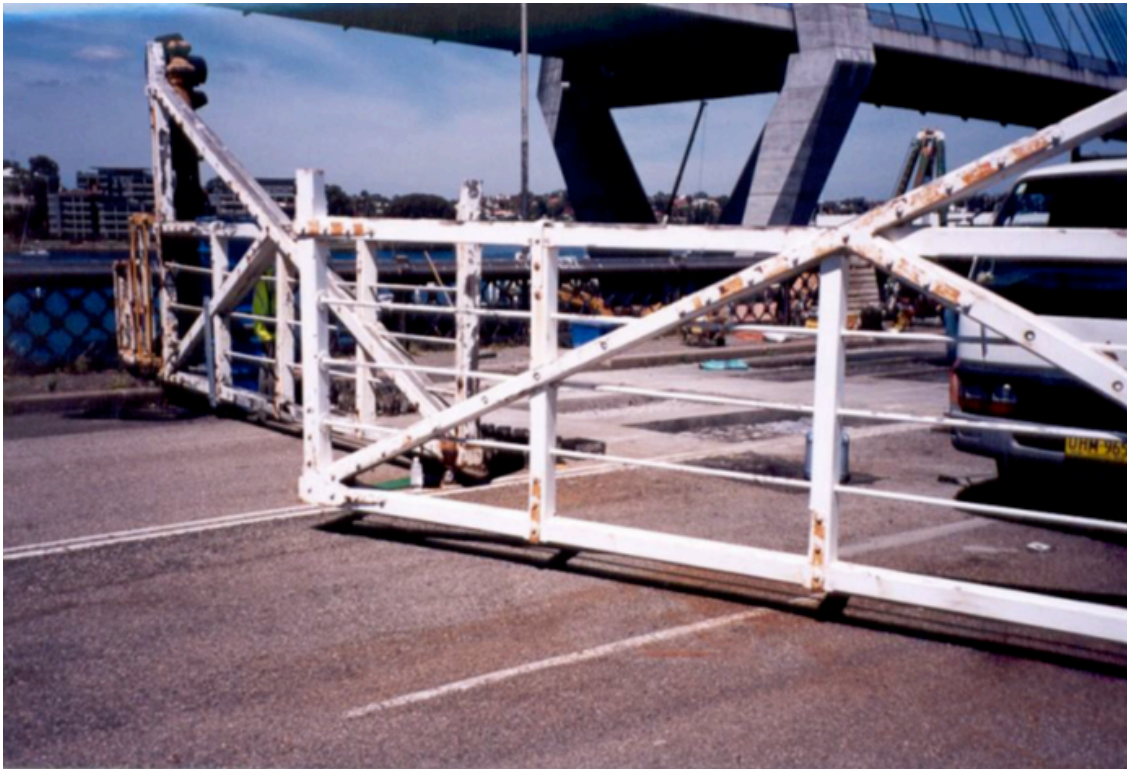
There are four sets of combined traffic and pedestrian gates located on the approach spans. The gates are timber framed, with three rows of horizontal steel rods, and are strap hinged for stability to a decorative cast iron column (Figure 9.22).

**Figure 9.22 Glebe Island Bridge vehicle and pedestrian gates**

The outer ends of the traffic gates were originally stayed by a steel rod/strap, which was attached to a collar near the top of the cast iron columns. The steel rod/strap has been replaced by a timber stay and the gates appear to have been rebuilt since the Bridge was opened.

The pedestrian gates are simply cantilevered off the hinge post of the traffic gate. The original pedestrian gates, which were of timber and steel, have been replaced by steel framed gates with mesh covering.

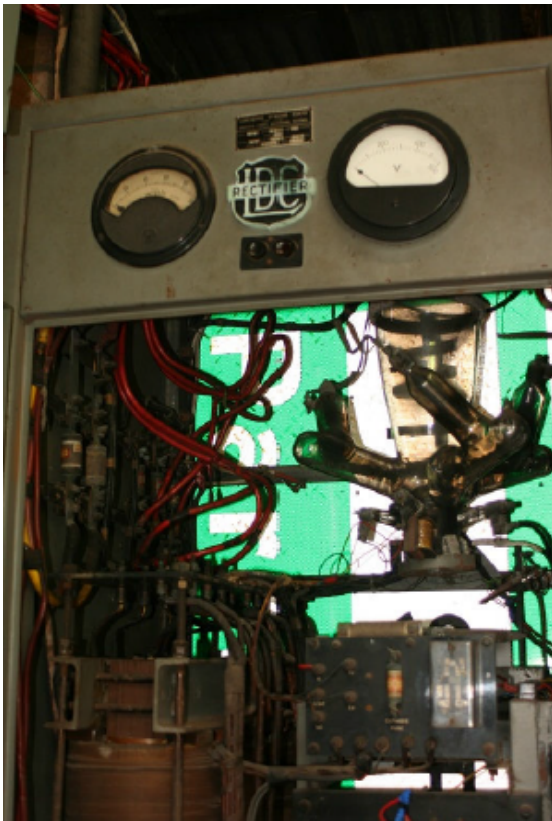
**Figure 9.24** The Mercury Arc Rectifier Cabinet, with the door open and the glass bulb upper right with reactors, wiring and relays at the base. Manufactured by Lancashire Dynamo Coates Pty Ltd, of Goodwin Street, Richmond, Victoria. A silicon rectifier unit is mounted on the wall adjacent (Source: Brassil, 2011)

The Glebe Island Bridge MAR then is an excellent, single, unitary example of a historically significant electrical technology which is one of the last examples in Australia still performing the function for which it was installed. It is a key functional component within the operating system for the State-significant Glebe Island Bridge and is historically associated with the cessation of electrical tramway operations in Sydney (Brassil, 2011).

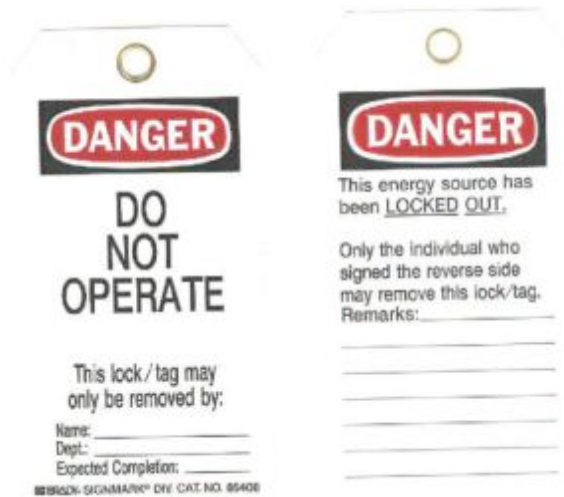
Site inductions, isolation, lock-out (see Figure 10.3) and tag-out procedures should be developed for all operational bridges. This is vital and should be mandatory when numerous multi-discipline personnel are working at the same time on the bridge, often during shutdowns, at night and over water.

**Figure 10.3 Danger lock out tags front and back**

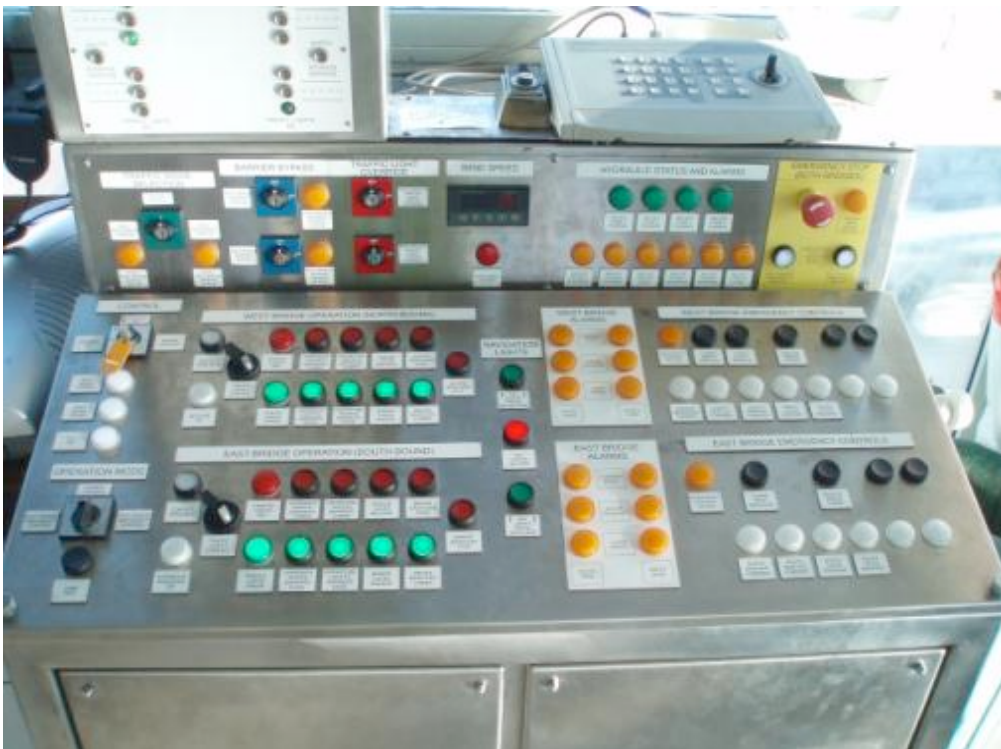
In addition modern day control panels can ensure operate error is virtually removed from the lifting and operating sequence (see Figure 10.4).

**Figure 10.4 Control panel upgrade Swansea Bridge**
