106 GOULBURN STREET, TARAGO INTERIM ENVIRONMENTAL MANAGEMENT PLAN

Project name 106 Goulburn Street, Tarago, Interim Environmental Management Plan

Description The report describes environmental management procedures to minimise

risks from contaminated soil, dust and paint at the former Station Masters

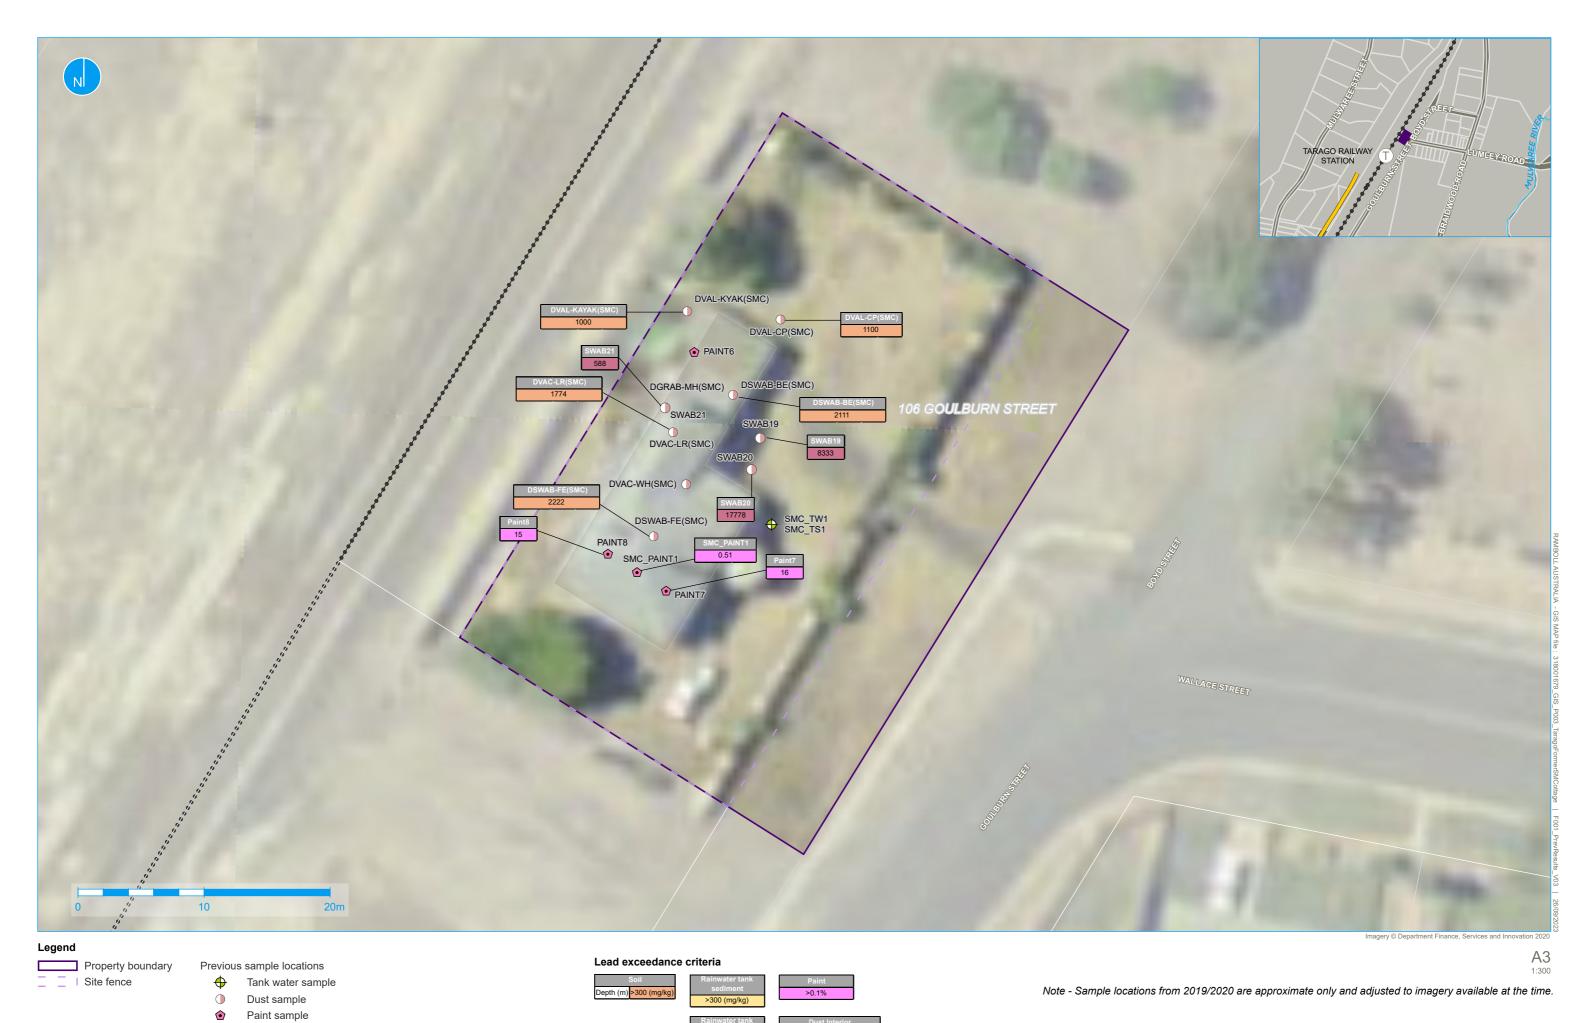
Figure 1 : Interior building lead samples and exceedances

The distribution of contaminant concentrations exceeding adopted human health and ecological guidelines are shown in **Figure 1 and 2**, **Appendix 1**.

Soils, internal dust, and paint onsite contain concentrations of heavy metals which exceed the adopted human health criteria and subsequently have the potential to harm human health. The distribution of contamination is defined by exceedances of adopted assessment criteria presented on **Figure 1 and 2, Appendix 1** and identify the presence of elevated lead, zinc and copper in shallow soils across the site and elevated lead throughout building interiors.
