L004 (Interim Audit Advice Tarago Woodlawn Siding Rev 0)

L004 Interim Audit Advice (0503-2303-004) – Tarago Woodlawn Siding NSW

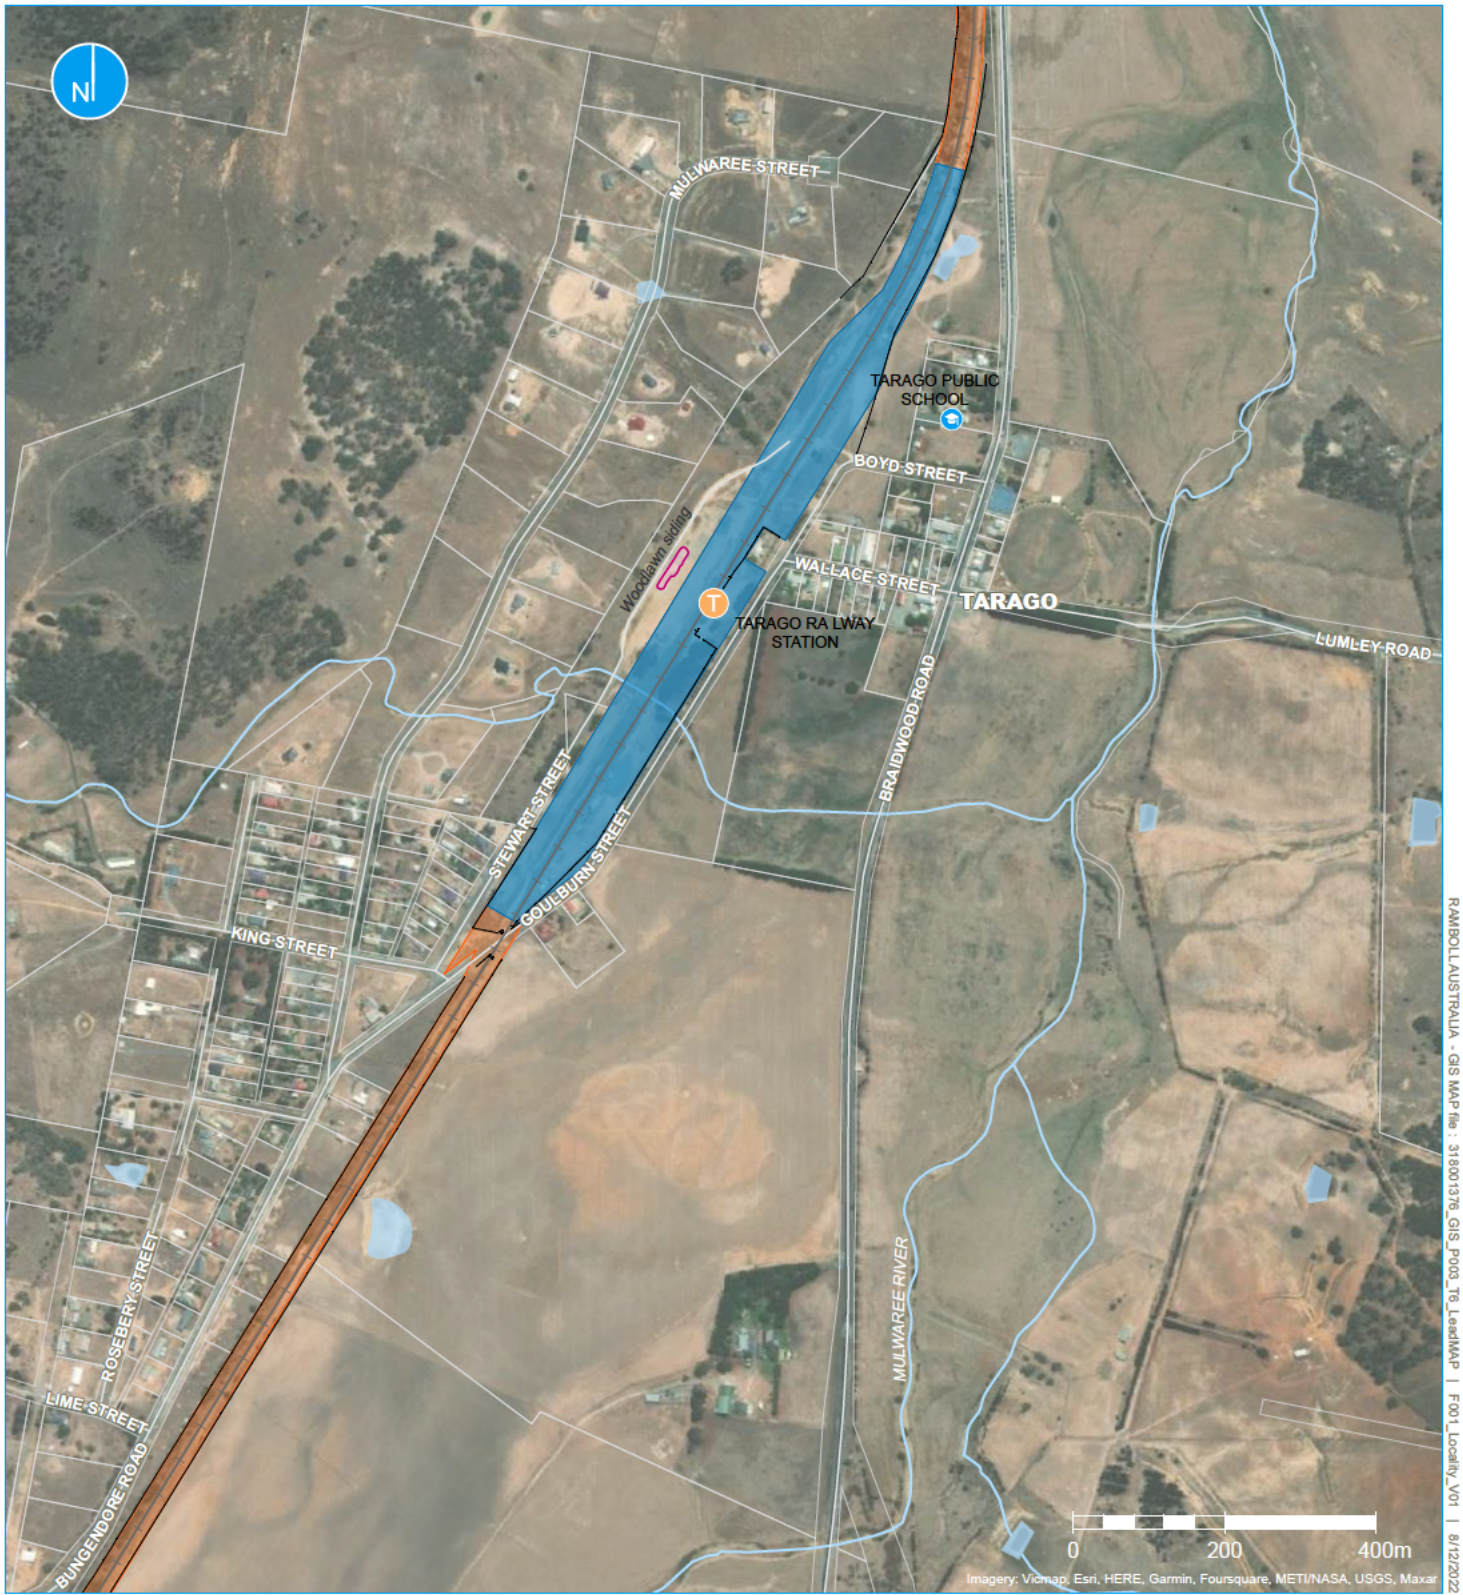
Figure 1 | Locality Plan

Andrew Lau of JBS&G Australia Pty Ltd (JBS&G), has been engaged by Transport for NSW (TfNSW, the client) to conduct a site audit on a portion of the Goulburn – Bombala Country Regional Network (CRN) rail corridor in Tarago NSW identified as part Lot 22 in Deposited Plan (DP) 1202608 (the site). The site occupies a strip of land of approximately 7.5 hectares. The extent of the site area and the location of the site are shown in Figure F1, in Attachment 2.
