# Terania Street Bridge Demolition

**Review of Environmental Factors**

August 2024

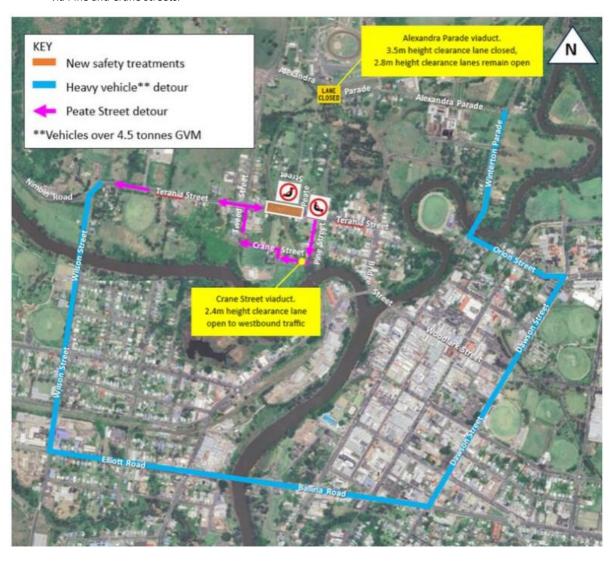
Plate 1: Detour routes for the project

- A detour for all heavy and light vehicles is available via Wilson Street, Elliott Road and Ballina Road.
- Light vehicles can access Terania and Bridge streets via Dawson and Woodlark streets, which are not suitable for heavy vehicles. Light vehicles with 2.4 metre clearance can access Tweed Street northbound from Terania Street via Pine and Crane streets.

Currently Terania Street is open to local light vehicular traffic (as of June). Heavy Vehicles will continue to be detoured (>4.5t and 6m length) in accordance with current detour arrangements (refer **Figure 3-1**). This detour will remain in place during the works until demolition is complete and single lane access can be safely restored (with traffic management). Other detour information is as follows (refer **Plate 1**):

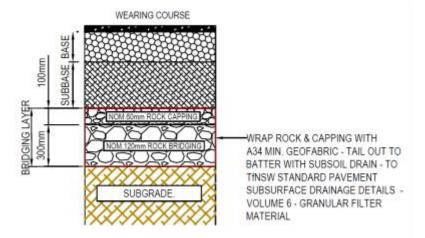
Plate 2: Hardstand detail for compound hardstand (pending further investigation and minus wearing course)

An example of the design is shown at Plate 2, however without the asphalt wearing course installed.

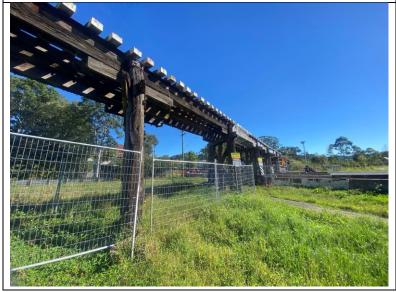
Photo 3: Terania Street bridge - detail

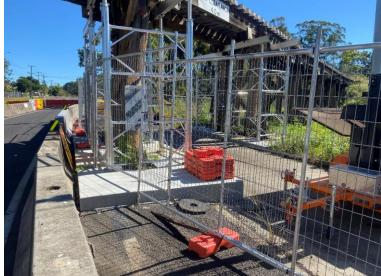
Photo 5: Safety scaffolding; note poured concrete bases, which will require removal following demolition (est. 4-5 days)

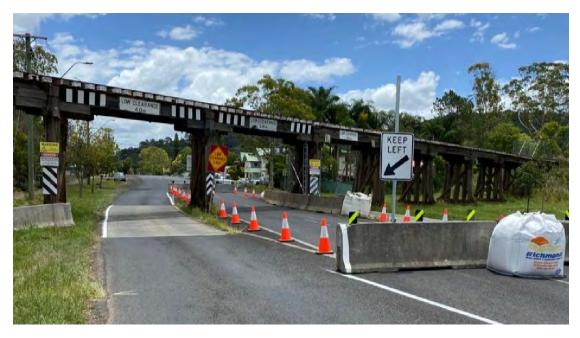
Figure 2-5 Terania Street Underbridge east elevation (Source: FBE)

There is evidence of temporary works supporting corbels at the pier on the north side of the main carriageway. There are no records of when this was implemented but it appears that the corbels and girders were in poor condition and were most likely damaged by a vehicle strike. This resulted in pier displacement which needed additional supports to ensure stability. There is also evidence of the central girder being missing over the main carriageway due to the damage likely caused by previous vehicle strike. Vertical clearance is limited to 3.8 m at the main carriageway and 4.0m at both overheight bypass spans.

In addition to the main carriageway at span 6, there are two single lane overheight bypass roads under the adjacent spans 5 and 7 (see Figure 2-5).

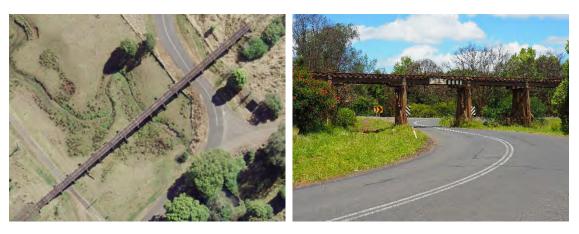
Figure 2-8 Winterton Parade aerial view and elevation (Source: FBE)

The minimum vertical clearance at Winterton Parade is 4.5 m over the road, while typical span length of the underbridge is 7.4 m. The superstructures for both underbridges consist of three (3) square double girders topped with square transoms and is supported via square corbels on top of timber trestles. The timber trestle piers comprise 5 vertical circular embedded piles, diagonal braces and are seated on dual sill logs and support two capwales at the top.

Winterton Parade Underbridge is a 16-span timber transom topped timber girder underbridge that crosses the two lane local road and flood plain adjacent to the Wilson River (see Figure 2-8).

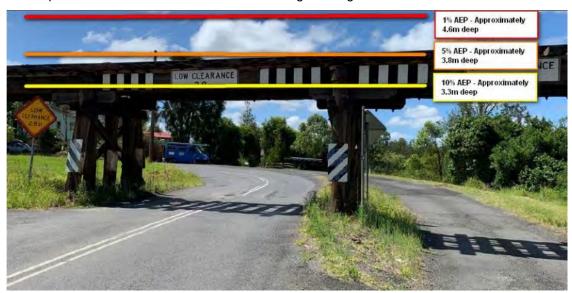
Figure 6-1 Alexandra Parade Underbridge flood levels (Source: LCC)

- Events. Lack of vertical clearance between the flood level and bridge soffit to enable rescue evacuation during 5% AEP (Average Exceedance Probability) and 10% AEP flood events, see Figure 6-1 where:
  - o Red line: 1% AEP probability of flood event to occur 1 in 100 years.
  - o Orange line: 5% AEP probability of flood event to occur 1 in 20 years.
  - Yellow line: 10% AEP probability of flood event to occur 1 in 10 years.
- Risk. Impossible to permanently relocate residents from flood prone areas due to the risks
  presented by the bridge to rescue boats. The bridge was identified by LCC as moderate
  impediment to rescues and evacuation during flooding.

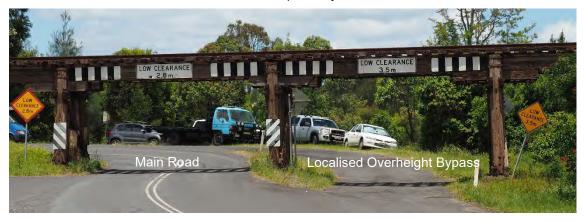
Figure 6-2 Alexandra Parade - Elevation view - Looking South (Source: FBE)

Alexandra Parade Underbridge is a timber transom top underbridge with low vertical and horizontal clearances. It spans over a two-way two-lane sealed road (east span) and one-way sealed local diversion road with a higher vertical clearance (see Figure 6-2).

- **Height accessibility Main Road.** Vertical clearance over 2 lane (two way) main sealed road of 2.8 m is lower than general access vehicle height requirement of 4.6 m.
- **Height accessibility Overheight Bypass.** Vertical clearance of one-way side diversion road of 3.5 m is lower than general access vehicle height requirement of 4.6 m.
- Width accessibility. The sealed road width of 5.2 m has approximately 2.5 m wide lanes which is less than 3.5 m minimum width required by Austroads.

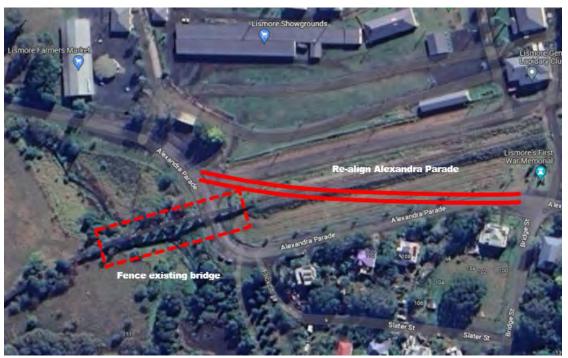
Figure 6-3 Alexandra Parade proposed alternate route (Source: FBE)

The proposed alternate route at Alexandra Parade is shown in Figure 6-3. This road layout is preferred over LCC proposal as it would reduce the length of the new road connection while addressing most or all of the project and site constraints. Appendix E, Section 4 details the alternate route options proposed independently by FBE and LCC.

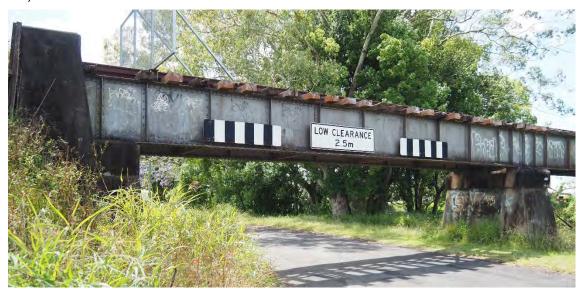
Figure 7-1 Crane Street low clearance 2.5 m (Source: FBE)

There is substandard vertical clearance of 2.5 m under Crane Street Underbridge (see Figure 7-1).

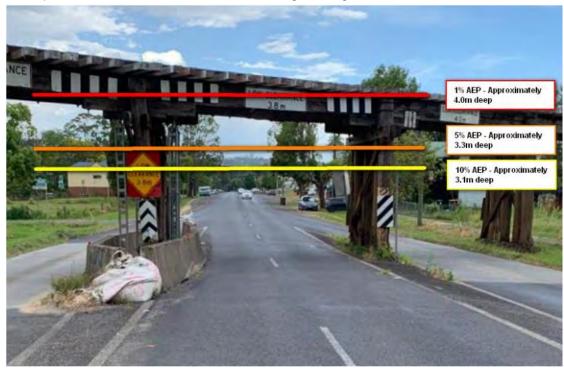
Figure 8-1 Terania Street - Flood levels (Source: LCC)

- Events. Lack of vertical clearance between the flood level and bridge soffit to enable rescue evacuation during 1% AEP 5% AEP and 10% AEP flood events, where Figure 8-1 shows
  - Red line: 1% AEP probability of flood event to occur 1 in 100 years.
  - o Orange line: 5% AEP probability of flood event to occur 1 in 20 years.
  - Yellow line: 10% AEP probability of flood event to occur 1 in 10 years.
- Risk. Impossible to permanently relocate residents from flood prone areas due to the risks
  presented by the bridge to rescue boats. The bridge was identified by LCC as a high
  impediment to rescues and evacuation during flooding.

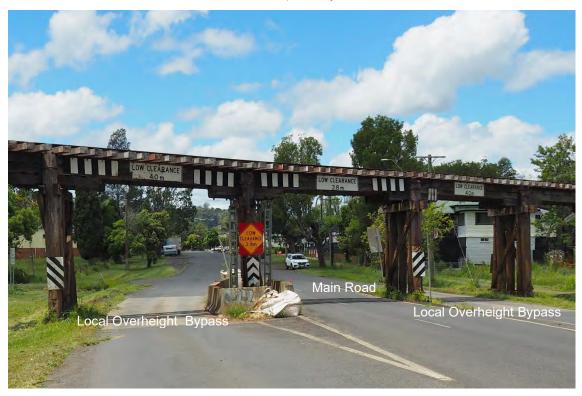
Figure 8-2 Terania Street - Elevation view looking south (Source: FBE)

- **Height accessibility Main road.** Vertical clearance over 2 lane (two way) main sealed road of 3.8 m is lower than general access vehicle height requirement of 4.6 m.
- Height accessibility Overheight Bypass. Vertical clearance of one-way west and oneway east local diversion roads of 4.0 m is lower than general access vehicle height requirement of 4.6 m.
- **Width accessibility.** The sealed road width of 4.6 m has approximately 2.1 m wide lanes which is less than 3.5 m minimum width required by Austroads.

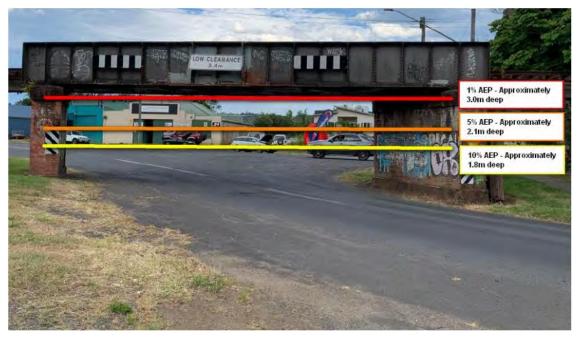
Figure 9-1 Union Street underbridge flood levels (Source: LCC)

- **Events.** Lack of vertical clearance between the flood level and bridge soffit to enable rescue evacuation during 1% AEP 5% AEP and 10% AEP flood events, see Figure 9-1 where:
  - o Red line: 1% AEP probability of flood event to occur 1 in 100 years.
  - o Orange line: 5% AEP probability of flood event to occur 1 in 20 years.
  - Yellow line: 10% AEP probability of flood event to occur 1 in 10 years.
- Yellow. Impossible to permanently relocate residents from flood prone areas due to the
  risks presented by the bridge to rescue boats. The bridge was identified by LCC as a high
  impediment to rescues and evacuation during flooding.

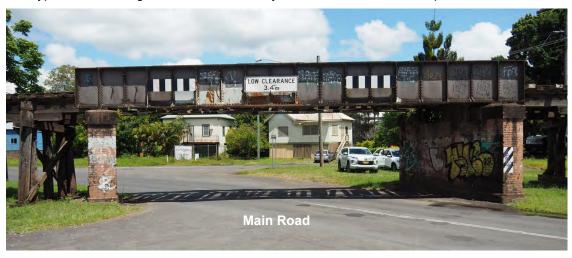
Figure 9-2 Union Street Underbridge road clearance over main road (Source: FBE)

- **Height accessibility Main Road.** Low vertical clearance over 2 lane main sealed road of 3.4 m is lower than 4.6 m required for general access vehicles.
- **Height accessibility Overheight Bypass.** Low vertical clearance of one-way bypass roads of 4.5 m is just below the requirement of 4.6 m for general access vehicles. The local bypass road is single lane and allows only one vehicle at the time to pass.

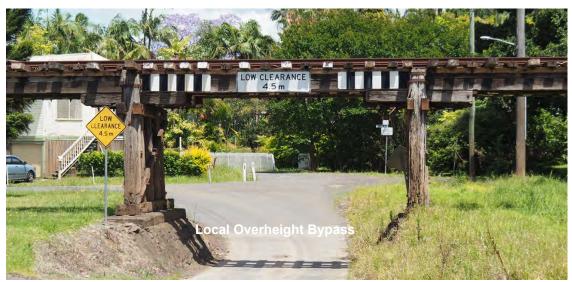
Figure 9-3 Union Street Underbridge road clearance over bypass road (Source: FBE)

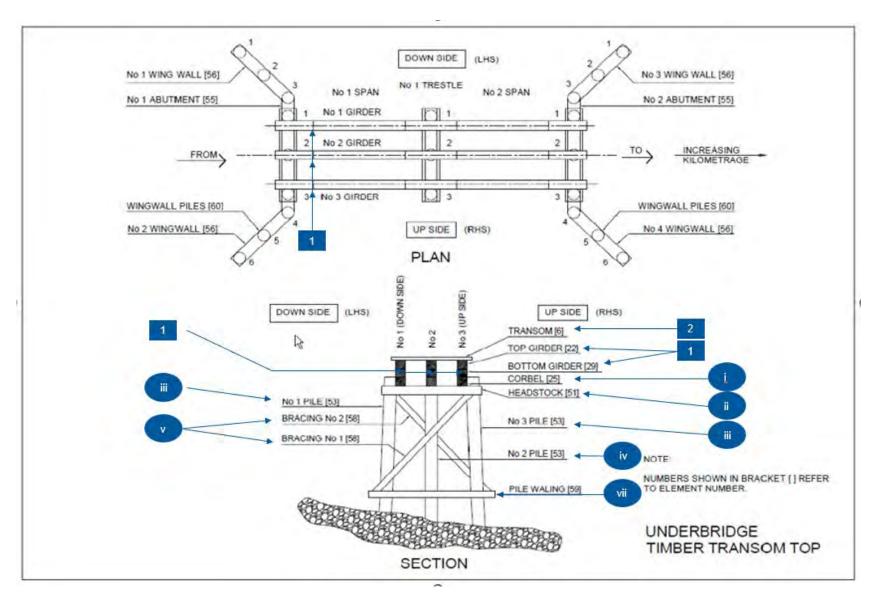
Figure A-2 Typical timber girder bridge elements (Source: ARTC)

Mark	Bridge element	Material	Section size (typical not measured)
Timbe	r girder spans		
1	Girder	Timber	2x 300 mm x 300 mm beams
2	Transoms	Timber	300 mm x 200 mm
3	Ties & Connections	Wrought iron	Bolts, ties, base plates & braces
Timber	trestle pier		
i	Corbel	Timber	300 mm x 300 mm x 2800 mm
ii	Headstock	Timber	300 mm x 300 mm
iii	Raking pile	Timber	450 mm diameter
iv	Vertical pile	Timber	450 mm diameter
V	Bracing	Timber	200 mm x 100 mm
vi	Ties & connections	Wrought iron	Bolts, ties, base plates & braces
vii	Wale	Timber	300 mm x 200 mm
Founda	ations		
а	Concrete sill	Un-reinforced	1500 mm width
b	Timber pile		Same as above
С	Ties & connections	Wrought iron	Bolts, ties, base plates & braces

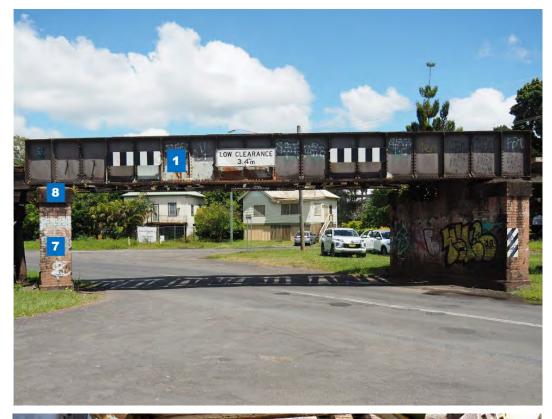
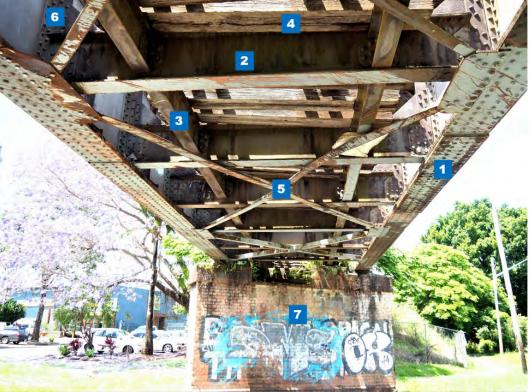
Figure A-2 Union Street metal span elements (Source: FBE)

Union Street Underbridge element numbering can be found in Figure A-2. Elements, their description and materials are shown in Table A-2.

Mark	Bridge element	Material	Description
1	Main girder	Wrought iron	Riveted plate girder
2	Cross beam	Wrought iron	PFC beam
3	Stringer	Wrought iron	I-beam
4	Transoms	Timber	Square or rectangular section
5	Horizonal restraint	Wrought iron	Flat plates
6	Web stiffener	Wrought iron	Plates and angles
7	Pier	Masonry	Brick wall
8	Pilaster	Masonry	Bricks

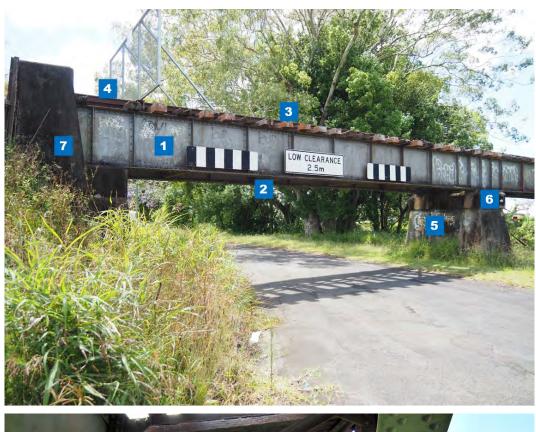
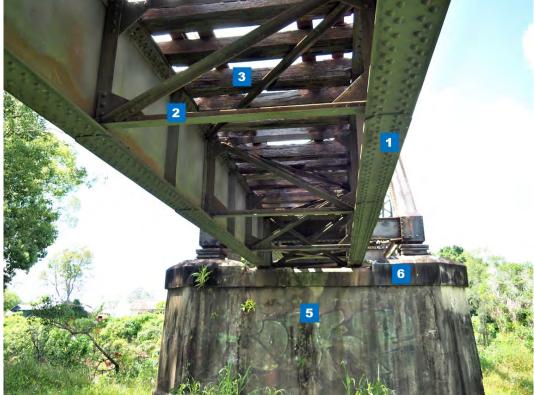
Figure A-3 Crane Street Underbridge elements (Source: FBE)

Crane Street Underbridge element numbering can be found in Figure A-3. Elements, their description and materials are shown in Table A-3.

Mark	Bridge element	Material	Description
1	Main girder	Wrought iron	Riveted plate girder
2	Cross frame	Wrought iron	Angles
3	Transoms	Timber	Square or rectangular section
4	Rail	Wrought iron	Rail section
5	Pier	Concrete	Concrete wall
6	Pilaster	Concrete	Concrete capping
7	Abutment	Concrete	Concrete wall

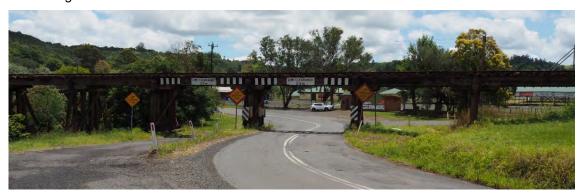
Figure B-1 Alexandra Parade – North elevation (Source: FBE)

Please refer to Figure B-1 through to Figure B-5 for photographs of the typical condition of the underbridge.

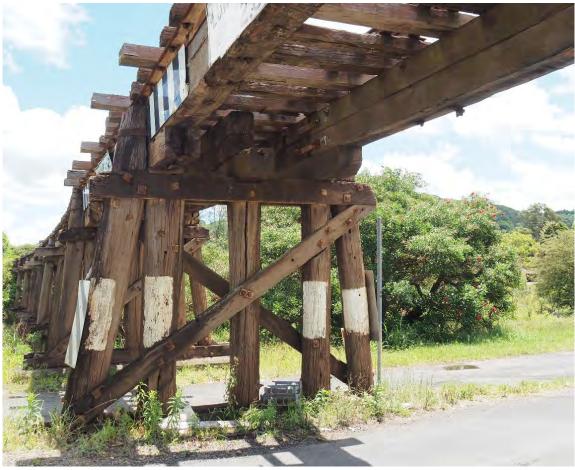
Figure B-2 Alexandra Parade – Pile with evidence of splitting and decay at Pier 23 (Source: FBE)

The substructure has more detrimental global risks to the underbridge due to the poor condition of the trestle piers, corbels and headstocks. The piles are typically split or splitting with many having rotten or are infested with termites. The assessment does not account for vehicular accidents that would damage piers and cause local and global structure instability. The foundations are typically seen and estimated to be in a good to fair condition.

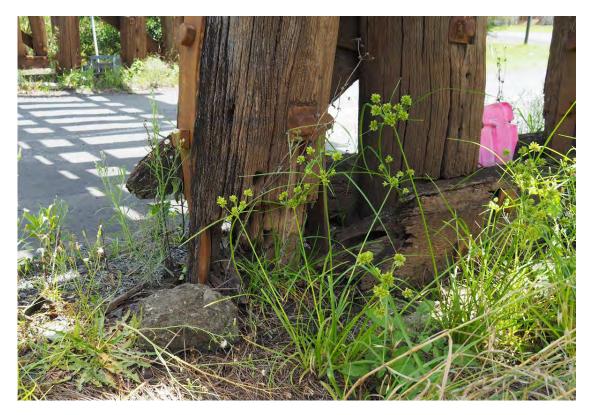
Figure B-3 Alexandra Parade - Rotten/Infested pile & whaling at Pier 23 (Source: FBE)

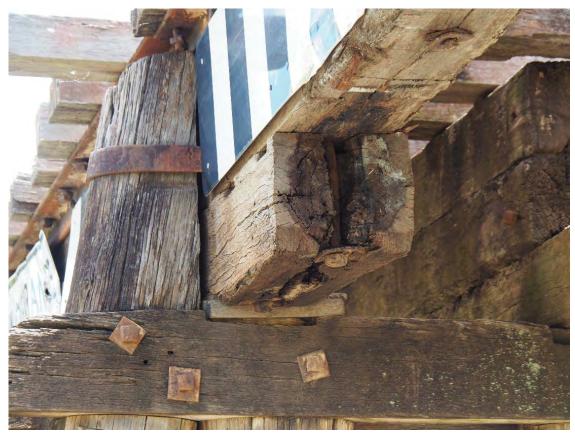
Figure B-4 Alexandra Parade – Rotten/Infested corbel, typical condition (Source: FBE)

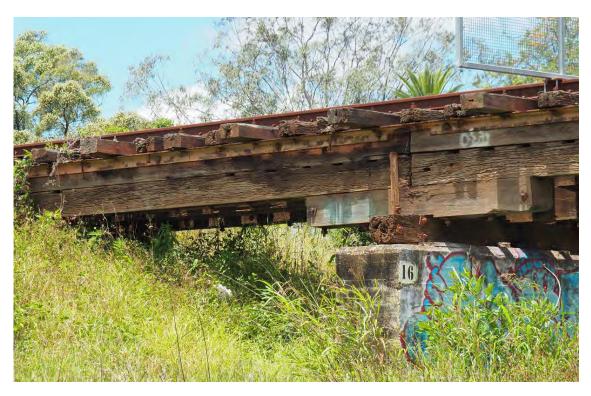
Figure B-5 Alexandra Parade - Decayed and infested transoms at Span 27 (Source: FBE)

The superstructure is in a predominantly poor condition and has a high risk of transoms falling off along with bolted connections. The main girders are also a medium to high risk of failure primarily due to rot and termite infestation.

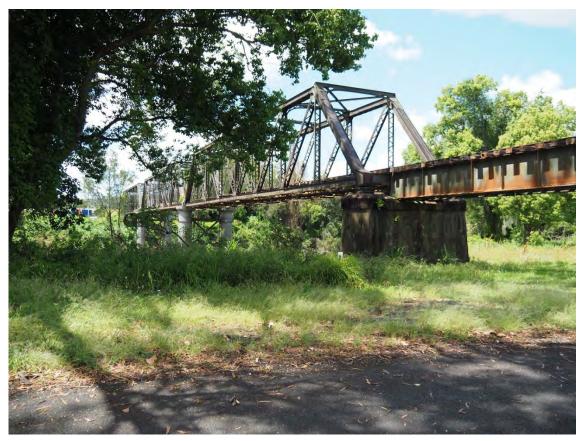
Figure B-6 Crane Street - Pratt truss east elevation, typical condition (Source: FBE)

The superstructure is in a predominantly fair condition however the transoms are severely rotten and are a risk to pedestrians below and the environment. The substructure is in a good to fair condition with wall type piers and abutments in predominantly good to fair condition. The river bridge piers are estimated to be in a good to fair condition as no rust or pitting is visible and there is no settlement noted by prior inspections. The foundations are found to be in a good to fair condition. Please refer to Figure B-6 through to Figure B-11 for photographs of the bridge presenting typical conditions.

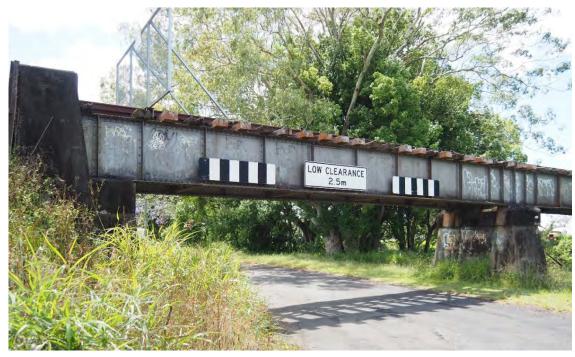
Figure B-7 Crane Street - East elevation, typical condition (Source: FBE)

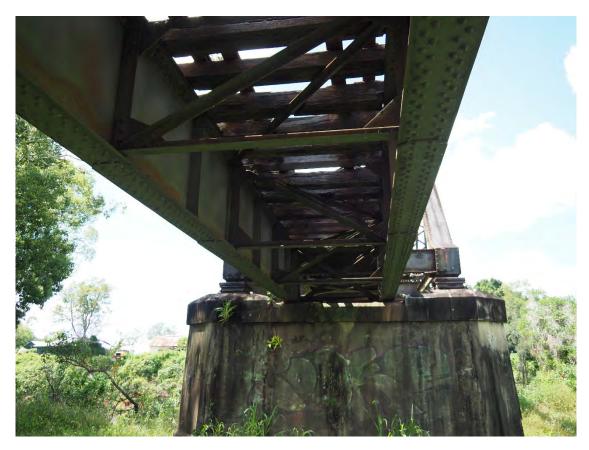
Figure B-8 Crane Street - Superstructure view from underside, Span 2 (Source: FBE)

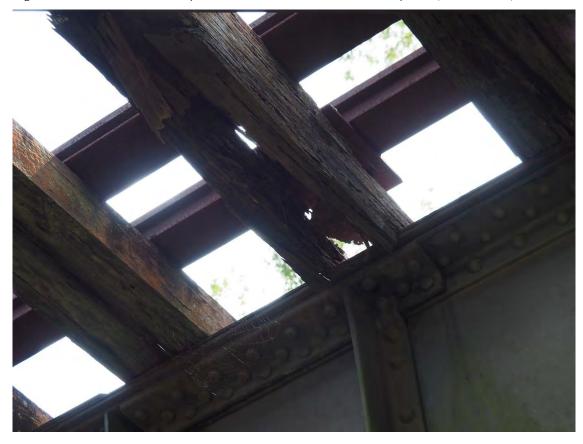
Figure B-9 Crane Street - Decayed transoms at Span 1, typical condition (Source: FBE)

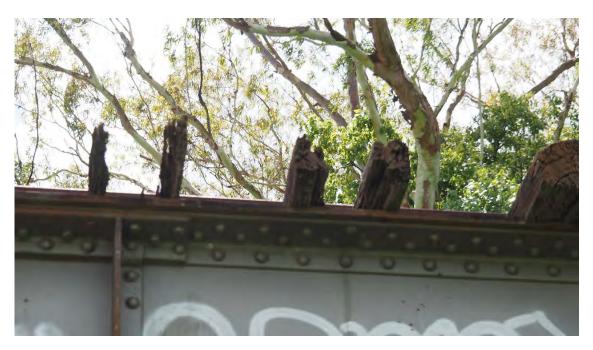
Figure B-10 Crane Street - Decayed transoms at Span 1 (Source: FBE)

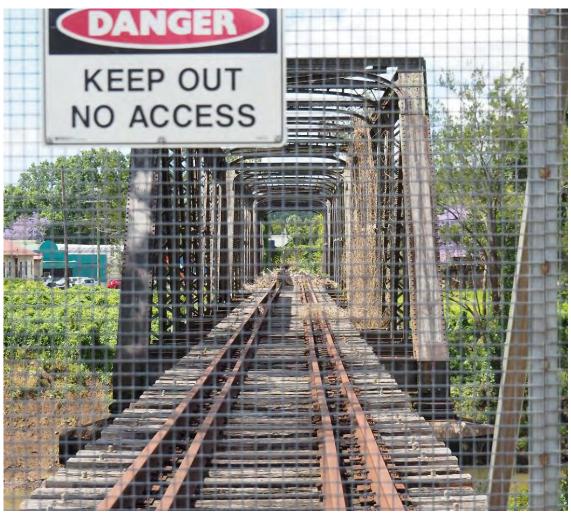
Figure B-11 Crane Street - View over looking south (Source: FBE)

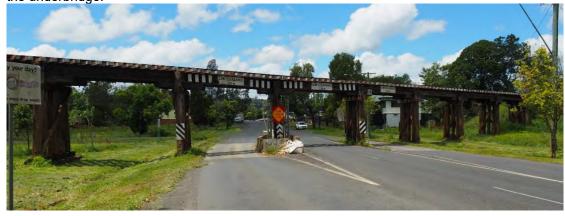
Figure B-12 Terania Street - West elevation view (Source: FBE)

Please refer to Figure B-12 through to Figure B-17 for photographs of the typical condition of the underbridge.

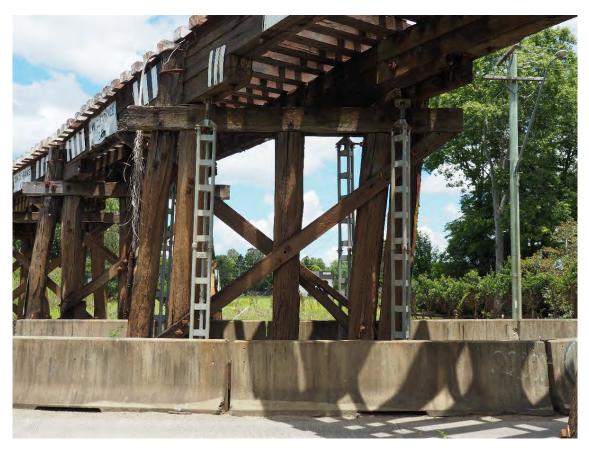
Figure B-13 Terania Street – Evidence of global rotation of Pier 6 together with failed pile (Source: FBE)

The superstructure is in a predominantly poor condition and has a high risk of transoms falling off along with bolted connections. The main girders are also a medium to high risk of failure primarily owing to rotting and termite infestation. The substructure has more detrimental global risks to the underbridge due to the poor condition of the trestle piers, corbels and headstocks. The piles are typically split or splitting with many having rotten or are infested with termites. The assessment does not account for vehicular accidents that would damage piers and cause local and global structure instability. The foundations are typically seen and estimated to be in a good to fair condition.

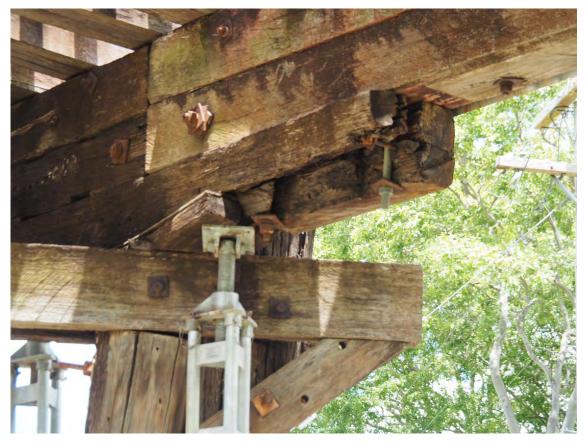
Figure B-14 Terania Street - Rotten and damaged east corbel at Pier 6 (Source: FBE)

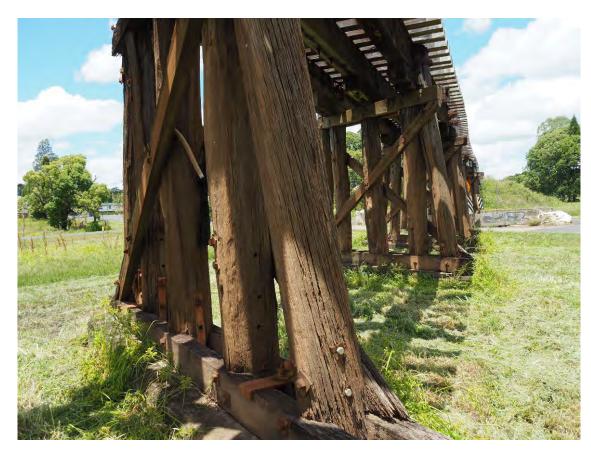
Figure B-15 Terania Street - Splitting & weathering of piles at Pier 11 (Source: FBE)

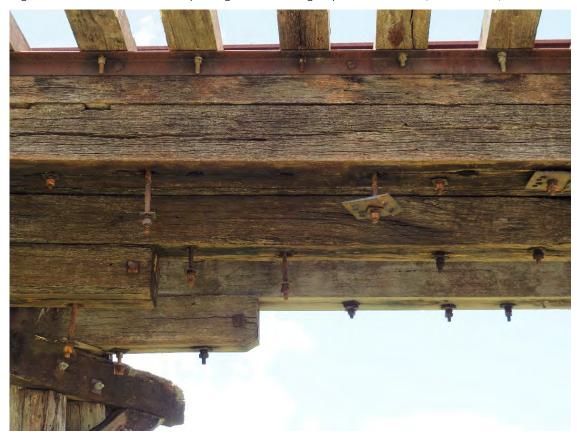
Figure B-16 Terania Street - Loose connections & weathered beams (Source: FBE)

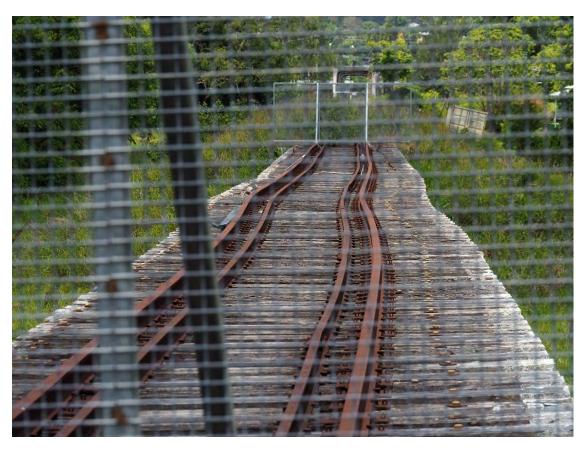
Figure B-17 Terania Street - View over looking south (Source: FBE)

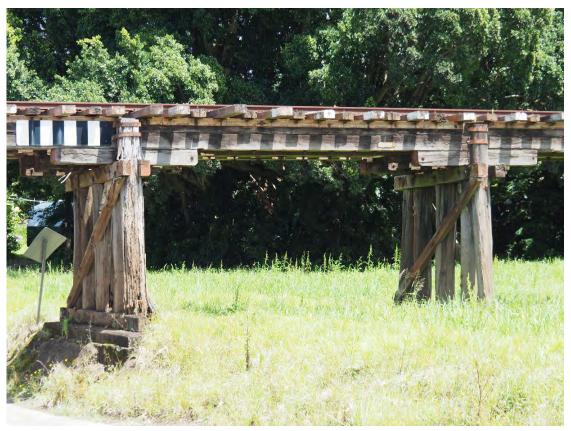
Figure B-18 Union Street - View looking west, typical condition of timber span (Source: FBE)

The superstructure is in a fair to poor condition and has a high risk of transoms falling off along with bolted connections. The substructure has more detrimental global risks to the underbridge due to the poor condition of the trestle piers, corbels and headstocks. The assessment does not account for vehicular accidents that would damage piers and cause local and global structure instability. Please refer to Figure B-18 through to Figure B-21 for photographs presenting the typical condition of the underbridge.

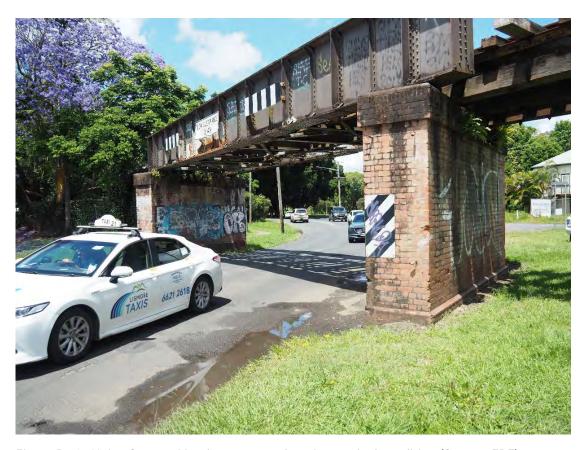
Figure B-19 Union Street - Metal span west elevation, typical condition (Source: FBE)

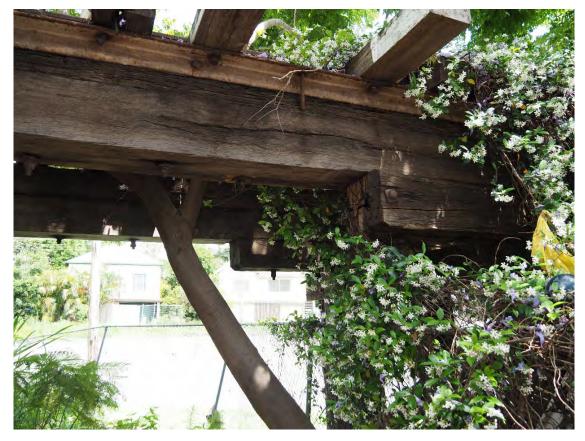
Figure B-20 Union Street - West elevation, typical timber girder condition (Source: FBE)

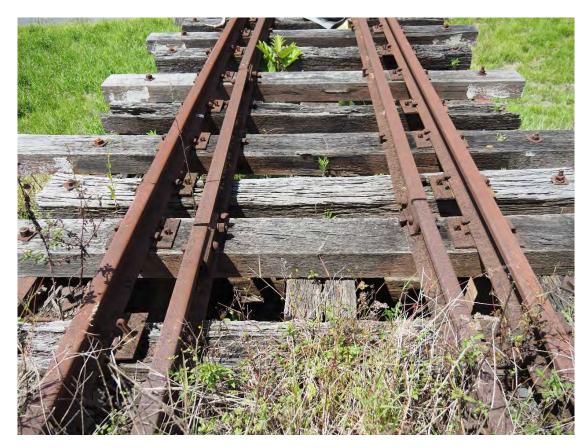
Figure B-21 Union Street - View overlooking south, typical condition (Source: FBE)

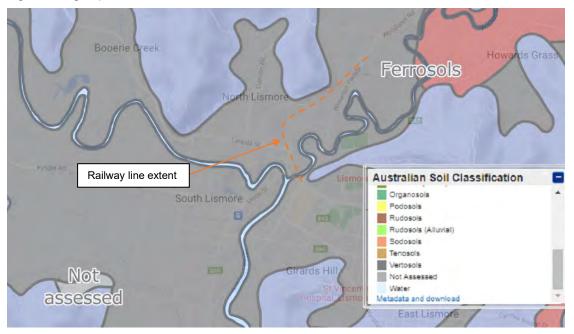
The associated soils in the area are classified as "Vertosols" under the Australian Soil Classification. Figure C-6 provides indicative soil classifications along the rail corridor. Vertosols are brown, grey or black soils typically consist of 35% or more clay and as such do not possess high bearing capacities.

Figure C-6 Lismore City - Australian Soil Classification - Vertosol (Source: eSPADE 2.2)

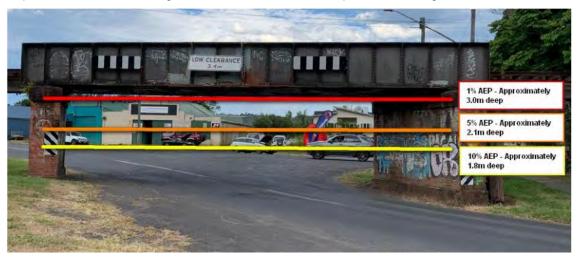
Figure C-7 Union Street – Flood levels (Source: LCC)

In the same letter LCC identified that it would require a vertical clearance of 1.6 m to 1.8 m to allow a standard rescue boat to pass under the bridge during a flood event. For example, with 3.0 m flood level of 1% AEP a vertical clearance above the road level of 4.8 m (1.8 m + 3.0 m) would be required at Union Street Underbridge. With the current low clearance of 3.4 m this requirement is seen as a significant obstacle for rescue operations during a flood.

As may be seen in the Figures C-7 to C-9 and as summarised below in Table C-1 the required freeboard of 1.8 m is not obtainable during most flooding events. It should also be noted that superstructure levels may also be an obstacle for rescue boats to traverse when flood levels are above the deck. It is therefore recommended that the removal of the underbridges should be considered a necessity in order to mitigate severe and catastrophic risks in the future. Whilst flood levels for Crane Street and Winterton Parade have not been provided it is foreseen that similar levels will prevail owing to the extent of the flooding.

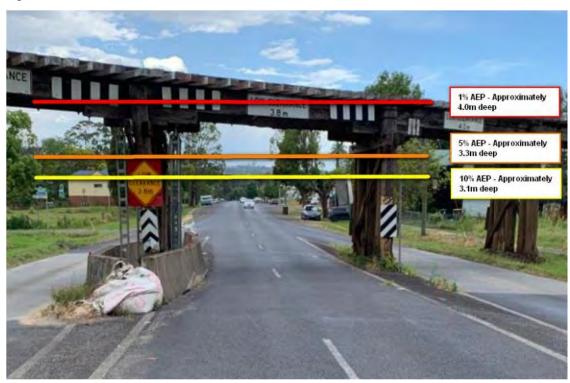
Figure C-8 Terania Street – Flood levels (Source: LCC)

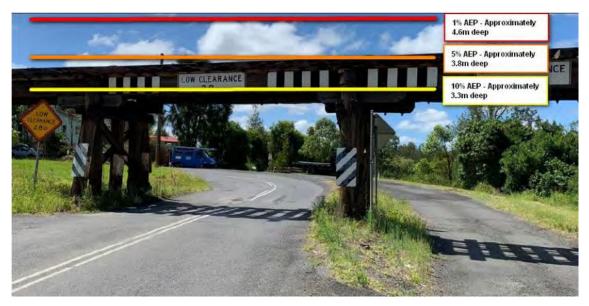
Figure C-9 Alexandra Parade - Flood levels (Source: LCC)

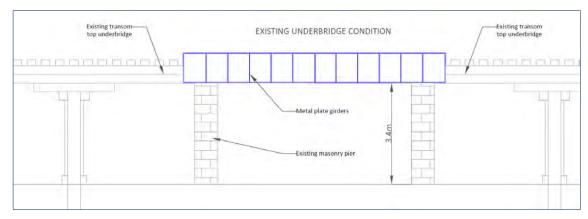
Figure E-1 Option 1 – Existing underbridge condition (Source: FBE)

The main girders would be supported by a fully designed and certified temporary support works and frame which shall then be lifted via crane. The crane shall have respective outriggers placed on support pads for stabilisation. Figure E-1 through to Figure E-3 shows the proposed methodology before, during and after raising the metal span. The temporary falsework and frame would be designed for the dead load of the span and its own self weight.

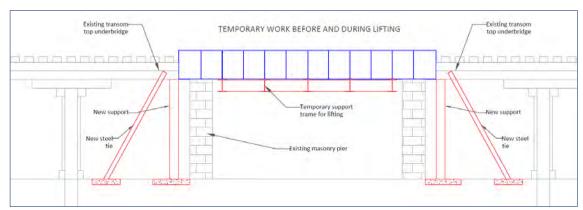
Figure E-2 Option 1 – Proposed temporary works (Source: FBE)

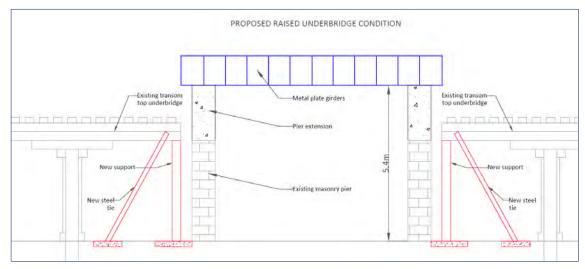
Figure E-3 Option 1 – Proposed raised underbridge condition (Source: FBE)

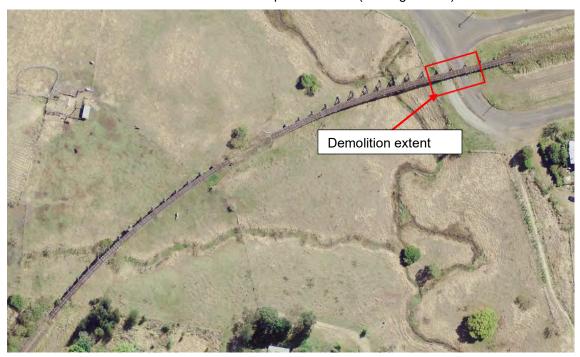
Figure E-4 Alexandra Parade – Demolition extent, spans 22 to 25 (Source: FBE)

Partial demolition involves removal of the road spans and adjacent spans including stabilisations works to the remaining timber girder spans to maintain their structural integrity and ensure public safety. This option would be feasible for all bridge sites and would eliminate most of the existing site constraints with some residual risks associated with the remaining spans. Partial demolition is considered possible for all the rail underbridges except for Crane Street Underbridge due to continuous spans arrangement. The extent of demolition would vary at each site and the extent at each site is illustrated in the following figures. Partial demolition of Alexandra Parade would involve removal of spans 22 to 25 (see Figure E-4).

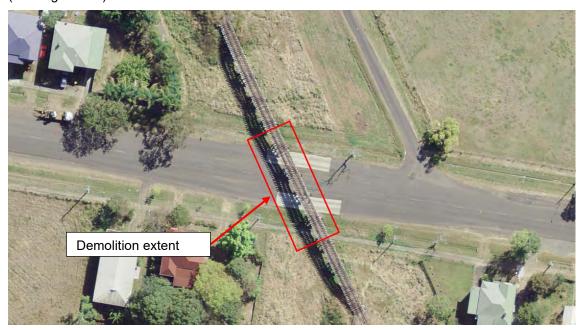
Partial demolition of Terania Street underbridge would involve the removal of the spans 4 to 8 (See Figure E-5)

Figure E-5 Terania Street - Demolition extent, spans 4 to 8 (Source: FBE)

It is proposed that at each site that the road would be temporarily closed in order to demolish the extent of each bridge as shown in Figure E-4 to Figure E-7. The remaining portions of the bridges after partial demolition would be propped by new supports as required and restrained by ties. Figure E-8 shows an idealised sketch of the proposed stabilisation works and the layout of the underbridge following partial demolition.

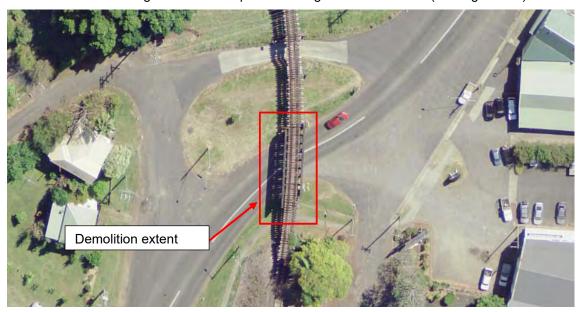
Union Street Underbridge would have spans 2 through to 5 demolished (see Figure E-6).

Figure E-6 Union Street Bridge – Demolition extent, spans 2 to 5 (Source: FBE)

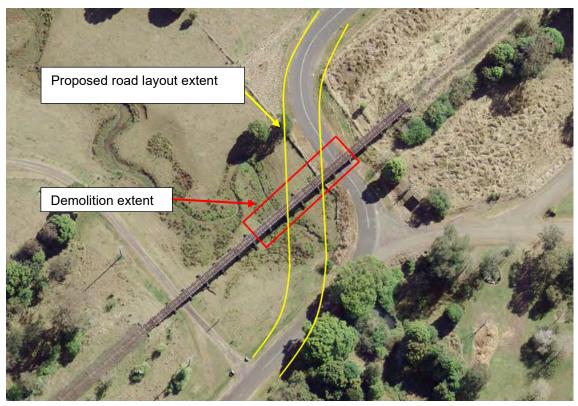
For Winterton Parade underbridge it is proposed that spans 8 to 14 are demolished for this option to allow for a proposed road re-alignment (see Figure E-7).

Figure E-7 Winterton Parade – Demolition extent, spans 8 to 14 (Source: FBE)

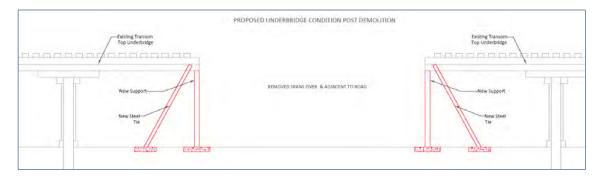
Figure E-8 Proposed layout of the underbridges post partial demolition (Source: FBE)

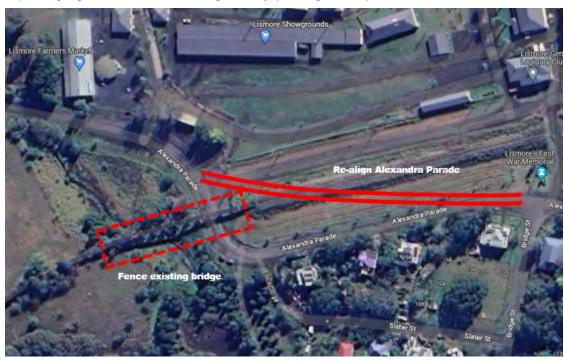
FBE proposed to realign the road by cutting through the non-operational railway line directly east of the bridge road crossing. This would improve the level of service for road users by improving sight distances and road geometry (see Figure E-9).

Figure E-9 Option 4A – FBE proposed alternate route at Alexandra Parade (Source: FBE)

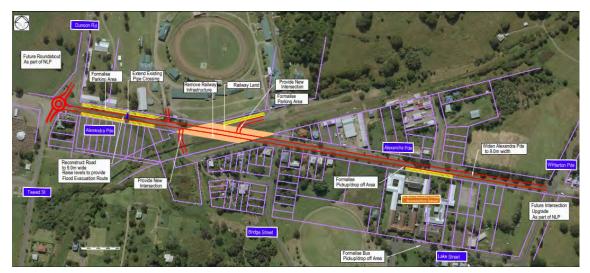
Figure E-10

The LCC proposed alternate road route would encompass the realignment of the existing Alexandra Parade and provision for construction of a new portion of road. The new portion of road would bypass the existing underbridge by following the proposed or similar alignment from the Alexandra Parade and Bridge Street intersection, through to the proposed roundabout at the intersection of Dunoon Road and Alexandra Parade (see Figure E-10).

Option 4 – LCC proposed alternate route at Alexandra Parade (Source: LCC)

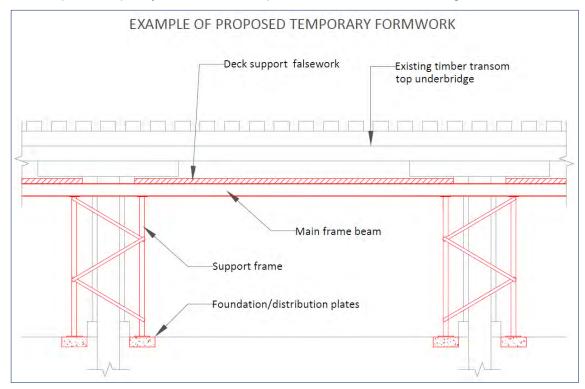
An example of temporary works for timber span rehabilitation is shown in Figure E-11.

Figure E-11 Example of proposed temporary falsework (Source: FBE)

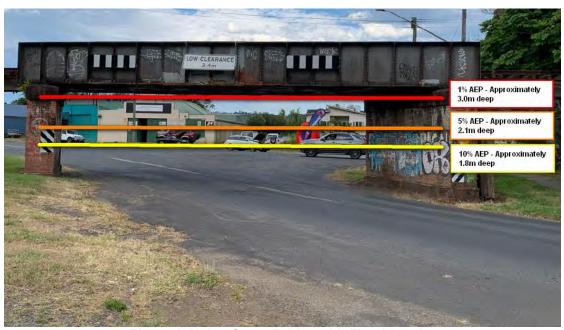
Please refer to Figure 1 below that approximately shows the height of each flood event in relation to the current bridge structure. We have assumed that a standard aluminium boat (tinnie) that was commonly used during the 2022 flood rescues to require between 1.6 to 1.8m of clear space as being the minimum vessel appropriate for flood rescues. When considering this it appears that the Union Street rail bridge is problematic for all flood events from 10% AEP (1 in 10yr) up to the 1% AEP (1 in 100yr) as clear space for the boats cannot be achieved under the structure. It must also be noted that whilst the aluminium boat has been chosen as the

typical vessel there are many variants and larger boats that are used to perform rescues which require a greater clearance. The removal of this bridge back to the embankments would provide approximately 60m of clear space for boats to get through during rescue operations to service a significant proportion of South Lismore.

Figure 1: Union Street Bridge with Flood Depths

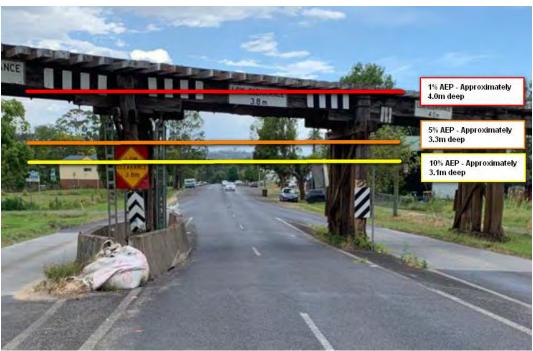
Please refer to Figure 2 below which approximately shows the height of each flood event in relation to the current bridge structure. Similarly, to the assessment above when considering the smallest vessel used for flood rescues this bridge does not have adequate clearance in any flood event. The removal of this bridge back to the embankments would provide approximately 80m of clear space for boats to get through during rescue operations to service a significant portion of the population in North Lismore.

Figure 2: Terania Street Bridge with Flood Depths

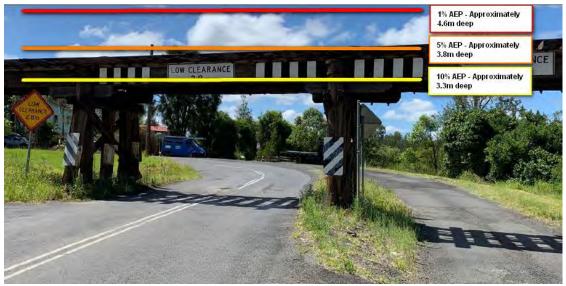
Please refer to Figure 3 below which approximately shows the height of each flood event in relation to the current bridge structure. This structure is again problematic when looking at clearance especially for the 10% and 5% flood events. It does appear however that during a 1% AEP flood event a vessel may be able to travel over the top of the structure as there could be approximately 1.0m of clear space (depending on type of vessel and actual height of bridge).

Figure 3: Alexandra Parade Bridge with Flood Depths

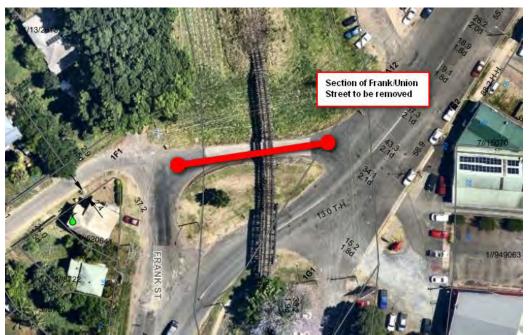
- The bridge is completely removed between the embankments (approximately 60m span)
- The section of Frank/Union Street shown below in Figure 4 to be removed and the natural ground level reinstated.
- Council would support the future Rail Trail being at ground level through this area which then utilises the existing or slightly modified embankments to get back to existing raised track levels.
- Establishment of an appropriate pedestrian/cyclist crossing on Union Street to service the Rail Trail. Council envisages that given the traffic volumes of Union Street this crossing may become quite busy in the future and additional traffic calming and signage may be required.

Figure 4: Section of Frank/Union Street to be removed

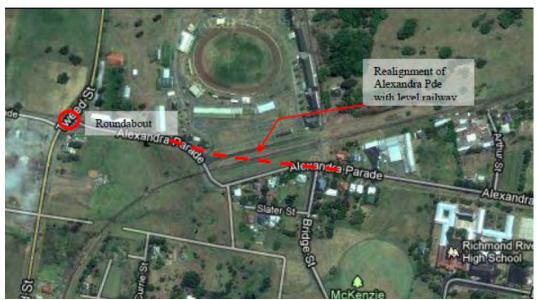
heritage values that the Alexandra Parade realignment project be considered for funding instead. See sketch of the potential realignment at Figure 5.

Figure 5: Potential realignment of Alexandra Parade to preserve railway bridge.

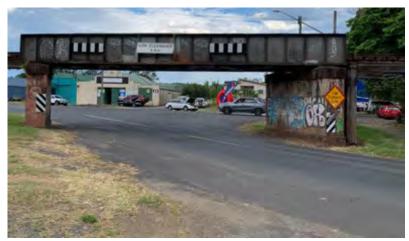
Photo 1: No edge lines - Union Street viaduct

Number	Description	Risk Rating	
Site 1	Union Street, South Lismore		
1	No Advance Warning Sign for the Low Clearance (Northbound)  There is no advance warning sign ('Low Bridge Ahead, High Vehicle Detour') northbound.  There is a risk that a high vehicle could collide with the viaduct.	Severity:	Rare Moderate Low
2	Minimal Vertical Clearance  The vertical clearance at the viaduct is less than 4.6m, which is the typical minimum for clearance over a roadway (5.4m for main and arterial roads).  Without adequate advance warning, and suitable high vehicle detour routes in place, there is a risk that a high vehicle could collide with the viaduct.	Severity:	Rare Moderate Low
3	No Outer Lane Delineation  There are no edge lines on Union Street beneath the viaduct. Edge lines help to delineate the path of travel through the viaduct.  There is a risk that a vehicle could collide with a viaduct pylon.  Refer to Photo 1	Severity:	Possible Serious High

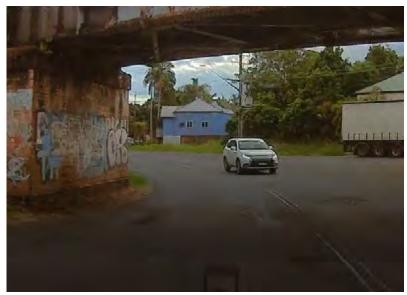
Photo 2: Minimal edge clearance - Union Street viaduct

4	Edge Clearances  There is minimal clearance from edge of the road carriageway to the pylons.  There is a risk that a vehicle could collide with a viaduct pylon.  Refer to Photo 2	Severity:	Possible Serious High
5	Missing Width Marker  There is no width marker on the pylon, southbound, left-hand side.  There is a risk that a vehicle could collide with a viaduct pylon.  Refer to Photo 3	Severity:	Rare Serious <mark>Medium</mark>

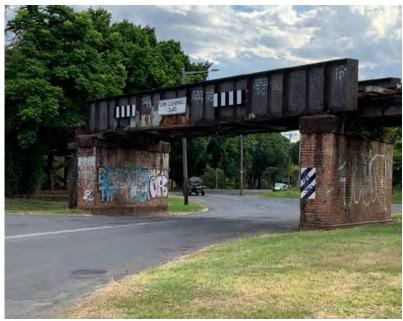
Photo 3: Missing width marker on pylon - Union Street viaduct

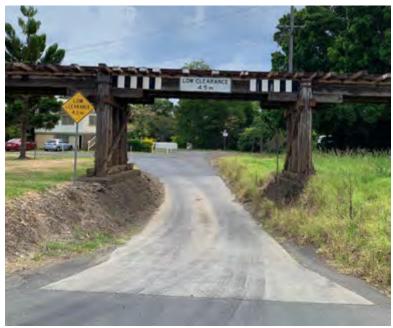
Photo 4: Road width - Frank Street viaduct

6	Frank Street Viaduct	Likelihood:	Rare
	The width of the roadway is only suitable for one way traffic – priorities are not defined.	Severity: Risk:	Serious Medium
	There is a risk of a head-on or rear-end collision in the viaduct. There is a further risk of stopped vehicles queuing onto Union Street.		
	Refer to Photo 4		
7	Frank Street Intersections	Likelihood:	Rare
	There are no intersection controls ('Stop/Give Way' signs; hold lines; lane or edge lines) at either of the Frank Street/Union Street intersections. Vehicles entering or leaving Frank Street do not have a clearly defined travel path.	Severity: Risk:	Serious <mark>Medium</mark>
	There is a risk of a collision at the intersections.		
	Refer to Photo 5		
8	Condition of Signs and Lines	Likelihood:	Rare
	Some signs are in poor condition (not reflective; damaged; vandalised). The line marking generally is badly worn in places. There are no raised retro-reflective pavement markers (RRPM's).	Severity: Risk:	Moderate Low

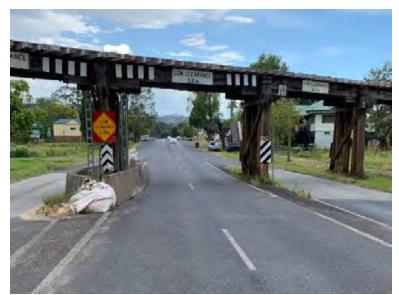
Photo 8: Narrow road width centre span - Terania Street viaduct

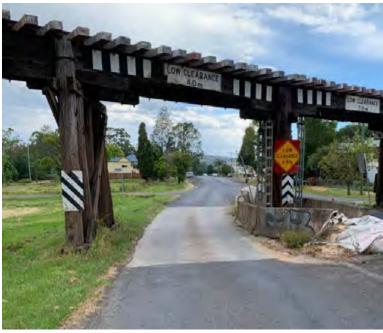
Photo 9: No edge lines - Terania Street viaduct

There is a risk that a vehicle could collide with a viaduct pylon.		
	Refer to Photo 9		
14	Edge Clearances	Likelihood:	Possible
	There is minimal clearance from edge of the road carriageway to the pylons.	Severity: Risk:	Serious High
	There is a risk that a vehicle could collide with a viaduct pylon.		
	Refer to Photo 10		
15	Ends of Safety Barrier	Likelihood:	Possible
	Recent works have been undertaken to support and protect the northern pylon of the centre span. This has included the placement of a New Jersey style concrete barrier around the pylon. The leading ends are protected by large sand-filled bags (one of which is broken). Delineation and protection of the ends is inadequate.	Severity: Risk:	Serious High
	There is a risk that an approaching driver may not adequately perceive the barrier ends and collide with the barrier.		
	Refer to Photo 11, 12

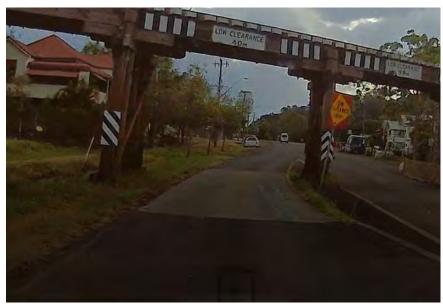
Photo 10: Minimal edge clearance - Terania Street viaduct

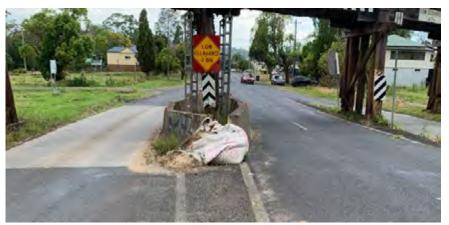
Photo 11: End of safety barrier (eastbound) - Terania Street viaduct

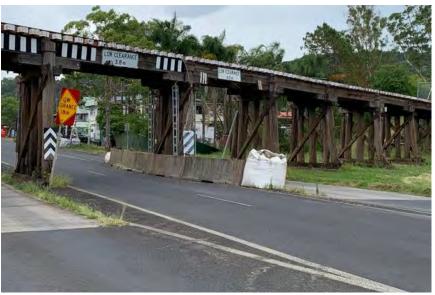
Photo 12: End of safety barrier (westbound) - Terania Street viaduct

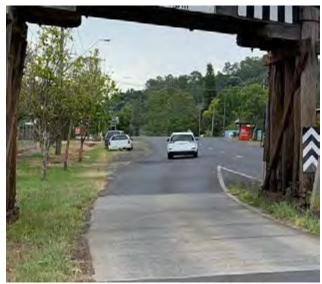
Photo 13: Lane merge priorities unclear (westbound) - Terania Street viaduct

16	Lane Merge Priorities Unclear	Likelihood:	Rare
	On approach to the viaduct (from either direction), a driver can	Severity:	Serious
	opt to pass through either the centre or outer span. On departure, merge priorities are unclear. There are no lines or signs to guide drivers.	Risk:	<mark>Medium</mark>
	There is a risk of a collision when vehicles merge.		
	Refer to Photo 13		
17	Condition of Signs and Lines	Likelihood:	Rare
	Some signs are in poor condition (not reflective; damaged).	Severity:	Moderate
	The line marking generally is badly worn in places. There are no painted chevrons in the traffic islands. The traffic island edge lines are under the concrete barriers. There are no RRPM's.	Risk:	Low
	Without adequate delineation, there is a risk that drivers could be confused by the road alignment, particularly at night, increasing the risk of a crash.		
	Refer to Photo 14		
Site 3	Winterton Parade, North Lismore

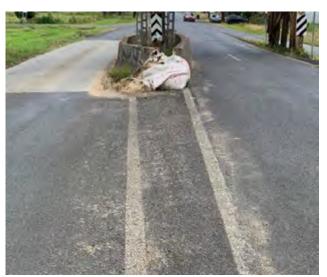
Photo 14: Poor condition and placement of lines - Terania Street viaduct

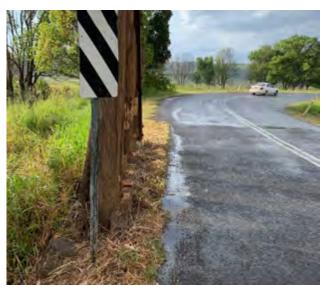
Photo 15: No edge lines and minimal edge clearance – Winterton Parade viaduct

21	Edge Clearances	Likelihood:	Possible
	There is minimal clearance from edge of the road carriageway to	Severity:	Serious
	the pylons.  There is a risk that a vehicle could collide with a viaduct pylon.	Risk:	High
	Refer to Photo 15		
	· ·		
22	No Advance Warning Signs or Advisory Speed for the 90° Bends in Approaches	Likelihood: Severity:	Possible Serious
	There are no advance warning signs or advisory speed signs for the bends (both approaches).	Risk:	High
	Without adequate advance warning and advice, there is a risk that motorists will not correctly anticipate the road's alignment, particularly at night, resulting in a collision with an oncoming vehicle, a roadside hazard, or a viaduct pylon.		
23	Inadequate Definition of Curve Alignments	Likelihood:	Possible
	There are some alignment delineation devices on the southern	Severity:	Serious
	bend, none on the northern bend. The devices on the southern bend are obscured by vegetation (northbound) and the viaduct pylons (southbound). These alignments could be considered hazardous without adequate delineation devices.	Risk:	High

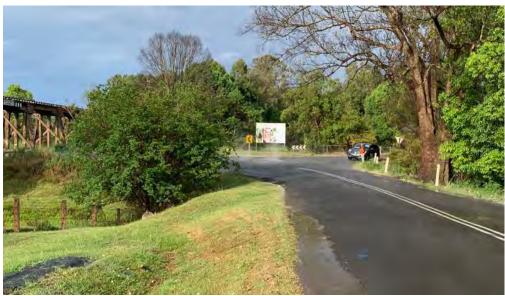
Photo 16: Inadequate definition of curve alignment – northbound approach to Winterton Parade viaduct

Without adequate delineation, there is a risk that motorists may not correctly anticipate the road's alignment, particularly at night, resulting in a collision with an oncoming vehicle, a roadside hazard, or a viaduct pylon.		
	Refer to Photo 16, 17		
24	No Advance Warning of Intersection	Likelihood:	Possible
	There are no advance warning signs ('Side Road Intersection on Curve') in either approach to the Lismore Turf Club intersection. This intersection could be considered busy on race days.	Severity: Risk:	Serious High
	There is a risk of rear-end collisions if a vehicle is slowing to turn at this intersection and other drivers are not anticipating vehicles stopping ahead.		
25	Lismore Turf Club Intersection	Likelihood:	Possible
	There is no line marking in the intersection, or 'Stop' or 'Give Way' signs. Sight distance to the north from the intersection (through the viaduct) is limited.	Severity: Risk:	Serious High
