# Terania Street Bridge Demolition

**Review of Environmental Factors**

August 2024

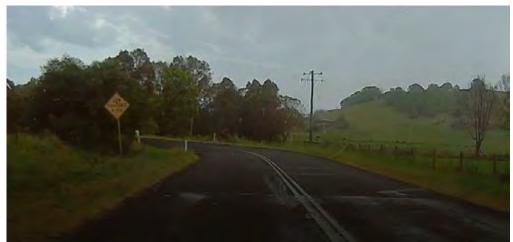
Photo 17: Inadequate definition of curve alignment – southbound approach to Winterton Parade viaduct

Without adequate delineation, there is a risk that motorists may not correctly anticipate the road's alignment, particularly at night, resulting in a collision with an oncoming vehicle, a roadside hazard, or a viaduct pylon.		
	Refer to Photo 16, 17		
24	No Advance Warning of Intersection	Likelihood:	Possible
	There are no advance warning signs ('Side Road Intersection on Curve') in either approach to the Lismore Turf Club intersection. This intersection could be considered busy on race days.	Severity: Risk:	Serious High
	There is a risk of rear-end collisions if a vehicle is slowing to turn at this intersection and other drivers are not anticipating vehicles stopping ahead.		
25	Lismore Turf Club Intersection	Likelihood:	Possible
	There is no line marking in the intersection, or 'Stop' or 'Give Way' signs. Sight distance to the north from the intersection (through the viaduct) is limited.	Severity: Risk:	Serious High

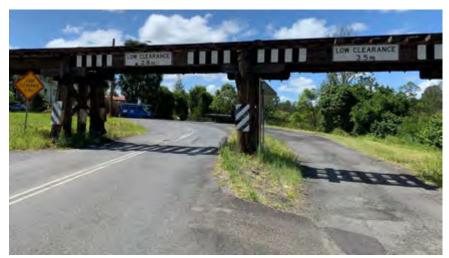
Photo 25: No edge lines and minimal edge clearance – Alexandra Parade viaduct

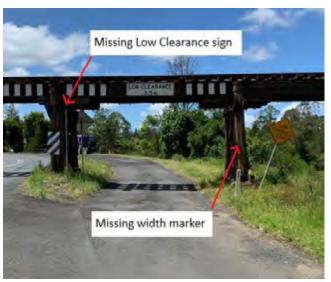
Photo 26: Missing width marker and Low Clearance sign – Winterton Parade viaduct eastbound

34	Edge Clearances  There is minimal clearance from edge of the road carriageway to the pylons, particularly in the main carriageway.  There is a risk that a vehicle could collide with a viaduct pylon.  Refer to Photo 25	Likelihood: Severity: Risk:	Possible Serious High
35	Missing Signs  There are no width markers on the western pylons (outer pylon on 3.5m clearance lane), either direction.  A 'Low Clearance' sign is missing on the central pylon, eastbound.  There is a risk that a vehicle could collide with a viaduct pylon.  Refer to Photo 26	Likelihood: Severity: Risk:	Rare Serious <mark>Medium</mark>
36	Bypass Viaduct Width  The roadway width of the bypass viaduct is only suitable for one way traffic – priorities are not defined.  There is a risk of a head-on or rear-end collision in the bypass viaduct.  Refer to Photo 27	Likelihood: Severity: Risk:	Rare Serious <mark>Medium</mark>

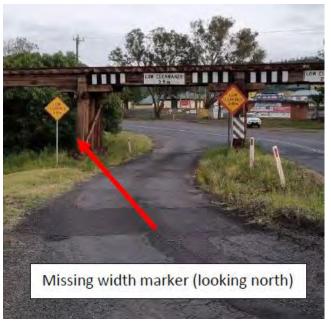
Photo 27: Missing width marker – Winterton Parade viaduct eastbound

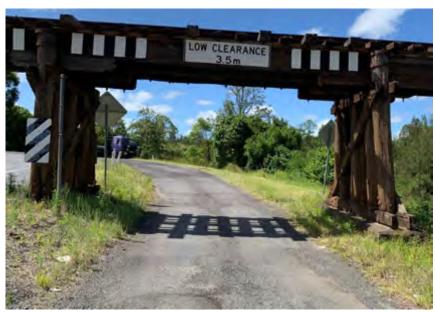
Photo 28: Road width – Alexandra Parade bypass viaduct

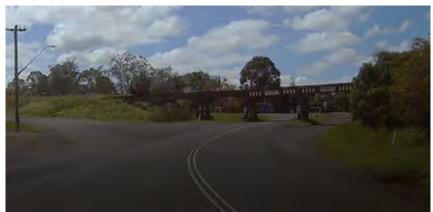
Photo 29: Eastbound approach to bypass viaduct – Alexandra Parade. Driver must cross BB lines

37	Access/Egress Bypass Viaduct	Likelihood:	Rare
	To access the bypass viaduct (eastbound), a driver must cross double barrier lines on a bend, with sight distance obstructed by the viaduct and embankments.	Severity: Risk:	Serious <mark>Medium</mark>
	On departure from the bypass viaduct (westbound), merge priorities are unclear. There are no lines or signs to guide drivers.		
	There is a risk of a collision when vehicles use the bypass viaduct.		
	Refer to Photo 28		
38	Narrow Road Width in Centre Span	Likelihood:	Possible
	The two-way road under the main span has a sealed width of only 5.2m. This is less than Councils minimum standards.	Severity: Risk:	Serious High
	If two vehicles try to pass, there is a risk that these vehicles may collide with each other or into a pylon.		
39	Advance Warning of Intersection	Likelihood:	Rare
	There is no advance warning sign ('Side Road Intersection on Curve') in the westbound approach to the Showground access road. This intersection could be considered busy on days or nights when the showground is in use. The intersection is obscured by the viaduct.	Severity: Risk:	Serious <mark>Medium</mark>

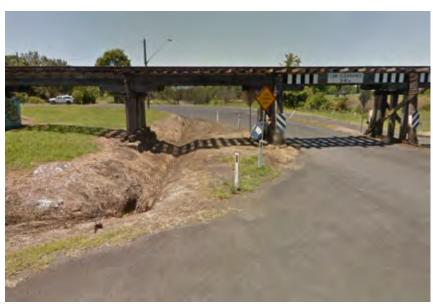
Photo 30: Sight distance from Showground access road through Alexandra Parade viaduct (courtesy Google Street View)

There is a risk of rear-end collisions if a vehicle is slowing to turn at this intersection and other drivers are not anticipating vehicles stopping ahead.		
40	Showground Access Road Intersection	Likelihood:	Rare
	There is no line marking in the intersection, or 'Stop' or 'Give Way'	Severity:	Serious
	signs. Sight distance to the south from the intersection (through the viaduct) is limited. (It is noted that this is probably a private road).	Risk:	<mark>Medium</mark>
	There is a risk that vehicles exiting the Showground access road could collide with through traffic.		
	Refer to Photo 29		
41	Road Condition	Likelihood:	Possible
	There are some potholes in the eastbound lane.	Severity:	Serious
	There is a risk of a crash if vehicles try to avoid the potholes. There is a further risk to cyclists using the road.	Risk:	High
	Refer to Photo 30

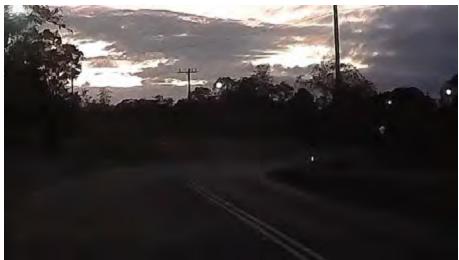
Photo 33: Night visibility - eastbound approach to Alexandra Parade viaduct

The bends and the viaduct are poorly delineated at night, in	Severity:	Serious
	particular eastbound. The line marking, guideposts, and delineation are inadequate. There are no RRPM's.	Risk:	<mark>Medium</mark>
	Without adequate delineation, particularly at night, there is the potential for a crash on the bends or at the viaduct.		
	Refer to Photo 33

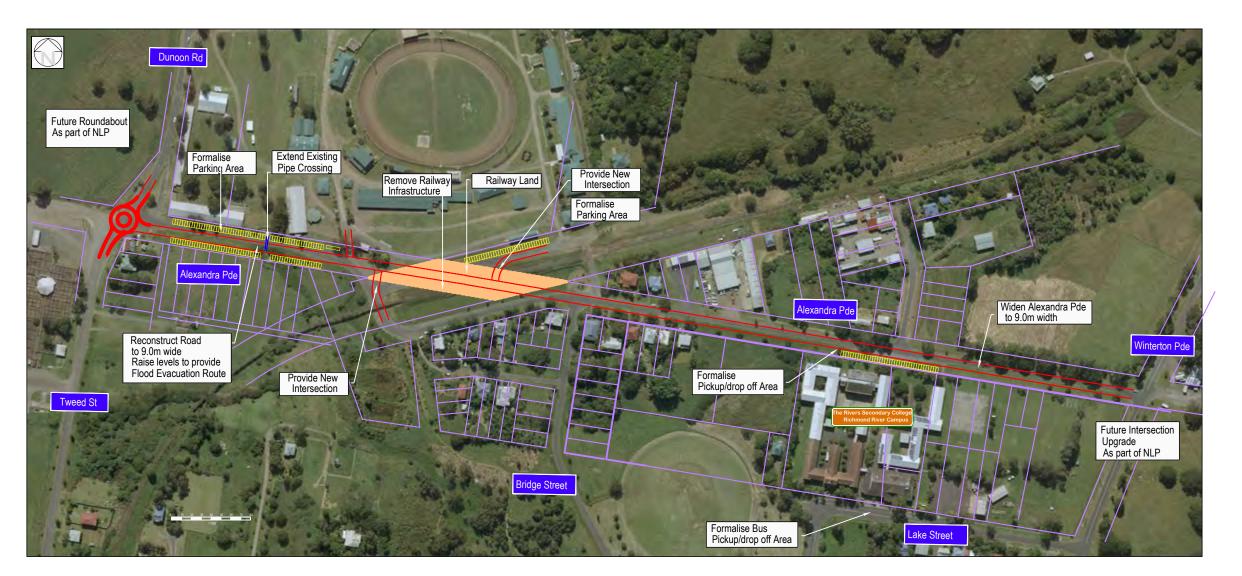
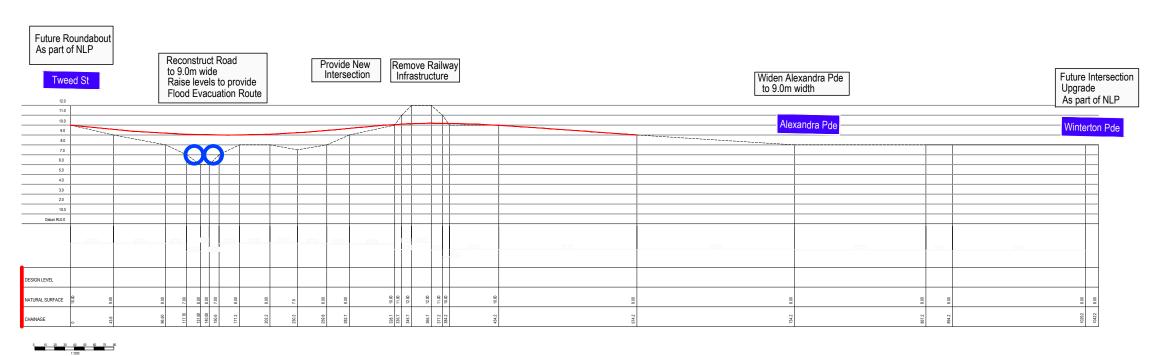
Alexandra Parade alternate route plans by LCC (Ref. No. 8)

#### CONCEPT PLAN

#### LONGITUDINAL SECTION

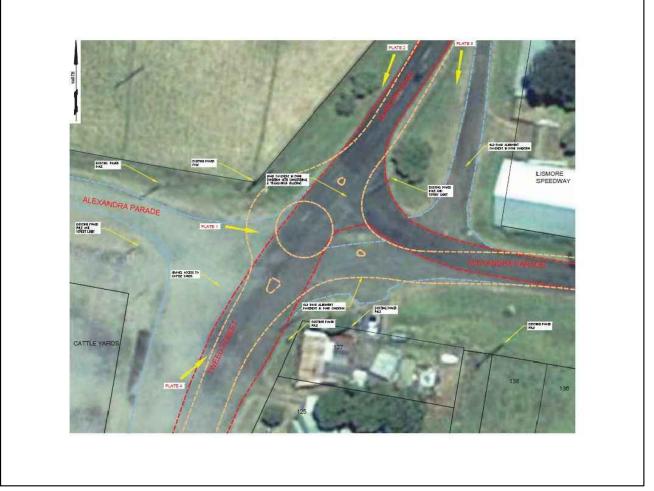
Future Roundabout As part of NLP

PROPOSED ROUNDABOUT TWEED STREET AND ALEXANDRA PARADE

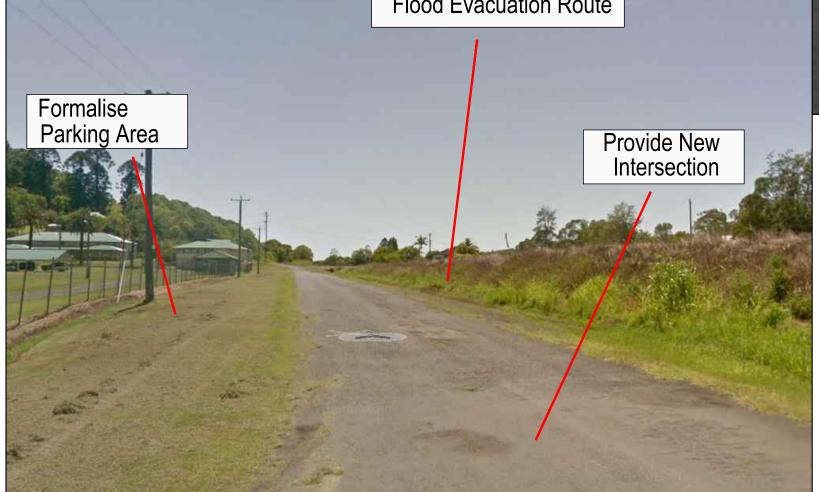
Provide New Intersection

Reconstruct Road to 9.0m wide Raise levels to provide Flood Evacuation Route

Alexandra Pde

VIEW TO SOUTH FROM ALEXANDRA PARADE (WEST)

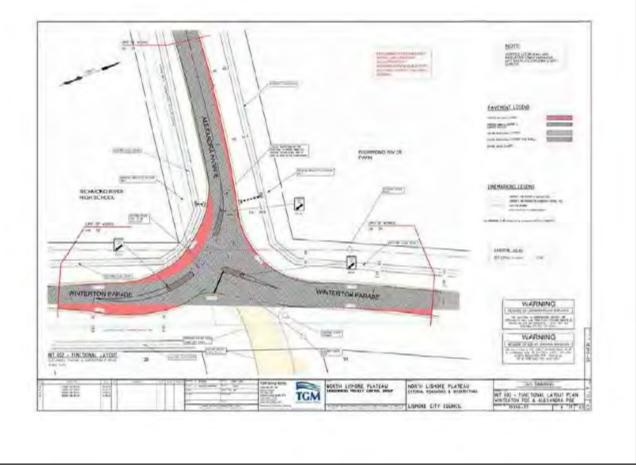
Future Intersection Upgrade As part of NLP

#### PROPOSED INTERSECTION UPGRADE ALEXANDRA PARADE AND WINTERTON PARADE

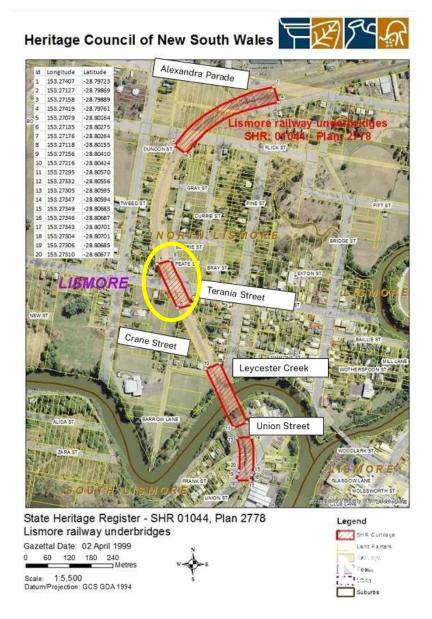
Figure 1.4 SHR boundary listing plan for Lismore railway underbridges. Terania Street underbridge is circled in yellowSource: State Heritage Inventory, accessed February 2024

Terania Street underbridge (12 spans), the site subject to this application, is circled in yellow on the SHR map below. It is located in Lismore forms part of the SHR listed Lismore railway underbridges.

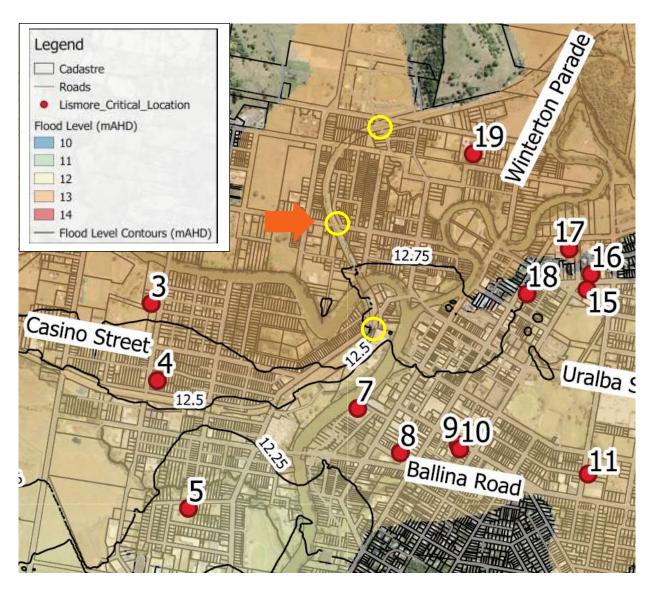
Figure 1.5 Part of the Vulnerable Land Uses and Infrastructure showing the Real Levels in Australian Height Datum of the Lismore Area. [Om AHD is sea level]. Source: Final Lismore Floodplain Risk Management Study, prepared by Engeny Water Management dated 2021

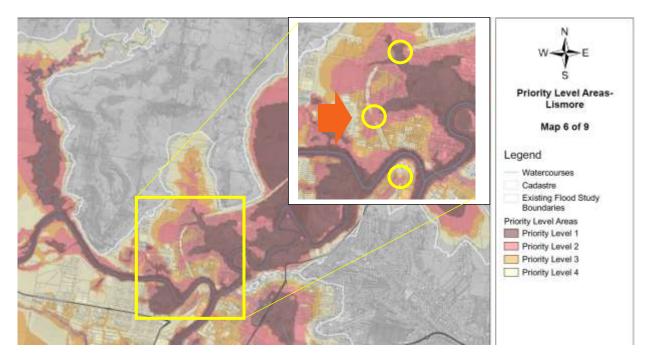
Figure 1.6 The map shows each of the Lismore Railway underbridges (circled yellow) are located in Priority Level Areas 1 and 2 where the Resilient Homes Program applies. Source: NSW Government Flood Hazard Information, Refer to Lismore Map 6 of 9 showing Priority areas, Flood Hazard Information | NSW Government, accessed February 2024

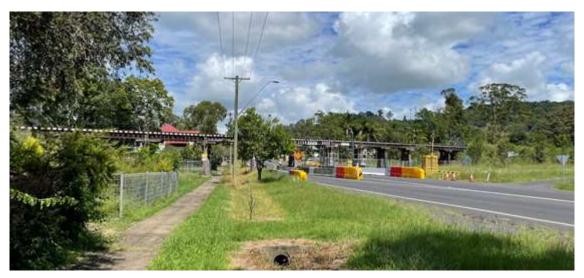
Figure 1.8 showing Terania Street underbridge looking west. Source TfNSW January 2024

The proposed works area for the Terania Street underbridge is shown on the following aerial photographs and street views in January 2024. Also refer to the attached works documentation. (Attachments 1a and 1b)

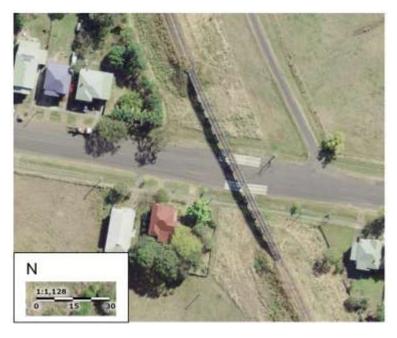
Figure 1.9 Aerial view of Terania Street underbridge. Source Aerial imagery, Six maps, September 2012

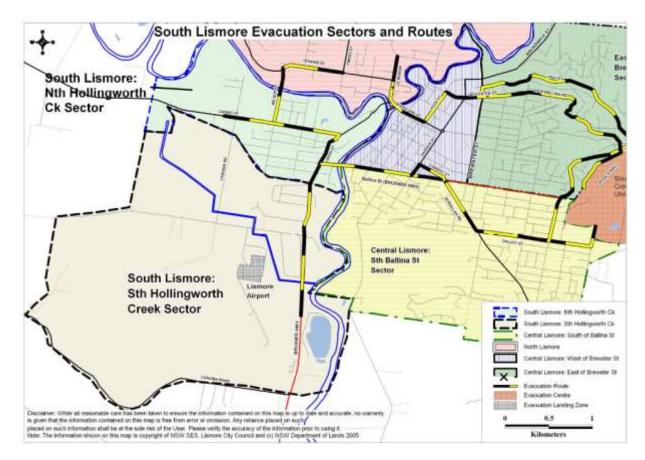
Figure 1.11 The Lismore City Local Flood Emergency Plan identifies Terania Street as Evacuation Routes for South Lismore, 2006 map included in the updated 2023 report. Source Lismore City Local Flood Emergency Plan August 2023.

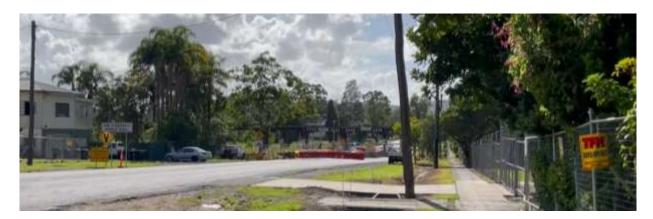
Figure 4.1 Photo of Terania Street underbridge taken at Tweed Street corner, showing a low lying single storey horizontal structure that is not highly visible along the street from any distance. (facing east). Source TfNSW February 2024

The following image demonstrates the limited nature of the views and vistas of this structure in its immediate setting, which is a combination of residential and rural environments. Its removal will have a minimal impact on its setting.

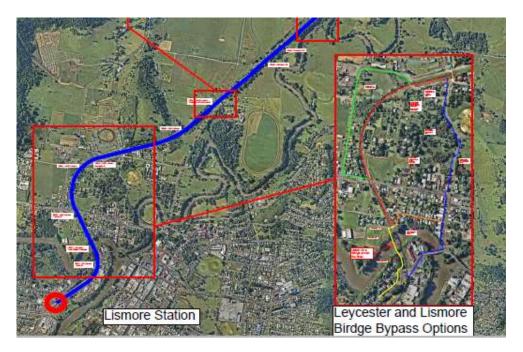
Figure 4.2 Lismore City Council Business Case, October 2023 shows options for the rail trail through Lismore. Source: LCC

The Lismore City Council business case for the rail trail notes that the Lismore underbridge at Terania St will be bypassed, and as shown on the plan provided above., Figure 4.2.<sup>42</sup> There is a feasibility study in progress to re-introduce rail services, however the Terania Street underbridge will need to be demolished and replaced to comply with current rail safety and design standards.

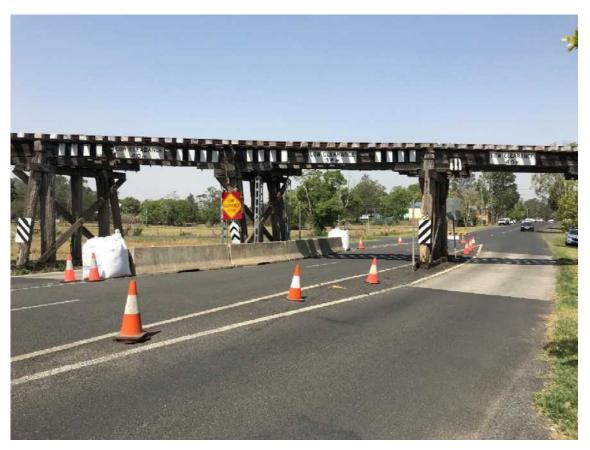
Figure 3-2 Downside elevation of bridge over Terania Street (looking east)

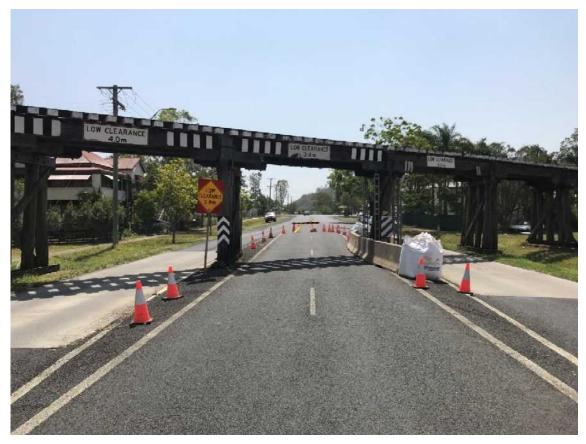
Figure 3-3 Upside elevation of bridge over Terania Street (looking west)

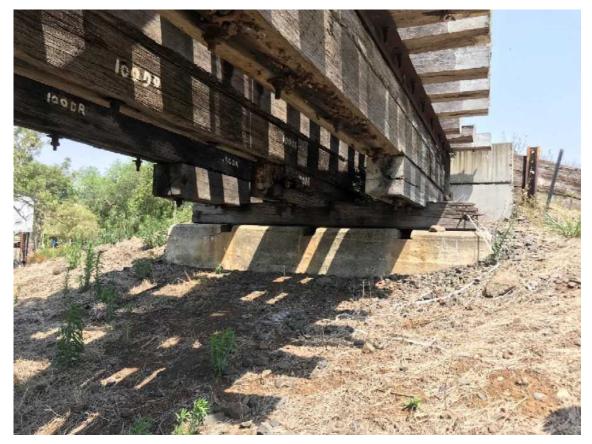
Figure 3-4 General view of Abutment 1 (south)

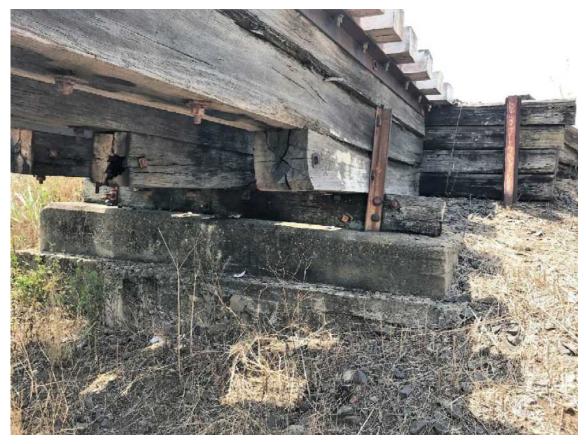
Figure 3-5 General view of Abutment 2 (north)

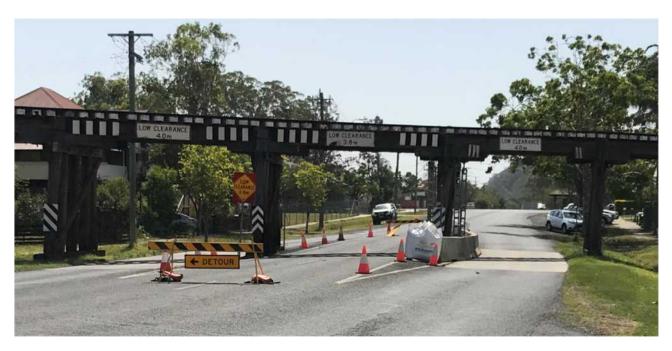
Figure 4-2 Underbridge facing west

The westbound lane lies between piers 4 and 5, the original carriageway between piers 5 and 6 and the eastbound lane between piers 6 and 7. Vertical clearance of the west and east bound lanes to the underbridge is 4 m and that of the original carriageway is 3.8 m.

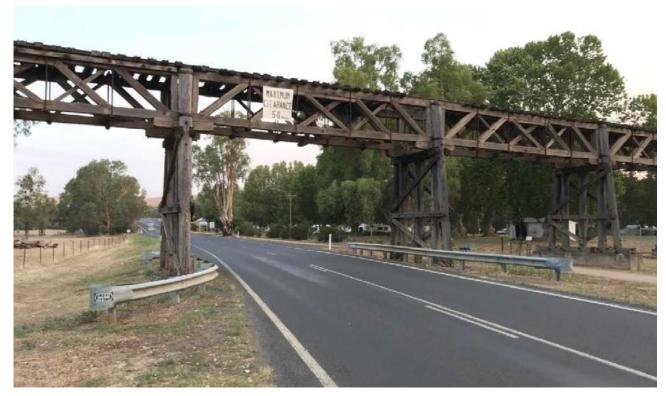
Example of Guard Rail protecting timber trestles (Gundagai, NSW)

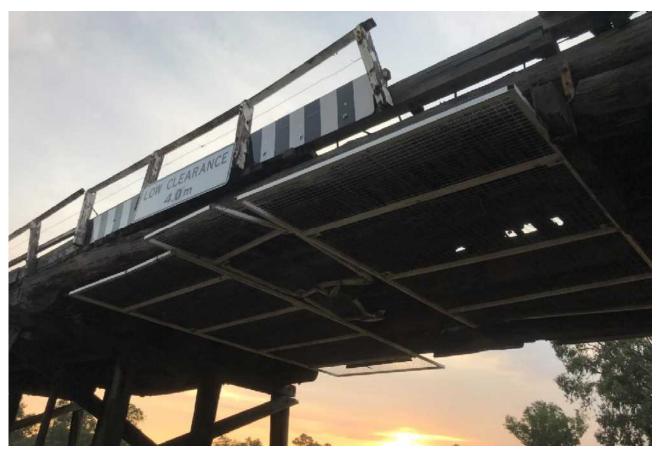
Example of Underbridge Protection (Gundagai, NSW). Note middle panel has been struck resulting in displacement

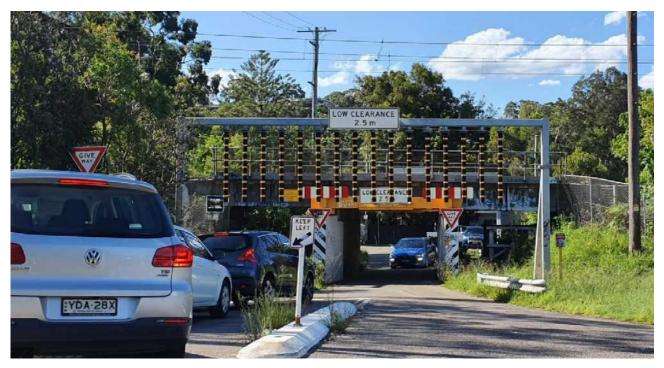
Example of Overhead Early Warning System (Woy Woy, NSW)

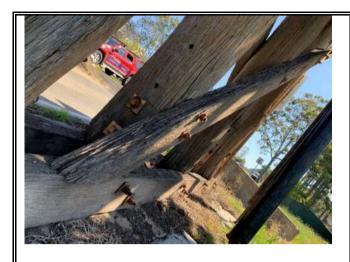
Pier 7 north diagonal brace weathered

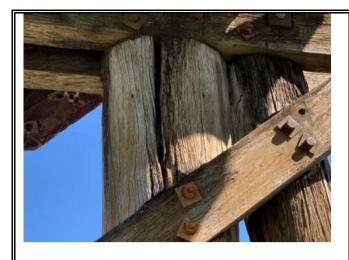
Pier 7 top of west pile split & evidence of white ants

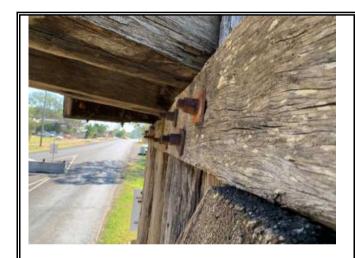
Pier 7 capwales on south side have minor 20mm sag

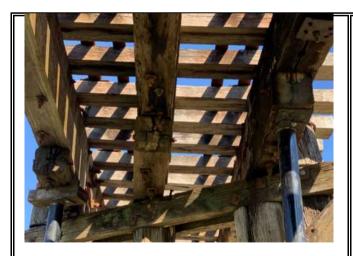
Pier 7 north end of corbels

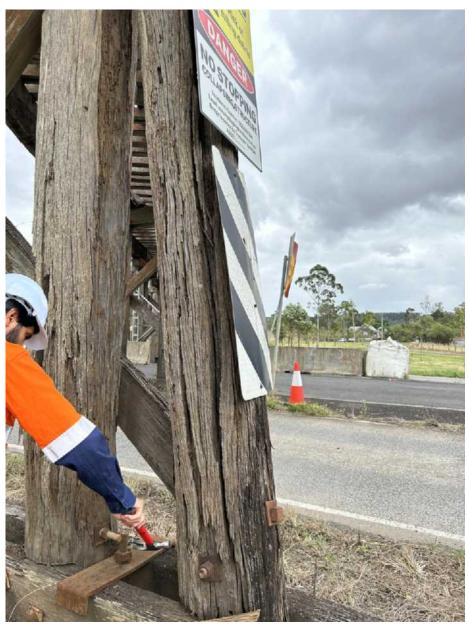
Figure 2: Pier 4 - post split

If this pier were to be hit by a vehicle it is likely that the pier column facing the traffic would break at its base and the pier may displace similar to Pier 7.

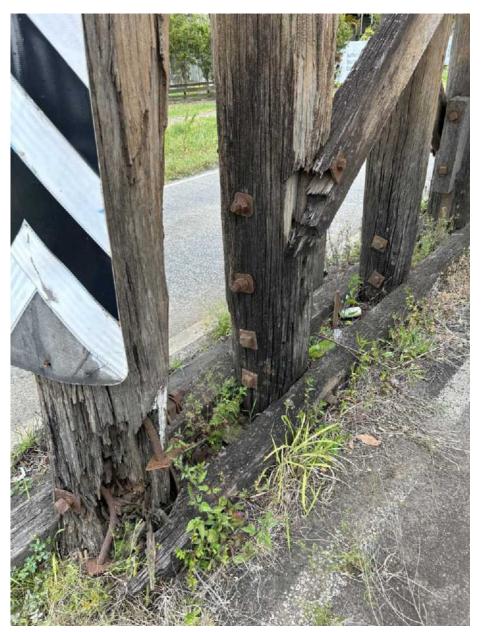
Figure 3: Pier 5 - Inclined post rotted

If this pier were to be hit by a vehicle it is very likely that the pier column facing the traffic would break at its base and the pier may displace similar to Pier 7.

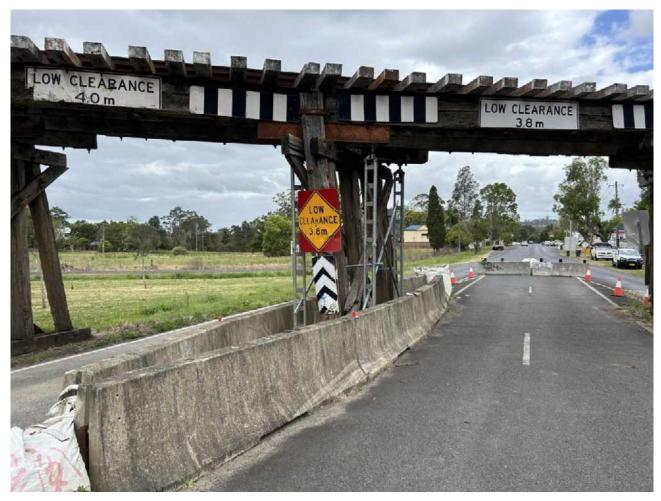
Figure 4:Pier 6 – Props and pier not vertical

It was noted that while the props are clearly assisting in the support of the load of the superstructure, it was observed that they are not vertical and are supported on timber packers. Additionally, the cross bracing installed between these props will have limited capacity to provide lateral restraint as the connections are mostly clamp type connections and simply rely on friction to hold the braces in place.

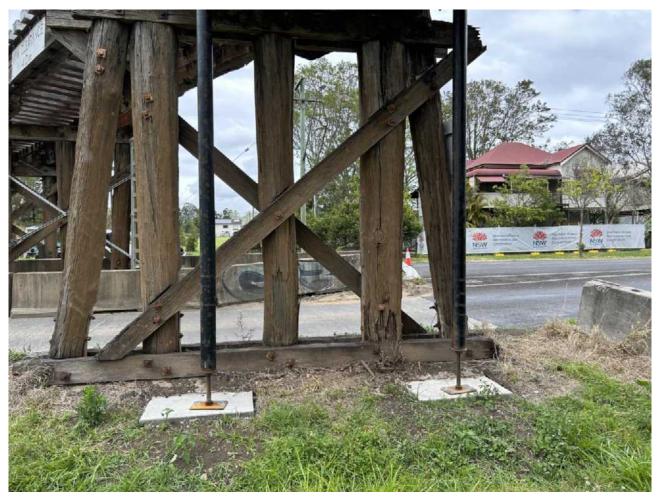
Figure 5:Pier 7 – Props installed

The pier is not vertical and props have been installed to prevent further movement. The props appeared to be vertical and are supported on concrete footings.

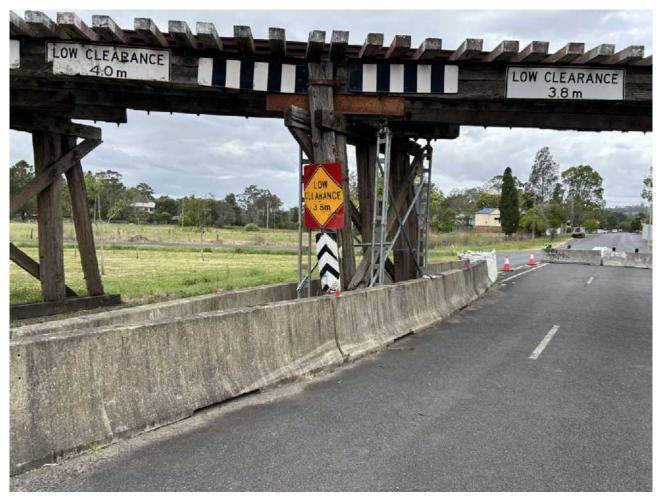
Figure 6:Signs of impacts with superstructure

The beams over the roadway show signs of impacts from tall vehicles.

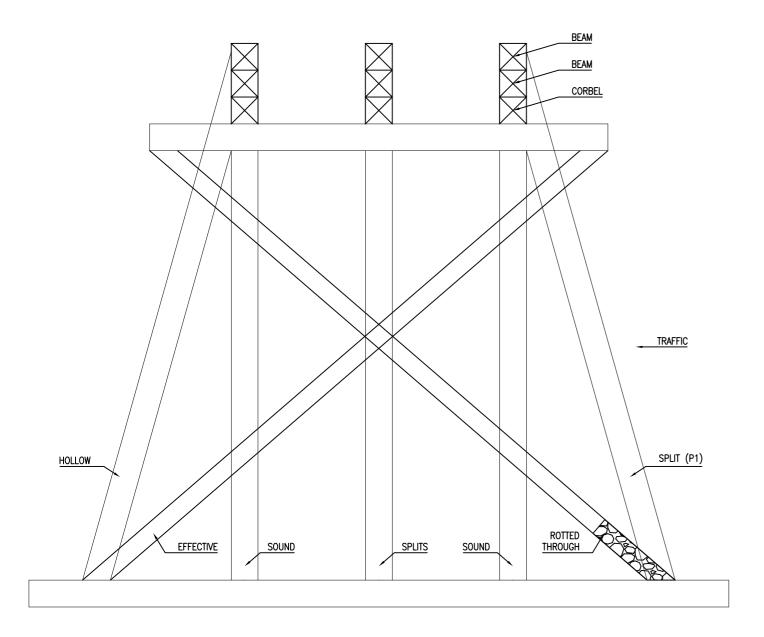
\*OVERALL QUITE SOUND, NOT  $\frac{\mathrm{PIER}\ -4}{\mathrm{Vertical}\ \mathrm{Maybe}}$  displaced from impact

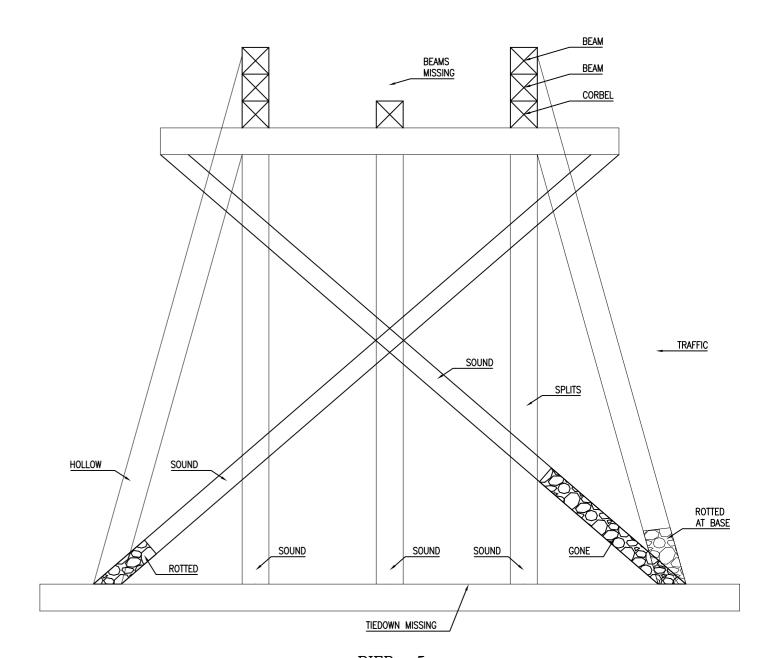
$\underline{PIER~-5}_{\text{*INCLINED POST FACING TRAFFIC WOULD PROBABLY BREAK AT THE BASE IF IMPACTED}}$

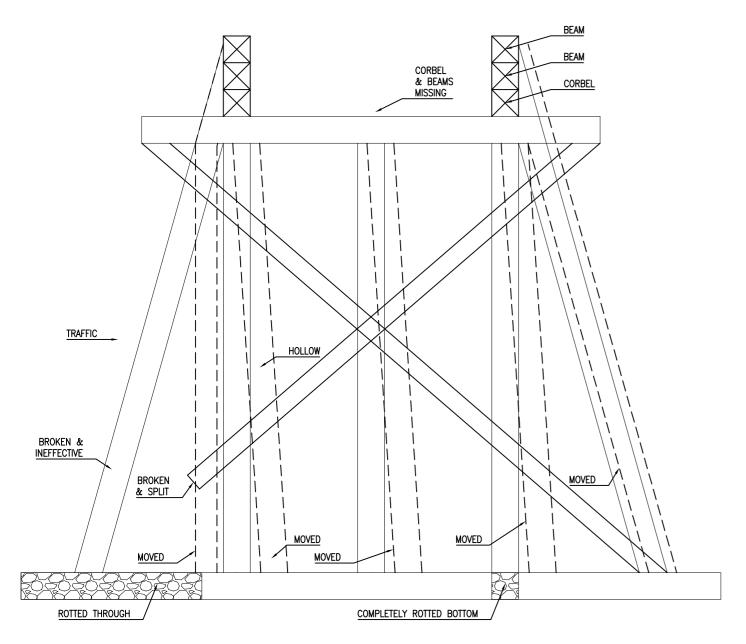
\*cannot be relied upon to carry load safely, needs complete independent props
