Roads & Maritime Services

Great Western Highway (Forty Bends Upgrade)

Purple Copper Butterfly Management Plan

November 2013

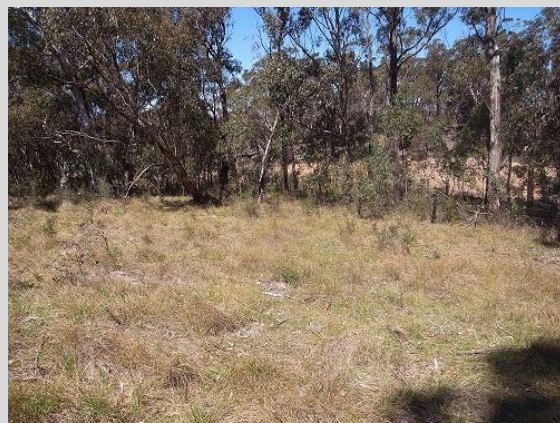
Photograph 3: Occupied habitat area east of the study area (photograph courtesy of R. Mjadwesch)

enough and flat enough to ensure that they also receive full sun. A common factor between many of sites is high levels of disturbance such as mining, roadways, electricity easements and frequent fire (DSEWPAC 2013; NPWS 2001). Examples of Bathurst Copper Butterfly habitat are provided in Photographs 3 and 4 below.

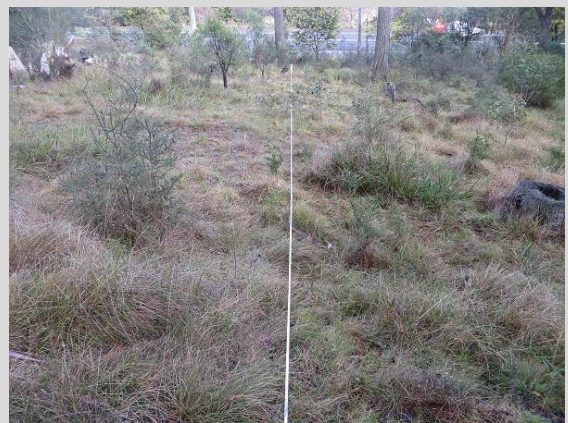
Photograph 4: Occupied habitat area at Bowenfels, north-west of the study area
