Kamay Wharf, Captain Cook Drive, Kurnell and Anzac Parade,  
La Perouse

Audit Number: MP186\_B

# Site Audit Report

Development consent (SSI 10049, issued on 21 July 2022) was granted by the Minister for Planning for the construction of two wharves one at La Perouse and one at Kurnell. The consent was subject to several requirements of which conditions E64, E65 – E70 relate to contamination and require a site audit statement as follows:

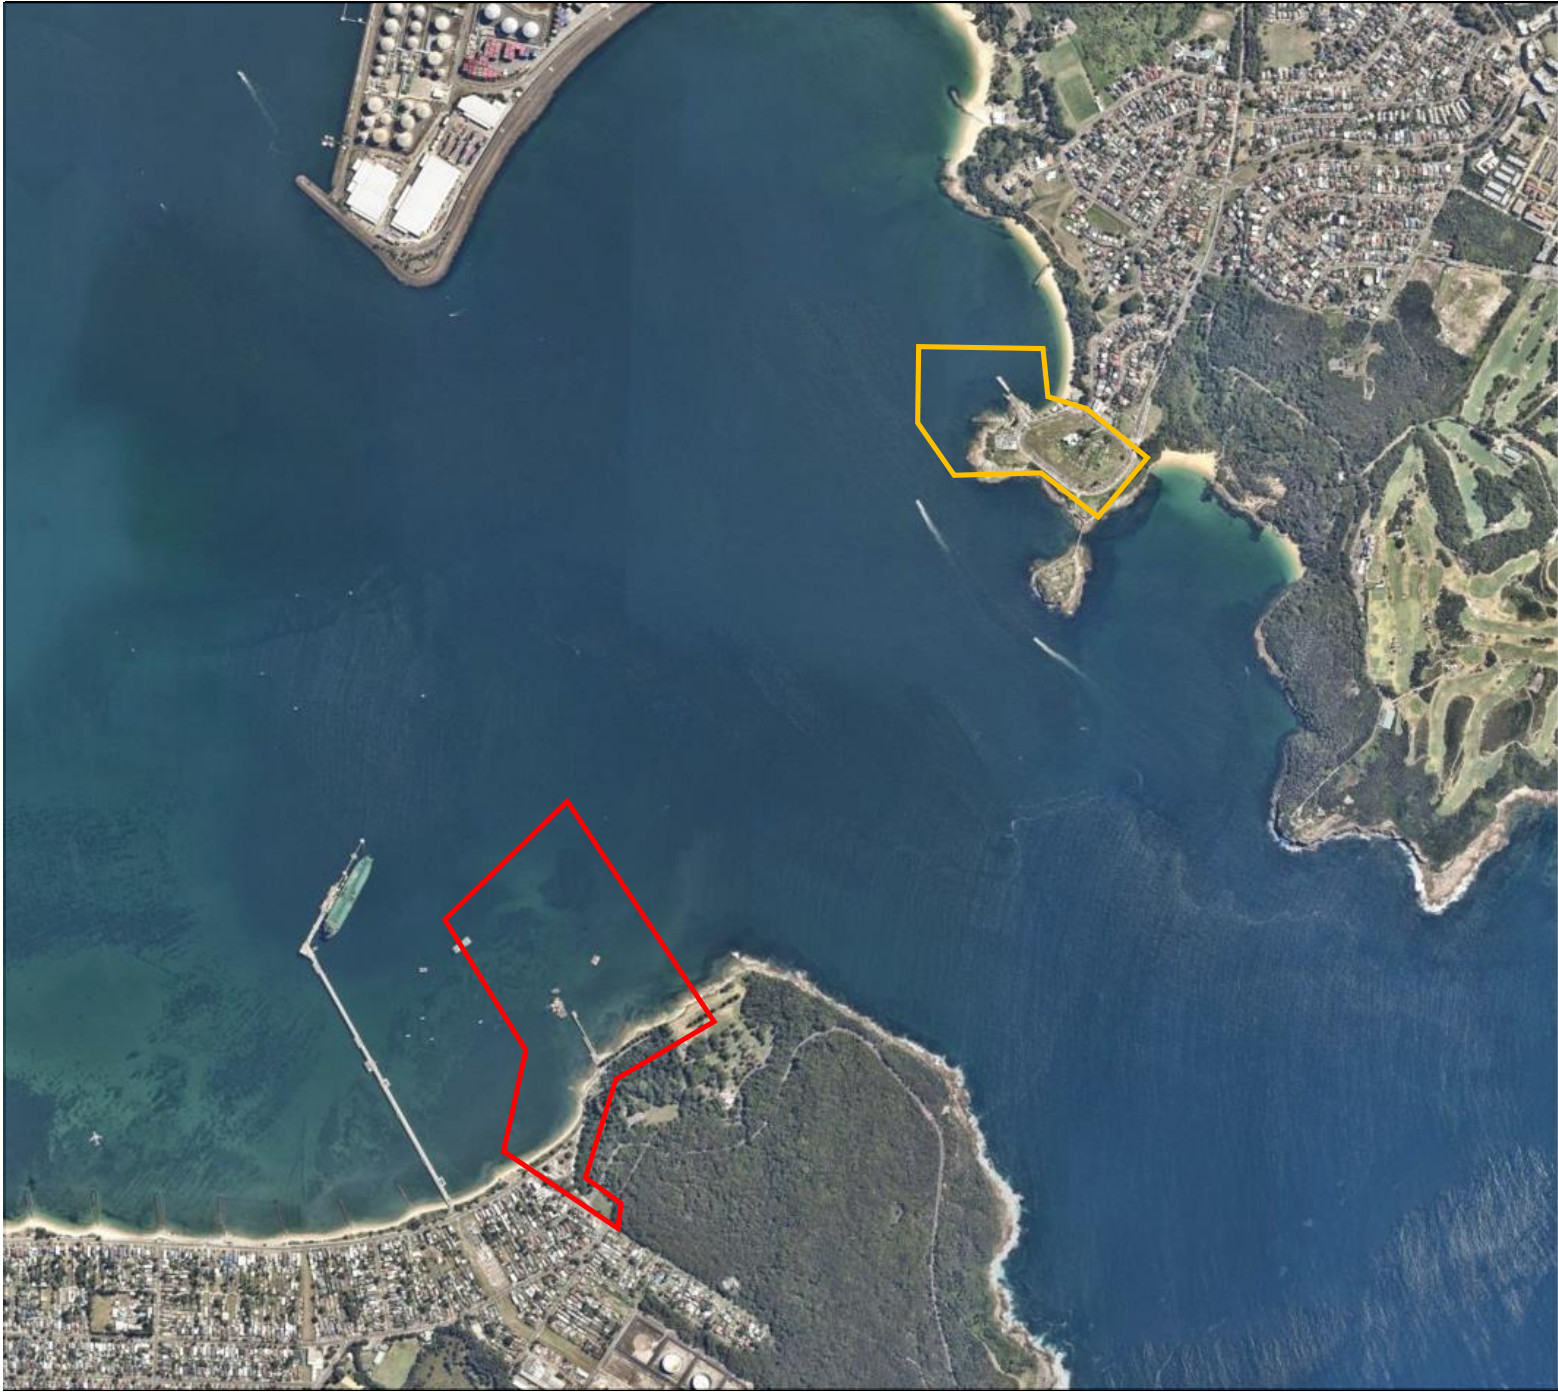
Kamay Ferry Wharves Project, Kurnell and  
La Perouse NSW

DETAILS:	
Figure Name:	Figure 1: Project Boundary
Client Name:	McConnell Dowell
EDP Reference:	S-05009.SRVR.002
Date:	12 August 2024

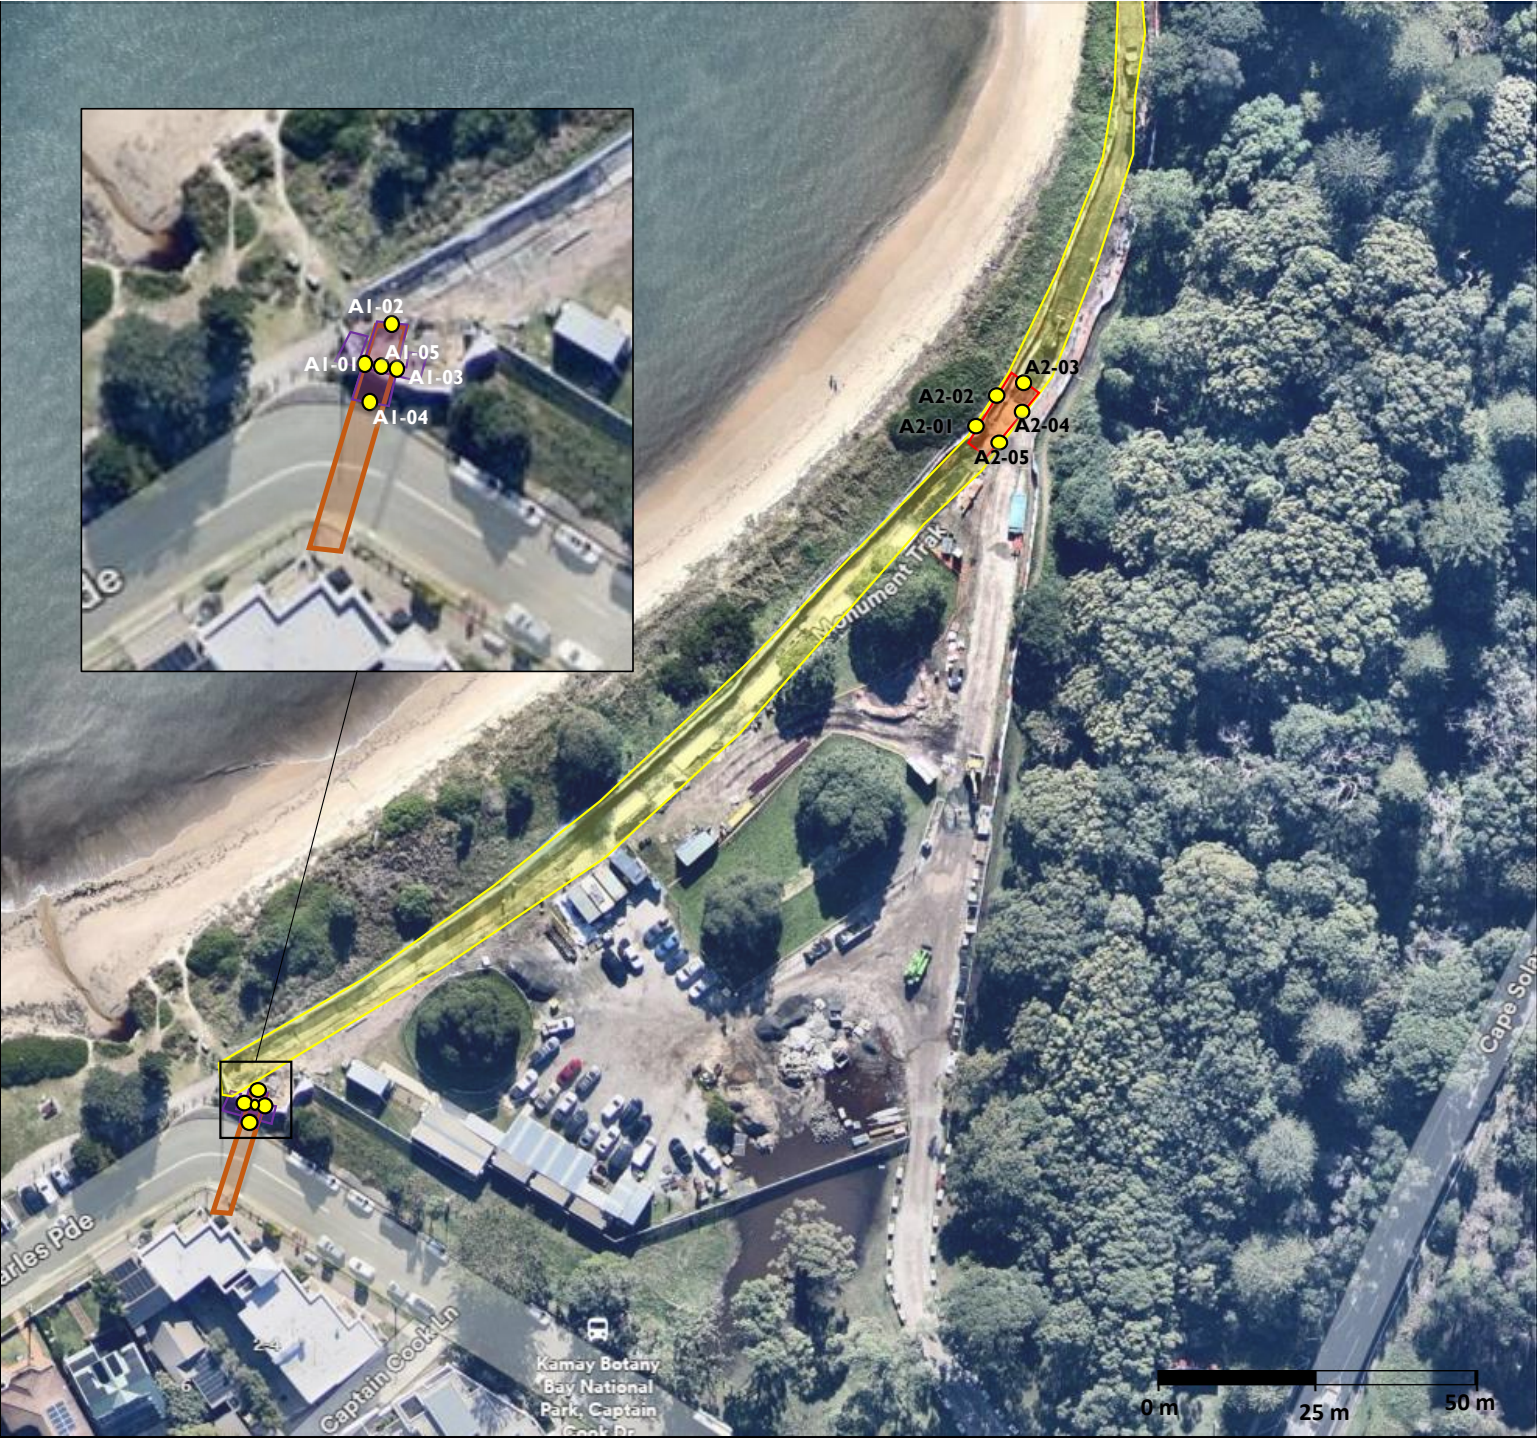
Kamay Ferry Wharves Project, Kurnell and  
La Perouse NSW

<b>Figure Name:</b>	Figure 4: Kurnell Validation Samples
<b>Client Name:</b>	McConnell Dowell
<b>EDP Reference:</b>	S-05009.SRVR.002
<b>Date:</b>	12 August 2024

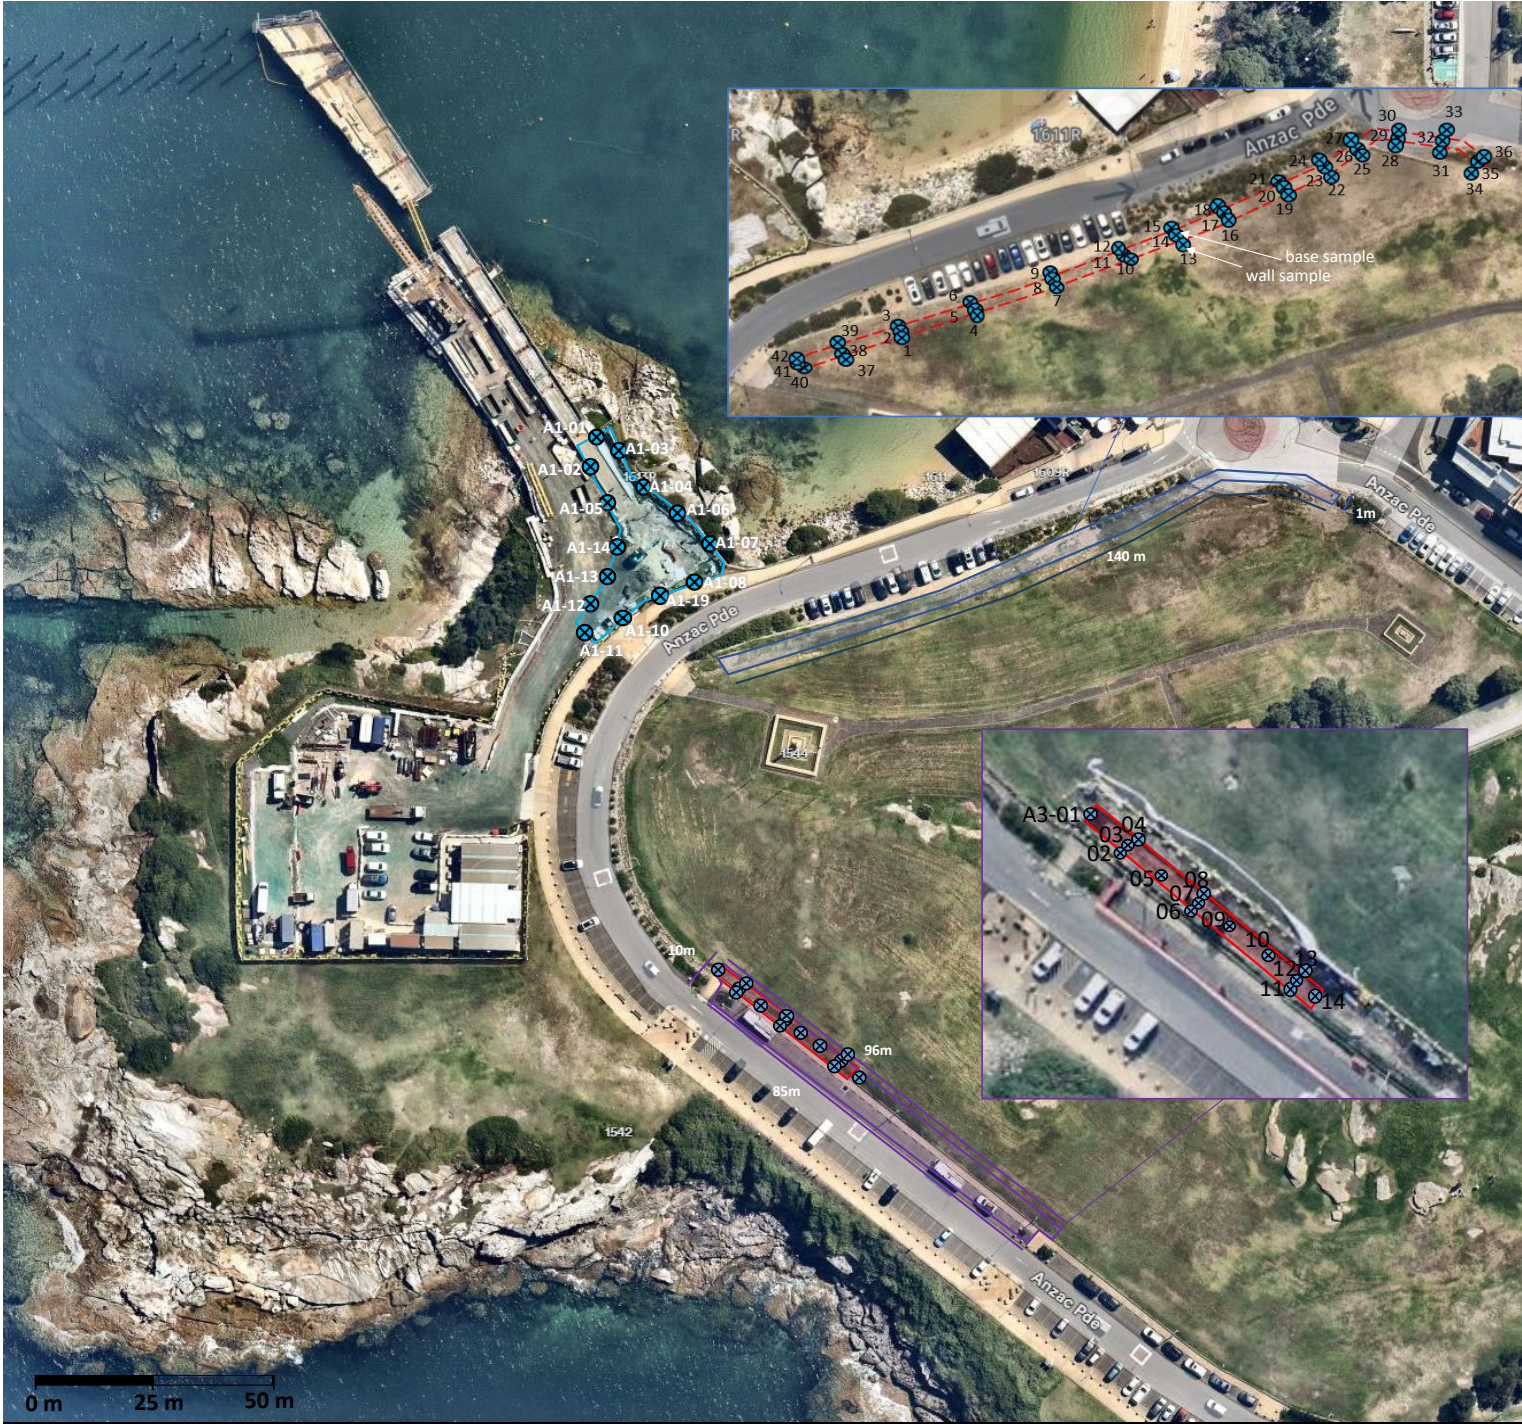
Kamay Ferry Wharves Project, Kurnell and  
La Perouse NSW

<b>Figure Name:</b>	Figure 5: La Perouse Validation Sample Locations
<b>Client Name:</b>	McConnell Dowell
<b>EDP Reference:</b>	S-05009.SRVR.002
<b>Date:</b>	12 August 2024

- As the appendices have not been provided, the auditor is unable to cross-check updates against the report and Figure 5. Please consider holding off providing partial interim reports and provide a complete report once all validation is completed and all documentation received.
