# RE: Windsor Bridge Replacement Project; Archaeological Management Strategy for Barrel Drain Relating to Construction of Water Pipelines

# 1. Project Background

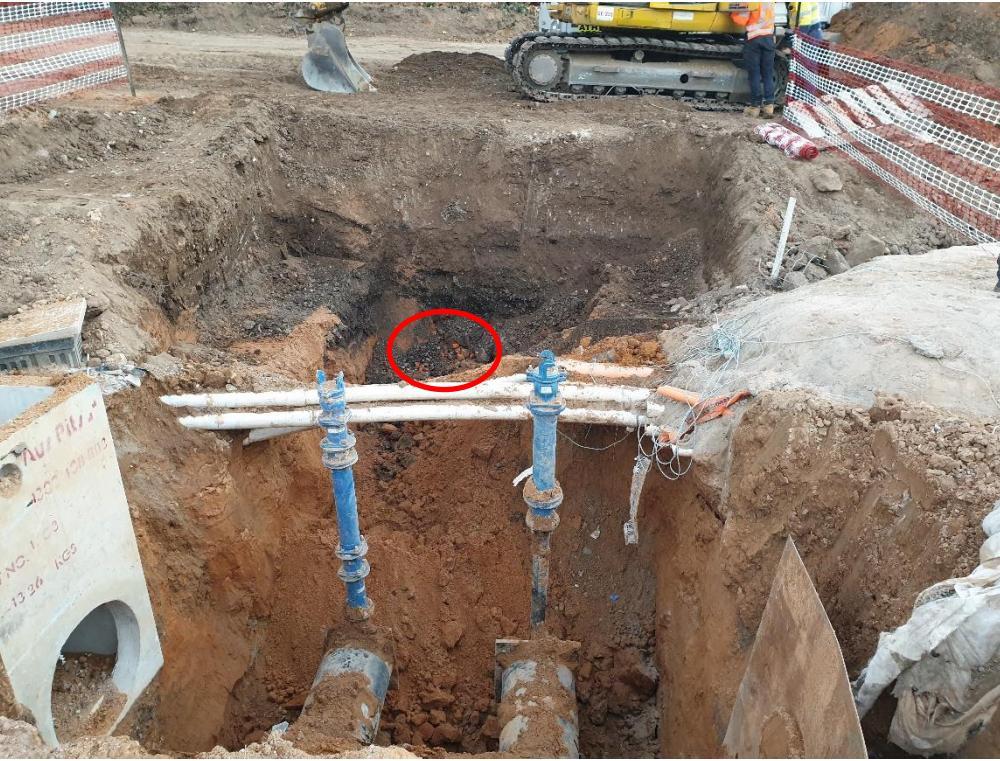
# Figure 1 West facing view showing condition of trench upon arrival at site. Note brick fragments circled in red.

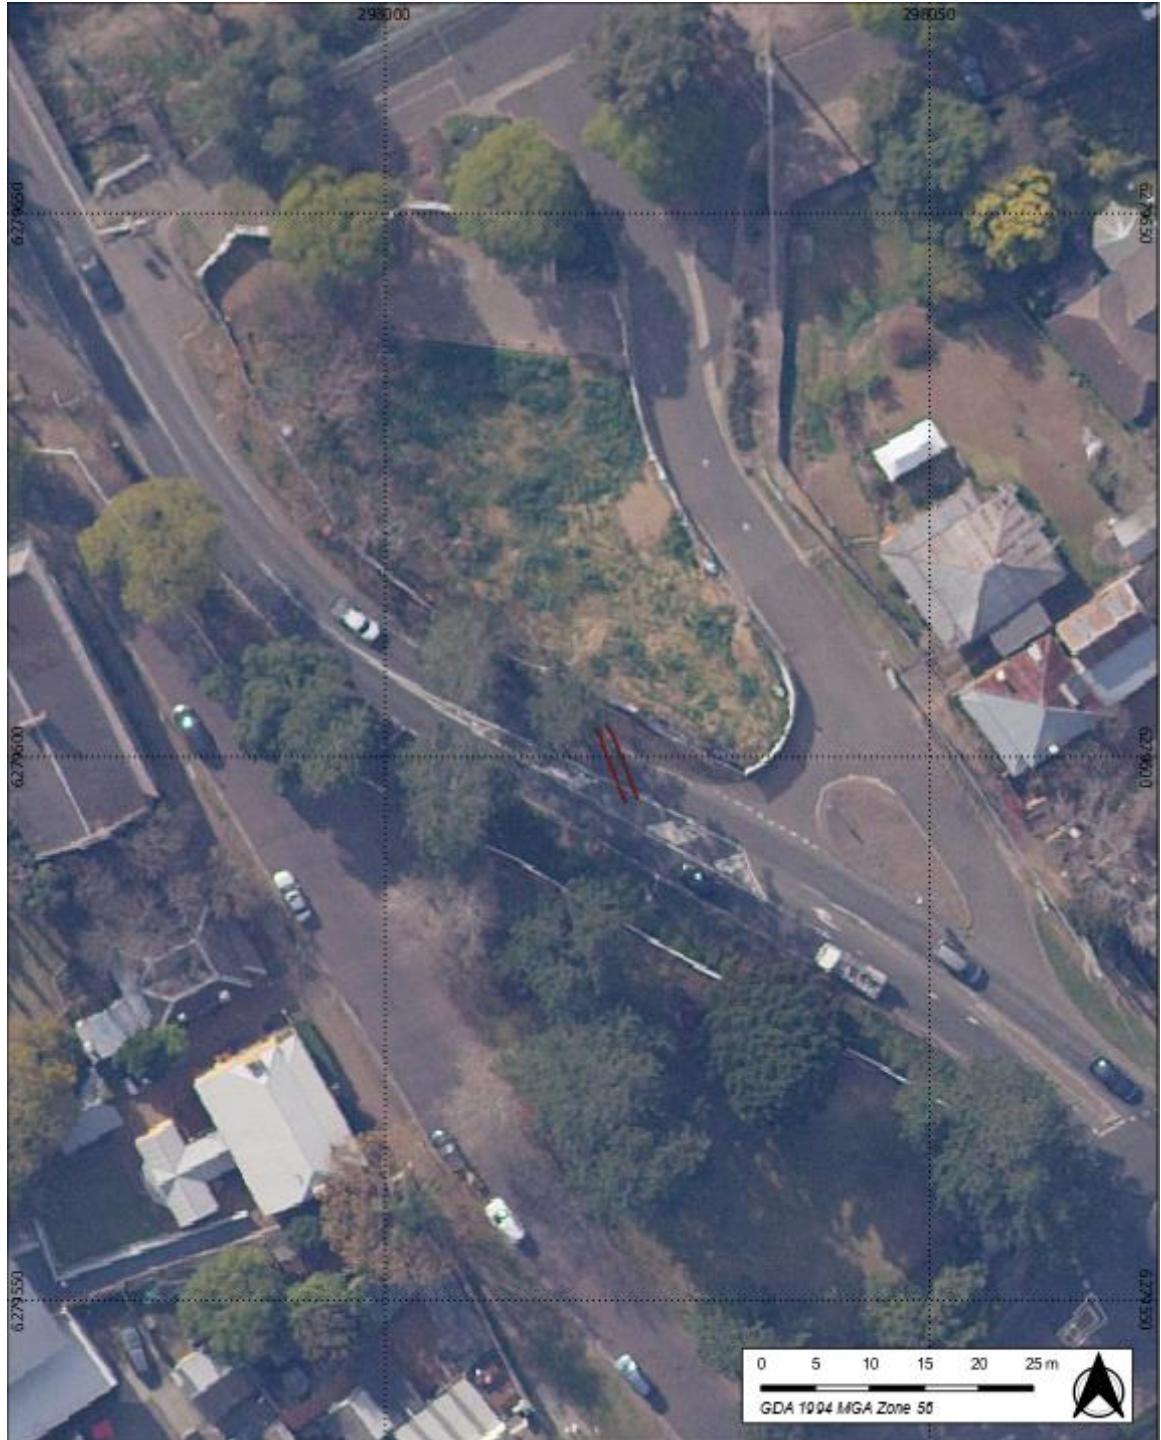
Figure 2 Preliminary plan showing location of barrel drain marked in red.

By the completion of the archaeological investigations, a length of 7.42 metres of drain had been exposed, which is the length that will be affected by the installation of the two watermains plus an adjacent council recycled water main (Figure 2 and Figure 3). The barrel drain had been heavily impacted by construction of the Bridge Street cutting in the 1930s, which had truncated the upper courses of the drain with the exception of one section at the northern end where part of the upper curve remained (Figure 4).

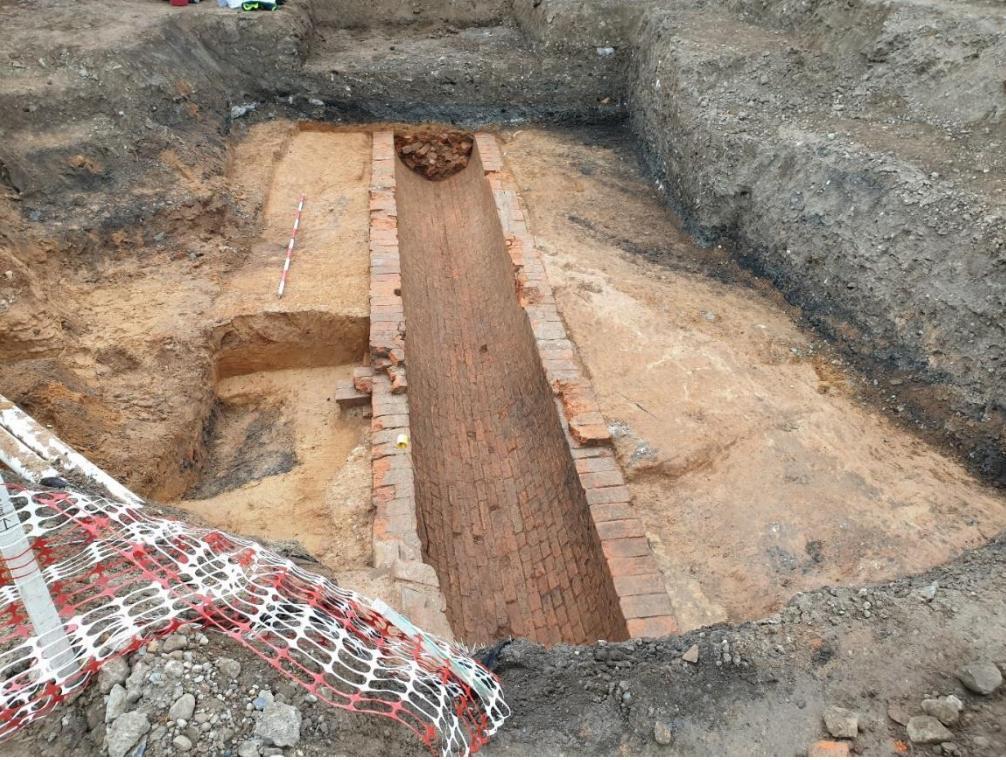
Figure 3 South-west facing view looking along the length of exposed drain.

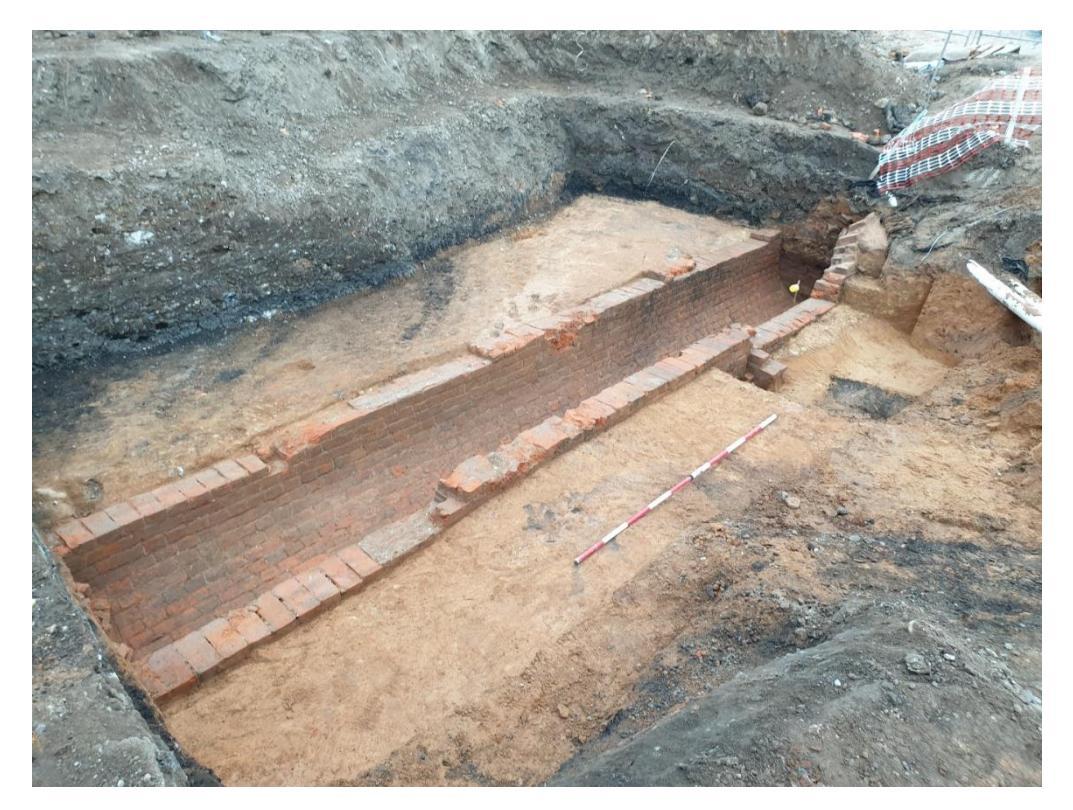
Figure 4 East facing view showing the length of exposed drain. Note the remnant of the curve of the upper part of the eastern wall.

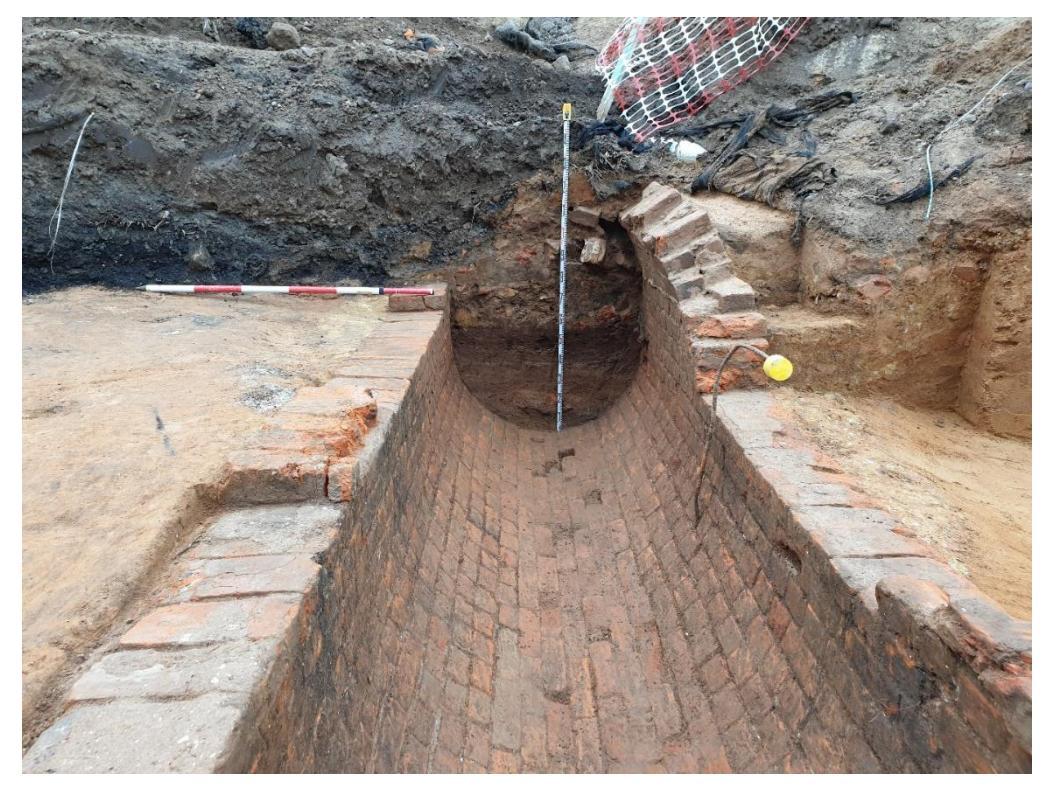
Figure 5 North-east facing view showing the south-facing section with curve of drain truncated by Bridge Street cutting.

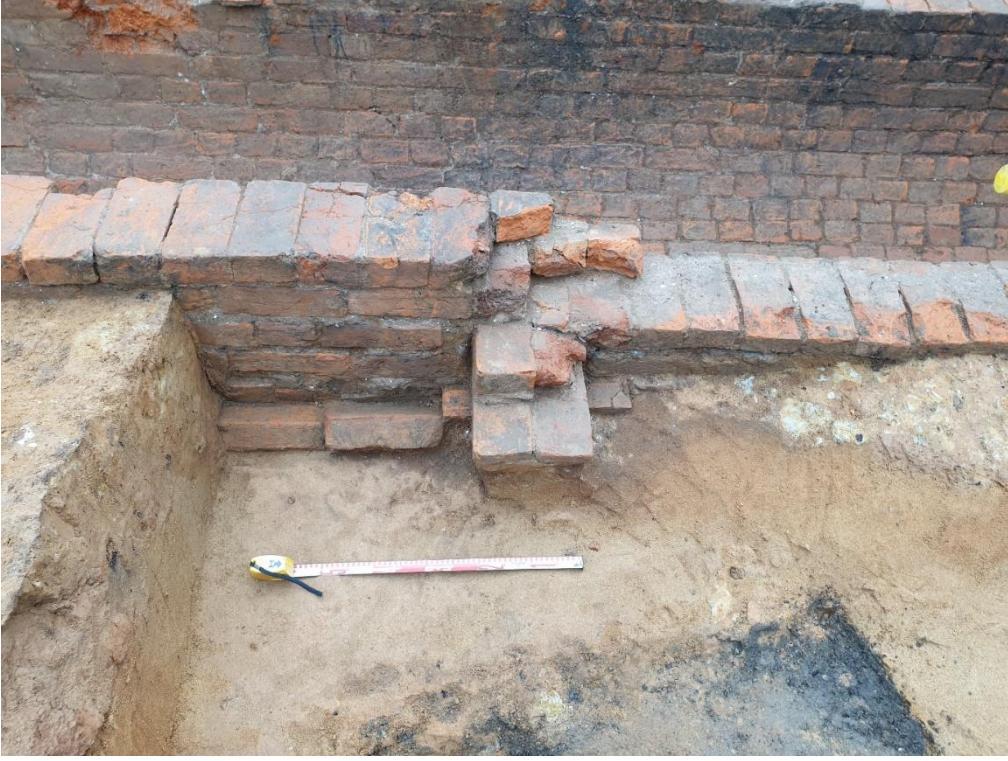
Figure 6North-west facing view showing vertical section of wall and keyed-in brickfeature.

As with the previous section, the drain structure consisted of a shallow inverted segmental arch forming the base (the invert). It was not possible to view the invert to determine whether it was a single skin of bricks, but as with the previous section, the invert was laid in stretcher bond. The walls were laid as two skins constructed using English bond; however, the stretcher courses present in the complete section of drain were missing from all except the northernmost part of the eastern wall (Figure 5). Whereas the walls on the originally identified section were straight battered with a receding slope (AAJV 2018, p.28), the side walls of the newly identified section of drain were almost vertical (Figure 6 and Figure 7). One structural element was noted which had not been seen elsewhere along the drain, and this related to several bricks which were keyed into the main drain at a right angle (Figure 6 and Figure 7). The feature consisted of two courses of bricks bonded with shell mortar laid directly on to the sand which was used to fill the cut of the drain. The purpose of these bricks is unknown, but it is assumed that it was potentially conceived of functioning as an engaged pier to provide structural support to the wall during the construction process or subsequent to it

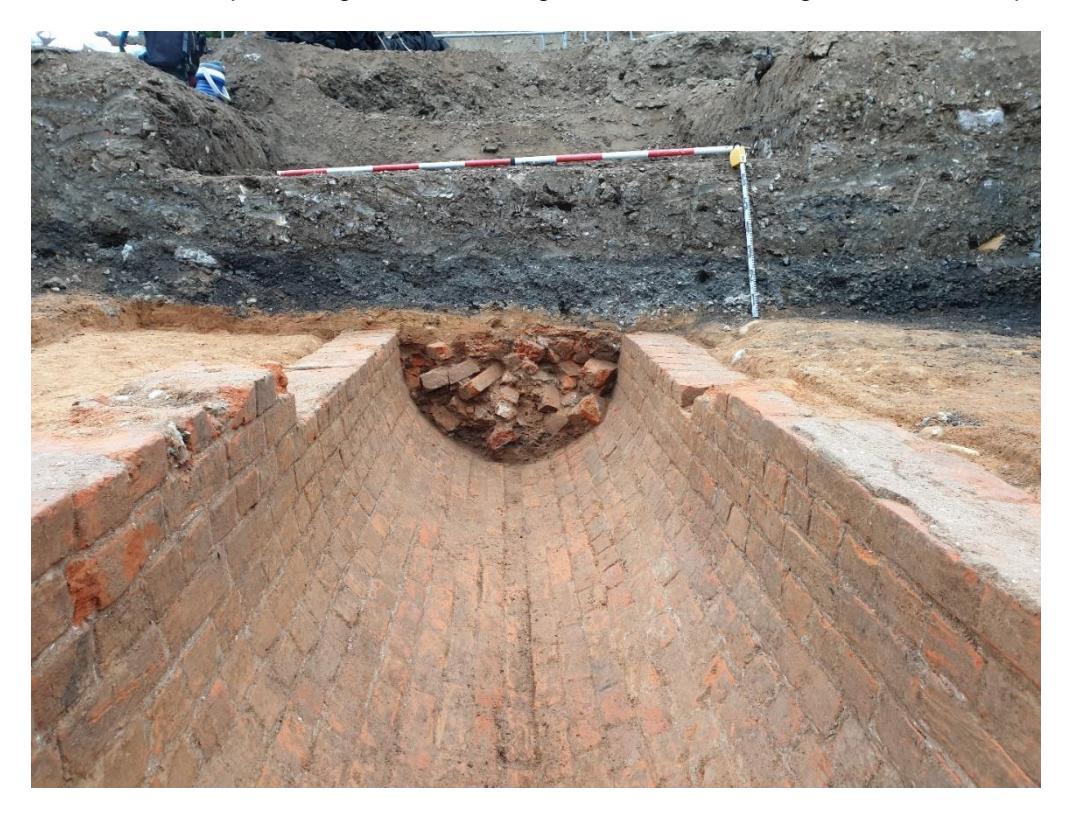
Figure 8 South-west facing view showing north-eastern section. Note rubble blocking the drain below layers associated with construction of the Bridge Street road.

The interior of the drain was predominantly filled with a demolition deposit containing the bricks from the upper arch of the drain held in a clay matrix. This deposit would have formed following demolition of the drain in the 1930s, and it was capped in the section by various blue metal and bitumen deposits associated with construction of the Bridge Street road surface (Figure 8). However, at the northerly (downhill) end of the drain, a noticeable accumulation of silt was present in its base which measured 580 millimetres thick at the northern section (c.f. Figure 5). It is presumed that this related to the where the drain had previously been breached as part of the construction of the 1874 road alignment and where it had been filled up with large rocks, blocking the drain and causing the silt to back up.

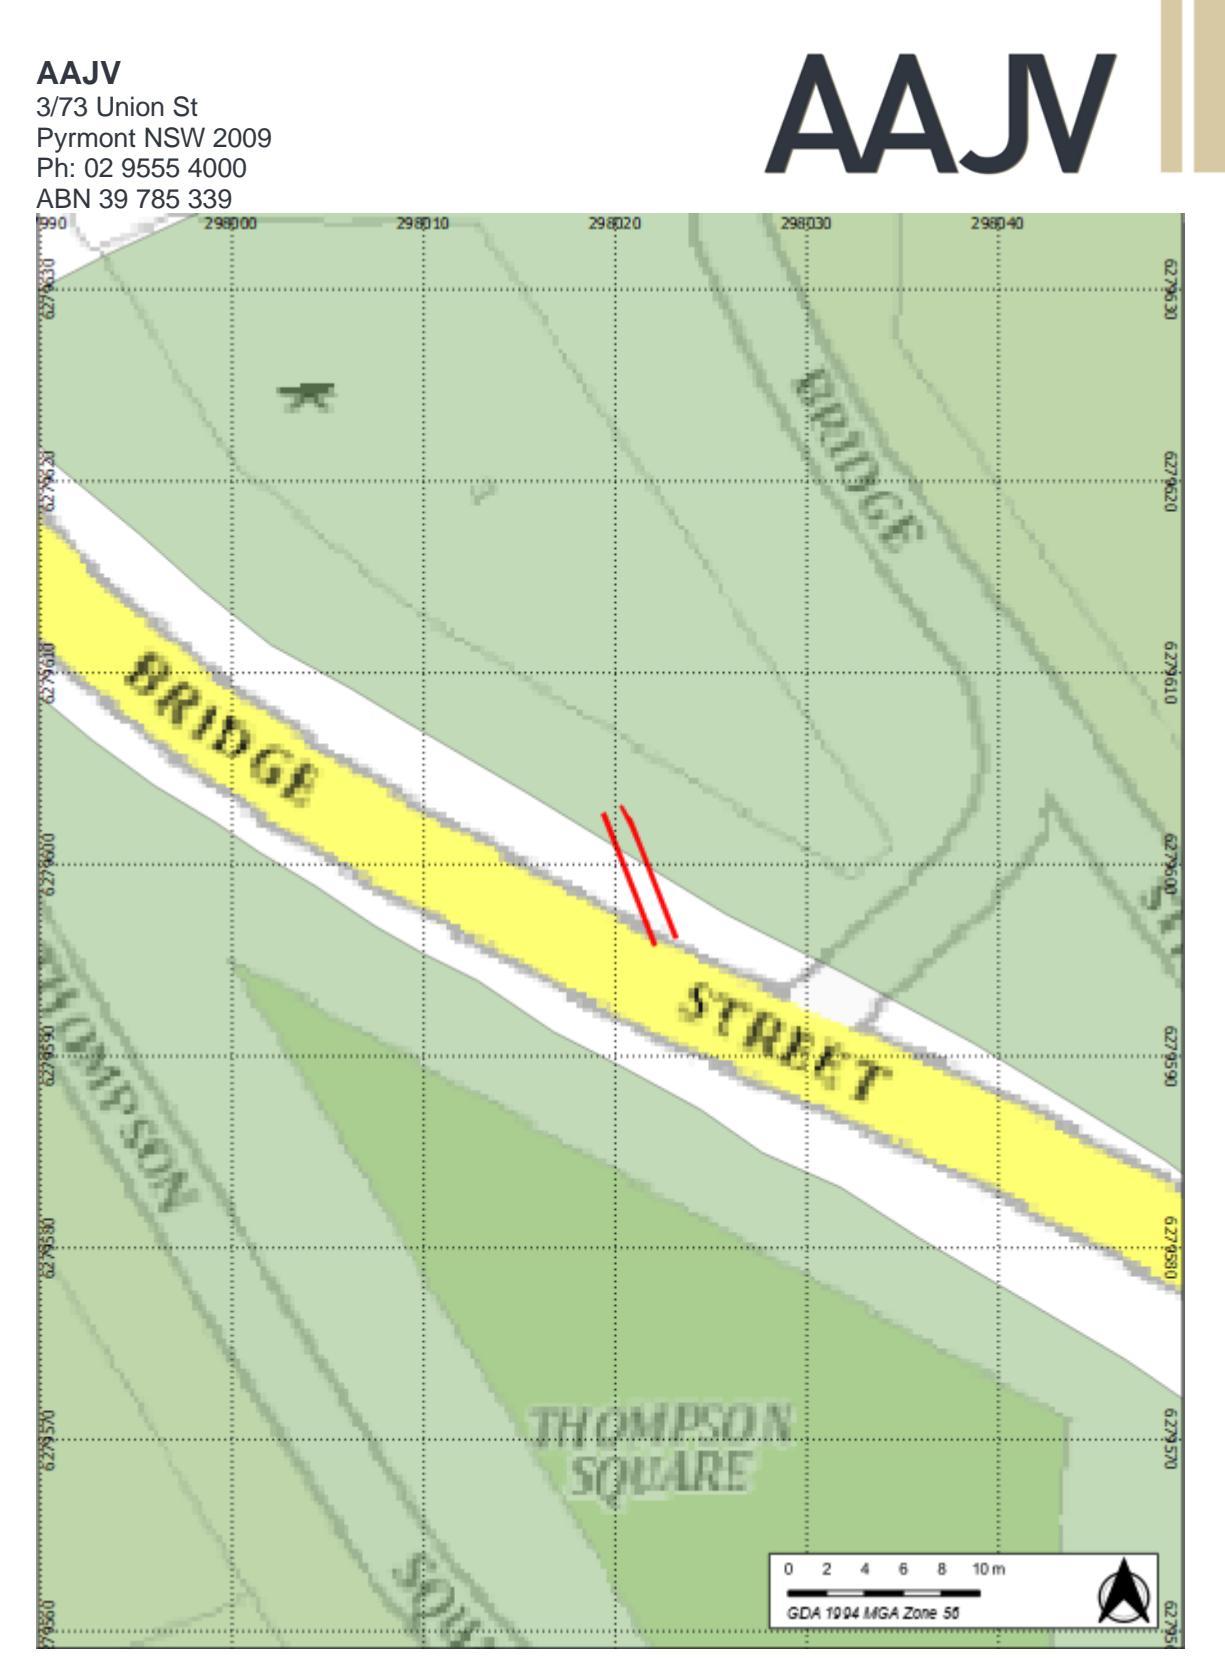
Figure 9 Preliminary plan showing SHR curtilage (green) in relation to brick barrel drain (red)

It is noted that the identified section of barrel drain is located within the Bridge Street cutting, and this is therefore predominantly outside of the State Heritage Register curtilage for Thompson Square Conservation Area (SHR #00126) (Figure 9).

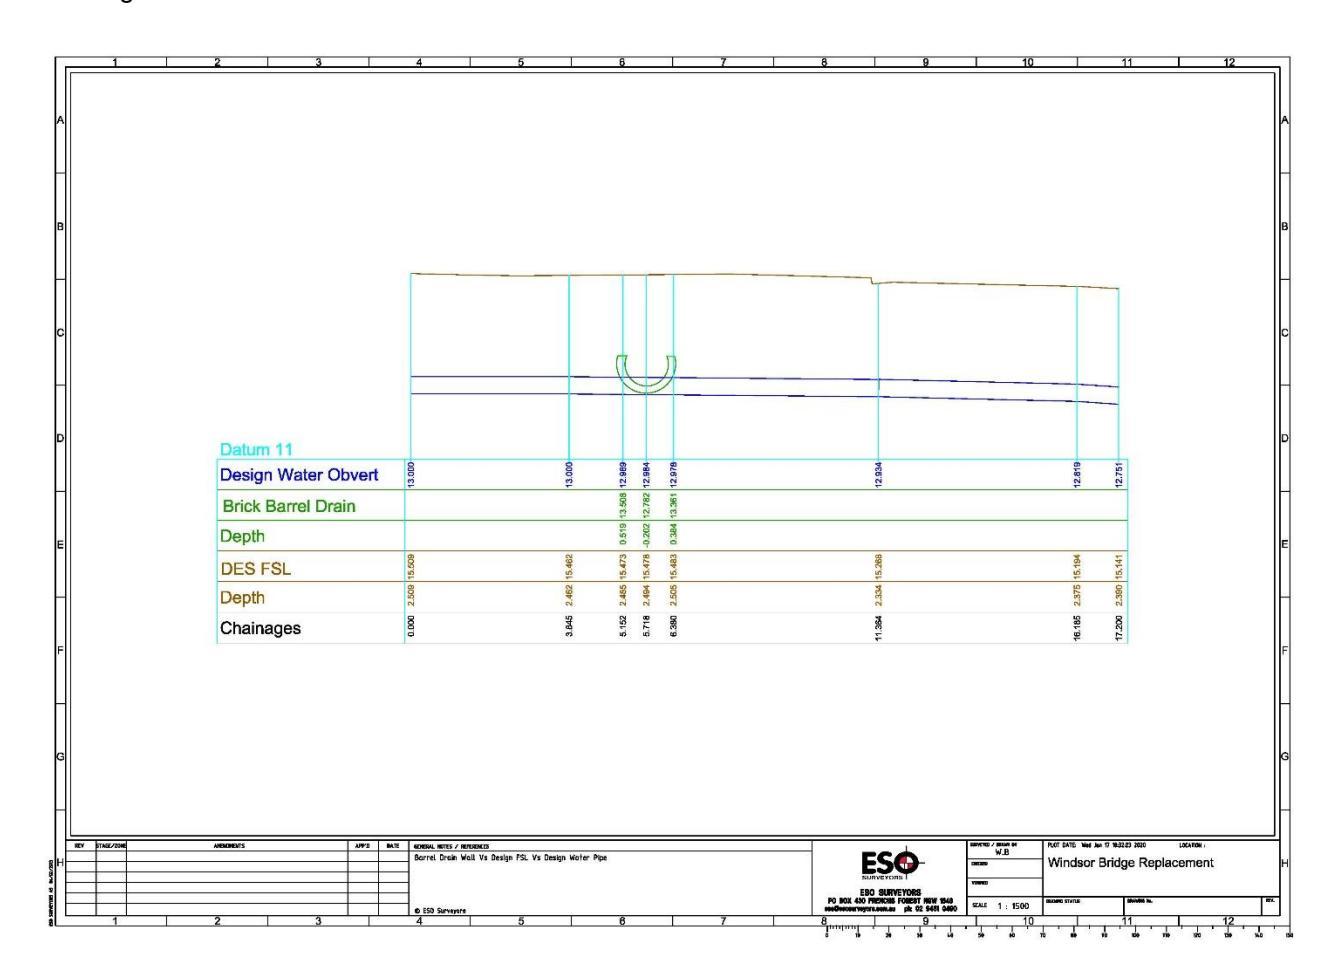
# Presently the three water mains cannot be installed as designed without the remnant barrel drain being damaged. This is because the water mains intersect with the lower part of the barrel drain; as detailed in the Figure 10 below:

# Figure 10 Comparison of barrel drain (green) with proposed level of watermain (blue).

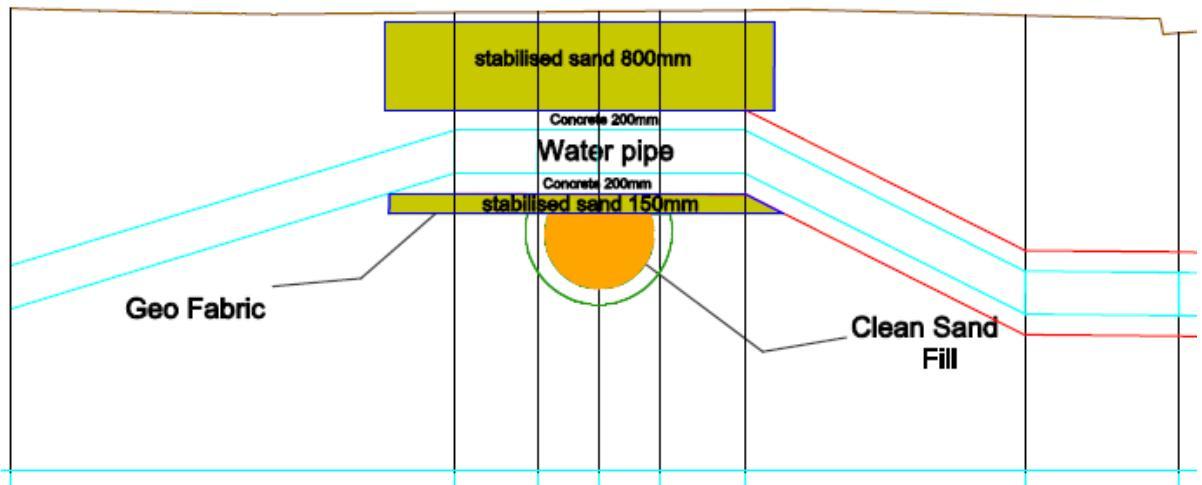
Option 1 results in the water mains being redesigned to pass above the barrel drain. This requires the installation of additional bends and the concrete encasement of the mains as shown in the Figure 11 below.

# Figure 11 Detail from provided survey plan showing required clearances to allow for recommended depth of service.

- As detailed in Figure 11, the minimum gap between the base of the concrete encased watermain and the top of the remnant barrel drain would only be 150 millimetres. With only this gap, it is possible that the concrete encased watermain would placing loading on the barrel drain and that some loads may be transferred during construction; and
- This redesign would have to be approved by Sydney Water before work could continue.

- 1. Filling of the barrel drain structure with clean sand to the level of the top of the structure;
- 2. Covering the filled structure with geotextile;
- 3. Placing a 150 millimetre layer of cement stabilised sand above the drain; and
- 4. Filling the water main trench with stabilised sand to eliminate the need for compaction above the barrel drain remains.
