Transport for NSW

Pendle Hill Station

### Construction Noise Contours Area 9

APPENDIX C

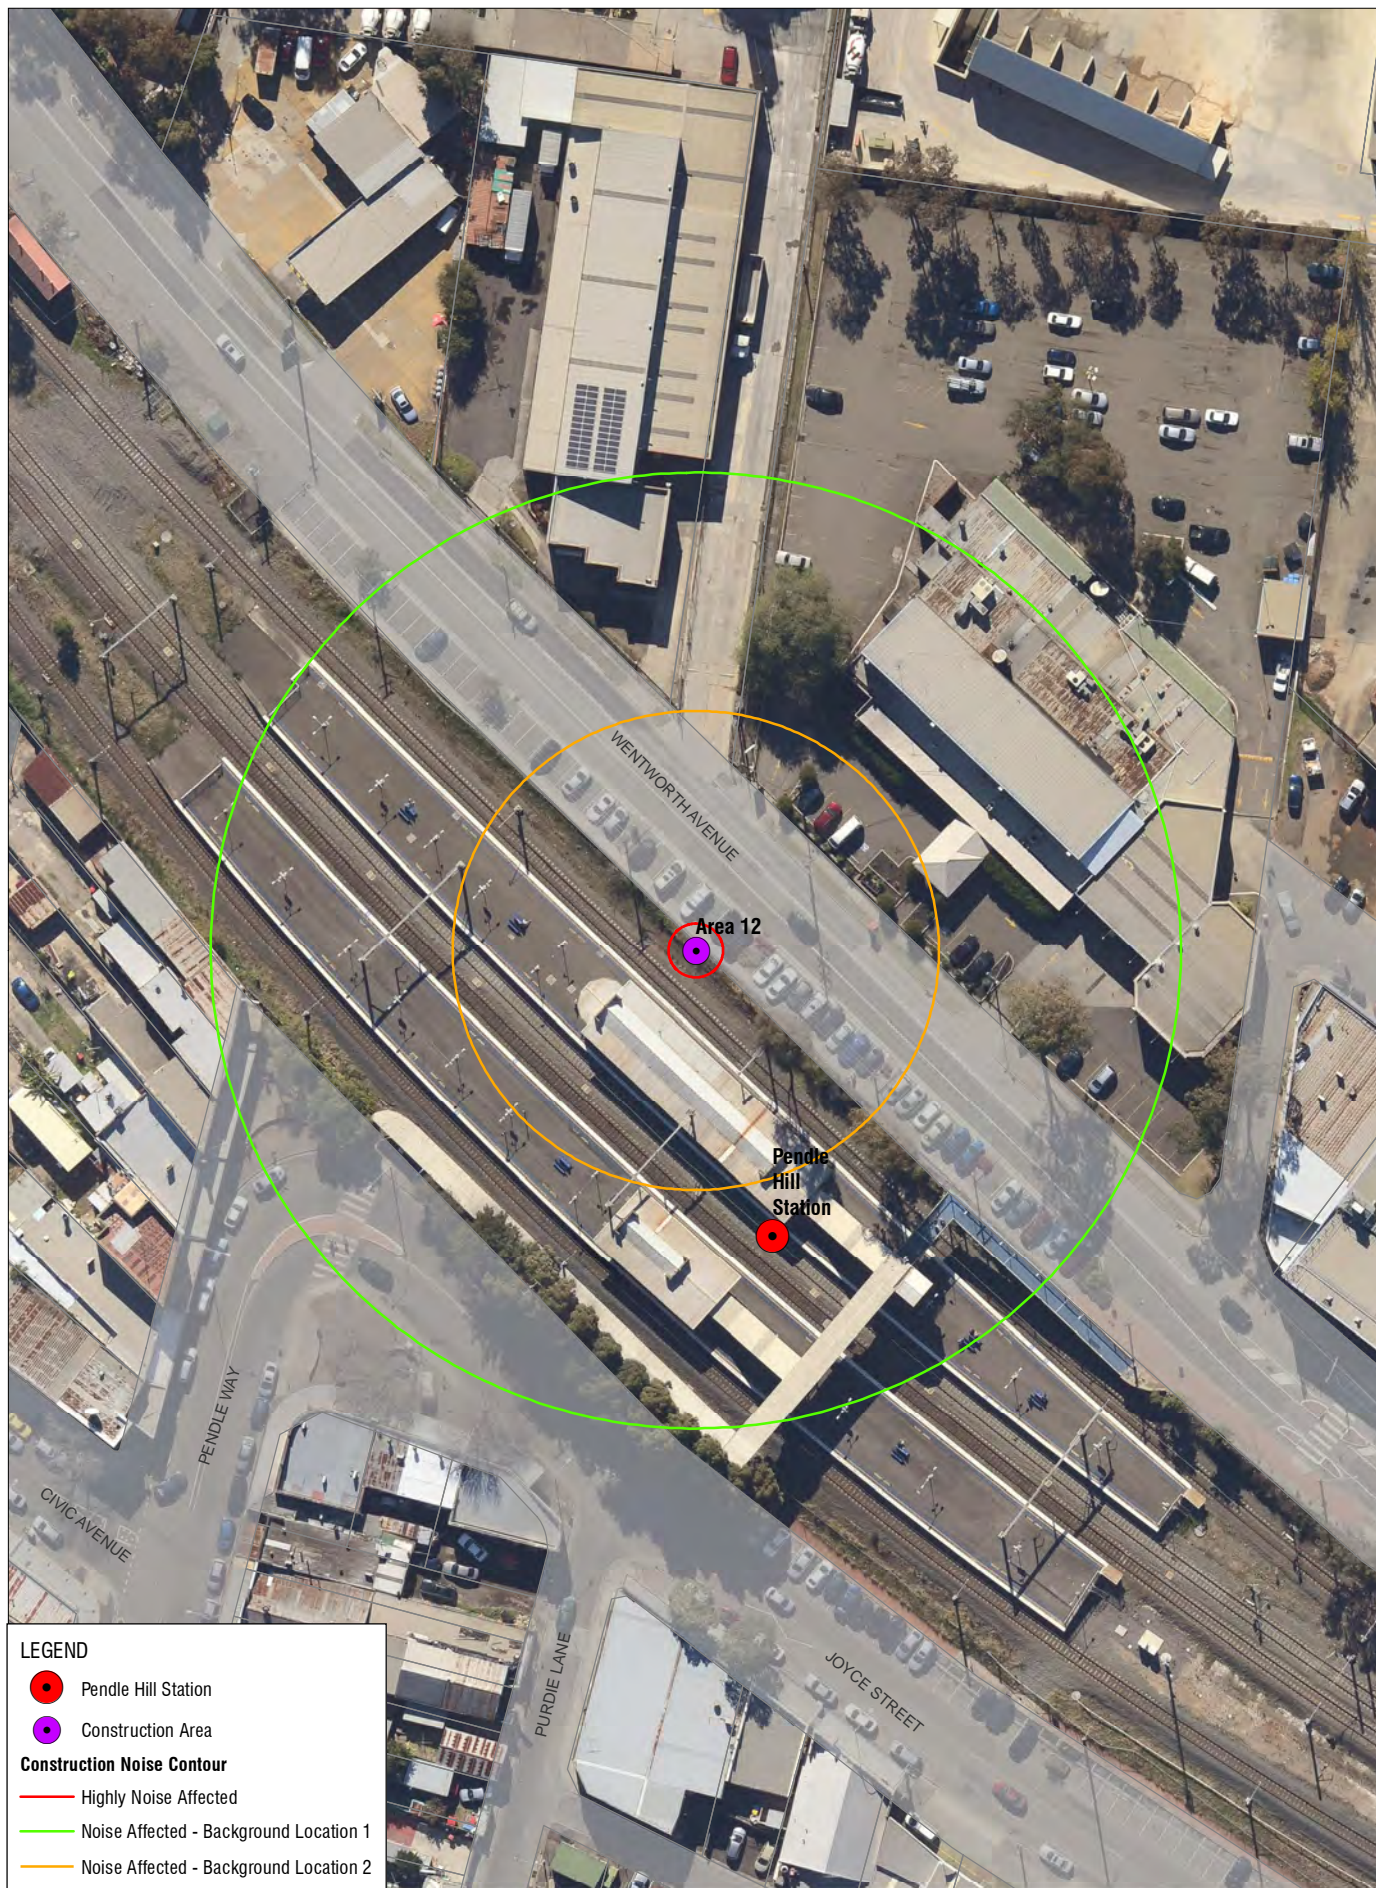
#### Construction Noise Contours Area 12

- Highly Noise Affected
- Noise Affected - Background Location 1
- Noise Affected - Background Location 2

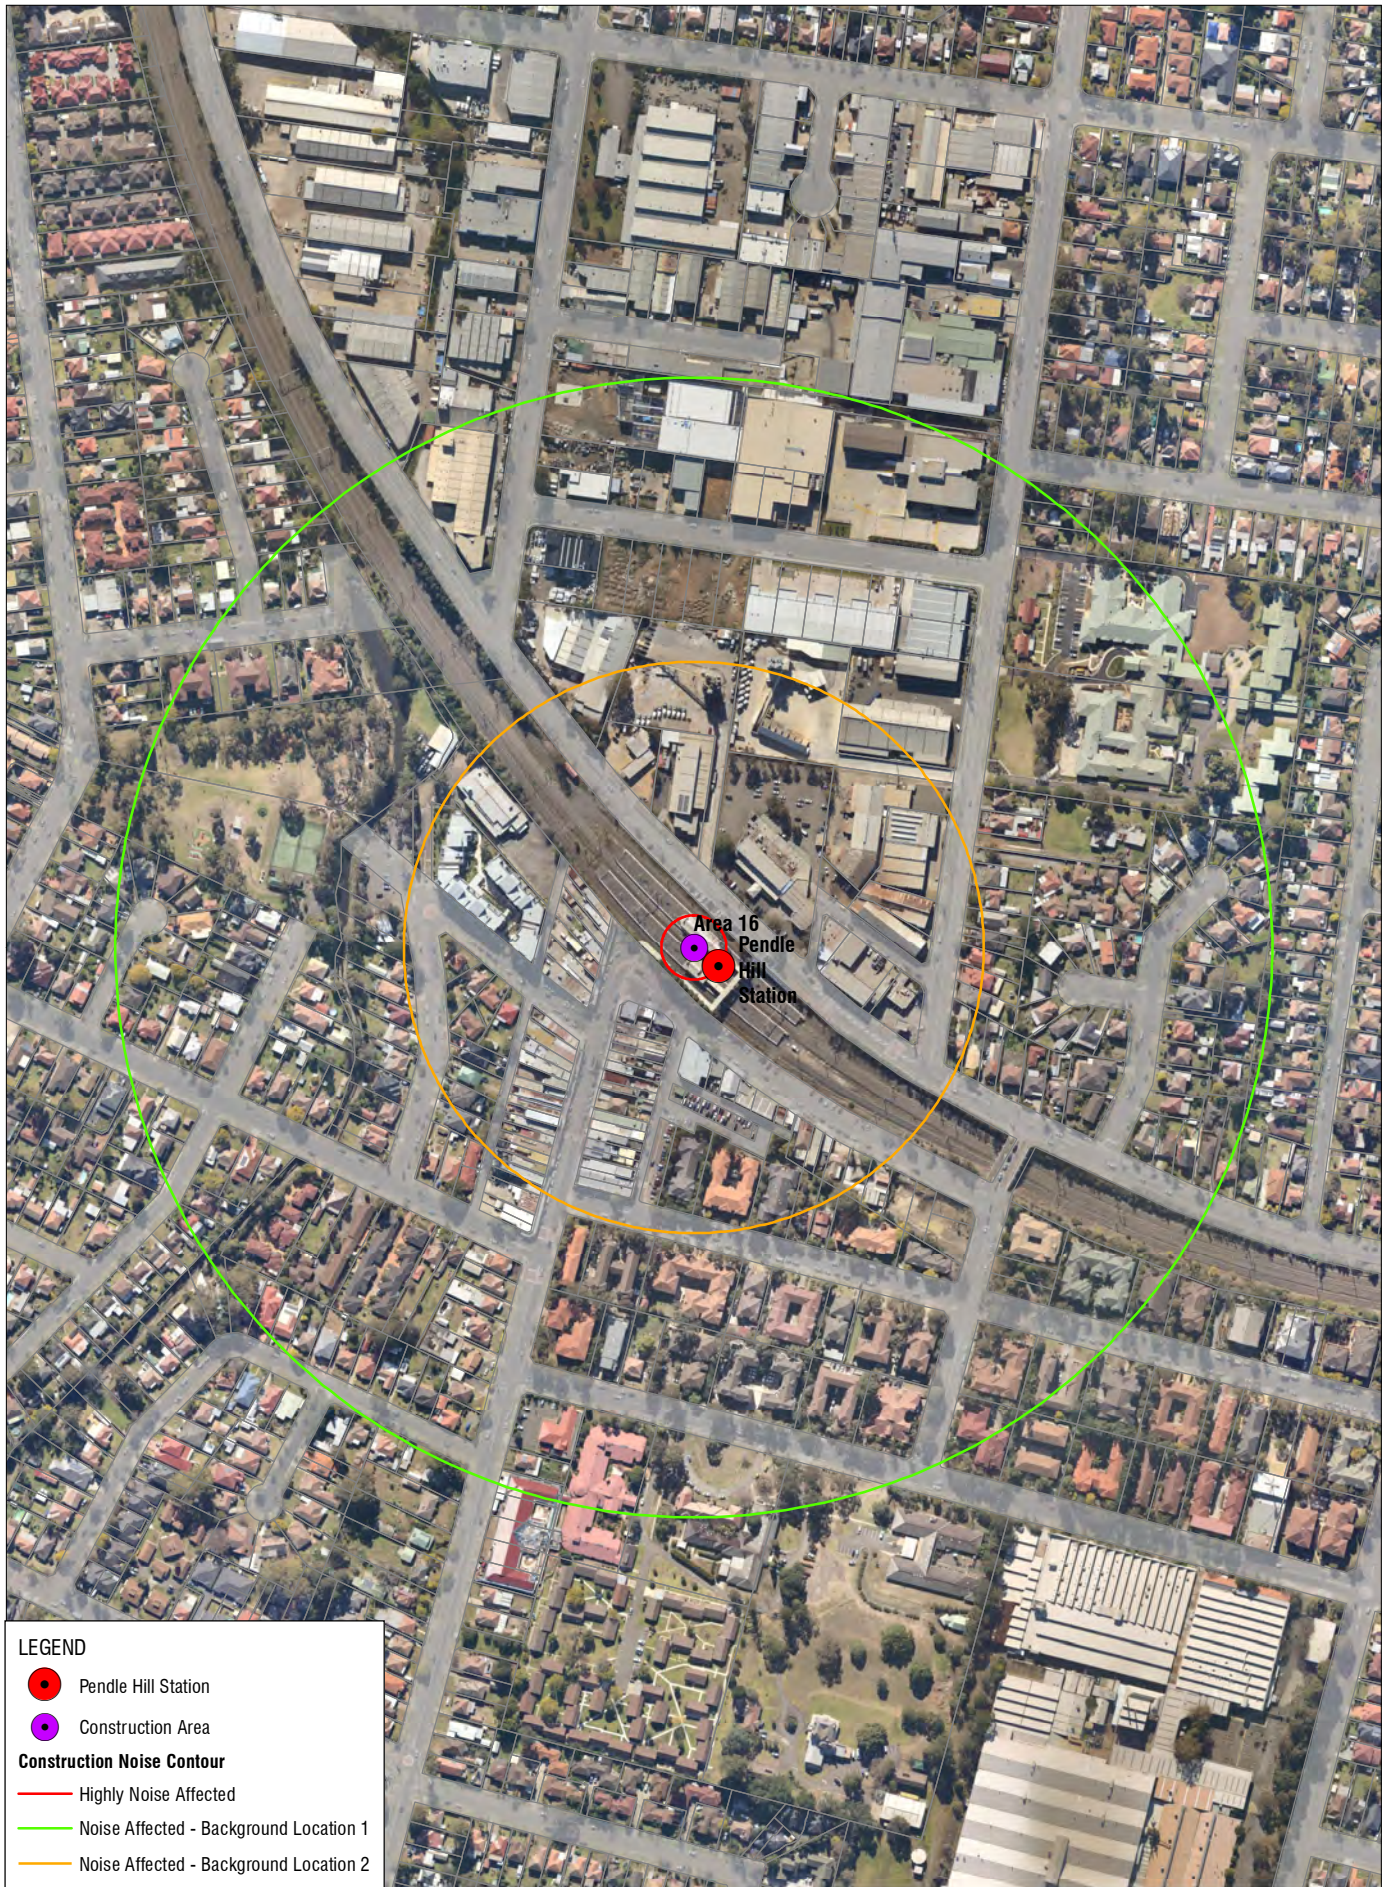
### Construction Noise Contours Area 16

- Highly Noise Affected
- Noise Affected - Background Location 1
- Noise Affected - Background Location 2

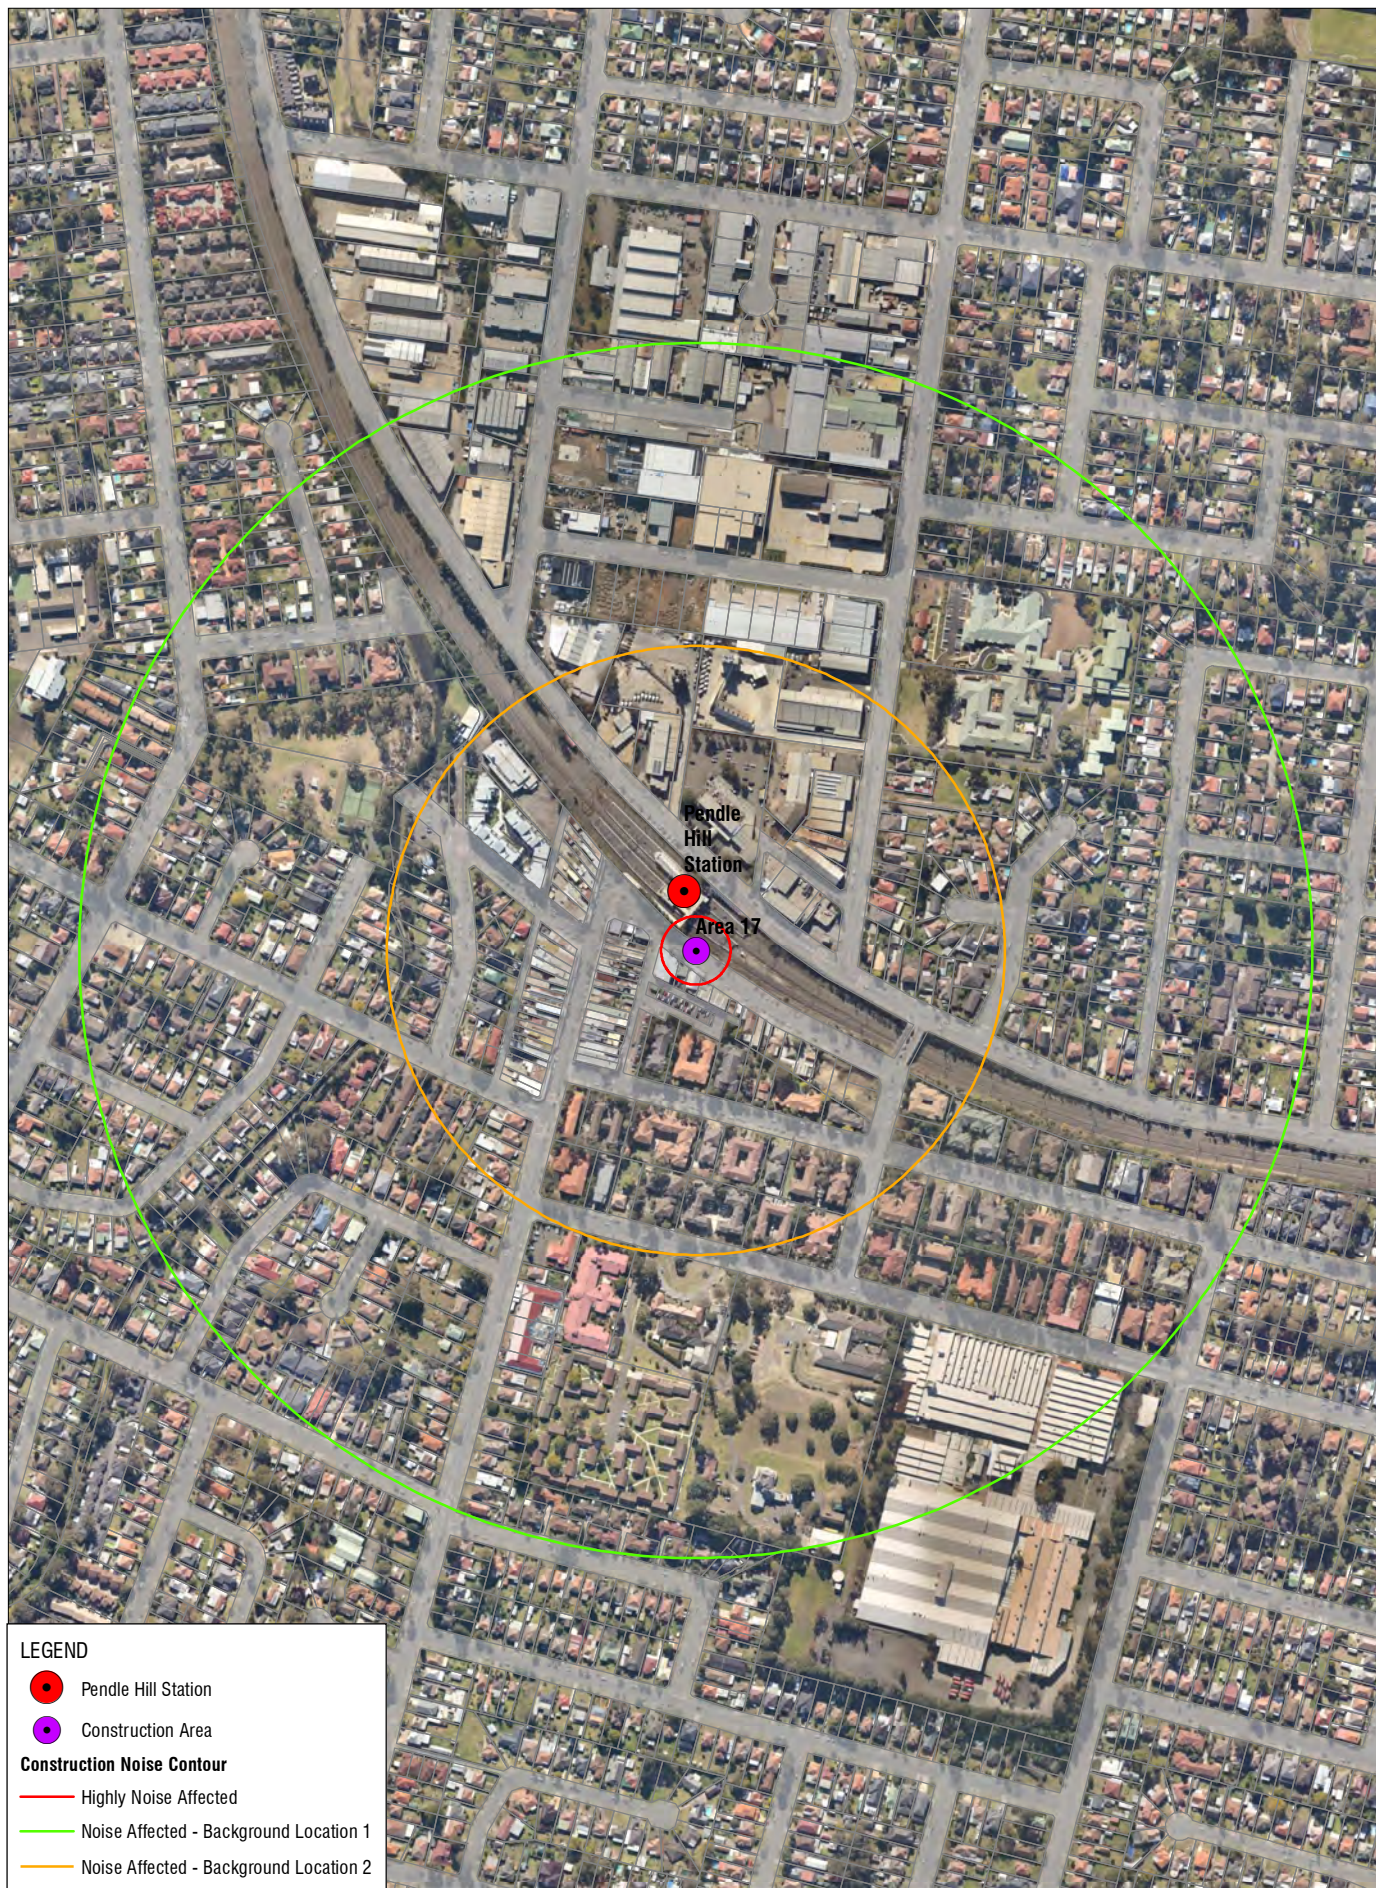
#### Construction Noise Contours Area 17

- Highly Noise Affected
- Noise Affected - Background Location 1
- Noise Affected - Background Location 2

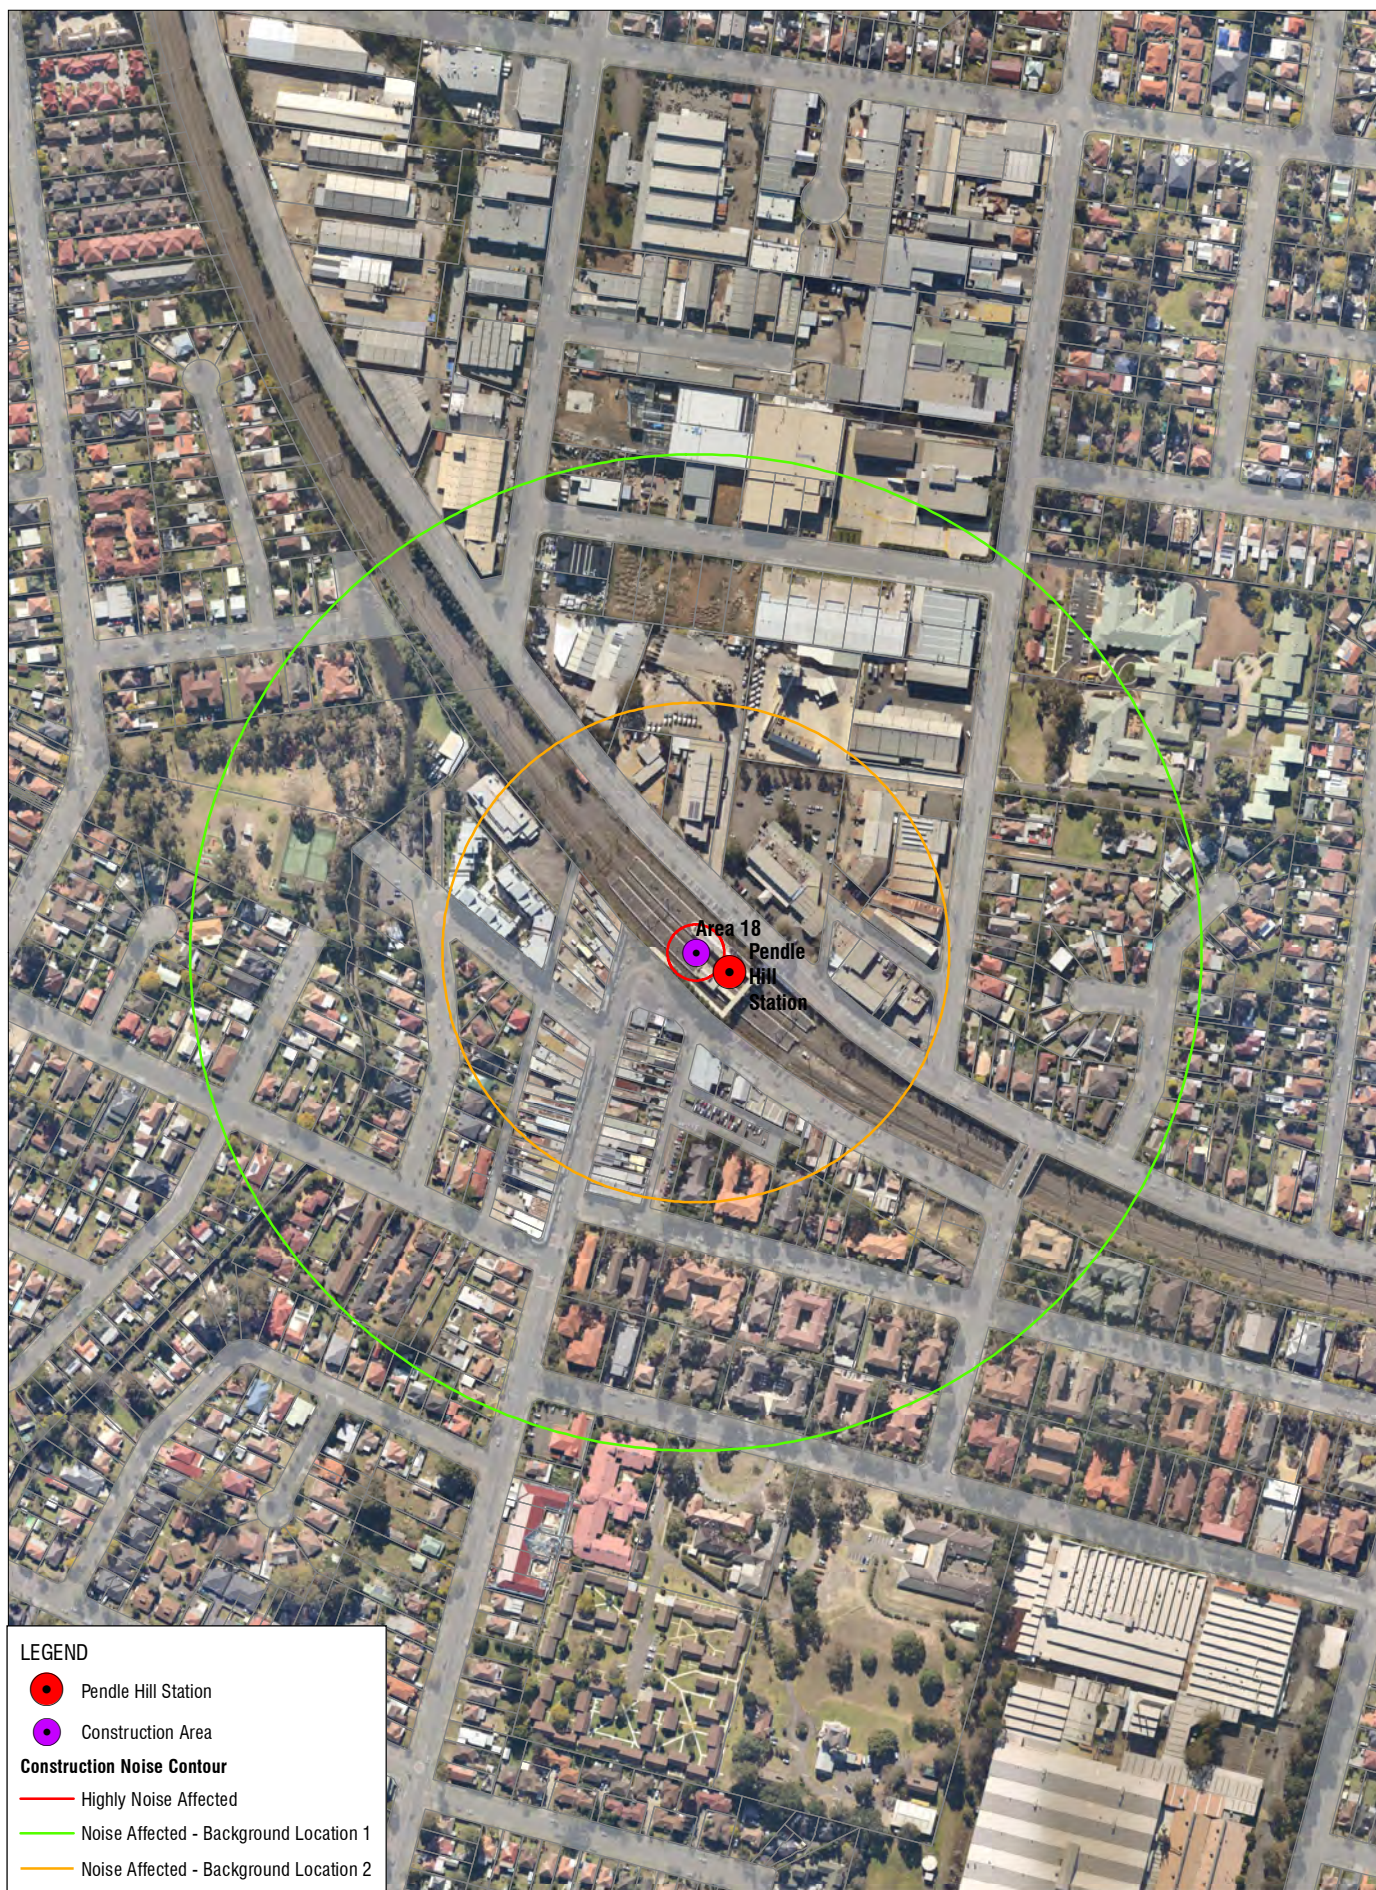
### Construction Noise Contours Area 18

- Highly Noise Affected
- Noise Affected - Background Location 1
- Noise Affected - Background Location 2

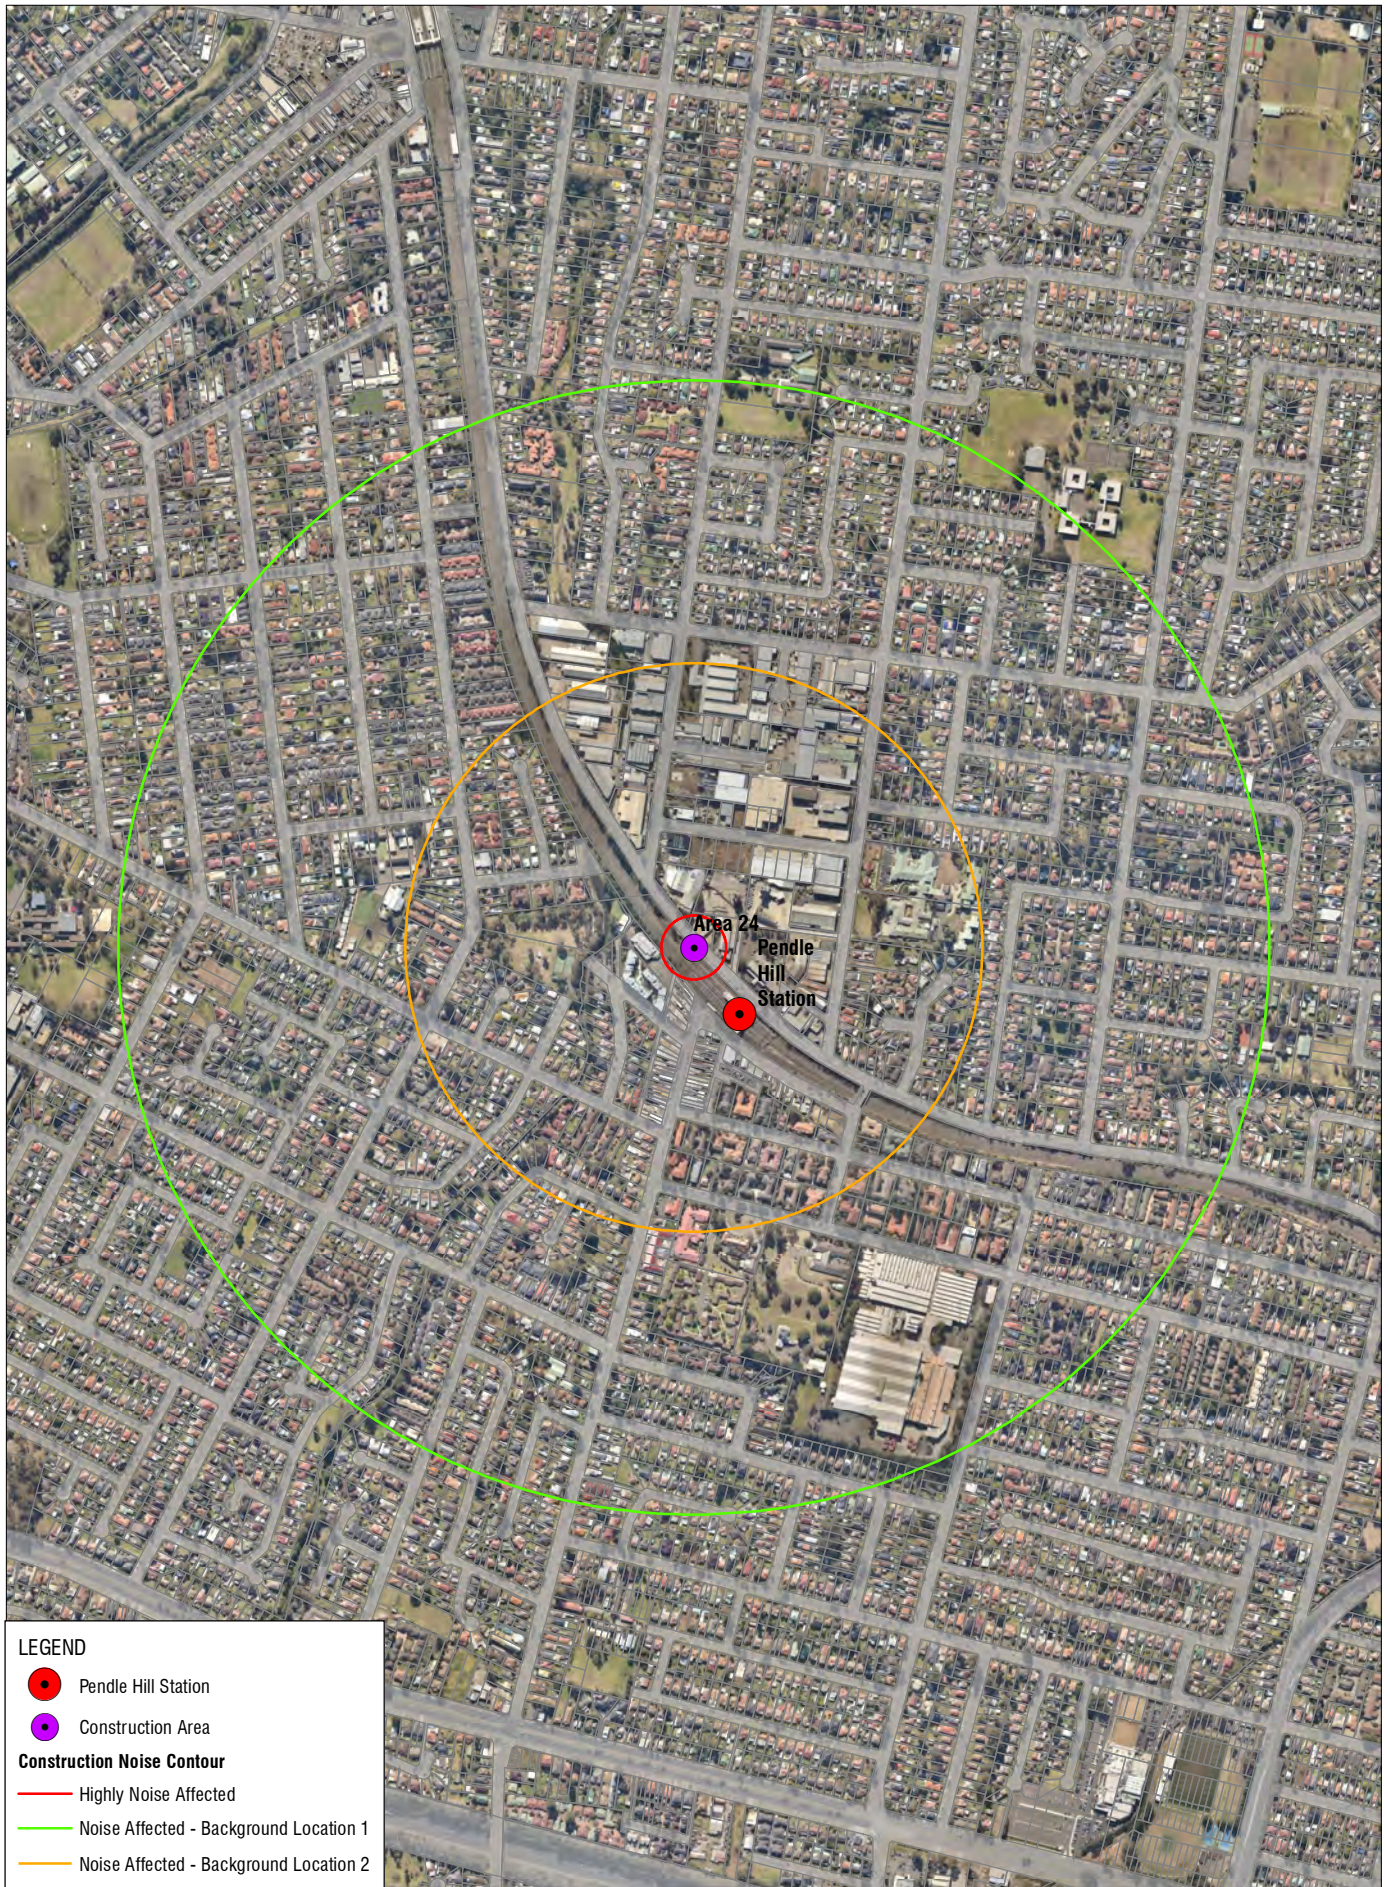
### Construction Noise Contours Area 24

- Highly Noise Affected
- Noise Affected - Background Location 1
- Noise Affected - Background Location 2

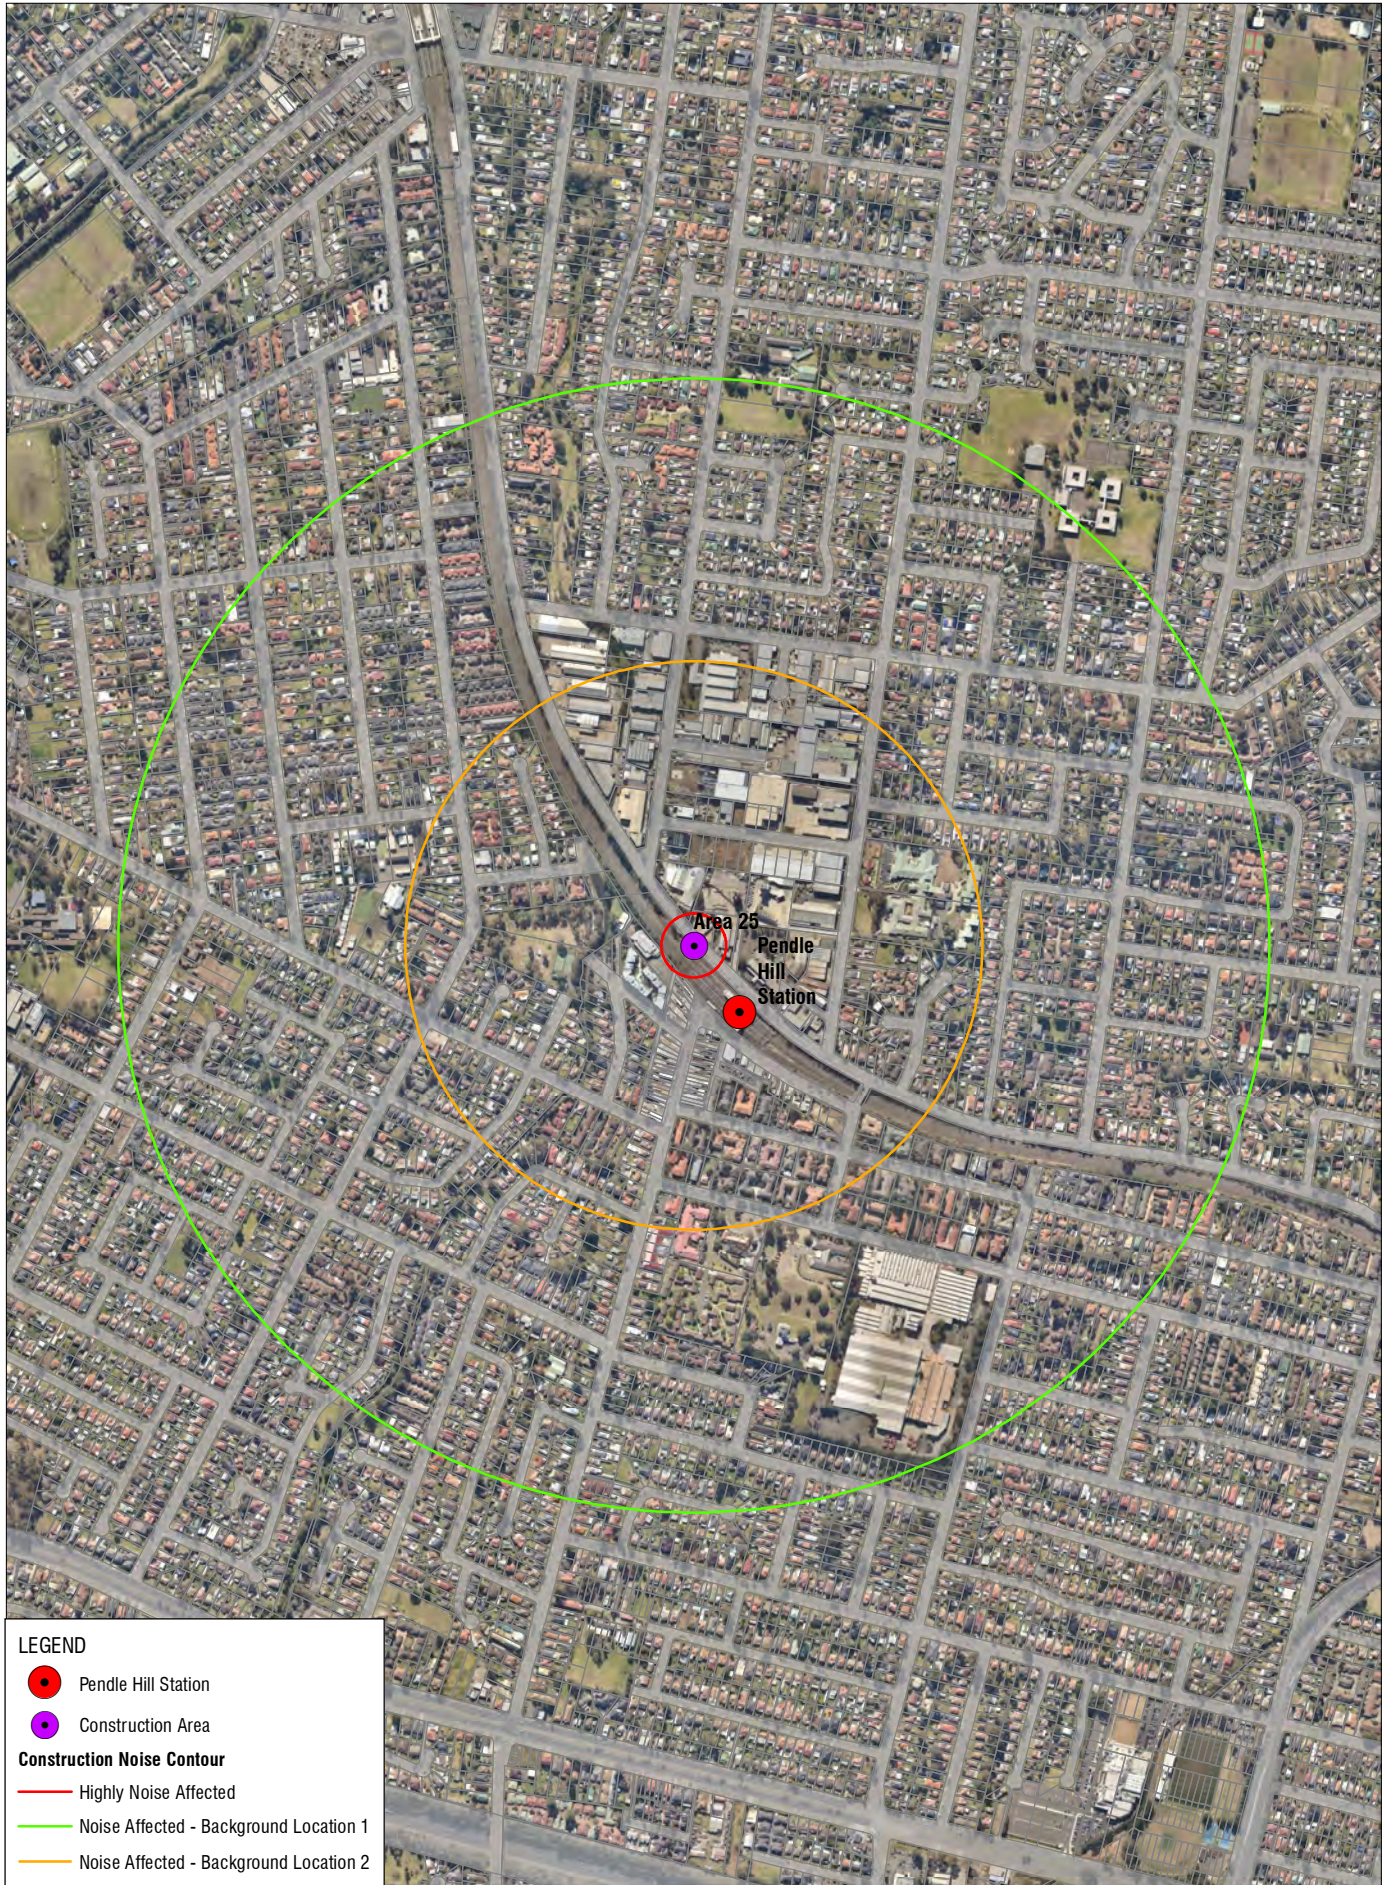
### Construction Noise Contours Area 25

- Highly Noise Affected
- Noise Affected - Background Location 1
- Noise Affected - Background Location 2

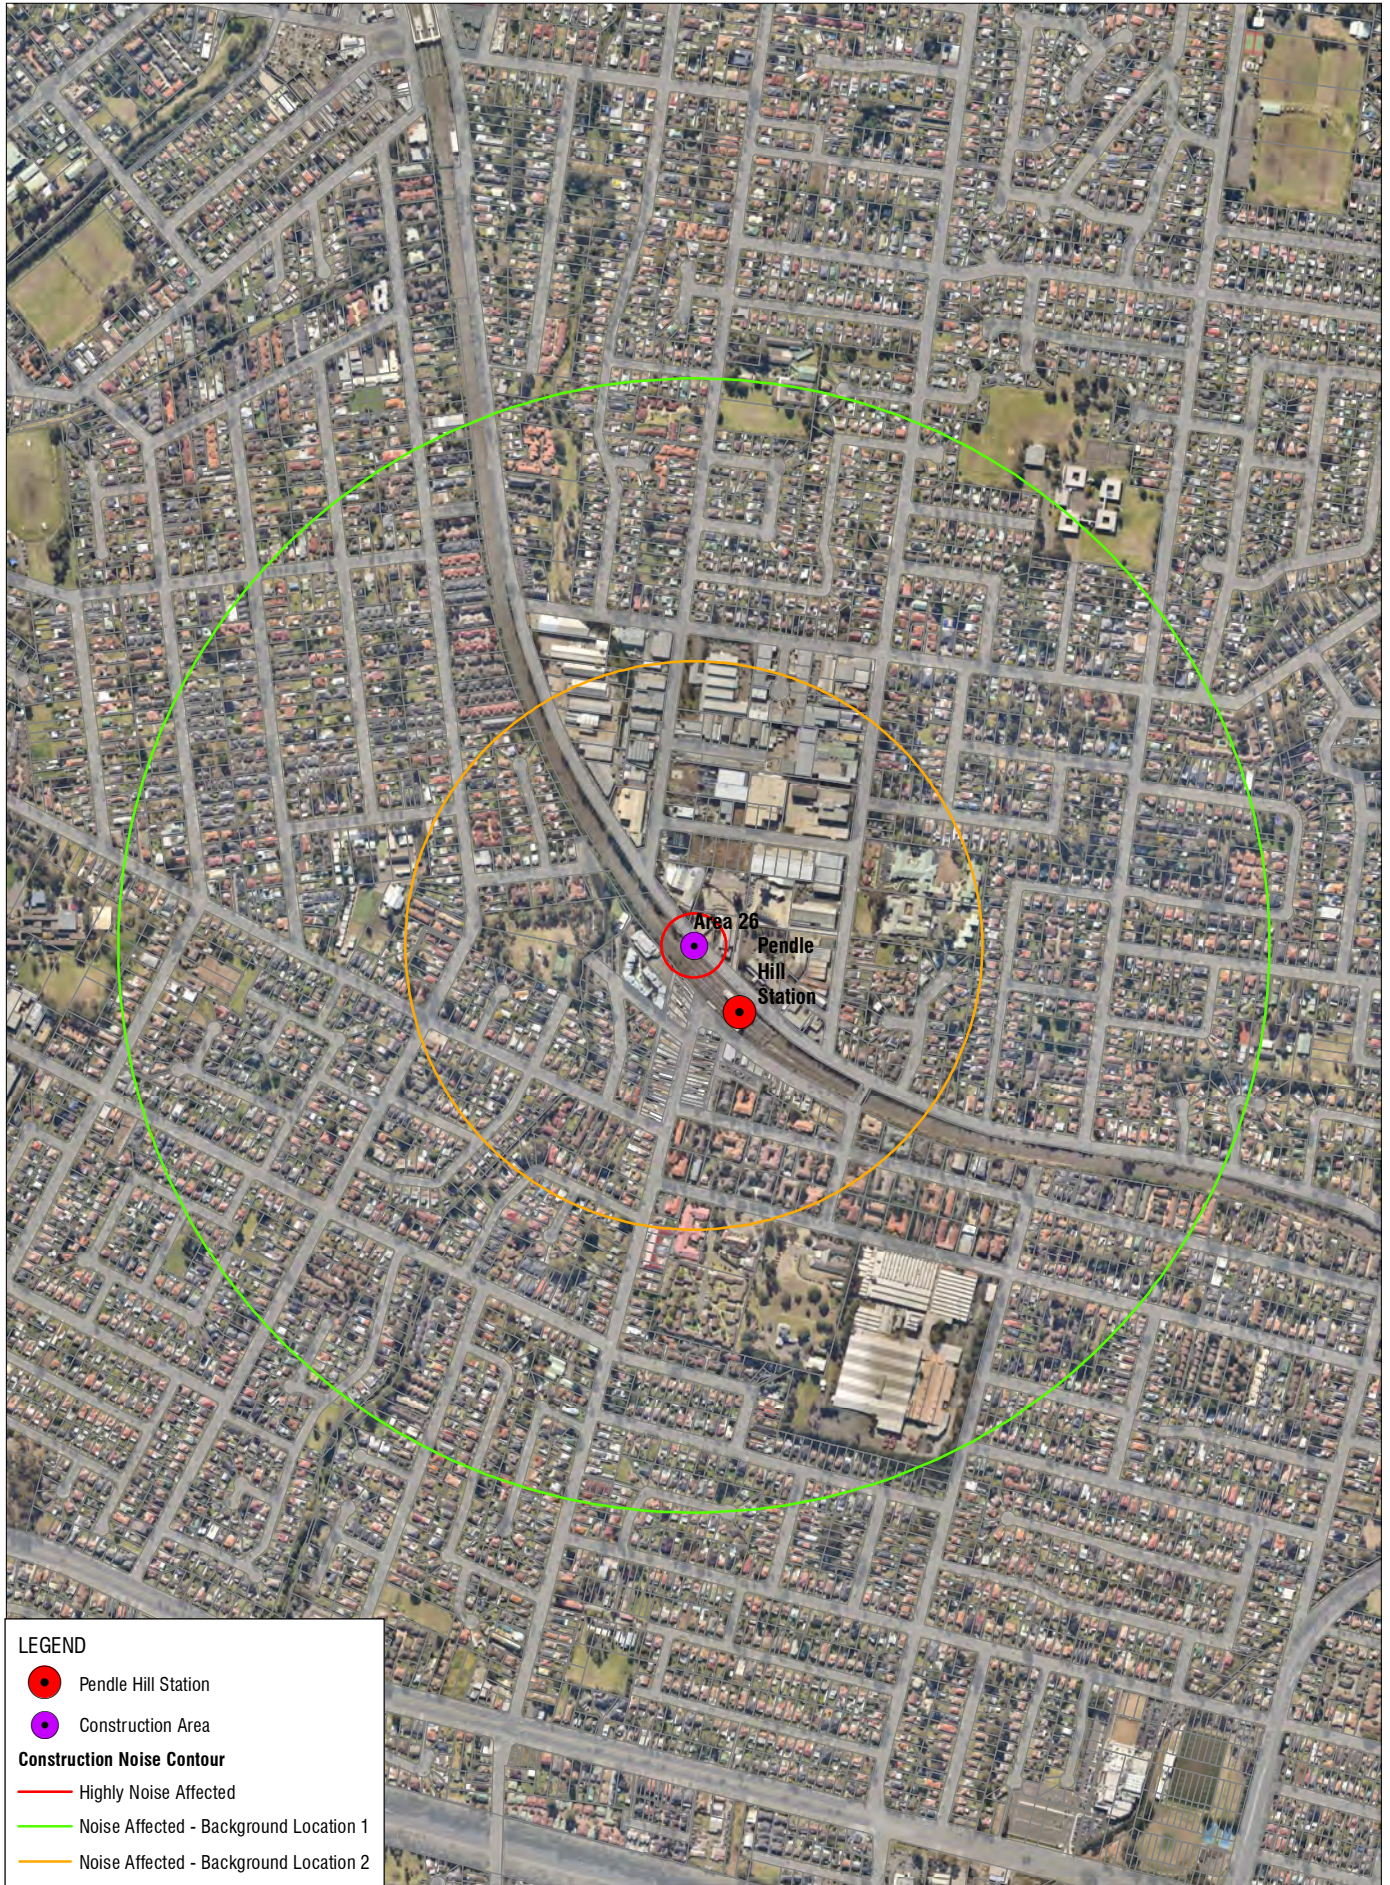
### Construction Noise Contours Area 26

- Highly Noise Affected
- Noise Affected - Background Location 1
- Noise Affected - Background Location 2

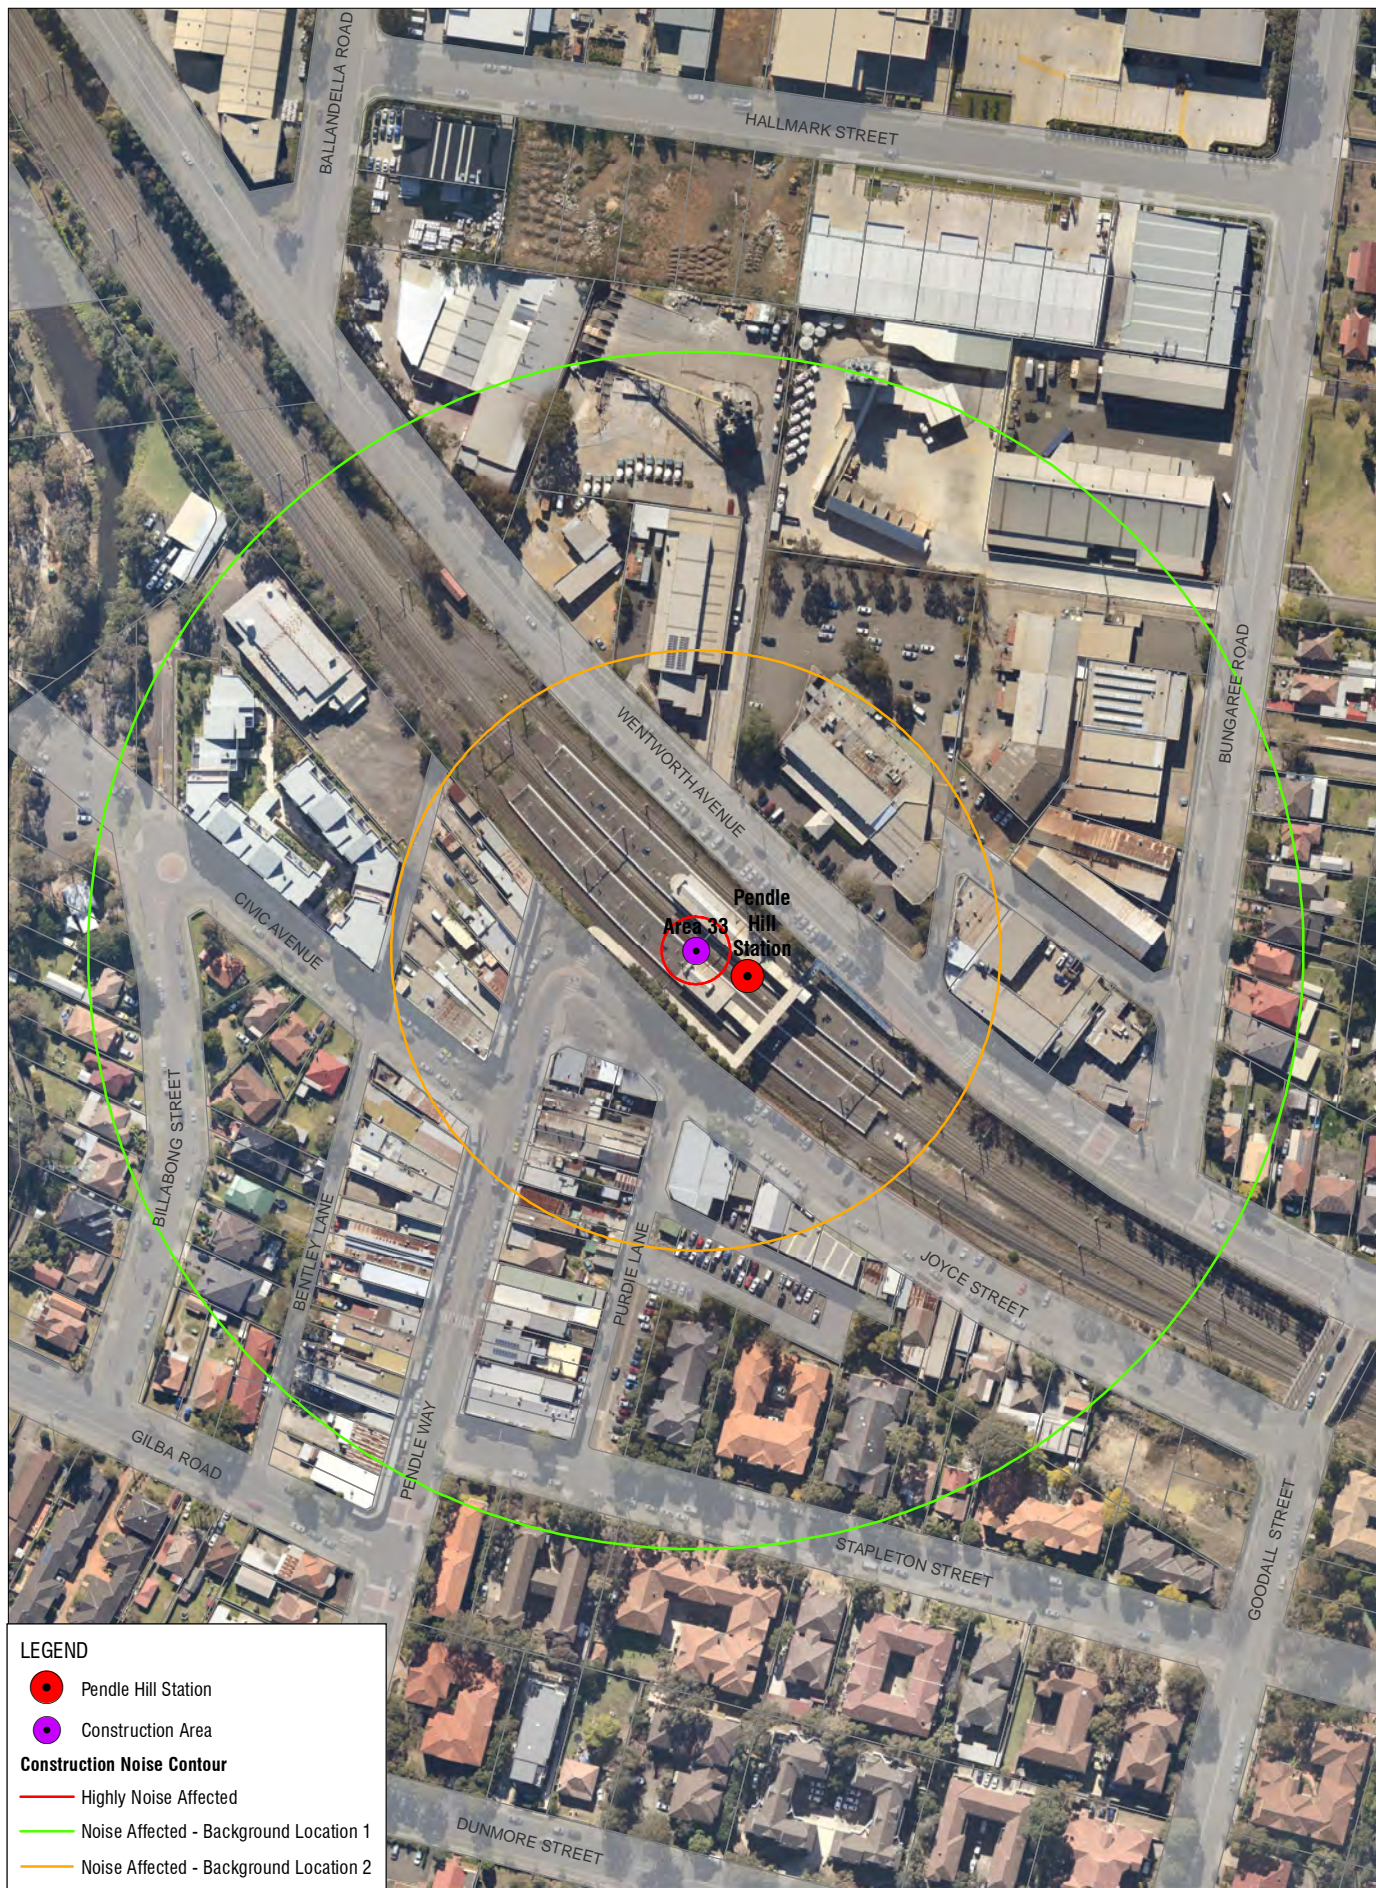
## Construction Noise Contours Area 33

- Highly Noise Affected
- Noise Affected - Background Location 1
- Noise Affected - Background Location 2
