Appendix D2

RMS Factual Geotechnical Investigation Report

APPENDIX A
BOREHOLE LOGS AND CORE PHOTOS

PROJECT : BERRY BYPASS
LOCATION : SOUTHERN ALIGNMENT

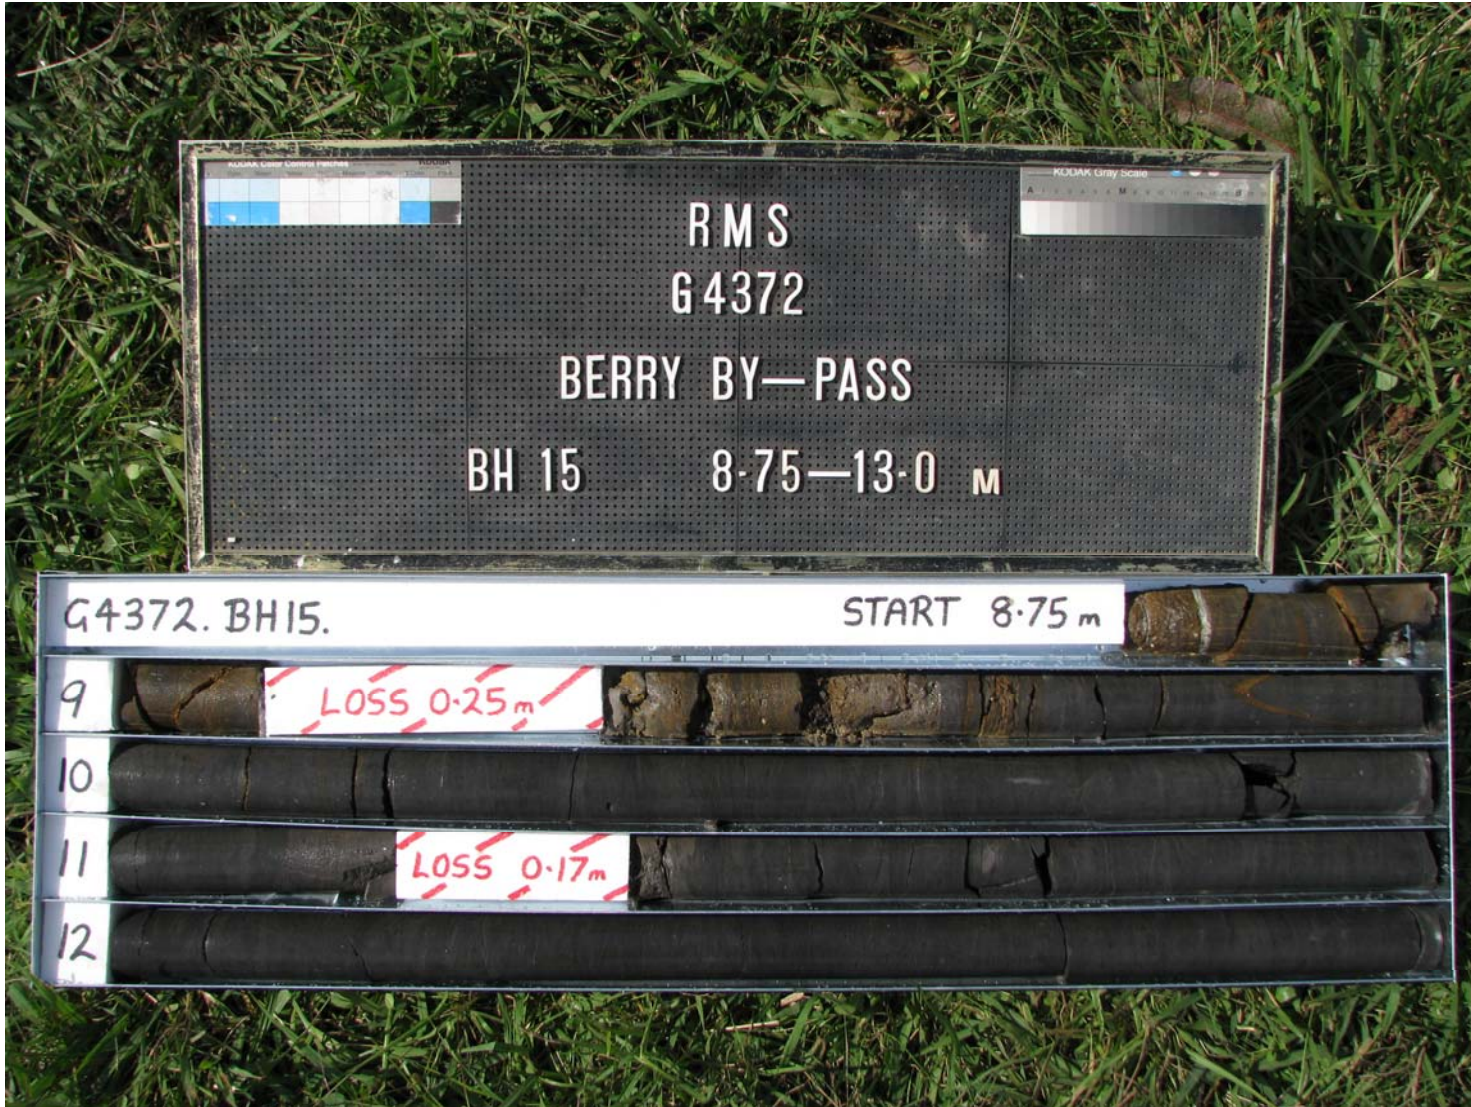
Photo 1 of 2

Geotechnical Investigation
Bore Hole: B15

Table with columns: DRILLING (Progress, Depth, Graphical Log), MATERIAL (Description, Weathering, Strength, Fractures), and ADDITIONAL DATA (Visual, Joints, etc.). Rows describe geological layers from 8.0m to 14.73m depth, including silty sandstone, sandy siltstone, and clay beds.

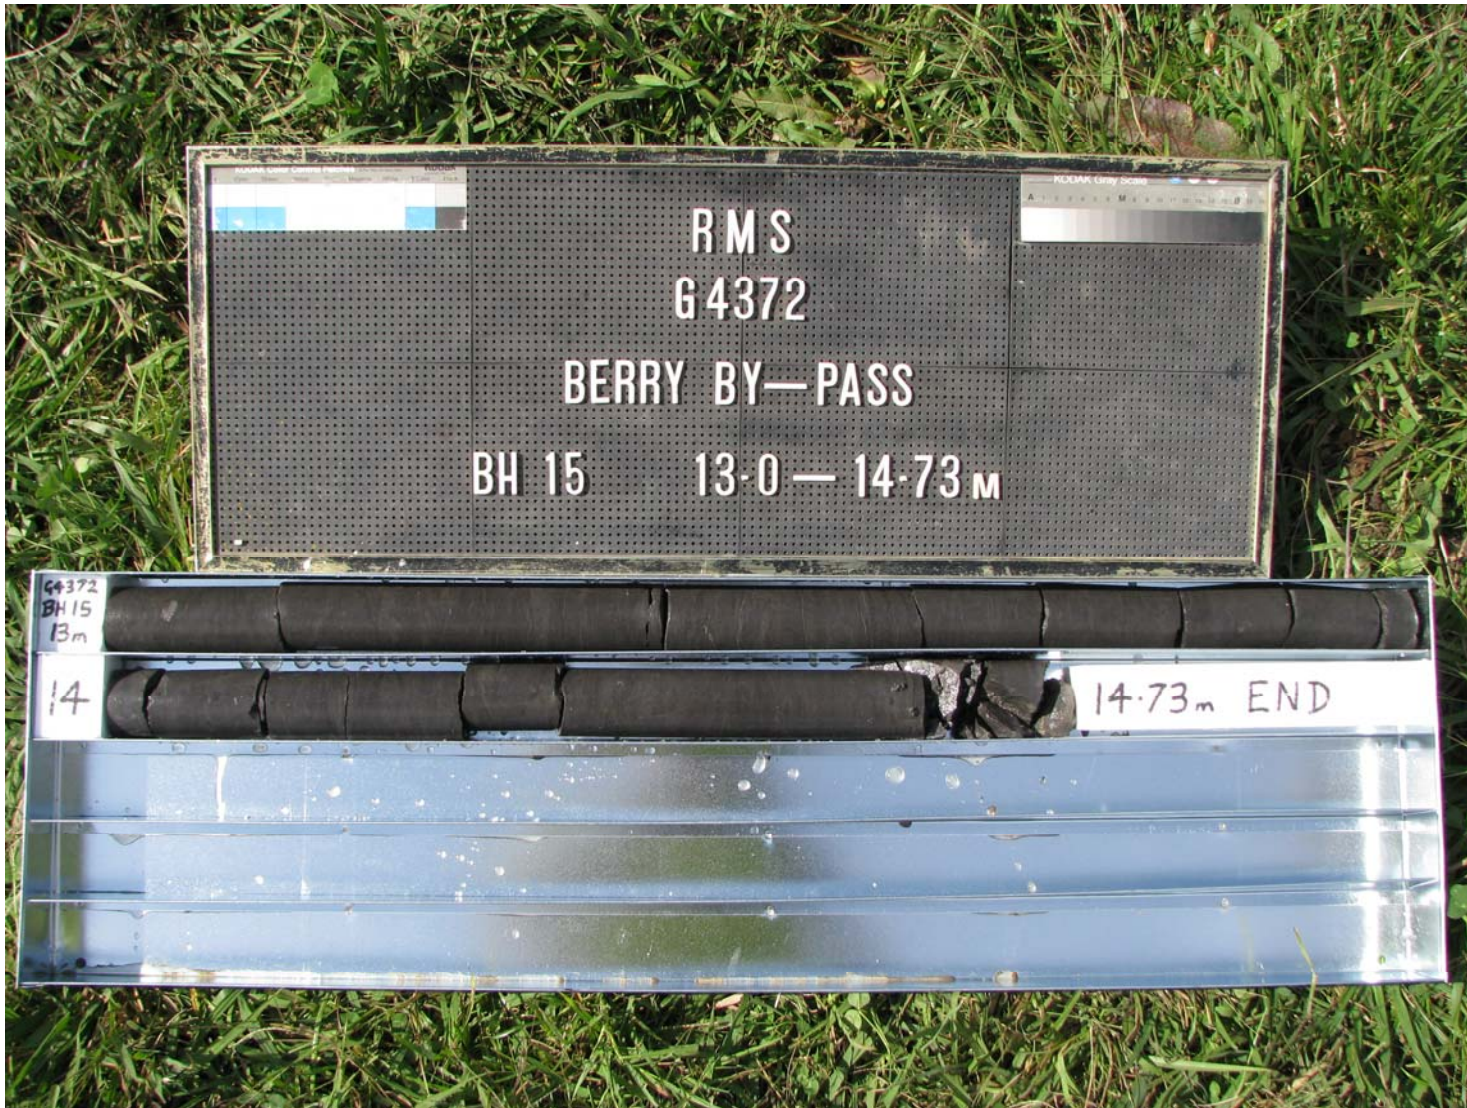
Photo 2 of 2

Geotechnical Investigation
Bore Hole: B15

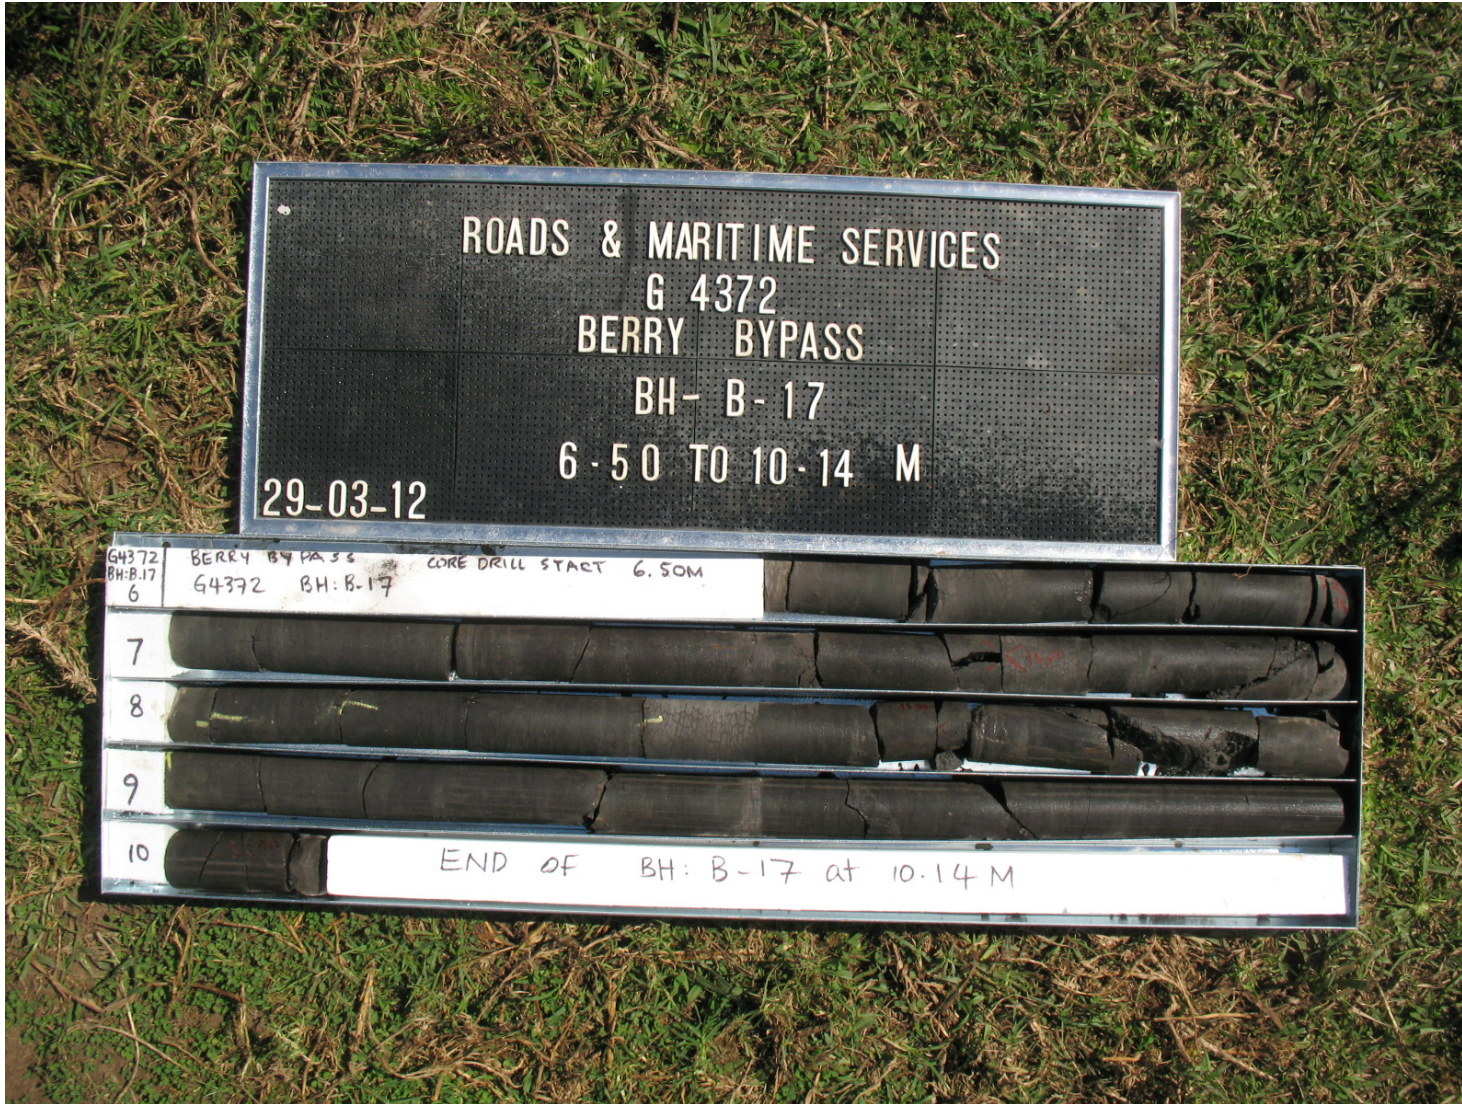
Photo 1 of 1

Geotechnical Investigation
Bore Hole: B17

7.0		SILTY SANDSTONE: dark grey, fine grained, with very thin siltstone laminations, moderately to well cemented	SW to F								
		0% LOSS													
		2% Water LOSS

8.68		9.0							
		0% LOSS	Is(50) d=1.15 a=1.61 MPa	10.0	●	BOREHOLEB17 TERMINATED AT 10.14 m Standpipe Installed		●			
		10.14		10.14							
				11.0

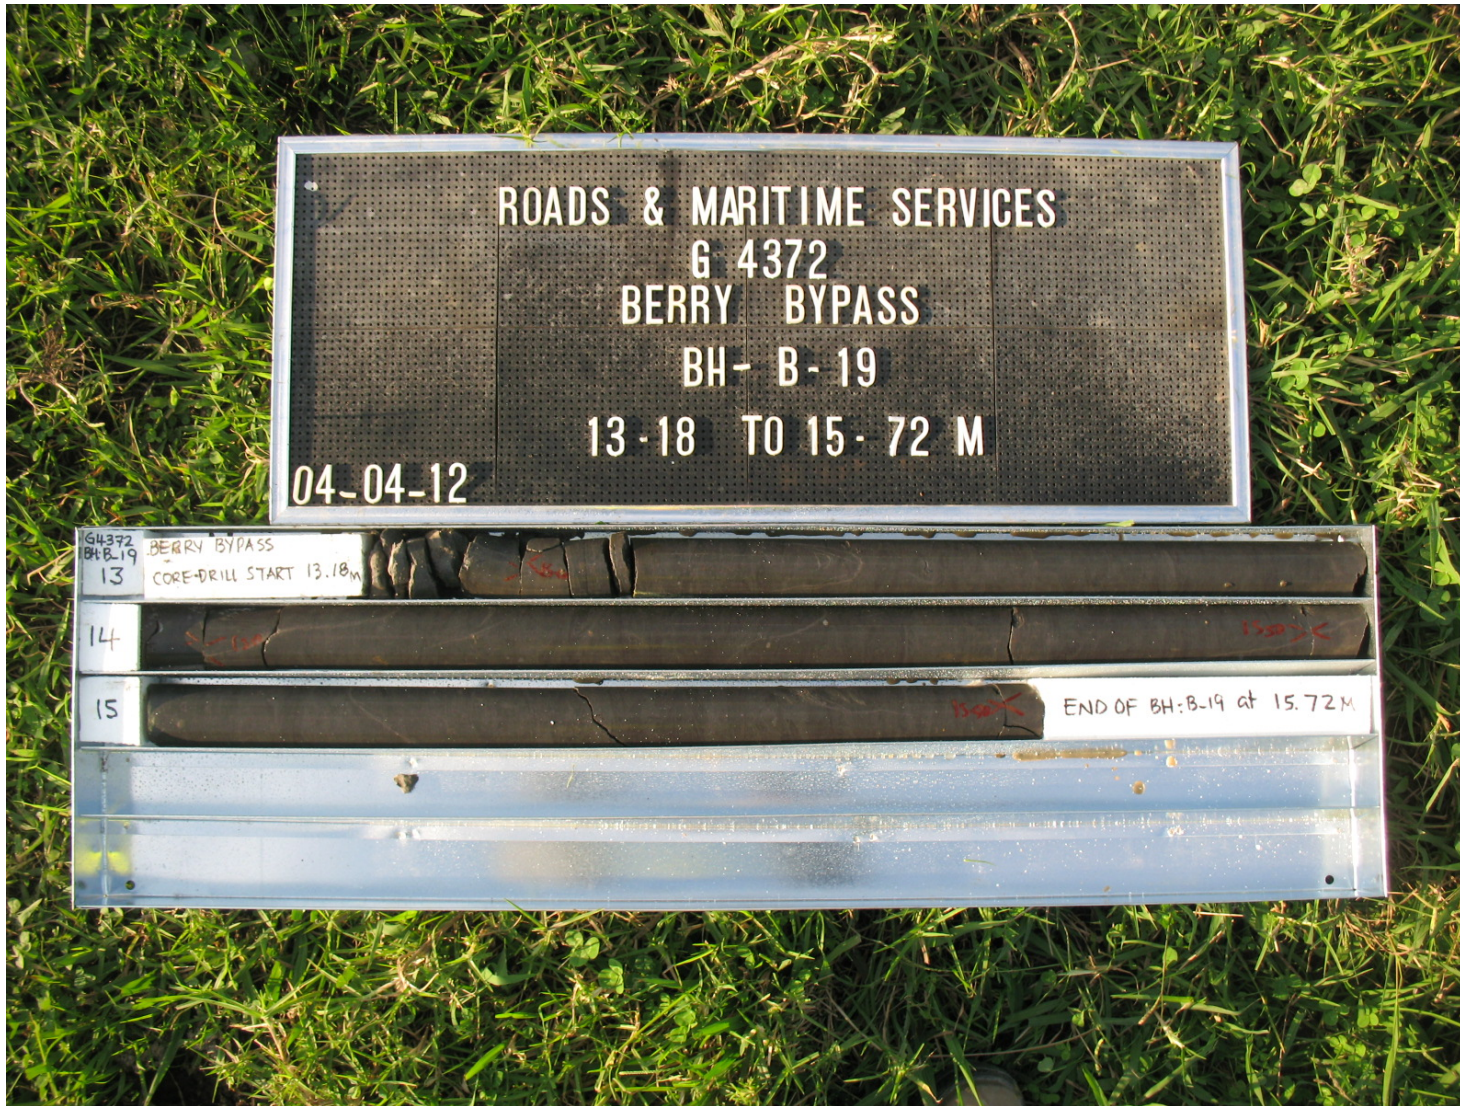
Photo 1 of 1

Geotechnical Investigation
Bore Hole: B19A

8.0							
				9.0							
				10.0							
				11.0							
				12.0							
				13.0							
				13.18		13.18m START CORING AT 13.18m					
				14.0		SILTY SANDSTONE / SANDY SILTSTONE: grey and dark grey, fine grained, layered, thickly bedded, moderately to well cemented, poorly sorted, thin carbonaceous siltstone veneers and laminations at 0°	SW to F

14.70								
			15.0								
				15.72		15.72m					
				16.0		BOREHOLEB19A TERMINATED AT 15.72 m

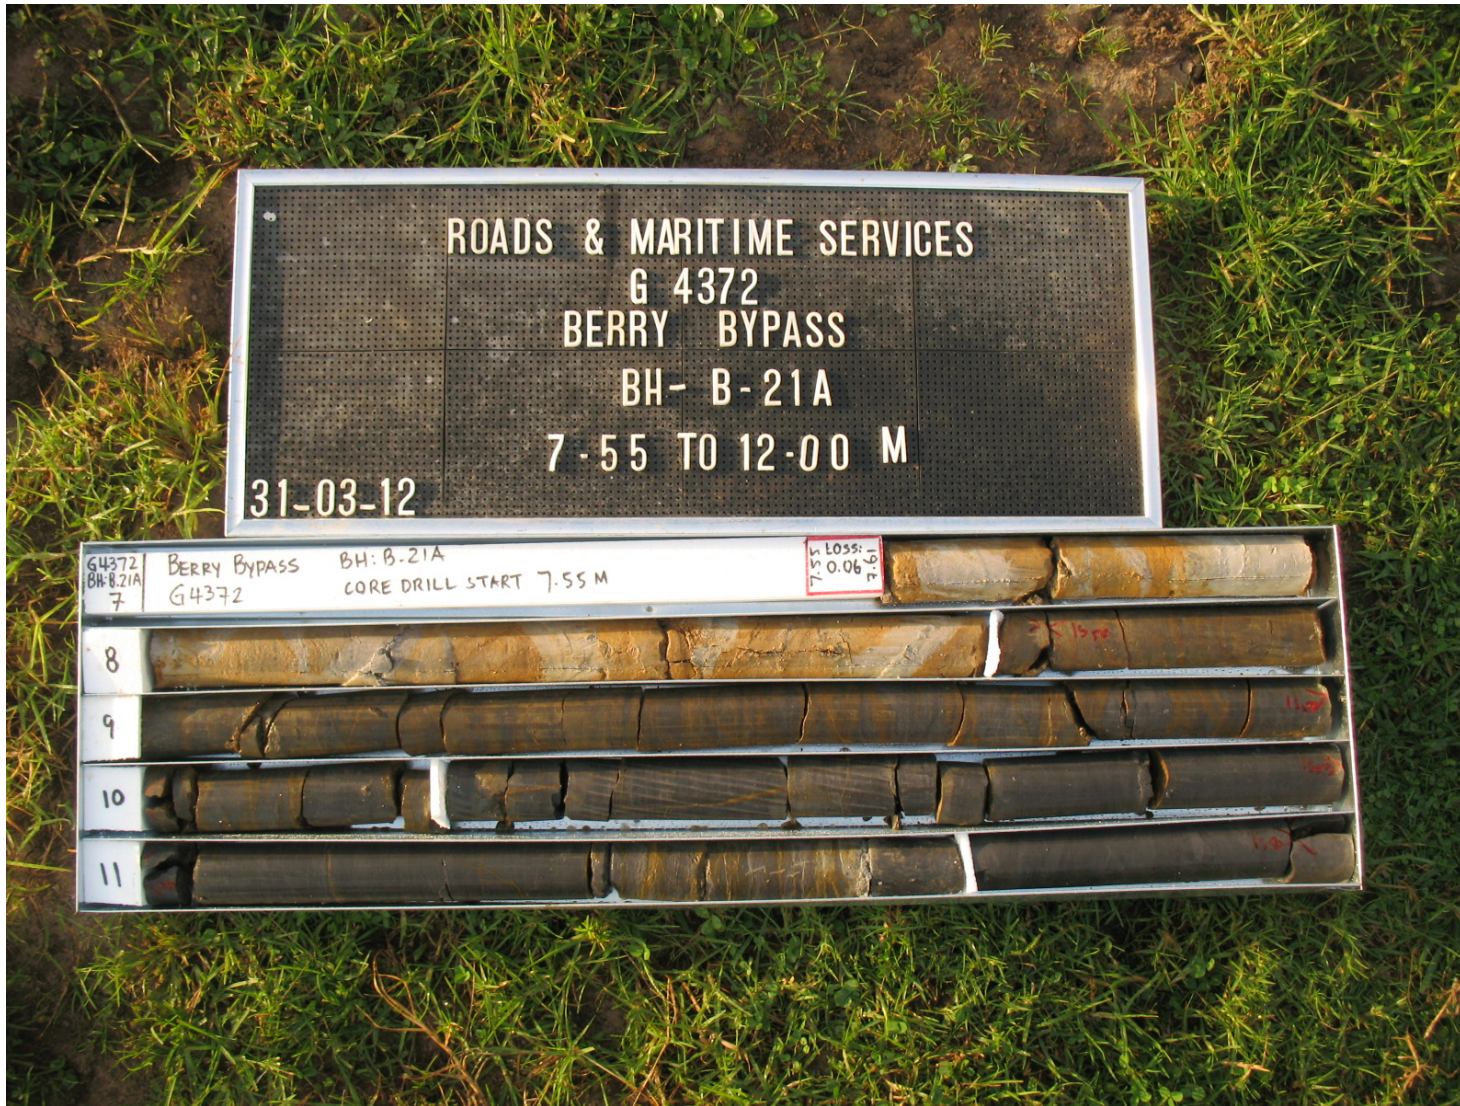
Photo 1 of 2

Geotechnical Investigation
Bore Hole: B21A

7.61		CORE LOSS 0.06m (7.55-7.61)								
				8.00		SANDY SILTSTONE / SILTSTONE: brown and orange brown, occasional clay seams to 100mm	HW	EW	HW					JT 30° Clay IR RF

8.70									
		10.25									
		11.69									
NMLC	0% Water LOSS	0%	Is(50) d=0.71 a=0.84 MPa	10.0	13.05m	SANDY SILTSTONE: dark grey brown and dark grey, fine grained sand, numerous closed joints at 0° - 10°, carbonaceous laminae and veneers throughout	MW to SW

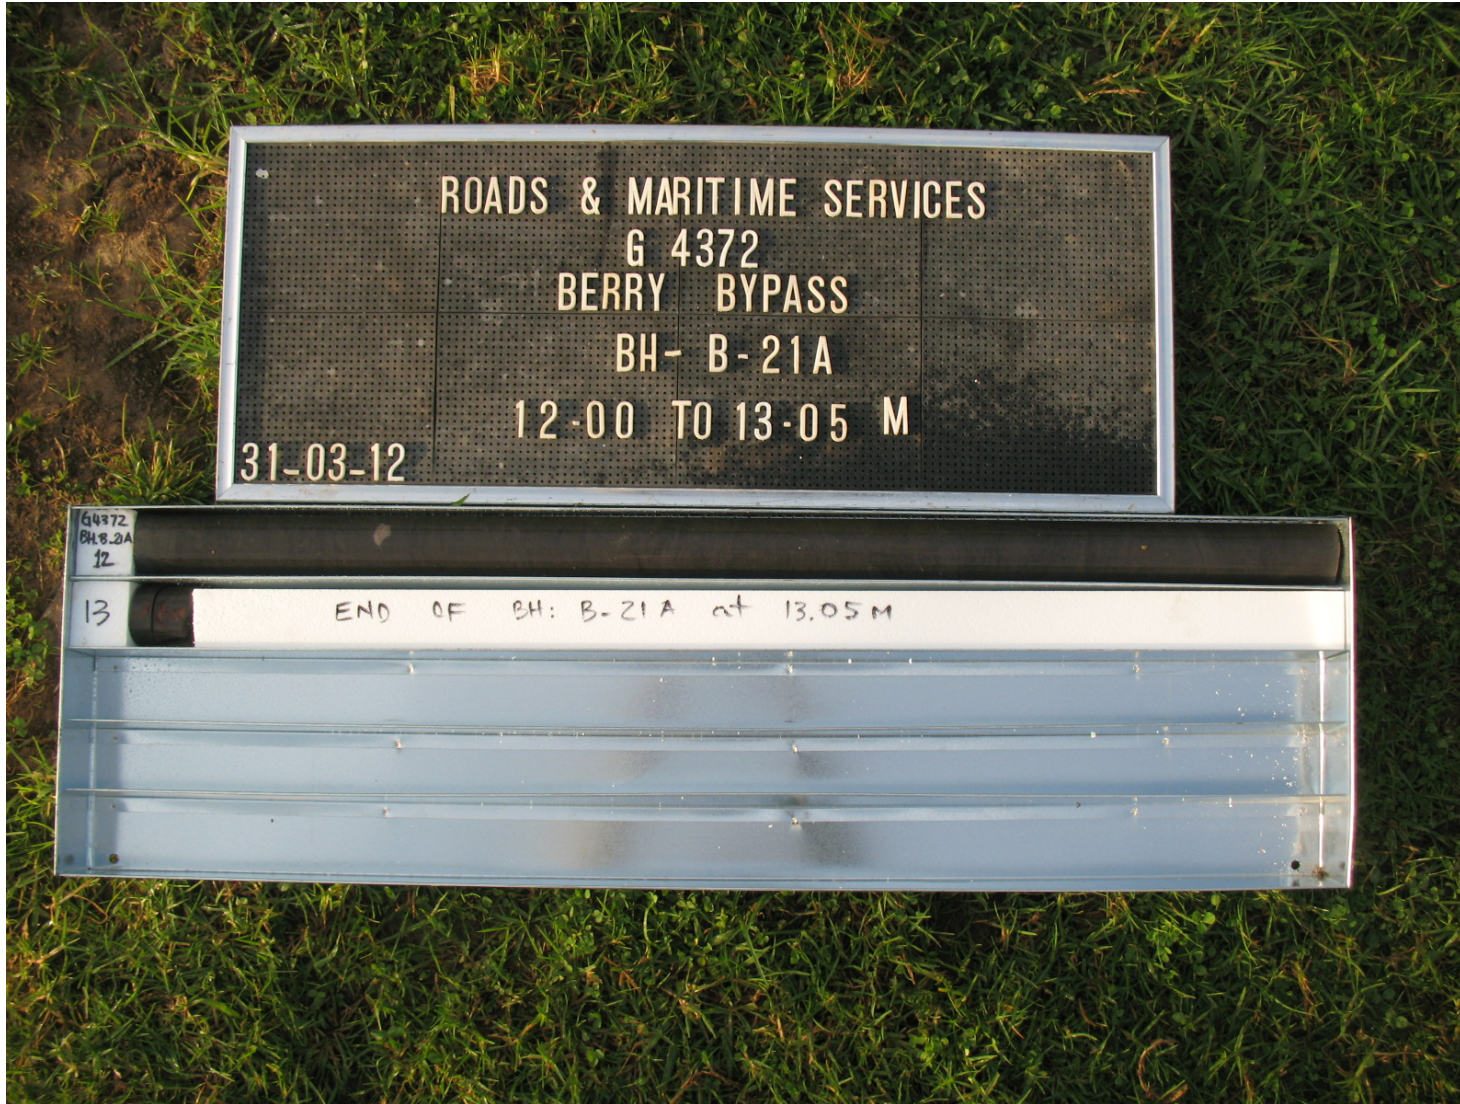
Photo 2 of 2

Geotechnical Investigation
Bore Hole: B21A

11.69									
NMLC	0% Water LOSS	0%	Is(50) d=0.36 a=0.52 MPa	11.0	13.05m	BOREHOLEB21A TERMINATED AT 13.05 m	MW to HW SW to F				
		11.69									
NMLC	0% Water LOSS	0%	Is(50) d=5.39 a=7.53 MPa	12.0	13.05m	BOREHOLEB21A TERMINATED AT 13.05 m
