Geotechnical investigations:

RMS Factual Geotechnical Investigation Report

APPENDIX A
BOREHOLE LOGS AND CORE PHOTOS

G4372
HW 1 - Princes Highway
Berry Bypass

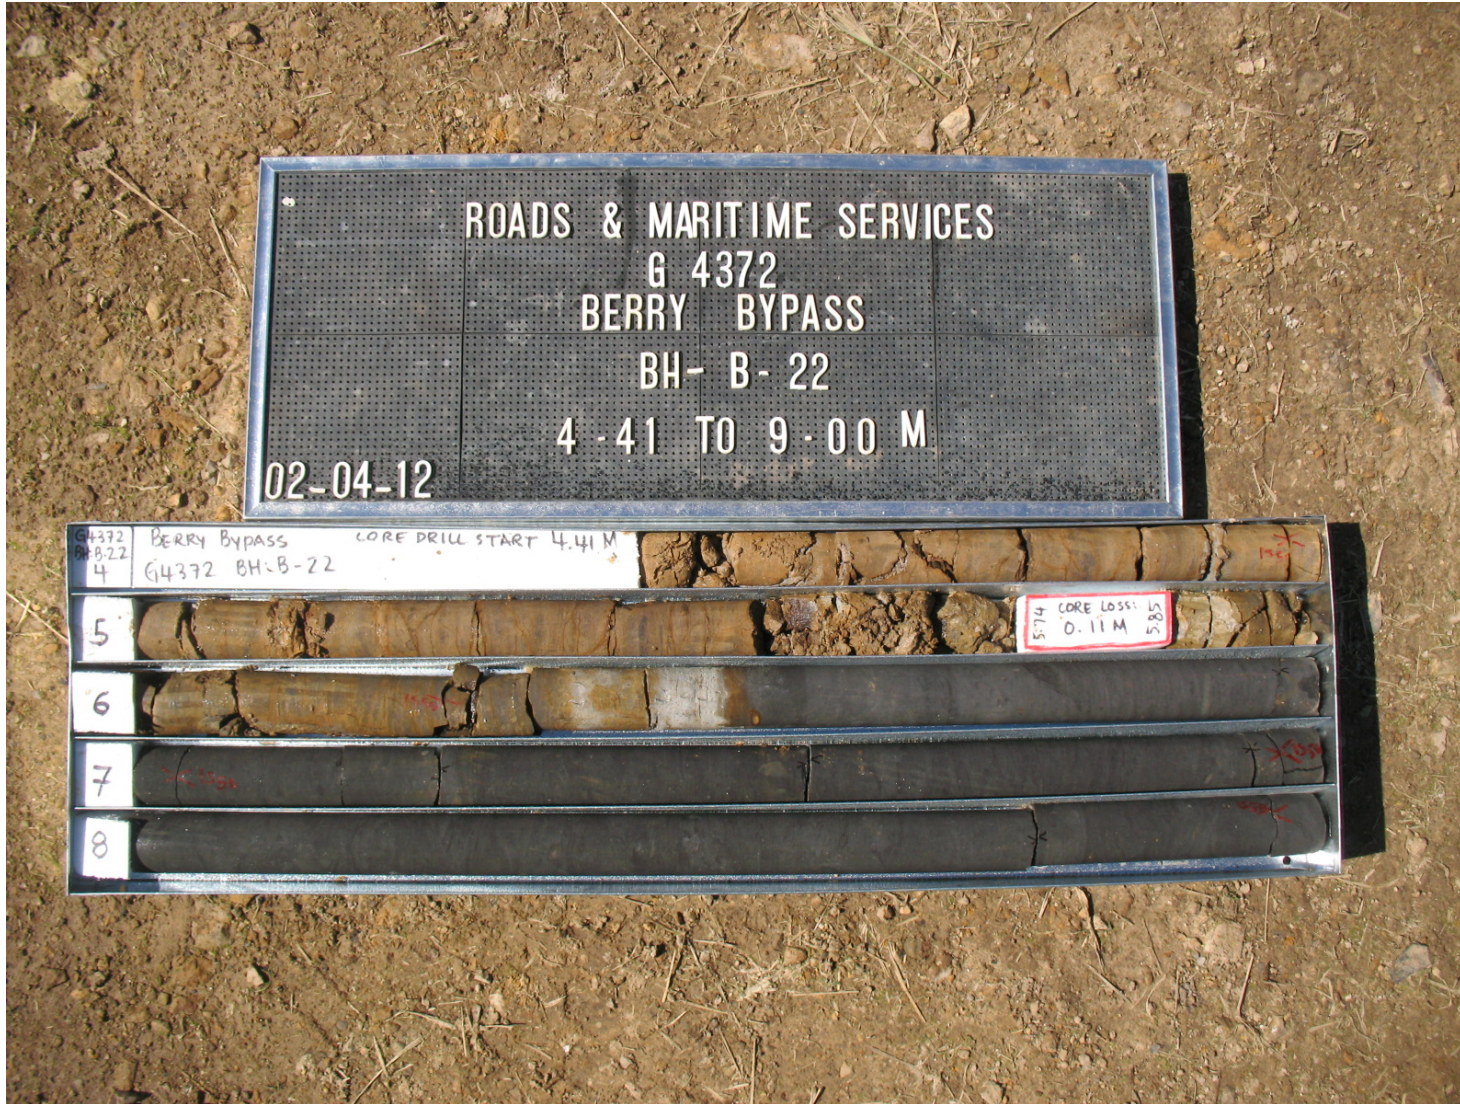
Photo 1 of 2

Geotechnical Investigation
Bore Hole: B22

0.0								
				4.41m		START CORING AT 4.41m						
		0% LOSS		5.0		SILTY SANDSTONE / SANDY SILTSTONE: brown and grey brown, fine grained, numerous iron stained joints and laminations	EW MW to HW					FZDB JT 35° Clay IR RF BP 0° Clay IR RF JT 60 - 50° Fe IR RF BP 0° Fe IR RF BP 0° Fe IR RF BP 0° Fe IR RF BP 5° Clay IR RF JT 0° Fe IR RF BP 10° Fe IR RF BP 0° Fe IR RF BPHB 0° Fe IR RF BPHB 0° Fe IR RF BPHB 5° Fe IR RF FZ DL
		7% LOSS		5.74m			EW					
		0% Water LOSS		5.85m		CORE LOSS 0.11m (5.74-5.85)

6.0		SILTY SANDSTONE / SANDY SILTSTONE: brown and grey brown, fine grained, iron stained throughout	EW MW to HW					SM 0° Clay 70 mm JT 50° Fe IR RF BP 0° Fe IR RF JT 10° Fe IR RF

6.49m			EW					BPHB 0° Fe IR RF SM 0° Clay 20 mm SM 0° Clay 50 mm
		0% LOSS		7.0		SILTY SANDSTONE / SANDY SILTSTONE: grey and dark grey, fine grained, layered, thickly bedded, well cemented, poorly sorted, very thin laminae and veneers throughout	EW SW to F					HB HB DL DL

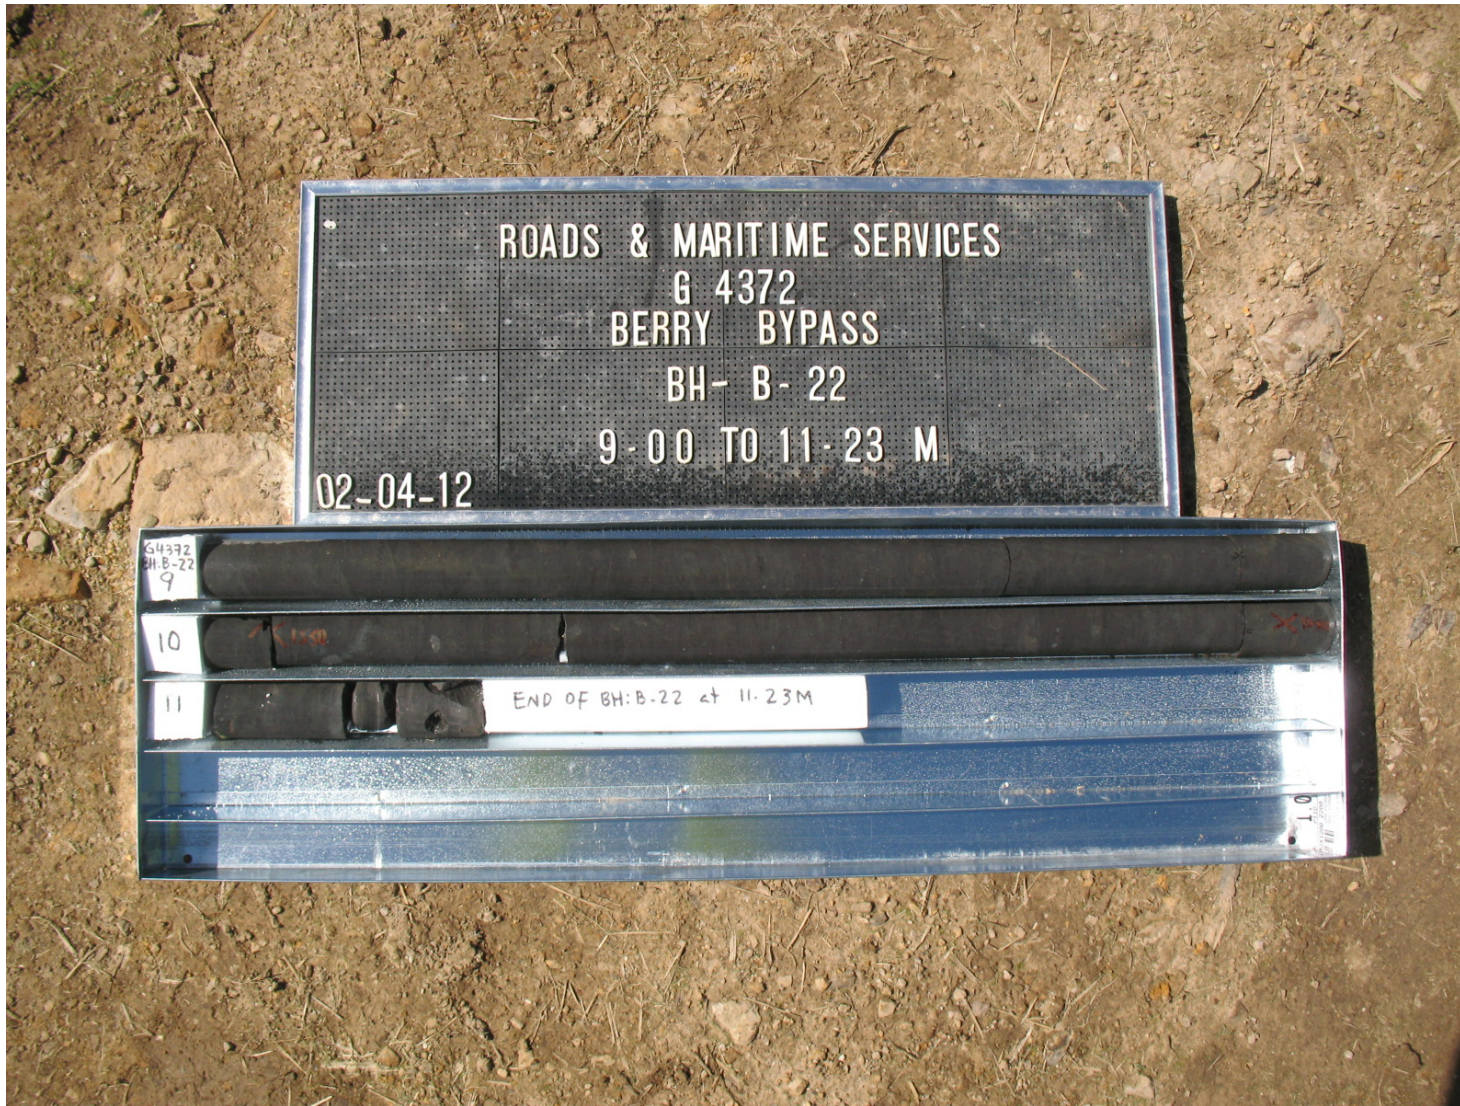
Photo 2 of 2

Geotechnical Investigation
Bore Hole: B22

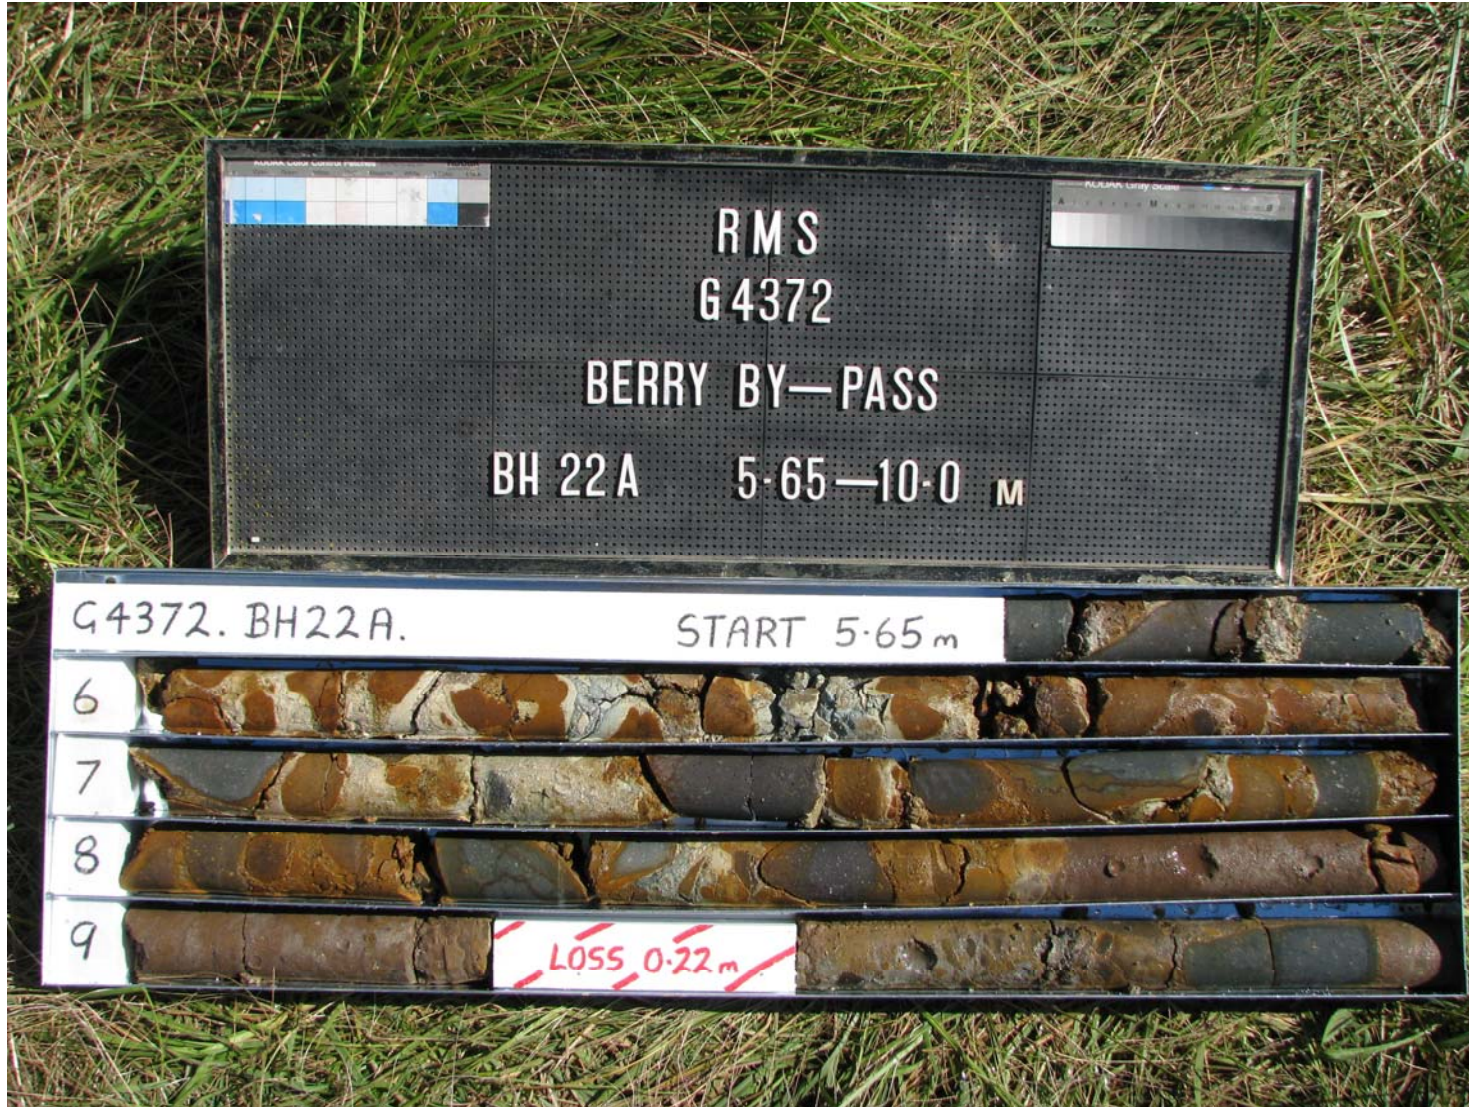
Photo 1 of 3

Geotechnical Investigation
Bore Hole: B22A

BASALT GRAVEL AND COBBLES: grey, pale to dark red brown and off white, low to high plasticity tuffaceous clay matrix. Fine to coarse grained tuffaceous sand. Possible boulders	SW and EW

SW to EW basalt gravel and cobbles in a tuffaceous clay matrix

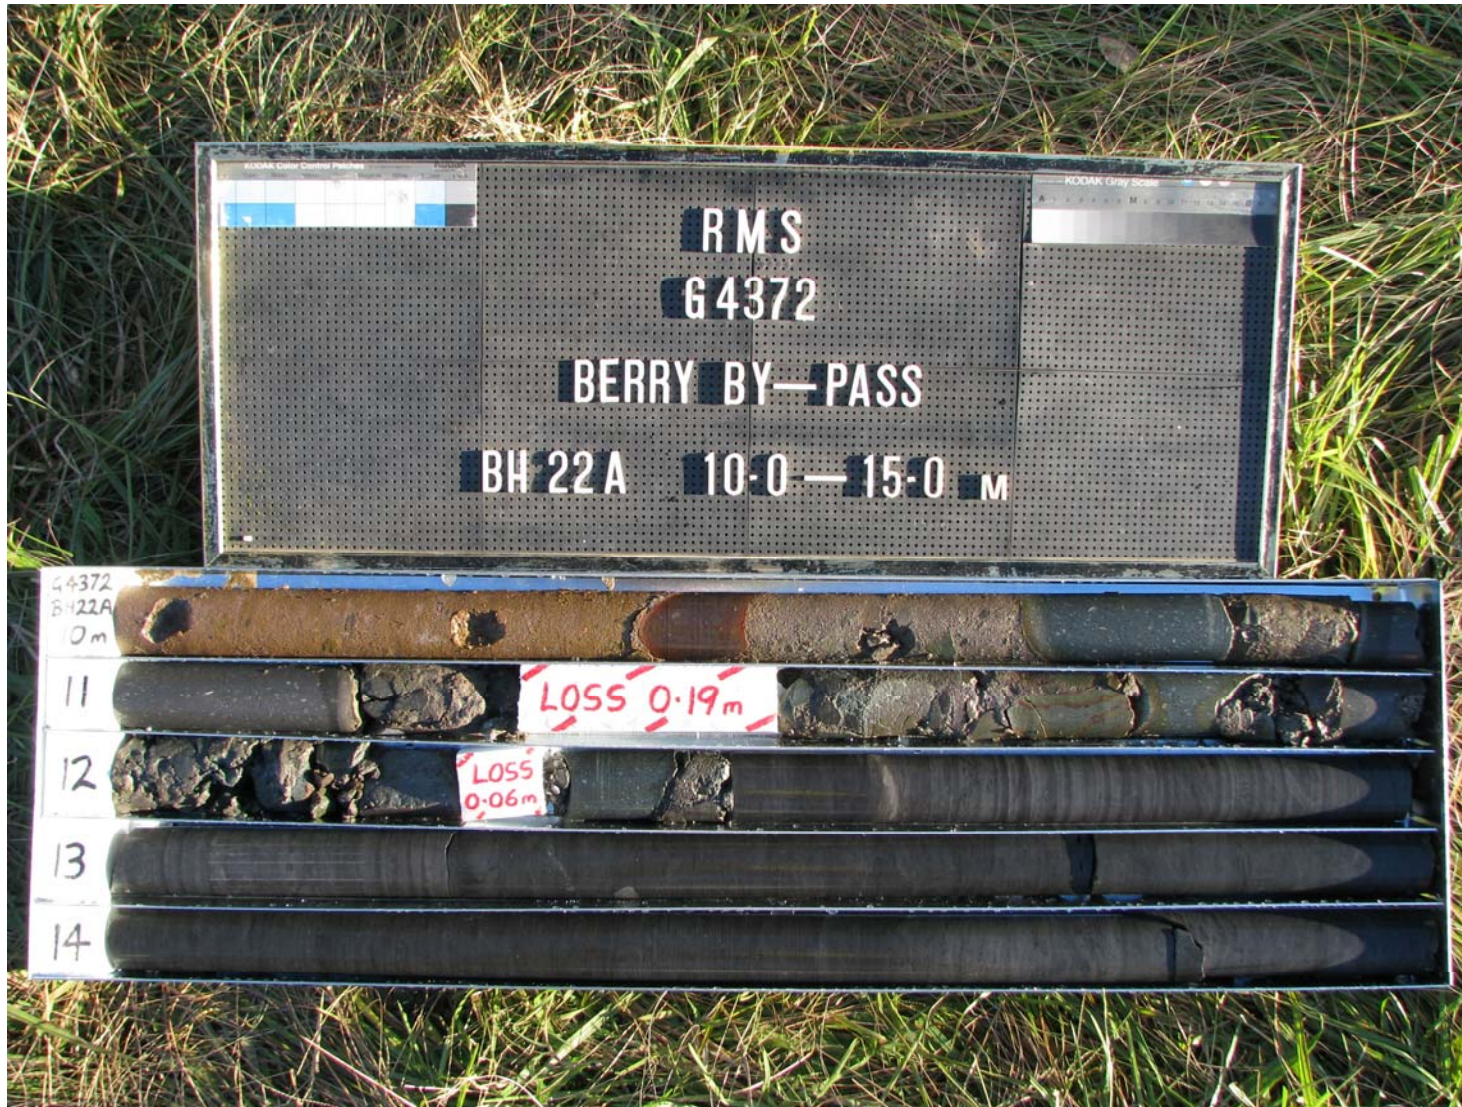
Photo 2 of 3

Geotechnical Investigation
Bore Hole: B22A

8.40							
19% LOSS	8.66m						
	9.0		CLAYEY SAND AND SANDY CLAY: sand is red grey brown, fine to coarse grained sand, trace fine to coarse sandstone and basalt gravel, and charcoal fragments; clay is low with medium plasticity				ALLUVIUM

10.40m						
	11.0		CLAYEY SANDY GRAVEL COBBLES, AND BOULDERS: grey and red grey brown, fine to coarse gravel, rounded to angular, basalt, fine to coarse grained sand, low plasticity clay, very high strength basalt cobbles, and boulders				ALLUVIUM

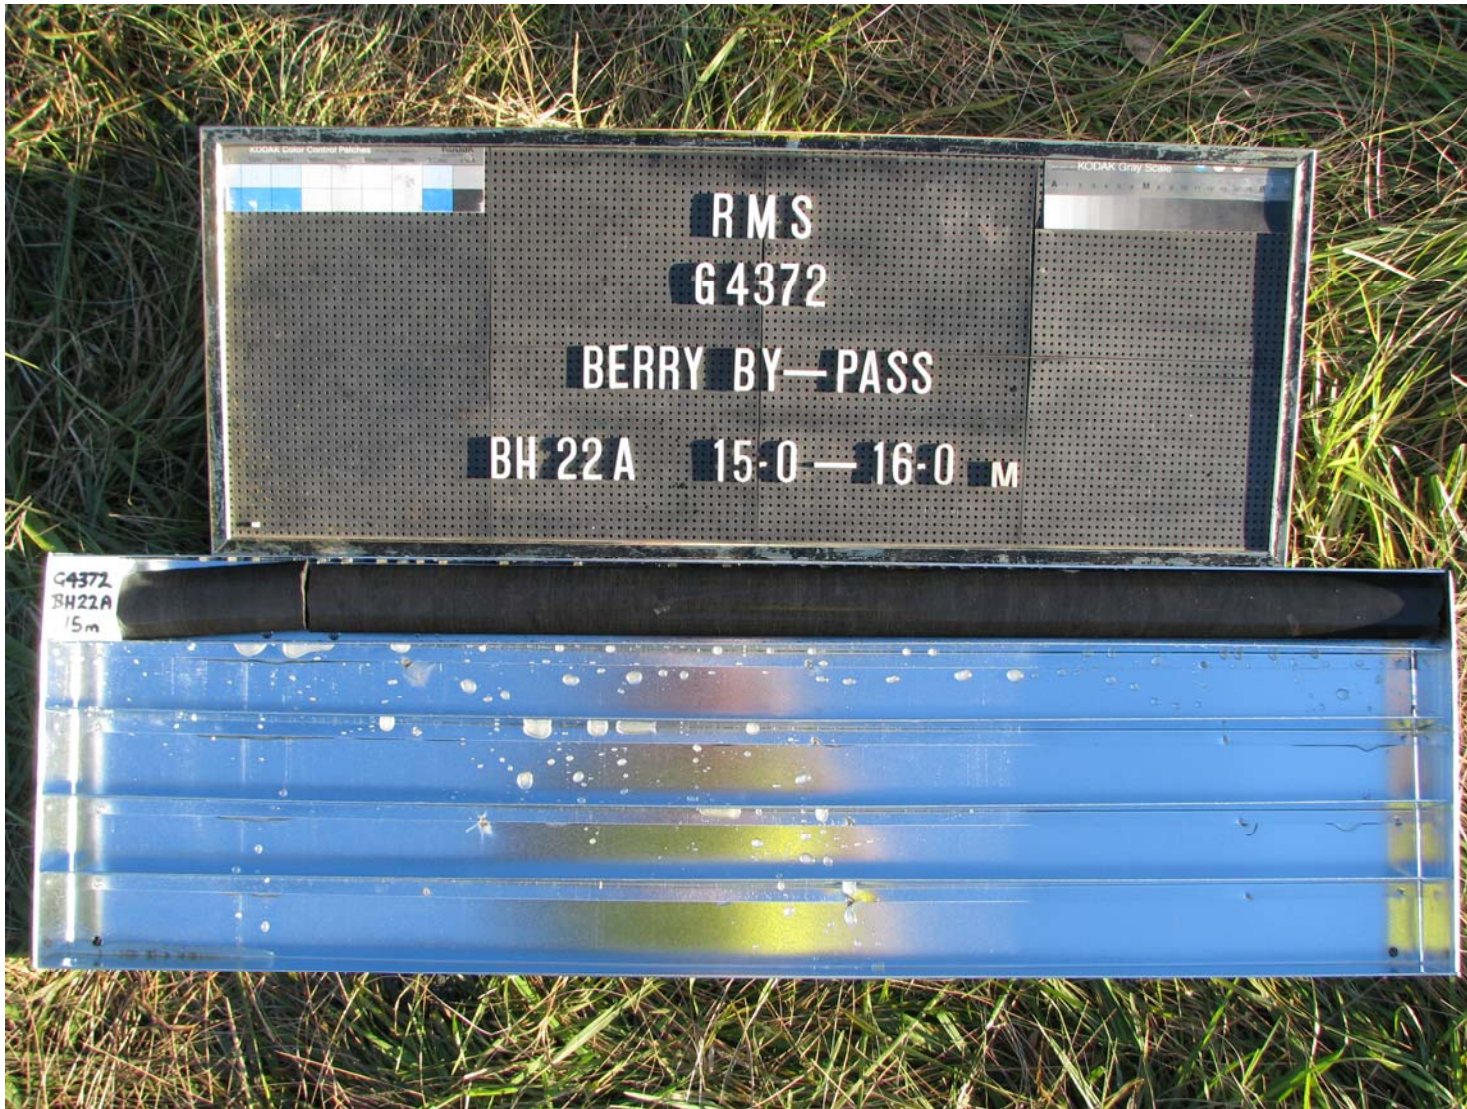
Photo 3 of 3

Geotechnical Investigation
Bore Hole: B22A

13.0		SILTY SANDSTONE AND SANDY SILTSTONE: grey and dark grey, fine grained, layered, current and disturbed bedding at 0° - 15°	F			HB
	13.25						DL
0% LOSS	13.25						DB

14.0		predominantly sandy siltstone with silty sandstone				HB
	15.0		SANDY SILTSTONE: dark grey, layered, current and disturbed bedding at 0° - 15°, fine grained sand with trace medium and coarse grained sand				DB

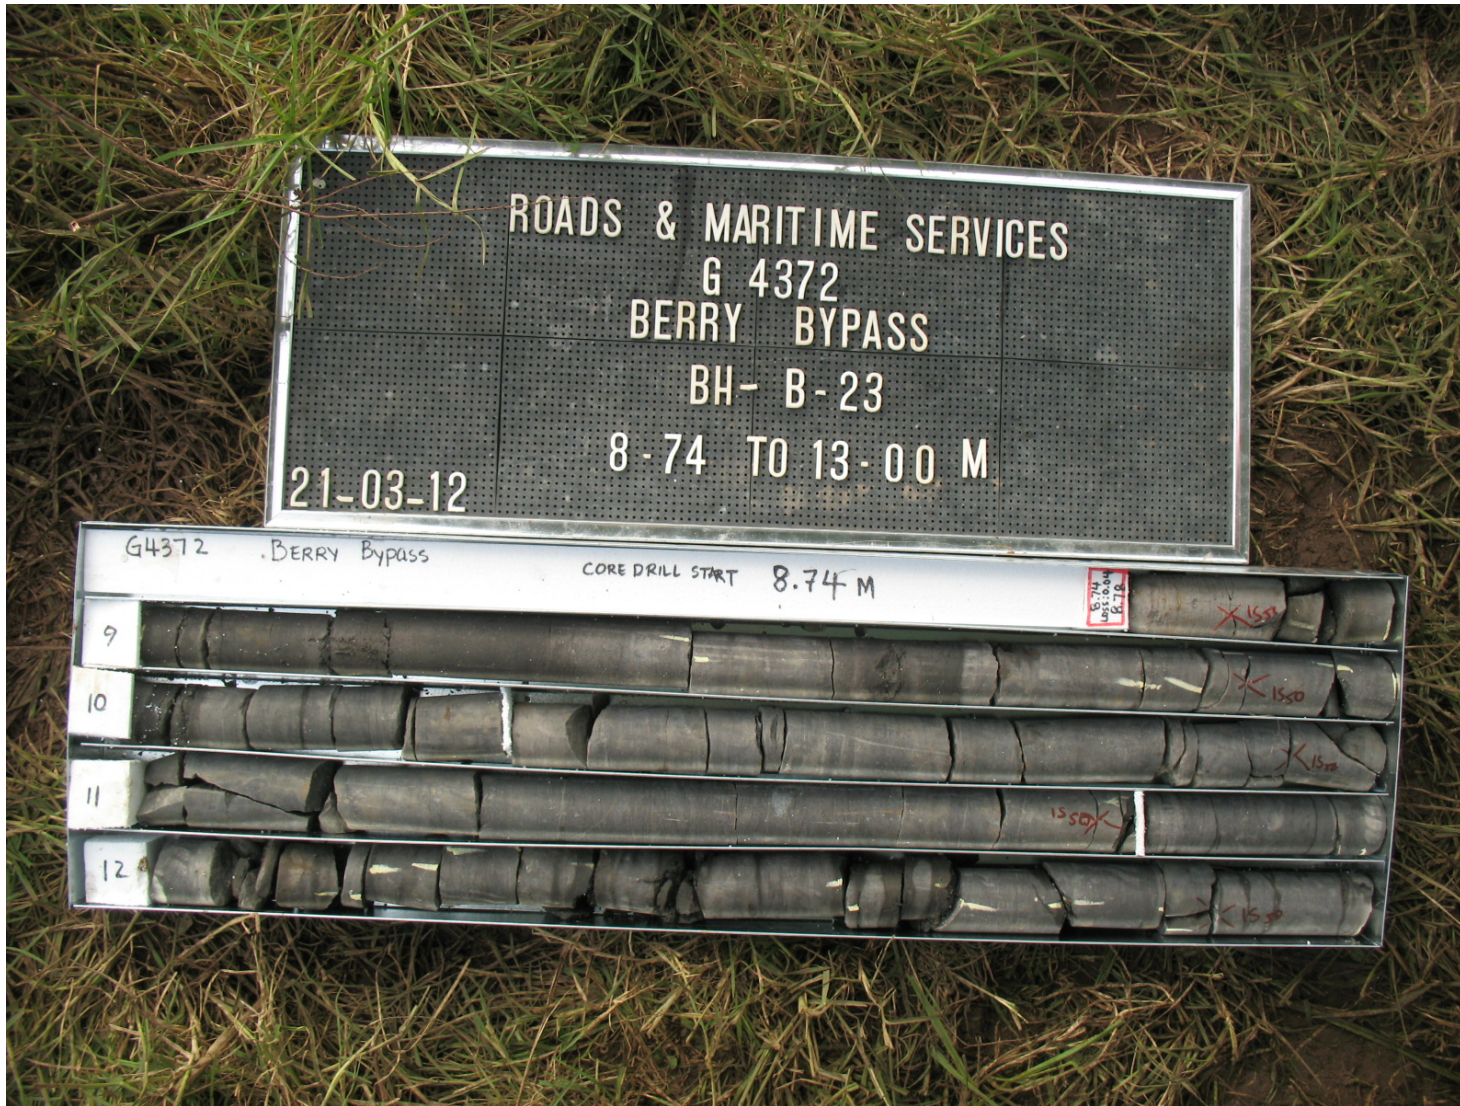
Photo 1 of 2

Geotechnical Investigation
Bore Hole: B23

8.0										
	8.74m		START CORING AT 8.74m								
	8.78m		CORE LOSS 0.04m (8.74-8.78)								
	9.0		SANDY SILTSTONE / SILTY SANDSTONE: dark grey to black, fine grained, very thin laminations 0°-10°. Moderately to well cemented. Poorly sorted. Numerous closed fractures / bedding planes 0°-10°.	MW to SW	●		DB BPDB 0° CN ST RF BP sDB CN IR RF

10.0			MW to SW	●		BP s 0° CN IR RF				
	11.0			SW to F	●		BPDB 0° CN IR RF DB BP 0° CN UN RF BP sDB 0° CN IR RF BP 20° CN IR RF BP sDB 0 - 5° CN IR RF BP 0 - 10° BP s 0 - 10° DBs

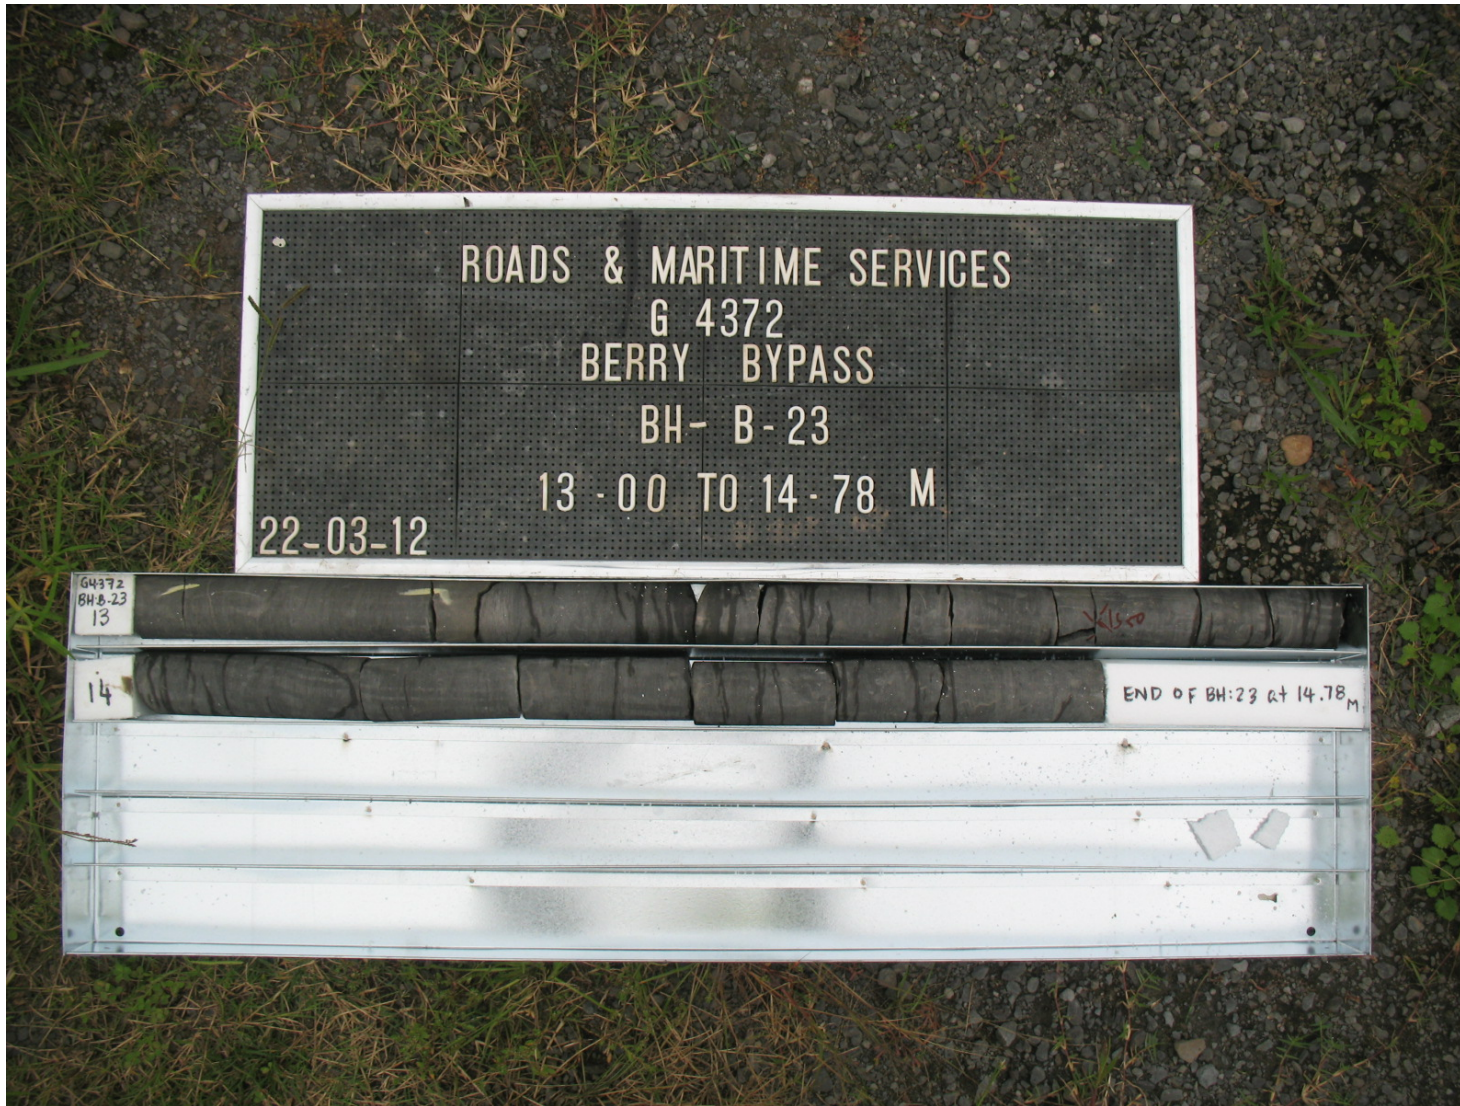
Photo 2 of 2

Geotechnical Investigation
Bore Hole: B23

12.0			MW to SW	●		DBs JT 40° Pyrite IR RF JT 80° Pyrite IR RF DB JT 70° CN DIS RF				
	13.0			MW to SW	●		DB DB DL DB FZs DBs BP 0° CN IR RF BP 0° CN IR RF BP CN IR RF JT 30° CN IR RF JT 20° CN IR RF DB

14.0						DB HB DBs DBs				
	14.78						BP? 5° CN IR RF BPDB 0° MU IR RF BP?DB 5° MU IR RF BPDB 0° MU IR RF DB				
	15.0		BOREHOLEB23 TERMINATED AT 14.78 m

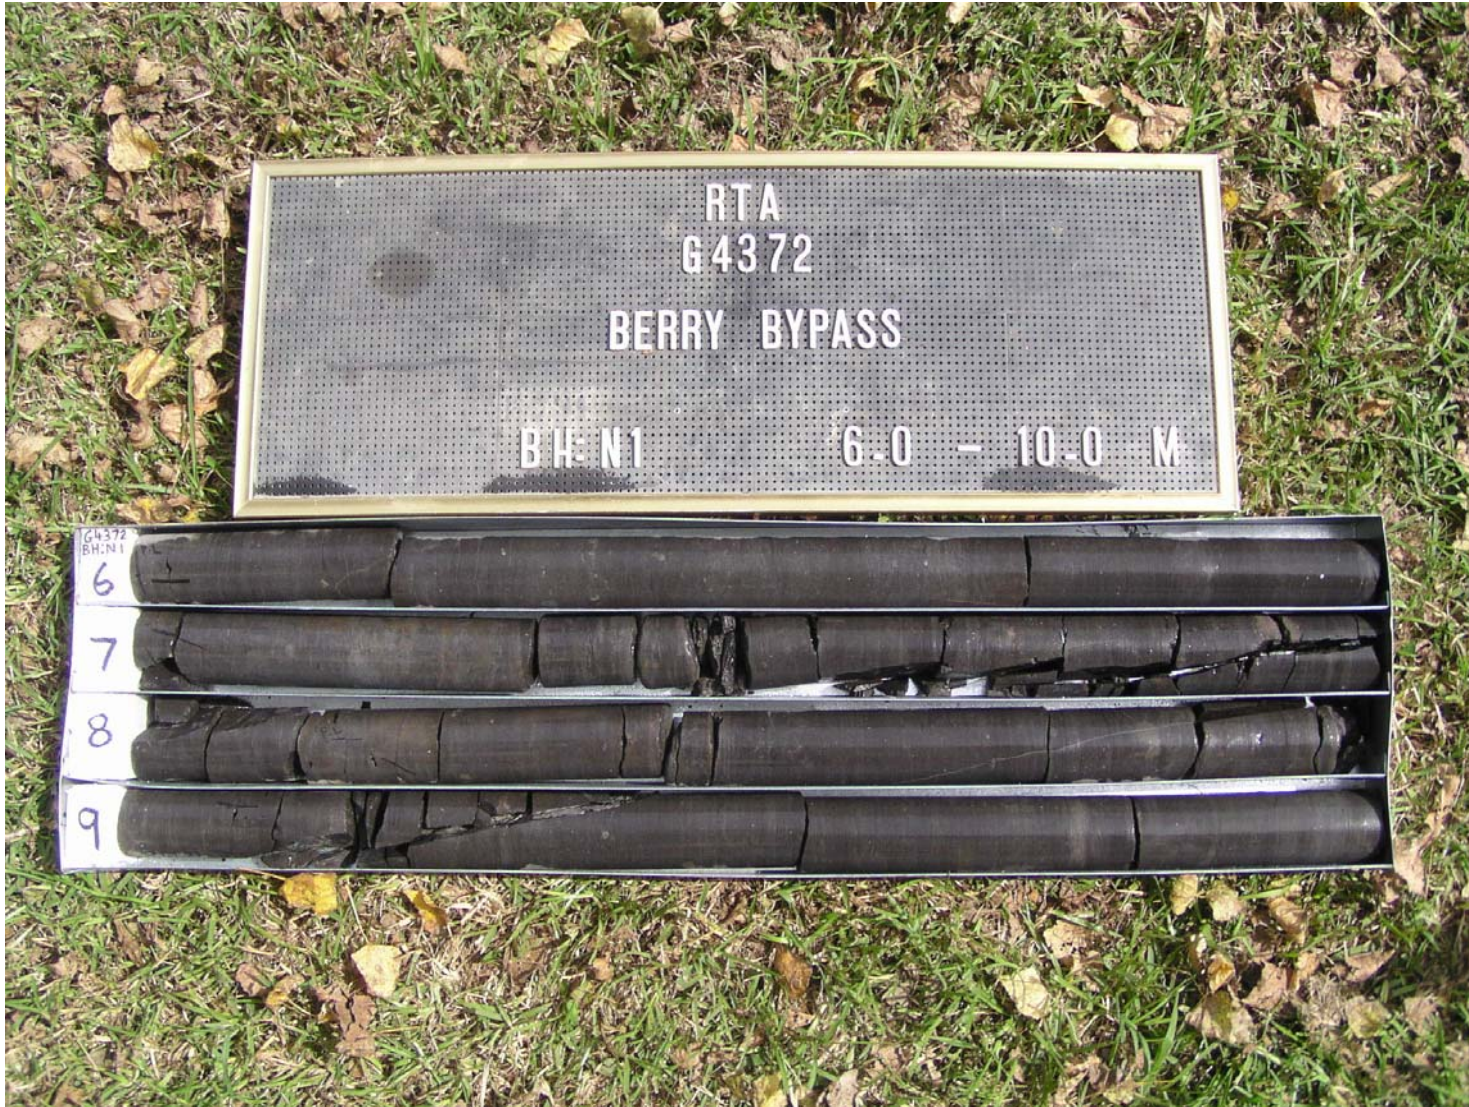
Photo 1 of 1

Geotechnical Investigation
Bore Hole: N1

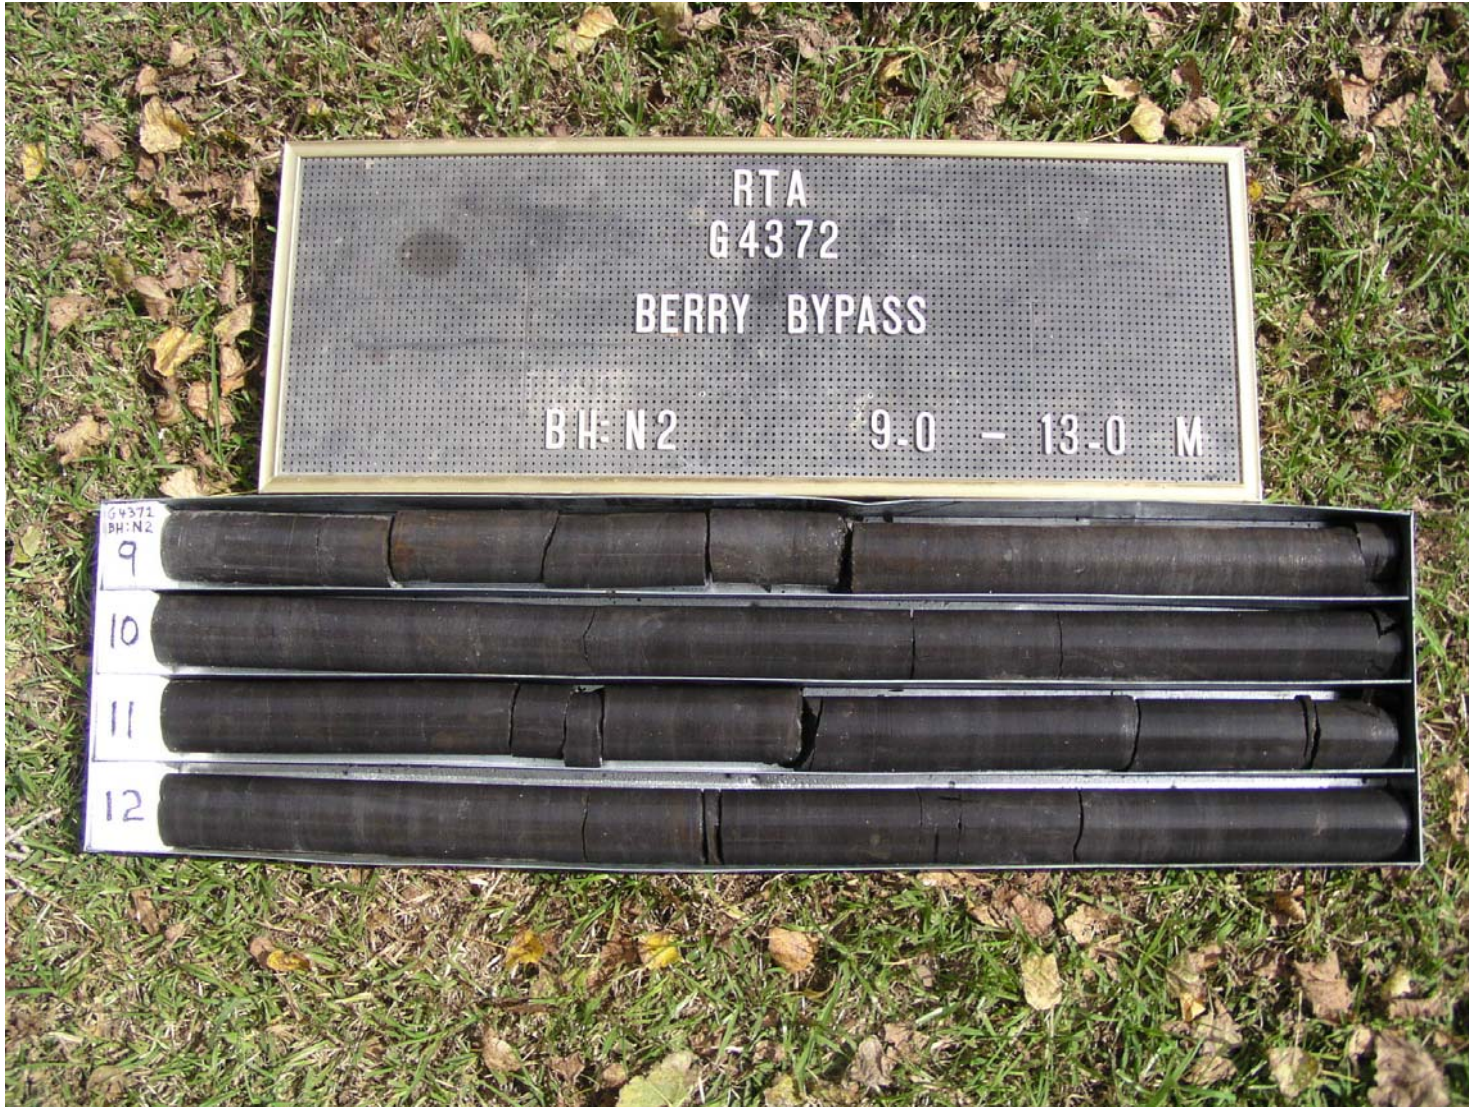
Photo 1 of 1

Geotechnical Investigation
Bore Hole: N2
