Henry Lawson Drive Upgrade Stage 1A

Preliminary Site Investigation

**Transport for New South
Wales**

16 May 2021

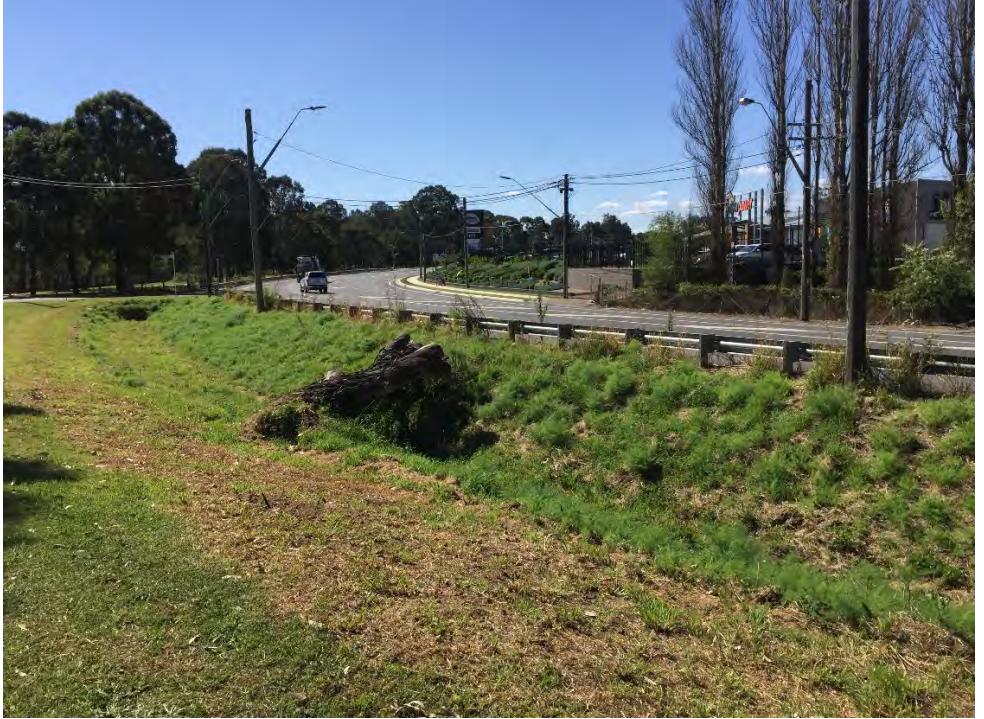
Photo No. 1	Date 28/10/2020	<p>Description</p> <p>South of Raleigh Road, there is a large drainage line running along Henry Lawson Drive on the western side.</p>

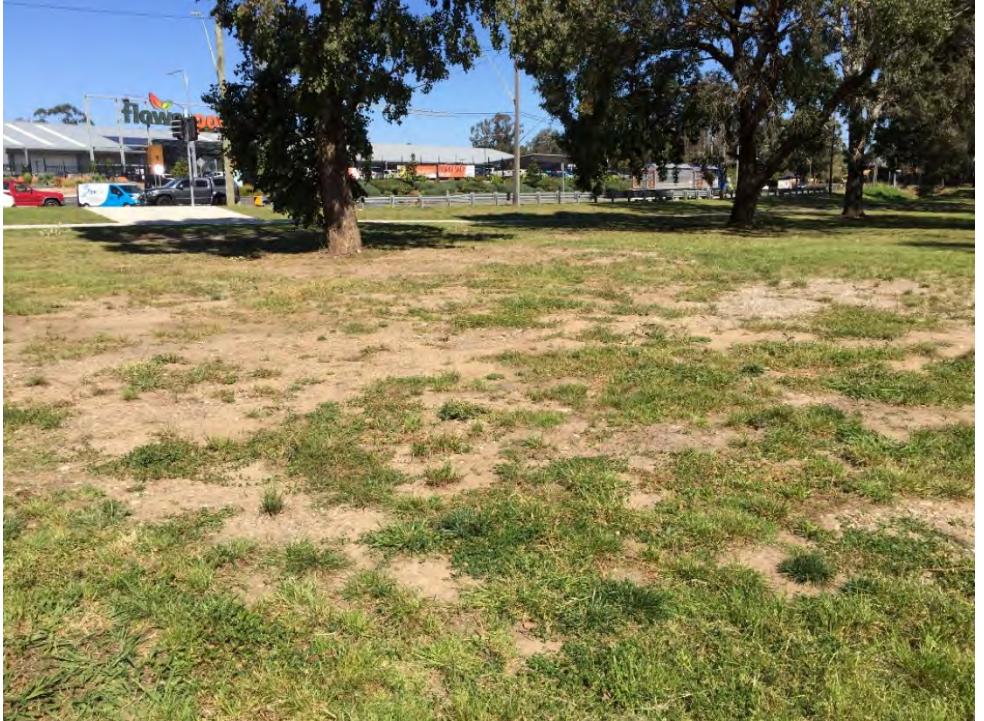
Photo No. 2	Date 28/10/2020	<p>Description</p> <p>Surface conditions near the southern boundary of the study area (south of Keys Parade). Vegetated land (grass covering) with patches of bare earth and some angular to sub angular rocks and gravels.</p>

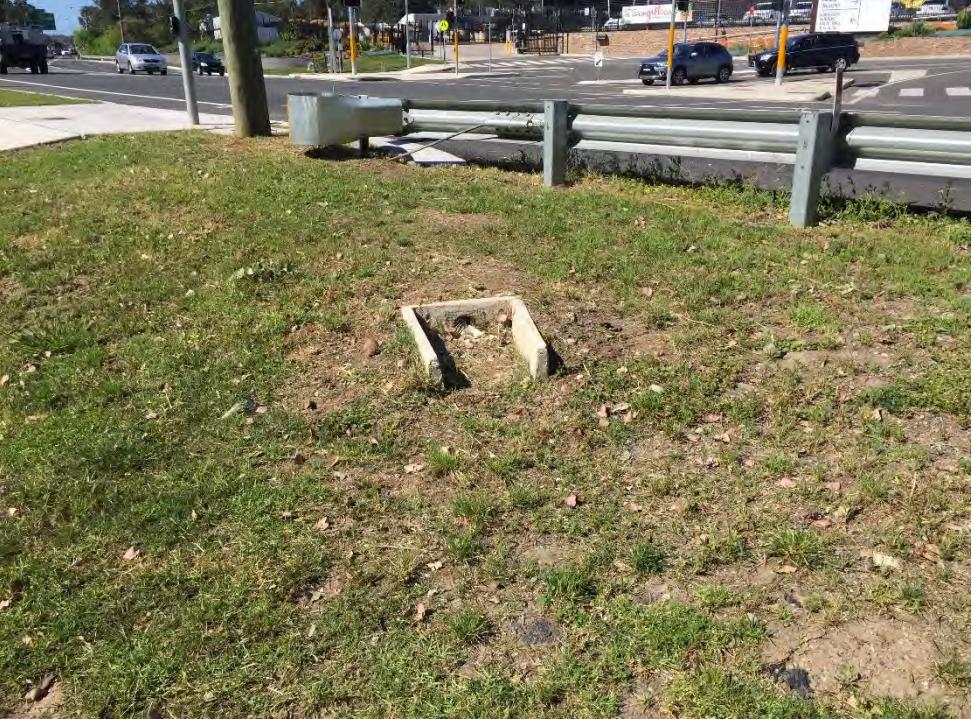
Photo No. 5	Date 28/10/2020	<p>Description</p> <p>At Keys Parade: The site is highly urbanised with numerous artificial drains and gutters along Henry Lawson Drive. Some of these drains lead into the large drainage ditch to the south.</p>

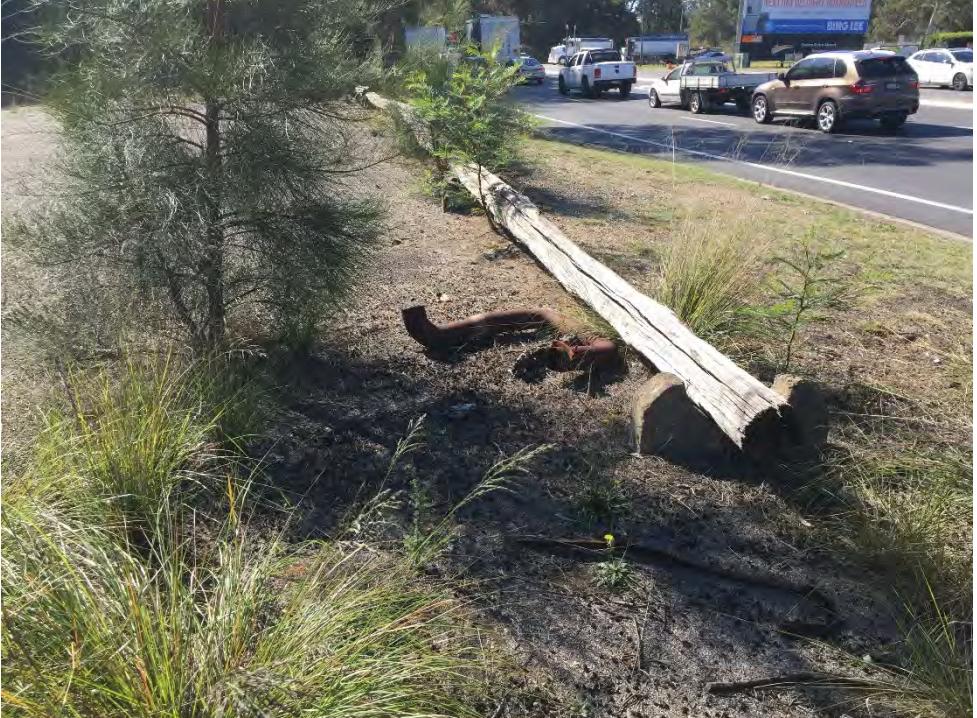
Photo No. 17	Date 28/10/2020	<p>Description</p> <p>Old or damaged car parts were observed dumped in the gated hardstand area adjacent to Henry Lawson Drive opposite the BP Tuckstop. The material consisted of a rusty exhaust pipe, metal poles, a tyre and car seat.</p>

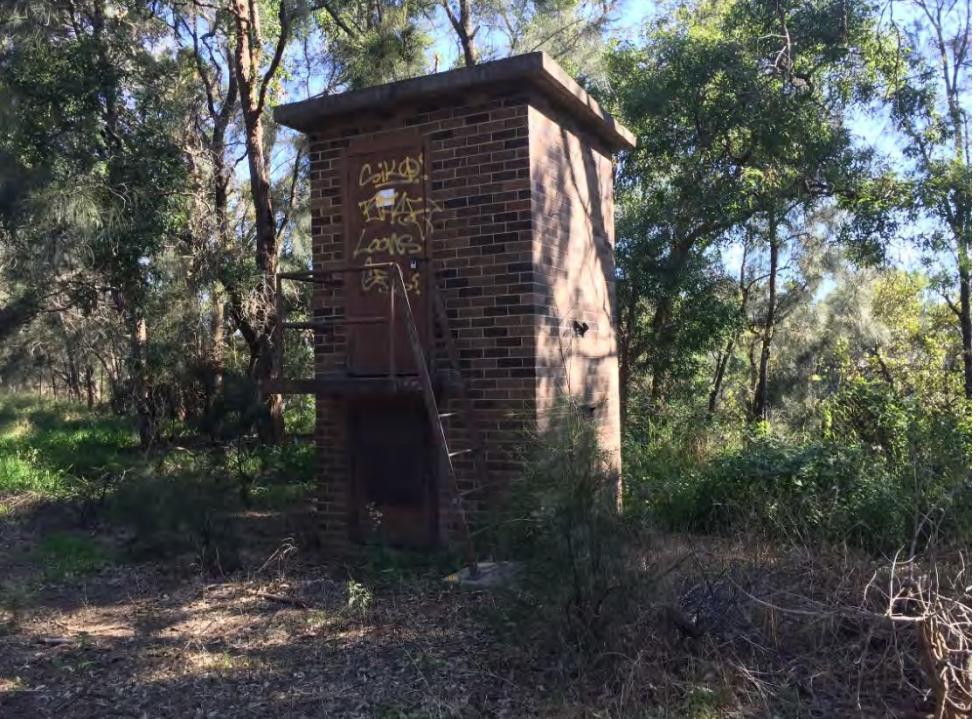
Photo No. 18	Date 28/10/2020	<p>Description</p> <p>An old building with rusty infrastructure is present in the north, adjacent to Georges River. Potential Hazardous Building Material (HBM) due to the age of the building.</p>

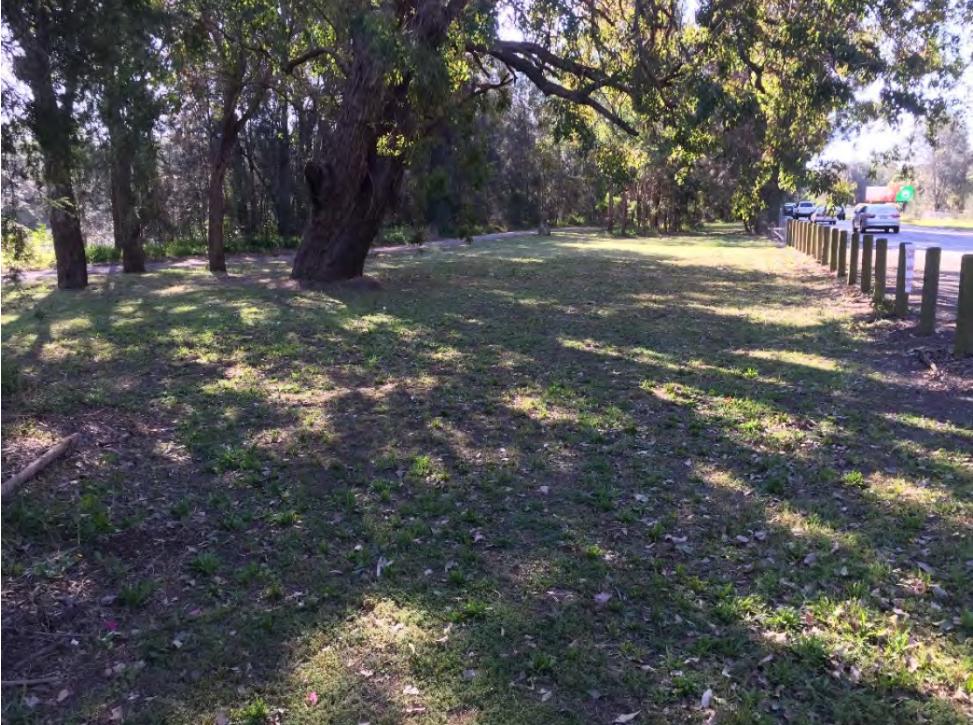
Photo No. 23	Date 28/10/2020

Description Surface conditions near the far north western boundary of the site. Coverage consisted of vegetated land (grass covering) with patches of bare earth and general rubbish. There were some rocks and gravels observed on the surface

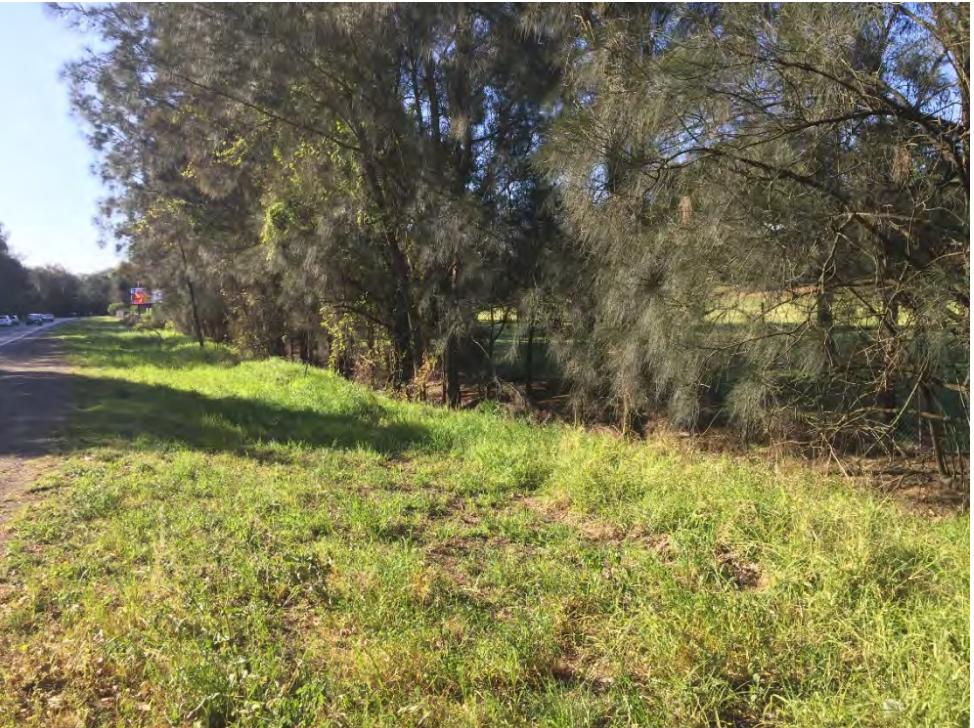
Photo No. 24	Date 28/10/2020

Description North of Tower Road. There is a slight to moderate gradient falling from Henry Lawson Drive towards a drainage line along the Georges River Golf Course.

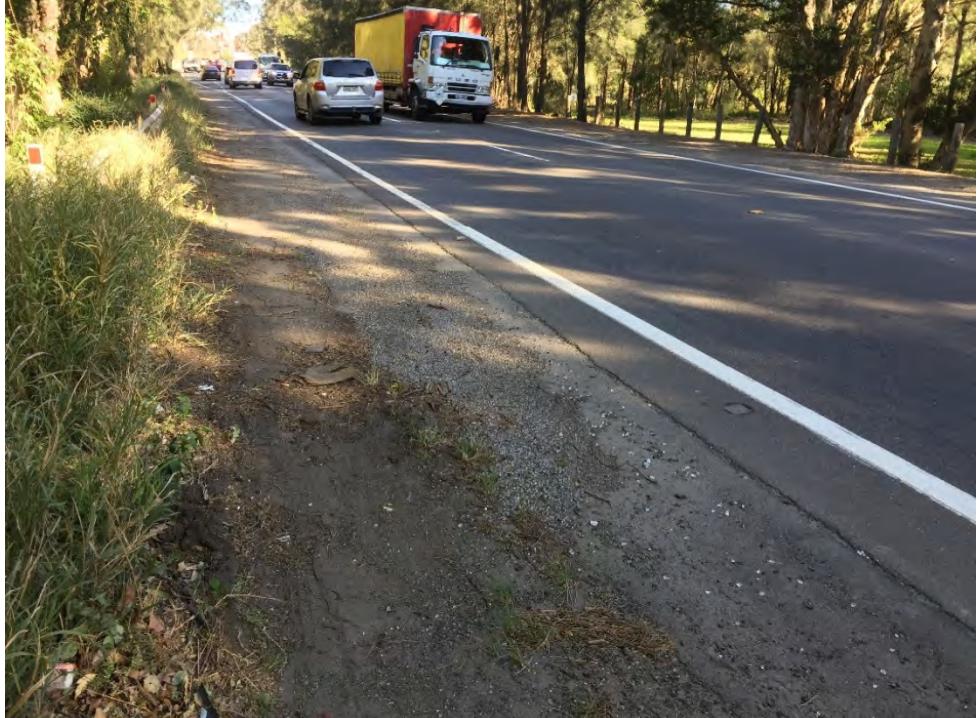
Photo No. 25	Date 28/10/2020

Description There is a lot of broken glass adjacent to Henry Lawson Drive near the northern boundary of the site. This could potentially be from vehicle accidents and wreckage, which could cause contamination from leaking of car fluids (fuel, lubricant and coolant).

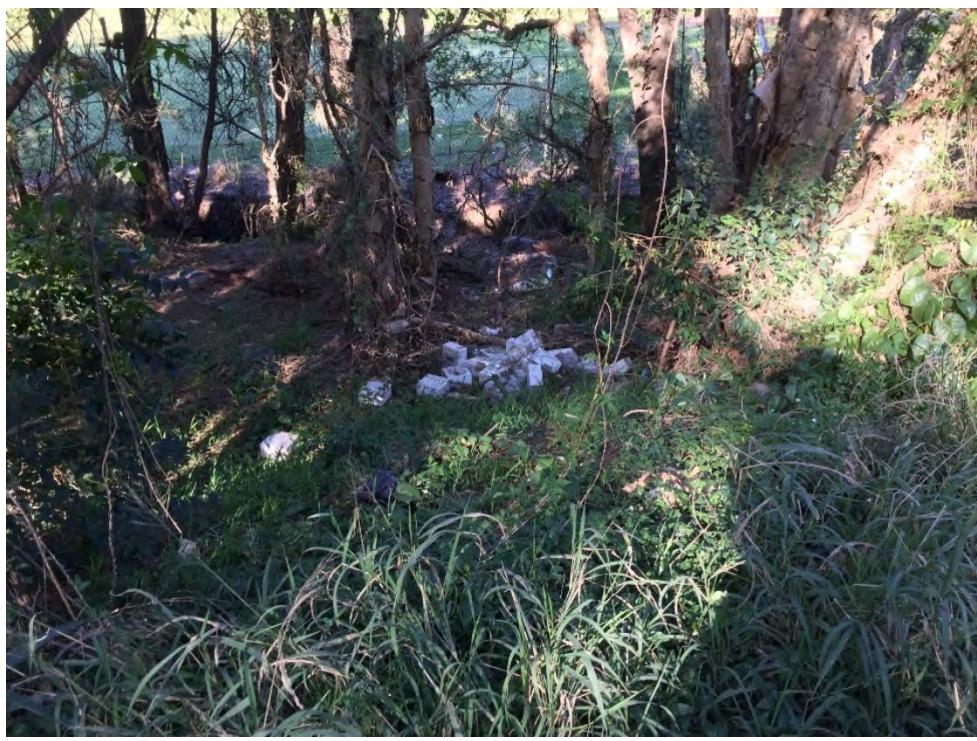
Photo No. 26	Date 28/10/2020

Description Significant amounts of general rubbish were observed along Henry Lawson Drive, adjacent to the Georges River Golf Course.

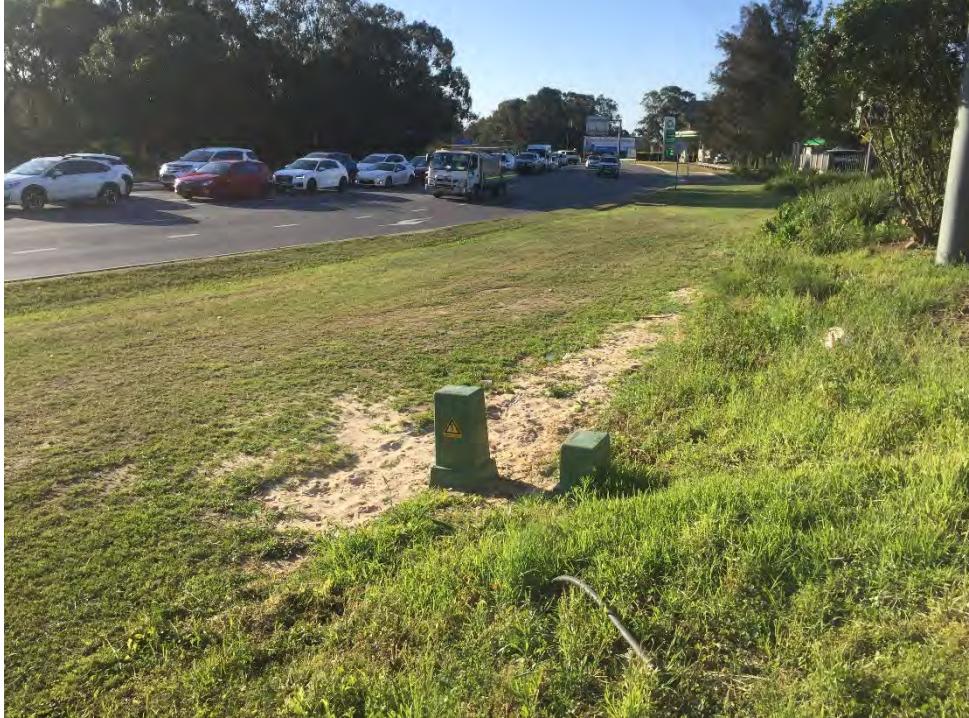
Photo No. 31	Date 28/10/2020

Description Small to moderate patches of sand were observed along the base of the mound.

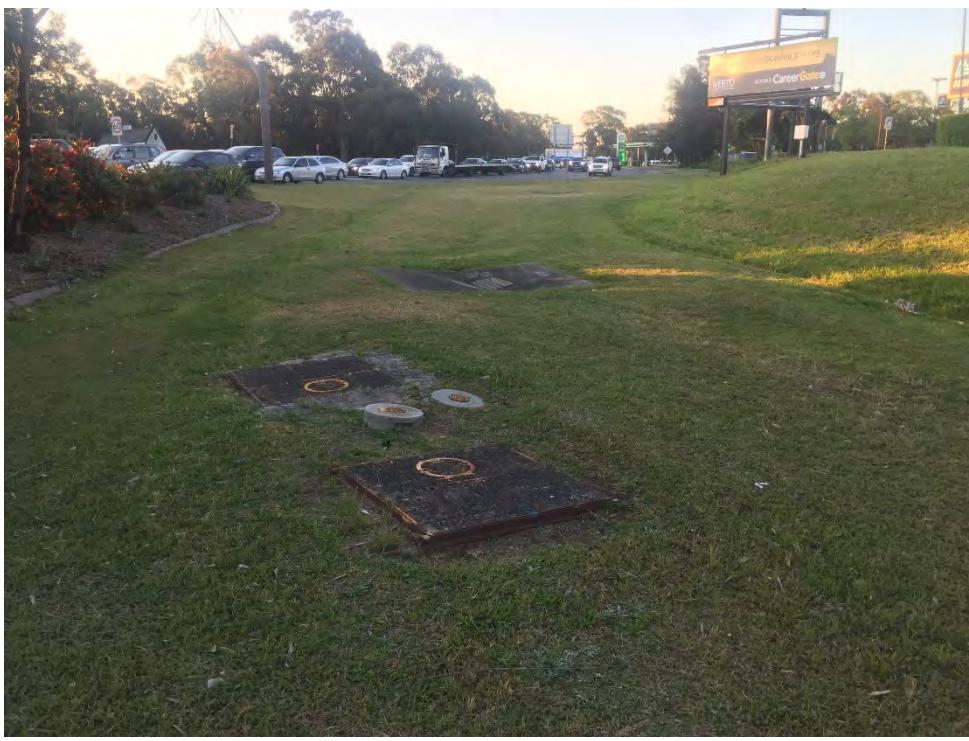
Photo No. 32	Date 28/10/2020

Description There were two large artificial drains with accompanying infrastructure adjacent to the mound and business park, located at the intersection of Henry Lawson Drive and Milperra Road.

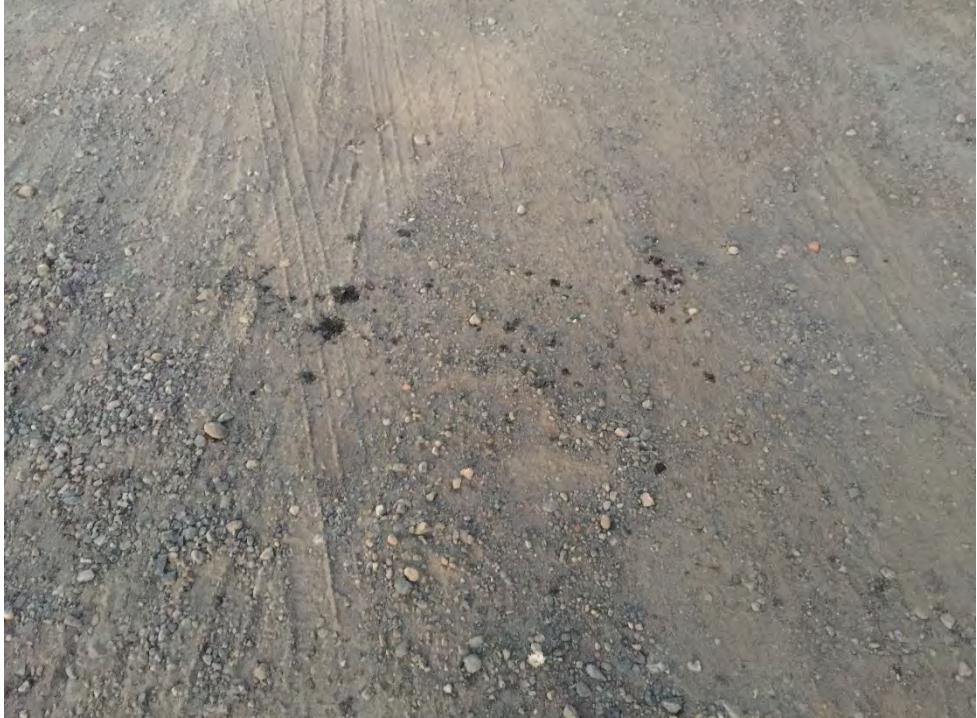
Photo No. 39	Date 28/10/2020

- There were multiple areas of cleared non-vegetated gravelly land along Henry Lawson Drive and Milperra Road, which were potentially used for informal parking, temporary stopping, storage and dumping of old/damaged car parts. These areas could be minor potential sources of contamination due to the leaking of car fluid (fuel, oil, lubricant and coolant). Surface covering consisted of mostly angular to subangular rocks and gravels (refer Photograph 6, 16, 36 and 38). Some of these small areas located south along Henry Lawson Drive, could be potential sources of contamination due to signs of chemical staining (refer Photograph 39 and 40).

Description Potential chemical staining from vehicles adjacent to Henry Lawson Drive.

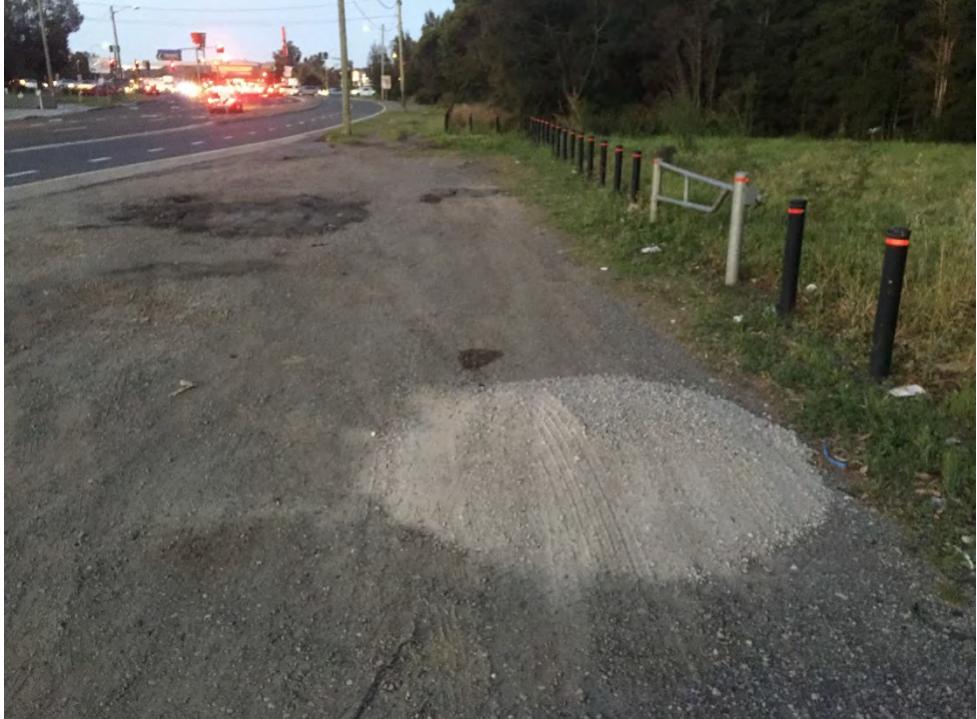
Photo No. 40	Date 28/10/2020

- Aurecon noted evidence of fill across the site, angular to sub angular rocks, pebbles and gravels were observed on the ground surface and within the soil (refer Photographs 6, 8, 13, 16, and 40)

- There was a small stockpile of potential fill with angular to sub angular rocks and gravels observed in a cleared area to the south adjacent to Henry Lawson Drive (refer Photograph 40)

Description There were signs of uncontrolled fill near the south eastern boundary of the site. South of Milperra Road on the eastern side of Henry Lawson Drive A small patch of dumped asphalt and a stockpile of material with angular to subangular rocks and gravels were present. There are also obvious patches of chemical staining adjacent to the stockpile and asphalt, which could contaminate the surrounding environment.

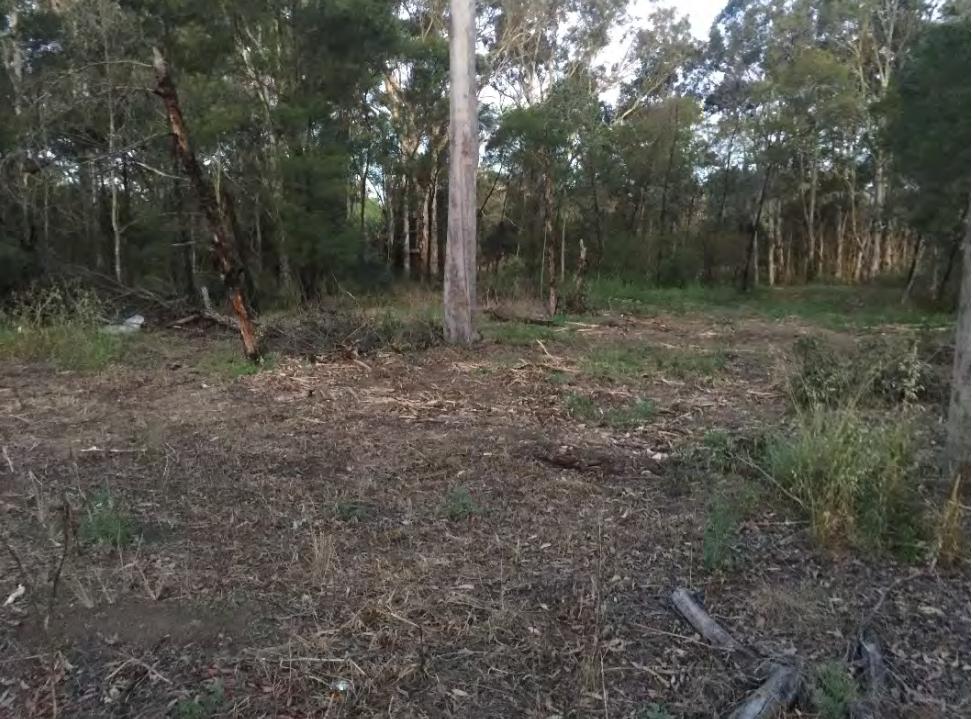
Photo No. 41	Date 28/10/2020	Description Surface conditions in the south eastern portion of the site, north of Auld Avenue. Coverage consisted of vegetated land (grass and leaf covering) with patches of bare earth and rock and gravels.
