# ENVIRONMENTAL SITE ASSESSMENT

MEMORIAL AVENUE UPGRADE

## PHASE 1 ENVIRONMENTAL SITE ASSESSMENT

### Memorial Avenue Upgrade

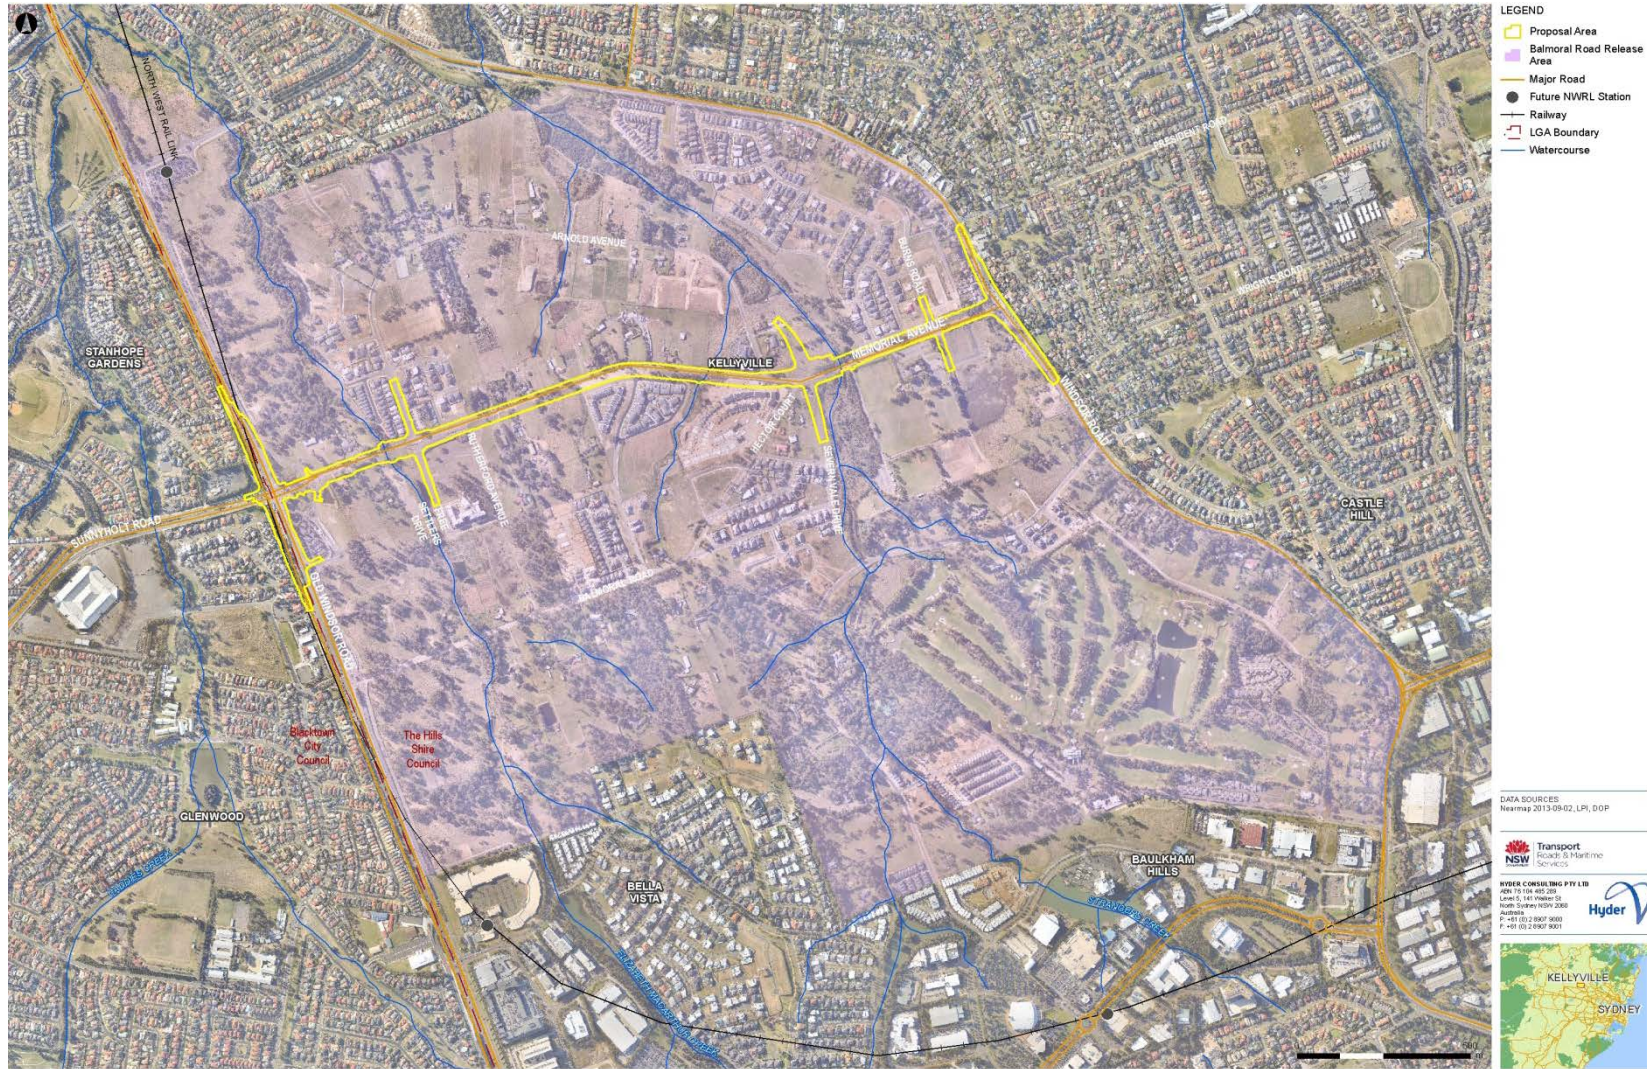
Figure 1: Site location and boundary

Figure 1 below shows the site boundary and locality.

Figure 1 above.

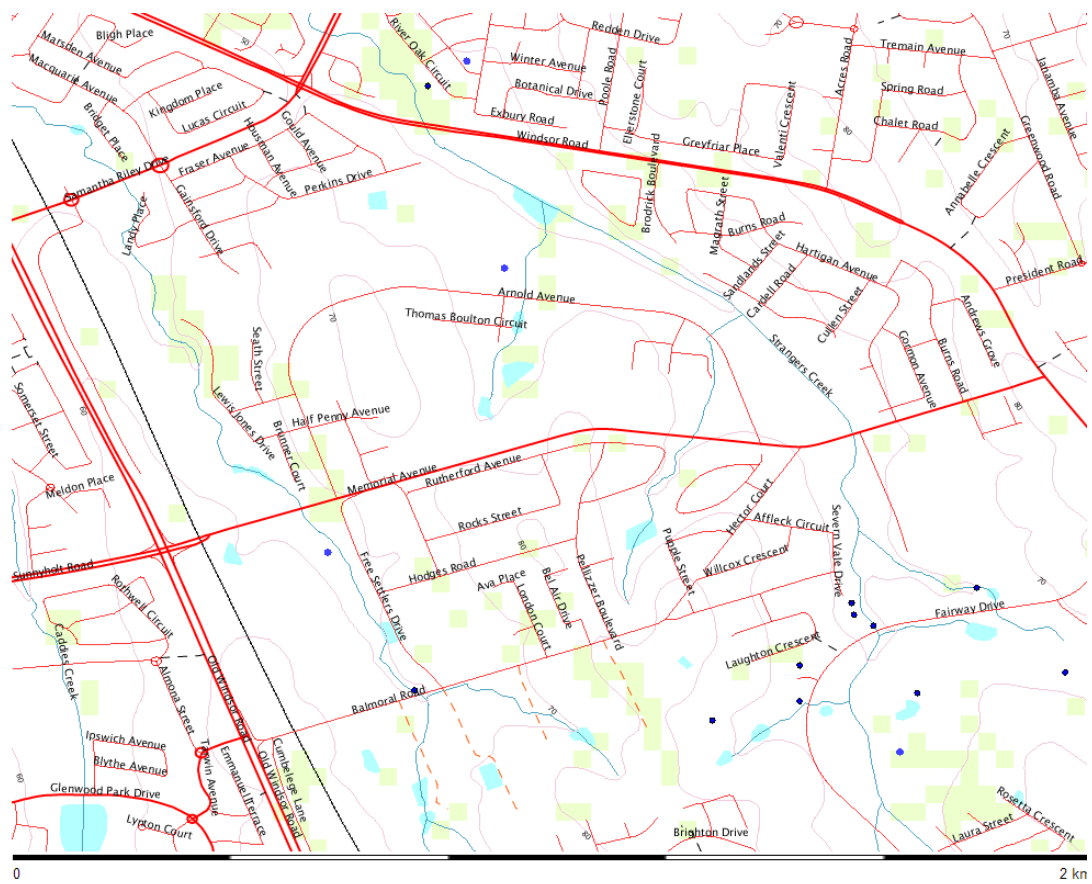
Figure 2: Indicative location of groundwater boreholes within 2 kilometres of the site

The location of groundwater bores (indicated by blue dots) within the vicinity of the site are shown in Figure 2 below.

There are 15 groundwater bores located within a two kilometre radius of the site. Two bores are used for recreational purposes, one for domestic purposes, one for monitoring and all others contained no data. The permanent groundwater table varies considerably around the site and is estimated to be at a depth between 1.6 metres in the southeast (400 metres from the site) - to eight metres just north (250 metres) and west (250 metres) of the site - to 53 metres in the far north (500 metres from the site). The considerable variability of groundwater levels around the site presents the risk of inaccurate measurements and further highlights the need for onsite and technical investigations.
