John Holland Rail Tarago Track Rehabilitation Worksite Dust & Lead Evaluation & Recommendations.

24th October, 2019.

Prepared by:
Banksia EOHS Pty Limited.

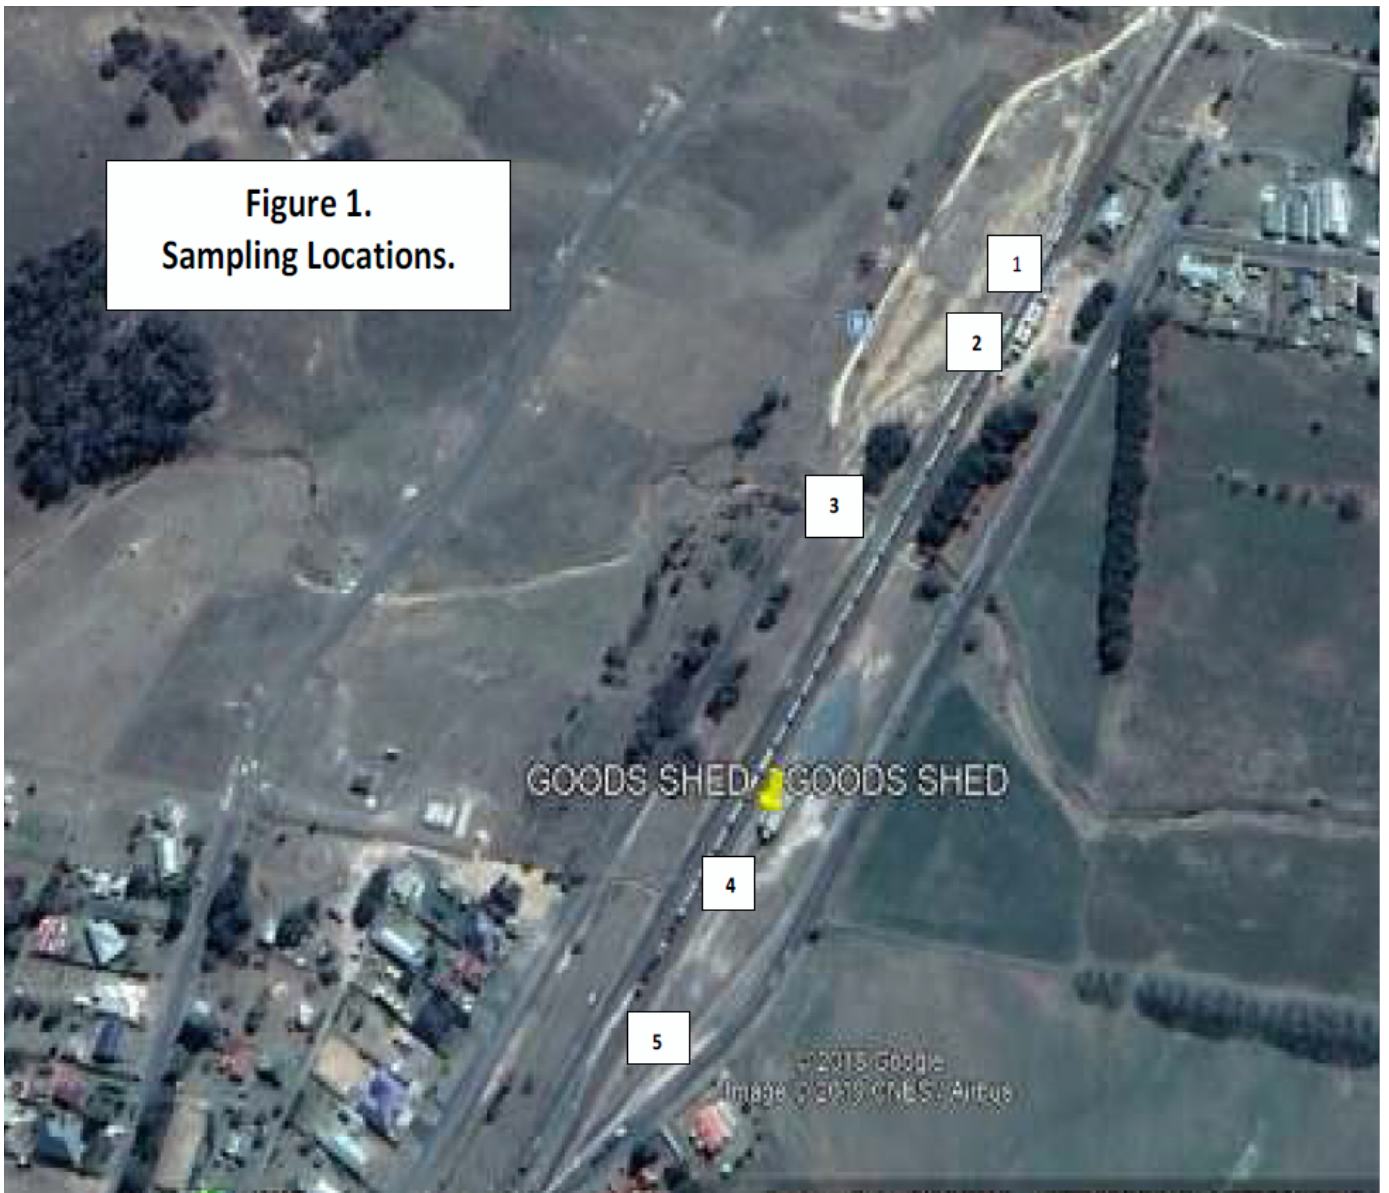
**Figure 1.
Sampling Locations.**

Real time sampling was undertaken using a Dust Trak II dust monitoring instrument (Photograph 2). Six sample locations were established as shown in Figure 1 and measurements were made at each location at 7.30am, 8.30am, 9.30am, 10.30am and 11.30am.

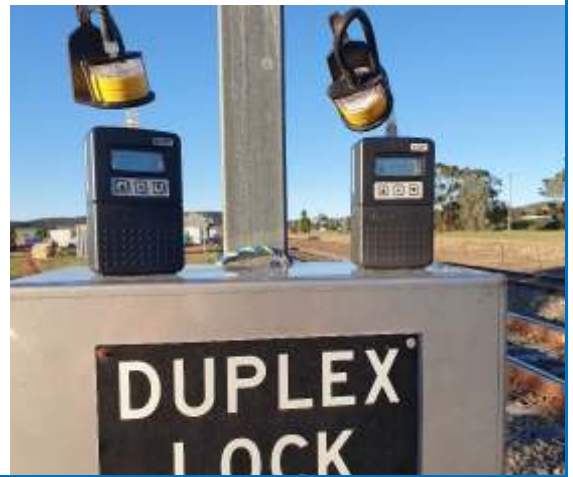
Photo 4: Sample Site 3 And Two Dynamic Samplers.

Filter papers - 37mm $0.8\mu\text{m}$ cellulose ester, are preweighed and placed in a sample cassette and cassette holder (Photograph 4). A calibrated sample pump was then field calibrated using a rotameter to deliver 2 L/min. The cassette holders were fitted to the pump and the sample pumps were run for about 5 hours giving a sample volume of around 600L.
