# Community information session Tarago Town Hall

# Project overview

- The Tarago Rail Loop Extension Project is a NSW Government project jointly funded by Transport for NSW and Veolia.
- Early planning work for the project started in 2015 and construction commenced in July 2019. Major work on the project was completed in January 2020.
- The project has converted the existing rail siding (a low-speed track section) into an open access passing loop to improve the rail network of freight and passenger services between Goulburn and Canberra and to support Veolia's Woodlawn facility in Tarago.
- Transport for NSW undertook the works in Tarago, as part of the NSW Government's Fixing Country Rail program across regional NSW. Works were completed by Transport for NSW's contractor, John Holland Rail.

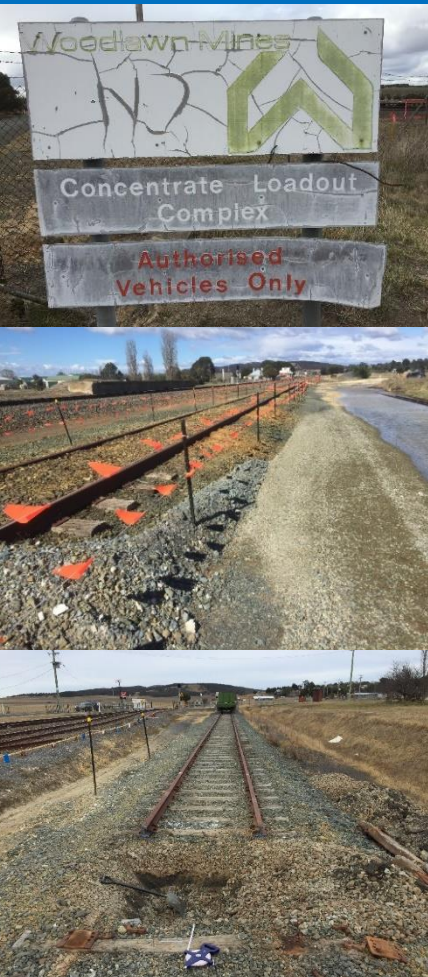
## Inside the rail corridor

- 109 shallow soil samples
- 18 samples from rail formation cap and subgrade layers
- Surface water sampling upstream and downstream of two drainage culverts (four locations)
- Field based measurement of lead concentrations in surface soils
- Samples were submitted to NATA accredited laboratories for analyses of potential contaminants of concern (mainly lead).

- Elevated lead concentrations were observed within about a 900m length of the rail formation and in the immediately surrounding soils. Other potential contaminants were observed at concentrations below criteria
- High lead and other metals were observed in surface water downstream of the rail formation

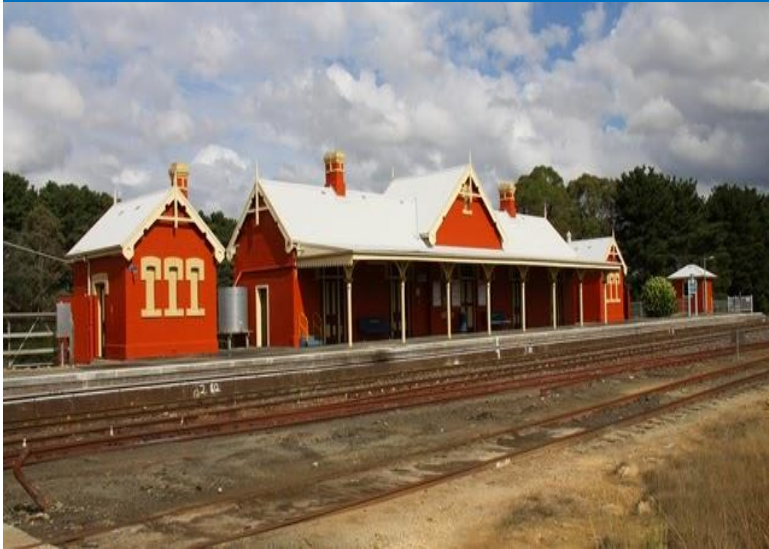
## Tarago Train Station

- Five dust samples from the Tarago Station platform
- Six shallow soil samples Tarago Station carpark
- Samples were submitted to NATA accredited laboratories for lead analyses

- Results indicate contaminant risks are low and acceptable

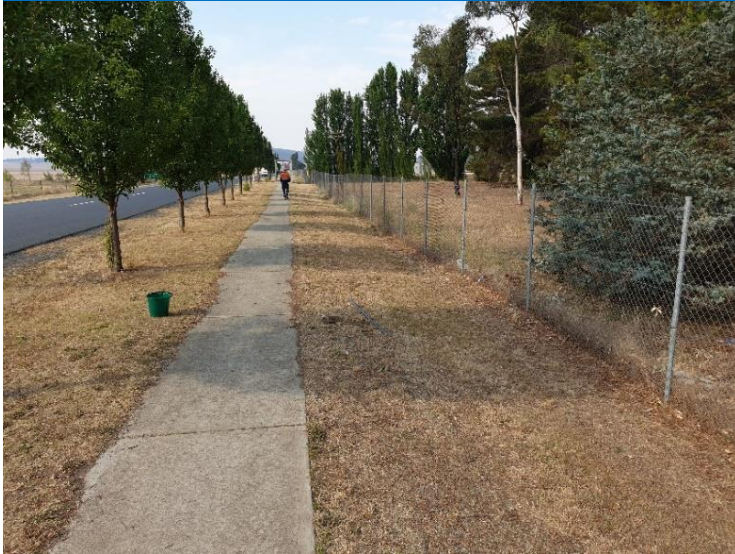
## Goulburn Street

- Assessment on Goulburn Street included collection of ten shallow soil samples adjacent to the footpath from the Station south past the Goulburn Street footbridge
- Samples were submitted to NATA accredited laboratories for lead analyses

- Results indicate contaminant risks are low and acceptable

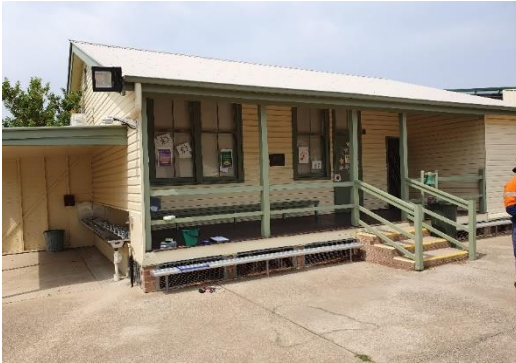
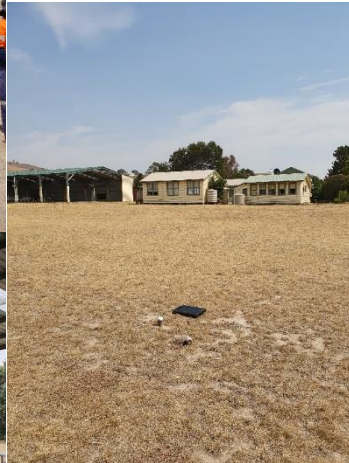
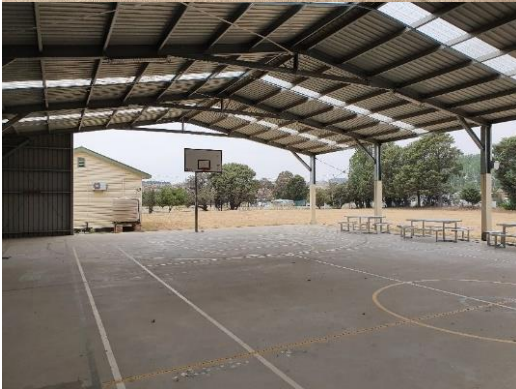
## Tarago Public School

- Ten shallow soil samples
- Five external paint samples
- Five external dust samples
- Five internal dust samples
- Samples were submitted to NATA accredited laboratories for lead analyses

- Results indicate contaminant risks are low and acceptable
