TARAGO, NSW **SEPTEMBER 2022 SURFACE WATER MONITORING REPORT**

Project name **Tarago Surface Water Monitroing**

318001376-T3 Project no.

This report describes the methodology and factual results for quarterly Description

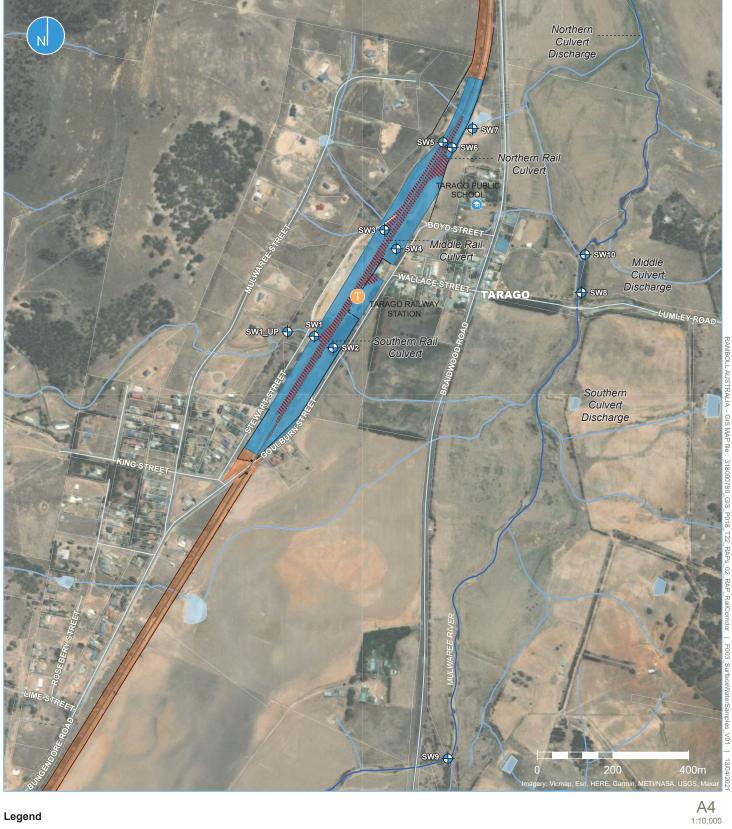
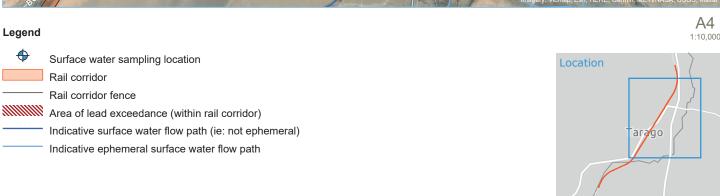
Figure 2-1: Surface Water Monitoring Locations

Contamination has been identified along approximately 900 lineal meters of the rail corridor (Ramboll, 2019). This area is herein referred to as "the Site" and is presented with surface water monitoring locations on **Figure 2-1**.

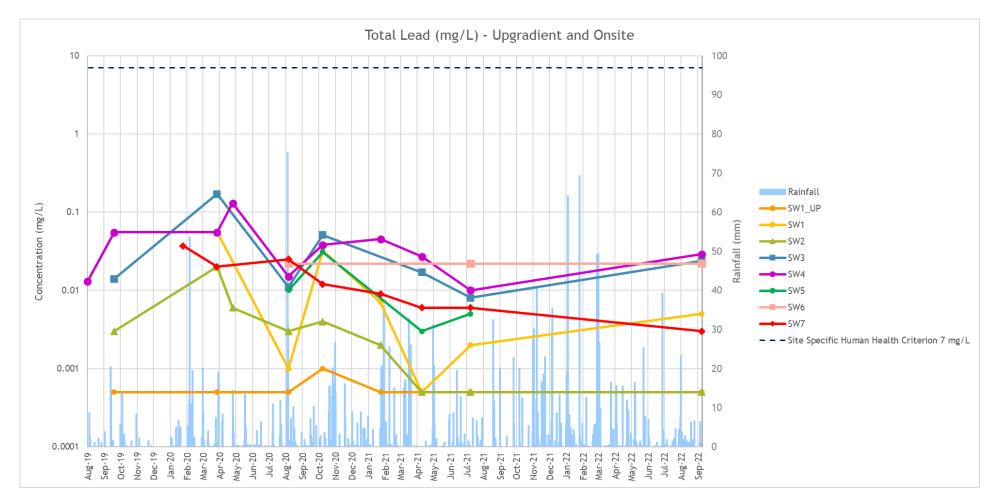
Figure 6-1: Upgradient and Onsite Total Lead Concentration Trend - Logarithmic Scale

All surface water samples collected on and near the site to date have reported total lead concentrations below the site-specific human health criterion. Slight increases in concentrations were reported at SW1, SW3 and SW4 (maximum increase of 0.019 mg/L at SW4) when compared to the previous monitoring event (July 2021).

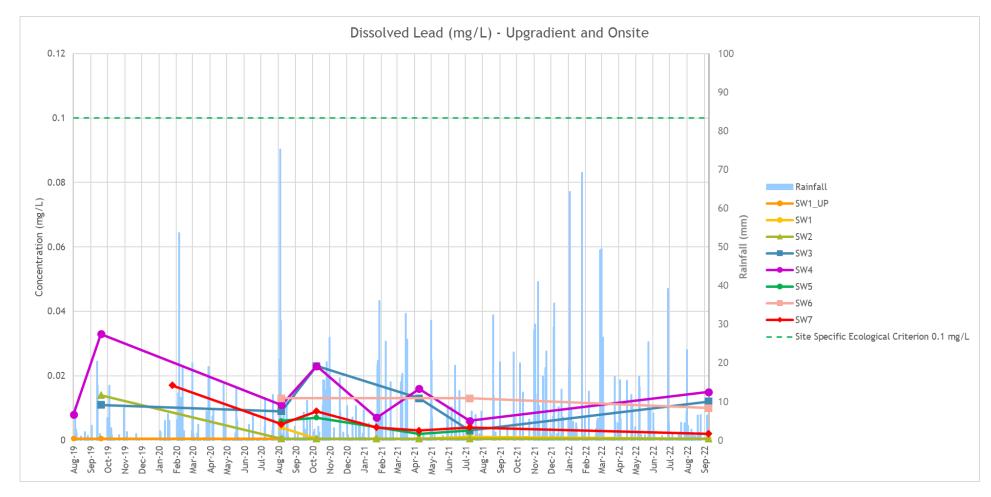
Figure 6-2: Upgradient and Onsite Dissolved Lead Concentration Trend

Figure 6-2 presents dissolved lead concentrations reported for the samples mentioned above. Data is presented relative to the EnRiskS (2020) site-specific ecological criterion for lead (0.1 mg/L). All samples to date have reported dissolved lead concentrations below the site-specific ecological criterion. Similar to total lead, slight increases in concentrations were reported at SW3 and SW4 (maximum increase of 0.009 mg/L at SW3 and SW4, respectively) when compared to the previous monitoring event (July 2021).

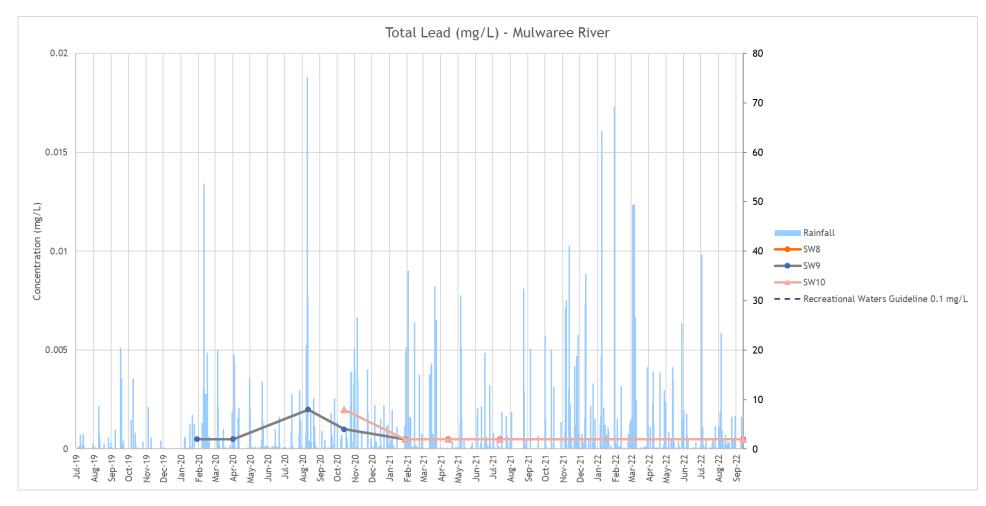
Figure 6-3: Mulwaree River (Offsite) Total Lead Concentration Trend

Figure 6-3 presents total lead concentrations reported in surface water samples (SW8, SW9, SW10) collected from the Mulwaree River located offsite. Total lead concentrations in surface water samples are approximately 50-times lower than the adopted human health criterion for recreational water (0.1 mg/L). Therefore, the criterion has not been plotted on the y-axis of the graph in order to allow visual assessment of the low concentration trends. Total lead has not been detected above the laboratory PQL (0.001 mg/L) in surface water samples collected from the Mulwaree River since January 2021.

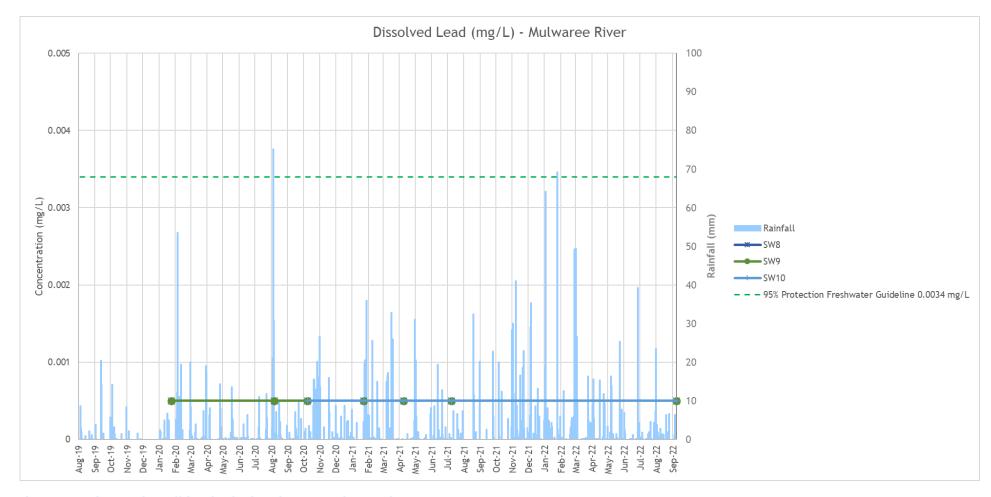
Figure 6-4: Mulwaree River Offsite Dissolved Lead Concentration Trend

For the assessment of ecological risk, dissolved lead concentrations in samples collected from the Mulwaree River have been plotted relative to the adopted criterion for 95% protection of species protection in freshwater aquatic ecosystems (0.0034 mg/L), presented in **Figure 6-4**. All samples collected from the Mulwaree River to date have reported dissolved lead concentrations below the laboratory PQL and below adopted ecological criterion. Samples do not exceed the less sensitive guidelines for irrigation (0.1 mg/L) and stock water (5 mg/L).

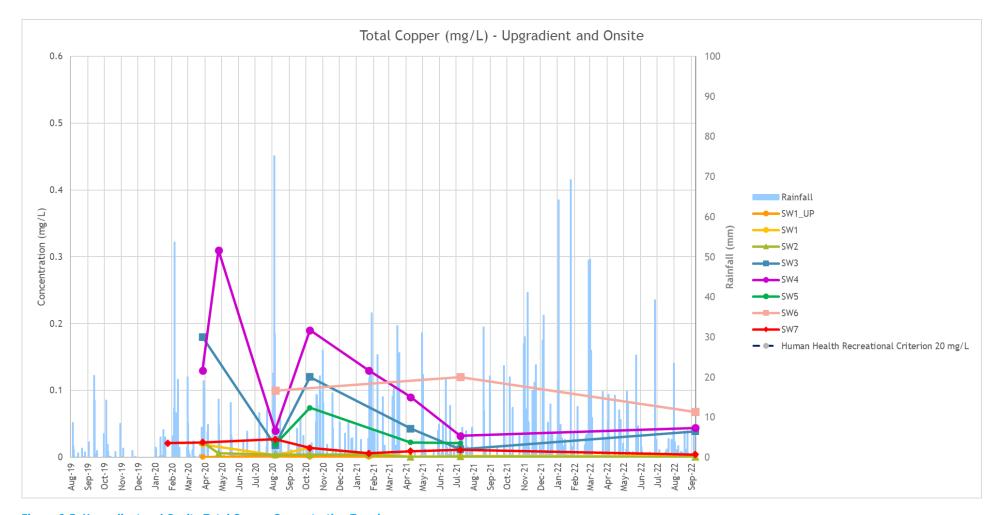
Figure 6-5: Upgradient and Onsite Total Copper Concentration Trend

Total and dissolved copper concentrations have historically been highest at SW4, located at the middle rail culvert. Recent monitoring events conducted in July 2021 and September 2022 have reported the highest concentrations at SW6, located at the northern rail culvert. SW7, located downgradient from the northern rail culvert, has consistently reported low copper concentrations (total and dissolved) when compared with remaining locations on or near the site.

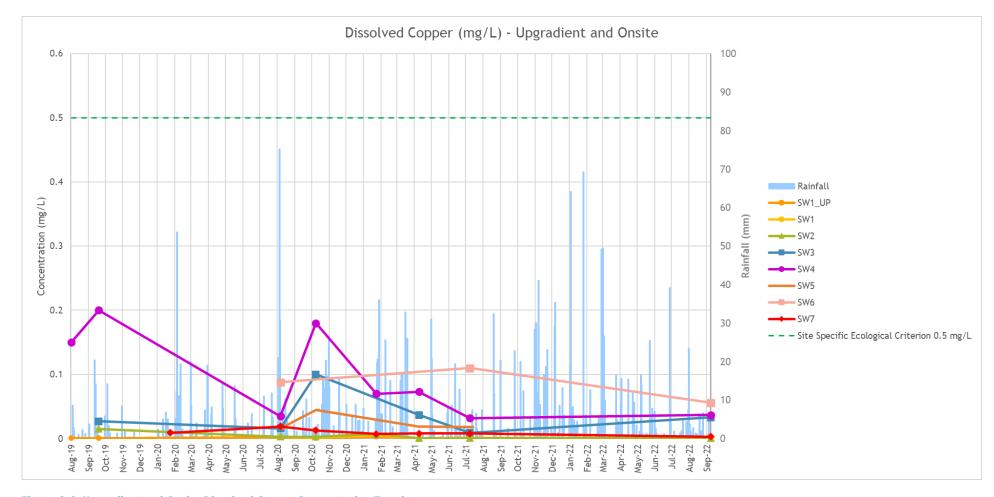
Figure 6-6: Upgradient and Onsite Dissolved Copper Concentration Trend

Figure 6-6 presents dissolved copper concentrations reported for the samples mentioned above, relative to the adopted site-specific ecological criterion (0.5 mg/L). All samples collected on and near the site to date reported dissolved copper concentrations below the site-specific ecological criterion.

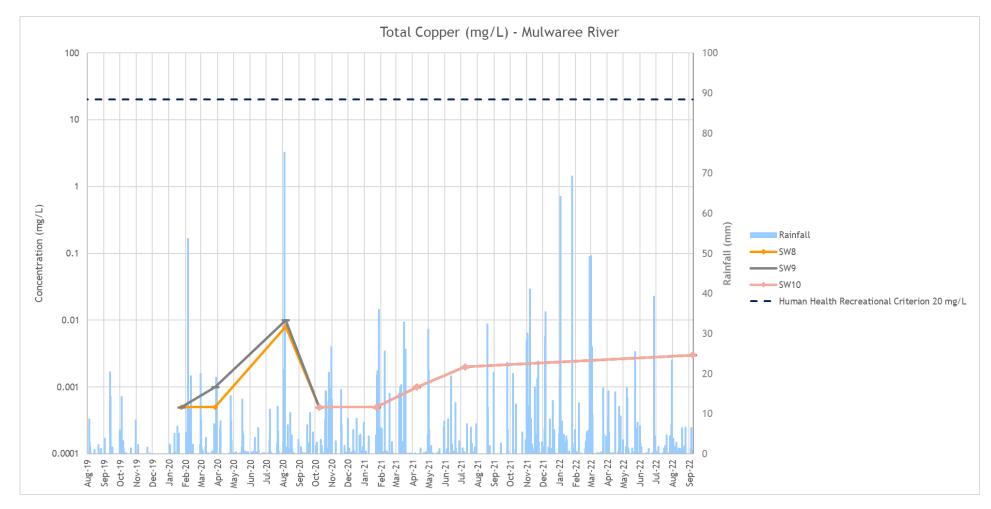
Figure 6-7: Mulwaree River (Offsite) Total Copper Concentration Trend - Logarithmic Scale

Figure 6-7 presents total copper concentrations reported in surface water samples (SW8, SW9, SW10) collected from the Mulwaree River located offsite. The data are shown relative to the human health criterion for recreational use (20 mg/L). The y-axis is presented on a logarithmic scale to allow for presentation of the relative variation in concentrations. All samples collected from the Mulwaree River to date have reported total copper concentrations below the human health assessment criterion. Similar concentrations have been reported in SW9 and SW8, located upstream and downstream of the Site, respectively with all locations reporting identical concentrations between October 2020 and September 2022. This indicates that total copper concentrations in the Mulwaree River are likely to be influenced by sources other than the Site and represent background conditions in the receiving waters.

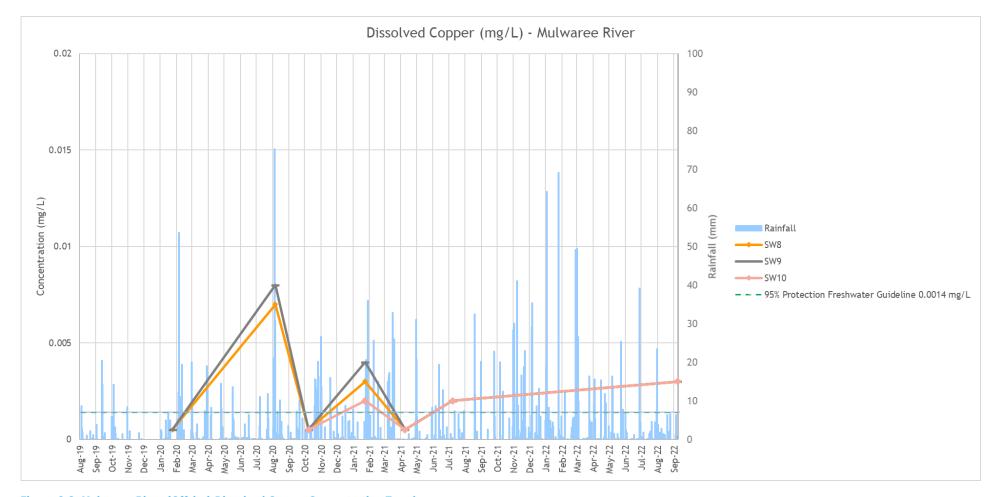
Figure 6-8: Mulwaree River (Offsite) Dissolved Copper Concentration Trend

Concentrations of dissolved copper in samples collected from the Mulwaree River relative to the adopted ecological assessment criterion (0.0014 mg/L) for 95% protection of freshwater species (ANZG, 2018) is presented in **Figure 6-8**. Dissolved copper concentrations exceeded the ecological assessment criterion for samples collected from the Mulwaree River in August 2020, January 2021, July 2021 and September 2022. Concentrations in all samples correlated closely, noting that sampling of the downstream location SW10 commenced in October 2020. Prior to April 2021, the highest dissolved copper concentrations were generally reported in SW9, located upstream. Dissolved copper concentrations in the Mulwaree River appear representative of background and not representative of impacts from the Site. Samples do not exceed the less sensitive guidelines for irrigation (0.5 mg/L) and stock water (0.1 mg/L).

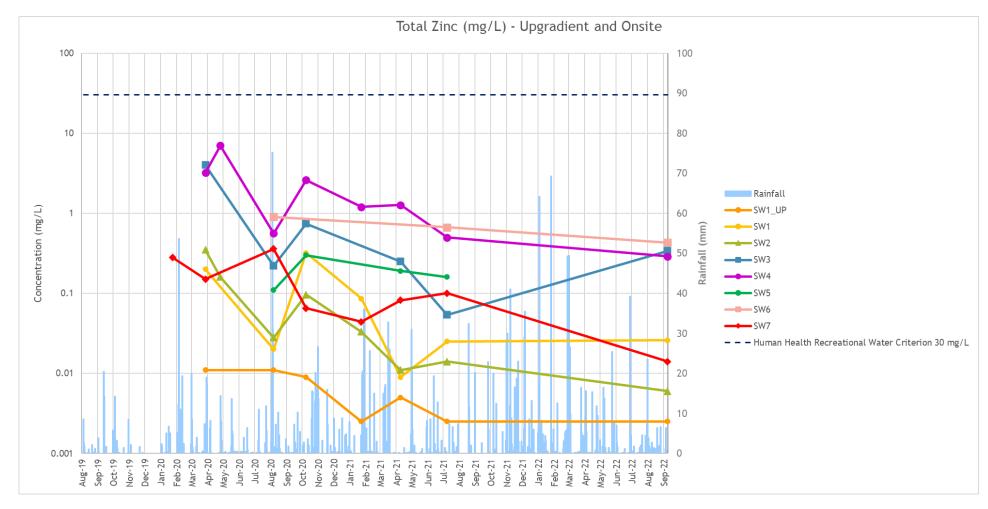
Figure 6-9: Upgradient and Onsite Total Zinc Concentration Trend - Logarithmic Scale

All surface water samples collected on and near the site to date have reported total zinc concentrations below the adopted human health criterion.

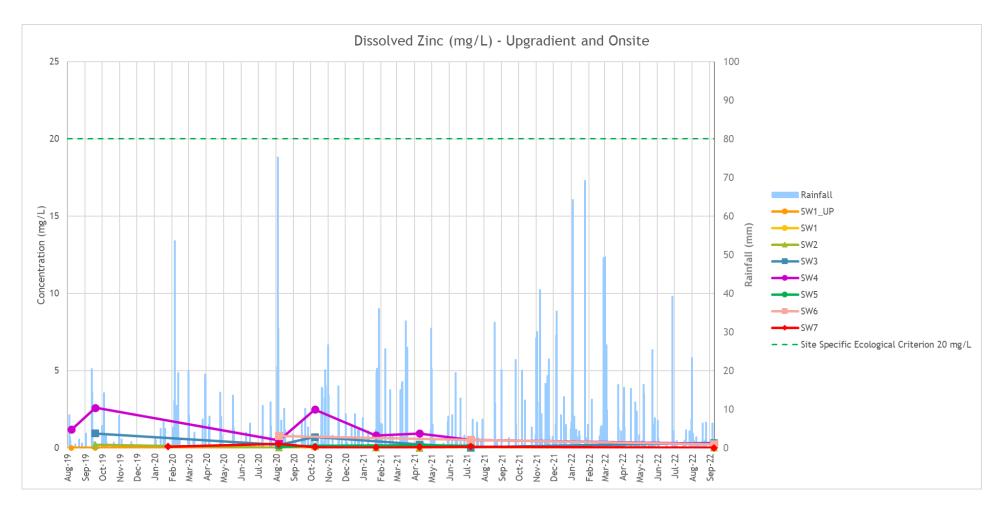
Figure 6-10: Upgradient and (Onsite) Dissolved Zinc Concentration Trend

Figure 6-10 presents dissolved zinc concentrations reported for the samples described above, relative to the site-specific ecological criterion of 20 mg/L. All samples collected on and near the site to date have reported dissolved zinc concentrations below the adopted criteria. Concentrations have been reported at or below 2.6 mg/L and have remained largely stable since January 2021.

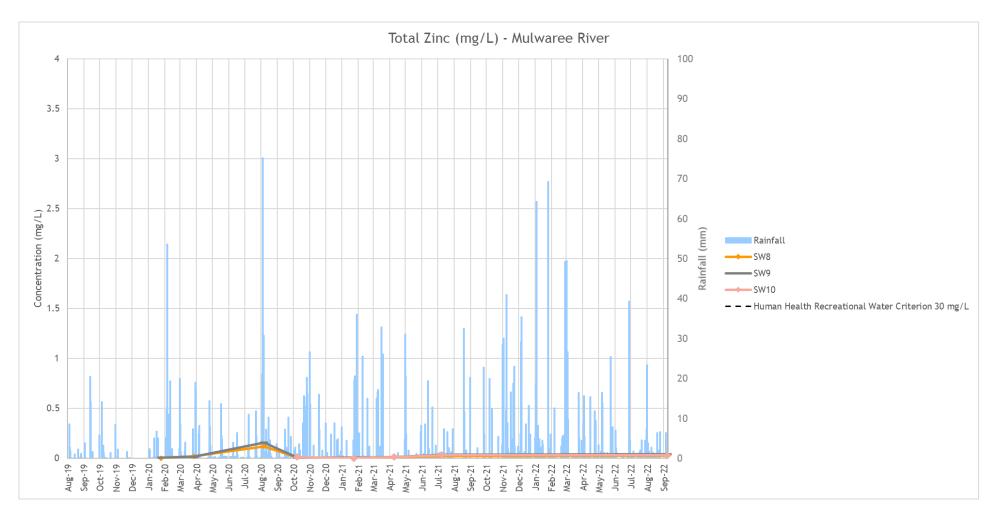
Figure 6-11: Mulwaree River (Offsite) Total Zinc Concentration Trend

Figure 6-11 presents total zinc concentrations in surface water samples (SW8, SW9, SW10) collected from the Mulwaree River located offsite. Total zinc concentrations in surface water are approximately 188-times lower than the adopted human health criterion for recreational water (30 mg/L). Therefore, the criterion has not been plotted on the y-axis of the graph in order to allow visual assessment of the low concentration trends. All samples collected from the Mulwaree River to date have reported concentrations below the adopted criteria. A minor increase (maximum 0.145 mg/L) at SW9 was identified following high rainfall in August 2020. Similar to copper, this increase in concentration was reported at both the upgradient (SW9) and downgradient (SW8) locations indicating a potential upstream contaminant source. A relationship between zinc in surface water from the Site and in the Mulwaree River was not identified.

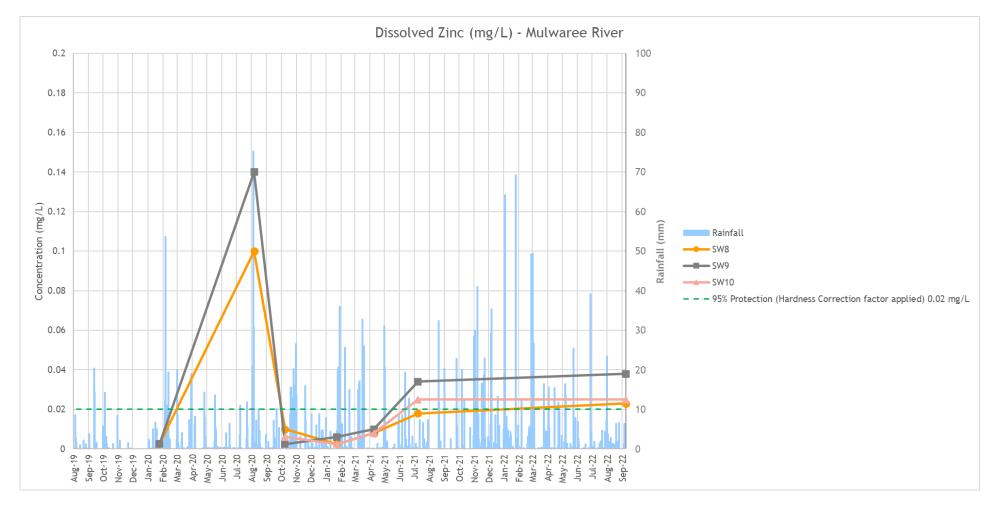
Figure 6-12: Mulwaree River (Offsite) Dissolved Zinc Concentration Trend

Figure 6-12 presents dissolved zinc concentrations in samples collected form the Mulwaree River relative to the adopted ecological criterion (0.02 mg/L). Concentrations of dissolved zinc exceeded the adopted ecological criterion at SW8 and SW9 in August 2020 and at SW9 and SW10 in July 2021. All samples exceeded the adopted ecological criteria during the most recent monitoring event (September 2022). The upgradient location (SW9) has generally reported the highest concentrations of dissolved zinc in the Mulwaree River (with the exception of October 2020). Similar to copper, concentrations in the Mulwaree River appear representative of background and not representative of impacts from the Site. Samples do not exceed the less sensitive guidelines for irrigation (20 mg/L) and stock water (5 mg/L).

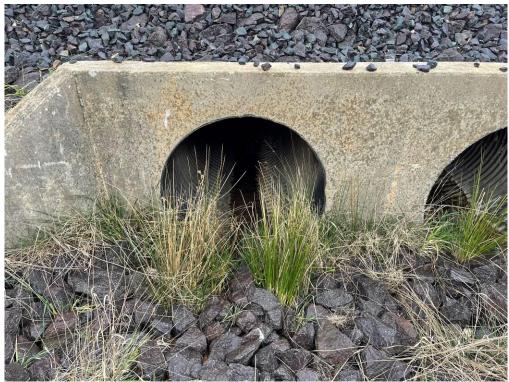
Photo 5: Sample location SW5 adjacent to the rail corridor, facing south-east. Unable to take sample due to the location being dry with very little water (12 September 2022)
