Transport
for NSW

Centre for Road Safety

Speed Camera Programs: 2019 Annual Review

Author: Centre for Road Safety
Date: March 2021
Version: 1.0
Division: Safety, Environment & Regulation

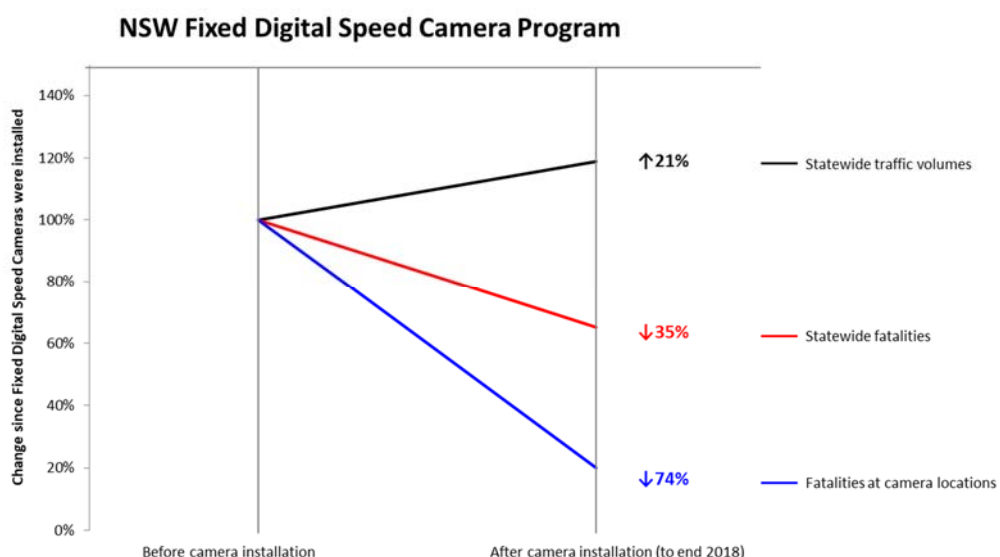
- 36 per cent reduction in casualty crashes
- 74 per cent reduction in fatalities
- 41 per cent reduction in injuries.

- 18 per cent reduction in casualty crashes
- 35 per cent reduction in fatalities
- 20 per cent reduction in injuries.

It should also be noted, alongside the crash data outlined above, that there has also been a notable increase in traffic volumes. Over the periods that fixed digital speed cameras have been reviewed within this report, there has been a 21 per cent increase in traffic volume across NSW.²

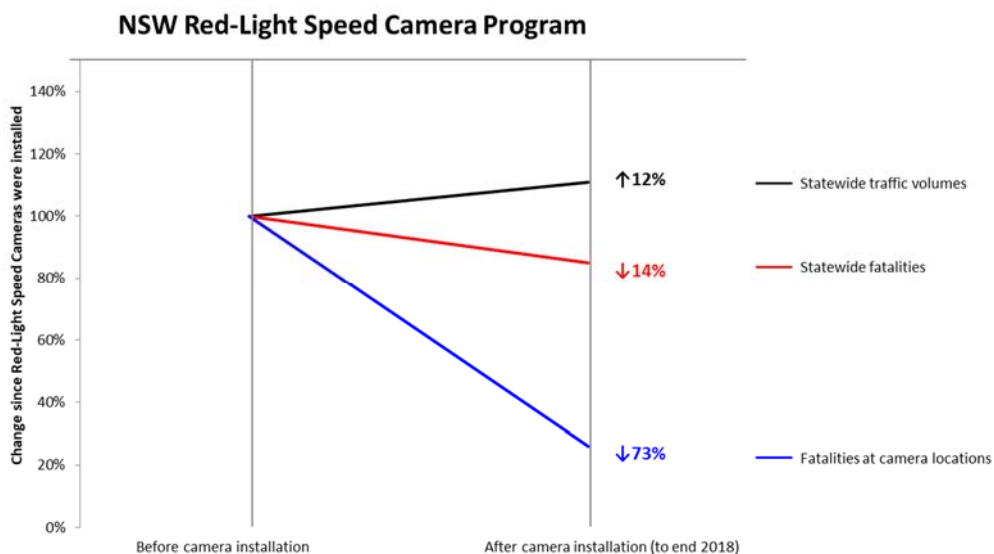
- 23 per cent reduction in fatal and serious injury crashes
- 73 per cent reduction in fatalities
- 24 per cent reduction in serious injuries
- 52 per cent reduction in pedestrian casualties.

- 10 per cent increase in fatal and serious injury crashes
- 14 per cent reduction in fatalities
- 11 per cent increase in serious injuries
- 30 per cent reduction in pedestrian casualties.

cameras have been reviewed within this report, there has been a 12 per cent increase in traffic volume across NSW.³

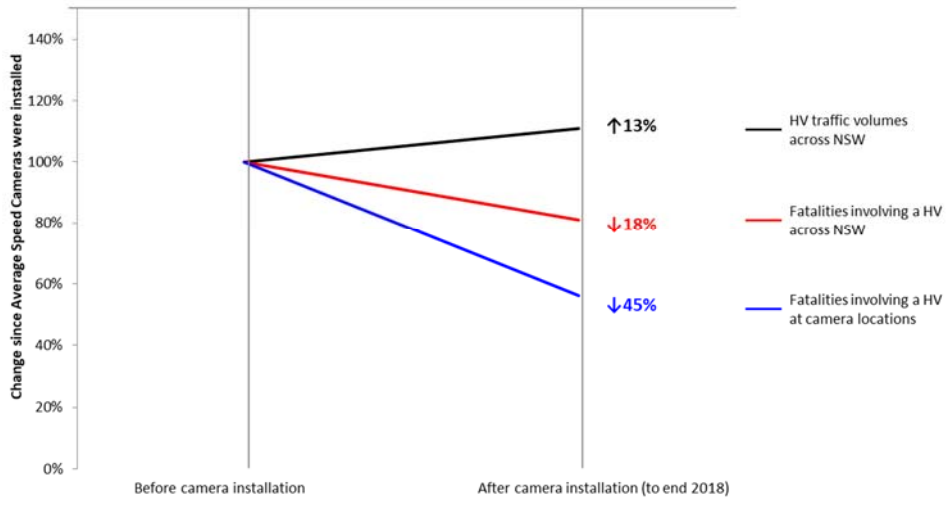
NSW Heavy Vehicle Average Speed Camera Program

- 27 per cent reduction in casualty crashes involving a heavy vehicle
- 45 per cent reduction in fatalities from crashes involving heavy vehicles
- 10 per cent reduction in serious injuries from crashes involving heavy vehicles.

- 10 per cent reduction in casualty crashes involving a heavy vehicle
- 18 per cent reduction in fatalities from crashes involving heavy vehicles
- 21 per cent increase in serious injuries from crashes involving heavy vehicles.

It should also be noted, alongside the crash data outlined above, that there has been a notable increase in heavy vehicle traffic volumes. Over the periods that average speed enforcement lengths have been reviewed within this report, there has been a 13 per cent increase in heavy vehicle volumes across NSW.⁵
