Transport
for NSW

Centre for Road Safety

Speed Camera Programs: 2020 Annual Review

Author: Centre for Road Safety
Date: September 2021
Version: 1.0
Division: Safety, Environment & Regulation

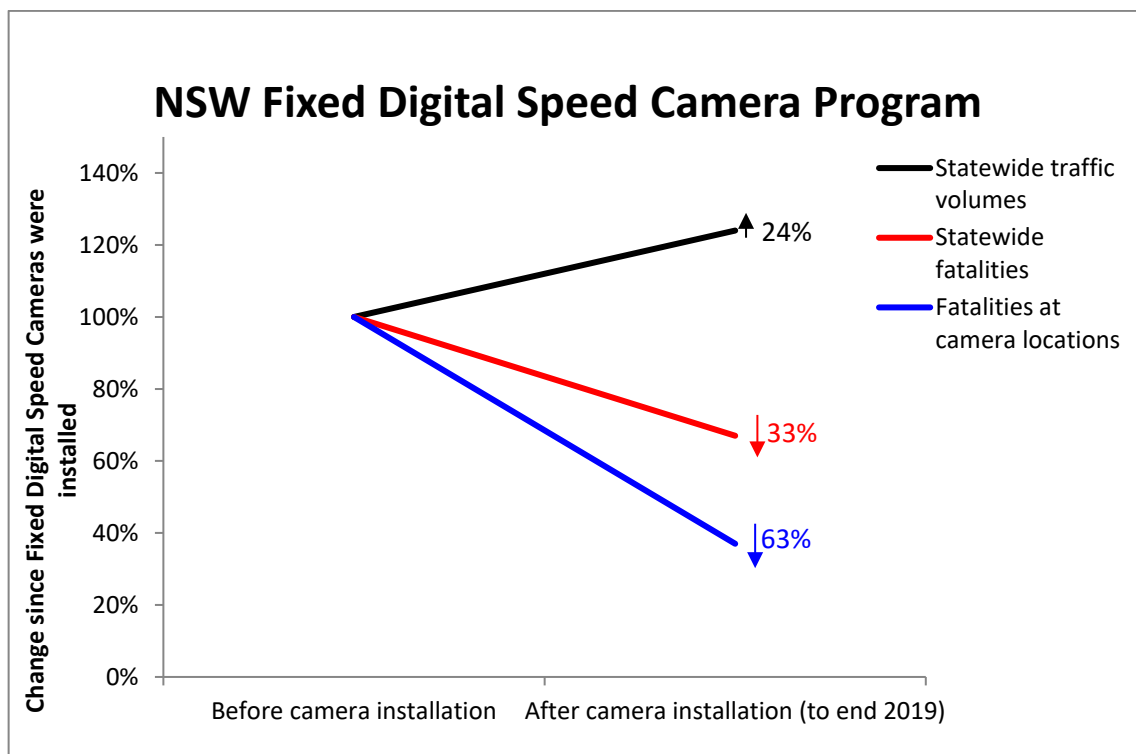
Overall, there has been a reduction in road trauma at fixed speed camera locations since the cameras were installed, compared with the five year period prior to installation.

Specifically, at fixed speed camera locations there has been a:

- 40 per cent reduction in casualty crashes
- 63 per cent reduction in fatalities
- 45 per cent reduction in injuries.

The trauma reductions at camera locations compare to the following rates of change observed across NSW over the same period:

- 23 per cent reduction in casualty crashes
- 33 per cent reduction in fatalities
- 26 per cent reduction in injuries.

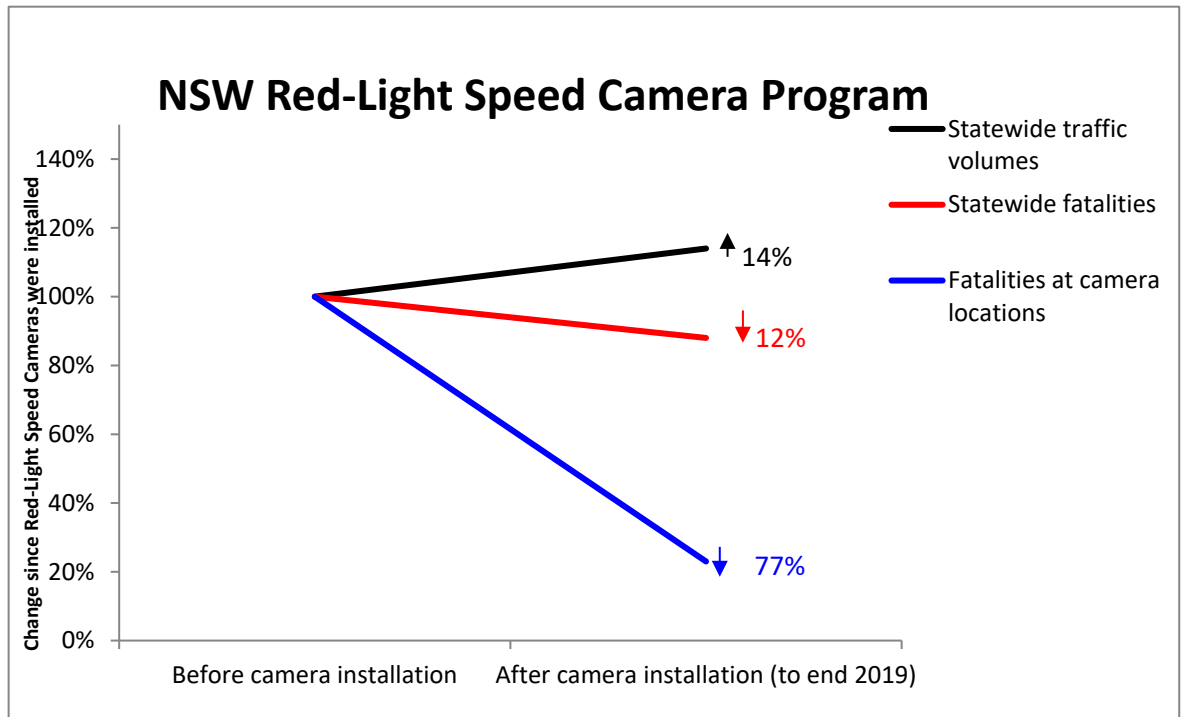
Overall, there has been a reduction in road trauma at red-light speed camera locations since the cameras were installed, compared with the five year period prior to installation.

Specifically, at red-light speed camera locations there has been a:

- 35 per cent reduction in fatal and serious injury crashes
- 77 per cent reduction in fatalities
- 36 per cent reduction in serious injuries
- 59 per cent reduction in pedestrian casualties.

The trauma reductions at camera locations compare to the following rates of change observed across NSW over the same period:

- 7 per cent increase in fatal and serious injury crashes
- 12 per cent reduction in fatalities
- 8 per cent increase in serious injuries
- 33 per cent reduction in pedestrian casualties.

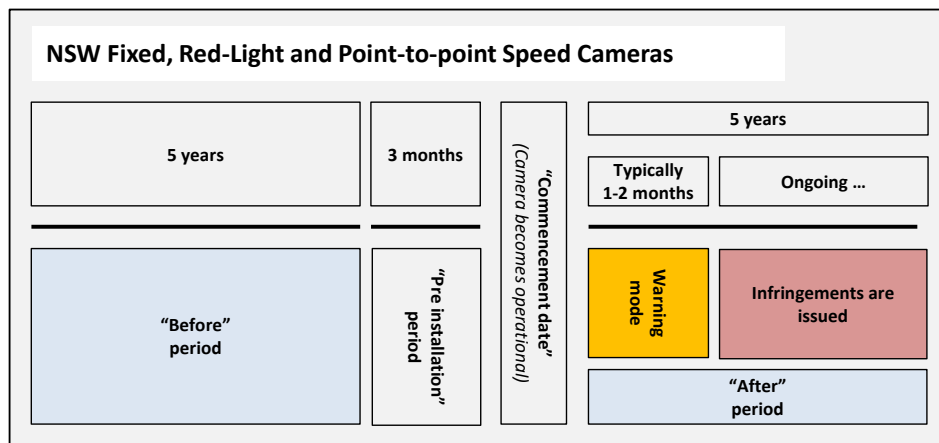
Figure 1: Before, After and Warning Mode periods
