APPENDIX D – Arboricultural Impact Assessment and Tree Protection Plan

ARBORICULTURAL IMPACT ASSESSMENT & TREE PROTECTION PLAN

**Coniston Electrical Upgrade
More Trains More Services (MTMS)**
Version 2

24 June 2022

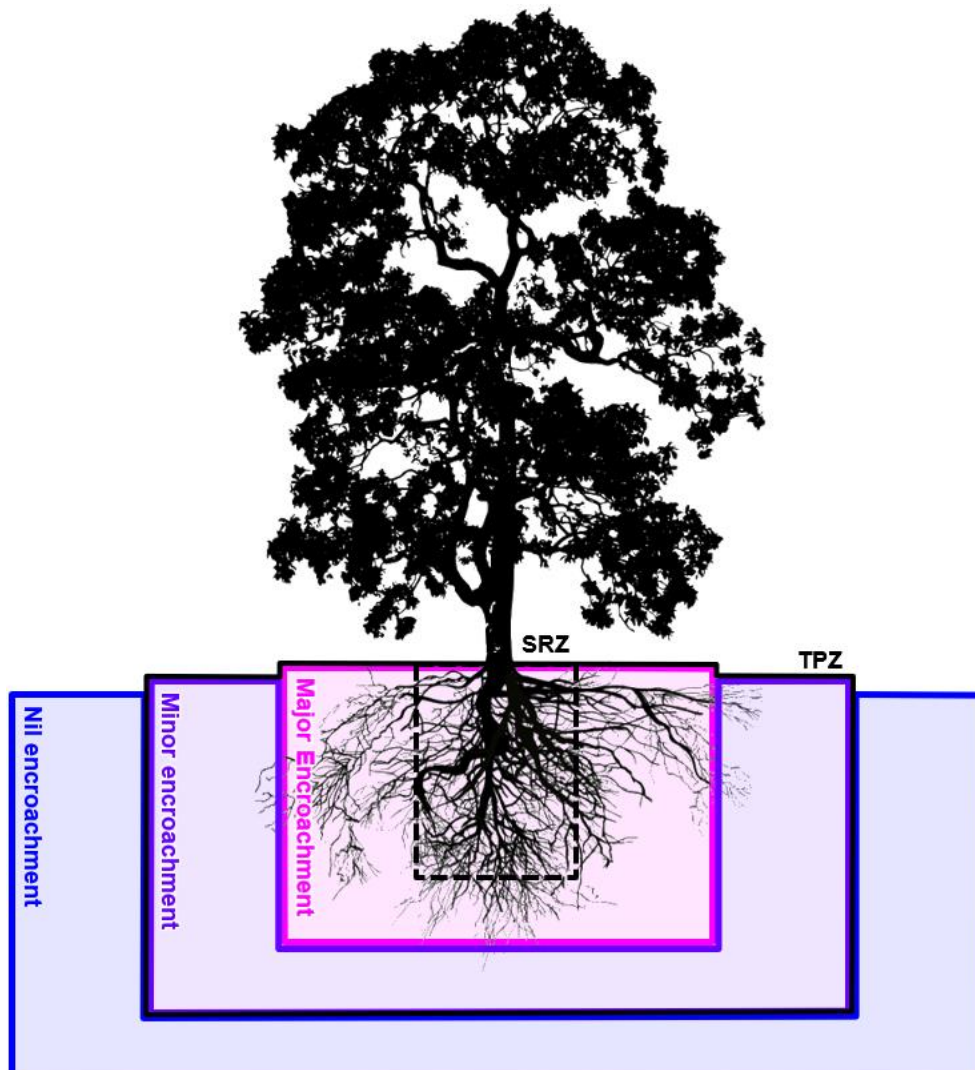
Figure 1: Three (3) levels of encroachment

Encroachment within the TPZ is acceptable, providing that the arborist can demonstrate that the tree will remain viable. There are three (3) levels of encroachment (as defined by AS 4970-2009):

- **Nil encroachment (0%):** No encroachment within the TPZ.
- **Minor encroachment (<10%):** The encroachment is less than 10% of the TPZ.
- **Major encroachment (>10%):** The encroachment is greater than 10% of the TPZ.

Encroachment within the TPZ should be compensated with a range of mitigation measures to ensure that impacts to the subject tree(s) are reduced or restricted wherever possible. Mitigation should be increased relative to the level of encroachment within the TPZ to ensure the subject tree(s) remain viable. The table below outlines requirements under AS 4970-2009, and mitigation measures required within each category of encroachment. These mitigation measures will only apply if trees are proposed to be retained.

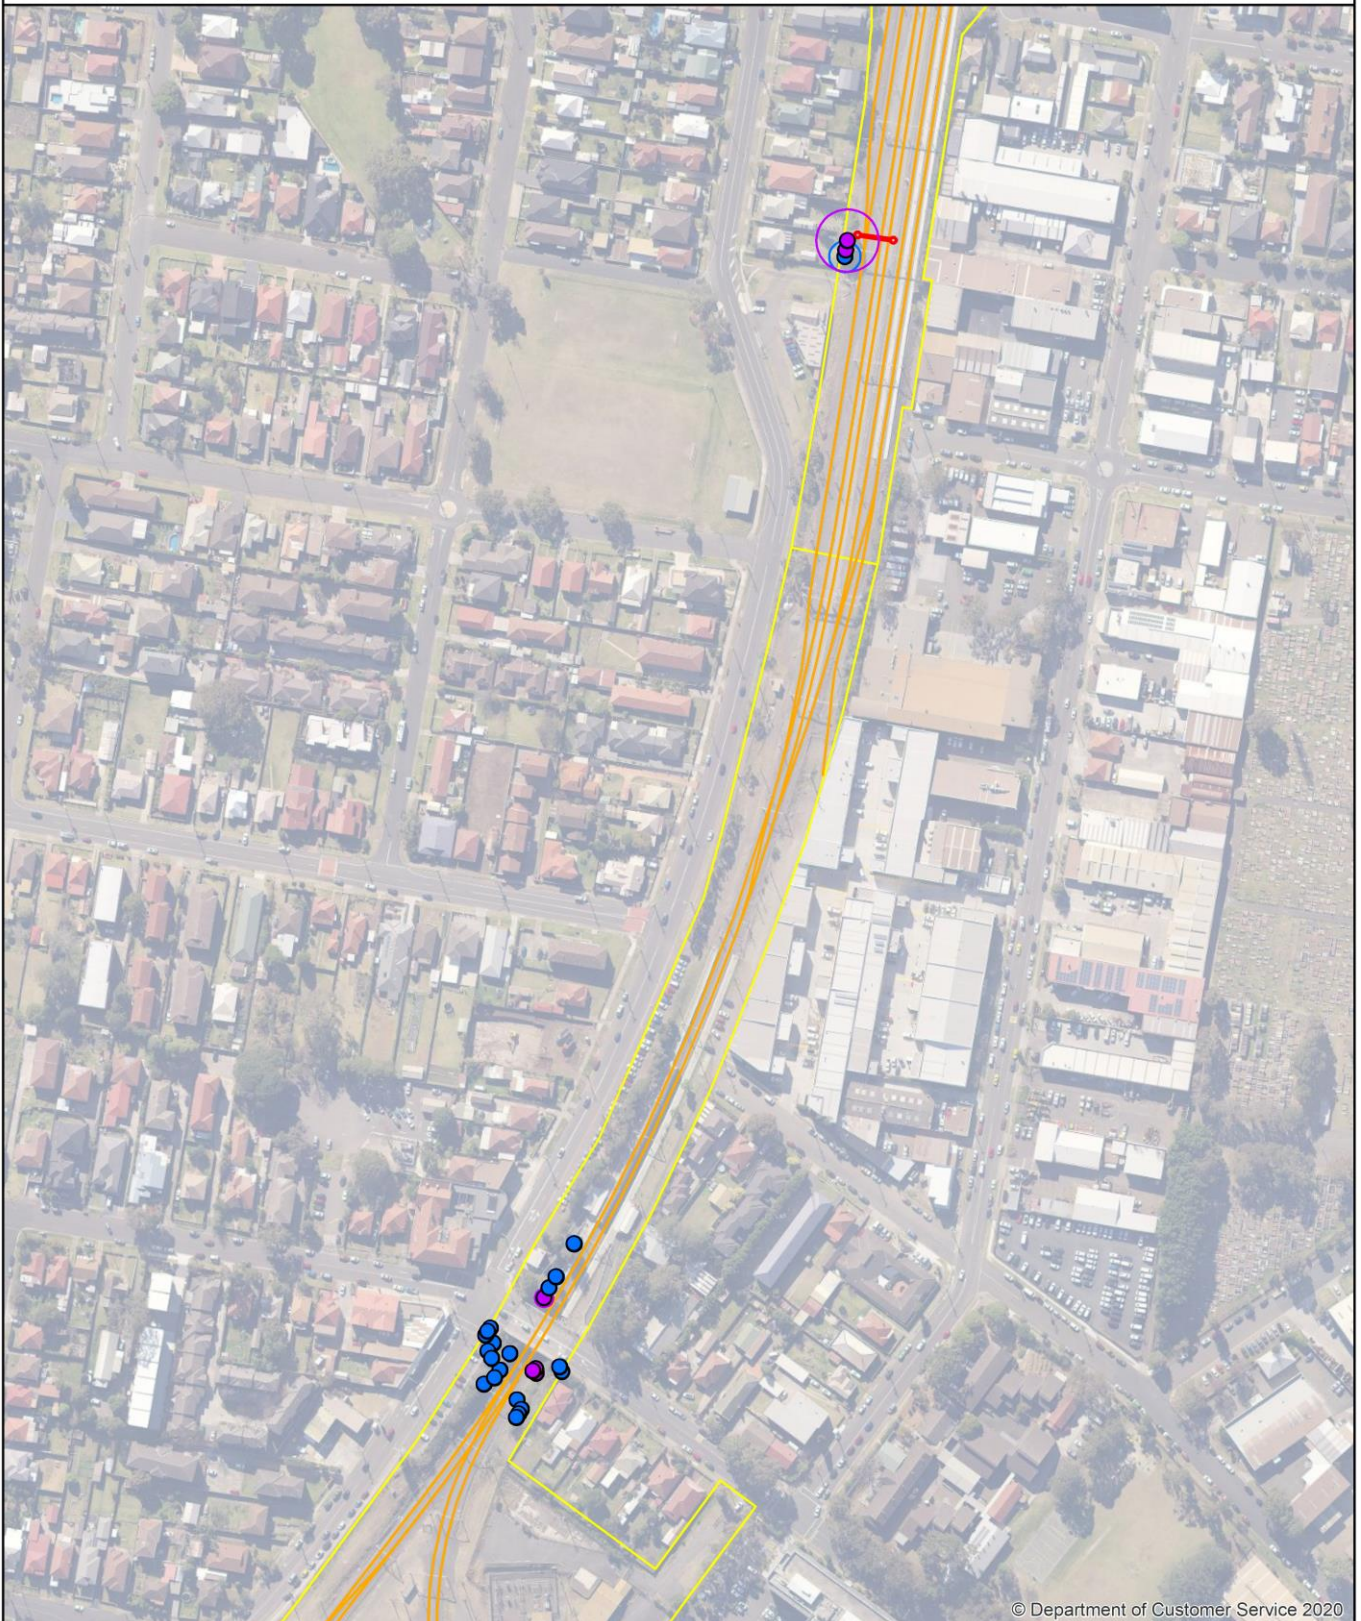
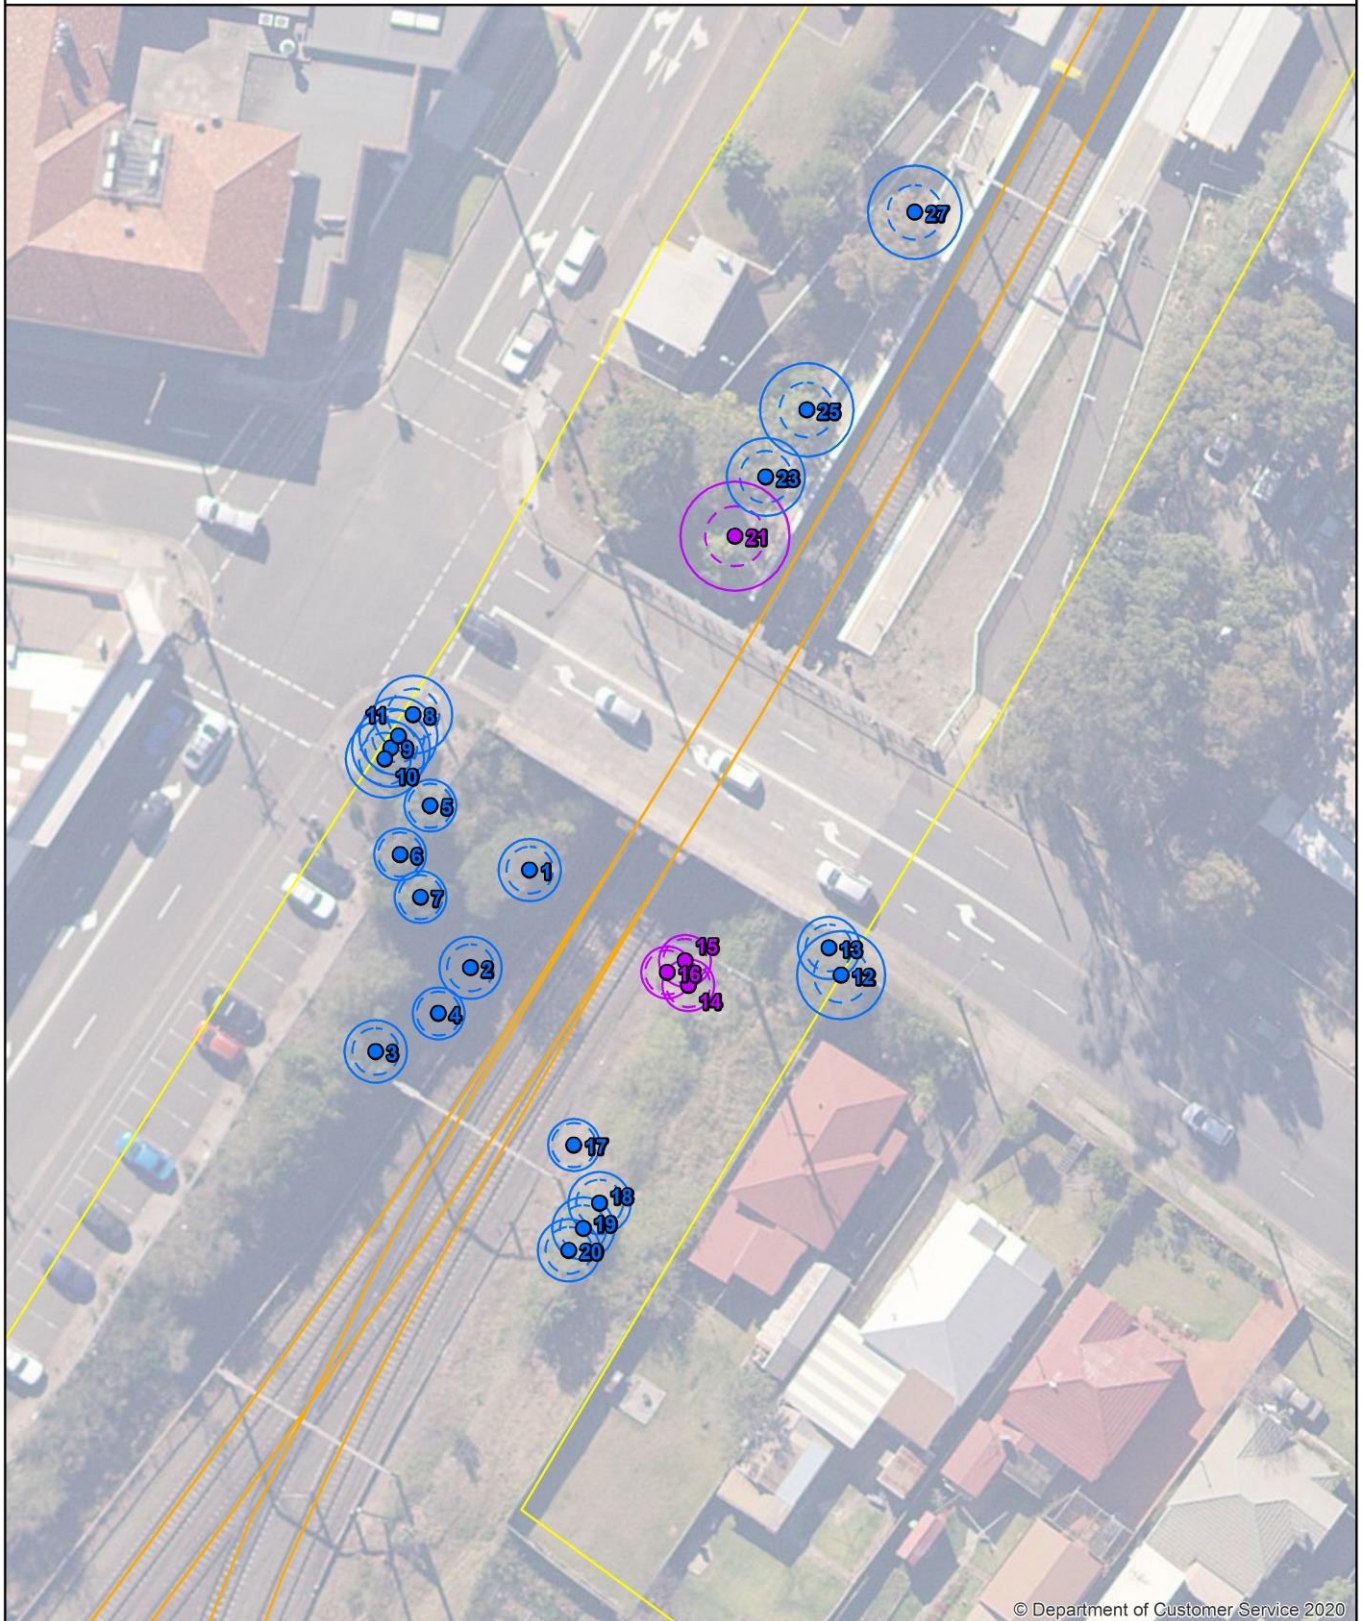
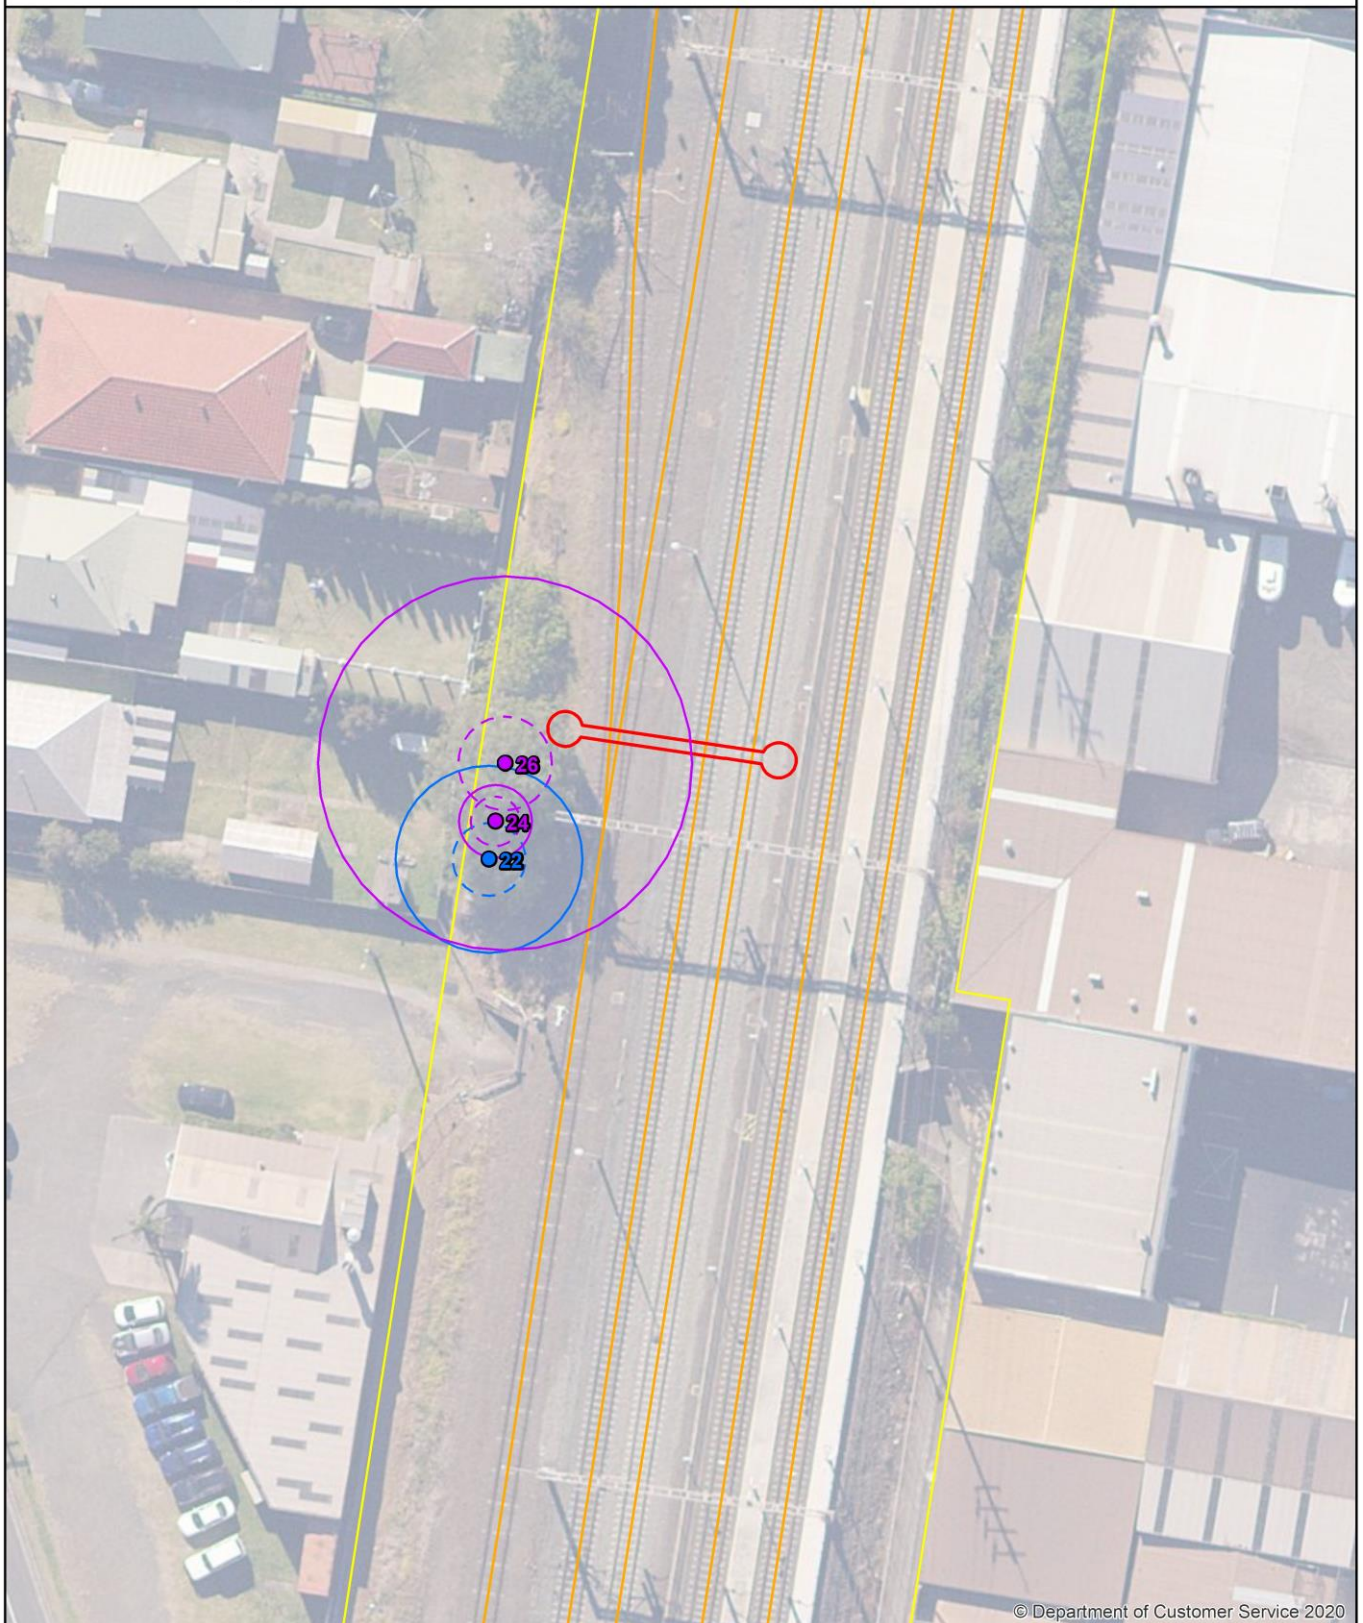
A summary of trees impacted directly by the proposed construction footprint is outlined below:

- **Nil encroachment (0%):** A total of **21** trees are located outside the construction footprint.
- **Minor encroachment (<10%):** A total of **6** trees will be subject to a minor encroachment.
- **Major encroachment (>10%):** A total of **0** trees will be subject to a major encroachment.

A total of **21** trees will be subject to no encroachment within the TPZ:

- **Retain:** A total of **21** trees are located outside of the proposed construction footprint. No impacts on these trees are foreseeable under the current proposal.
- **Remove:** No trees within the category of “nil encroachment” are proposed for removal.

A total of **6** trees will be subject to a minor encroachment of less than 10% within the TPZ:

- **Retain:** A total of **6** trees will be subject to a minor encroachment of less than 10% within the TPZ. The encroachment will not impact the SRZ and is highly unlikely to impact the overall health or condition of these trees. Under the current proposal, these trees can be successfully retained.
- **Remove:** No trees within the category of “minor encroachment” are proposed for removal.

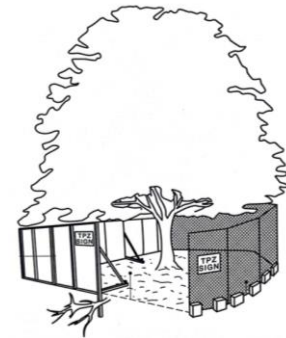
Tree protection fencing must be established at the perimeter of the TPZ (for trees that are proposed for retention). Existing fencing, site hoarding, or structures (such as a wall or building) may be used as tree protection fencing, providing the TPZ remains isolated from the construction footprint. Tree protection fencing must be installed prior to site establishment and remain intact until the completion of works. Once erected, protective fencing must not be removed or altered without the approval of the project arborist. Specifications for the tree protection fencing are as follows:

- Temporary mesh panel fencing (minimum height of 1.8m).
- Installed prior to site establishment and remain intact until the completion of works.
- Protective fencing must not be removed or altered without the approval of the project arborist.
- Prominently signposted with 300mm x 450mm boards stating, "NO ACCESS - TREE PROTECTION ZONE."
- Certified and inspected by the project arborist.

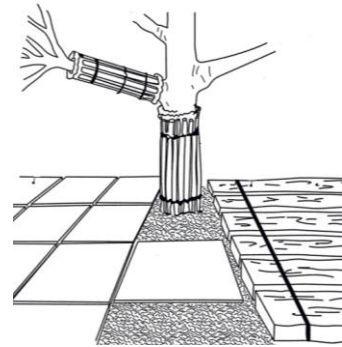
- A thick layer of carpet underfelt, geotextile fabric, or similar wrapped around the trunk to a minimum height of 2m.
- 1.8m lengths of softwood timbers aligned vertically and spaced evenly around the trunk (with a small gap of approximately 50mm between the timbers).
- The timbers must be secured using galvanised hoop strap (aluminium strapping).

The timbers shall be wrapped around the trunk but not fixed to the tree, as this will cause injury/damage to the tree.

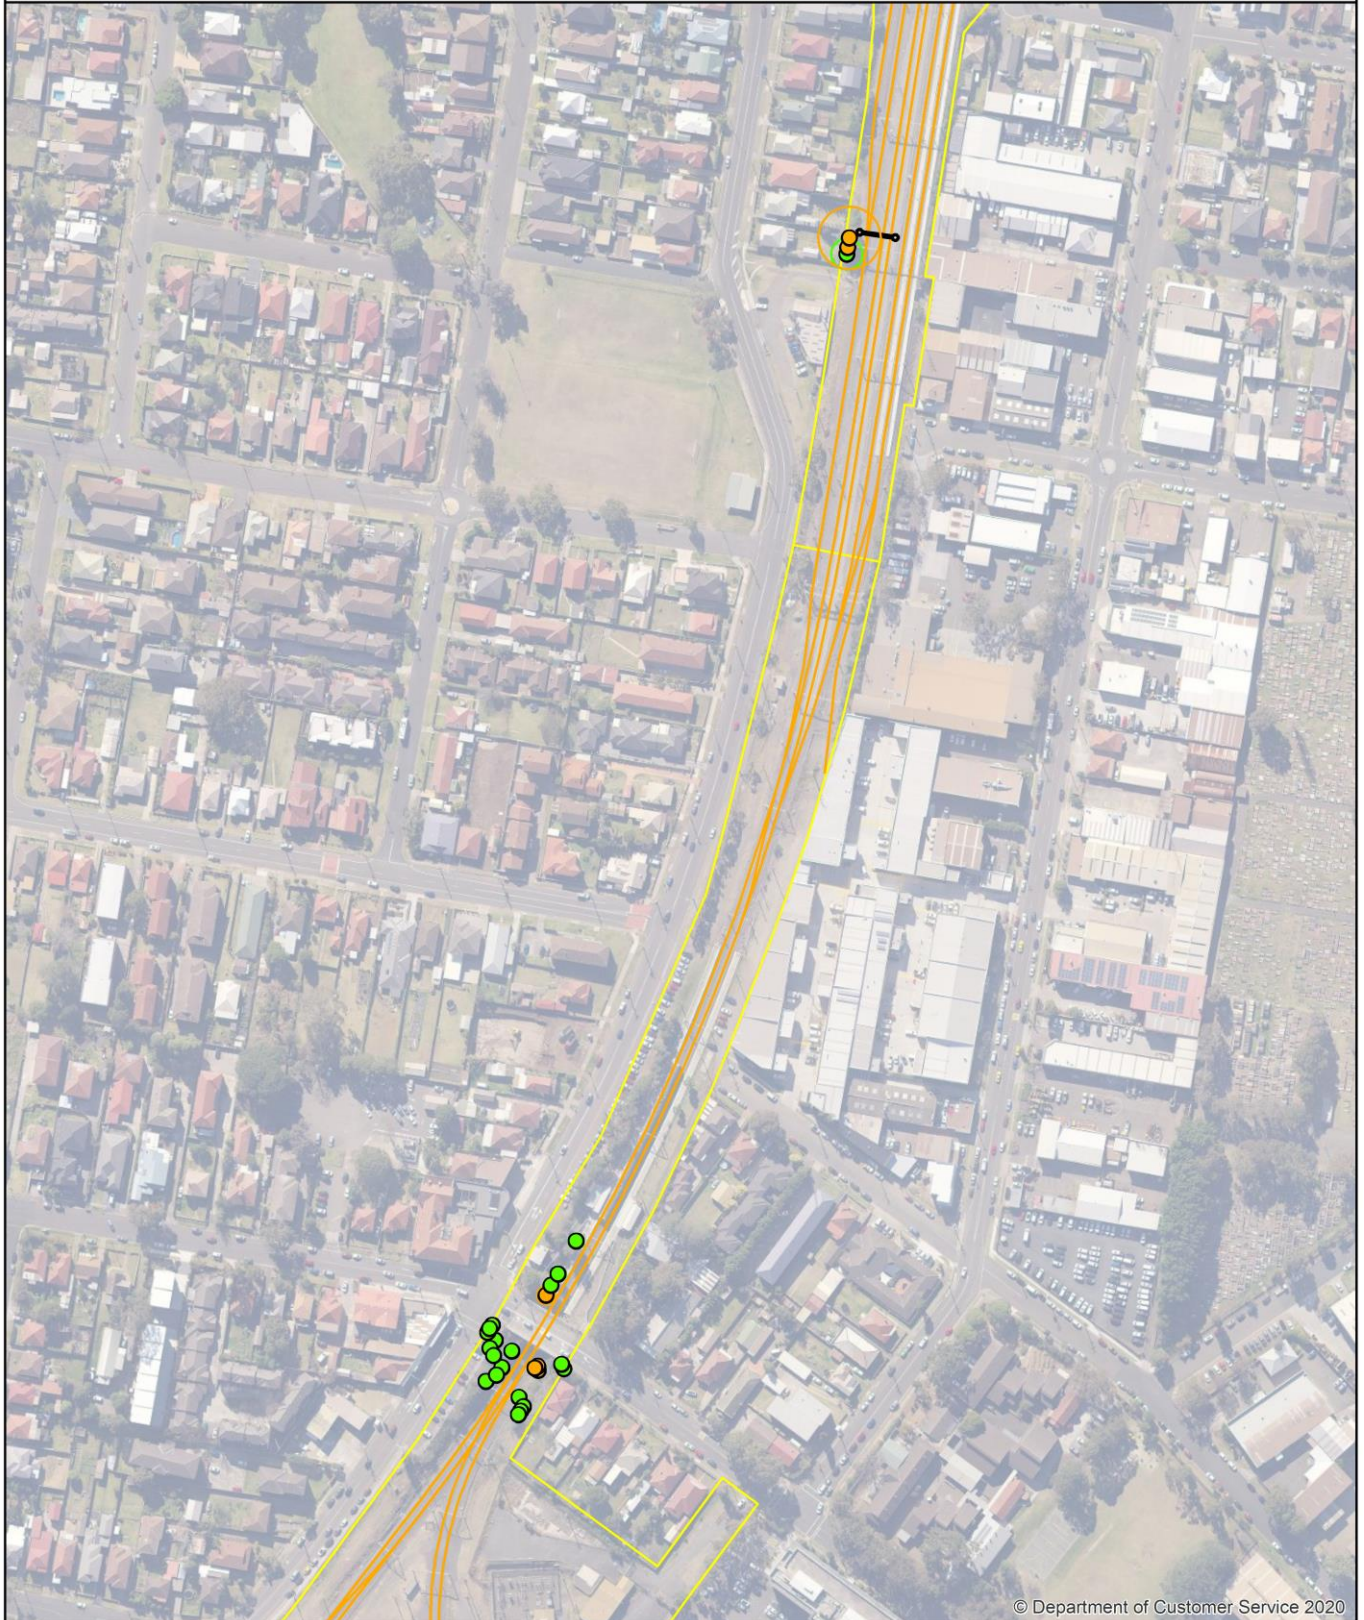
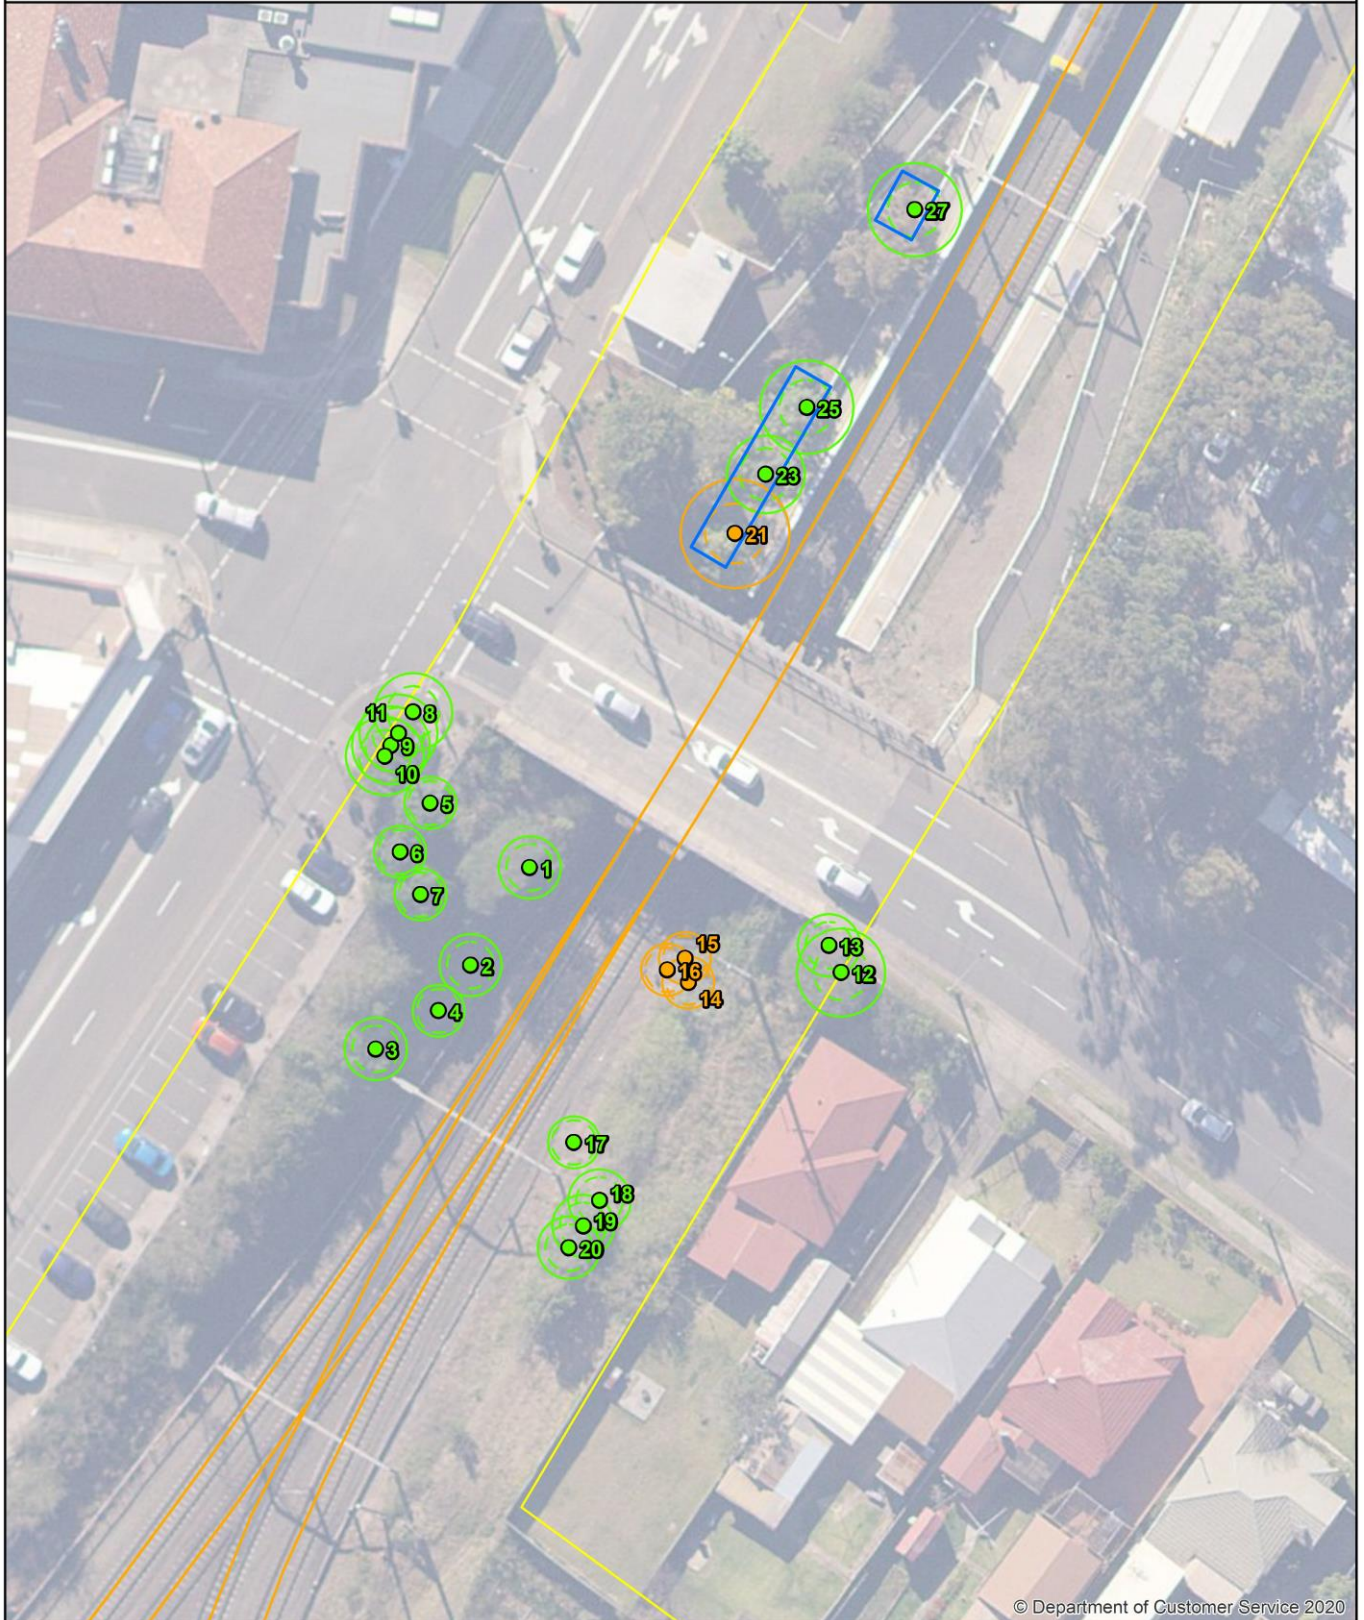
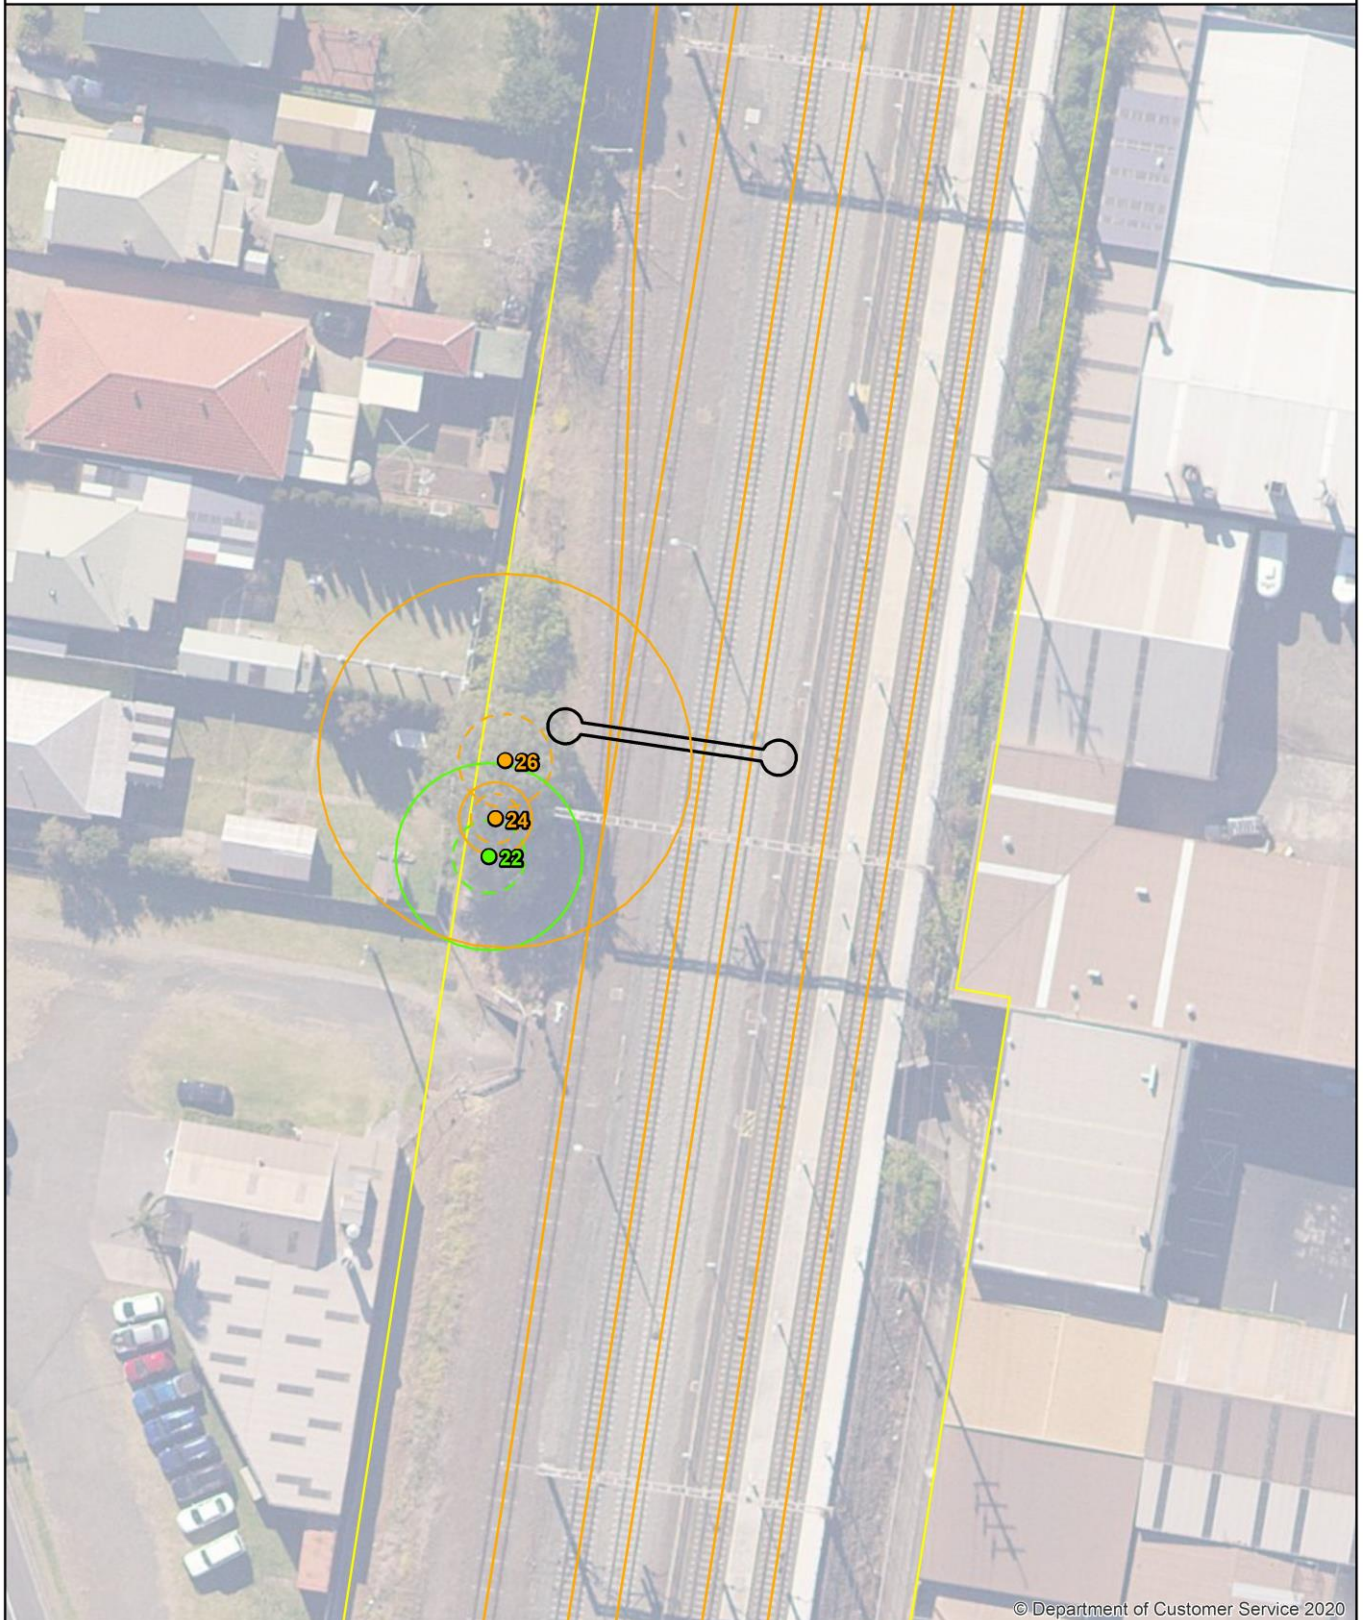
5.1 Tree removal and retention

- **Retain:** A total of **21** trees are proposed for retention.
- **Prune:** A total of **6** trees are proposed for pruning.
- **Remove:** A total of **0** trees are proposed for removal.

Minor vegetation trimming may be required to accommodate construction clearances. Standard pruning specifications are outlined below:

- Pruning must not exceed 10% of the overall canopy volume.
- No limbs greater than 150mm in diameter are to be removed.
- The final pruning cut shall be at the branch collar or growth point in accordance with the *Australian Standard AS 4373-2007, Pruning of Amenity Trees*.
- All tree pruning work is to be carried out by an arborist with a minimum AQF Level 3 qualification in Arboriculture, in accordance with Australian Standard AS 4373-2007, Pruning of Amenity Trees, and the NSW WorkCover Code of Practice for the Amenity Tree Industry (1998).
