Background:

Transport for NSW (TfNSW) is responsible for assessing damage and proposed restoration for culverts that are impacted by a Natural Disaster. This damage can range from loss of scour rock right through to the complete loss of the culvert structure. Often the restoration works are simple and will be fully funded under the NSW Natural Disaster Essential Public Asset Restoration Guidelines 2018. However, in some cases the repair method for the culvert is impacted by engineering and/or environmental constraints, resulting in other factors contributing to an overall 'best' solution.

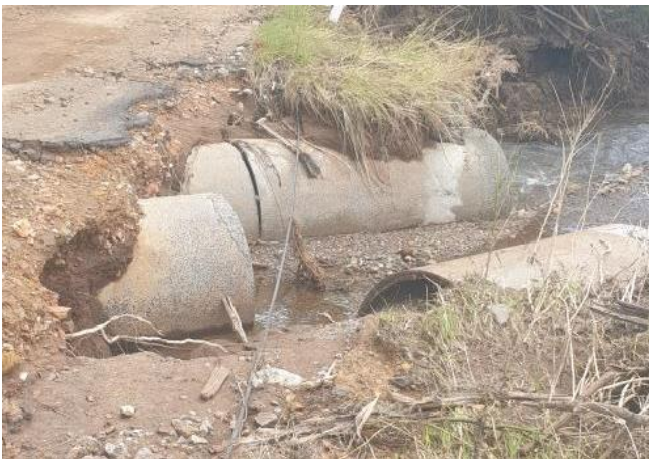
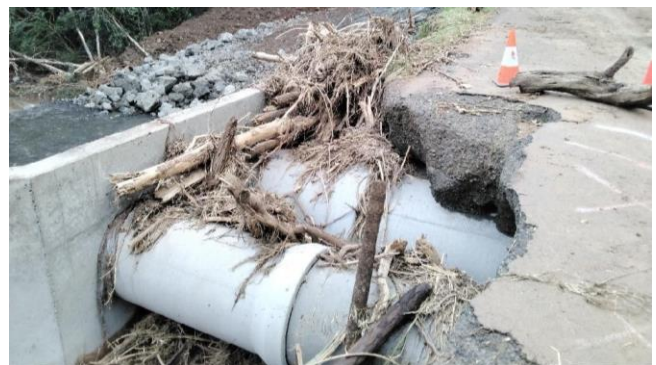
Example where Betterment may be eligible for Disaster Recovery restoration:

The entire length of a three cell 600mm diameter culvert has been damaged as a result of flood waters. The original three cell 600mm diameter culvert was designed to Q20 flood immunity. The current engineering standard for this location stipulates that Q50 flood immunity should be provided with four cells to comply.

The replacement of the three cells of the 600mm diameter culvert does not meet the current engineering standards, hence replacing the damaged culverts with four cells of 600mm as stipulated in Q50 is eligible for Disaster Recovery Funding.
