# Henry Lawson Drive Upgrade Stage 1A

Preliminary Site Investigation

**Transport for New South  
Wales**

16 May 2021

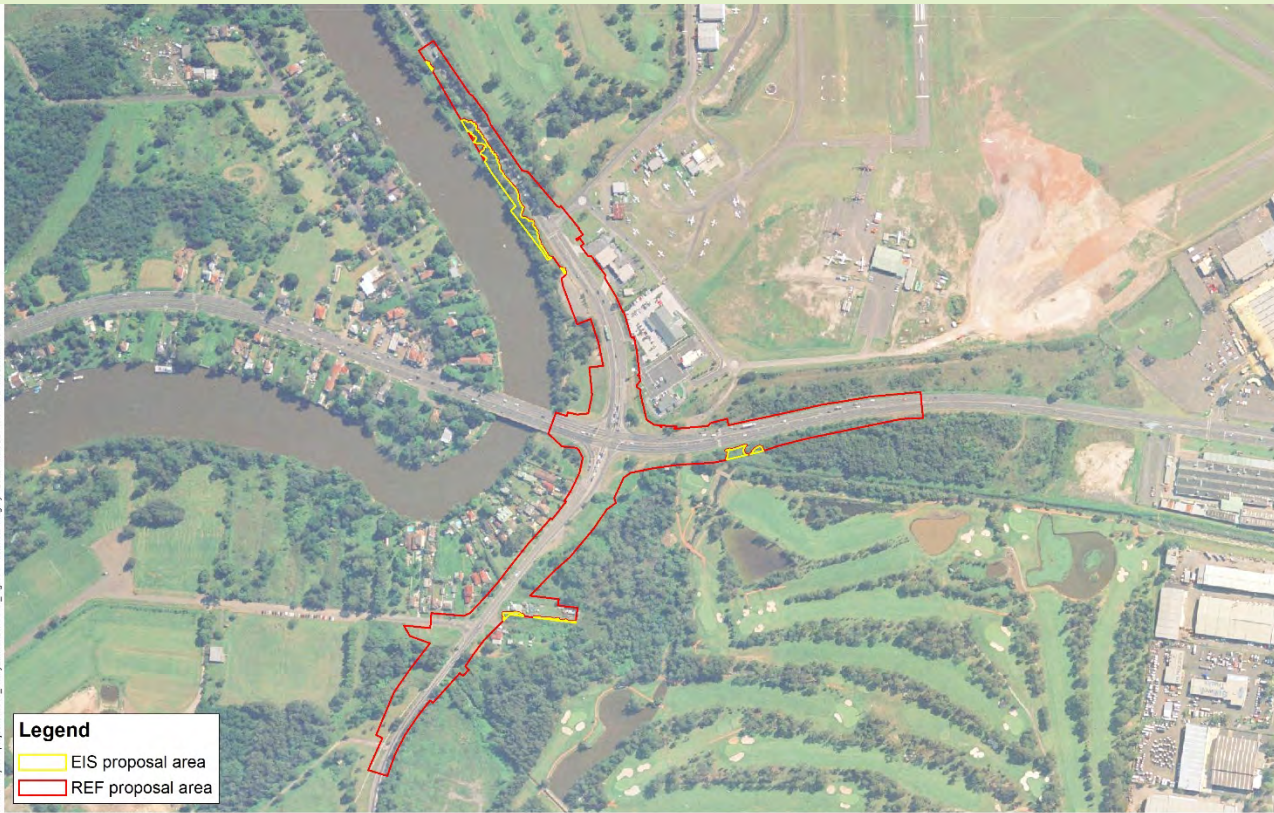
2002

Northeast corner has been developed into what appears to be a light industrial and commercial site.

Truckstop area has now been developed into several buildings and large complex. Aircraft parking and hangar facilities continue to expand on the airport site. Loss of some residential homes on the west bank of the Georges River.

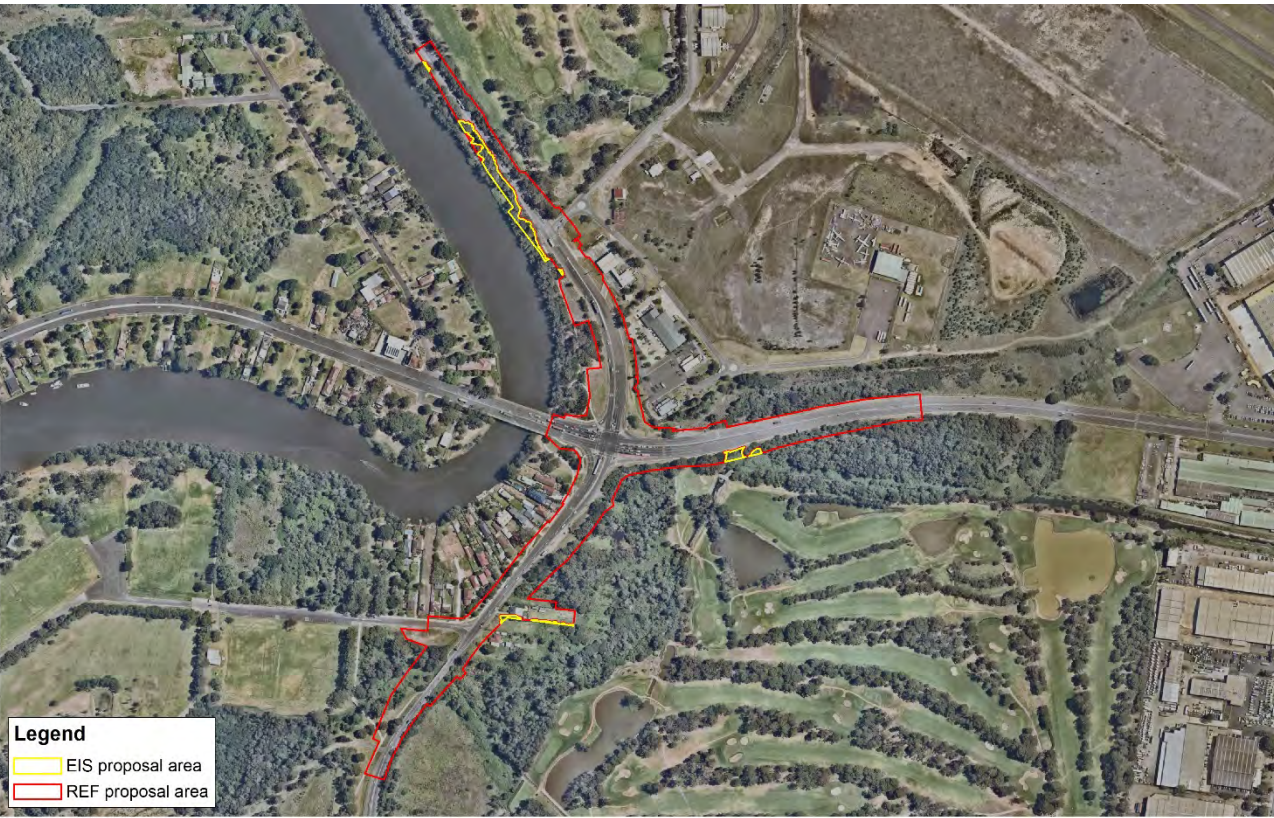
Year	Overall proposal area (REF and EIS)	Surrounding areas
2015	Regrowth of vegetation along the south east of Henry Lawson Drive and south of Milperra Road has occurred. No significant changes since 2002	Further loss of residential housing along the west bank of the Georges River. Roadway and surface excavations surrounding the hangar buildings at Bankstown Airport.

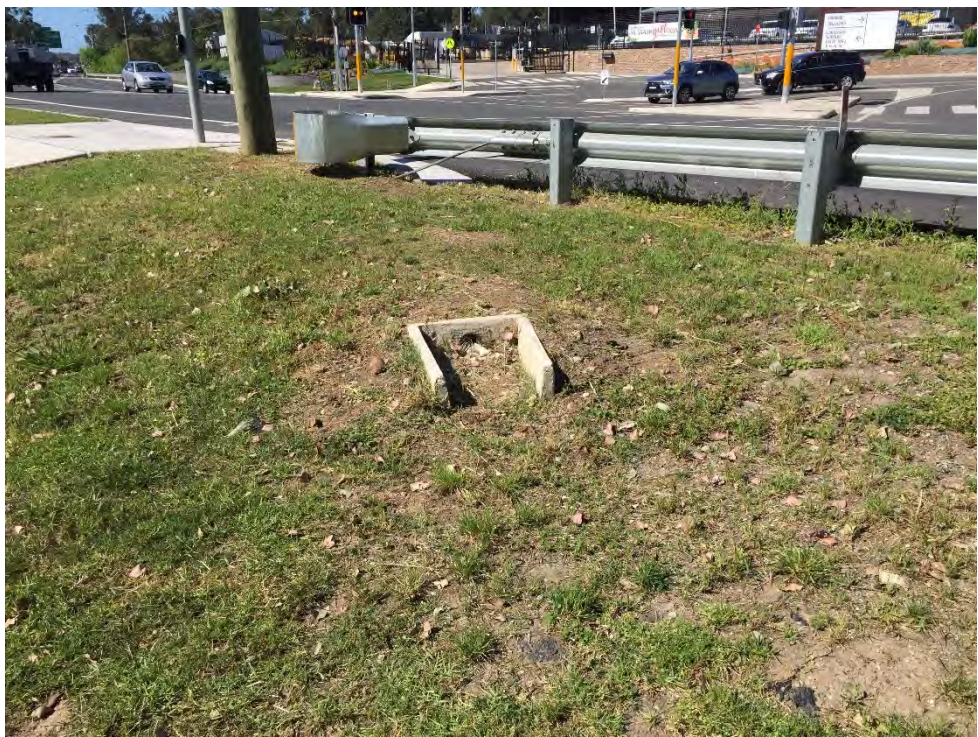
At Keys Parade: The site is highly urbanised with numerous artificial drains and gutters along Henry Lawson Drive. Some of these drains lead into the large drainage ditch to the south.

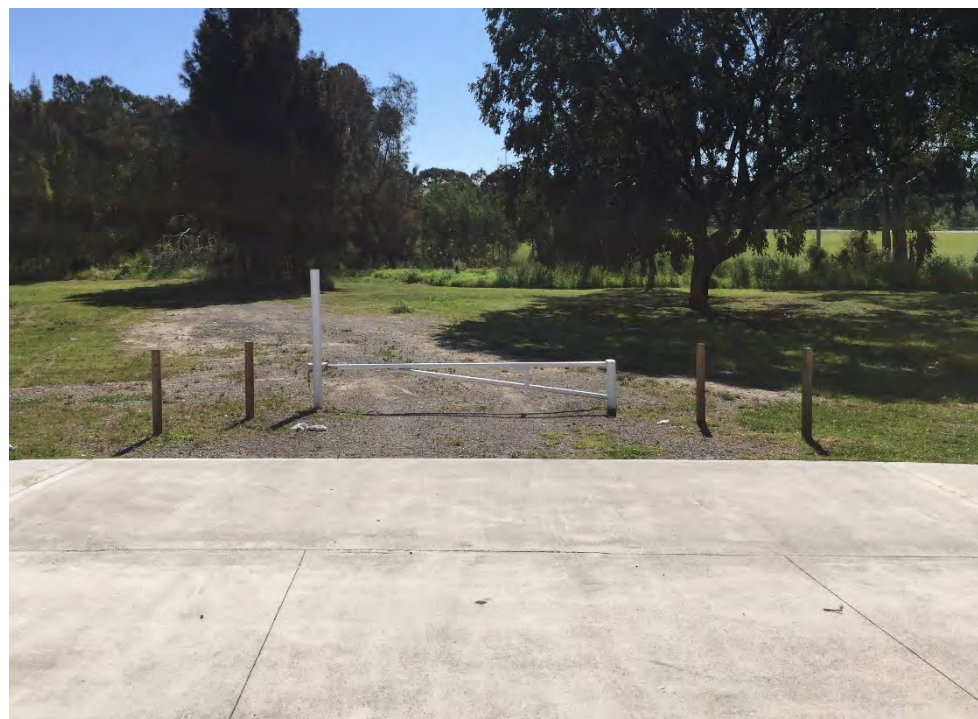
At Keys Parade: There is an entry and exit gate adjacent to Henry Lawson Drive, which lead into a large area potentially used for parking, storage and/or maintenance. Surface conditions consisted of cleared non vegetated land with angular to sub angular rocks and gravels.

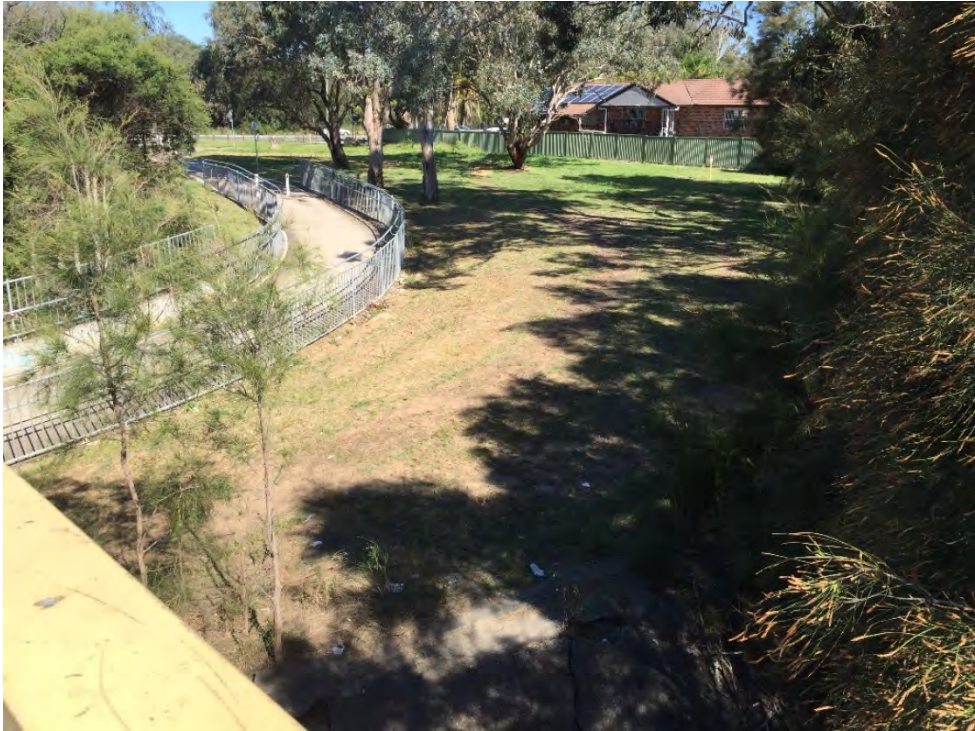
<b>Photo No.</b> 13	<b>Date</b> 28/10/2020

<b>Description</b> There is a large area of bare earth adjacent to the bridge and Milperra Road.

- Aurecon noted evidence of fill across the site, angular to sub angular rocks, pebbles and gravels were observed on the ground surface and within the soil (refer Photographs 6, 8, 13, 16, and 40)

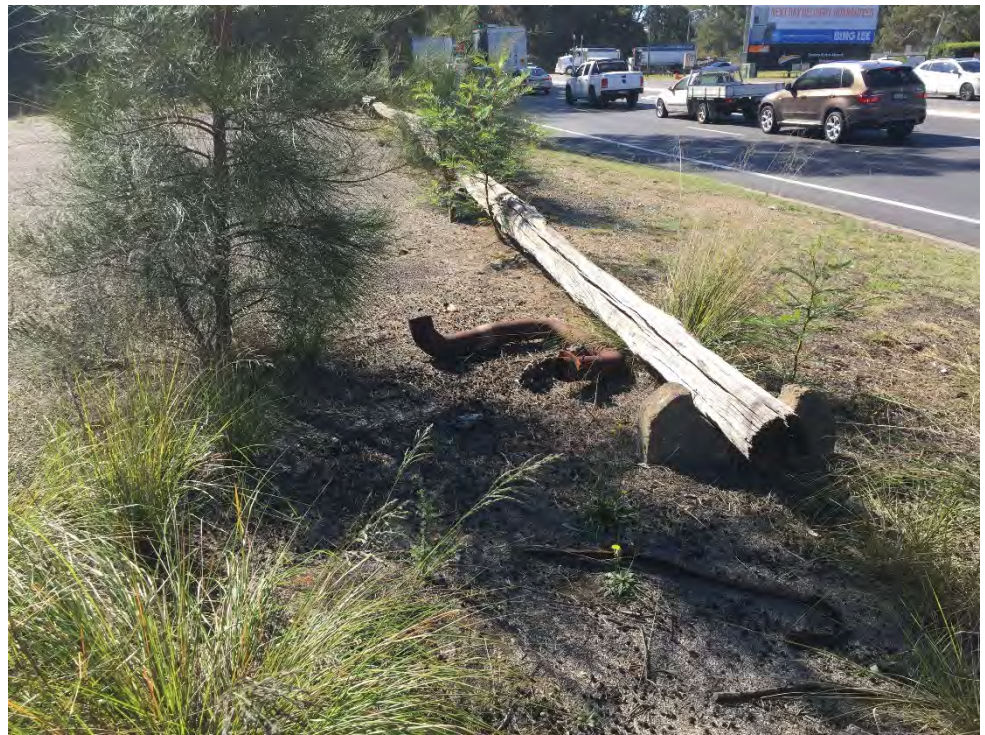
<b>Photo No.</b> 18	<b>Date</b> 28/10/2020
------------------------	---------------------------

**Description**  
Old or damaged car parts were observed dumped in the gated hardstand area adjacent to Henry Lawson Drive opposite the BP Tuckstop. The material consisted of a rusty exhaust pipe, metal poles, a tyre and car seat.

- There was a significant amount of general rubbish, plastic, rubber, cardboard, wrappers, pieces of glass, metal, metals poles and old/damaged car parts (rusty exhaust pipe, car tyres and seats) across the site and adjacent to main roads (refer Photograph 22)

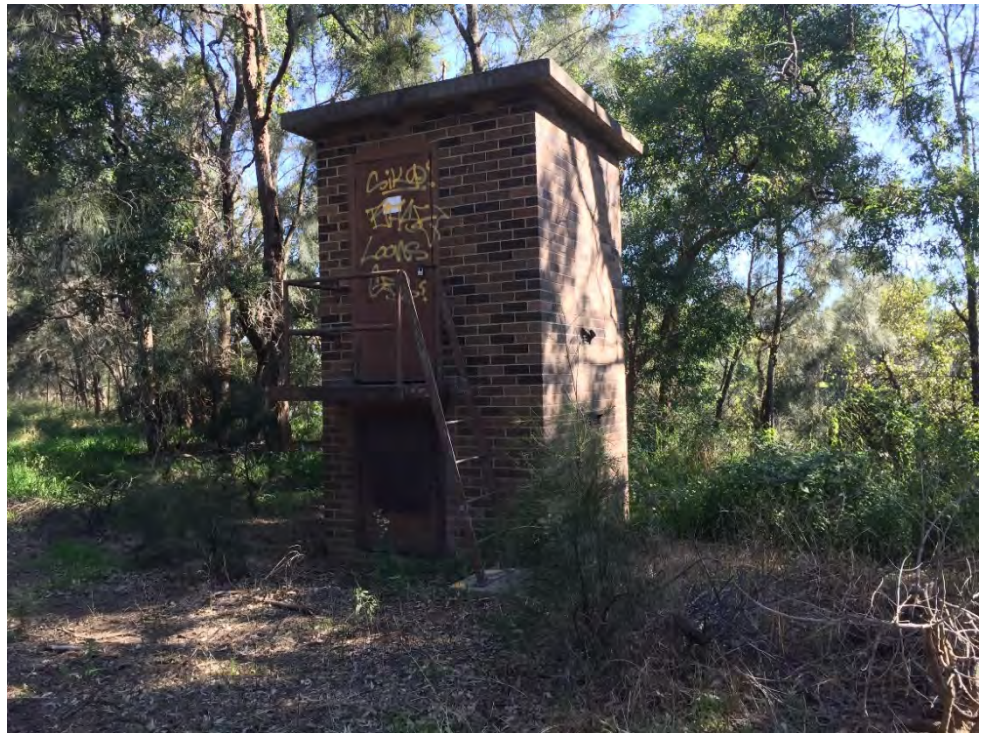
**Description**  
An old building with rusty infrastructure is present in the north, adjacent to Georges River. Potential Hazardous Building Material (HBM) due to the age of the building.

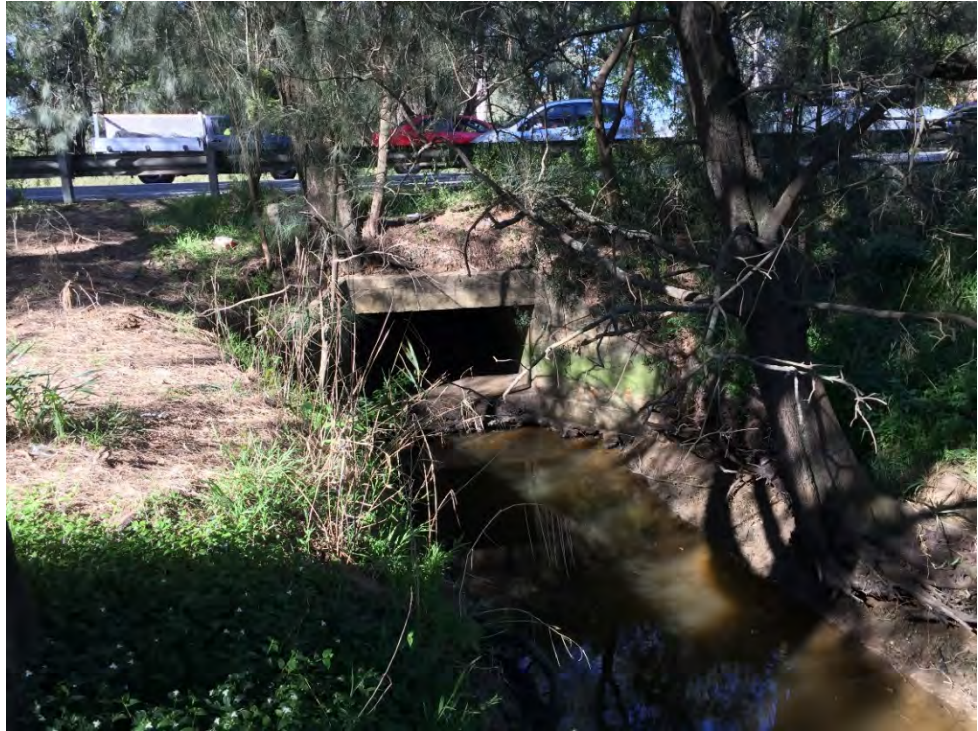
<b>Photo No.</b> 21	<b>Date</b> 28/10/2020
------------------------	---------------------------

**Description**  
To the north of Tower Road: there is a large artificial culvert and drainage line running east to west from Georges River Golf Course, under Henry Lawson Drive and into Georges River.

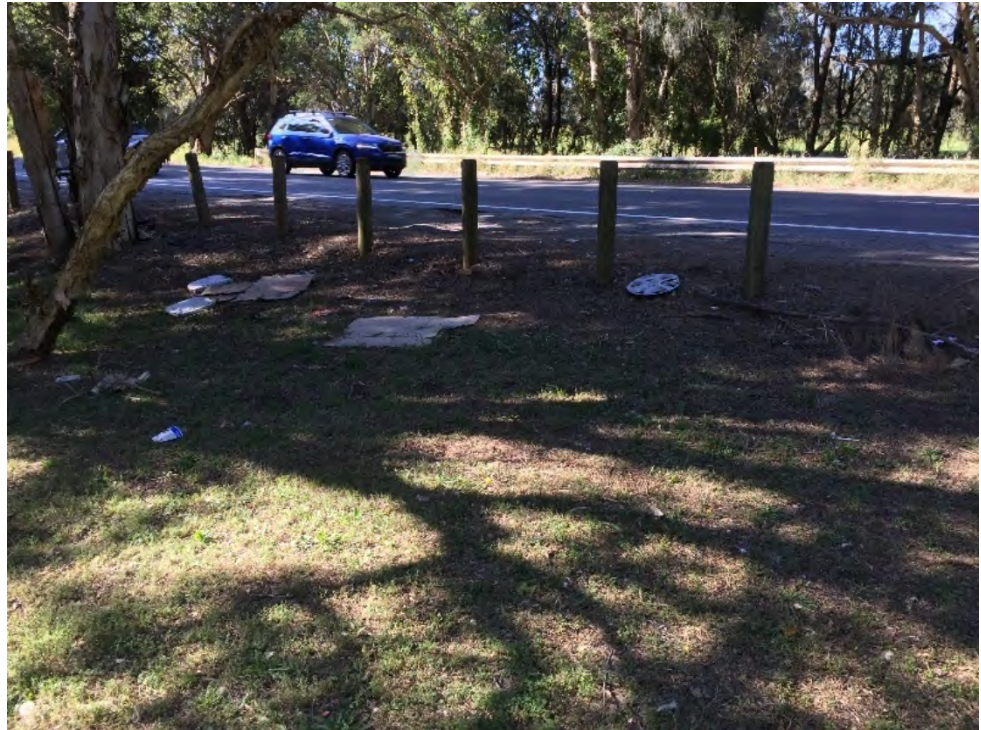
<b>Photo No.</b> 22	<b>Date</b> 28/10/2020
------------------------	---------------------------

**Description**  
To the north of Tower Road, there is a significant amount of general rubbish and some dumped old car parts adjacent to Henry Lawson Drive.

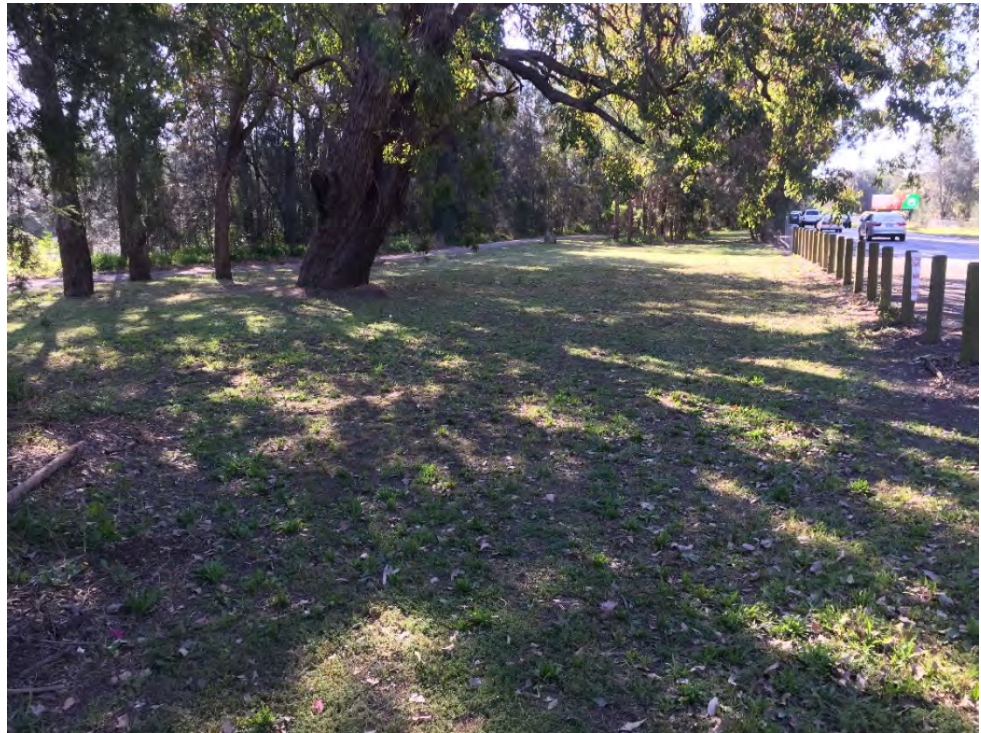
<b>Photo No.</b> 24	<b>Date</b> 28/10/2020
------------------------	---------------------------

**Description**  
Surface conditions near the far north western boundary of the site. Coverage consisted of vegetated land (grass covering) with patches of bare earth and general rubbish. There were some rocks and gravels observed on the surface

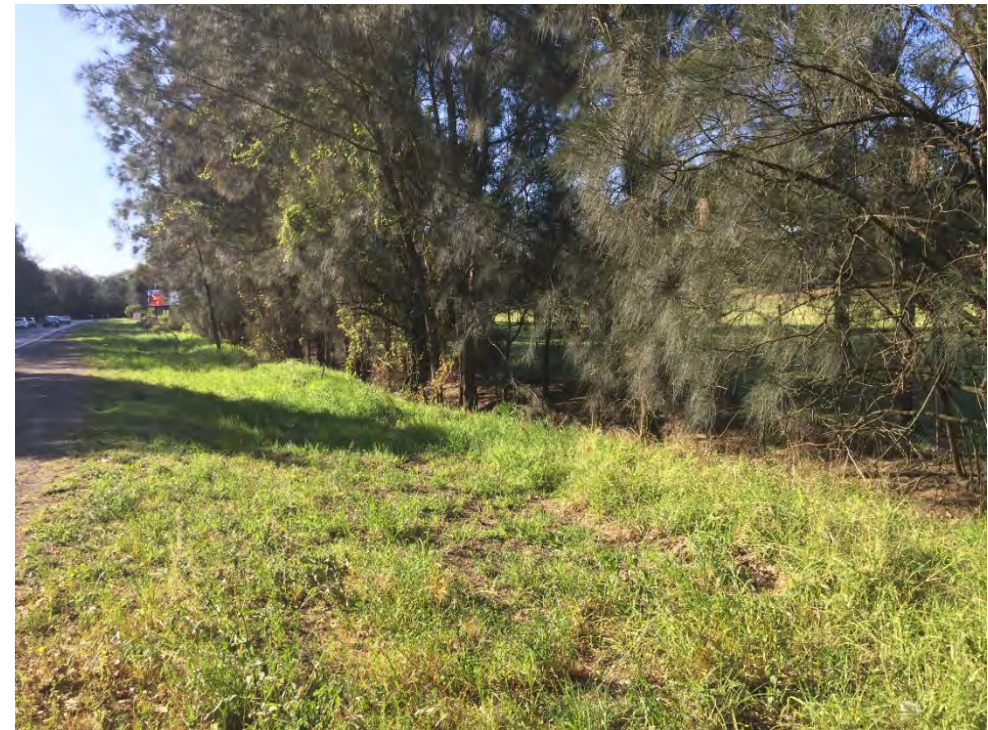
**Description**  
North of Tower Road. There is a slight to moderate gradient falling from Henry Lawson Drive towards a drainage line along the Georges River Golf Course.

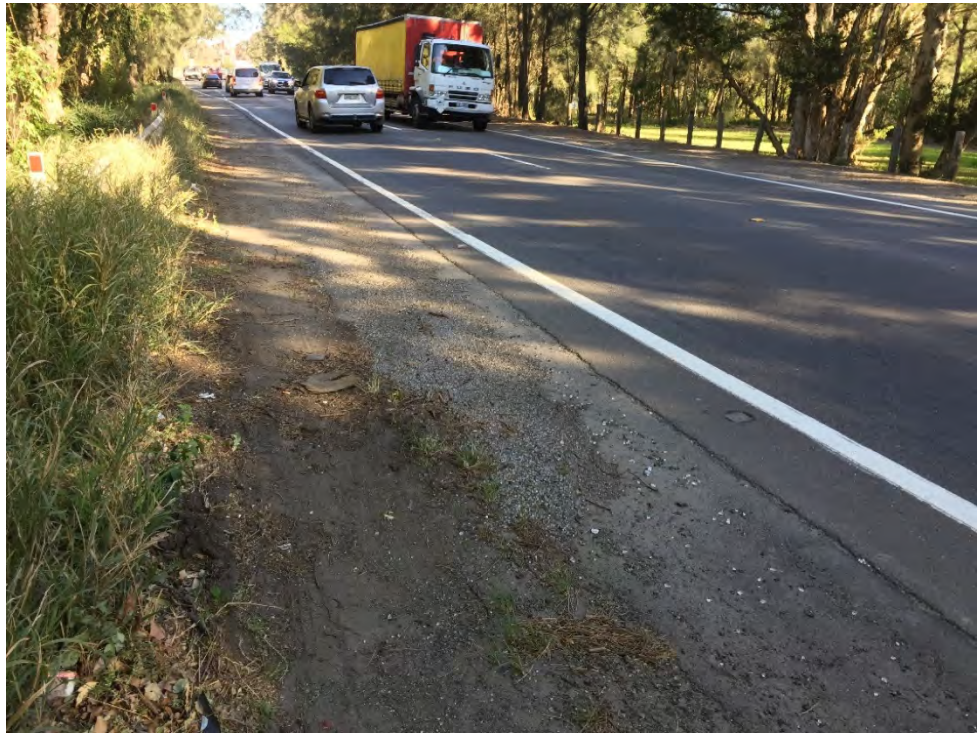
<b>Photo No.</b> 26	<b>Date</b> 28/10/2020
------------------------	---------------------------

**Description**  
There is a lot of broken glass adjacent to Henry Lawson Drive near the northern boundary of the site. This could potentially be from vehicle accidents and wreckage, which could cause contamination from leaking of car fluids (fuel, lubricant and coolant).

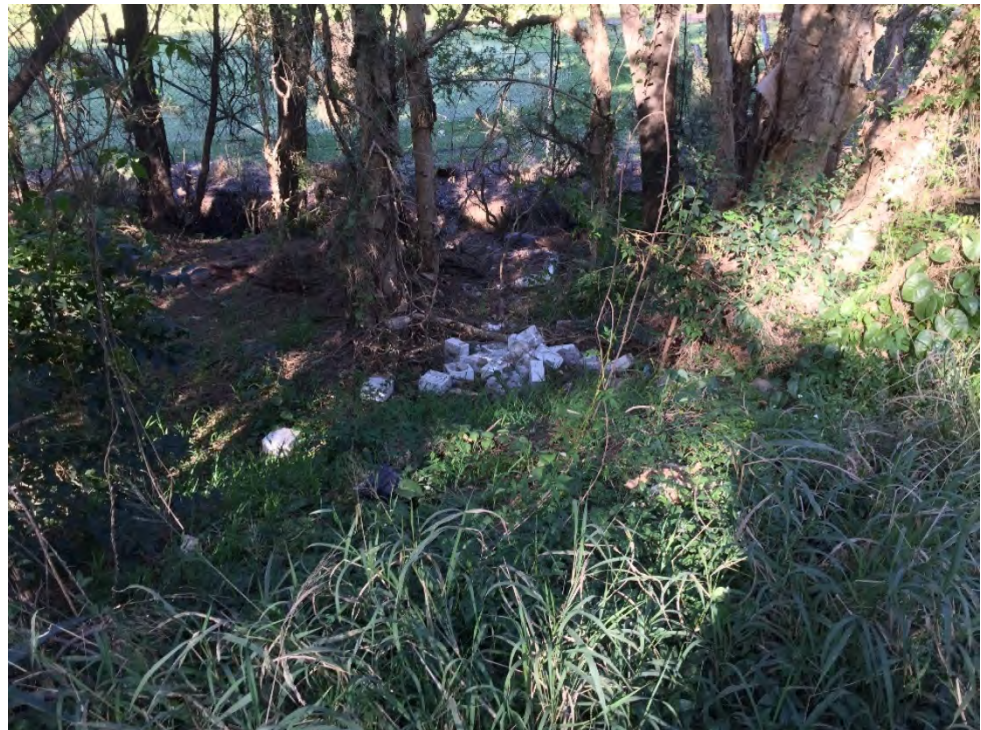
**Description**  
Significant amounts of general rubbish were observed along Henry Lawson Drive, adjacent to the Georges River Golf Course.

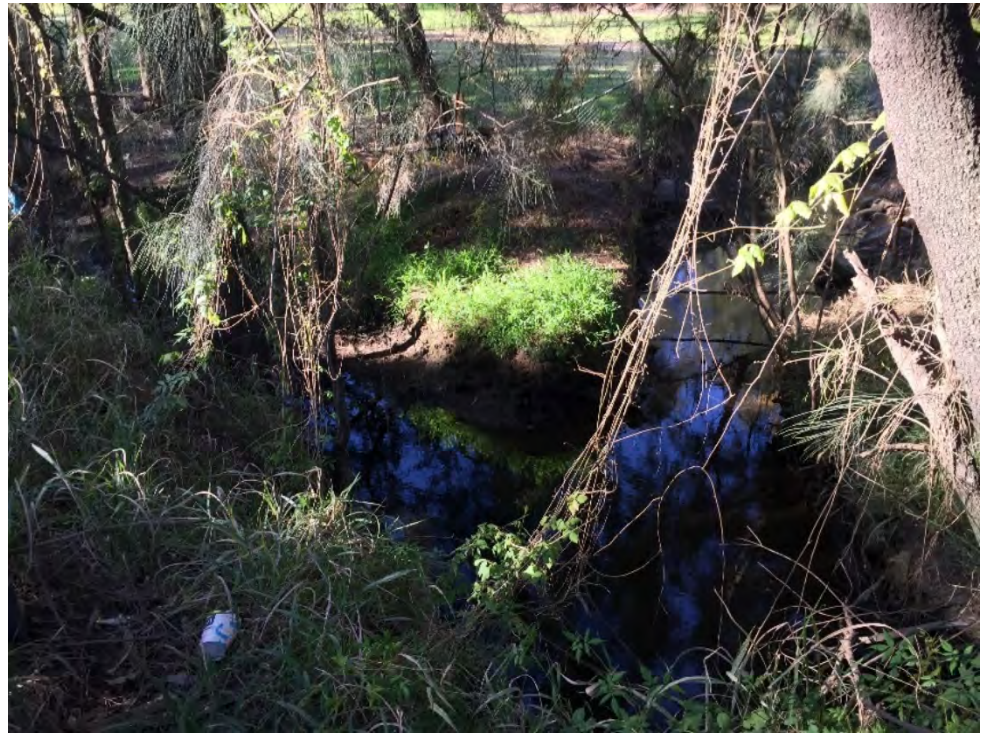
<b>Photo No.</b> 27	<b>Date</b> 28/10/2020
------------------------	---------------------------

**Description**  
There is an artificial drainage line running north west to south east along Henry Lawson Drive, which diverted from the Georges River Golf Course.

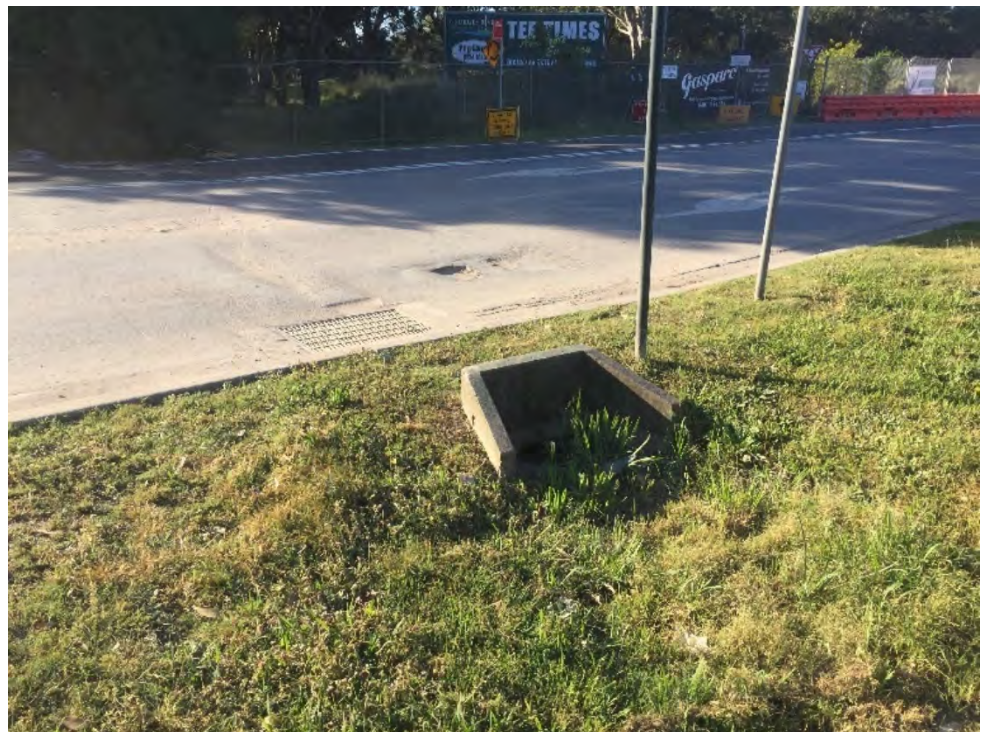
<b>Photo No.</b> 28	<b>Date</b> 28/10/2020
------------------------	---------------------------

**Description**  
Majority of the site is highly urbanised and developed with an artificial rain gutter and numerous drains running along both sides of Henry Lawson Drive to the north.

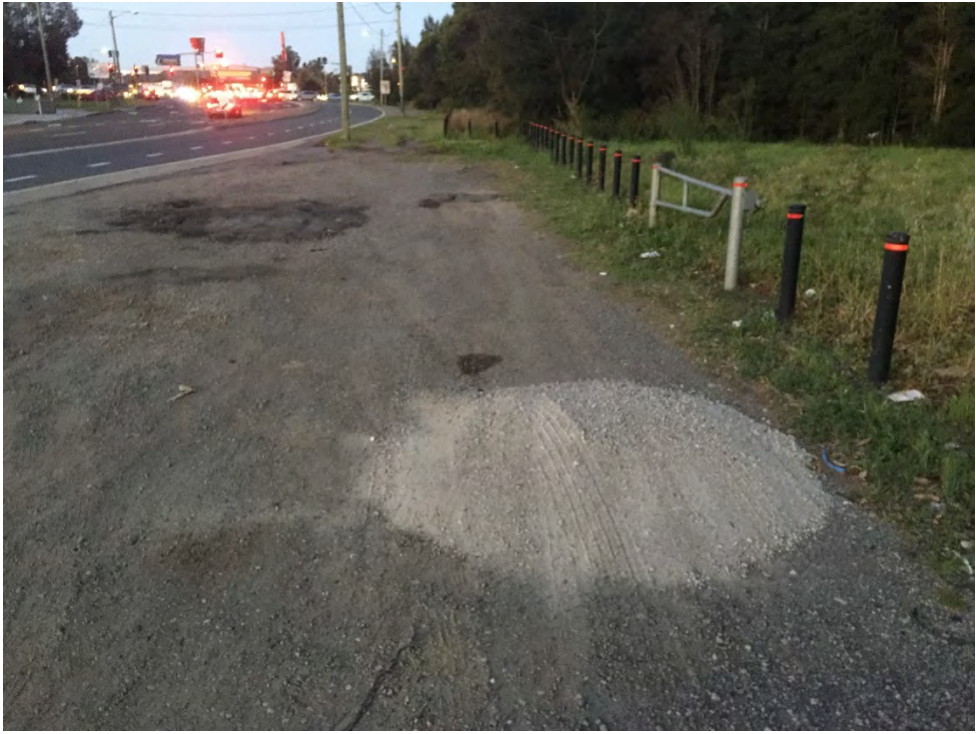
<b>Photo No.</b> 40	<b>Date</b> 28/10/2020

<b>Description</b> There were signs of uncontrolled fill near the south eastern boundary of the site. South of Milperra Road on the eastern side of Henry Lawson Drive A small patch of dumped asphalt and a stockpile of material with angular to subangular rocks and gravels were present. There are also obvious patches of chemical staining adjacent to the stockpile and asphalt, which could contaminate the surrounding environment.

- There were multiple areas of cleared non-vegetated gravelly land along Henry Lawson Drive and Milperra Road, which were potentially used for informal parking, temporary stopping, storage and dumping of old/damaged car parts. These areas could be minor potential sources of contamination due to the leaking of car fluid (fuel, oil, lubricant and coolant). Surface covering consisted of mostly angular to subangular rocks and gravels (refer Photograph 6, 16, 36 and 38). Some of these small areas located south along Henry Lawson Drive, could be potential sources of contamination due to signs of chemical staining (refer Photograph 39 and 40).

- There was a small stockpile of potential fill with angular to sub angular rocks and gravels observed in a cleared area to the south adjacent to Henry Lawson Drive (refer Photograph 40)

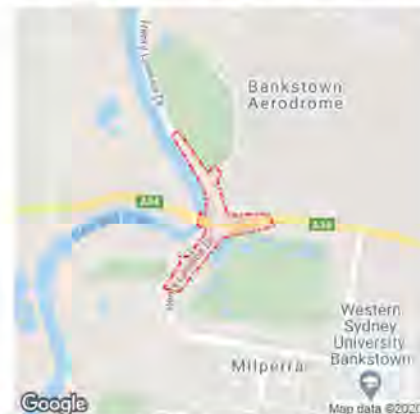
This search is based on the geographical position of the dig site as denoted in the Dial Before You Dig caller confirmation sheet and an overview is provided:

Address:	Henry Lawson Drive Milperra NSW 2214
Job #:	20310876

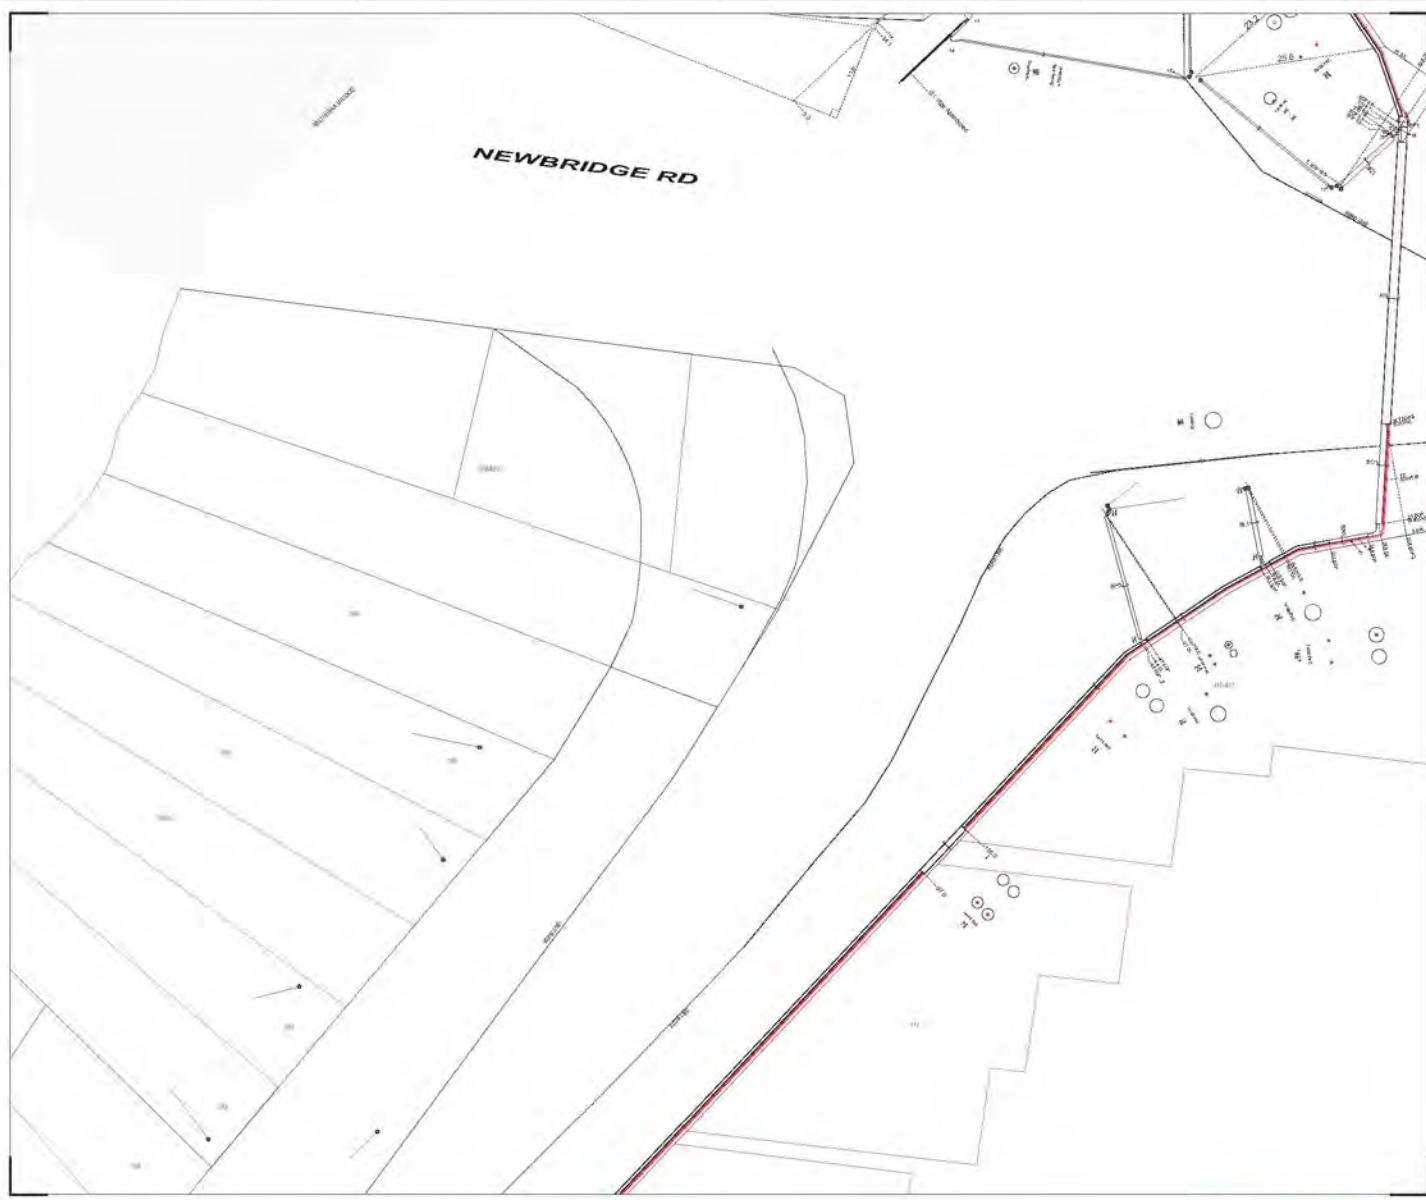
EH314  
 MOCS  
 Page 1 of 1  
 1:250  
 0 5 10 meters

EH314 - AI1  2x125 PVC N/A 0.607 Ref: B10	EH314 - BH1  2x125 PVC N/A 0.507 Ref: D9
EH314 - BL1  2x125 PVC N/A 0.607 Ref: D9	EH314 - BN1  2x125 PVC N/A 0.507 Ref: D10
EH314 - BO1  2x125 PVC N/A 0.507 Ref: C10	EH314 - BP1  2x125 PVC N/A 0.507 Ref: B10
EH314 - BO1  2x125 PVC N/A 0.507 Ref: B10
