Two more landslip sites repaired near Cambewarra Mountain

Natural disaster recovery on Moss Vale Road

June 2023

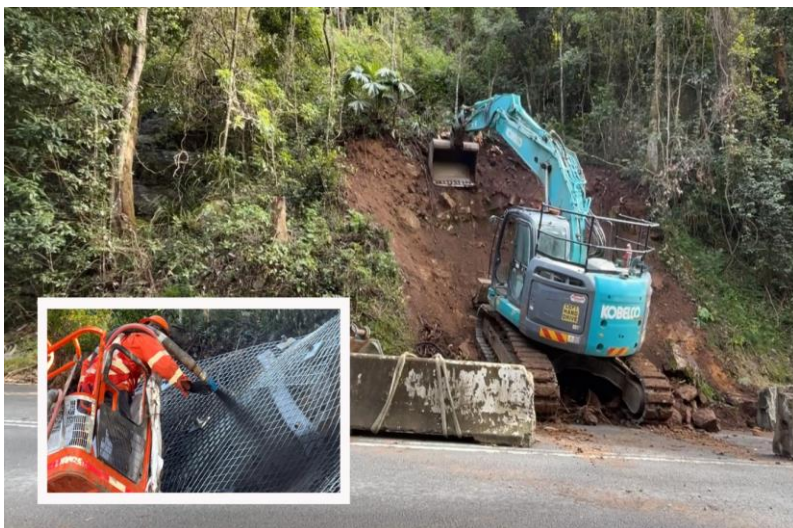
A long-reach excavator was used to remove loose material and drill the soil nails, while workers accessed the steep slope from an elevated work platform (inset) to complete tasks like applying shotcrete.

- soil nails and rock bolts that add strength across the slope
- a durable layer of Geomesh
- spray-on concrete mix known as “shotcrete”.

- removed nine cubic metres of loose material
- installed 40 soil nails and 17 rock bolts
- laid 36 square metres of Geomesh mat
- applied 20 cubic metres of shotcrete.
