Re: Amended REF—Aboriginal and Historic Heritage Constraints and Recommendations

Lendlease Communities (Figtree Hill) Pty Ltd (Lendlease) has engaged GML Heritage Pty Ltd (GML) to undertake Aboriginal and historical heritage assessment and management for the following amended changes, required by Transport for NSW, to the Appin Road design. The Amended Review of Environmental Factors (REF) boundary includes:

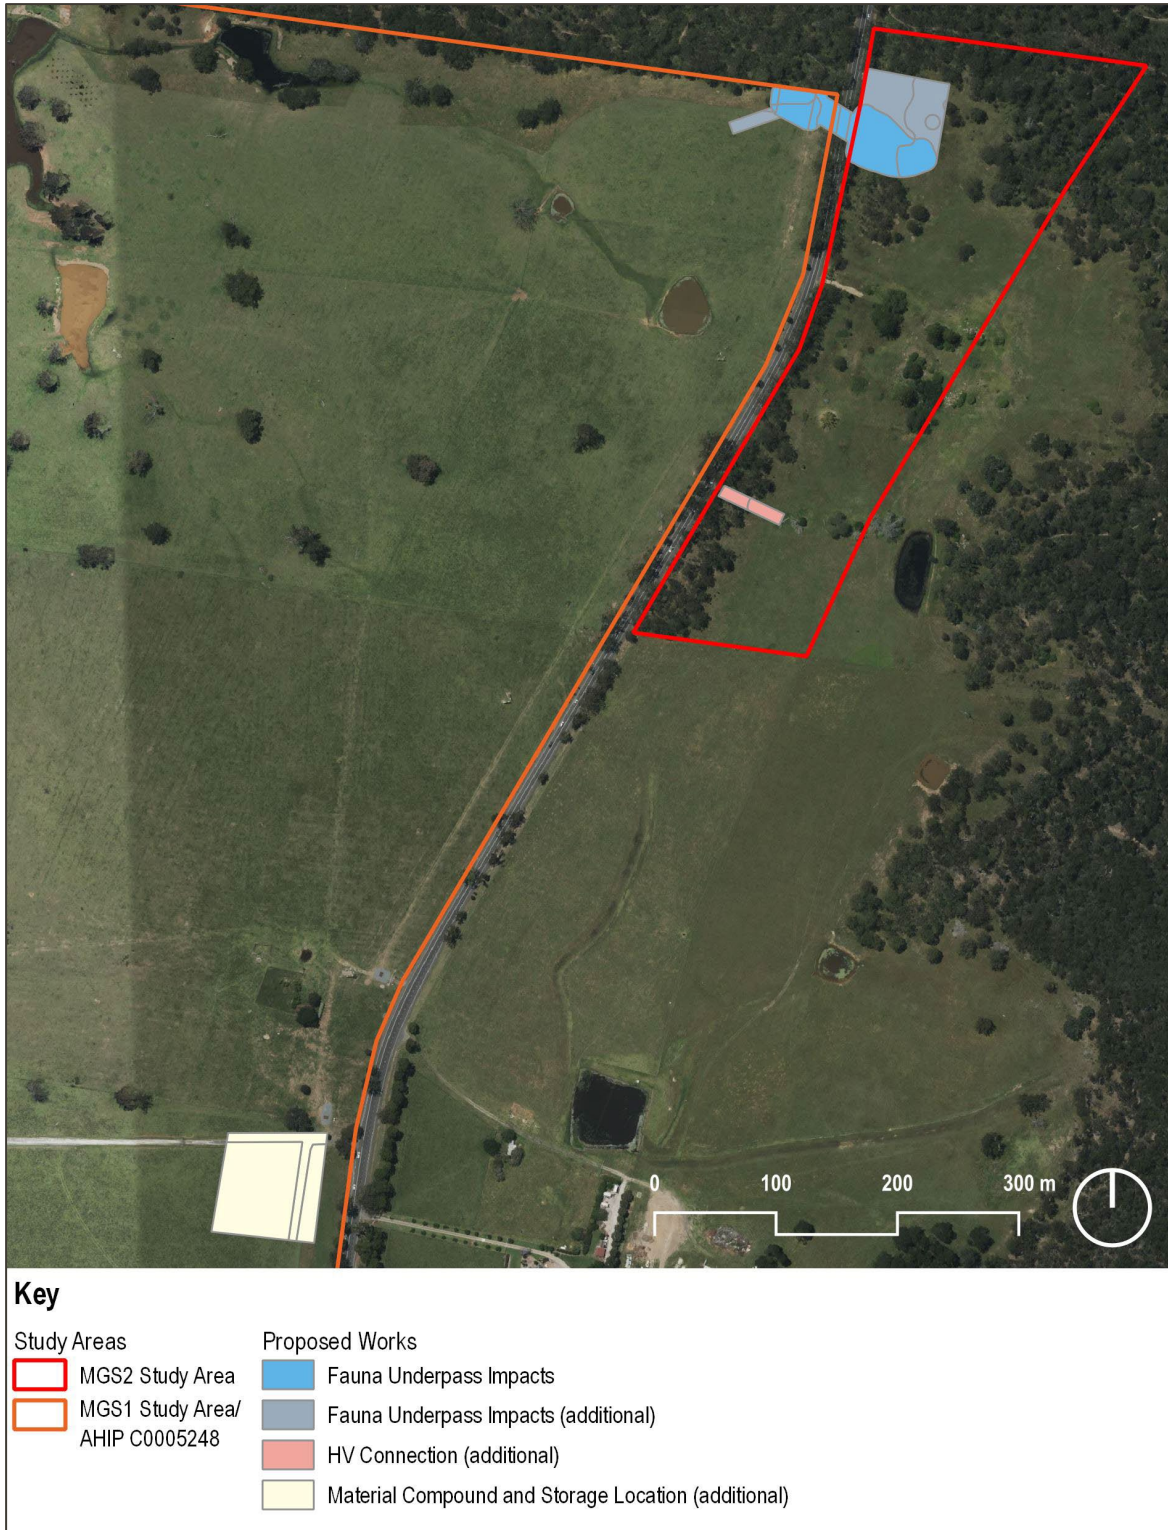
Figure 1 The proposed works in relation to Mount Gilead Stage 1/AHIP C0005248 (orange outline) and Mount Gilead Stage 2 (red outline). (Source: Lendlease, NSW LPI Imagery with GML overlay)

The proposed works, as well as the previously assessed Fauna Underpass Impacts, are presented in Figure 1.

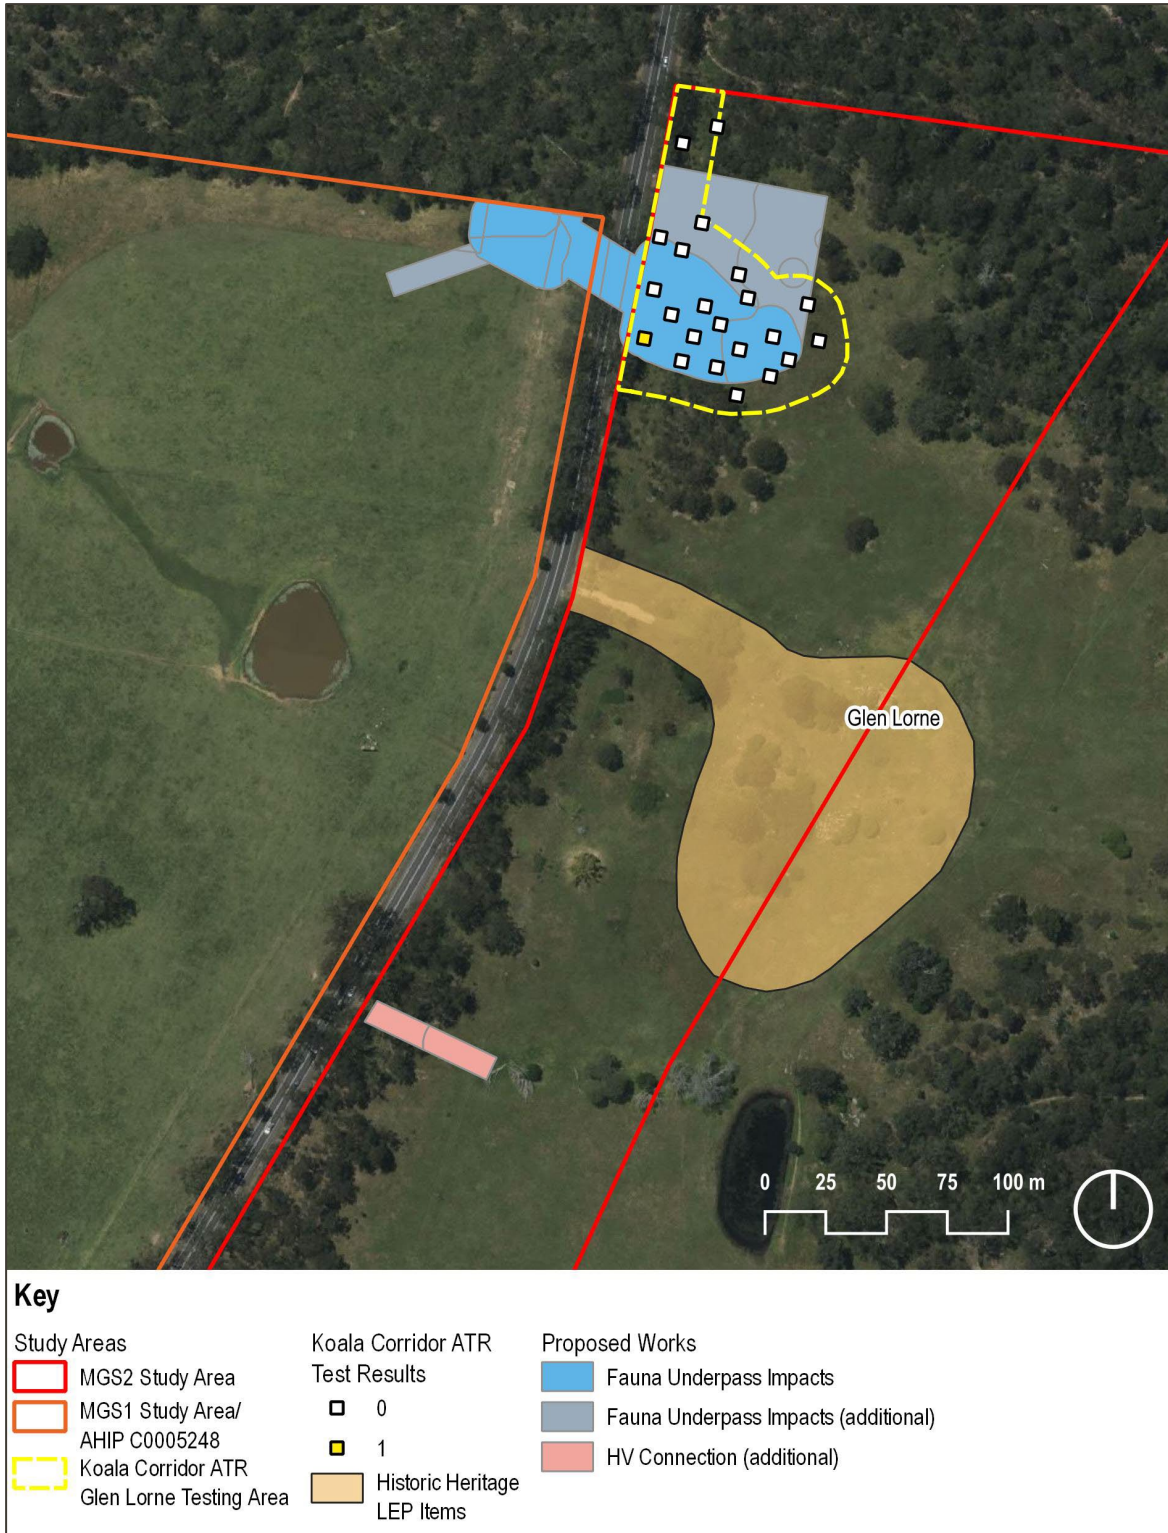
Figure 2 The proposed Fauna Underpass Impacts (additional) and additional area of HV connection in relation to the Glen Lorne CLEP item (I55) and Aboriginal archaeological test excavation units. (Source: Lendlease, NSW LPI Imagery with GML overlay)

The works proposed as part of the Fauna Underpass Impacts (additional) extend the area of impact to the northwest of that area assessed under the ATR. The proposed impacts will occur within the same landform, and in immediate proximity to the testing area (Figure 2). The assessment of the ATR can be applied to Fauna Underpass Impacts (additional) without the need for further archaeological excavations.

The works proposed as part of the HV connection occur on a similar landform to the Koala Crossing Glen Lorne testing area; however, the HV connection is located 285m to the south. Given the distance from the Glen Lorne testing area, the ATR findings cannot be applied to the HV connection impact area (Figure 2). The impacts from the works must be investigated following the same methodology presented in the ARD. The findings of these investigations must be presented in an additional ATR to be included as an appendix to the ACHAR.

The proposed works as part of Fauna Underpass Impacts (additional), and the additional area for HV connection are in the vicinity of Glen Lorne, identified in the Campbelltown Local Environmental Plan 2015 (CLEP) as an item of local significance (Item No. I55) (Figure 2). The proposed amendments to the Appin Road design do not impact on this or any other identified heritage item.

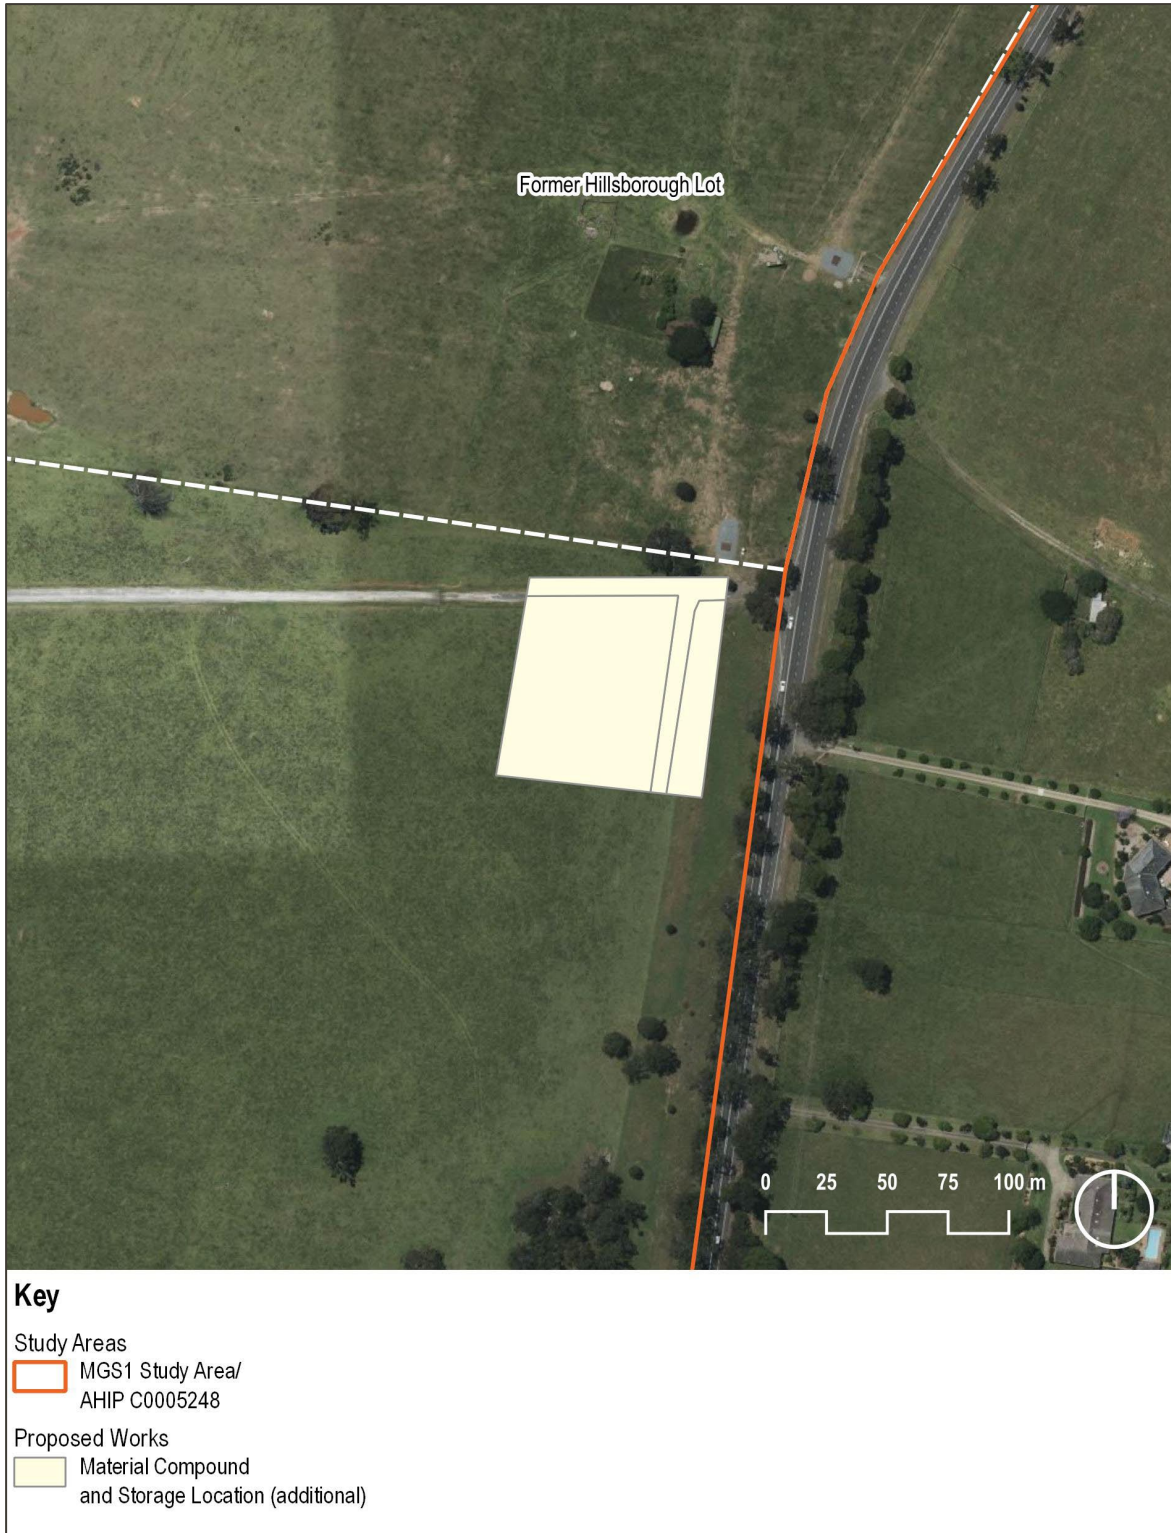
Figure 3 Proposed Material Compound and Storage Location (additional) works. (Source: Lendlease, NSW LPI Imagery with GML overlay)

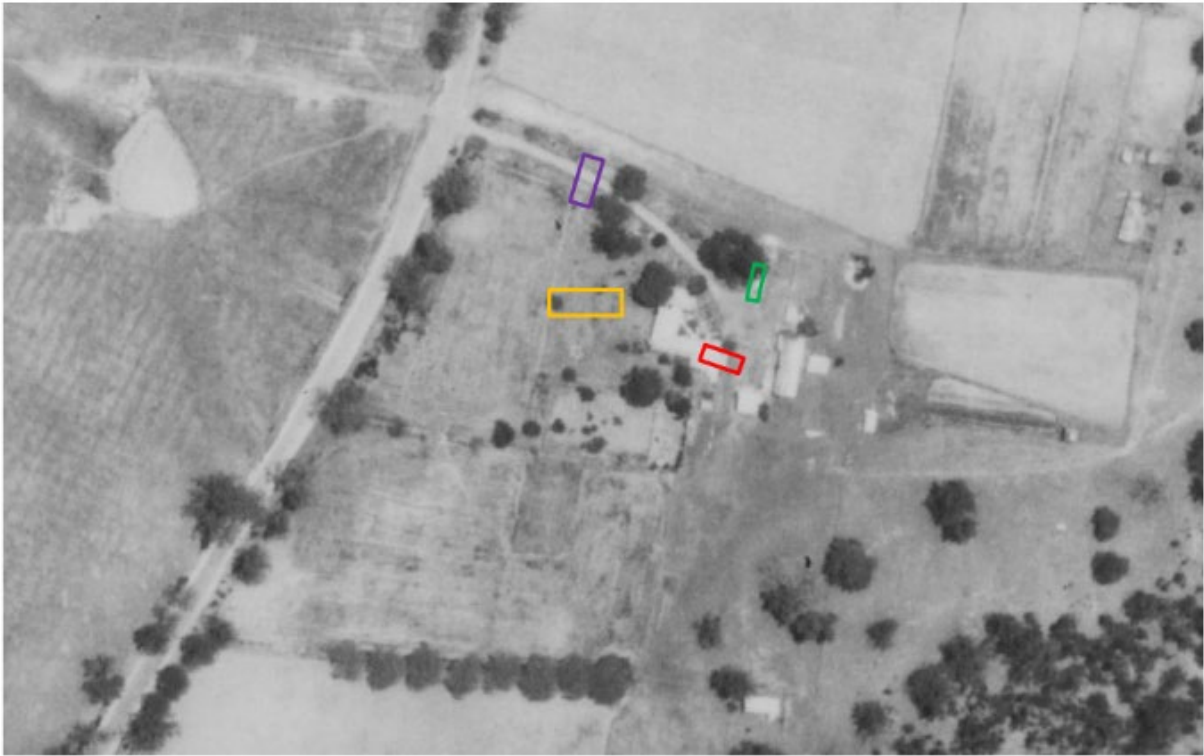
Figure 4 Proposed locations for future Glen Lorne research project historical archaeological testing, at the Glen Lorne site overlaid onto the 1943 aerial. (Source: SIX Maps with GML overlay)

Glen Lorne is subject to ongoing historical archaeological research. The Glen Lorne Archaeology Project is a joint venture between Lendlease, GML and the University of Sydney Archaeology Department. We have developed thematic research frameworks, an archaeological research design, and have ongoing research (including an honours project in 2023) which focuses on Glen Lorne. It is proposed that initial archaeological work will focus on excavation around the site, with trenches placed to investigate the eastern side of the Glen Lorne house, the site of the cold store, and the site of the former carriage loop, adjacent to the main entrance drive (Figure 4).

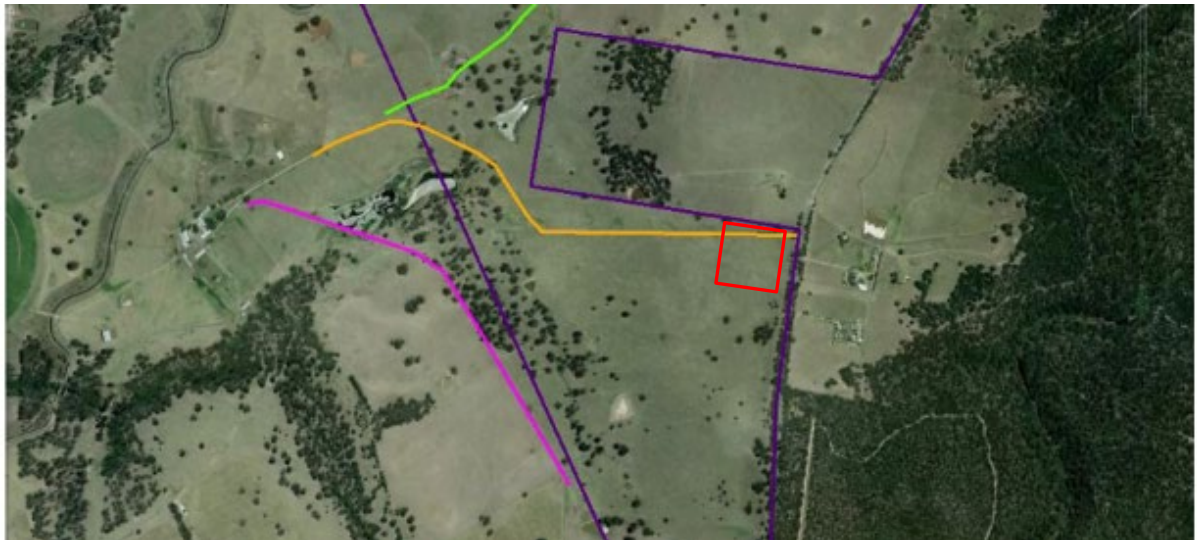
Figure 5 The former Mount Gilead estate carriageway (orange line) is within the approximate location of the proposed Material Compound and Storage Location (red square). (Source: Tropman and Tropman Architects/Navin Officer 2014, Figure 14)

Previous historical archaeological assessment of Mount Gilead (*Mount Gilead, Appin Road, Gilead Campbelltown, European Heritage Assessment*, Tropman and Tropman Architects/Navin Officer, June 2014) identified the potential for remains of the former estate carriageway within the approximate location of the proposed Material Compound and Storage Location (Figure 5). This section of the former carriageway is now covered in bitumen and gravel. It was recommended that the historic alignment of the carriageway should be retained in some form. Photographs of the carriageway from the c1880s show

There is some potential for archaeological remains associated with the former Mount Gilead carriageway within the proposed Material Compound and Storage Location. As such, any subsurface excavations in this area should be subject to an archaeological monitoring program. The proposed historical archaeological monitoring qualifies for a self-assessed Excavation permit Exception s139(4) under clause 2(e),
